Assessement of Riparian and Aquatic Habitat with the Coal Creek Watershed, Gunnison County, Colorado.

Prepared for

Coal Creek Watershed Coalition (CCWC)
c/o Crested Butte, P.O. Box 39
Crested Butte, Colorado 81224

December, 2009

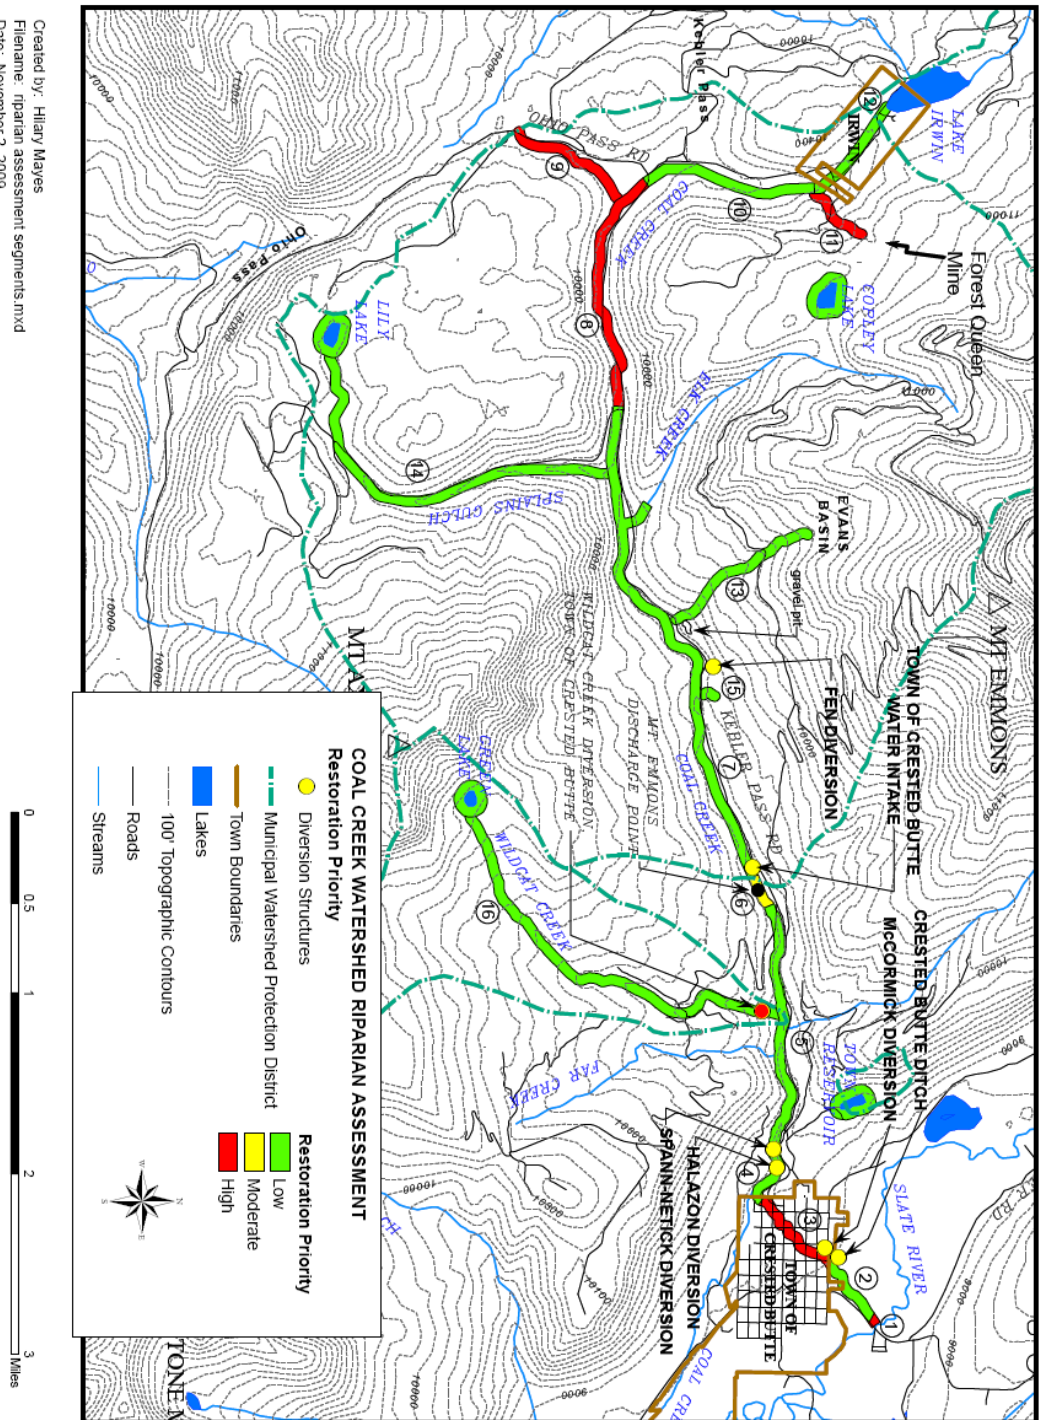
Map 2. Map of the Coal Creek watershed with the assessment segments prioritized for restoration priority.

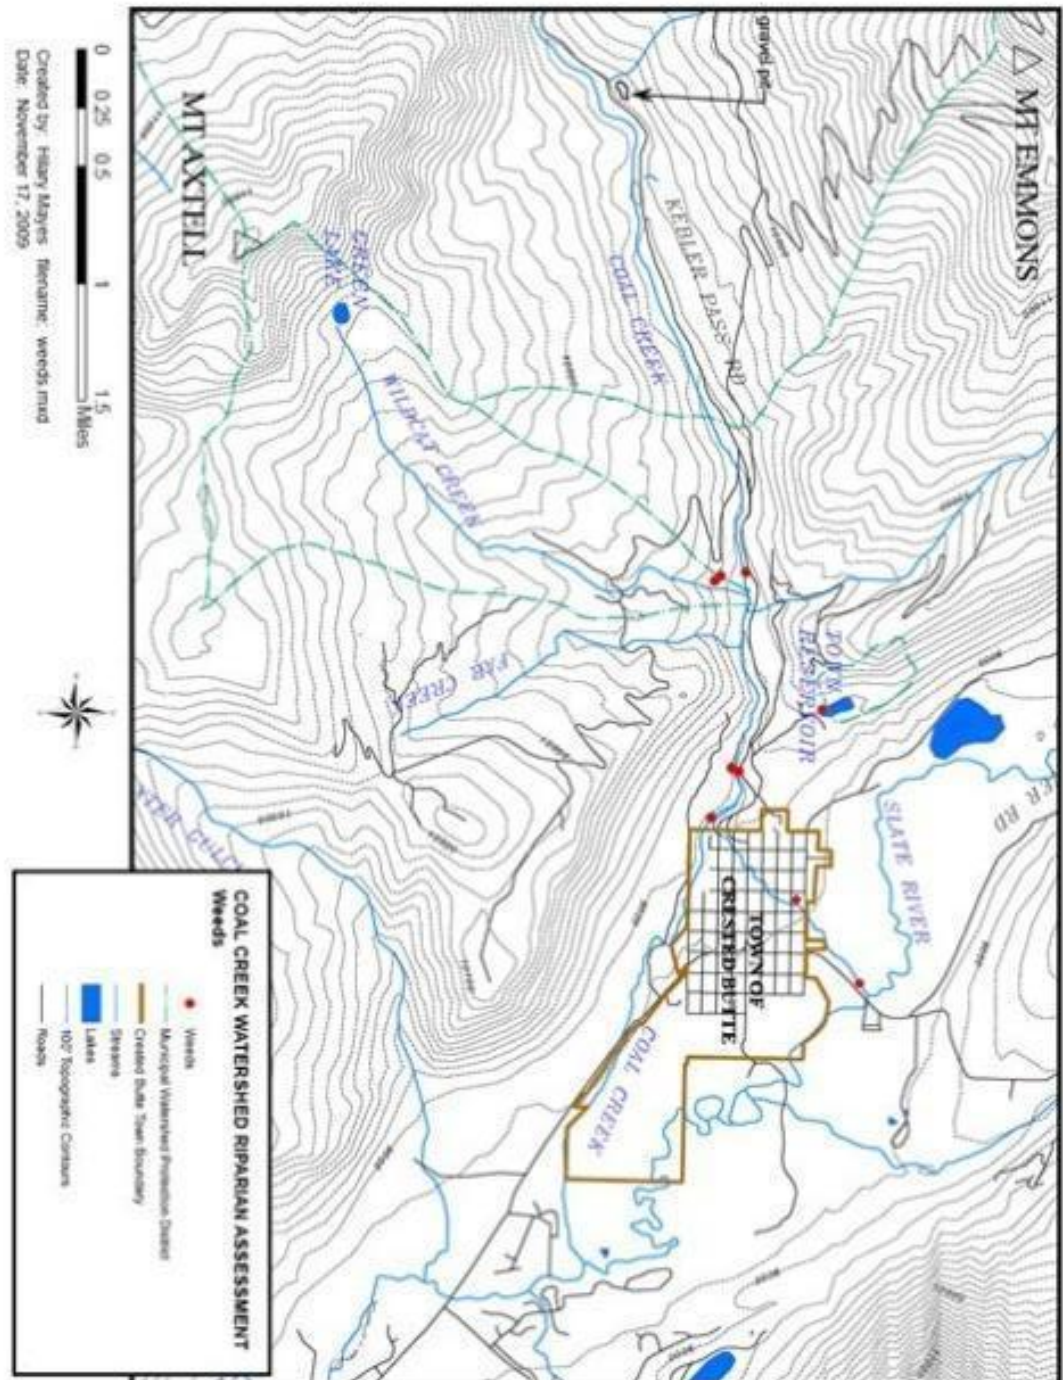
Map 3. Map of the portion of the Coal Creek watershed showing the locations of noxious and invasive weeds that were documented in this riparian assessment.

- The lower portion of the watershed needs noxious weed removal and management in the lower portion of the watershed.

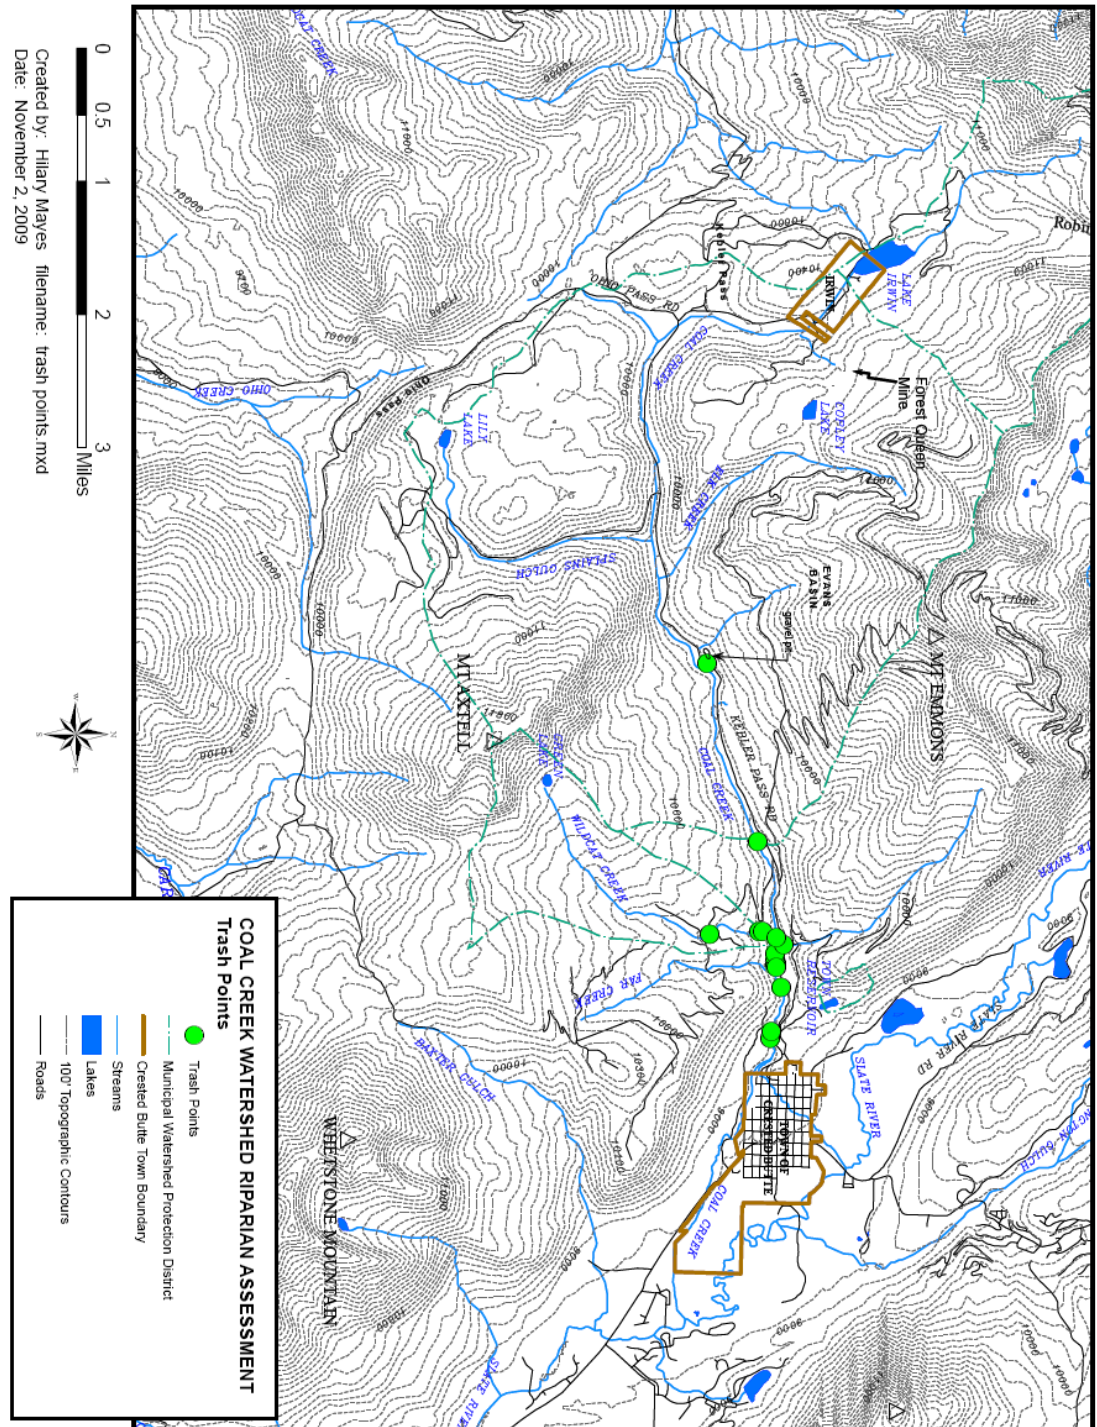
Map 4. Map of the Coal Creek watershed with the location of large concentrations of trash indicated by green circles.

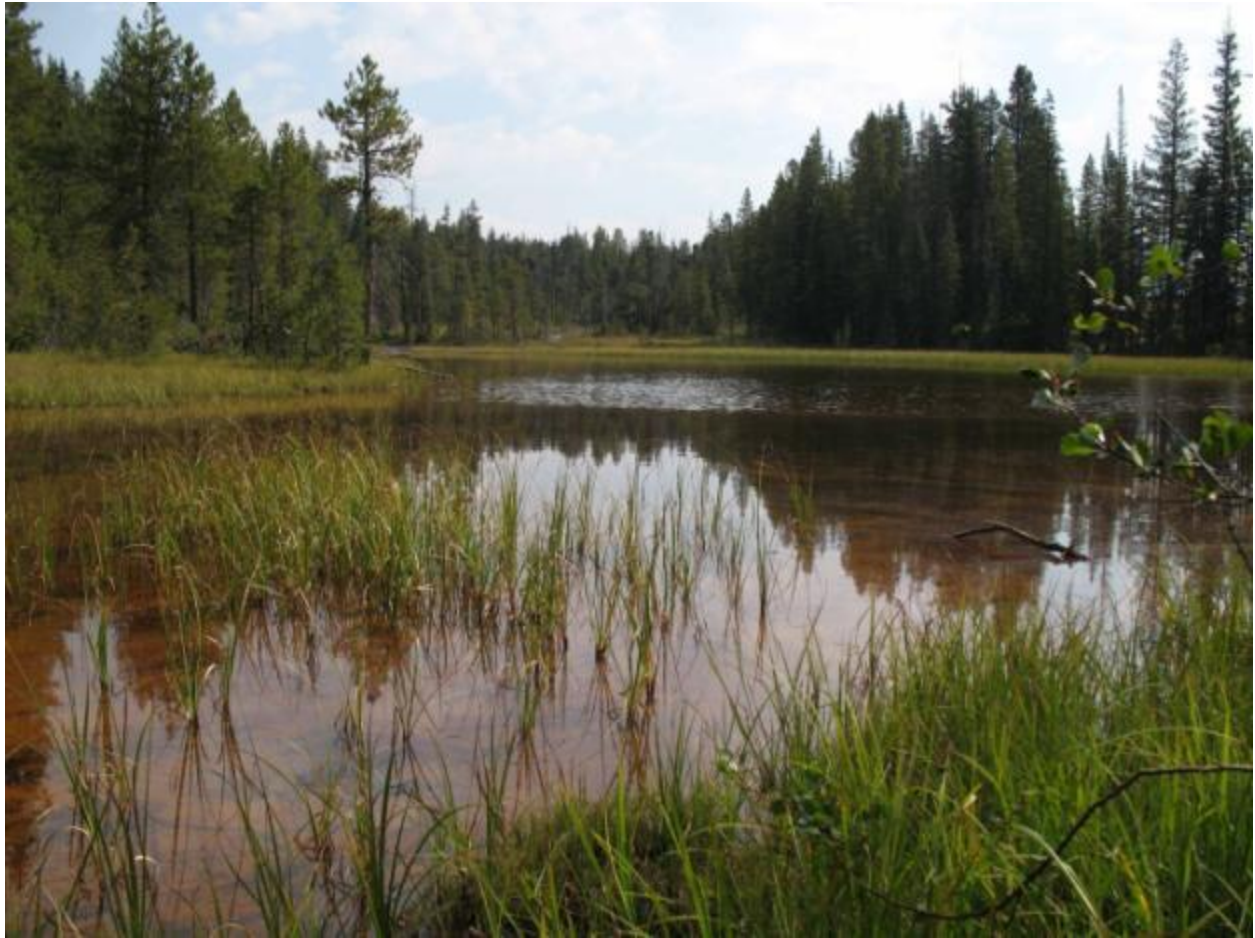
This riparian areas flows out of the Mount Emmons Iron Fen (Photograph 16), across Kebler Pass Road and into Coal Creek. Historically the outflow was channelized (Photograph 17) to divert its flow to the west and down a drainage to prevent it dispersed flow across a slope above Kebler Pass Road. The historical flow pattern caused slumping onto the road and it caused increased road maintenance and safety issues. However, this channelization and relocation of the flow caused a loss of wetlands and riparian communities across a large area and multiple small drainages. Currently, the diversion is clogged by downed trees and the water has recently ceased flowing in lower reaches of the diversion and has returned to areas, including peatlands, of its historical flow. This is naturally restoring the wetlands and riparian zones of its historical drainage but this natural restoration could be assisted by closing the ditch and returning the flow to its natural wetlands and riparian zone.

Photograph 16. Photograph taken Fall 2009 of Mount Emmons Iron fen pond from the pond outflow.

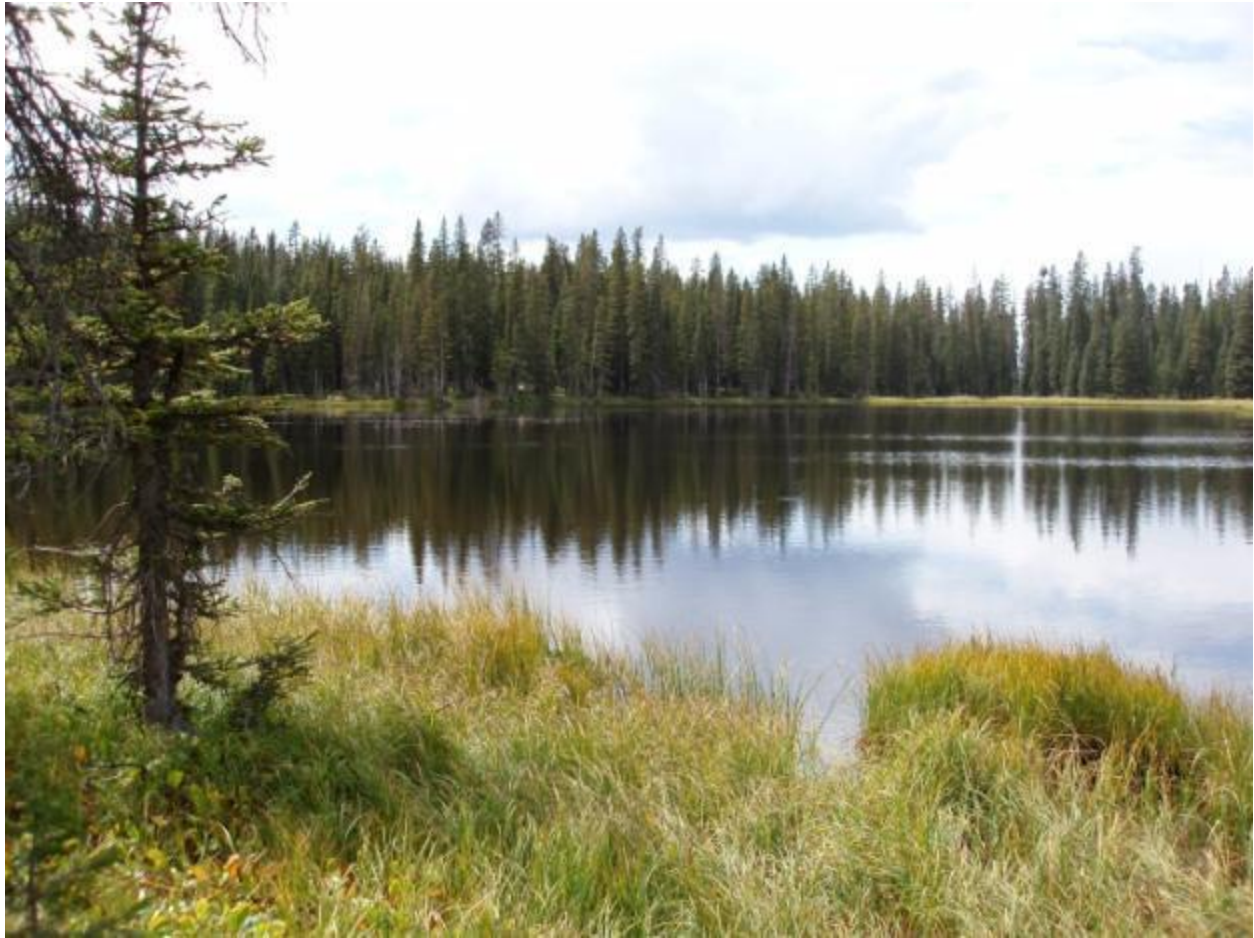
We visited the Mount Emmons Iron Fen (Photograph 16 and 17), Copley Lake (Photograph 18), Green Lake (Photograph 21), Lily Lake (Photograph 19) and the Town of Crested Butte Reservoir. Overall, these all had riparian zones that were in proper functioning condition. There were only some impacts to riparian zones by recreating humans that is causing some erosion, particularly to Green Lake. These impacts are minimal and difficult to regulate so no restoration is recommended at this time but the areas should continue to be monitored for deterioration. The Town of Crested Butte Reservoir had a riparian zone in Proper Functioning Condition except numerous noxious weeds were at the southeast end of the Reservoir. It is recommended that these be controlled by methods that would not include the use of herbicides since this is Crested Butte resident's drinking water.

Photograph 18. Photograph taken Fall 2009 of Copley Lake.

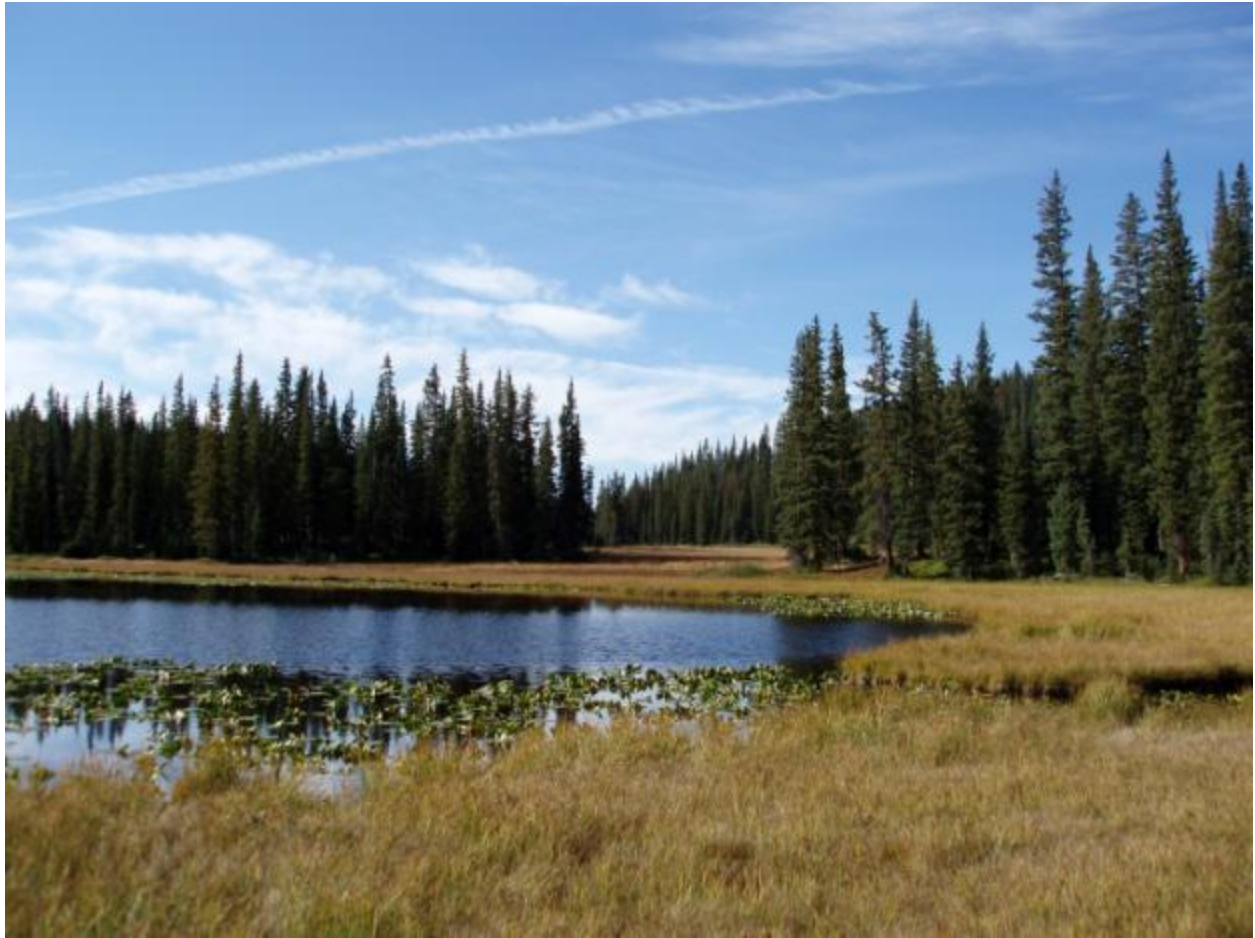
Photograph 19. Photograph taken Fall 2009 of Lily Lake.
