# *Ridgway Ditch & Otonowanda Reservoir*

## **Feasibility Study**

*Town of Ridgway  
Ouray County, Colorado*

***January, 2011***

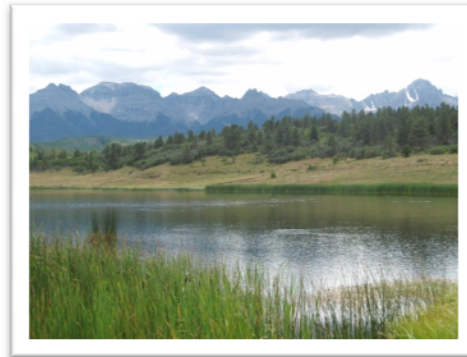
PHOTO 1 LAKE OTONOWANDA

If water is diverted into Lake Otonowanda, there is currently no method of making releases since the lake sits in the bottom of a natural depression. Discussions with Town staff and the Ortmans indicate that at one time the reservoir inundated the entire bottom of the natural depression and included an outlet tunnel on the northwest side. Then in 1936, the Town purchased approximately 39 acres of the lake area and constructed a small dam across the middle of the basin in order to

contain the water on the Town property. At some point, the outlet tunnel collapsed leaving the lake with no outlet.

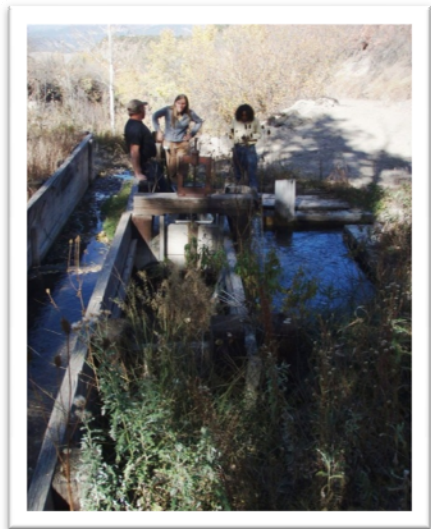
PHOTO 2 HAPPY HOLLOW DIVERSION

The Happy Hollow system consists of a wooden/concrete diversion structure on Cottonwood Creek. Flows are measured using a Parshall flume with a staff gage. After passing through the flume, water enters a pipeline which transports the water to the Town Reservoir. This diversion frequently diverts all water in Cottonwood Creek.

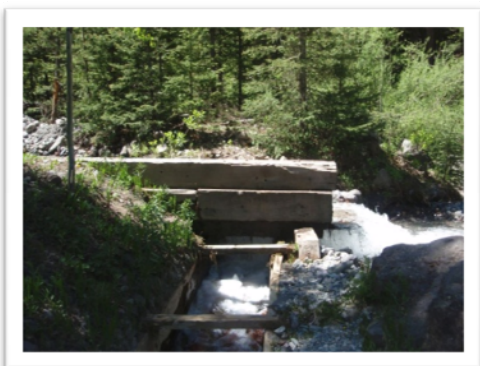
PHOTO 10 RIDGWAY DITCH HEADGATE

It is our understanding that the Town is interested in improving or replacing this structure in order to decrease the amount of maintenance it requires. Granular material passing through the intake grate accumulates in the rectangular channel as well as the main canal. This requires frequent cleaning during the peak runoff season. In 2010, very high runoff resulted in increased flows in the ditch which caused significant erosion of the ditch banks. Lastly, the existing stop log setup in the structure offers only a limited ability to precisely control the amount of water entering the ditch.
