SUBJECT: **Agenda Item 11, January 23-24, 2012 Board Meeting**
South Platte River Boat Chute Modification

WHITEWATER ON THE SOUTH PLATTE RIVER **SAFETY AND PERCEIVED SAFETY FOR THE NON-BOATING PUBLIC**

Ben Nielsen, EIT, LEED AP¹ – McLaughlin Whitewater Design Group
Joe Busto² – Colorado Water Conservation Board

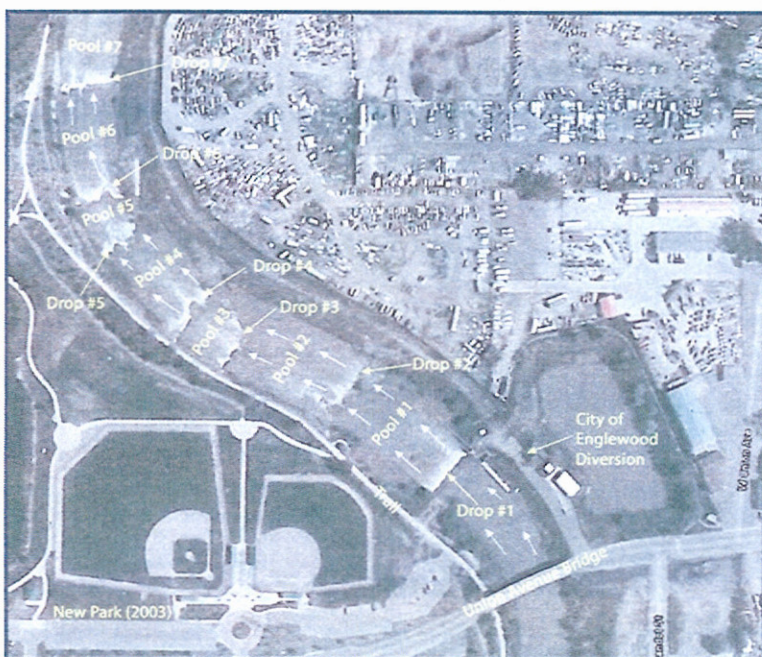
In 1992 the original dam diversion was modified and replaced by seven boatable drop structures and pools stretching a ¼ mile downstream. The six drop structures downstream of the dam have approximately two to three feet of vertical drop. The modified original dam structure has slightly more hydraulic drop at higher flows. Two modifications were made in 1998 and 2005. These entailed adding sloped riprap and a concrete chute to the most downstream drop.

Figure 2: Union Avenue Boat Chutes Present Day
