# Stillwater No. 1 Reservoir Dam Phase I – Feasibility Study

Yampa, Colorado

Tetra Tech

September 29, 2011

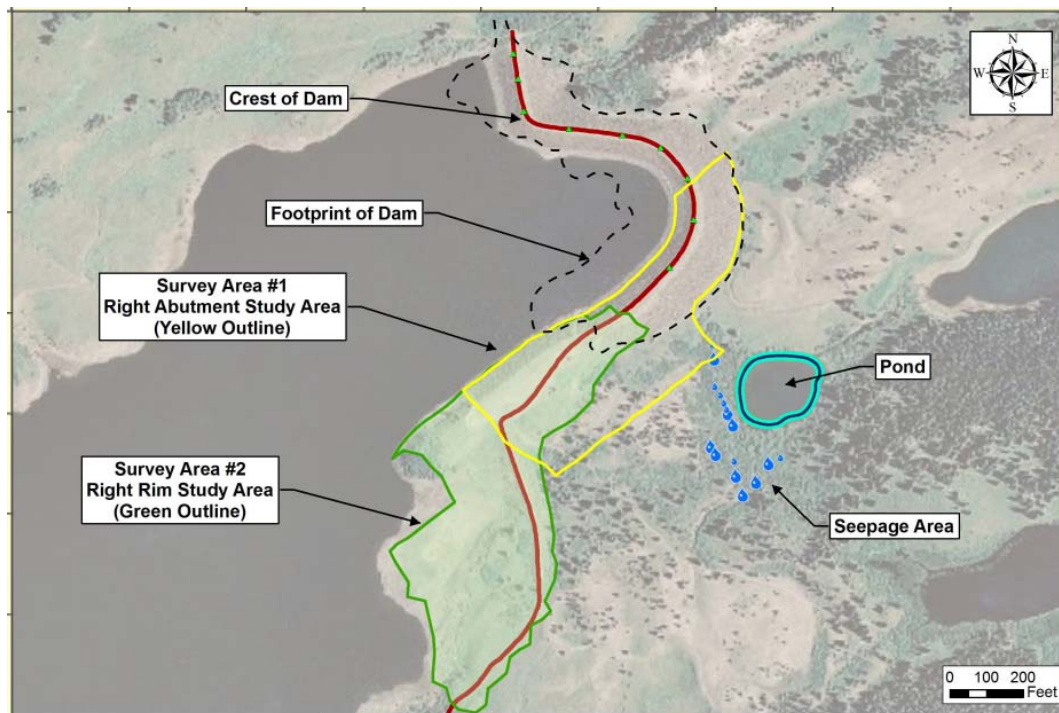
**Figure 3.3 Survey study areas**

Seepage in two areas was evaluated using the Willowstick method: Survey Area #1 (right abutment) and Survey Area #2 (Right Rim). Figure 3.3 shows the extent of these two study areas.
