Fairmont Drainage District System Inventory

August 17, 2006, rev. 3/14/07 & 4/26/07

The Lower Arkansas Valley Drainage System Rehabilitation Study
Colorado State Univ., Dr. John Wilkins-Wells, Sociology Water Lab
Clark Building B258, Fort Collins, CO 80523 Ph: 970-491-5635

Drainage District Infrastructure notes on the Fairmont Drainage District located in Otero County, Colorado. This district includes all or parts of Section 35 of T23S, R56 W, and Sections 1, 2, 10, 11, and 12 of T24S, R56W in Otero County, Colorado.

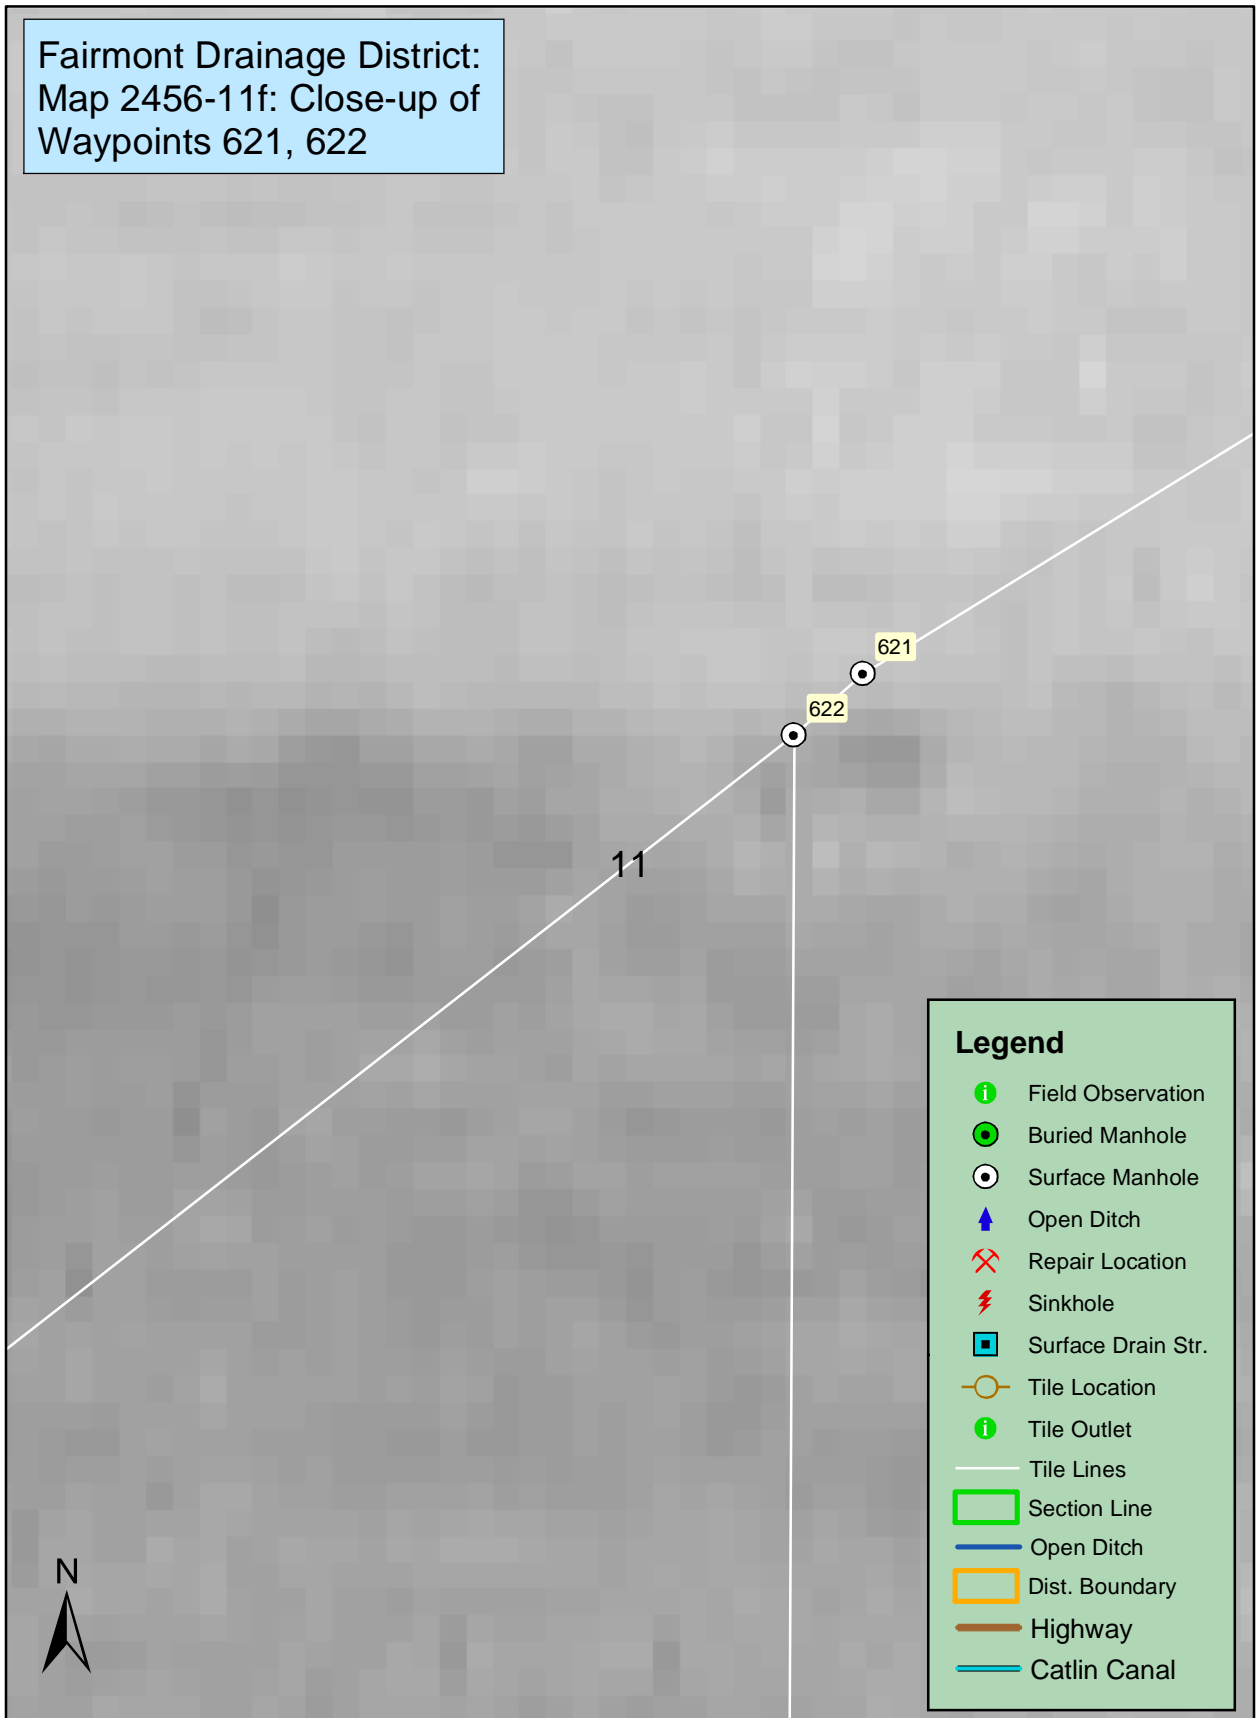
Fairmont Drainage District:
Map 2456-11f: Close-up of
Waypoints 621, 622

Location of brick manhole with wood cover. Through a hole in the cover, wate is observed, and measured approximately 30 inches from the surface of the manhole, which is 2-4" above the surrounding ground level.

Location of brick manhole with wooden cover southwest of Waypoint 622. Through a hole in the cover, water is observed approximately 31" from the surface. It is moving in the manhole, and is clear.
