Colorado Water Conservation Board
Emergency Funding for Damaged River Diversions/Dams
from the September 2013 Flood Event

Emergency Loan Application and Feasibility Study

As-Constructed Report Louden Irrigation Canal 2013 Flood Repair

January 2014

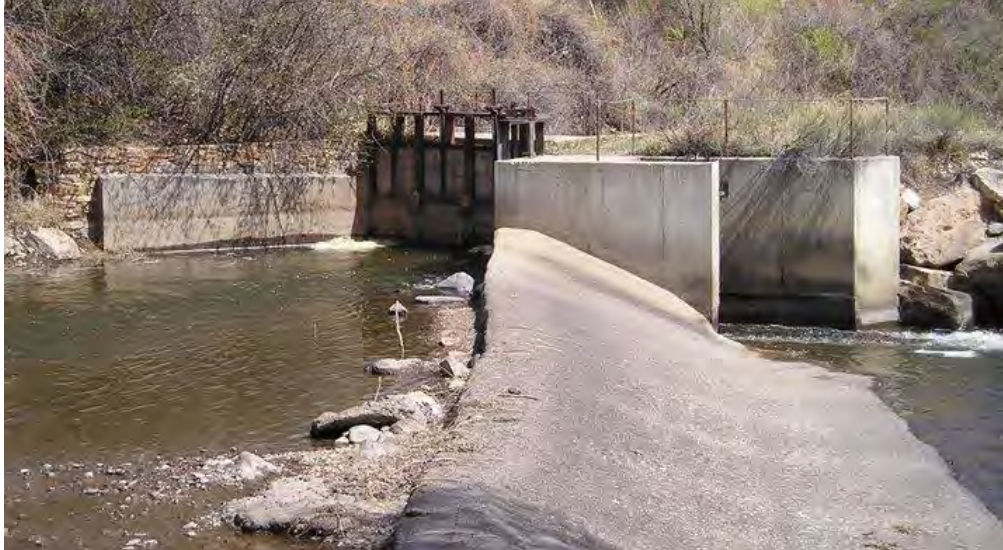
Photo 2 Headgate Start of the Flood September 12, 2013

- Approximately 140 feet of ditch downstream of the bridge requires repair, excavation, and embankment replacement.
- The downstream side of the ditch (as the water exists the headgate) is washed out for approximately 10-feet. This area previously was constructed with large rock and local soils (Photo 2).

- Rock, gravel, loam soil fills downstream of the headgate are washed out, requires approximately 200-300 cy of fill to restore previous ramp to the top of the diversion structure (Photo 2).

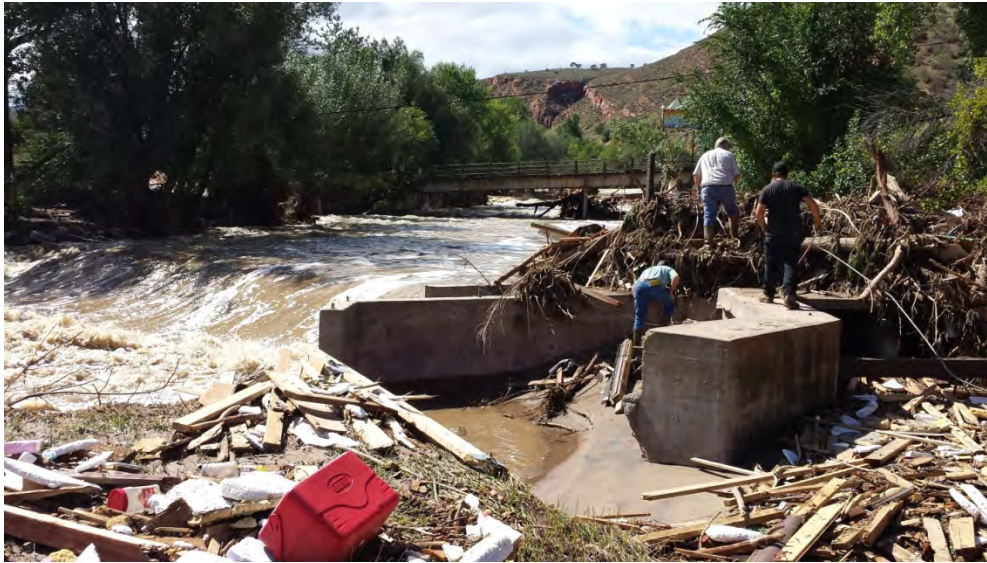
Photo 4 September 16, 2013 Outer Ditch Embankment Slide

stabilization at the toe (Photo 4). The fill was calculated using rough field measurements -the road eroded away along a 55 foot span on a slope about 24 feet high, which would be filled back to existing slope which is about 1.7:1 -> 760 cy of fill.

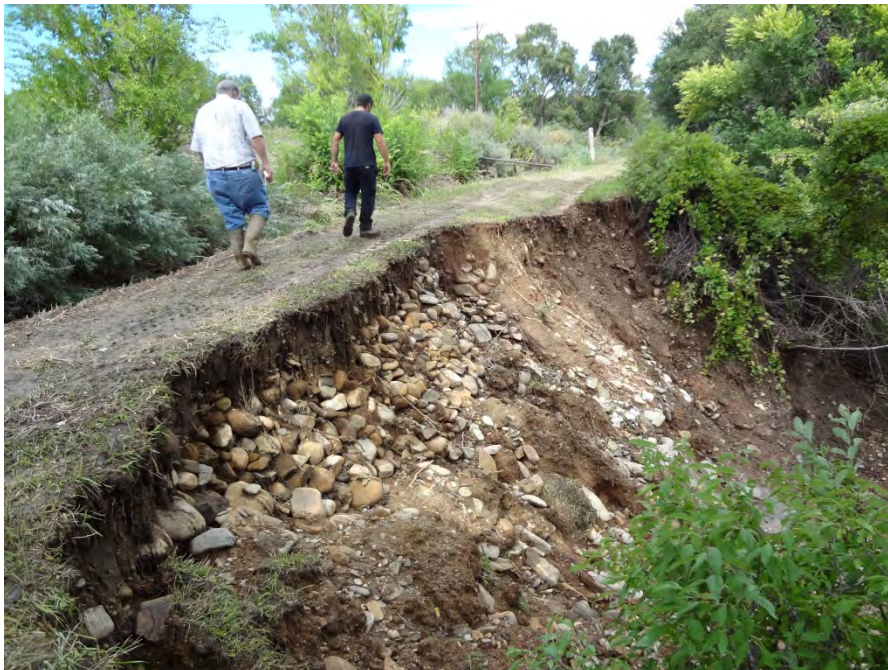
Photo 5 September 16, 2013 Typical Sediment Build Up

- Approximately 3,500-feet of ditch has 2-6 feet of sediment build up, totaling around 11,280 cy, requiring removal (Photo 5; $\sim 6.5'$ wide across top of sediment- $3,500 \text{ feet} \times \text{approximately } 87 \text{ square foot cross section} / 27 = \sim 11,280 \text{ cy}$).

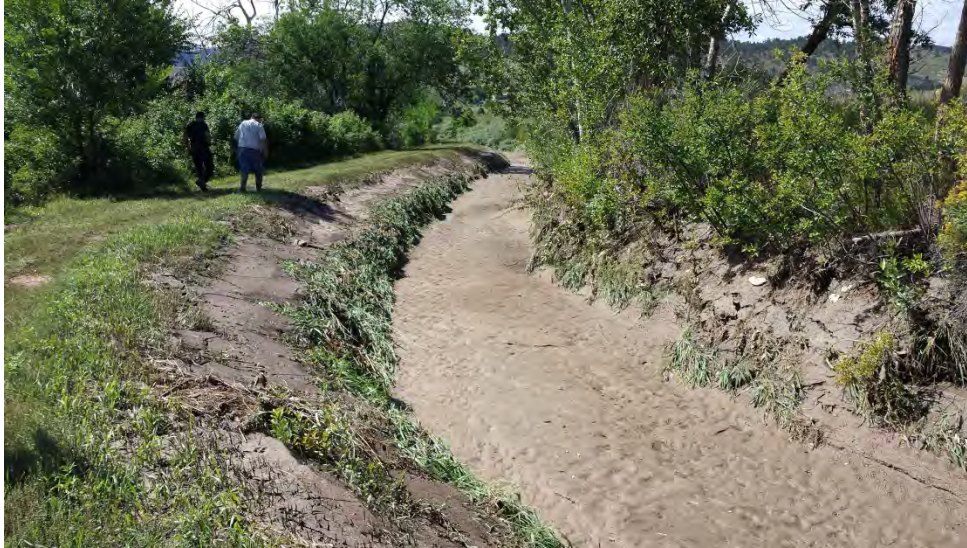
Photo 6 September 16, 2013 Previous Roundabout

- Dirt road 3,000-square-foot roundabout was washed out
- Steel safety rails embedded in the concrete along the top of the headgate were washed away or significantly bent
- One gate mechanism was cracked from the force of the flood (Appendix C Photo 3)

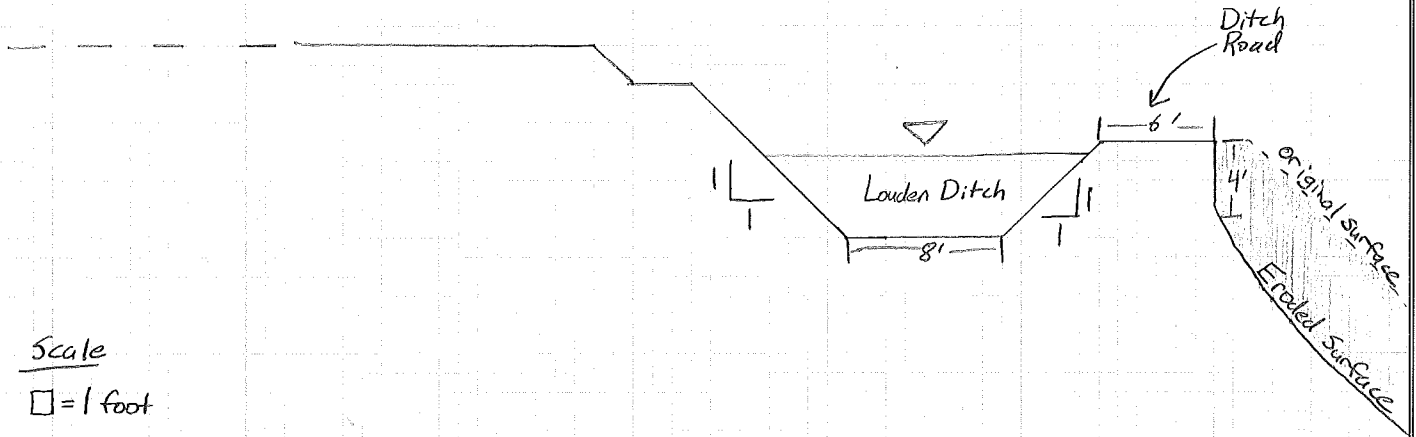
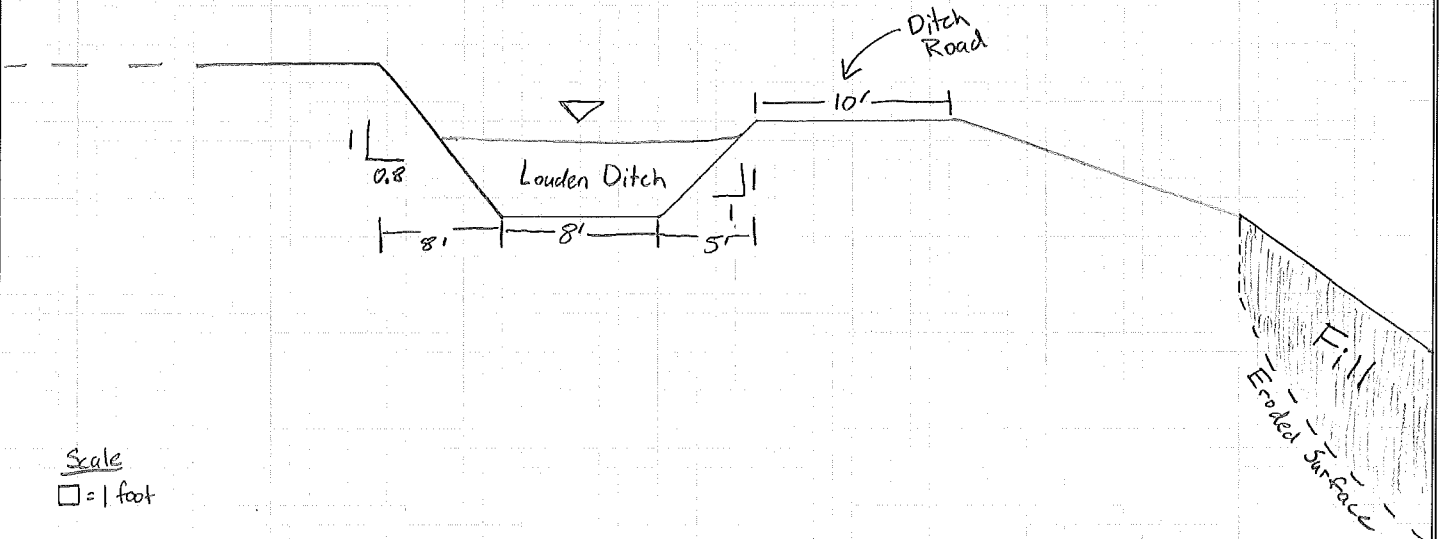
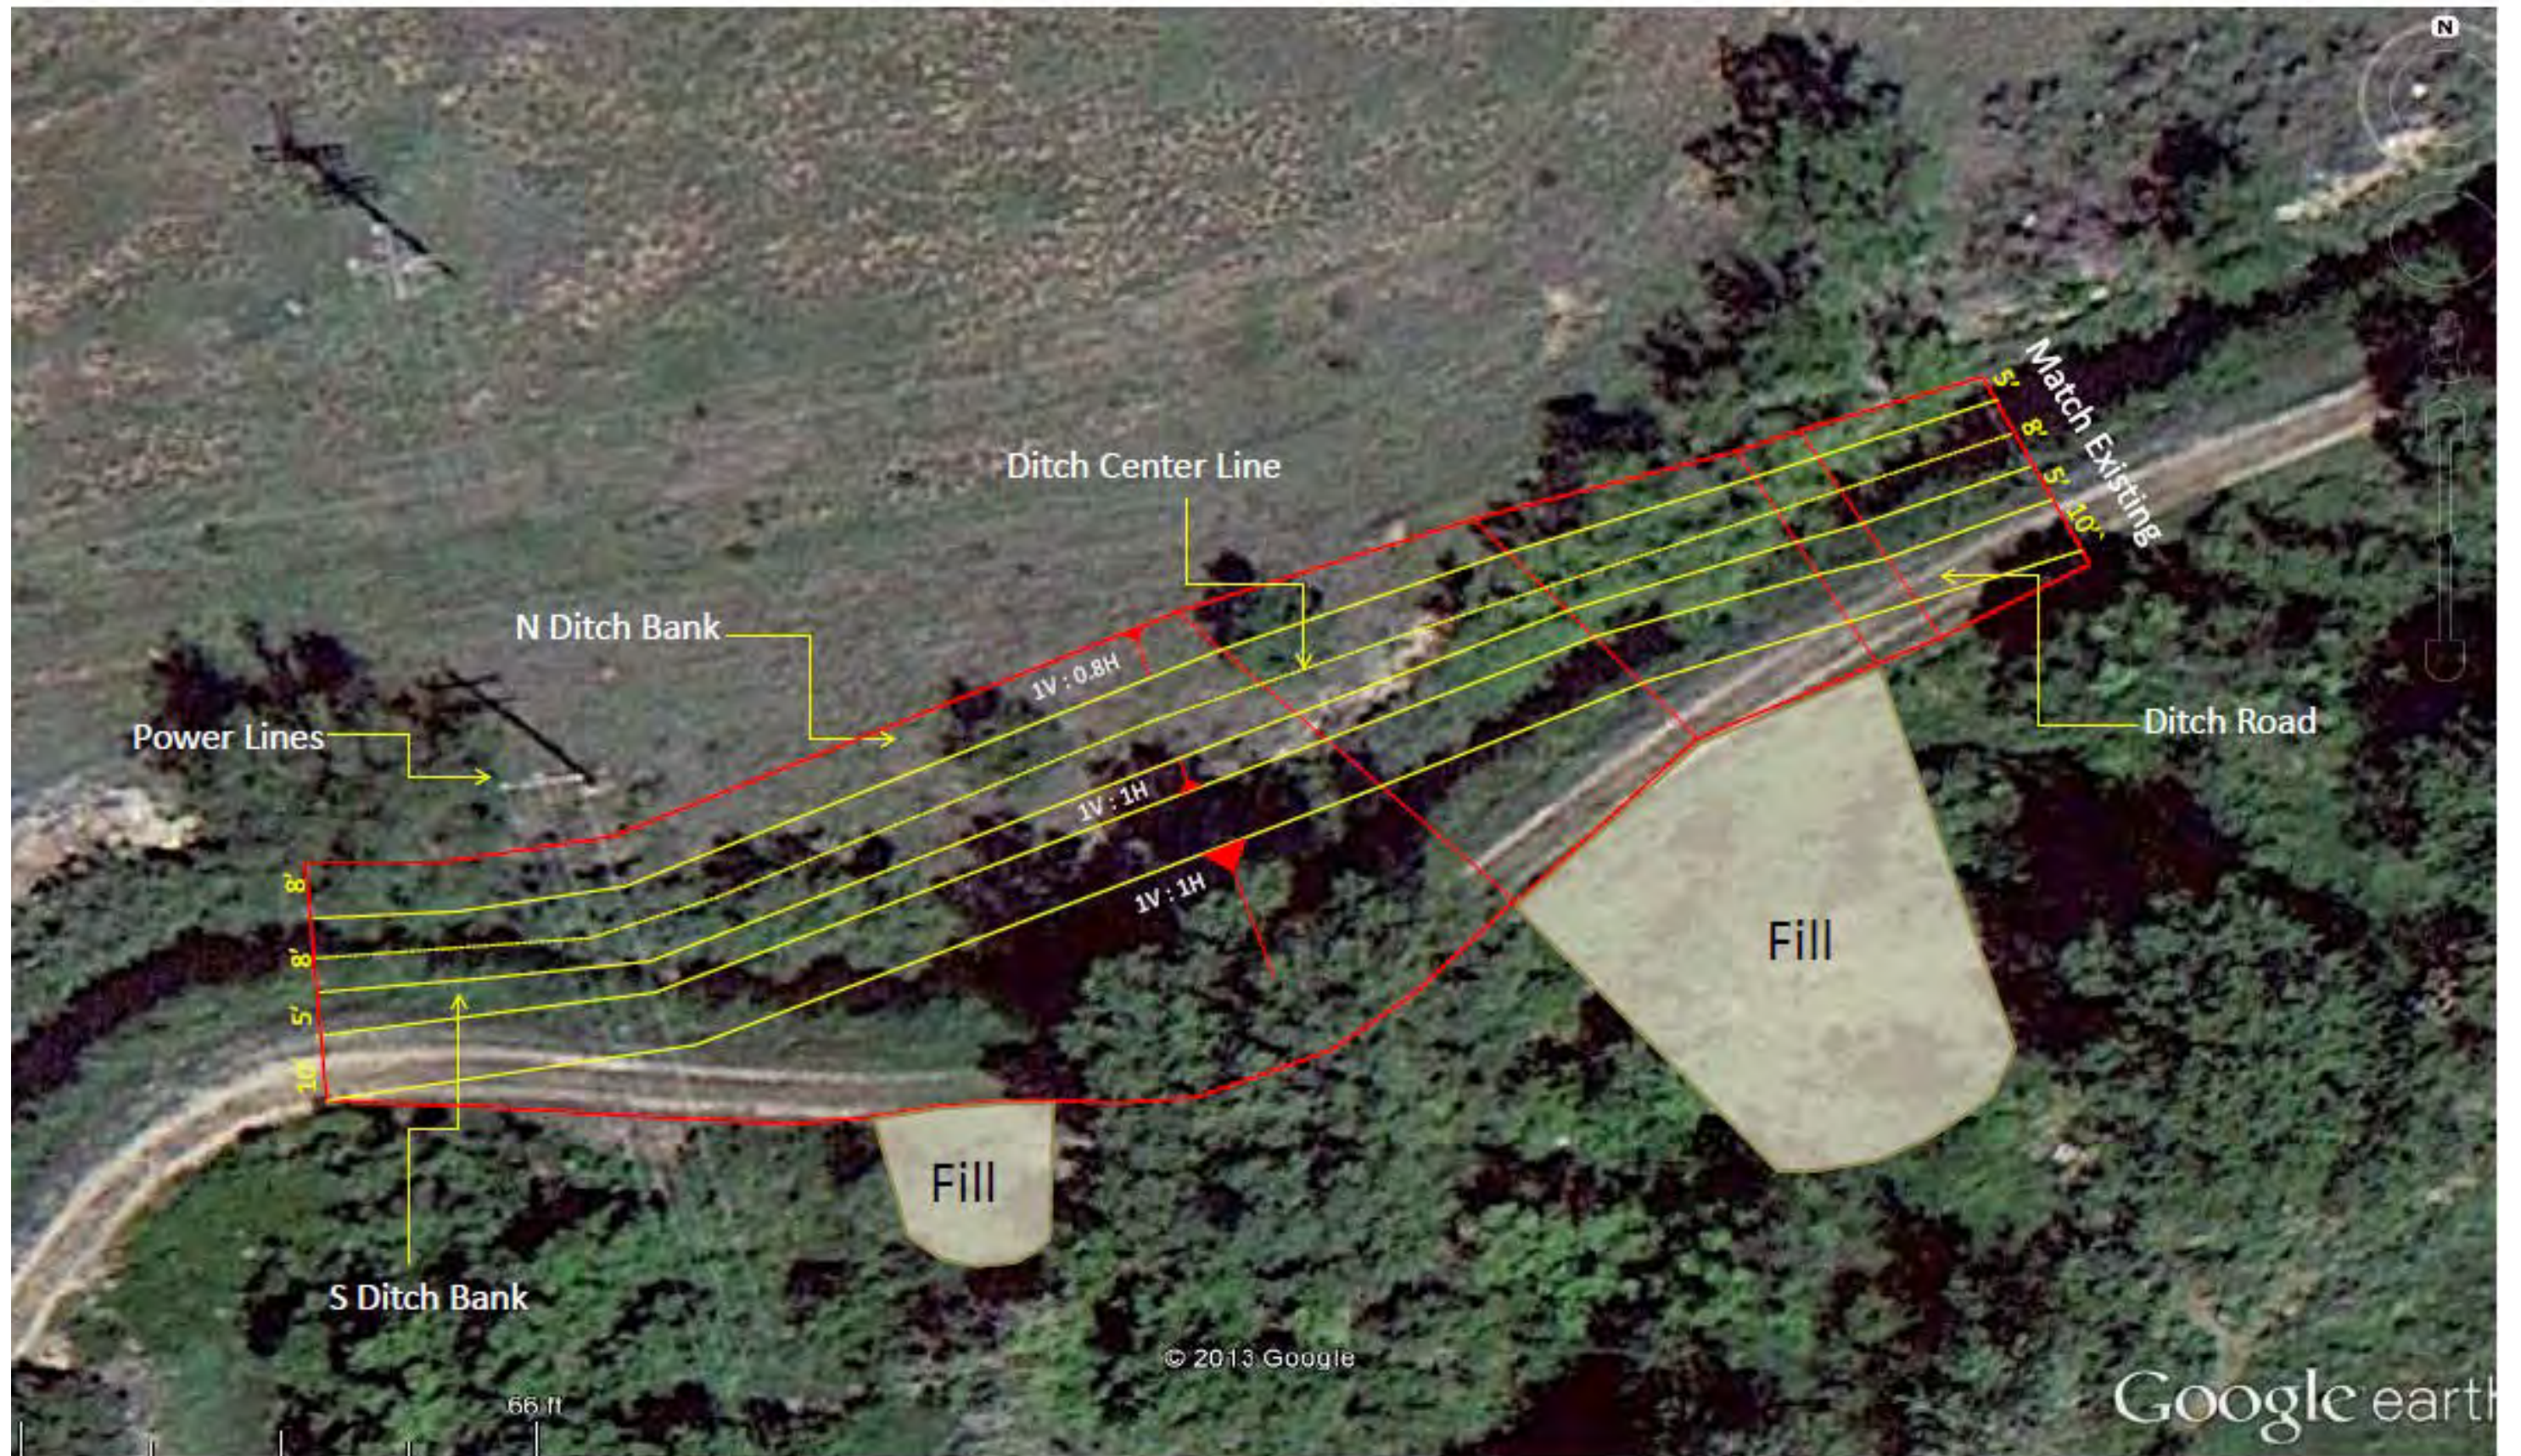
Figure 2
Louden Ditch Realignment

Two other major washouts occurred, approximately 3,500 ft down ditch from the headgate. The original design was to buttress and fill in these sections; the larger of the two washouts would have required about 500 cy of fill and the smaller about 35 cy of fill. Two major issues were encountered during the planning of the repair: 1) limited access and space for required equipment and 2) the large quantity of material required. Considering the condition of the road and the location of the washouts, the original repair plan (as shown in Appendix A Sketch 3) was not feasible in terms of time and cost. Telesto, the contractor, and Loudon discussed other options to repair the ditch access road and the washouts. Utilizing a field engineering and design approach, a plan was developed to realign the Ditch to the north of the washed-out region (Appendix C Sketch 1 and Figure 2). The completed realignment of the Ditch allowed for a straighter flow path and improved maneuverability. Furthermore, the realignment of the Ditch provided the appropriate material necessary to repair the washout areas. The completed repairs and realignment are shown in Appendix D Photo Sets 12 through 14.

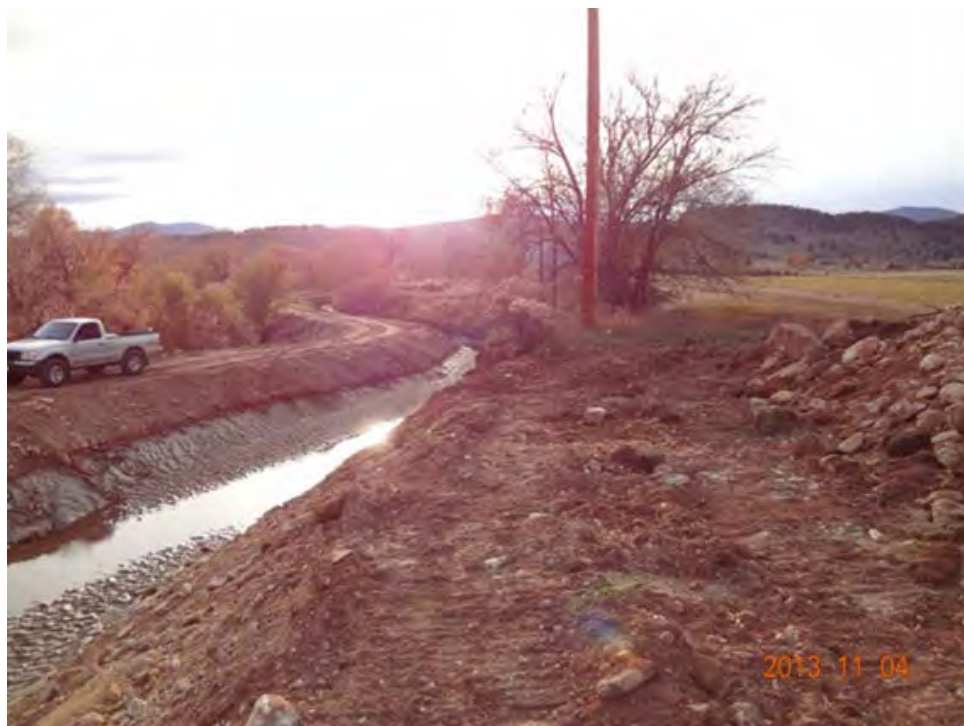
LOOKING WEST

FINISHED DITCH REALIGNMENT
