# **Riparian and Aquatic Habitat Assessment of Lower Tomichi Creek, Gunnison County, Colorado.**

Bio-Environs,  
114 N Boulevard, Suite 206  
Gunnison, Co. 81230  
970.641.8749

**December, 2012**

## Lower Tomichi Creek Riparian Assessment, 2011

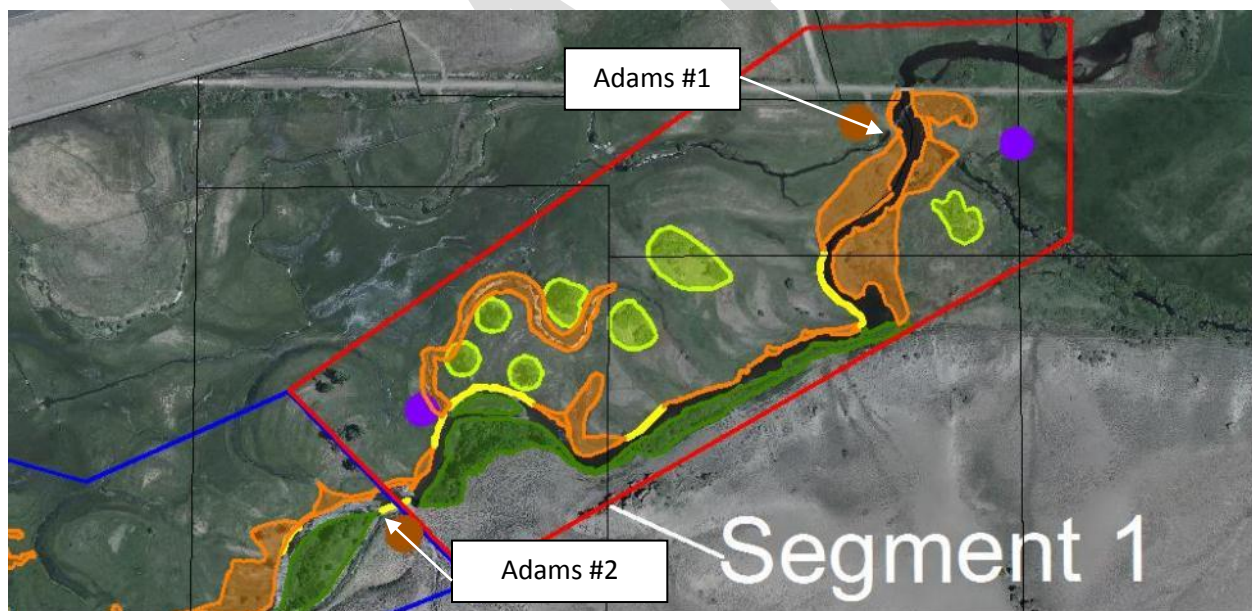
**Overview 1.** Aerial overview of Segment 1 (2010 NAPP imagery, Gunnison County).

60 percent of riparian areas are ranked as being in Proper Functioning Condition (PFC) although several riparian areas are isolated and disconnected from the marginal riparian area that exists along the stream course. The segment also includes approximately 840 linear feet of eroded streambank that is considered Nonfunctional (NF) due to a lack of little to no functional riparian vegetation (Table 1).

Segment 1 encompasses approximately 2650 linear feet of lower Tomichi Creek as it extends along the toe of Tenderfoot Mountain from a bridge that crosses the stream at the northern boundary of the study area to end just upstream of the Adams #2 irrigation diversion. This segment includes the Adams #1 irrigation diversion to the north and two irrigation drainage features that enter the stream from the south across from the Adams #1 diversion and the north near the southern boundary of segment. The northern streambank is adjacent to pasture land while the southern bank is bounded by a steep rocky hillslope that descends to the edge of the stream (Photograph 1). The steep bank located to the south of the channel naturally confines riparian vegetation with little extension of riparian areas beyond the edges of the southern streambank in this segment.

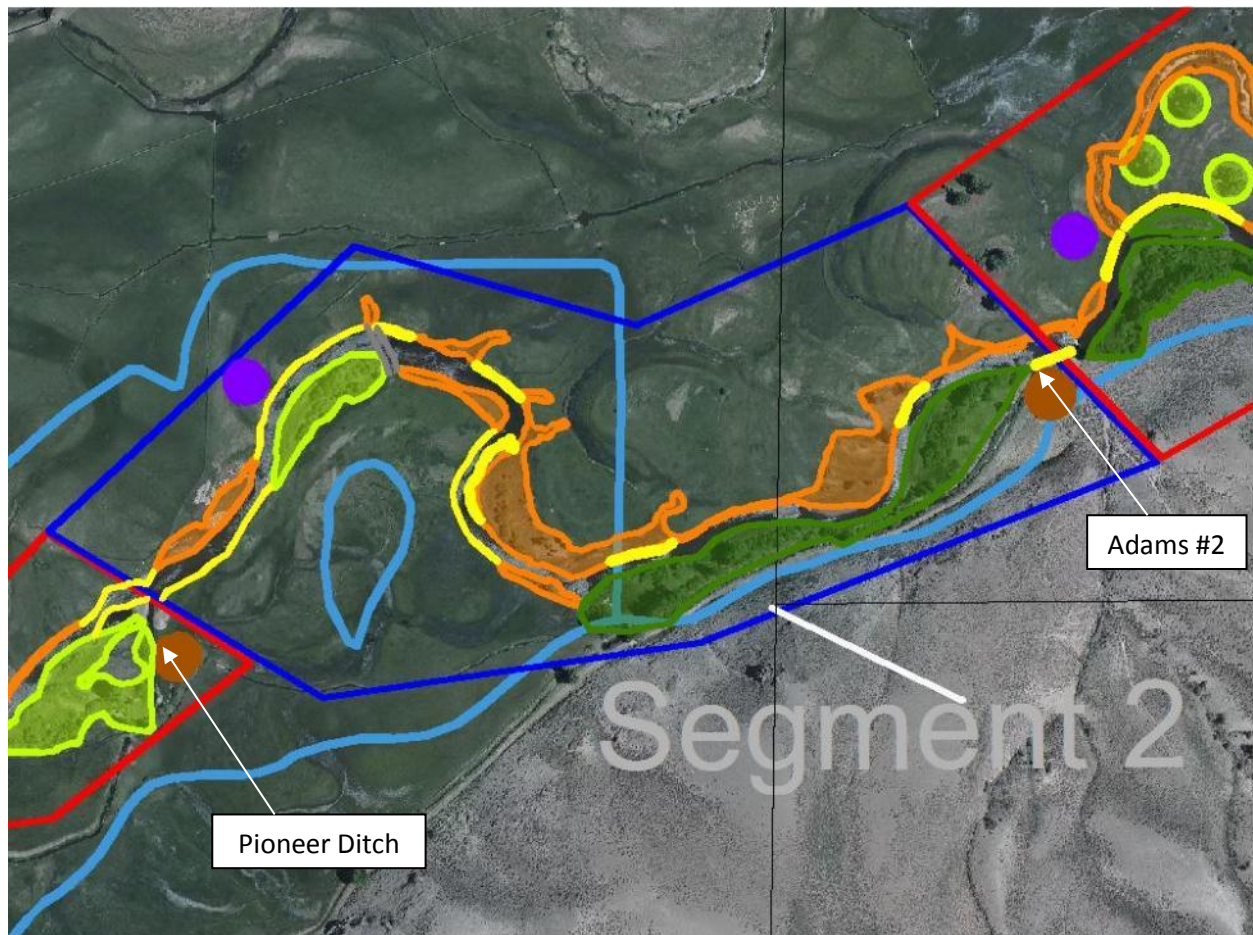
**Overview 2.** Aerial overview of Segment 2 (2010 NAPP imagery of Gunnison County).

Similar to Segment 1, the north bank in Segment 2 is comprised of riparian area that is largely Functioning at Risk and includes five separate sections, totaling approximately 2000 linear feet, of collapsed and eroded streambank that is in a Nonfunctional condition due to vegetation removal (Photograph 3, Table 1). Like Segment 1, the north bank is subject to active grazing and continuous entrance to the stream channel by livestock. The compromised function along the north bank is the result of narrow, fragmented riparian zones that lack riparian vegetation

with varying age class and species diversity. The lack of diversity appears to be due to the removal and hedging of vegetation by livestock and wildlife. The loss of vegetative diversity and coverage results in heavily eroded and failing streambank conditions (Photograph 7). The south bank in Segment 2 includes the Adams #2 irrigation diversion and a small stretch of streambank that is identified as Nonfunctional due to a lack of vegetation in association with the Adams #2 diversion structure (Photograph 4).

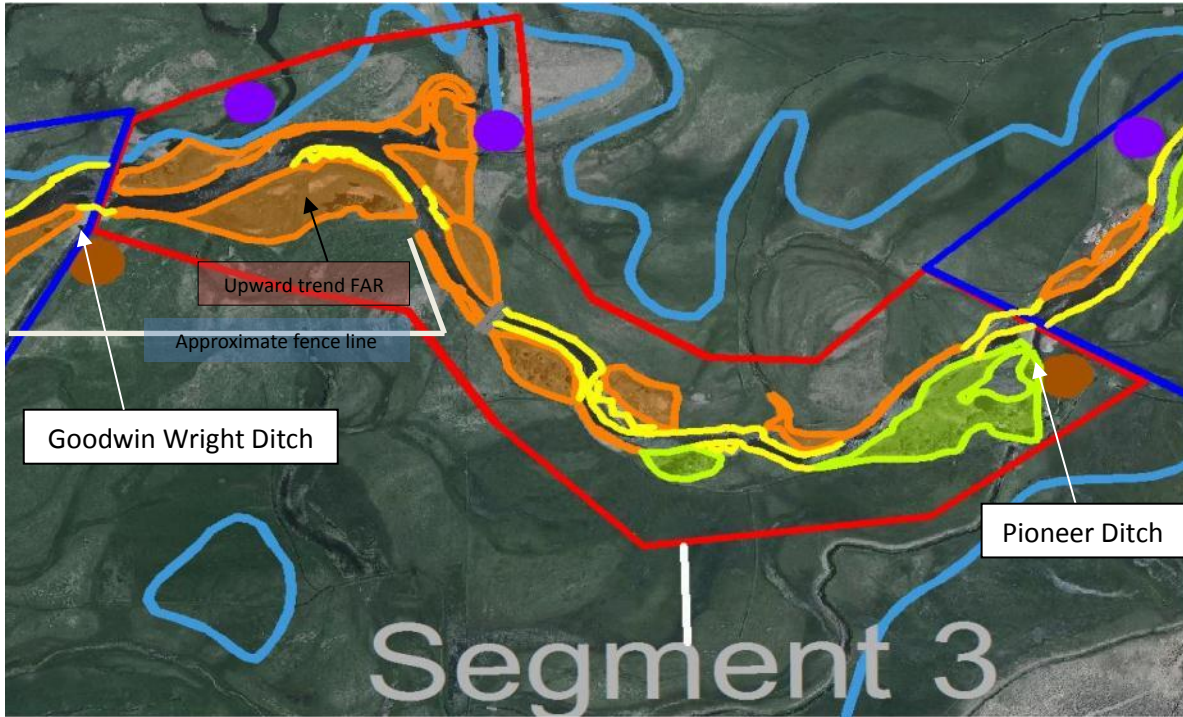
**Overview 3.** Aerial overview of Segment 3 (2010 NAPP imagery of Gunnison County).

structures of similar function necessitate. The north and south bank of the stream at this location are devoid of riparian vegetation in association with the newly constructed diversion leaving the banks in a Nonfunctional condition at the time of this assessment (Overview 3) however, this structure provides greater stability for long term recovery of riparian vegetation. Segment 3 also includes two drainage return features in the western portion. These

features appear to collect and contribute drainage waters that originate north of the stream. Segment 3 includes two small riparian areas that are identified as being fragmented Proper Function in Condition along the south bank in the eastern portion of the segment (Overview 3). These small areas provide an important node of functioning riparian zone that could be expanded upon with enhancement, restoration and modified land management along the creek (Photographs 10 and 11). Excluding these two locations, Segment 3 riparian condition continues to degrade with most riparian zones in a Functional at Risk status with extensive sloughing streambank in a Nonfunctional condition.

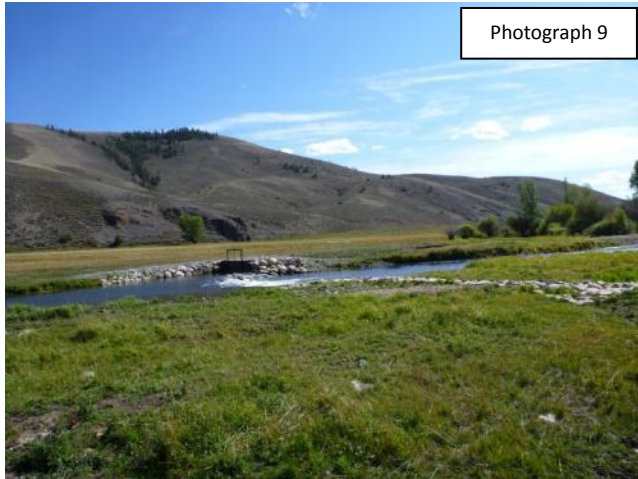
Photograph 9

The upstream boundary to Segment 3 is marked by the recent redesign and construction of the Pioneer irrigation diversion structure which supplies irrigation waters to much of the hay pasture that exists to the south of Tomichi Creek (Photograph 9). This diversion structure has been revamped in an effort to provide a more permanent diversion that does not require the maintenance that older, non-permanent

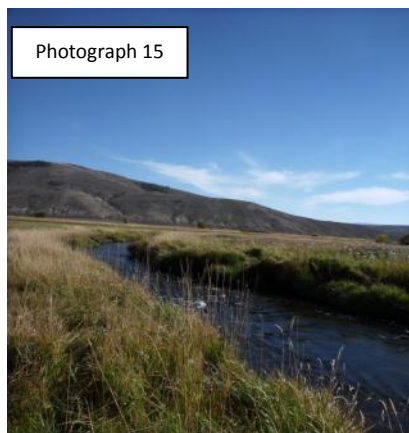
A recently created side channel exists just below the island in Segment 4 (Photograph 15). This naturally created channel is likely the result of heavy flows eroding the unprotected bank. As the bank began to fail, the stream vertically cut through the adjacent land to form a newly incised braid or stream channel that runs to the east of the current main channel to join the main channel to the south.

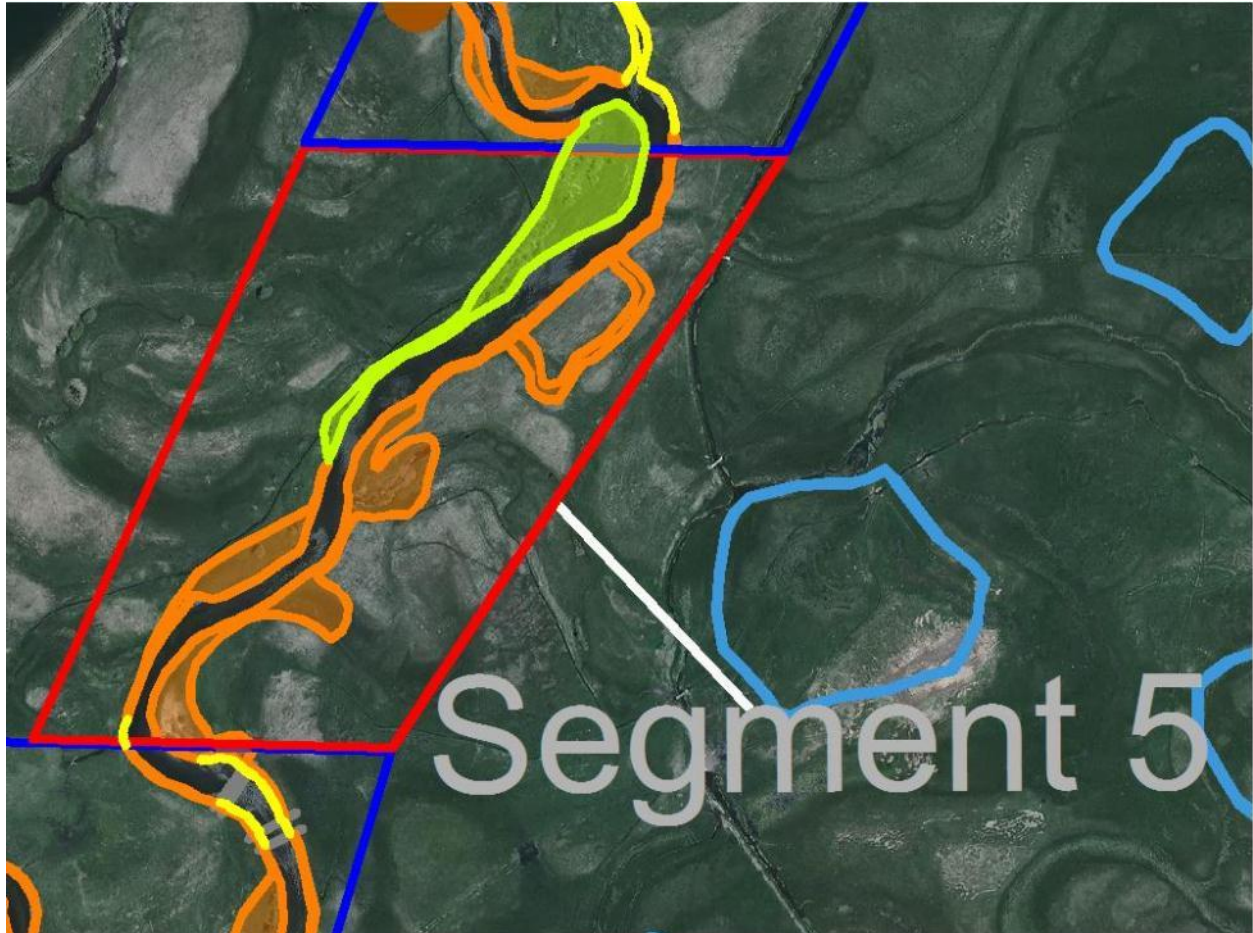
**Overview 5.** Aerial overview of Segment 5 (2010 NAPP imagery of Gunnison County).

Segment 5 includes a larger riparian node classified as fragmented PFC along the western bank. Excluding a short reach of NF streambank at the downstream boundary, the rest of the riparian zones are classified as FAR, however, these areas appear to be stable or experiencing a slight upward trend. Segment 5 represents a slight return to more balanced stream conditions than those experienced in Segments 3 and 4.

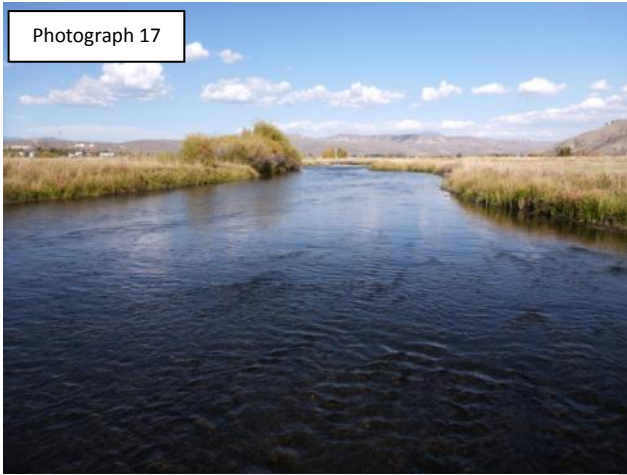
Photograph 17

Although much of the riparian zone along both banks lacks the presence of diverse vegetation of varying age class, it is relatively intact and un-fragmented thus providing better riparian function to the stream ecosystem. The stream in Segment 5 continues to show signs of historic widening. A decrease in stream depth and increase in distance between riffles (riffle to run ratio) indicates this continued trend in channel morphology and potential stream

degradation (Photograph 17). Like the segments upstream, these conditions will contribute to less stable water temperatures and less stable chemical and physical stream characteristics.

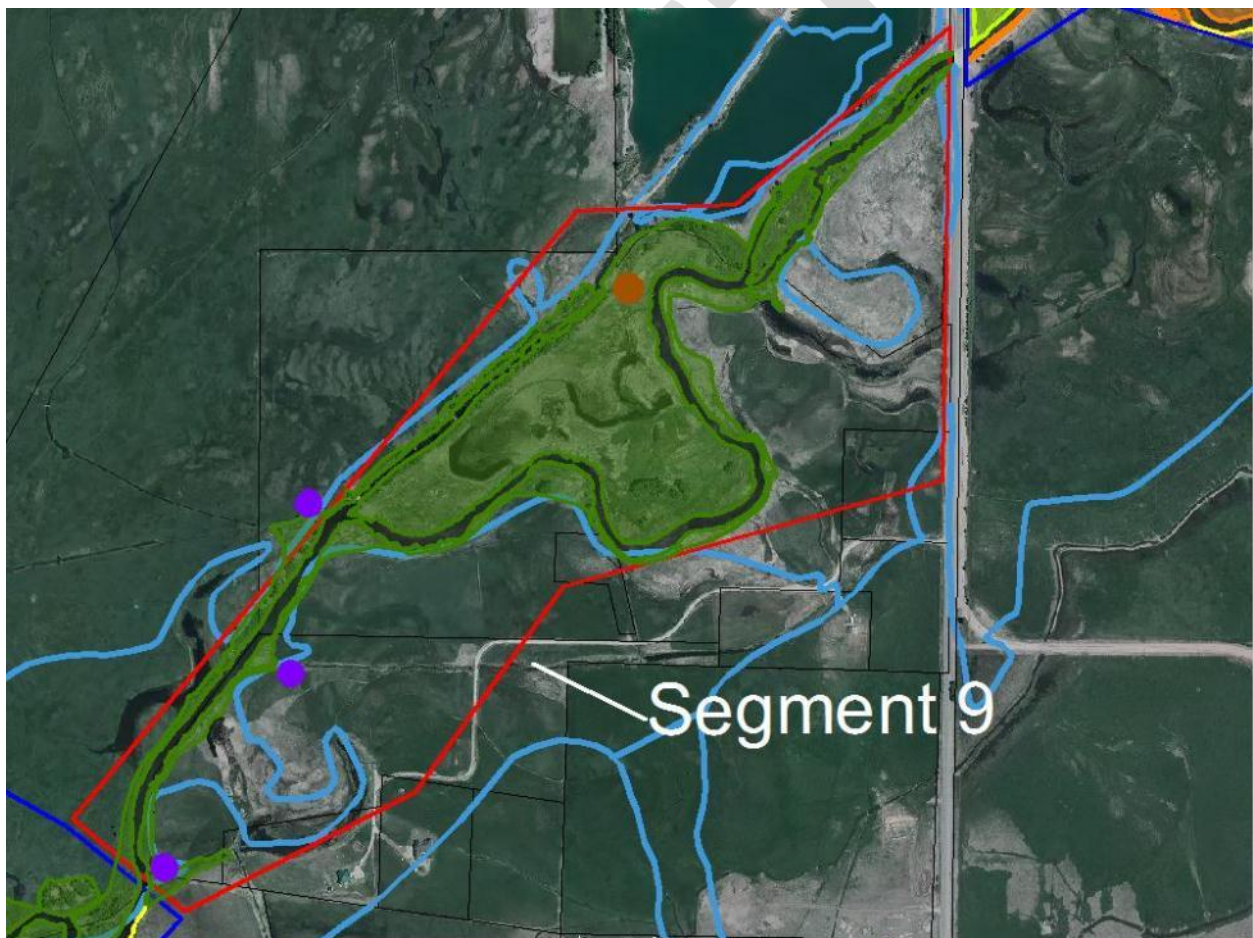
**Overview 7.** Aerial overview of Segment 9 (2010 NAPP imagery of Gunnison County).

*Assessment Segment 9 (6193 Lf, 1.17 mi.):* Segment 9 extends from the Gold Basin Road bridge southwest to a property boundary and a bend in the river channel that transitions the stream to a more westerly course as it nears the confluence with the Gunnison River. Segment 9 is comprised of large, intact riparian areas that are determined as being in Proper Functioning Condition. The segment includes one irrigation diversion and 3 irrigation return features. The area includes several abandoned stream oxbows within the mapped floodplain that support wetland conditions that comprise lateral wetlands that are associated with the stream corridor (Overview 7).

This segment shows a marked increase from the lower habitat assessment scores of upstream segments with an assessment score of 183/200. The rise in habitat quality is related to improvements in all assessment criteria (Appendix C, Table 3). Notably, dramatic improvement and enlargement of vegetative cover along both banks has increased scores from poor to an

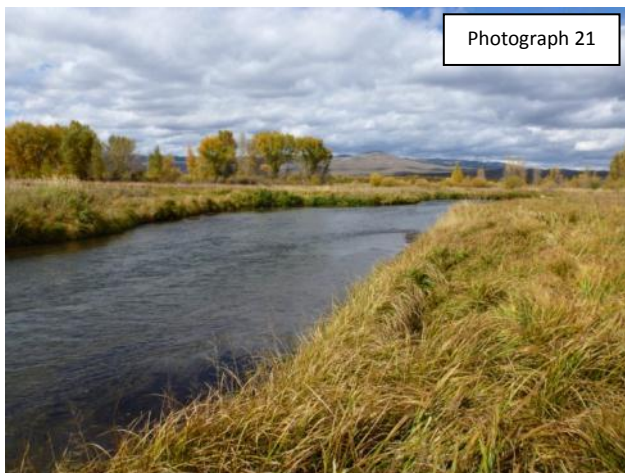
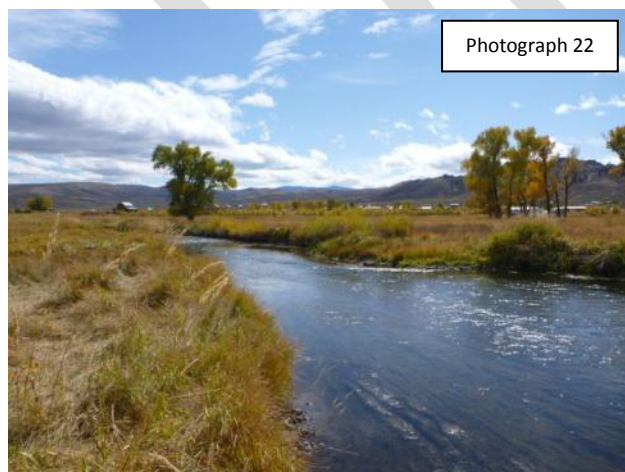
Although the restoration efforts which include the established Conservation Easement and a shift in agricultural use from that of overland grazing to an emphasis in hay production are relatively recent and of short duration, the effects on the existing riparian corridor are impressive especially in light of the riparian conditions that exist in the segments upstream of this area. Although some stream-banks lack the larger shrubs and trees that are vital to

healthy riparian zones, riparian areas along both banks appear to be recovering with robust riparian vegetation such as sedges and wetland grasses established to the Ordinary High Water Mark (OHWM) of the stream channel.

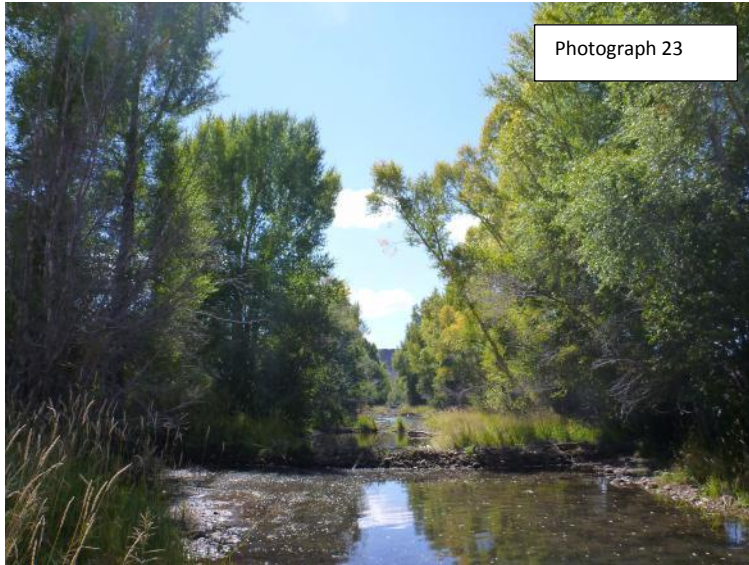
Photograph 23

and create a better riffle/run ratio (Photograph 22). Some areas along the restored channel are beginning to support plantings and some recruitment of the narrowleaf cottonwood trees that typically dominate the tree strata in Lower Gunnison Valley riparian zones (Photograph 23).

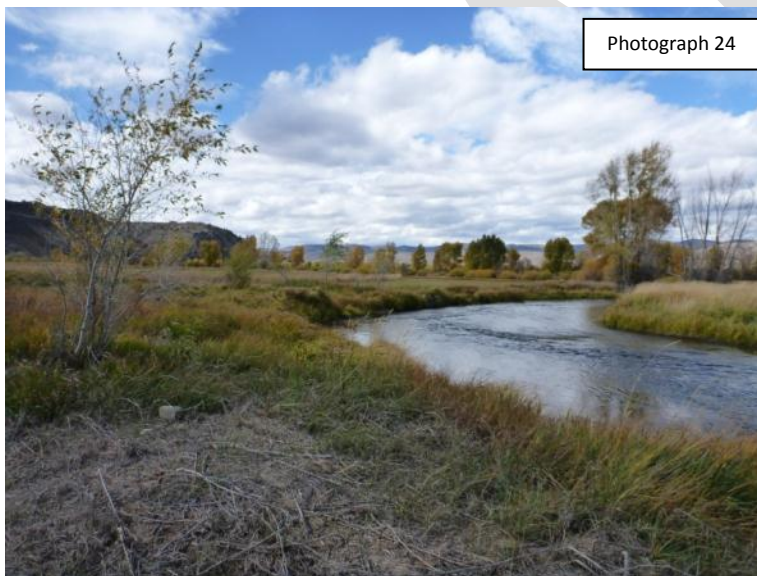
Photograph 24

The re-establishment of cottonwoods within the riparian areas along Tomichi Creek would greatly enhance riparian function and help to supply riparian functions such as bank stability, shading and contributions of large woody material to the stream ecosystem. The recovery of riparian vegetation is also apparent in the re-vegetation of point bars throughout the segment. Another benefit that is associated with

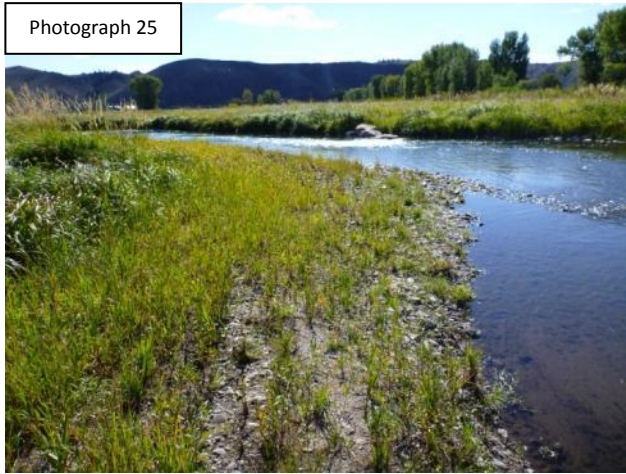
Photographs 25 and 26 exhibit the revegetation of point bars in Segment 9. Small willow recruits are becoming established along the point bar in Photograph 25 with the lush growth of reed canary grass up to 3 to 4 feet in height established along the bank in Photograph 26. Other areas associated with the restored stream channel and the historical channel within the segment support riparian that is an upward trend due to the decrease in grazing pressure and passive restoration that has taken place in this segment. In these areas willows, alder and some cottonwood are being restored as important components of these riparian zones.

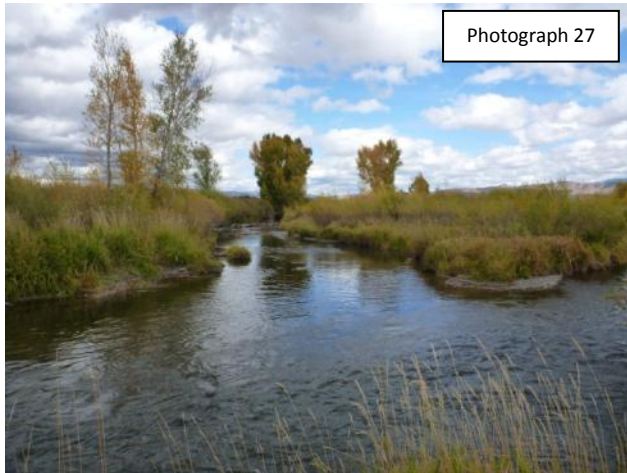
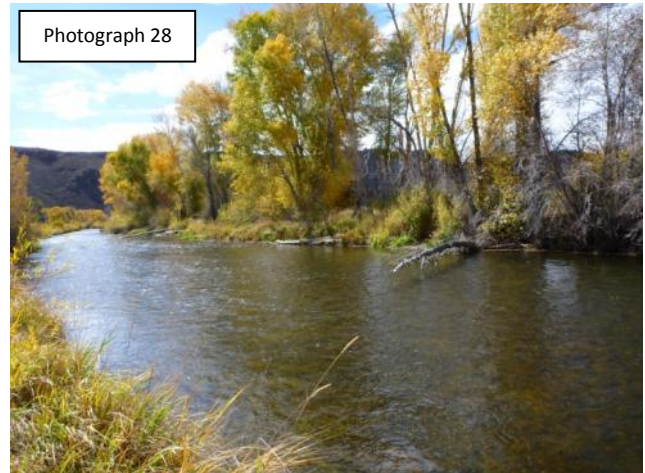
Where this restoration has occurred, riparian areas exhibit marked improvements in quality and function and reveal the potential improvements and recovery that modifications to land management and conservation of stream corridors can bring to valuable riparian zones along Tomichi Creek. Photographs 27 and 28 document healthy riparian areas in this segment that include the components of diverse species and age class of riparian vegetation that provide cover and stability to streambanks. The vegetative cover and stability provide the foundation to support continued improvements to stream health and balance throughout the segment.

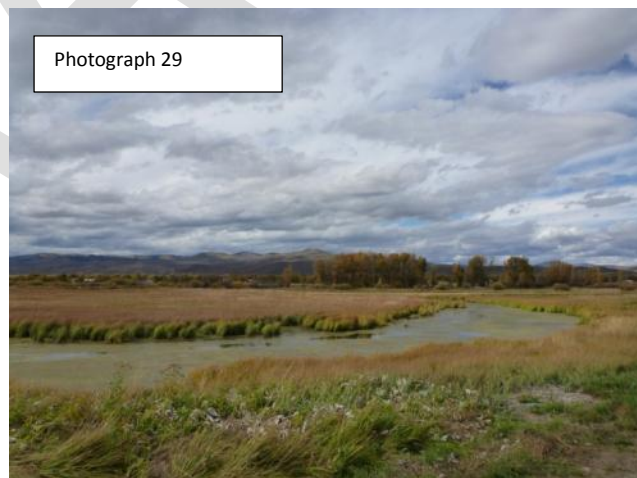
Segment 9 also includes large emergent wetlands that are associated with what appear to be abandoned oxbows of Tomichi Creek (Photograph 29). These conserved wetland are also contributing to the quality of aquatic resources and wildlife habitat that exists in this segment.
