# **Kerber Creek Restoration Project Final Report**

Trout Unlimited/Bureau of Land Management (BLM)

January – December 2011

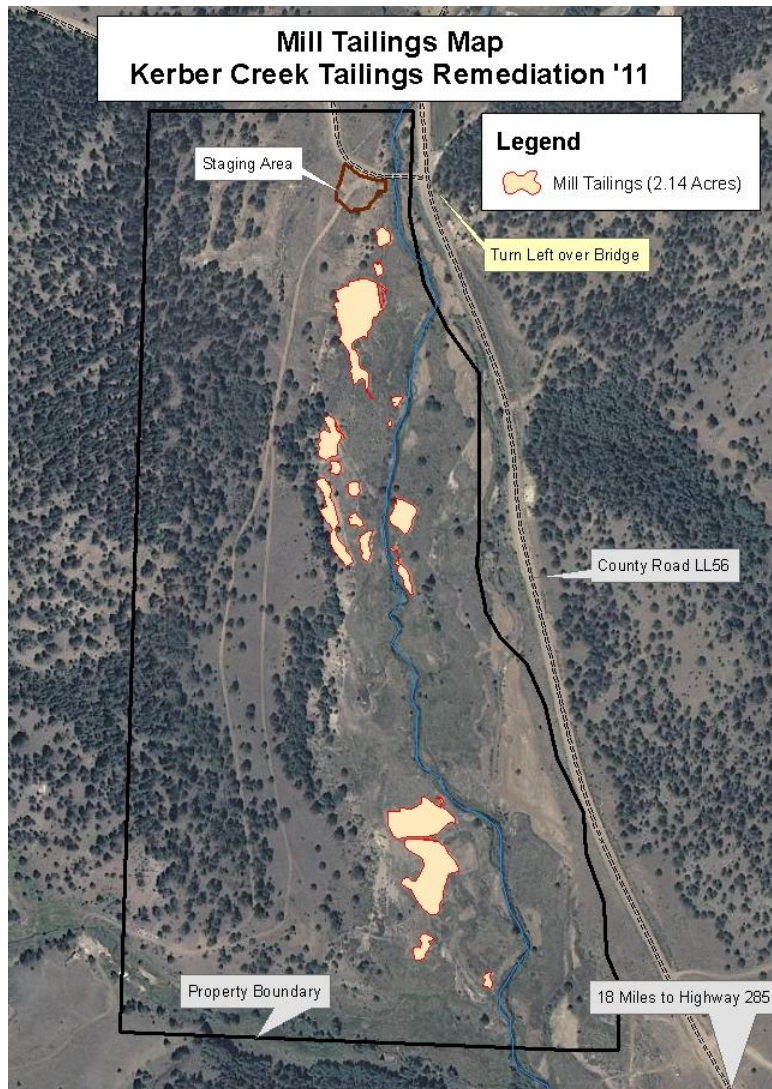
**Figure 1.1: KC 20 Plan View of Site map showing placement of mine waste areas, property boundary, and the section of Kerber Creek that was restored**

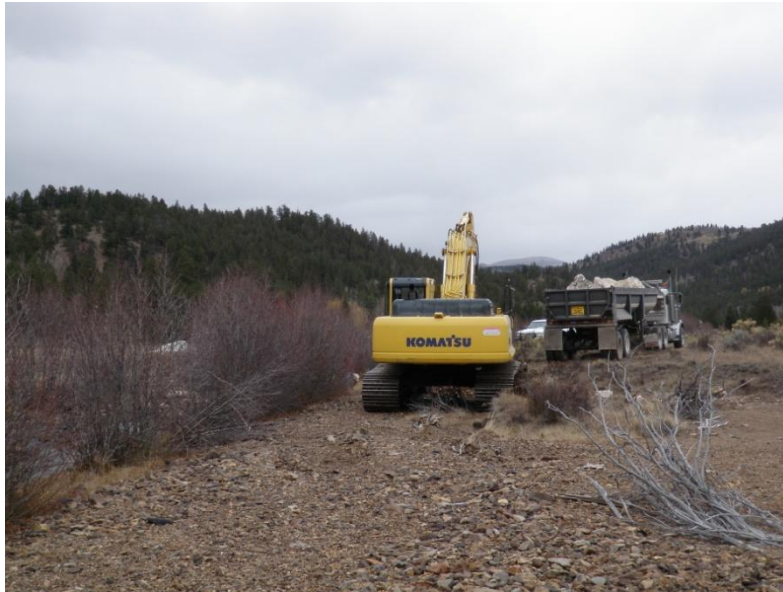
**Figure 4.1: Excavator and truck containing limestone in-stream rock along Kerber Creek at KC 20**
