Paonia River Park Project Final Report

August 30, 2013

Introduction

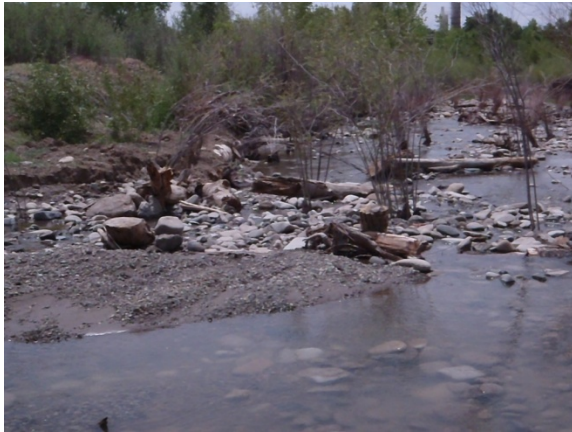
South side channel May 2013

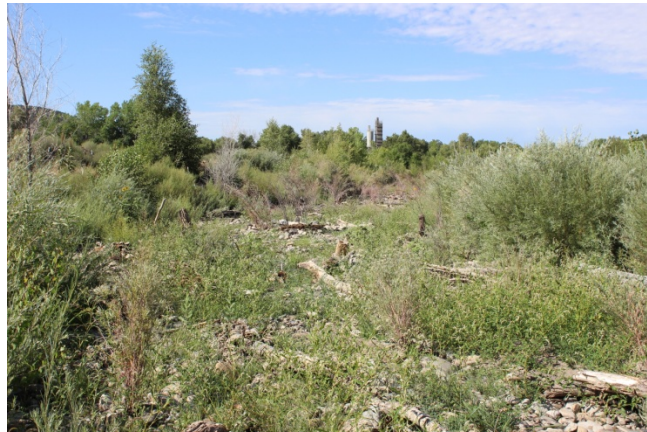
South side channel August 2013

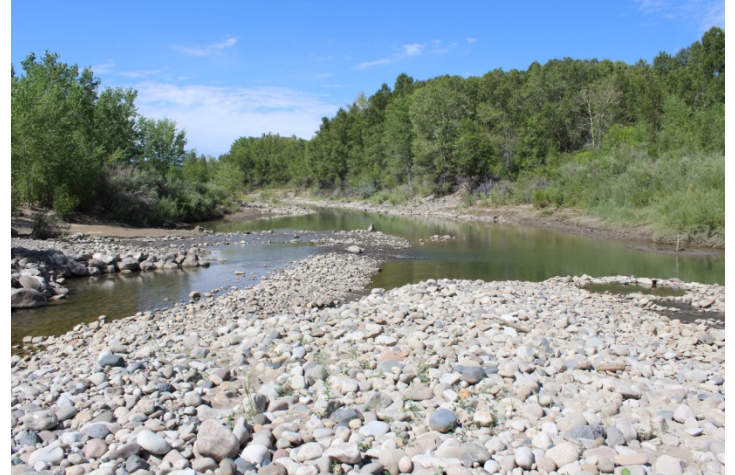
5+80 – This cross section traverses the previous south side channel where it met the current main channel upstream of Minnesota Creek. The side channel was filled at the confluence and stabilized with large rock. A series of wetlands were developed in the side channel for aquatic and terrestrial habitat. Willows, bulrush and cattails were planted around the perimeter of the wetlands. Two piezometers were installed along this cross section to measure the depth of groundwater relative to the surface water of the river. The main channel at this location deposited a new gravel bar on the north side of the river and is forming a new point bar. The main low flow channel was narrowed substantially and the depth decreased by about one foot. The floodplain is thriving with new riparian vegetation and the revetments along the south side of the bank remained unchanged. It is expected that the new point bar will grow over time and generate new vegetation as well. This would be a good location for additional adaptive management to stabilize the point bar and create additional fish holding structures above the bar.

New gravel point bar with main channel on left

- Construction of flow inhibitors across the new gravel point bar at cross section 5+80 to prevent future braiding;
- Additional rock at the lower two weirs where the channel widened by 25' to further consolidate low flows;
- An addition weir above the gravel point bar to enhance the pool there and maintain additional fish holding.

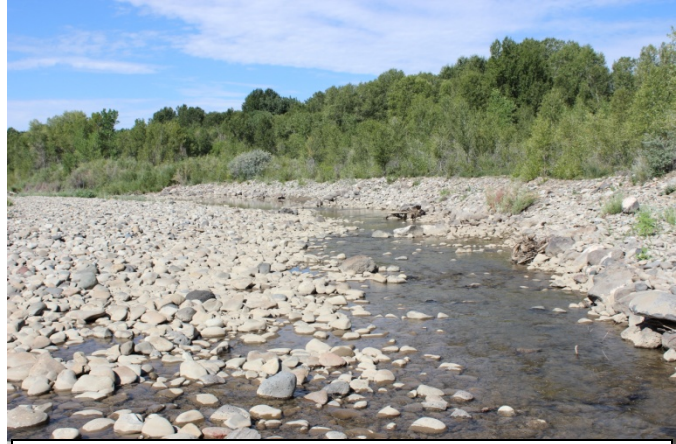
Looking downstream across the primary channel

channels. The primary channel is intact and the rock structures and bank revetments are stable and working as designed. The point bar on river left of the primary channel is also beginning to establish new vegetation. There is little change in the dimensions of the cross section between pre and post runoff. There are two other piezometers located along this cross section to measure groundwater depth relative to the surface water in the river.

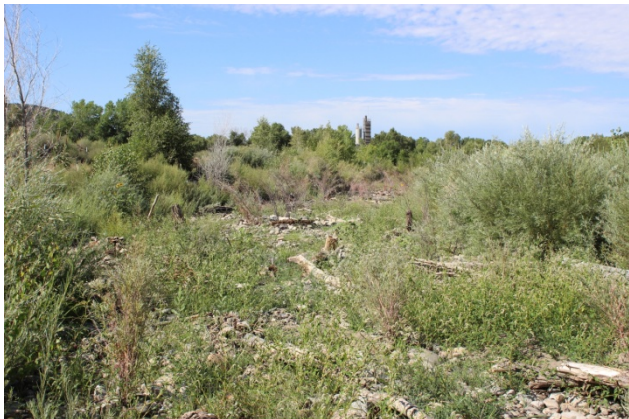
New riparian vegetation established

meander bend and stabilize the outside bank with boulders. There was about a one foot scour along the south side of the channel on the point bar as a natural adjustment to increased flows. The thalweg remained as constructed. There was substantial deposition in many locations across the reconstructed floodplain and the log flow inhibitors worked well. Many new riparian recruits have established across the floodplain.

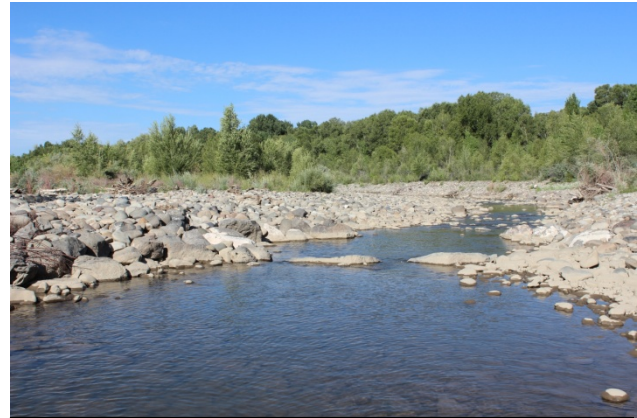
New pool above rock weir

prevent avulsion at this channel but constructed low enough to allow for overtopping. The overtopping occurred at about 1,200 cfs. The revetments held perfectly and the overtopping provided new sediment that was deposited in several locations by log flow inhibitors and live willow silt fences. A rock weir constructed at this section also remained unchanged and created a nice pool upstream. There was little change in the pre and post runoff measurements at all locations. New riparian vegetation has established throughout the floodplain across this cross section. The backwater channel has also established new riparian vegetation.

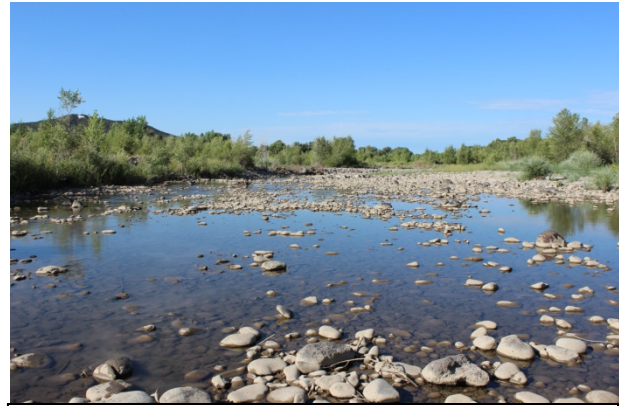
16+64 – This cross section was established at the upper end of the project. A rock weir was constructed just downstream of the section. This weir also remained unchanged between pre and post runoff. There was a small amount of gravel filled at the north side of the channel where the previous side channel had started. That fill material remained unchanged between pre and post runoff as well.

Wide channel above the project

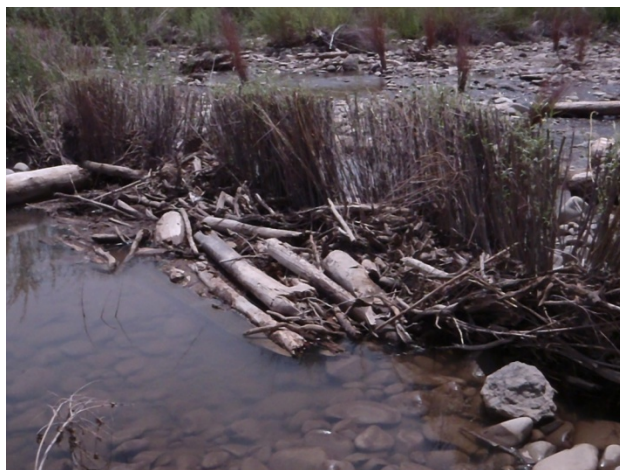
The ones planted in trenches across the side channels were primarily used as live willow silt fences. Their purpose was to filter out sediment and debris while allowing water to pass and slow flow velocities. These silt fences worked very well for their intended purpose but few of them established new vegetative starts. There are no definitive reasons for why most of these did not grow but possible reasons include too much water and too thick of a bundle. These silt fences were placed in locations of varying depth to groundwater with varying densities of sediment around the bundles but only about 20% of the willows in these trenches actually survived.

Debris and sediment captured & some growth

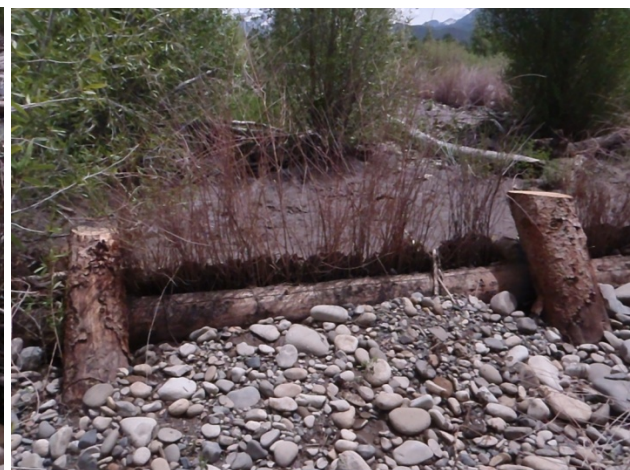
Sediment upstream, gravel downstream & no growth

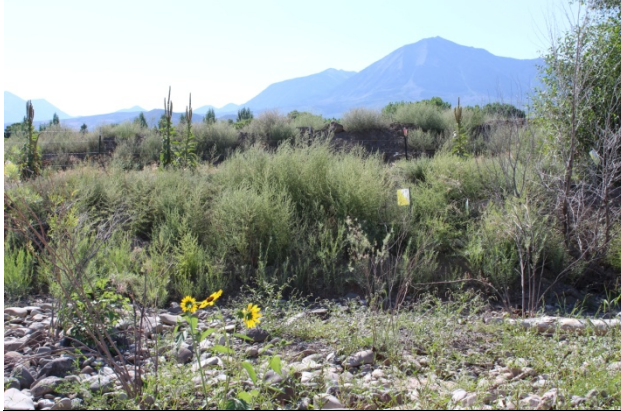
The best success rate of the willows planted occurred along the new primary riverbank and along the previous side channel riverbanks. The success rate in these locations was 90%. Most areas along the previous side channels had good soil coverage but the areas along the riverbank had little soil. Nevertheless both locations had strong success rates.

Willows thriving along previous side channel

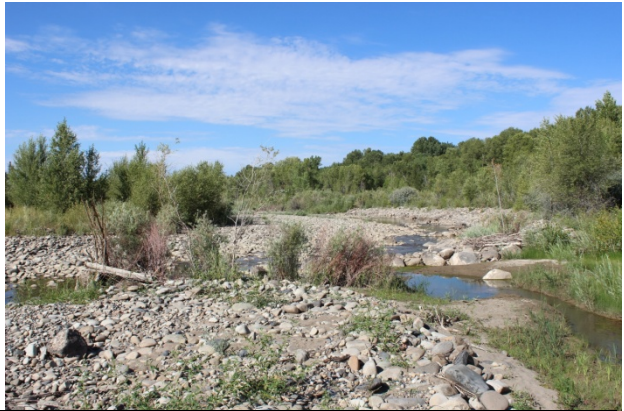
Willows along river doing well

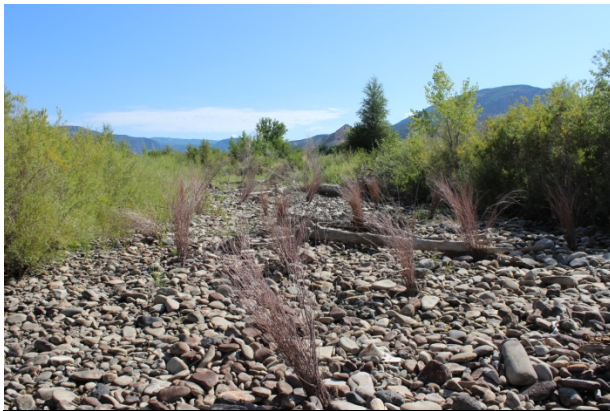
The individual willow plantings come with a mixed review. Some did well where others did not survive at all. There did not seem to be any definitive reason for the varied success. Overall the success rate was measured at 59%.

Unsuccessful willows in gravel bed

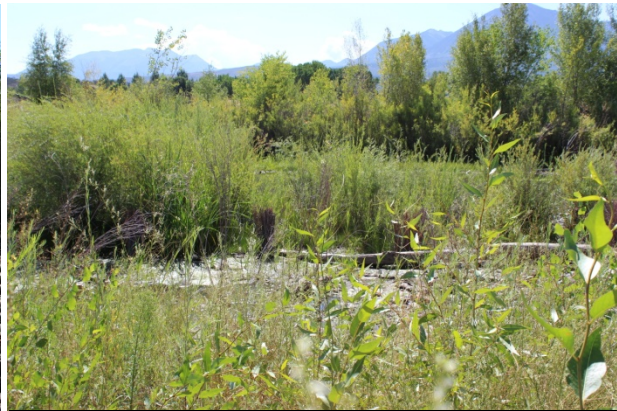
Willows thriving in side channel
