# Union Creek Stream Stabilization Project Final Report

Submitted to: Colorado Water Conservation Board

Submitted by: Colorado Mountain College Natural Resource Management Program

March 7, 2014

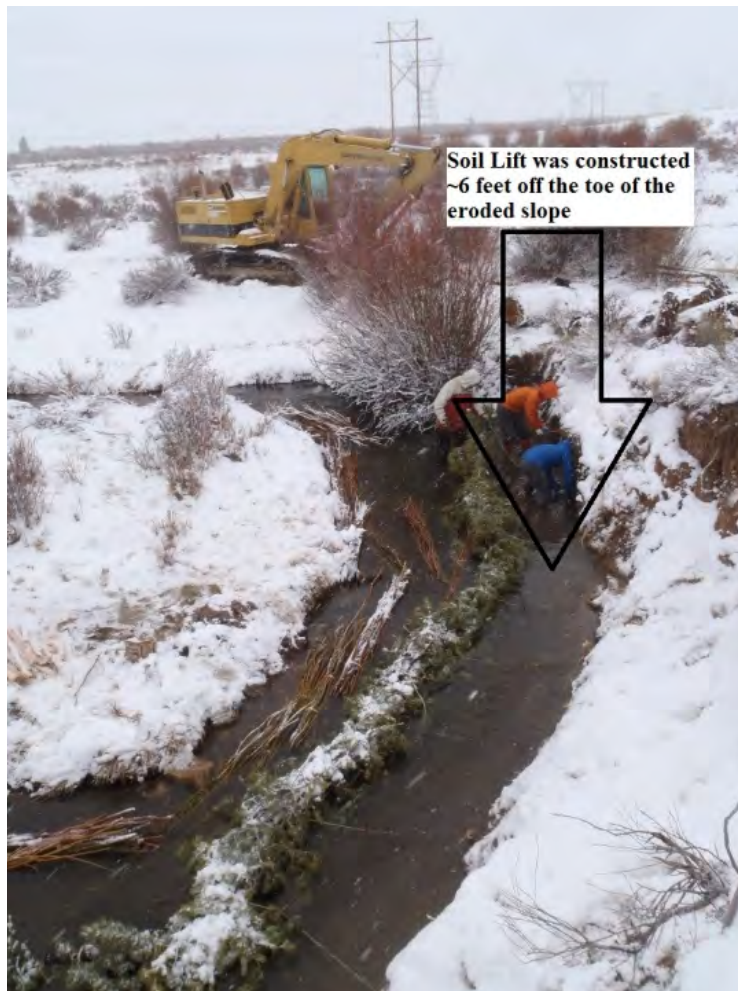
**Figure 20. Soil Lift construction. April, 2013**
