North Fork Gunnison River-Midway Stabilization and Riparian Improvements Project

Final Report December 14, 2011

MIDWAY BANK STABILIZATION
DEMONSTRATION PROJECT
NORTH FORK GUNNISON RIVER
DELTA COUNTY, COLORADO
OVERALL PLAN VIEW

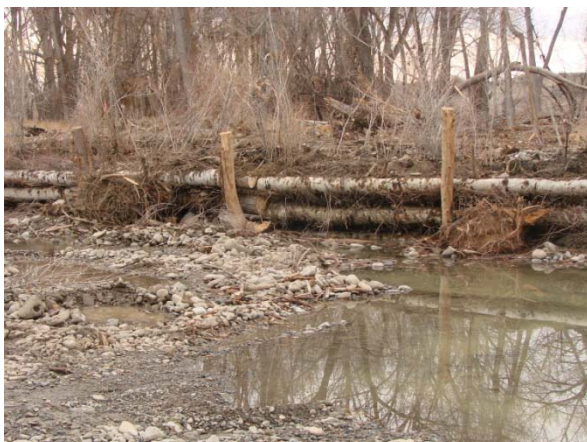
Avulsion channel 2010

Two different types of techniques were used to stabilize an existing bank and to divert water away from the avulsion and back into the original meander. The first was a log retaining wall type of structure along the bank erosion reach. Horizontal logs were secure on vertical posts with rebar and dovetail joints. The back side of the structure was planted with willow cuttings and cottonwood poles before backfilling. The reach along the avulsion also utilized horizontal logs but the posts were installed at varying

angles to act as a trap for woody debris. A trench behind the structure was used to plant a live willow silt fence designed to slow down rising waters and settle out sediment and the natural seed base found in the water.

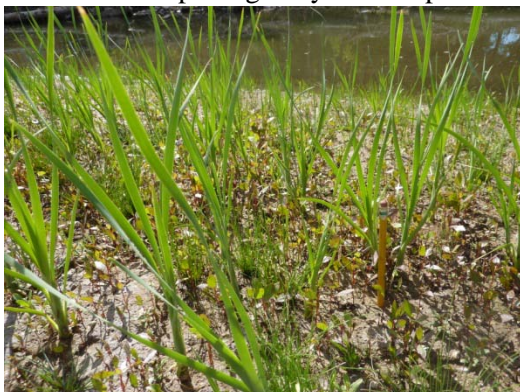
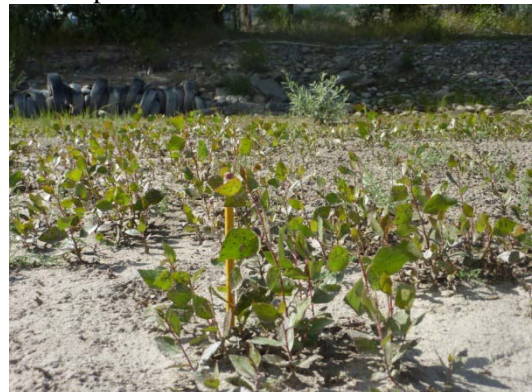
Prior to the Phase I Midway project of 2001 the river was extremely braided throughout this reach. The active channel consisted of multiple channels approximately 600 feet across. Since the Phase I project that active channel area had been reduced down to approximately 150 feet and previous braided channels have become healthy active floodplains with cottonwood stands 20 to 30 feet tall accompanying a thick understory of native grasses, sedges, rushes and willows. The same is expected of the avulsion channel. Furthermore, over time this reach is expected to narrow as it continues to balance morphologically as the riparian vegetation continues to expand.
