RE: Emergency Consolidated Home Supply Ditch and Reservoir Company ("CHSDRC"), Loan Contract #C150375 - Additional Loan Amount for Big Dam Flood Repairs and Mitigation.

**Re: Big Dam Diversion Structure, Examination and Proposed Repair;
D&A Job No. CG-0122.019.00**

This letter report presents our observations and recommendations for the proposed repair of Big Dam on the Big Thompson River. The top five feet of the dam was washed out during the flooding of September 11 through 15, 2013. Peak flows may have been of the order of 15,000 to 20,000 cfs with maximum overtopping of the structure of the order of 10 feet.

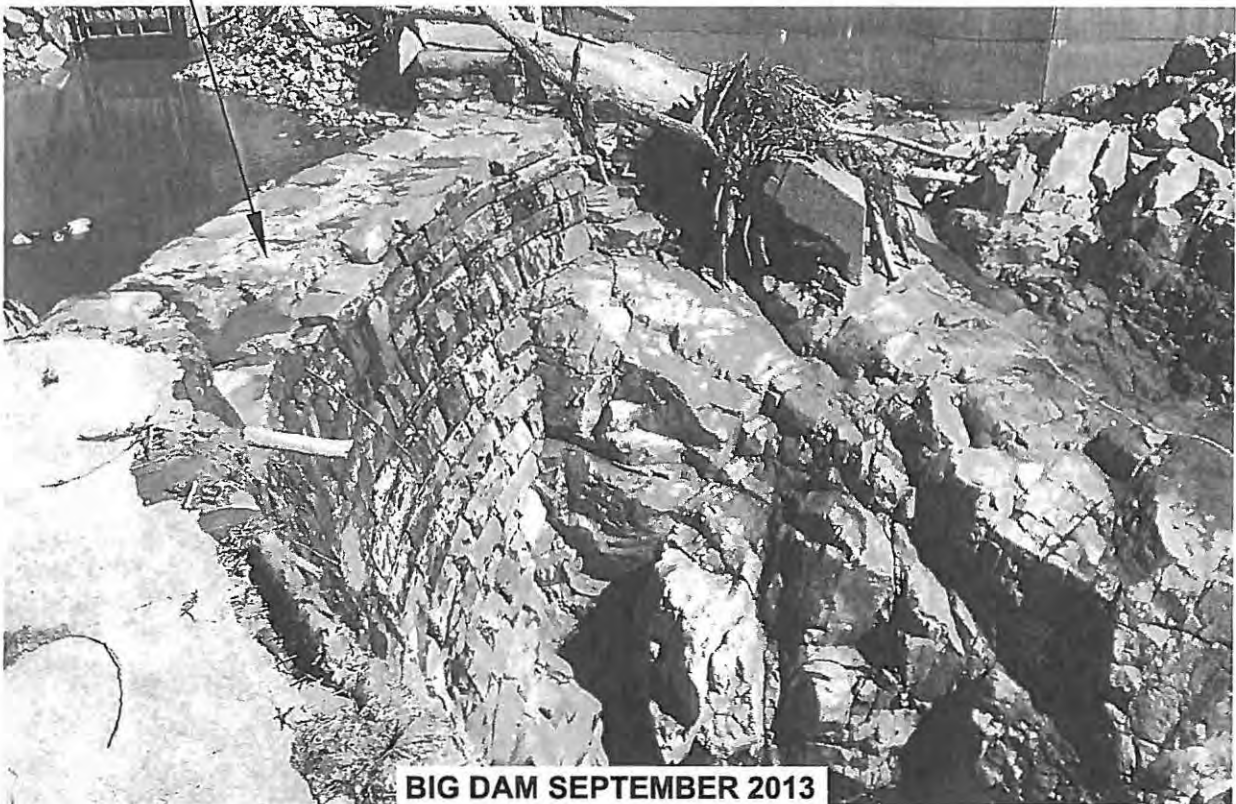
BIG DAM SEPTEMBER 2013
(VIEW NORTH)

MASONRY
REMOVED
BY FLOOD

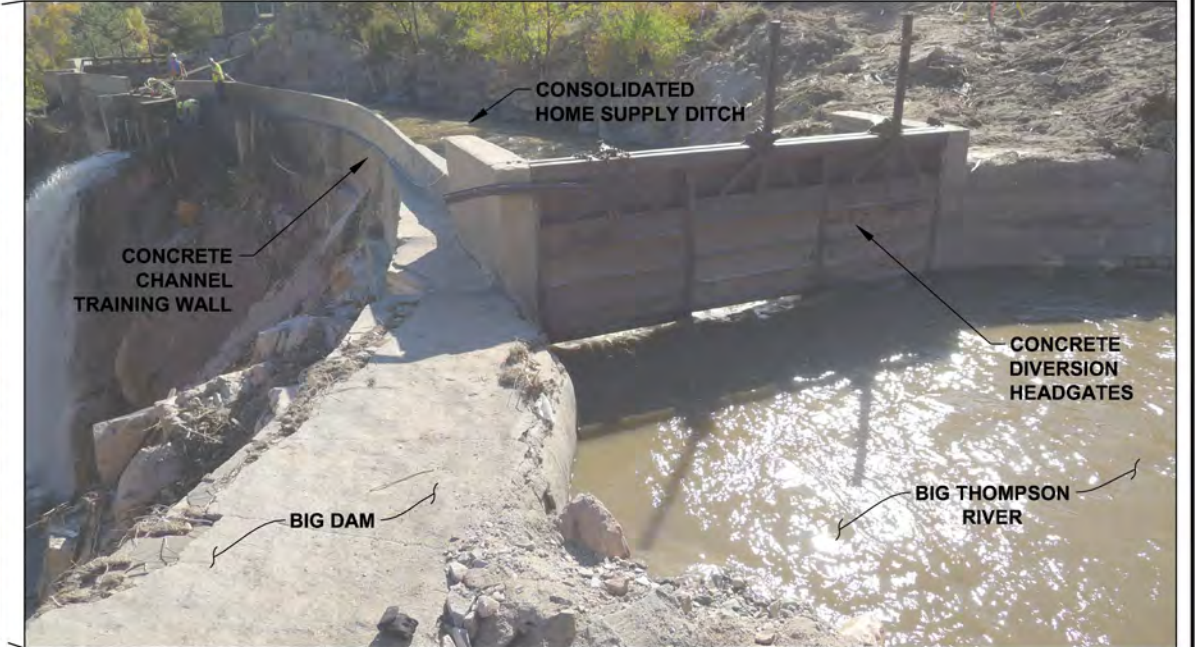
PHOTO A - CONCRETE DIVERSION STRUCTURE

the system inoperable. Photos of the concrete irrigation channel and sand out gates shortly after the flood are shown on **Figure 3**.

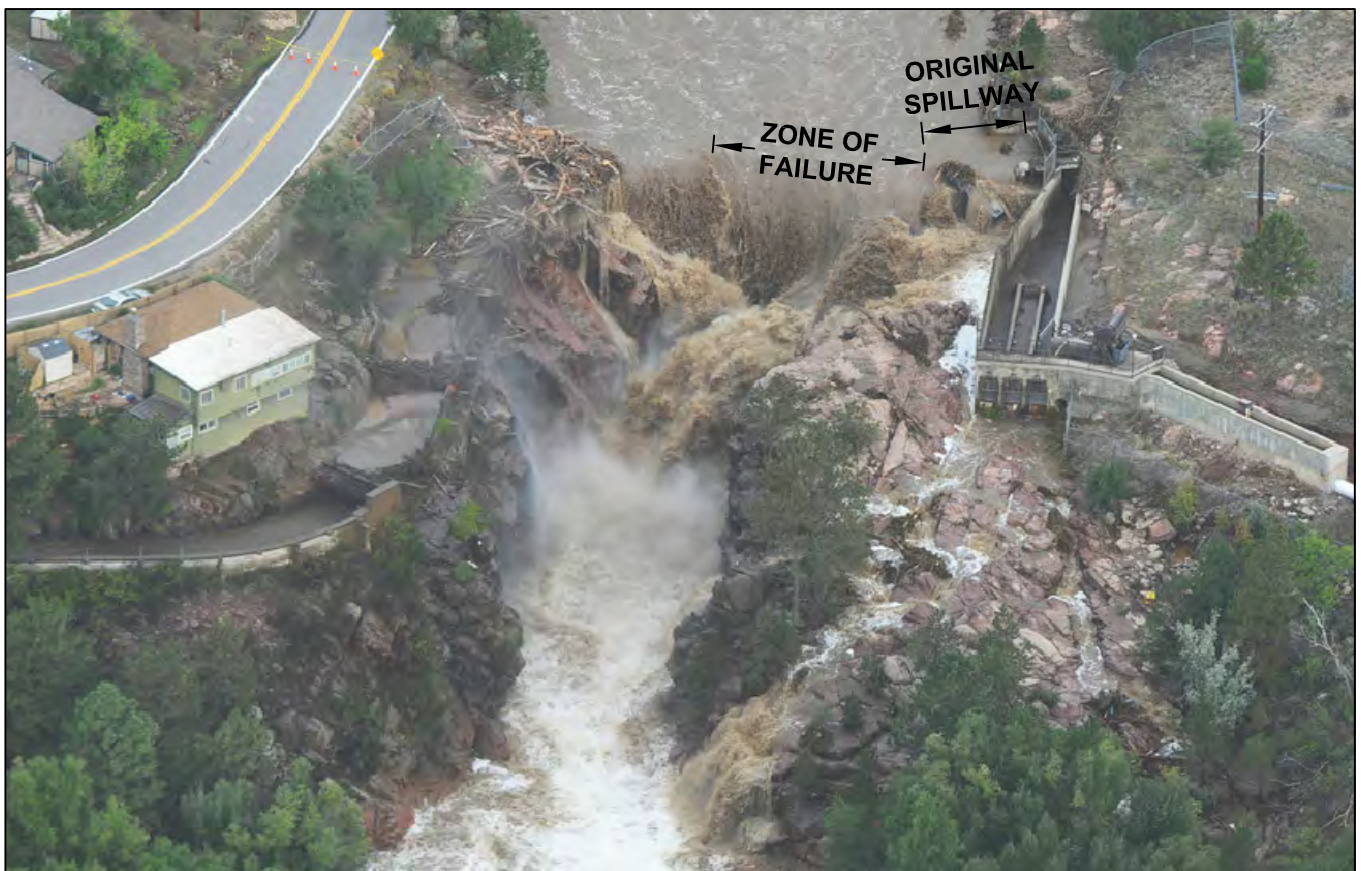
PHOTO DURING SEPTEMBER 2013 FLOODING

At the time of the flood, flood water could not be diverted around the dam and through the Consolidated Home Supply Ditch diversion structure headgate. This system was essentially inoperable during the flooding event because it was not safe to manually operate the gates. During the flood, debris overwhelmed the structure and ultimately got hung up on the various headgate supports and operators, and plugged the gate openings. As a result, the Consolidated Home Supply Ditch channel then filled up with sediment during the flood. This is shown on **Figure 4**. With high flow during the flood and with no functioning way to bypass flow around the dam, several courses of masonry stone were lost off the crest of the dam **Figure 5**.
