Lone Cabin Ditch and Reservoir Company

DAMID: 400404

Final Construction Report for Dam Repair, Lone Cabin Reservoir

September 11, 2014

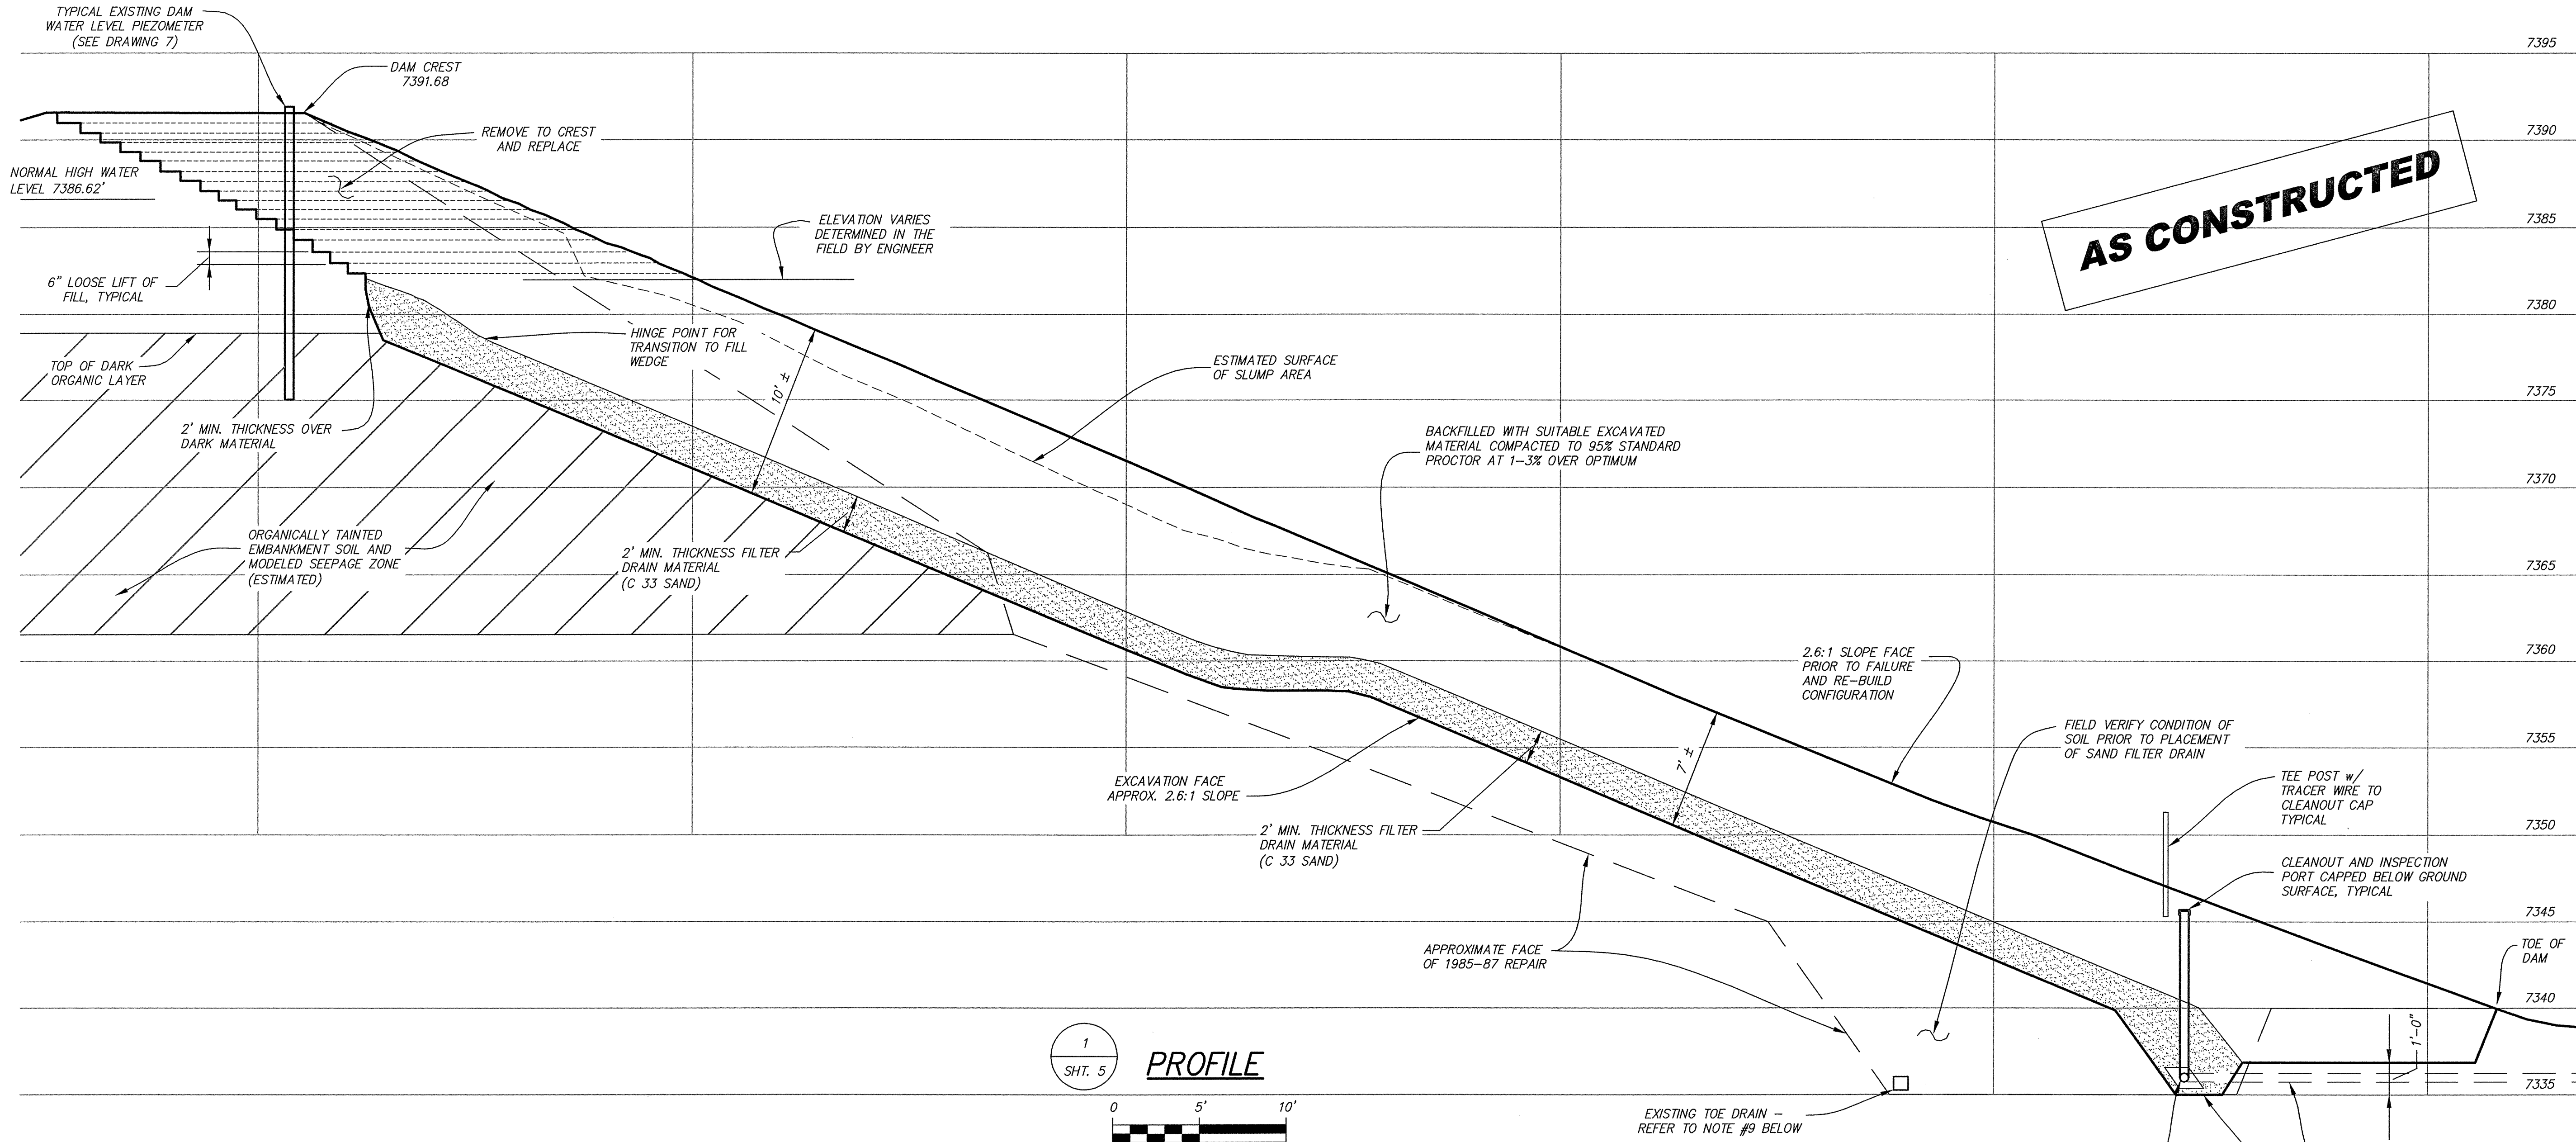
10. REPAIR DESIGN IS BASED ON CERTAIN ASSUMPTIONS OF HOW THE SLUMP OCCURED. IT IS POSSIBLE THAT THE REPAIR MAY REQUIRE MODIFICATION BASED ON FIELD FINDINGS AFTER THE SLUMP AREA HAS BEEN EXCAVATED AND SUBGRADE EXPOSED.

1. REMOVE SURFACE VEGETATION, TRASH, ORGANICALLY CONTAMINATED SOIL, ETC FROM THE DOWNSTREAM FACE OF THE DAM. EXCAVATE THE DOWNSTREAM FACE TO THE LINE AND GRADE SHOWN ON THE PLANS AND CREATE THE TOE DRAIN KEYWAY TRENCH. IF POCKETS OF ORGANICALLY CONTAMINATED SOILS OR SOFT SATURATED SOILS ARE EXPOSED ON THE EXCAVATED CUT FACE, THEY SHOULD BE REMOVED AND REPLACED WITH FILL COMPARABLE TO THE EMBANKMENT SOIL MATERIAL.

8. CONTRACTOR SHALL LOCATE AND PROTECT FOUR EXISTING PIEZOMETER INSTALLATIONS ALONG THE UPSTREAM TOP OF DAM CREST FROM DAMAGE DURING CONSTRUCTION.
9. EXISTING TOE DRAIN SHALL BE LOCATED, INCLUDING THE POINT OF DISCHARGE, CLEANED AS NECESSARY AND MADE FUNCTIONAL. IF FUNCTIONALITY CANNOT BE RESTORED, INCORPORATE OLD TOE DRAIN INTO THE NEW TOE DRAIN.
