FINAL REPORT

Upper Fountain Creek and Cheyenne Creek Flood Restoration Master Plan

Fountain Creek Watershed Flood Control and Greenway District

June 26, 2015

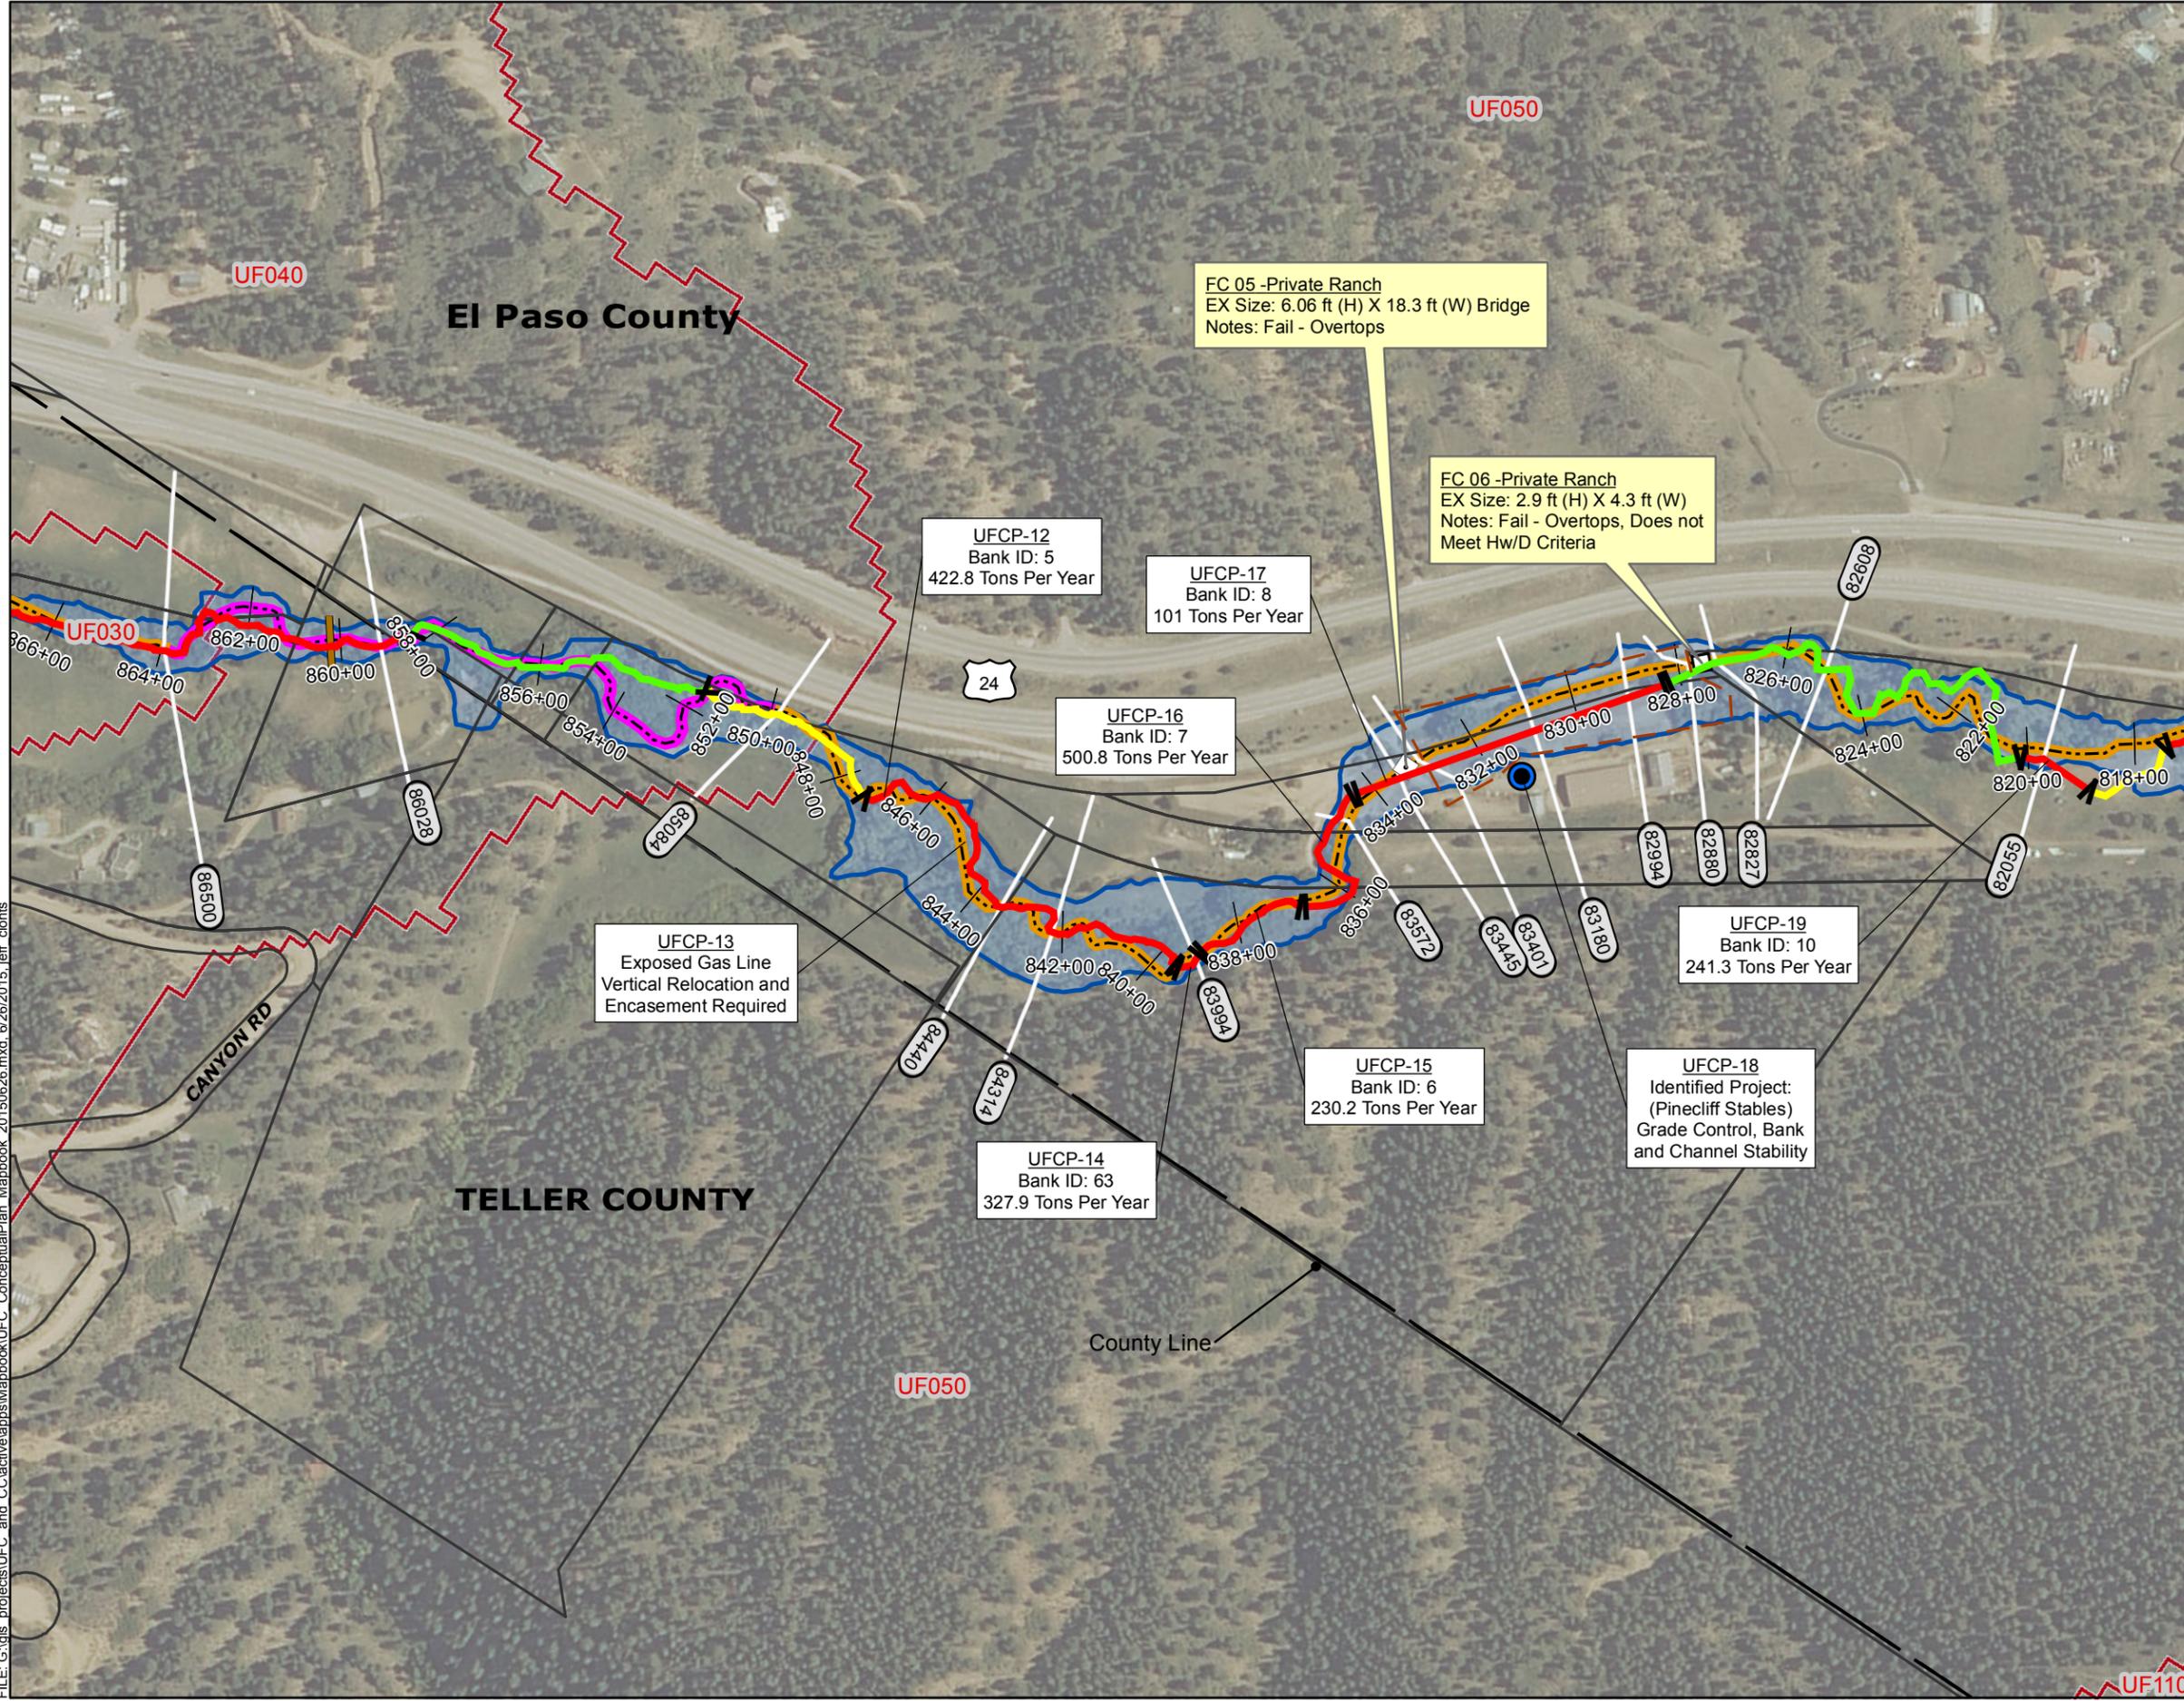
FC 05 -Private Ranch
EX Size: 6.06 ft (H) X 18.3 ft (W) Bridge
Notes: Fail - Overtops

FC 06 -Private Ranch
EX Size: 2.9 ft (H) X 4.3 ft (W)
Notes: Fail - Overtops, Does not Meet Hw/D Criteria

UFCP-18
Identified Project:
(Pinecliff Stables)
Grade Control, Bank
and Channel Stability

UFCP-19
Bank ID: 10
241.3 Tons Per Year

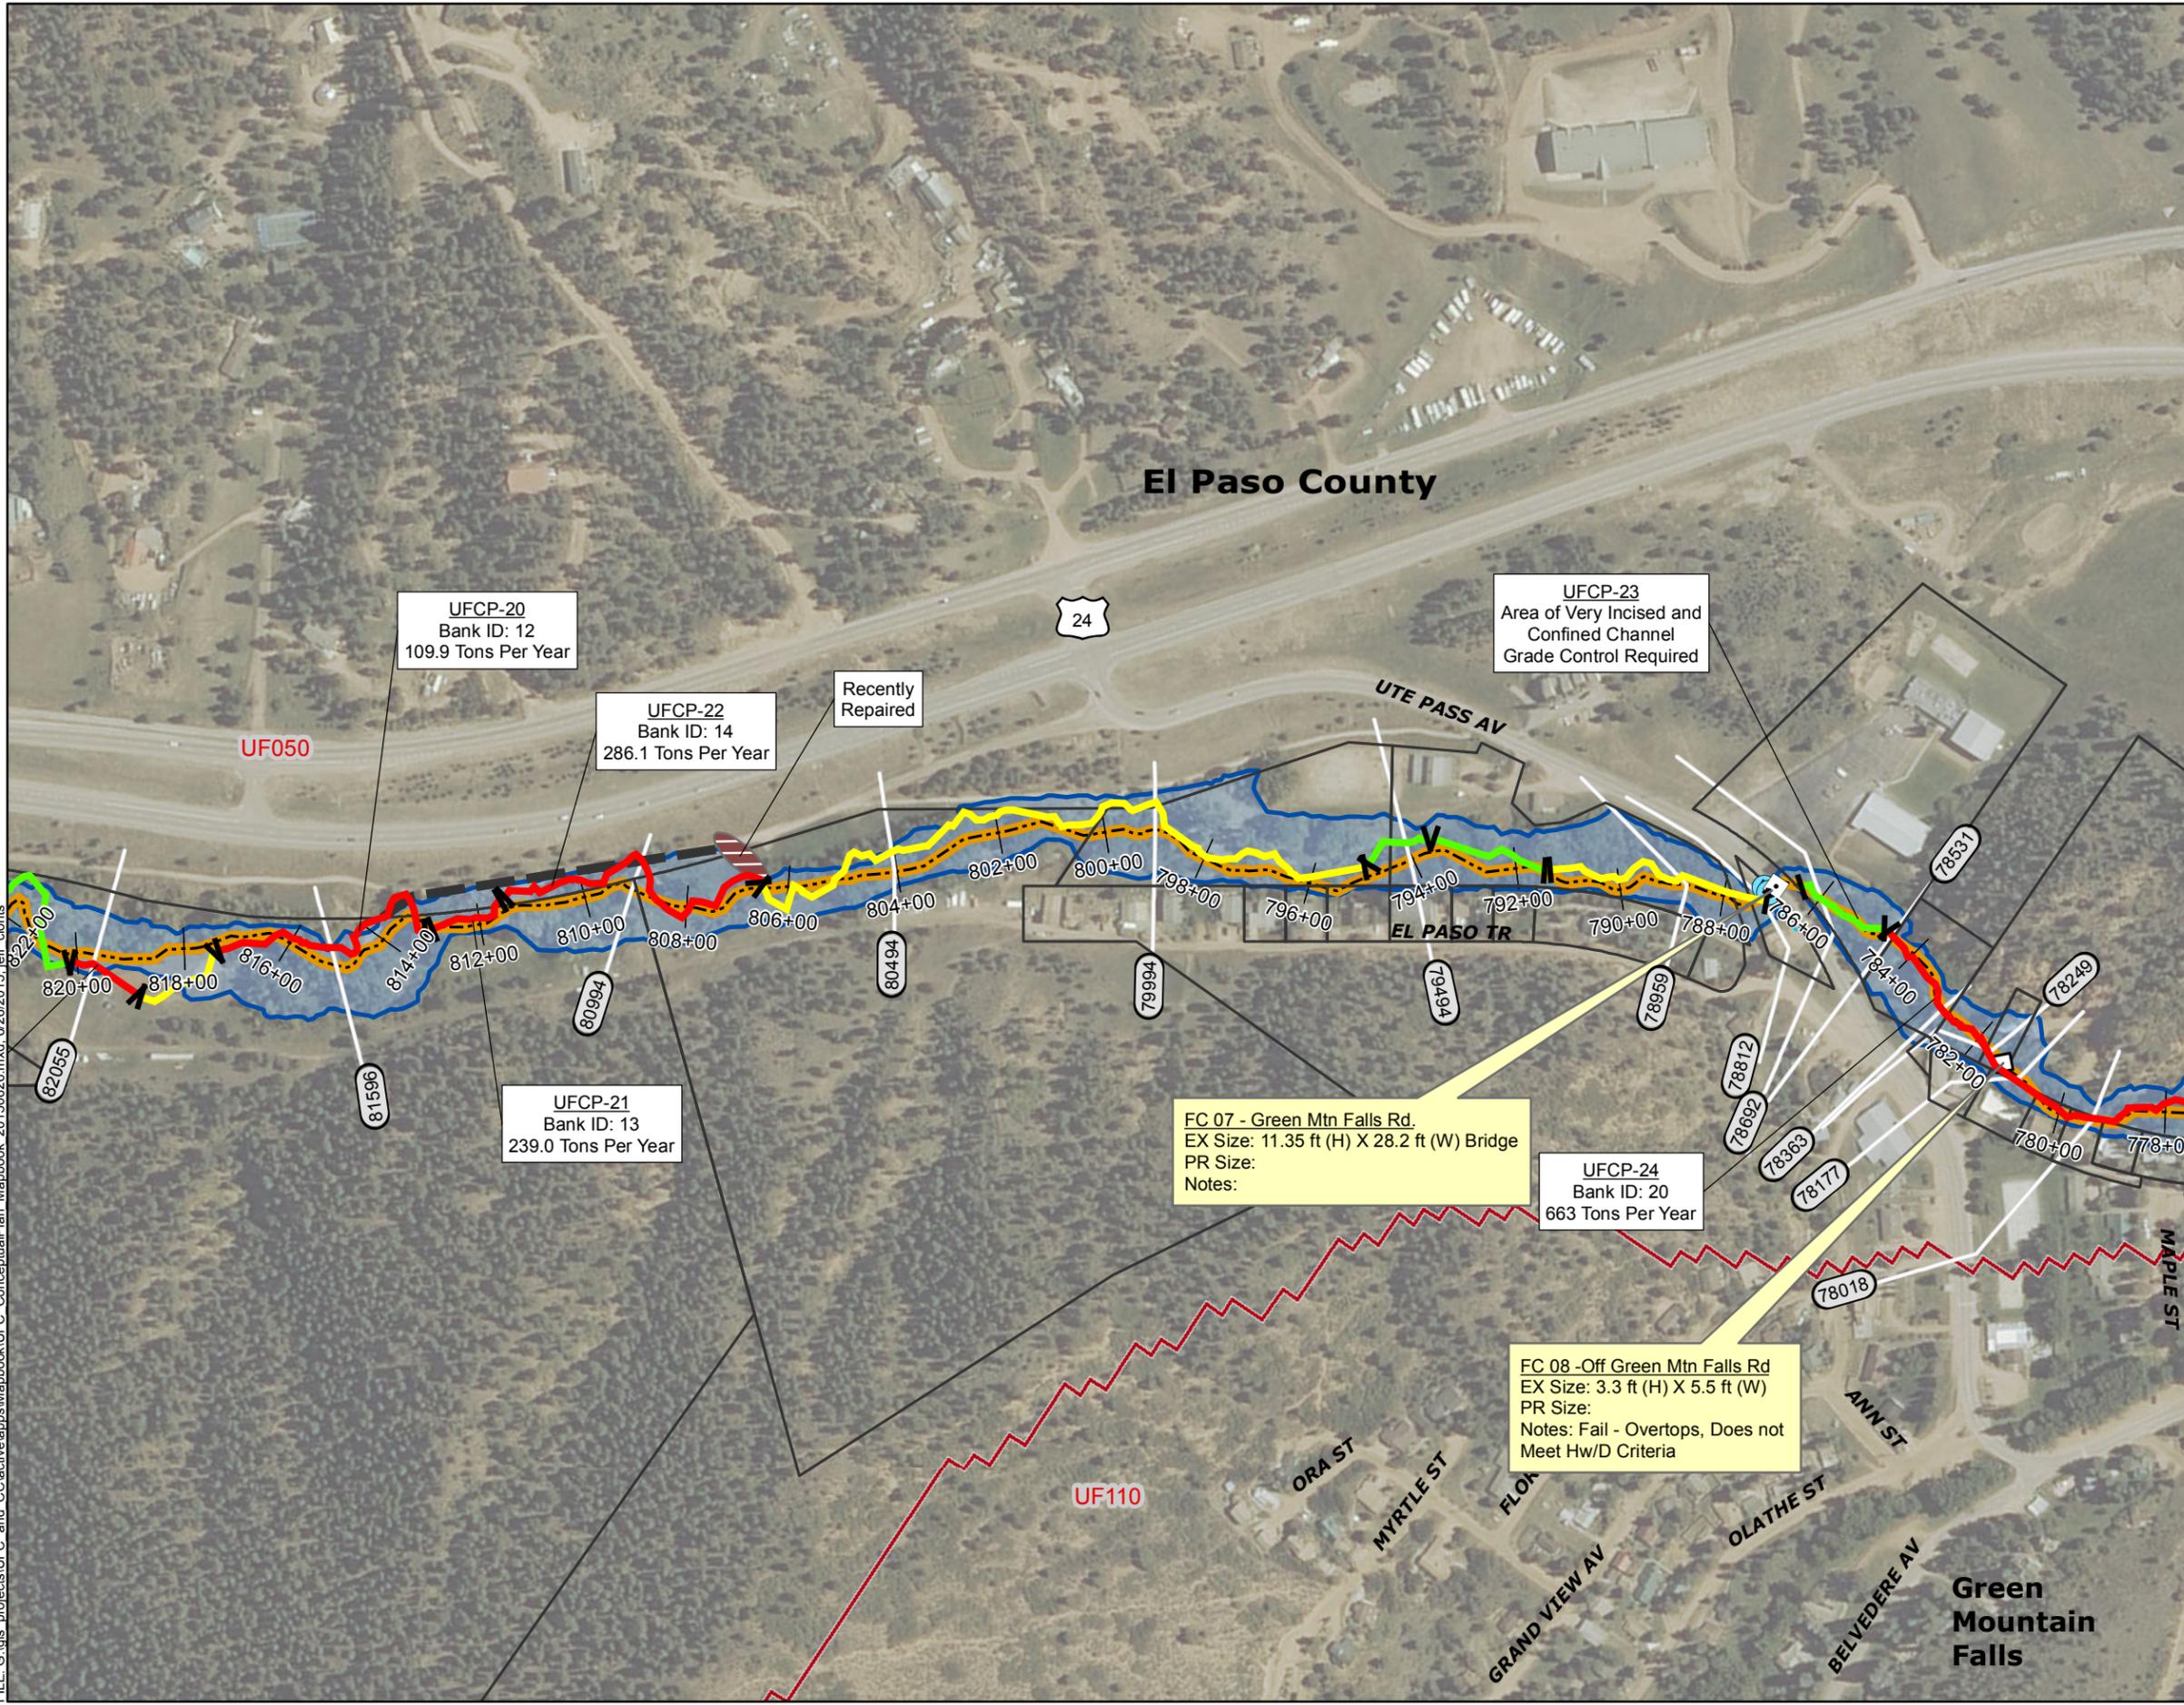
Sheet 6 of 25
 UFCP-20 thru UFCP-24
 Upper Fountain Creek
 Conceptual Plan
 El Paso County, CO

FC 07 - Green Mtn Falls Rd.
 EX Size: 11.35 ft (H) X 28.2 ft (W) Bridge
 PR Size:
 Notes:

UFCP-24
 Bank ID: 20
 663 Tons Per Year

FC 08 - Off Green Mtn Falls Rd
 EX Size: 3.3 ft (H) X 5.5 ft (W)
 PR Size:
 Notes: Fail - Overtops, Does not Meet Hw/D Criteria

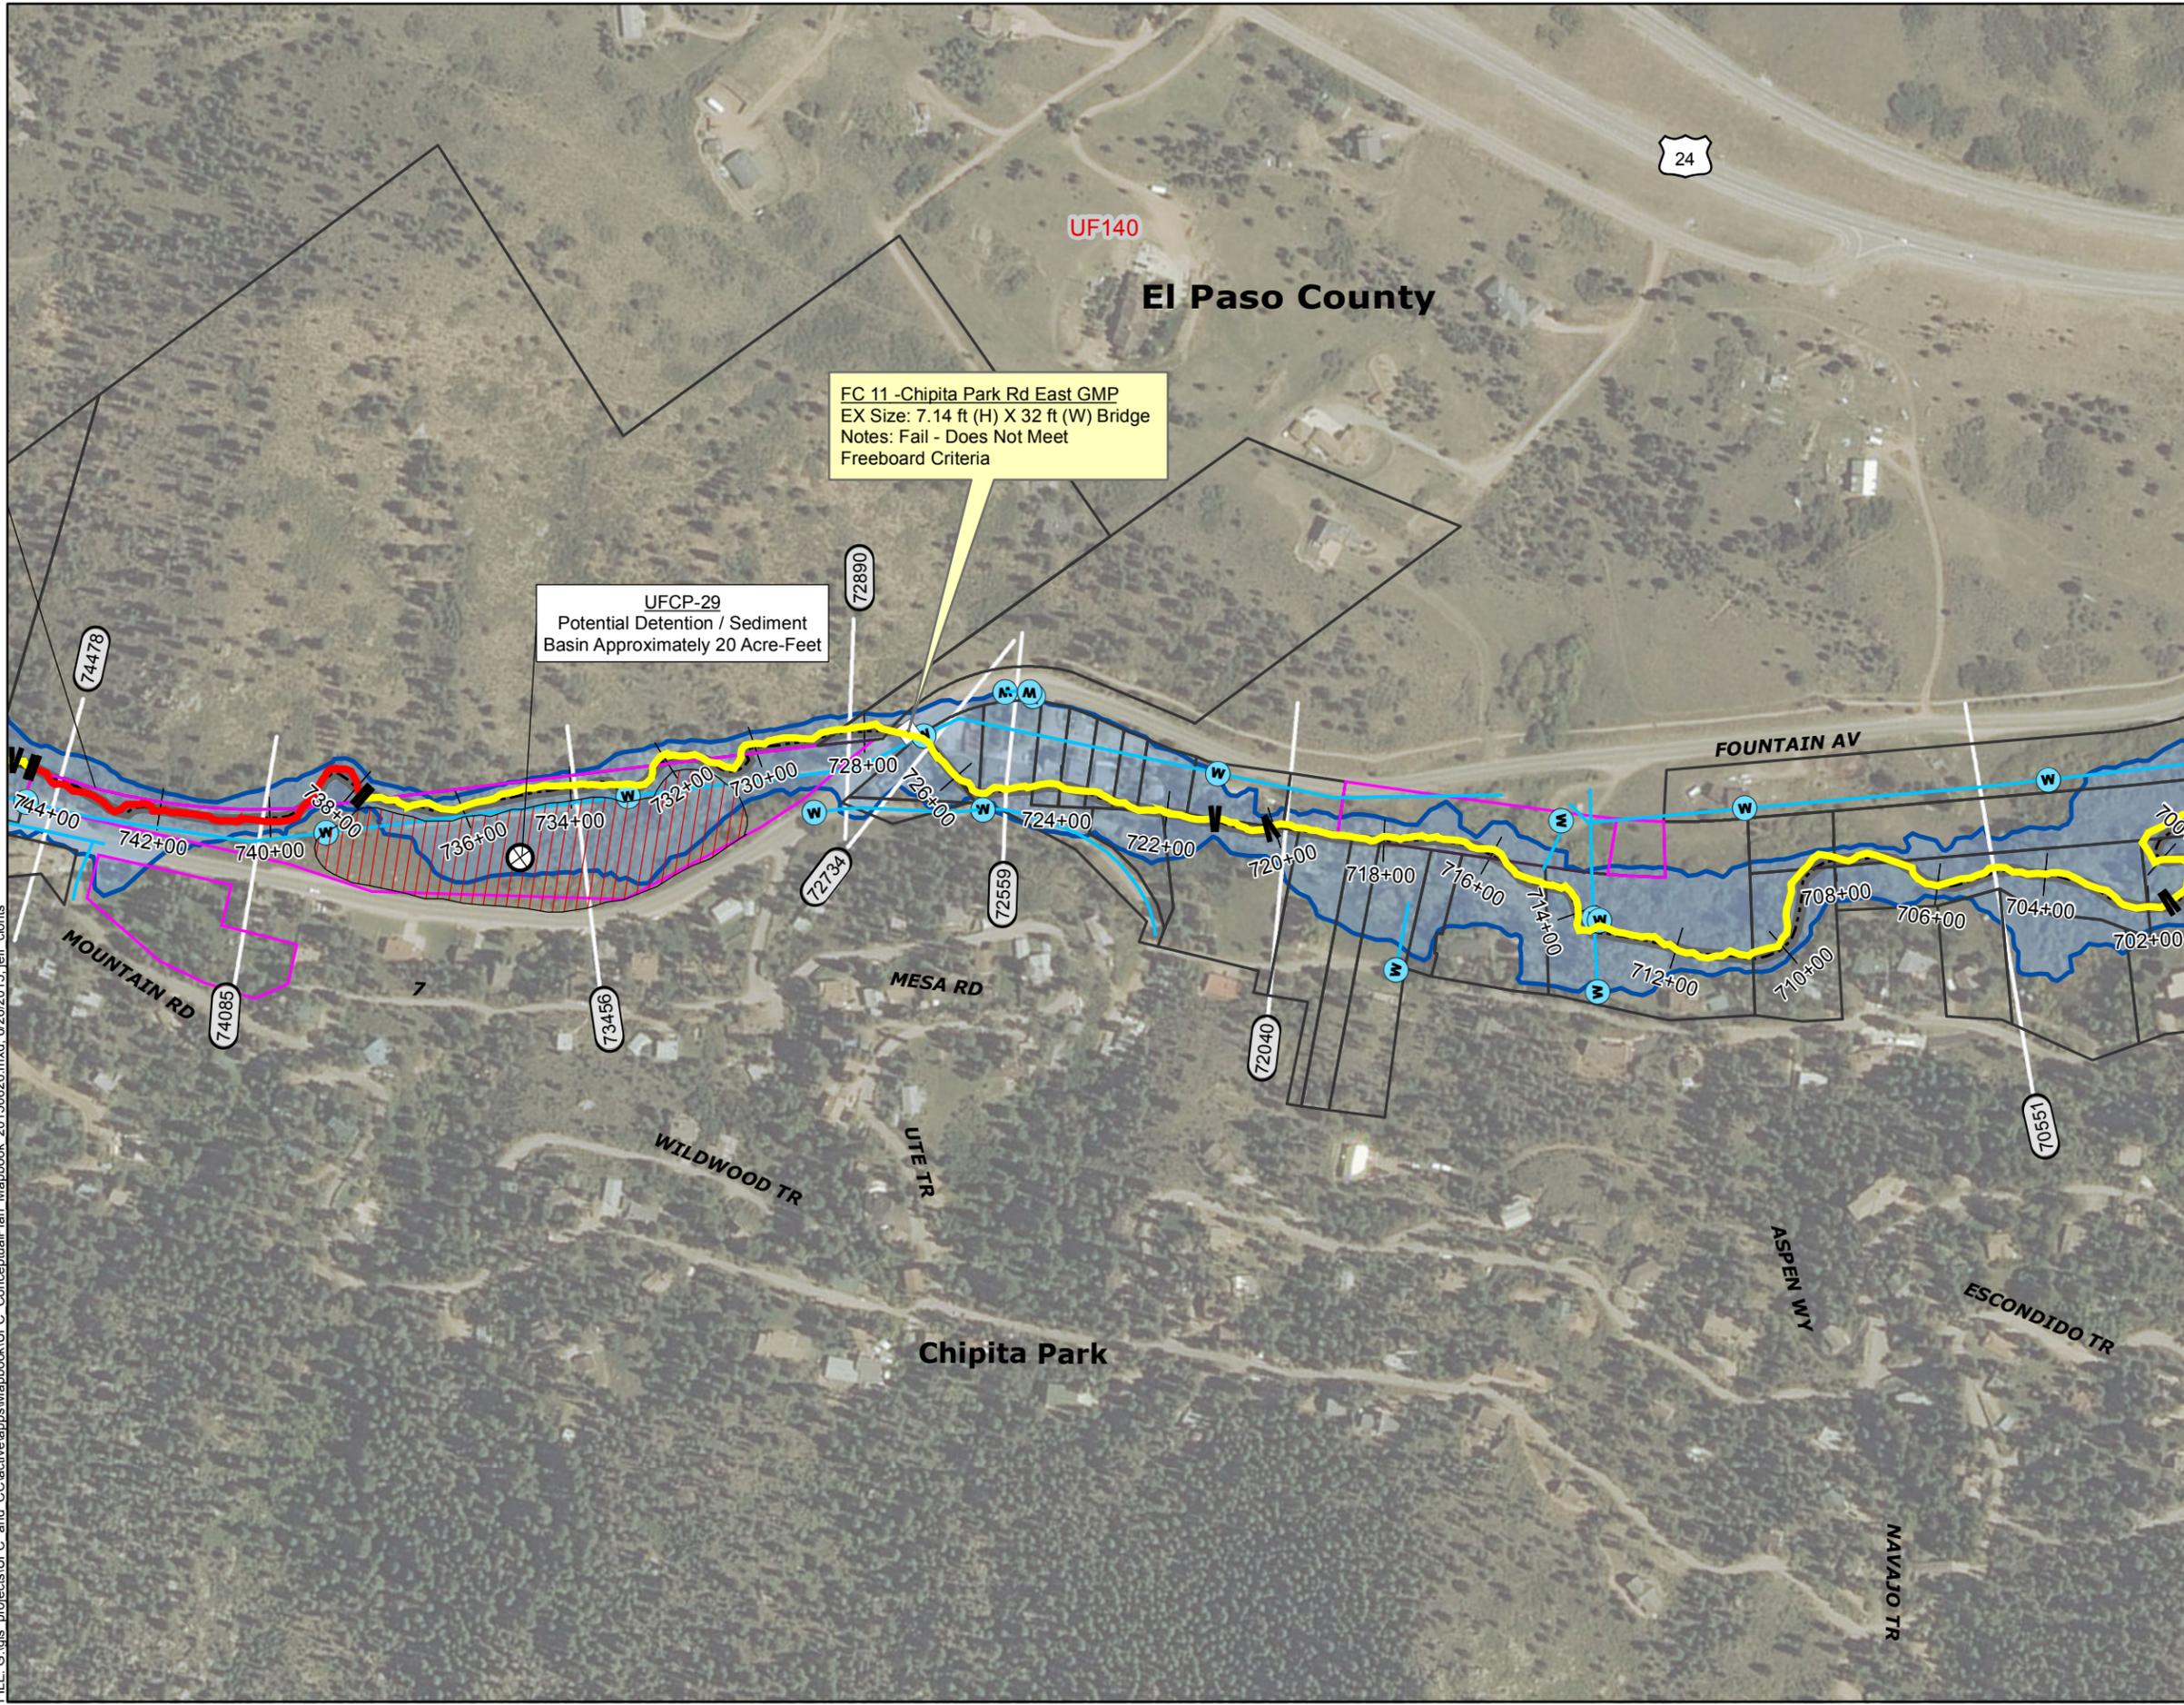
FC 11 -Chipita Park Rd East GMP
EX Size: 7.14 ft (H) X 32 ft (W) Bridge
Notes: Fail - Does Not Meet
Freeboard Criteria

UFCP-29
Potential Detention / Sediment
Basin Approximately 20 Acre-Feet

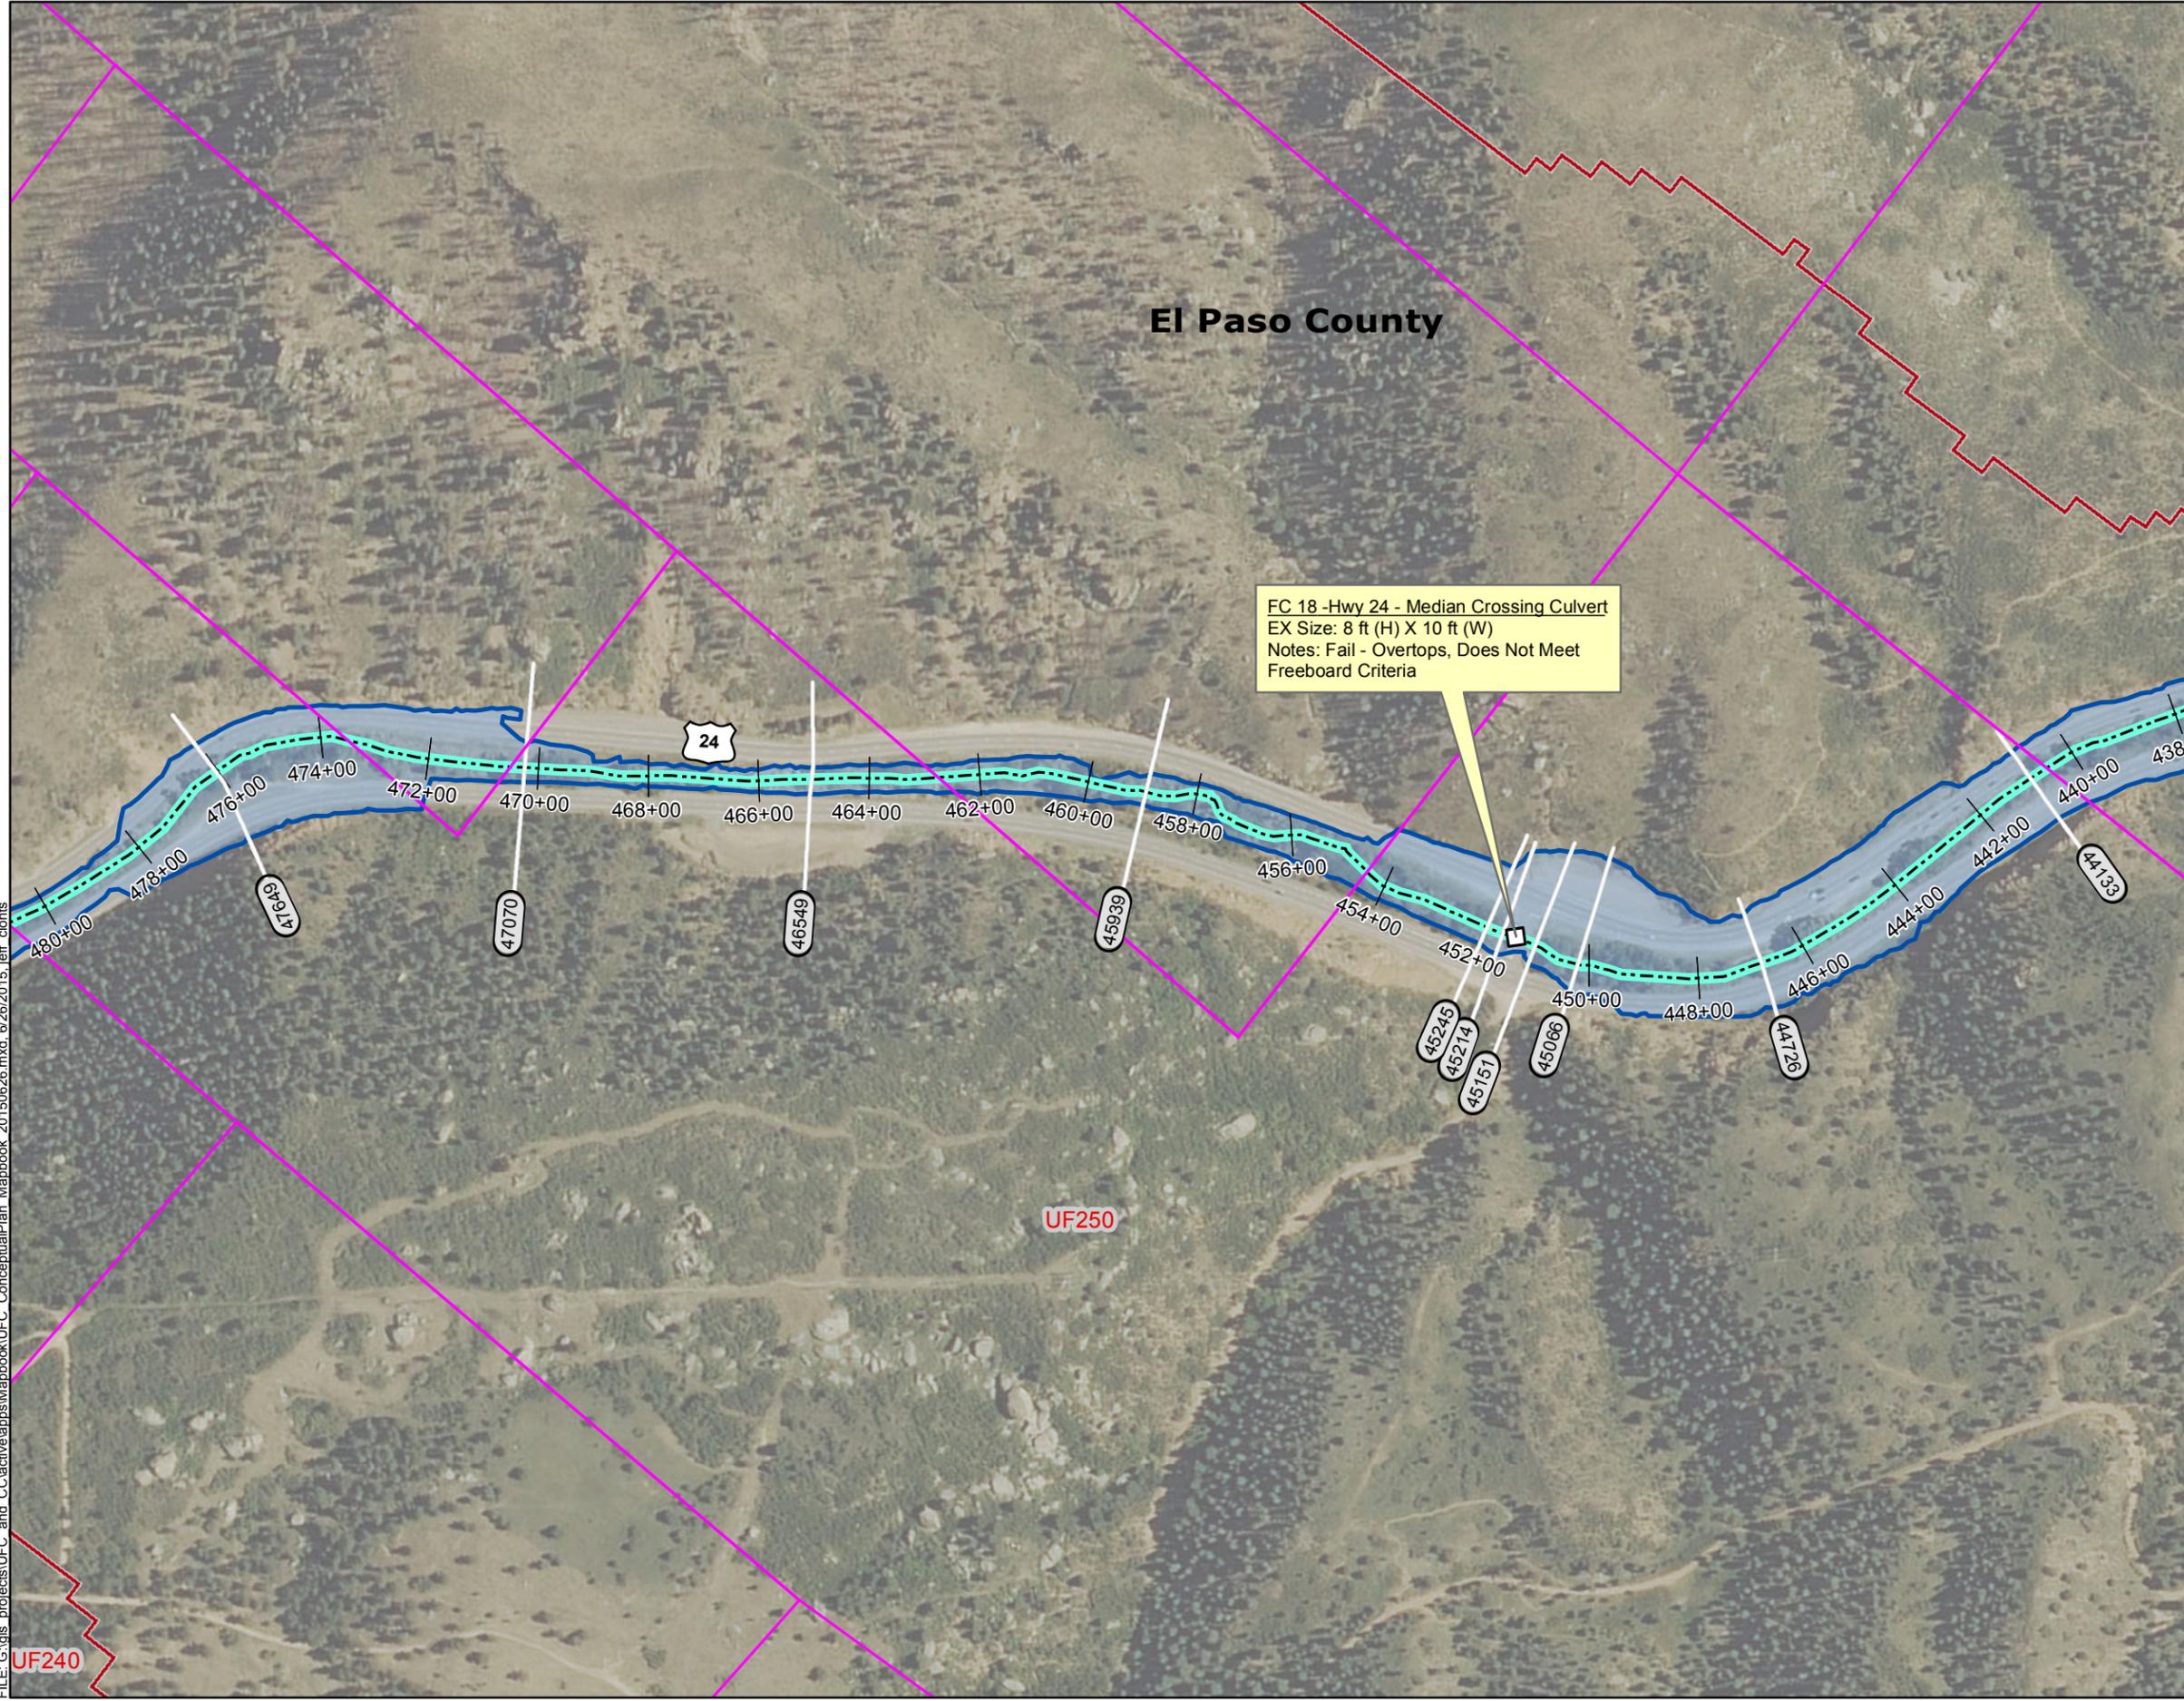
FC 18 - Hwy 24 - Median Crossing Culvert
EX Size: 8 ft (H) X 10 ft (W)
Notes: Fail - Overtops, Does Not Meet Freeboard Criteria

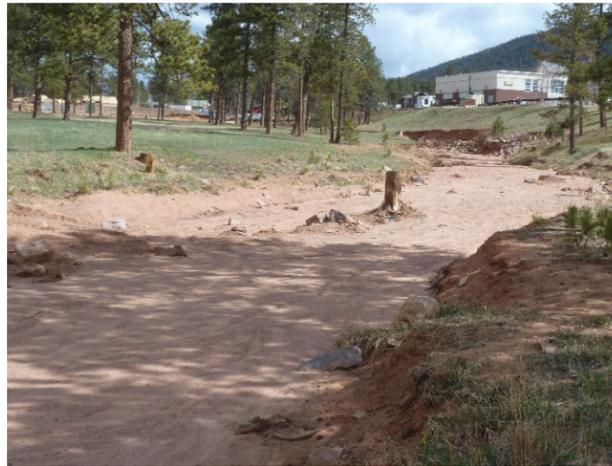
Figure 3-1. Bank 101 Erosion Example

UFCP-01: Sediment Supply Bank 101

This project is a sediment supply bank contributing a total of 490 tons/year of sediment to Upper Fountain Creek. Stabilization requires using bank stabilization and natural channel design methods.

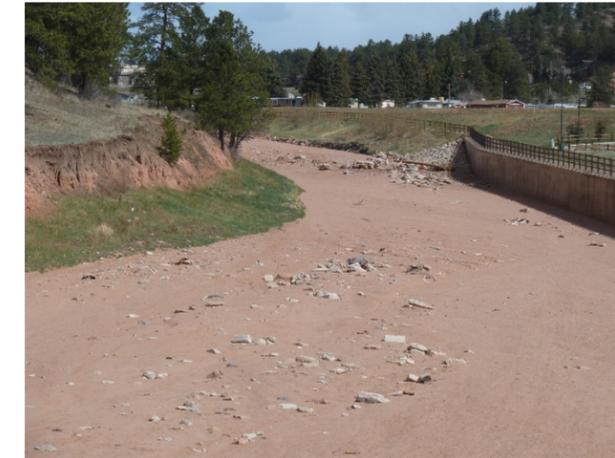
Figure 3-2. Bank 102 Erosion Example

UFCP-02: Sediment Supply Bank 102

This project is a sediment supply bank contributing a total of 2600 tons/year of sediment to Upper Fountain Creek. Stabilization requires using bank stabilization and natural channel design methods.

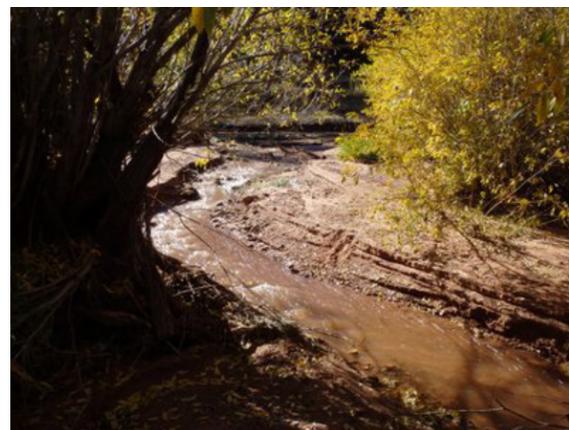
Figure 3-5. Bank 10 Erosion Example

UFCP-19: Sediment Supply Bank 10

This project is a sediment supply bank contributing a total of 240 tons/year of sediment to Upper Fountain Creek. Stabilization requires using bank stabilization and natural channel design methods.

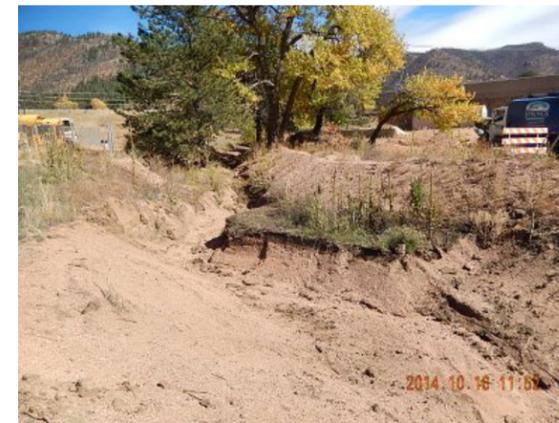
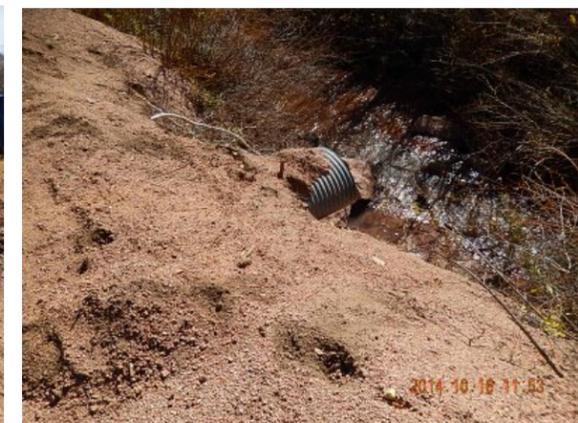
Figure 3-7. Sand Gulch Erosion and Culvert

UFCP-31, 32, 33, 34: Sand Gulch Tributary Confluence Improvements

This grouping includes improvements to the confluence of the Sand Gulch Tributary and Upper Fountain Creek. Sub-projects include bank and channel stability control, major erosion reduction, the addition of a sediment basin with a volume of approximately 6 ac-ft and the stabilizing of bank 35 (175 tons/year of sediment) and bank 65 (227 tons/year).

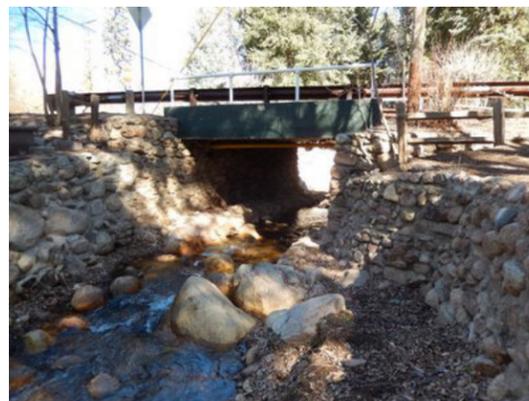
Figure 3-9. Stratton Ave Bridge

CC-P18: Stratton Ave Bridge

This project consists of replacing the bridge on Stratton Ave spanning Cheyenne Creek. The crossing does not pass the 100-yr flow and the project will aid with flood risk reduction.

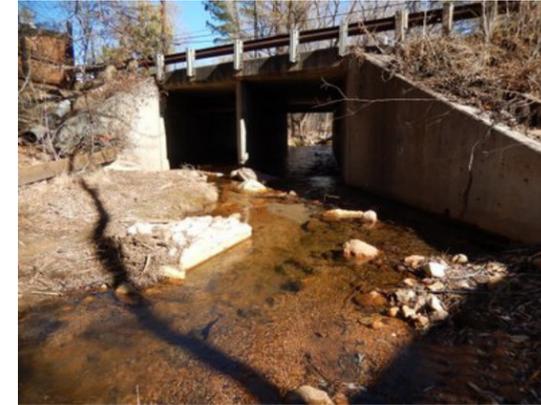
Figure 3-10. Cresta Road Bridge

CC-P23: Cresta Road Bridge

This project consists of replacing the bridge on Cresta Road spanning Cheyenne Creek. The crossing does not pass the 100-yr flow, and the project will aid with flood risk reduction.

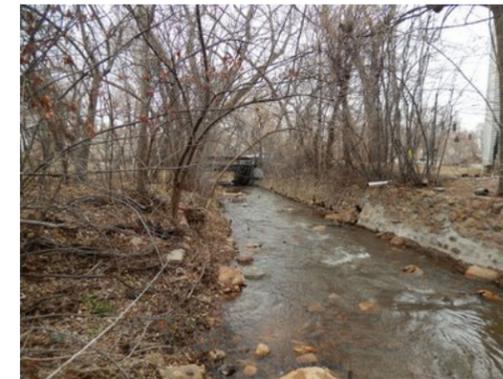
Figure 3-11. Cheyenne Road Bridge

CC-P45: Cheyenne Road Bridge

This project consists of replacing the bridge on Cheyenne Road spanning Cheyenne Creek. The crossing does not pass the 100-yr flow and creates a large backwater negatively affecting the upstream neighborhood. Project will aid with flood risk reduction.

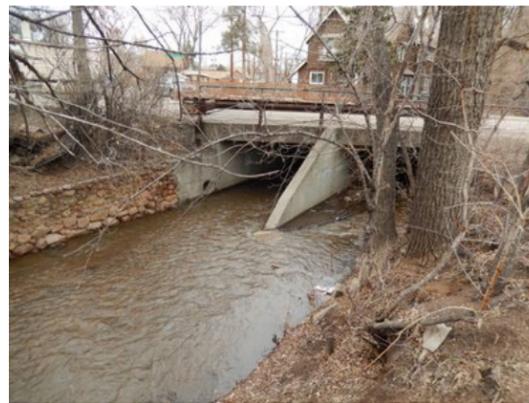
Figure 3-13. Brookside St. Bridge

CC-P51: Brookside Street Bridge

This project consists of replacing the bridge on Brookside Street spanning Cheyenne Creek. The crossing does not pass the 100-yr flow and creates a large backwater negatively affecting the upstream neighborhood. Project will aid with flood risk reduction.

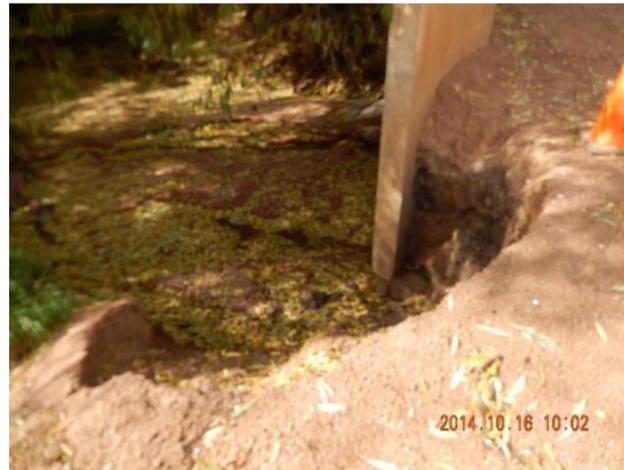
The reach extending from the CR21 Bridge to the El Paso County border is characterized by a channel of unconsolidated sandy alluvium that has been accumulating during past number of years. Flows are perennial upstream of the confluence of Crystola Canyon Creek just upstream from the Creekside Rd culverts. Crystola Canyon Rd crosses Upper Fountain Creek via a single arch concrete span at a fairly wide section of the floodplain. The 2013 and 2014 flooding events exceeded the capacity of the creek, inundated the floodplains and deposited excess sediment on the floodplains adjacent to the upstream face of the bridge. According to witnesses, the bridge was overwhelmed during the September 2013 flood curtailing access to the residences on the southwest side of the creek. The excessive sediment deposition on the floodplain has affected the drainage and caused minor seepage into adjacent buildings.

Figure 6-1. Crystola Canyon Rd Bridge Downstream Abutment

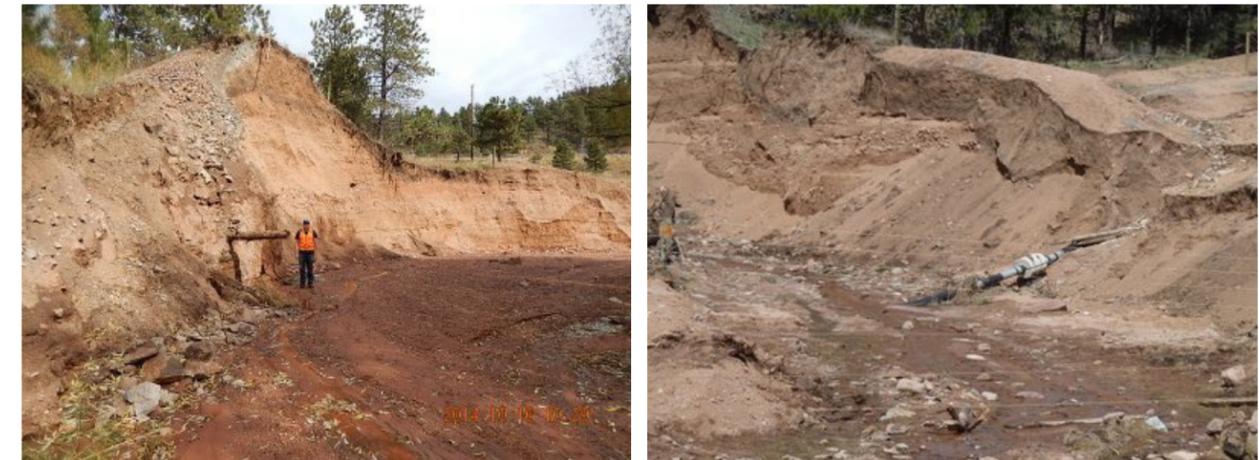
Figure 6-3. Bank Erosion Above Pinecrest Stables

Located approximately 1 mile downstream and east of the El Paso-Teller county line, the Pinecrest Stables suffered significant effects during from the 2013 and 2014 storm events. In addition to private access being affected, the stream channel and banks throughout this reach are unstable and eroding at an accelerated pace. Extensive sedimentation has occurred along the floodplain that is being grazed and compacted by the stable's horses. The unstable channel and banks extend upstream and will require bank and channel stabilization and grade control.

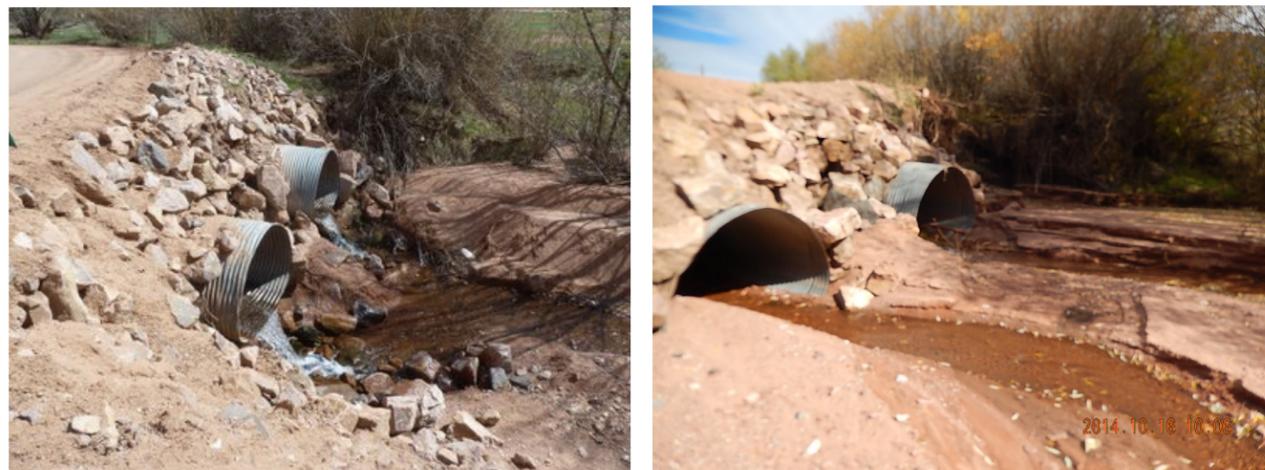
Located approximately 200 feet downstream of the Crystola Canyon Rd bridge crossing, Creekside Rd crosses Upper Fountain Creek through a pair of 60 inch CMP culverts. The upstream inverts of the culverts are buried in the accumulated sediment and the downstream inverts have filled with sediment from a deficit of nearly 2 feet in the spring of 2014. This reach requires expanded capacity and significant grade control through the Creekside Rd and Crystola Canyon Rd crossings.

Figure 6-2. Creekside Rd April 2014 (left) and October 2014

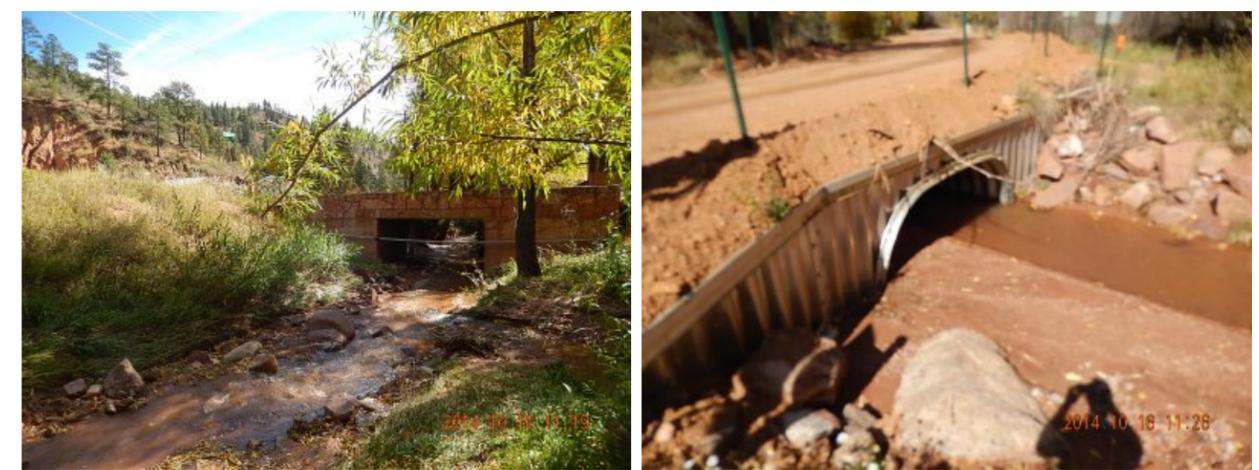
Two bridges that access El Paso Ave in Green Mountain Falls have limited capacity and may affect the residences and municipal properties on El Paso Ave. Both bridges are overtopped during the 10-year and greater storms.

Figure 6-4. Hotel St/ El Paso Ave Access in Green Mountain Falls

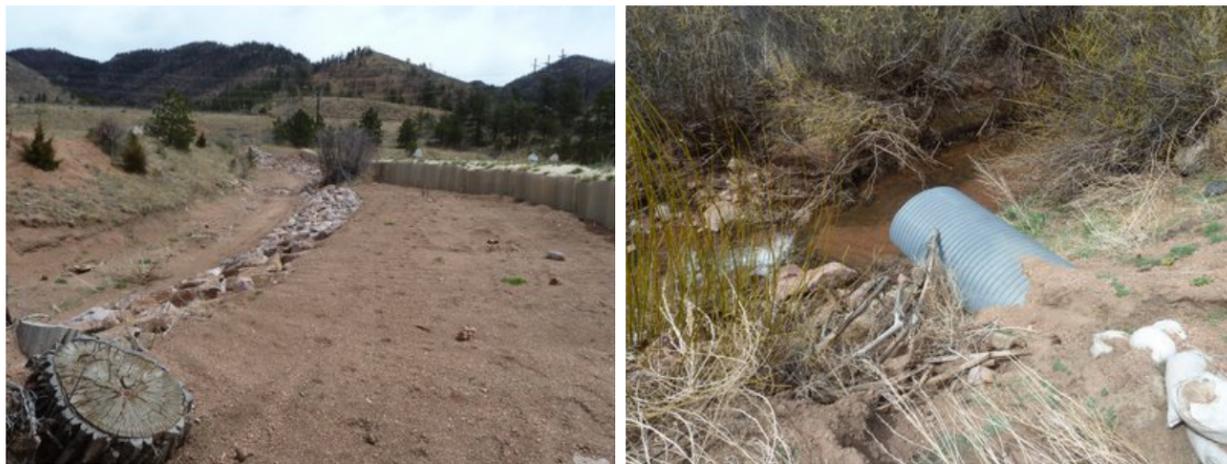
Below US24, Sand Gulch exits the highway culvert and flows in a channel past the Ute Pass School. This channel has been lined with trap bags to prevent flood water from inundating the school and school grounds. Below the school grounds, Sand Gulch flows through a culvert passing beneath Chipita Park Rd and two adjacent properties. The outfall into Upper Fountain Creek is perched approximately 3 feet above the invert of the creek.

Figure 6-5. The Lower channel section and outfall of Sand Gulch

Flood mitigation of the lower reach and culverts is required. Channel stabilization and grade control in the reach between the US24 culvert and the Chipita Park Rd culvert is advisable. Further hydraulic analyses of flood heights and discharges will be required for design of a channel and banks that can convey the discharge that has been attenuated by the EPC and CDOT sediment basins. This analysis will also be recommended for design and construction of a new Chipita Park Rd culvert with increased capacity. EPC has indicated the intention to purchase and remove the two private properties adjacent to the Sand Gulch outfall. Recommended mitigation measures for the confluence include, bank and channel stability, grade control, drop structures and possible additional sediment basin.

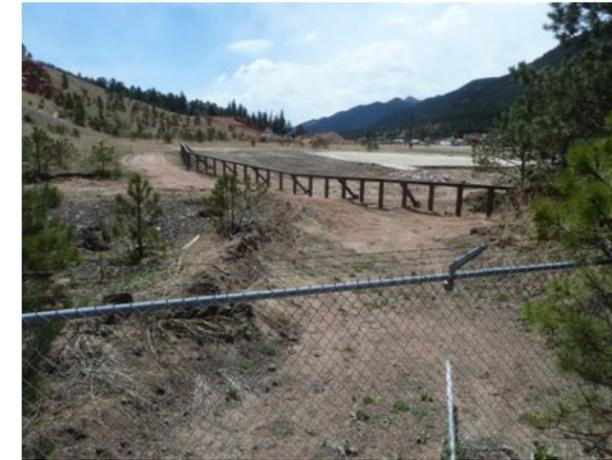
Wellington Gulch was burned during the Waldo Canyon Fire and exhibits excessive sediment transport and accumulation in the reaches east of US24. Similar to the emergency response actions in Sand Gulch, CUSP, EPC, and CDOT have installed sediment basins, debris rack, and erosion control in the reach upstream of US24.

Figure 6-6. Sediment Catchment Facility at in Lower Wellington Gulch

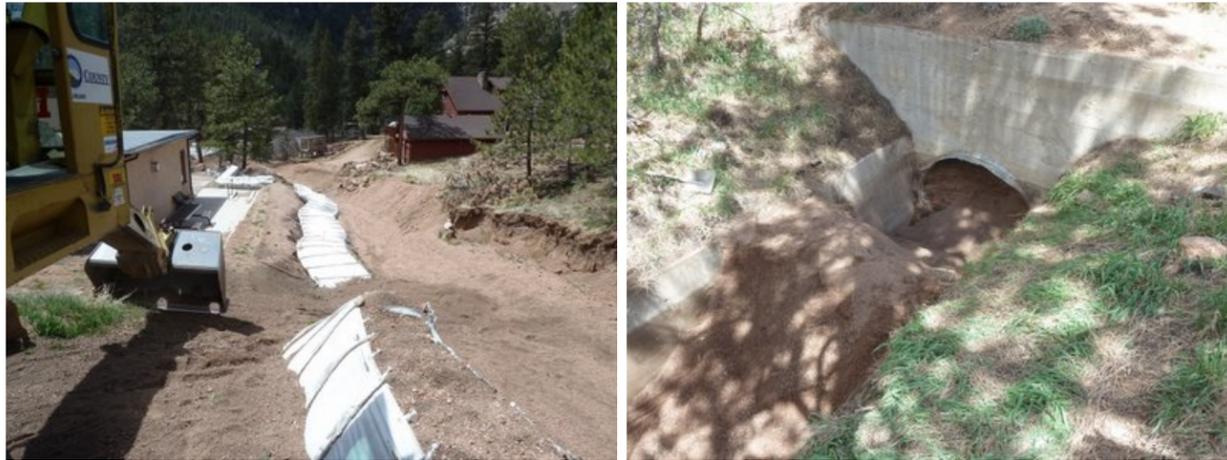
East Cascade Creek drains the Pyramid Mountain area of the Waldo Canyon Fire scar. Considerable work has been done in the upper reaches of East Cascade Creek by EPC and the U.S. Forest Service (USFS) following the Waldo Canyon Fire Watershed Assessment of River Stability and Sediment Supply (WARSSS) Report. The effects of the fire were widespread throughout this tributary to Upper Fountain Creek and the post fire mitigation efforts include revegetation, hill slope, stream bank, channel stabilization, and installation of sediment catchment basins.

Figure 6-7. Trap Bags and Blocked Culvert in East Cascade Canyon
