FINAL REPORT

Upper Fountain Creek and Cheyenne Creek Flood Restoration Master Plan

Fountain Creek Watershed Flood Control and Greenway District

June 26, 2015

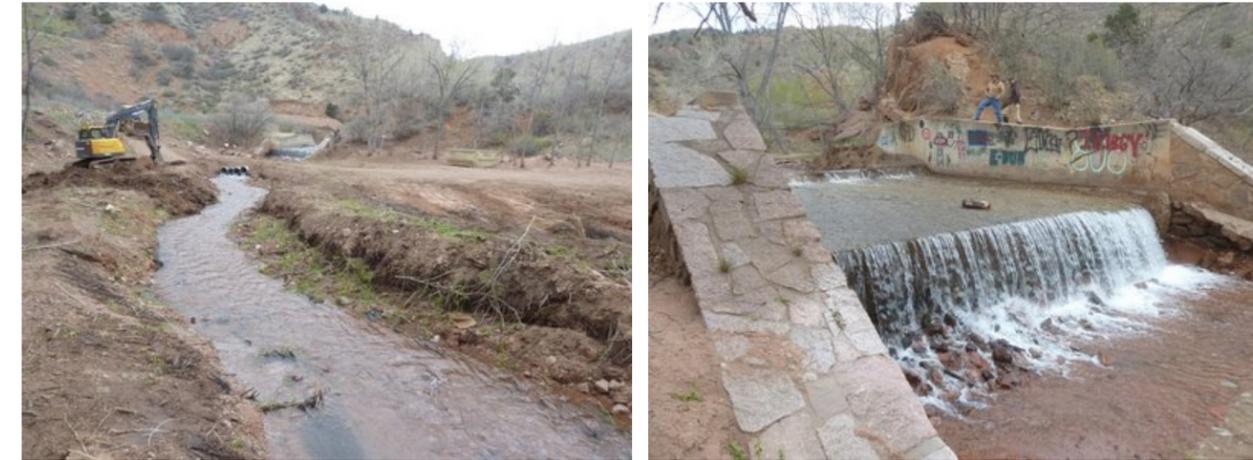
Below Waldo Canyon, the effects of the flooding in 2013 exposed a historic sediment catchment basin that was installed by the Civilian Conservation Corps in the 1930's. The basin had been filled for many years and was excavated for continued use by EPC in 2014.

Figure 6-8. CCC Designed and Renovated Sediment Catchment above Rainbow Falls
