Slate River, Gunsight Reach

Prediction Level Assessment of River Stability and Recommendations for Alleviating Instability Consequences

**Mark Beardsley, M.S.
February 19, 2014**

Prepared for: The Crested Butte Land Trust

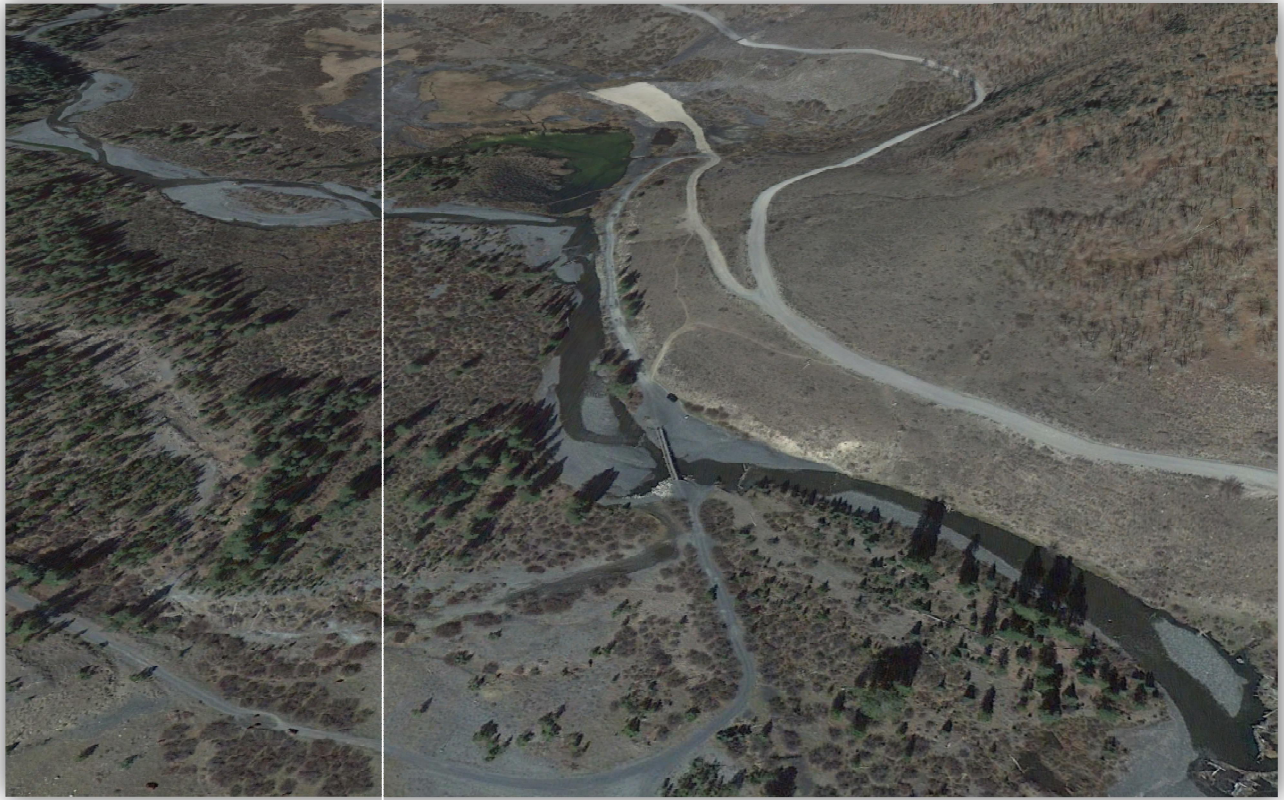
Figure 1: Oblique View of the Gunsight Reach

The study area for this project is a reach of the Slate River at the Gunsight Bridge on Crested Butte Land Trust (CBLT) property (**Figure 1**).

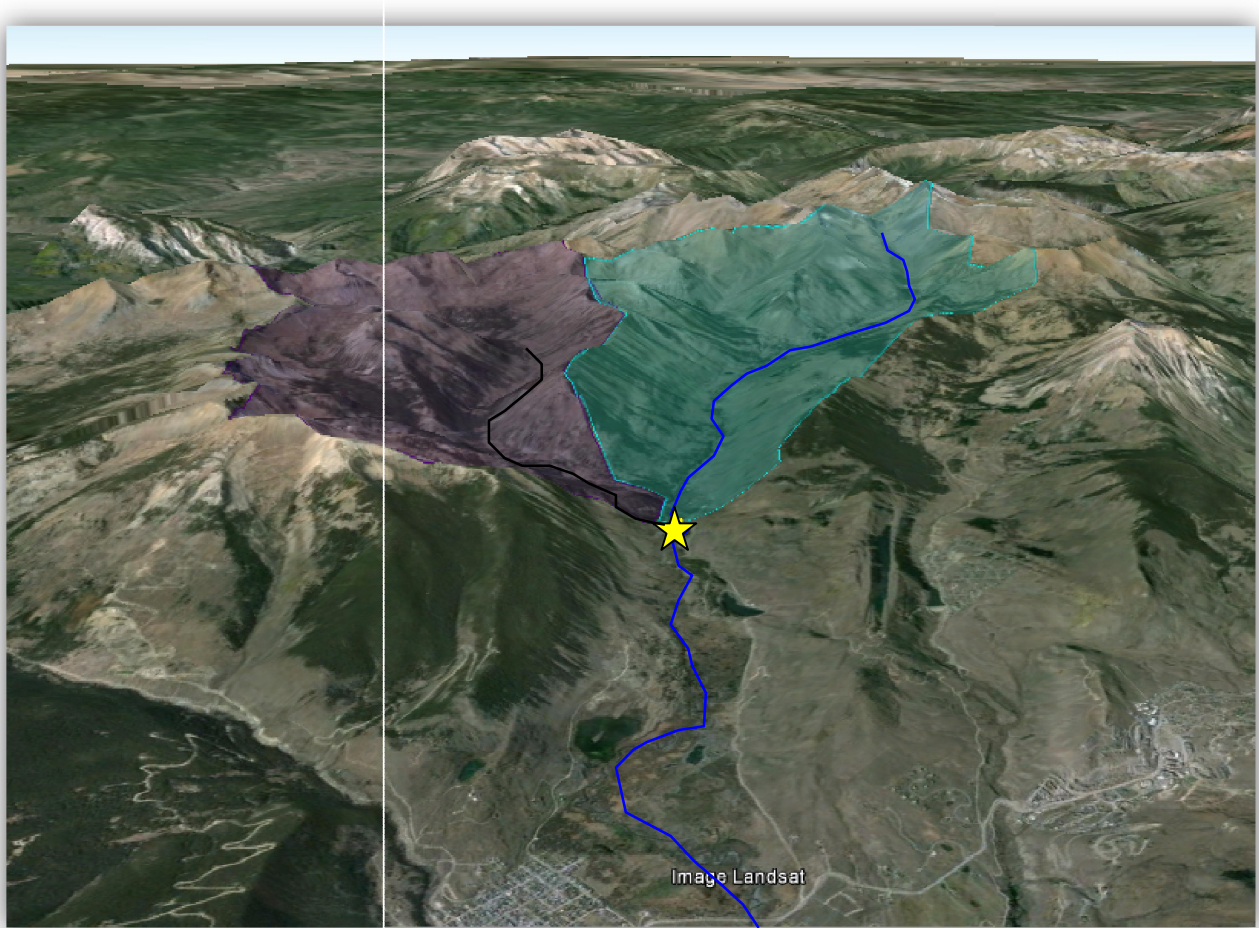
Figure 3: Oblique View of the Contributing Watershed

The approximate alignment of Slate River is shown by the blue line. The Shaded areas show the contributing watersheds including the Upper Slate (light blue) and Oh-Be-Joyful (purple) which joins the slate just upstream from the Gunsight Reach (yellow star). The Town of Crested Butte is visible in the foreground.

Our 2012 report contains a detailed qualitative assessment of these watersheds which can be summarized succinctly as follows. Most of the watershed area is undeveloped public land and/or wilderness. Human stressors on hydrology or flow regime are few and mostly insignificant. The natural snowmelt-driven hydrograph dominates, and there are probably just minor impacts to peak or base flow magnitudes, duration, and timing.

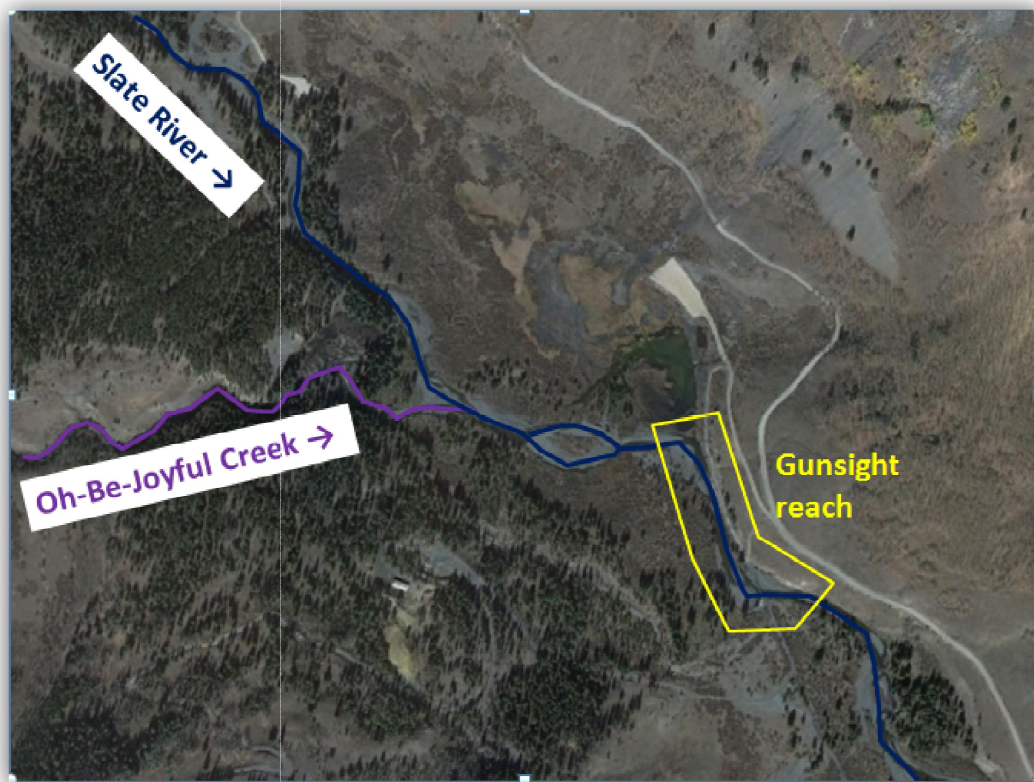
Figure 4: Reach Context

The Slate River is a braided D4 stream below Oh-Be-Joyful Campground and through the confluence of Oh-Be-Joyful Creek, and the braided condition appears to be the natural functional form. The braided stream form is very dynamic and greatly influenced by beavers, woody debris, and log jams. Below Oh-Be-Joyful Creek, the river flows diagonally across its valley in this channel form until it encounters the left edge of the valley which it hits at an almost perpendicular angle. This nearly 90-degree turn marks the upper end of the Gunsight Reach study area (**Figures 4, 5**) and the point where the channel becomes single-threaded and best described as C4.

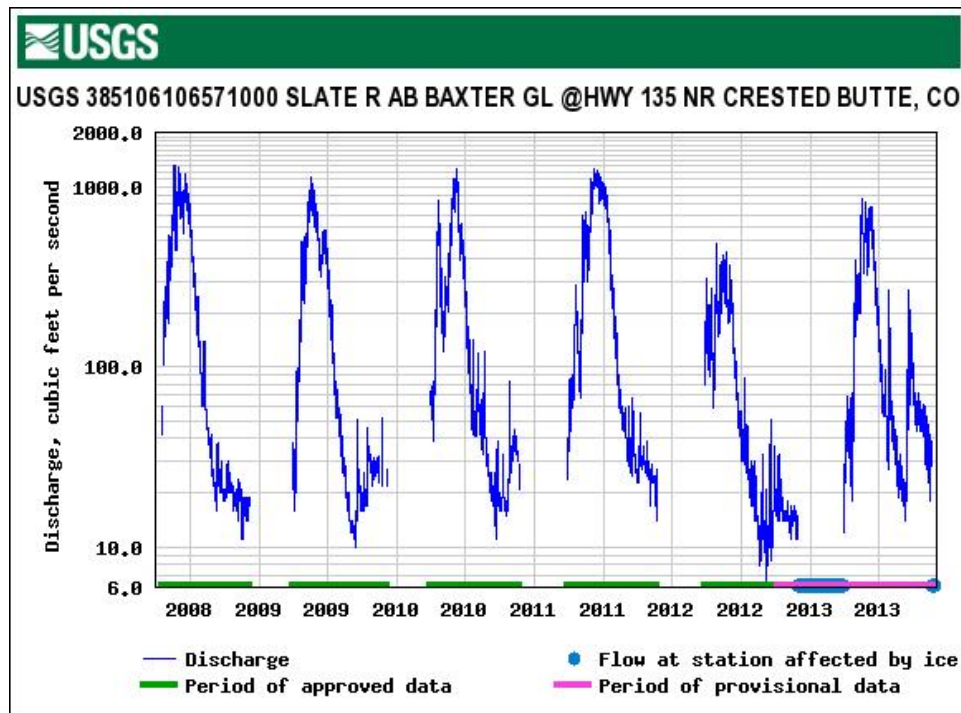
Figure 12: USGS Gauge Data for Slate River Above Baxter Gulch

Bankfull discharge is estimated to be approximately 500 cubic feet per second (CFS). This value was obtained by two methods. First, historic data from the USGS gauge above Baxter Gulch indicates a fairly consistent regular annual peak flow on the order of 1100 CFS (**Figure 12**). We did not see the need to calculate return intervals for this small data set, knowing that the level of precision would not be improved much over the simple observation that, aside from the two most recent drought years, peak flows during runoff were consistently in the range of 1200-1400 CFS. The average over all six years of record is approximately 1100 CFS which is probably close to a 1.5-year return interval and a reasonable approximation of bankfull discharge at that location. Drainage area at the gauge site is 73.4 mi², and if we assume a constant relationship of bankfull discharge per unit of drainage area for the contributing watershed, then bankfull discharge at the study site can be calculated from drainage area at that site which is 33.6 mi². This calculation results in a bankfull discharge estimate of about 500 CFS at the Gunsight Reach.

Gauge data from the Slate River above Baxter Gulch indicates regular peak flows in the range of 1200-1400 CFS at that location with a mean of about 1100 CFS. These data can be extrapolated to estimate peak flows at the study site using a constant drainage area relationship.

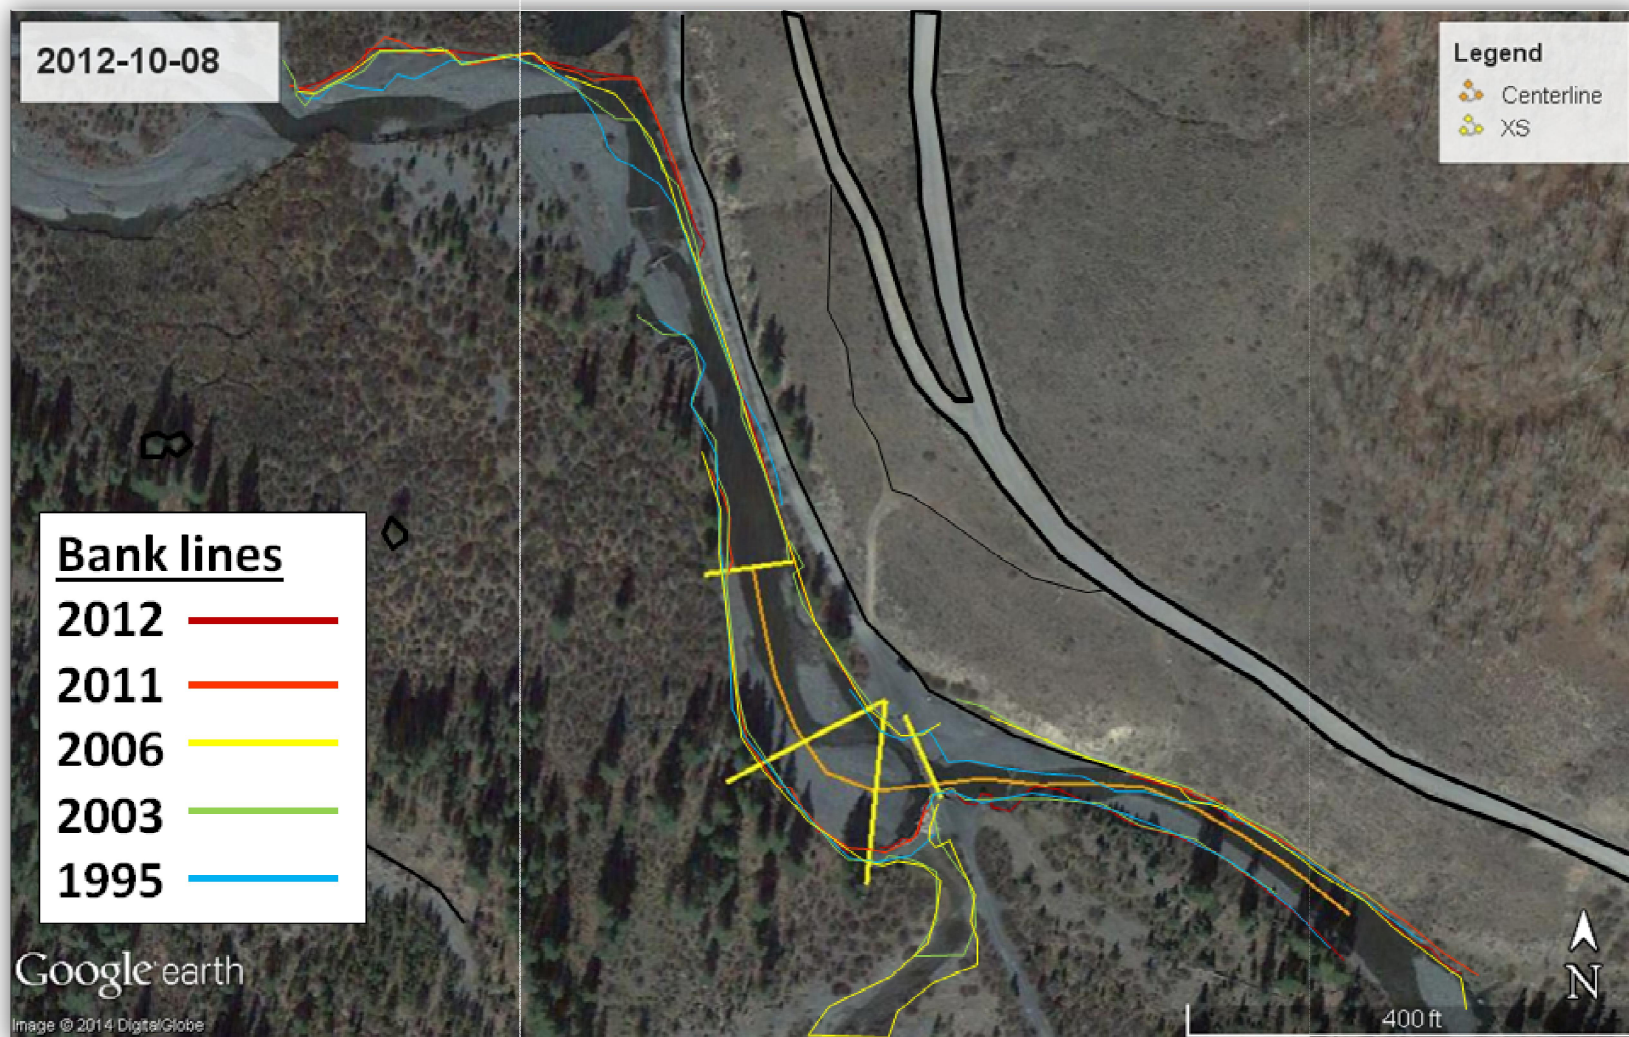
Figure 13: Historic Bank Lines for the Gunsight Reach

Channel migration and morphology changes over the past 18 years were documented by analyzing historical aerial photos going back to 1995. The analysis was performed on both the study reach and the braided reach upstream. **Figure 13** shows results for the study reach, and **Figure 14** shows the reach upstream. The level of precision of this method is not great, but locations with significant bank erosion, channel migration, and morphological changes are identifiable. On the study reach, there are two locations where such changes are detectable. The upper portion of the reach, where the river makes a sharp right turn just before meeting the Gunsight Pass Road is the site of significant migration and bank erosion (**Figure 15**). The left bank appears to have moved about 42 ft to the left over 18 years, with a mean migration rate of 2.3 ft/yr. This observed rate is similar but slightly greater than predicted rates of bank erosion made using the BANCS model in section 3.7 which were on the order of 1.2 to 1.8 ft/yr for these segments.

Historic bank lines are shown on the most recent imagery from 2012.

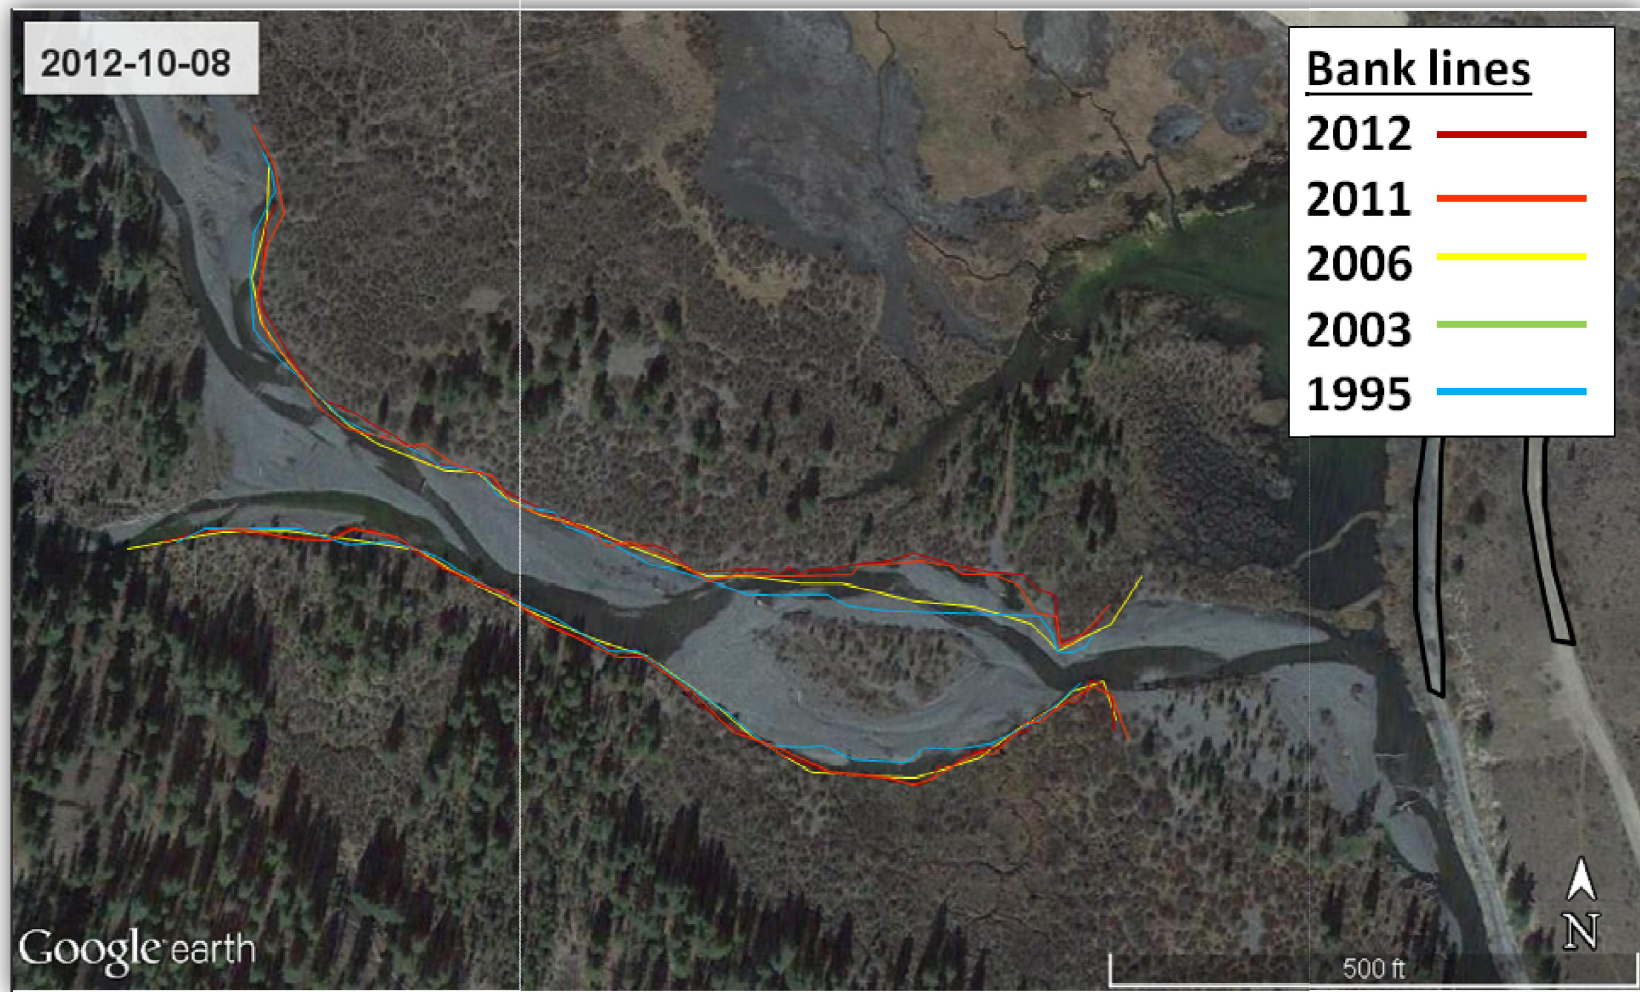
Figure 14: Historic Bank Lines for the Reach Above Gunsight

Historic bank lines are shown on the most recent imagery from 2012.

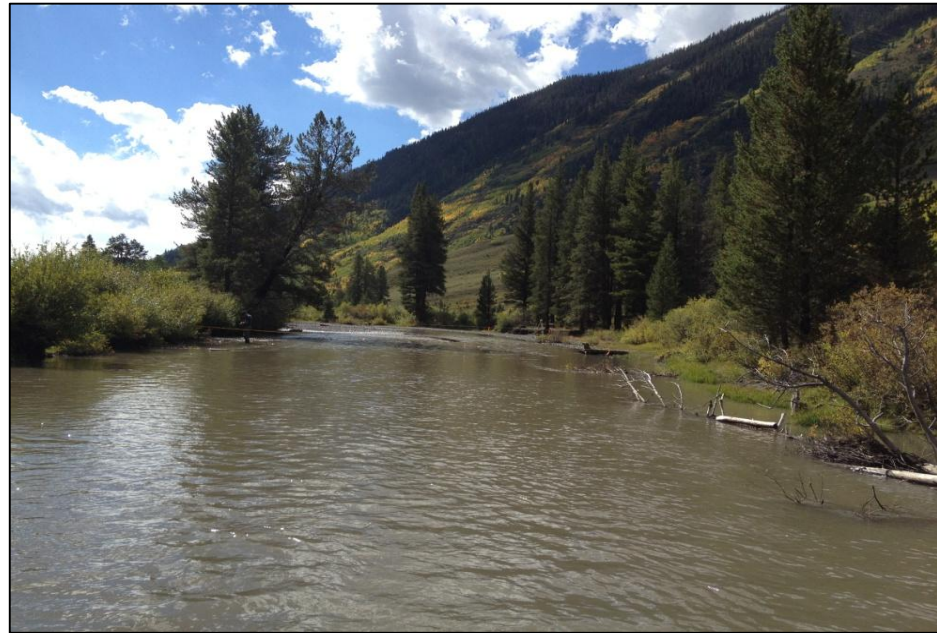
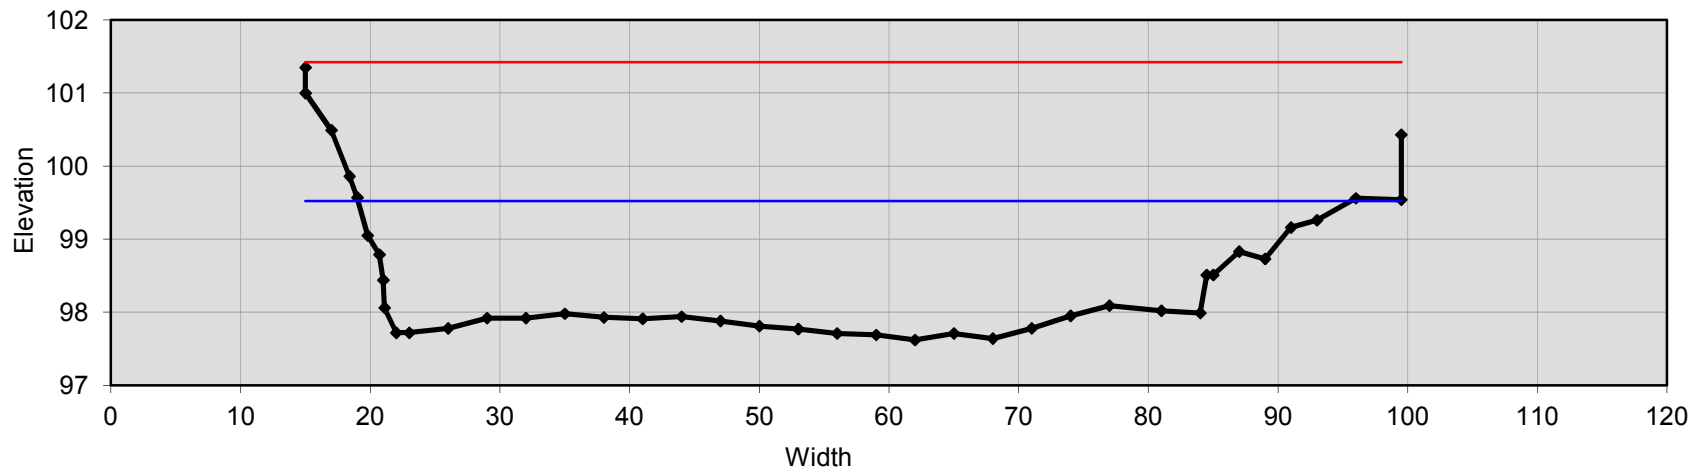
0 + 0 Slate river, Gunsight, Riffle

XS ID:	XS-000	Facet type:	Riffle
Station:	0	Class:	C4
Area (ft ₂)	117	BHR	1.0
Width (ft)	76	D _{max} /D	1.3
Depth (ft)	1.5	Slope %	0.51%
Max. depth	1.9	V (ft/s)	4.4
W/D	52	T (lb/ft ²)	0.46

Note: This XS is across the straight single-thread channel that parallels the Gunsight Road. It is presumably upstream of the influence from the slope change caused by bridge constriction.
