**South Platte River Restoration Design and  
Demonstration Project Final Report  
(April – June 2013)**

**April 3, 2015**

Prepared By:  
Ecological Resource Consultants, Inc

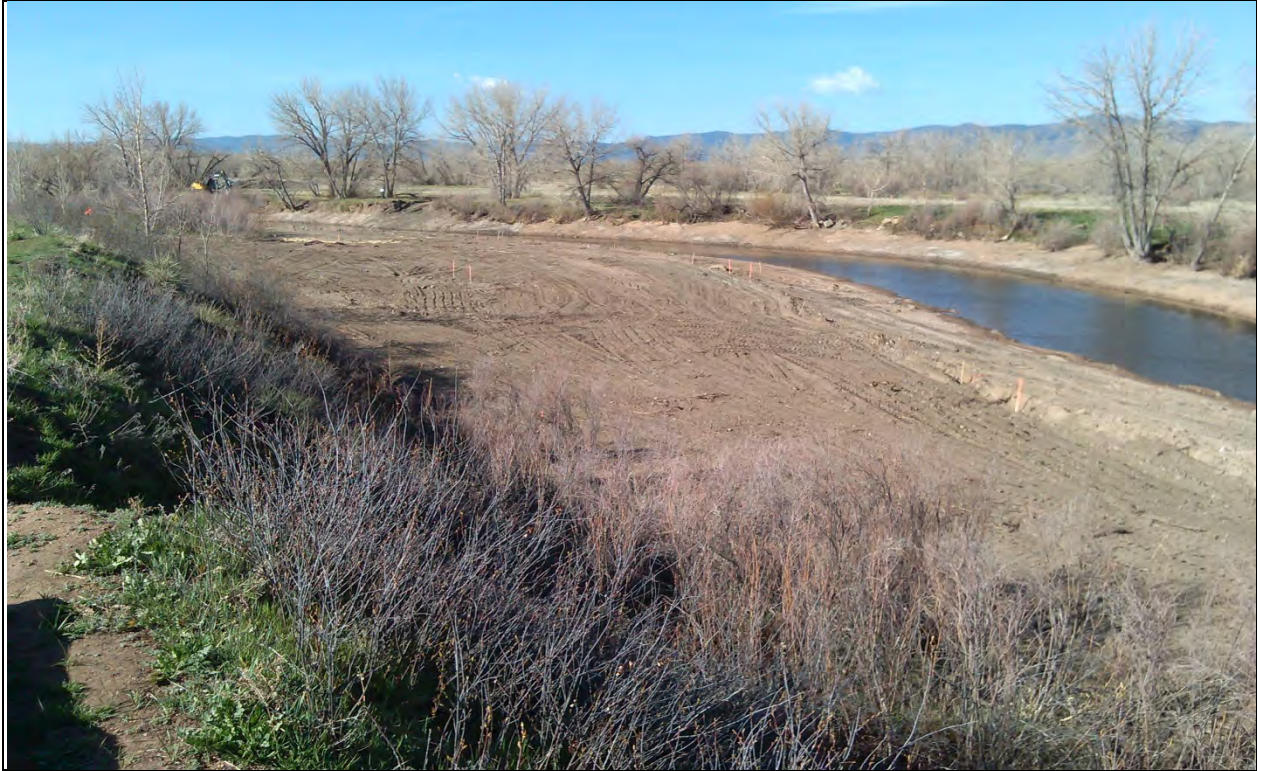
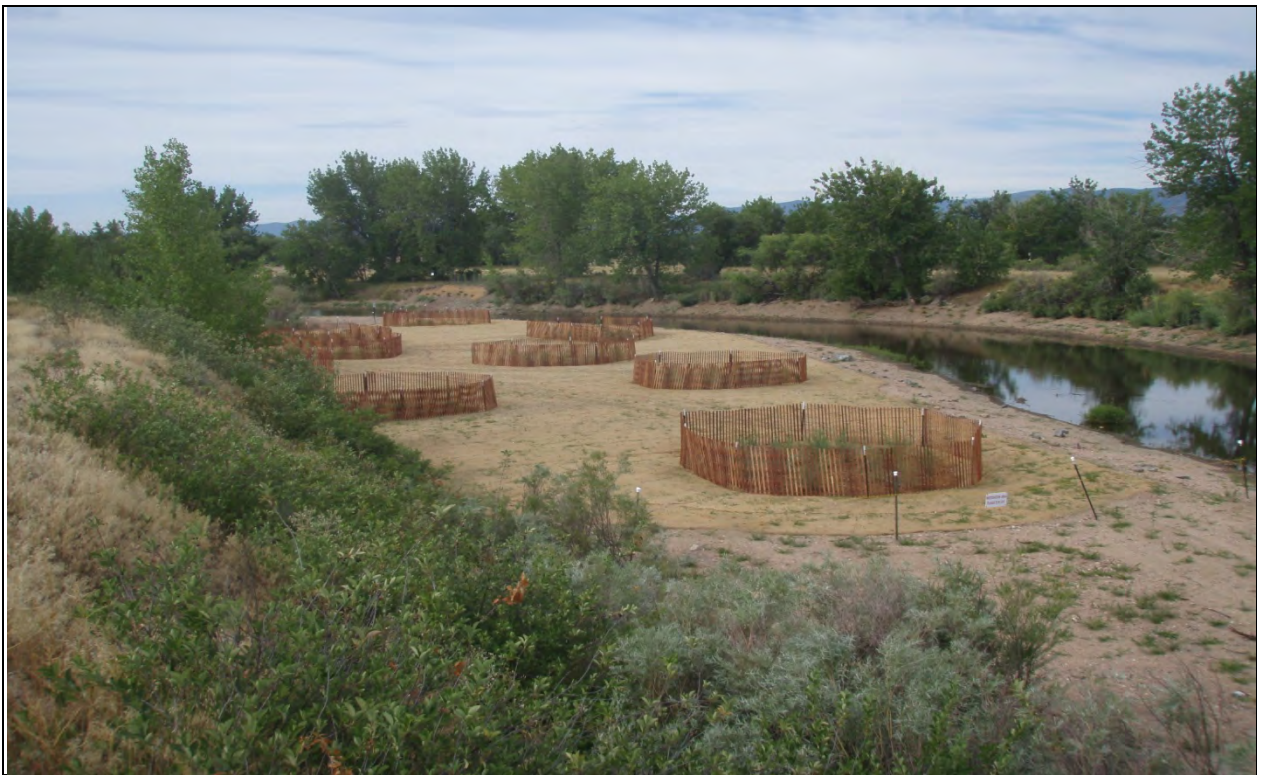
**Top:** Looking upstream at caving bank near Redtail Lake just after construction began (before).

**Bottom:** Type A bank stabilization installed to protect cut bank habitat (after).

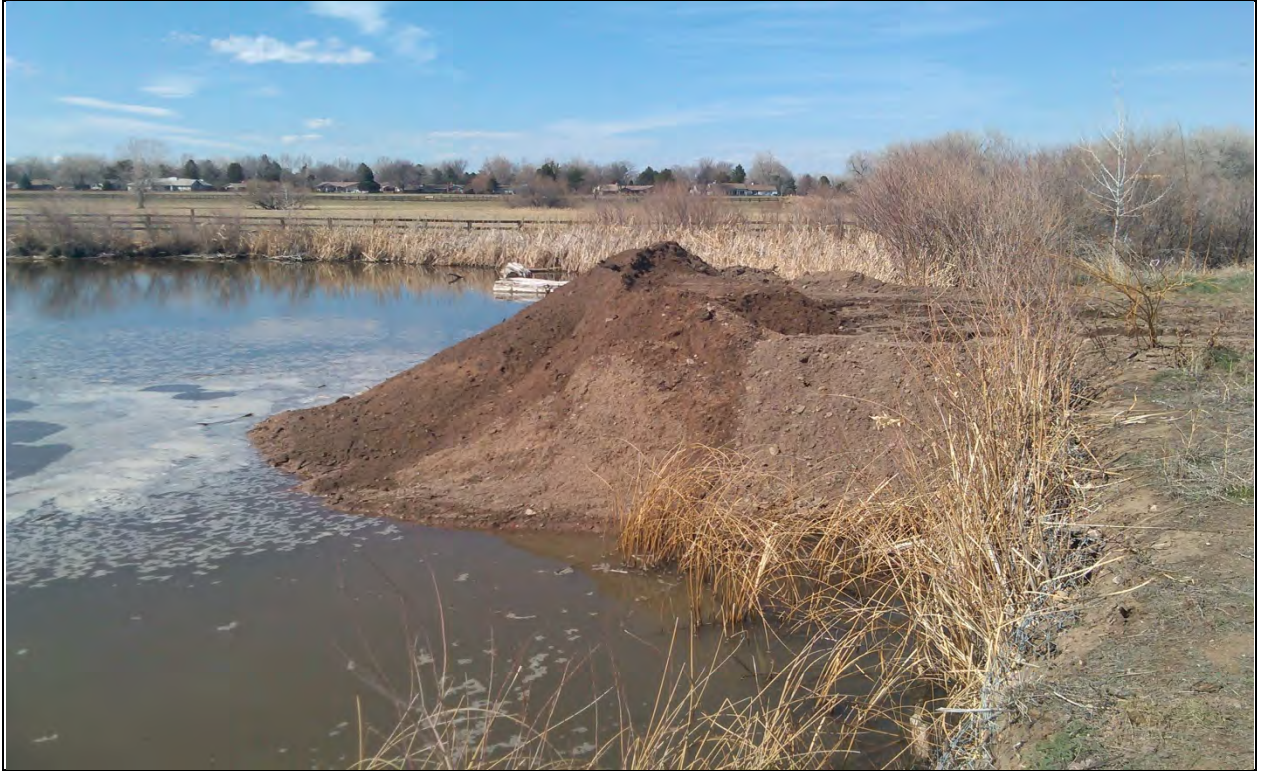
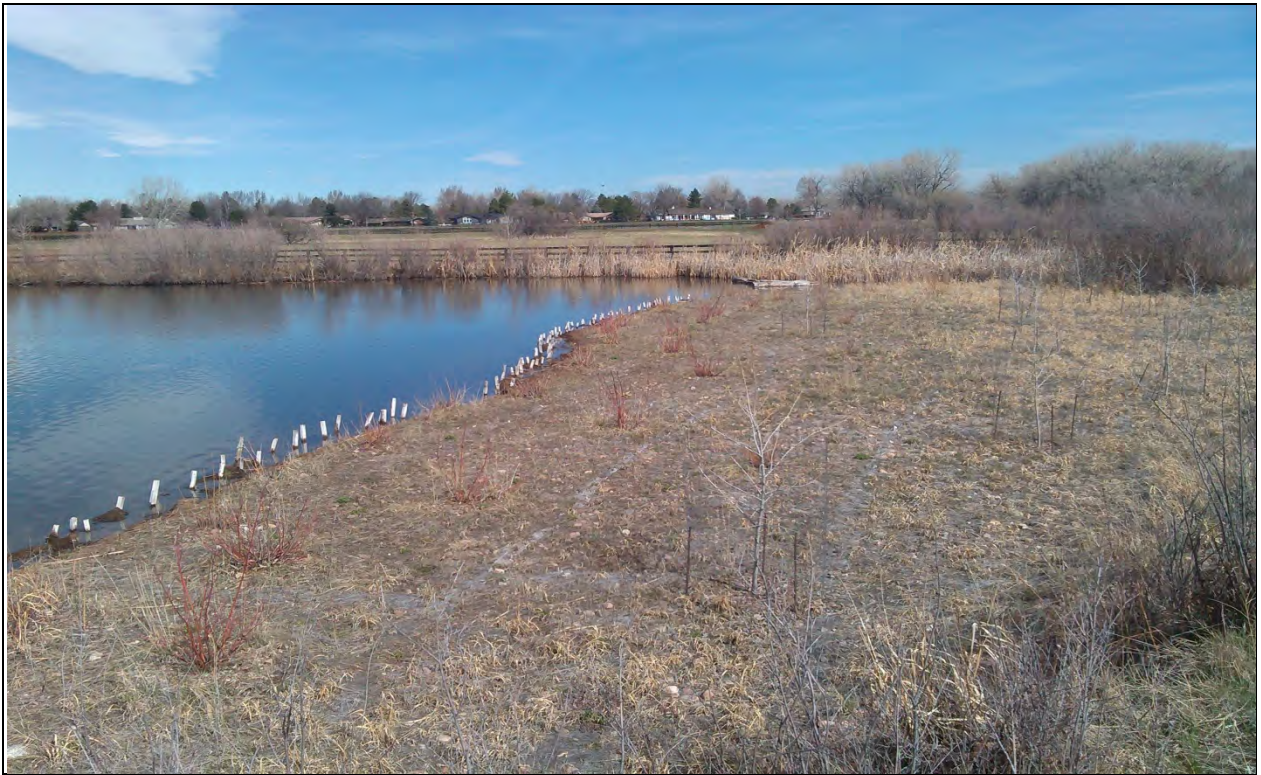
**Top:** Area of Redtail Lake marked for wetland creation (spoils staged).

**Bottom:** Wetland plugs established.
