Submitted to Bruchez and Sons, LLC P.O. Box 1359 Kremmling, CO 80459

Submitted by AECOM 804 Colorado Ave Suite 201 Glenwood Springs, CO 81601

ILVK Upper Colorado River Irrigation and Restoration Assessment Phase 1: K.B. Ditch to Blue River.

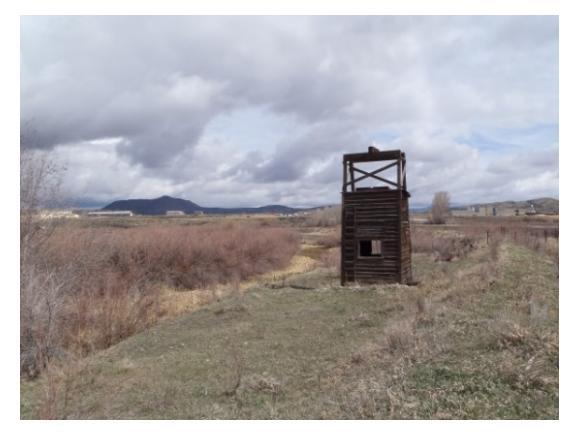
The S.D. 80 Pumps have undergone numerous repairs and upgrades over the years. The original pump stations consisted of a concrete wet well and wooden framed building on top, which housed the pump. Figure 1-2 shows a typical, original S.D. 80 Pump Station. A number of these pump stations are still in use and a few even have the original pumps. Of the eight S.D. 80 diversion structures owned by the ILVK (serving the McElroy No. 1 Ditch, McElroy No. 2 Ditch, T.A. Engle No. 1 Ditch, Thompson Pump No. 1, McElroy State Pump, Orr Pump No. 1, Orr Pump No. 2 and the Ennis Ditch Pump) two have been replaced due to changes in the river. The T.A. Engle No. 1 Ditch and the Thompson Pump No. 1 (a.k.a. Thompson Consolidated or Thompson ABC) pump stations were replaced in 1981 because channel incision (downcutting) and migration had left the intakes high and dry at normal flows. The remaining S.D. 80 Pumps largely use their original intakes.

Figure 1-2. Typical Senate Document 80 Pump Station.

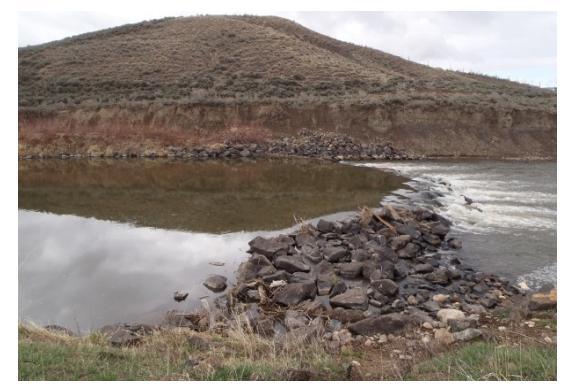
- These structures were installed with a curved planform with the centerline point the furthest downstream (Figure 1-3). This configuration forces water to flow against the bank and exacerbates bank erosion;
- The structures were installed without scour protection downstream which has allowed significant scour holes to form downstream of the structures leading to collapse of the structure;
- The structures were installed with limited preparation of the subgrade which has allowed for settling in certain locations, leading to collapse;
- The structures were constructed with only large boulder, leaving voids in the structure for water to flow through. The voids concentrate and accelerate flow with causes additional scour.

Figure 1-3. Diversion Drop Structure installed by Northern Colorado Water Conservancy District in 2004.

above described issues. These structures were replaced with new structures to demonstrate and test design criteria developed during this investigation.

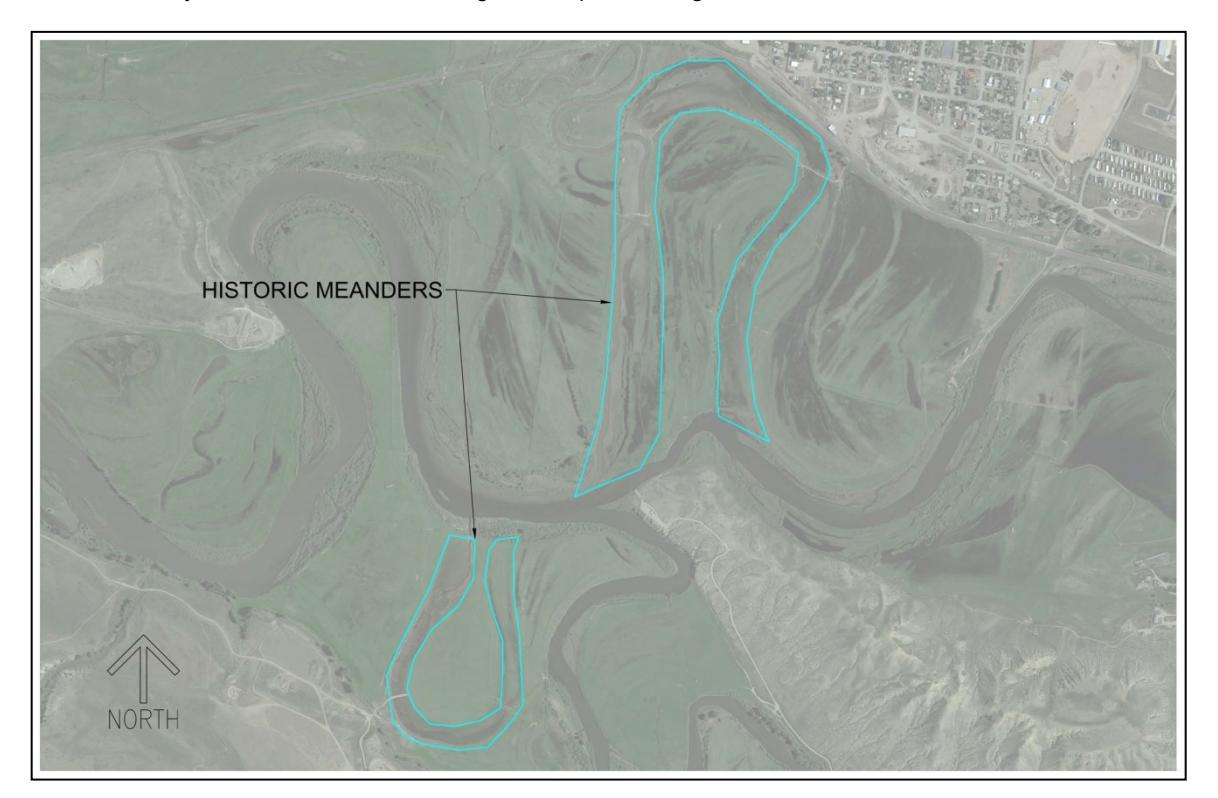
Headcuts can be caused by a variety of factors, both natural and human caused. Inspection of aerial photographs shows that there were two meanders downstream of the ILVK reach that have been cutoff from the main channel in recent geologic history. These are easily identified in the 2014 Google Earth photo in Figure 3-13.

Figure 3-13. Historic meanders evident in 2014 Google Earth Photo.

No information about the cutoff of the southwest meander was found, and it may be a historic Blue River channel. However, research discovered that early in the 20th century a channel was excavated that cutoff the northeast meander. Research of historic photographs indicates that this likely occurred between 1907 and 1914. The photos in Figure 3-14 show this meander on the McElroy Ranch. They were both taken from the ridgeline due north of the Town of Kremmling looking south towards the Eagle's Nest Range. The upper photo was taken between 1900 and 1907 and shows large meander close to Town. The scar of the historic meander is clearly evident in the lower photo, taken in 2010.

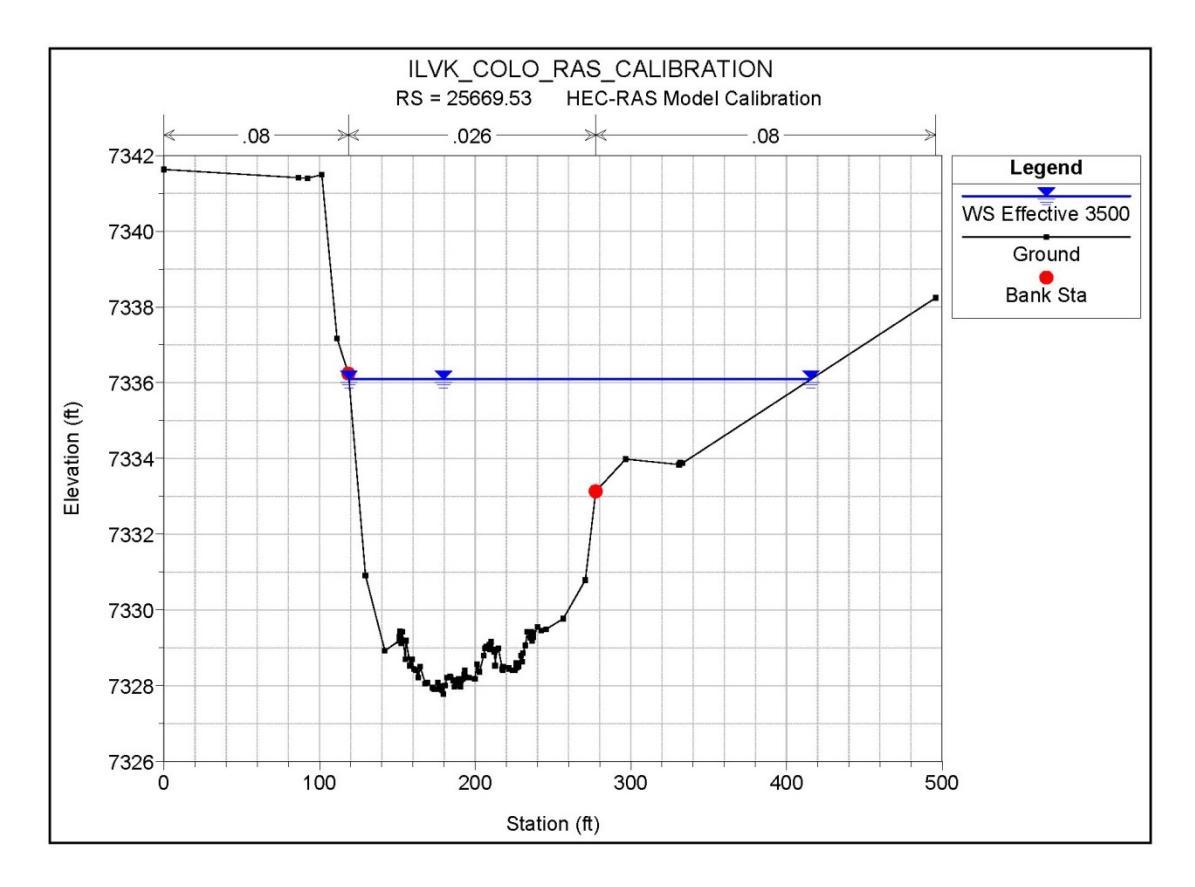
Figure 3-19. Typical Cross-section at bankfull flow.

Examination of the HEC-RAS results show that 3500 cfs is contained within the active channel at some of the cross-sections, but that for many of the cross-section 3500 cfs spills out of the active channel and onto deposition features such as point bars. Figure 3-19 shows a typical HEC-RAS cross-section at a discharge of 3500 cfs. The active channel is located between the two bank stations (red dots). On the right side of the right bank station there is the point bar (Station 280 to Station 500). This is the same point bar shown in Figure 3-18. Over the last 75 years this point bar has become vegetated. This vegetation causes deposition on the point bar during high flows. This deposition is slowly narrowing the channel over time.

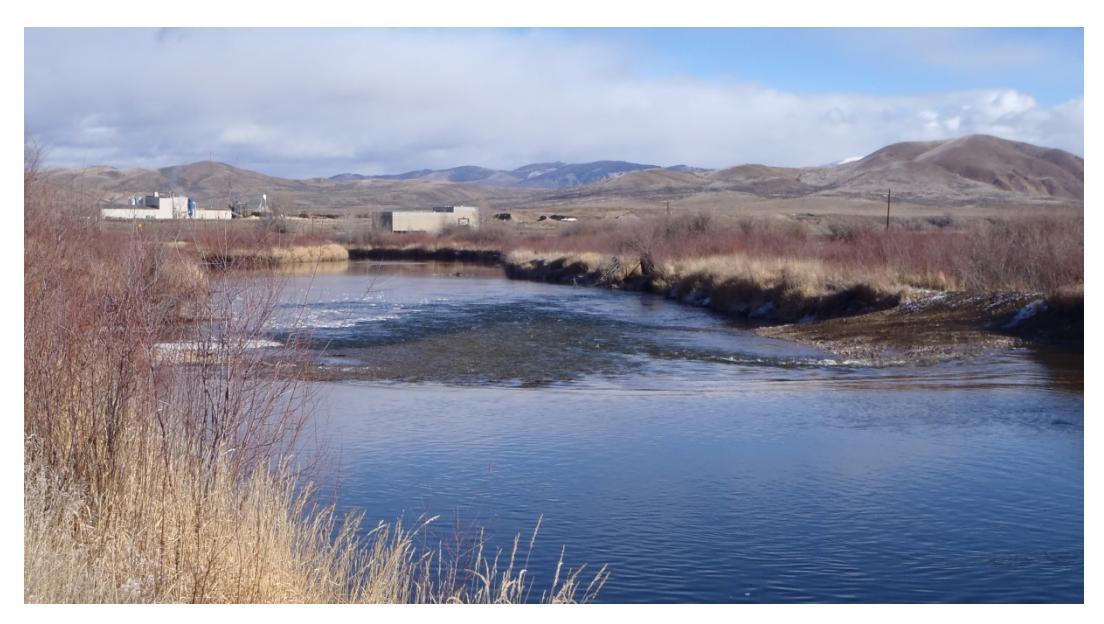
Figure 4-1 Grade Control Riffle at Riverside Ranch

These proposed Grade Control Riffles will provide adequate water surfaces for pumping operations while at the same time providing critical habitat. A demonstration Grade Control Riffle was constructed at the Thompson Consolidated Pump diversion in the fall of 2014 as a pilot project (Figure 4-1). The riffle was completed in early November 2014. Within a few months benthic invertebrates were found using the riffle habitat (Figure 4-2). The design of these riffles can be easily modified to include in-channel infiltration and/or sediment by-pass sluices.

A number of the ILVK diversion structures need to be replaced or reconfigured to improve intake performance. Several of them will require new grade control structures to replace those installed by Northern. These grade control structures should be designed to mimic a natural riffle as much as possible: what is being termed a "Grade Control Riffle" (Figure 4-1). The healthy, productive riffle at Brian's Bluff (see Figure 1-1) on Reeder Creek Ranch has a bed slope of approximately 0.25%. Constructing a slope as flat as 0.25% may not be achievable for these intake structures, but slopes should be minimized where possible.
