Bergen Ditch and Reservoir Company Loan Feasibility Study

**Colorado Water Conservation Board
Water Project Loan Program
August 2012**

**Rehabilitation of Bergen Reservoir No. 2
and Minor Improvements to Other Bergen Facilities
Located near C-470 and Bellevue
Jefferson County, Colorado**

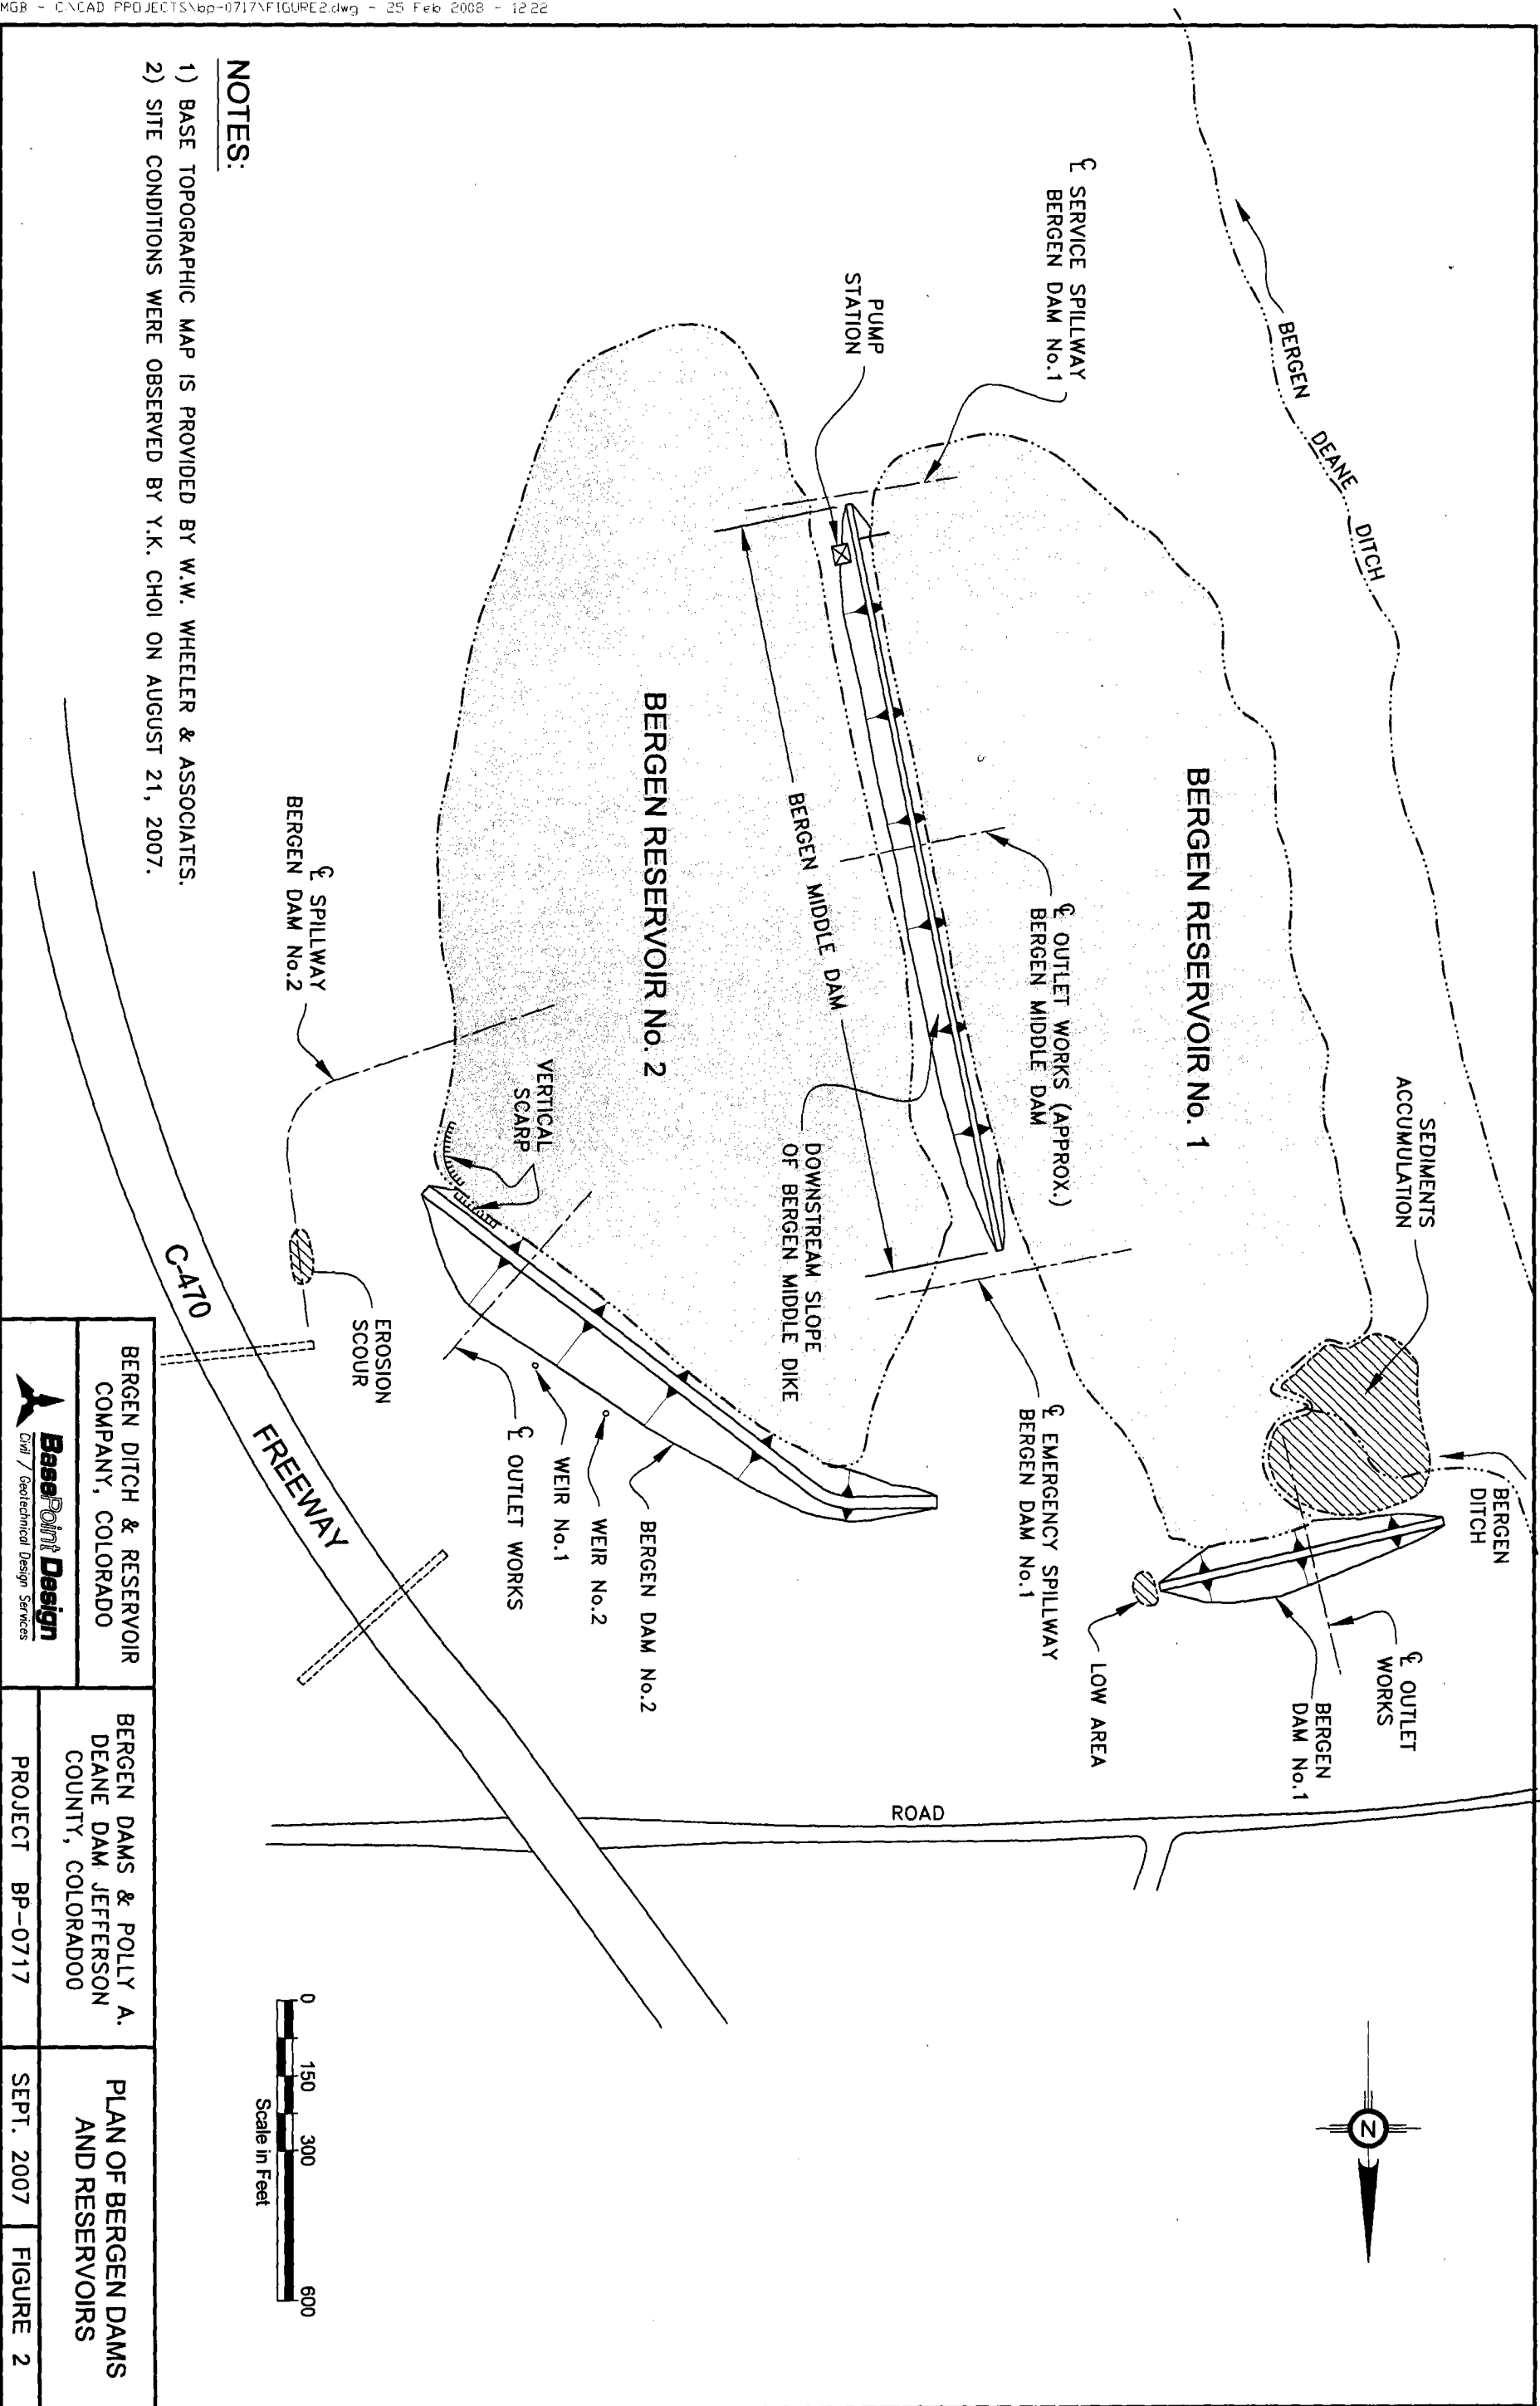
FIGURE 2

6. The seepage conditions of the dam are poor, and there was evidence of active piping through one of the tile drains, discharging into Weir No. 2 (Fig. 2). There are several weirs (e.g. see Photo B10 and B11) and flumes to monitor seepage along the toe and downstream of the dam, but these devices are all in poor conditions. In addition, these monitoring devices are not protected from cows grazing along the toe of the dam, and there appeared to be some animal damage.

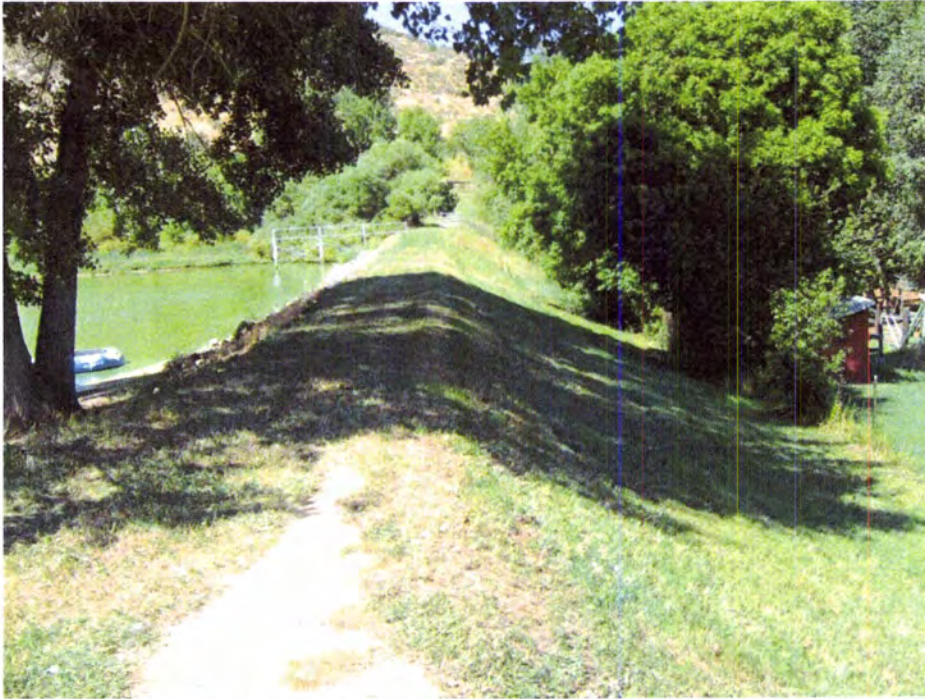
PHOTO A3 – View of dam crest and downstream slope, looking from the right abutment. Note heavy vegetation along entire toe of dam.

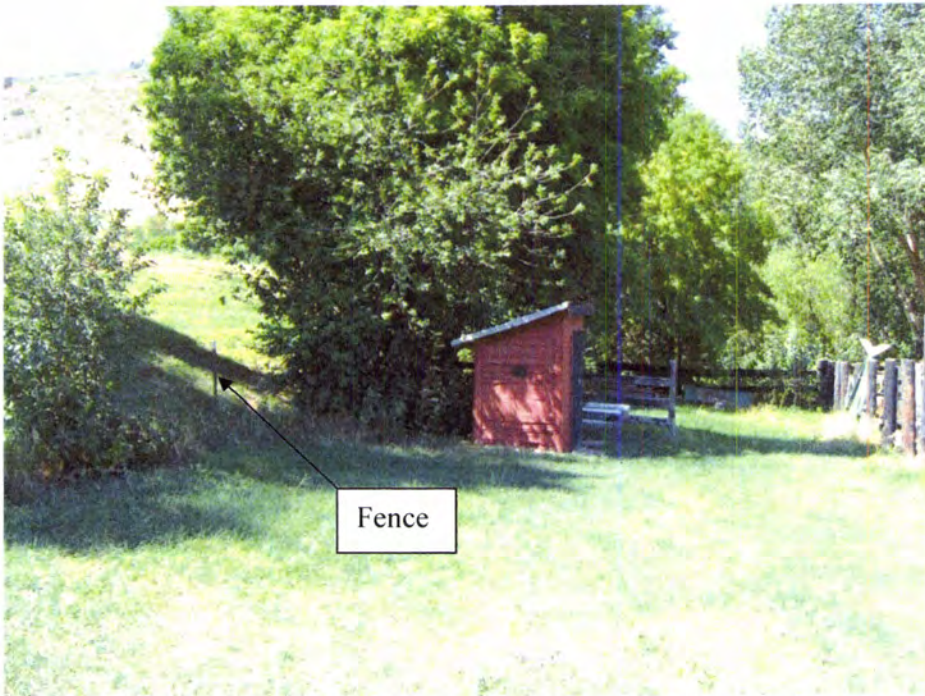
PHOTO A4 – View of the downstream toe of the dam, showing trees at the Toe, and the fence that is an obstacle for maintenance.

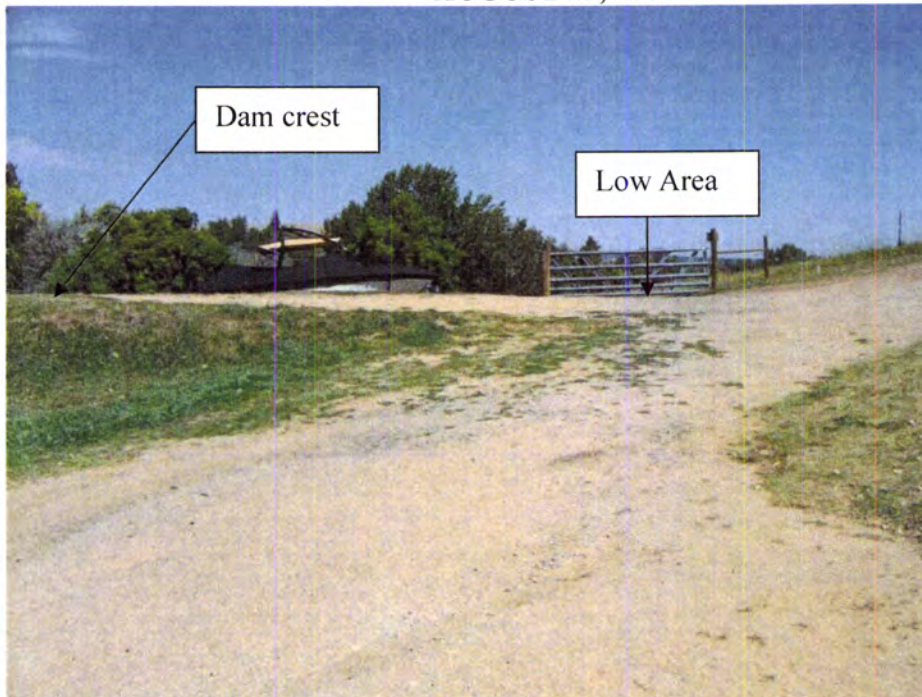
PHOTO A5 – View of right abutment, looking downstream. Note the low area in the right abutment.

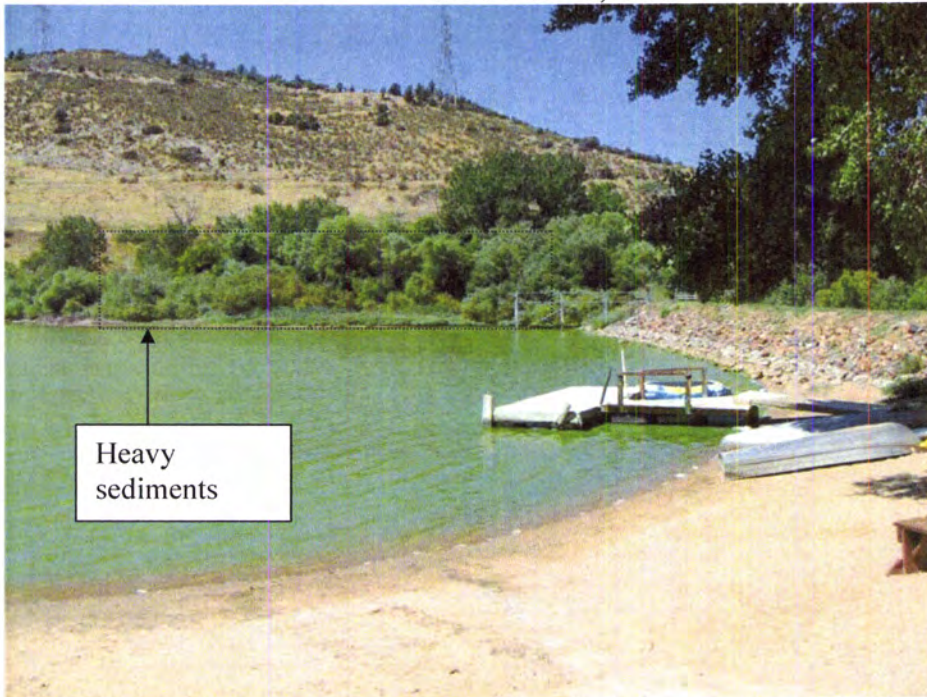
PHOTO A7 – West reservoir rim at the diversion inlet area. Note significant sediments accumulated at the inlet area.

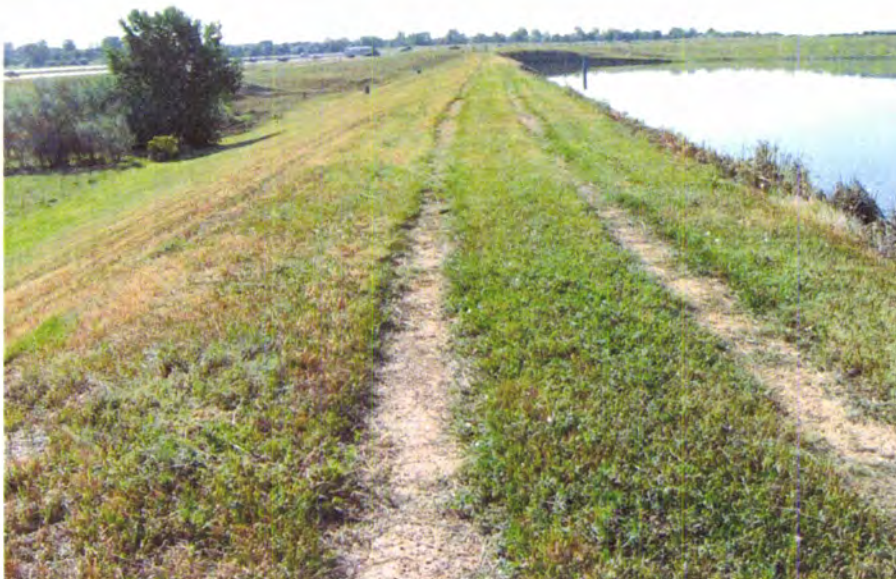
PHOTO B6 – General view of the dam crest, looking east toward the right abutment. Note minor ruts on the grass-lined crest surface.

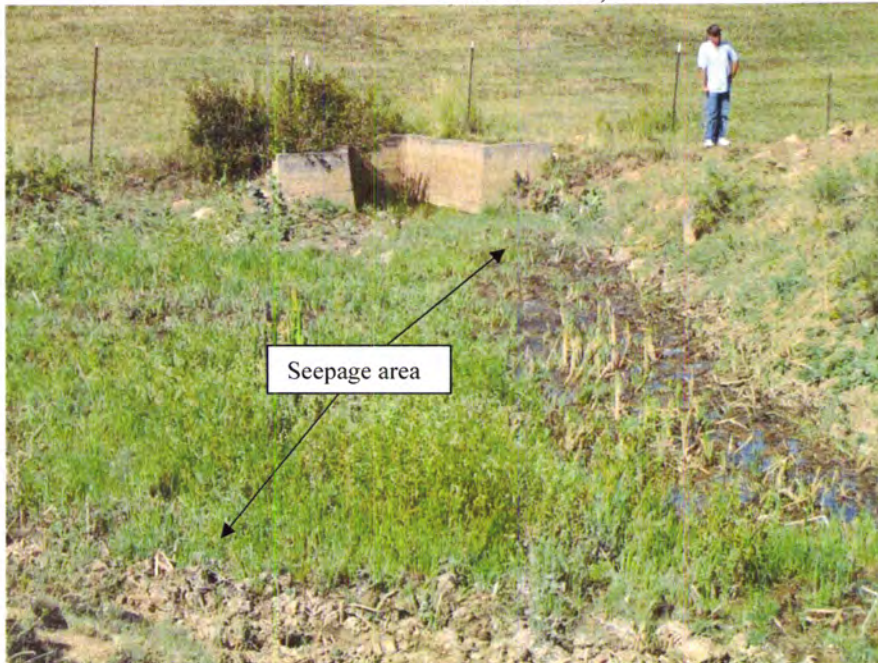
PHOTO B9 – Seepage area at the downstream toe of the dam just downstream of the outlet works discharge.

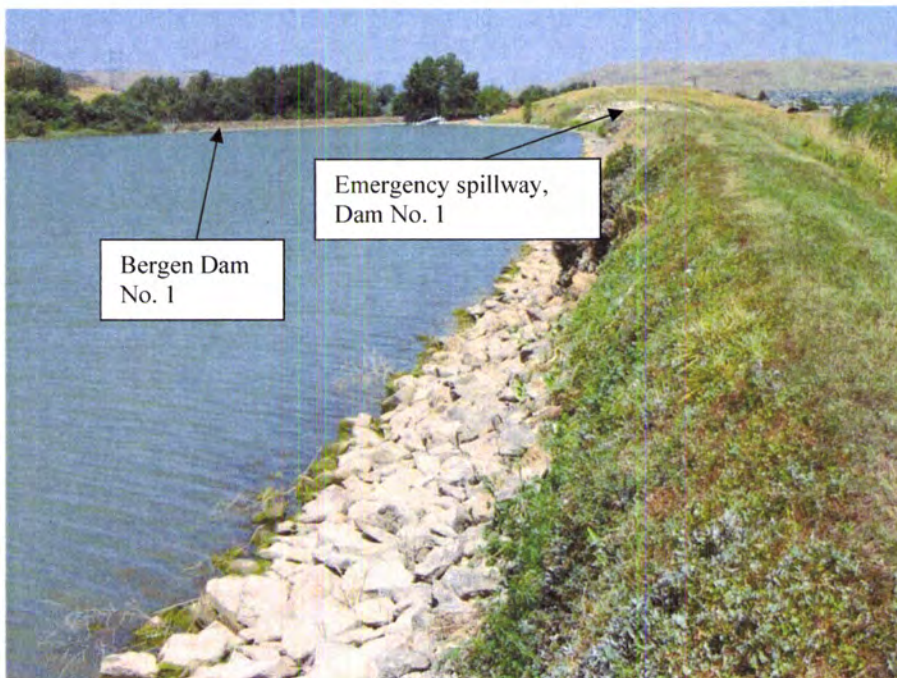
PHOTO C4 – Upstream slope of the dike, looking south. Upper slope of the dike is grass lined, and very steep. Bergen Dam No. 1 and its emergency spillway can be seen in the background.

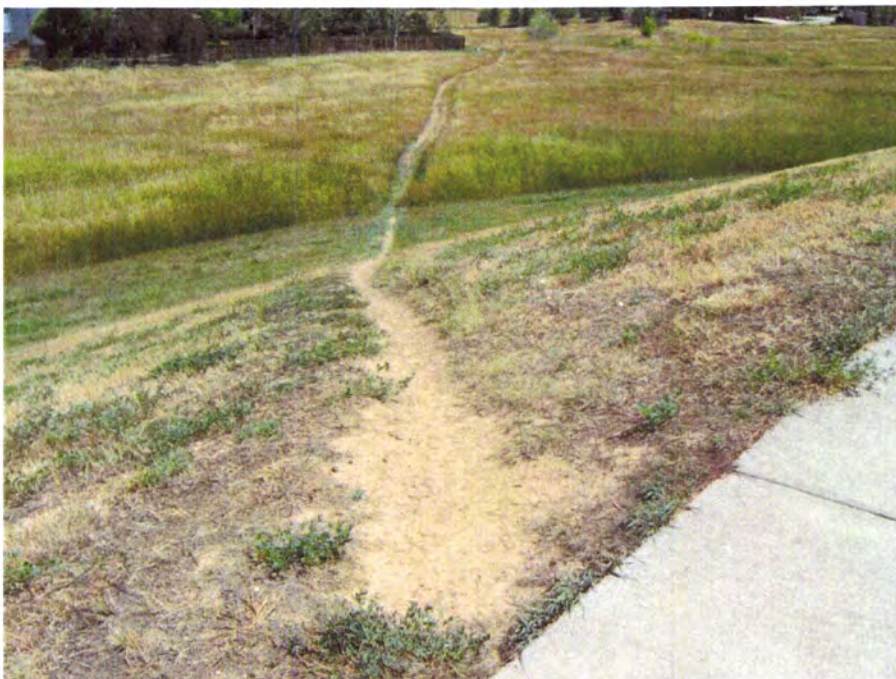
PHOTO D4 – View of the downstream slope of the dam, looking downstream, showing minor erosion of the slope face from a second footpath on the slope.

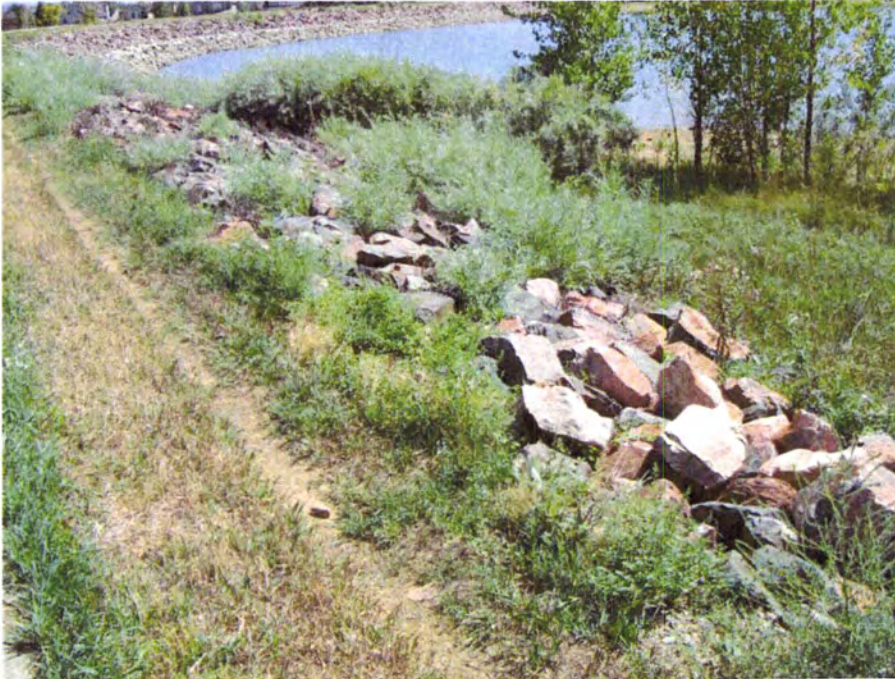
PHOTO D5 – View of the upstream left abutment and left end of the dam. Note minor vegetation on the upstream slope among the riprap.

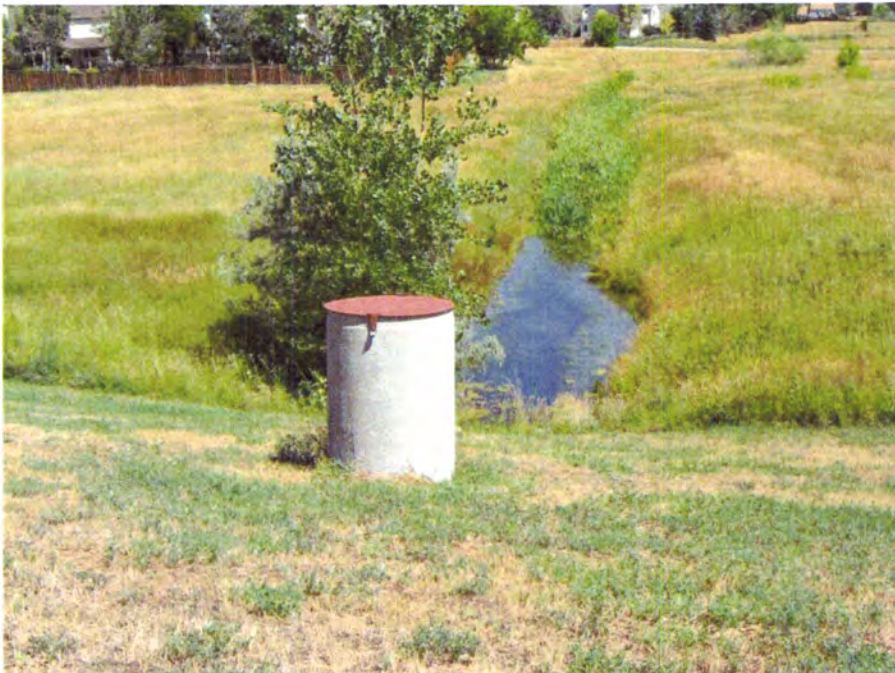
PHOTO D6 – View of the downstream toe of the dam at the outlet works discharge, looking downstream. Note drain manhole on the slope, outlet channel, and tree at the toe of the dam.

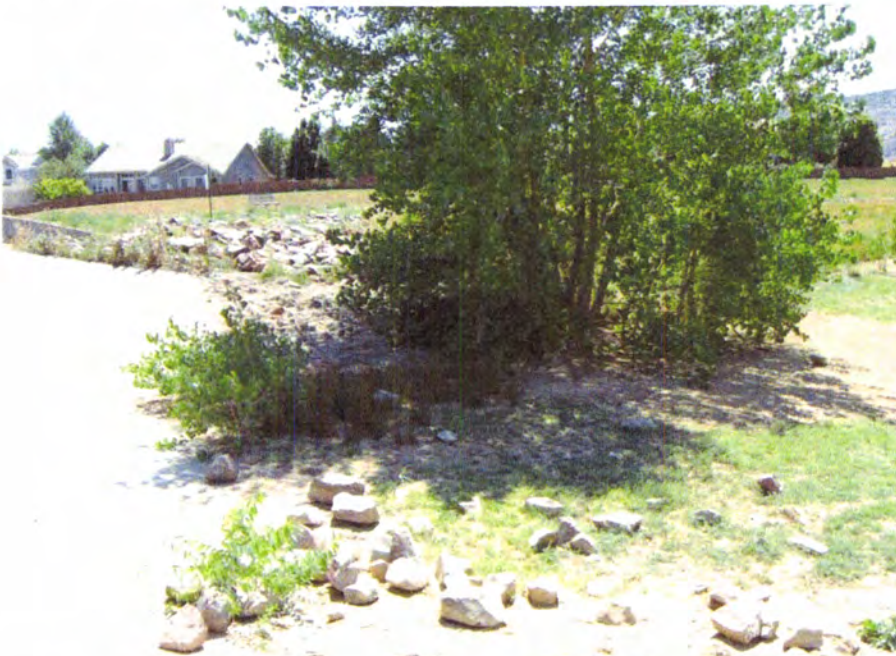
PHOTO D10 – Spillway approach channel, right side. Note several grown trees in the channel.
