## City of Lamar Transmission Line

## **Final Report**

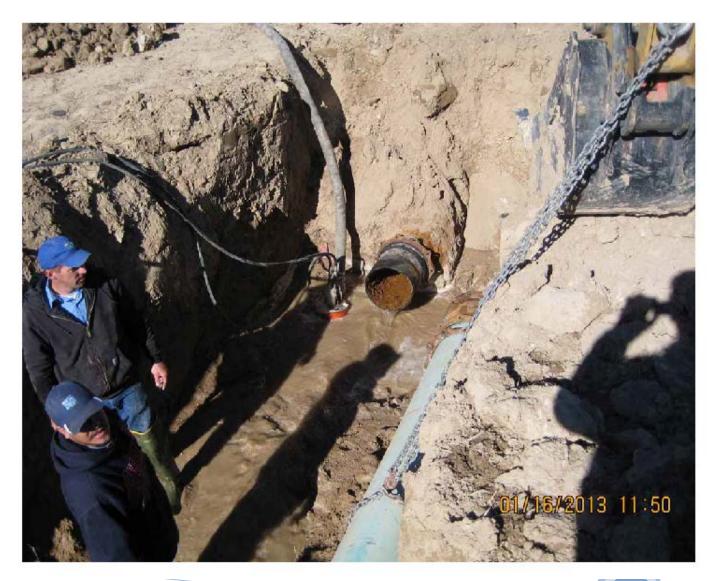
Honeywell helped the City of Lamar replace +/- 34,190 feet of 14" cast iron well transmission piping installed in the 1930's. The pipeline has been repaired in many locations, is leaking, has tuberculation, and has outlived its service life. The existing pipeline is installed on open ranch land and crosses two county maintained dirt roads.
