**Subject: Adobe Creek Dam Outlet Conduit and Seepage Evaluation,  
Water Division 2, Water District 17, Dam ID 170101,  
Wheeler Project No. 1830.04**

**Attachment A**  
**Adobe Creek Dam Outlet Conduit Inspection**  
**Photo Log**

**Attachment B**  
**Adobe Creek Dam Outlet Conduit Inspection**  
**Video Inspection**

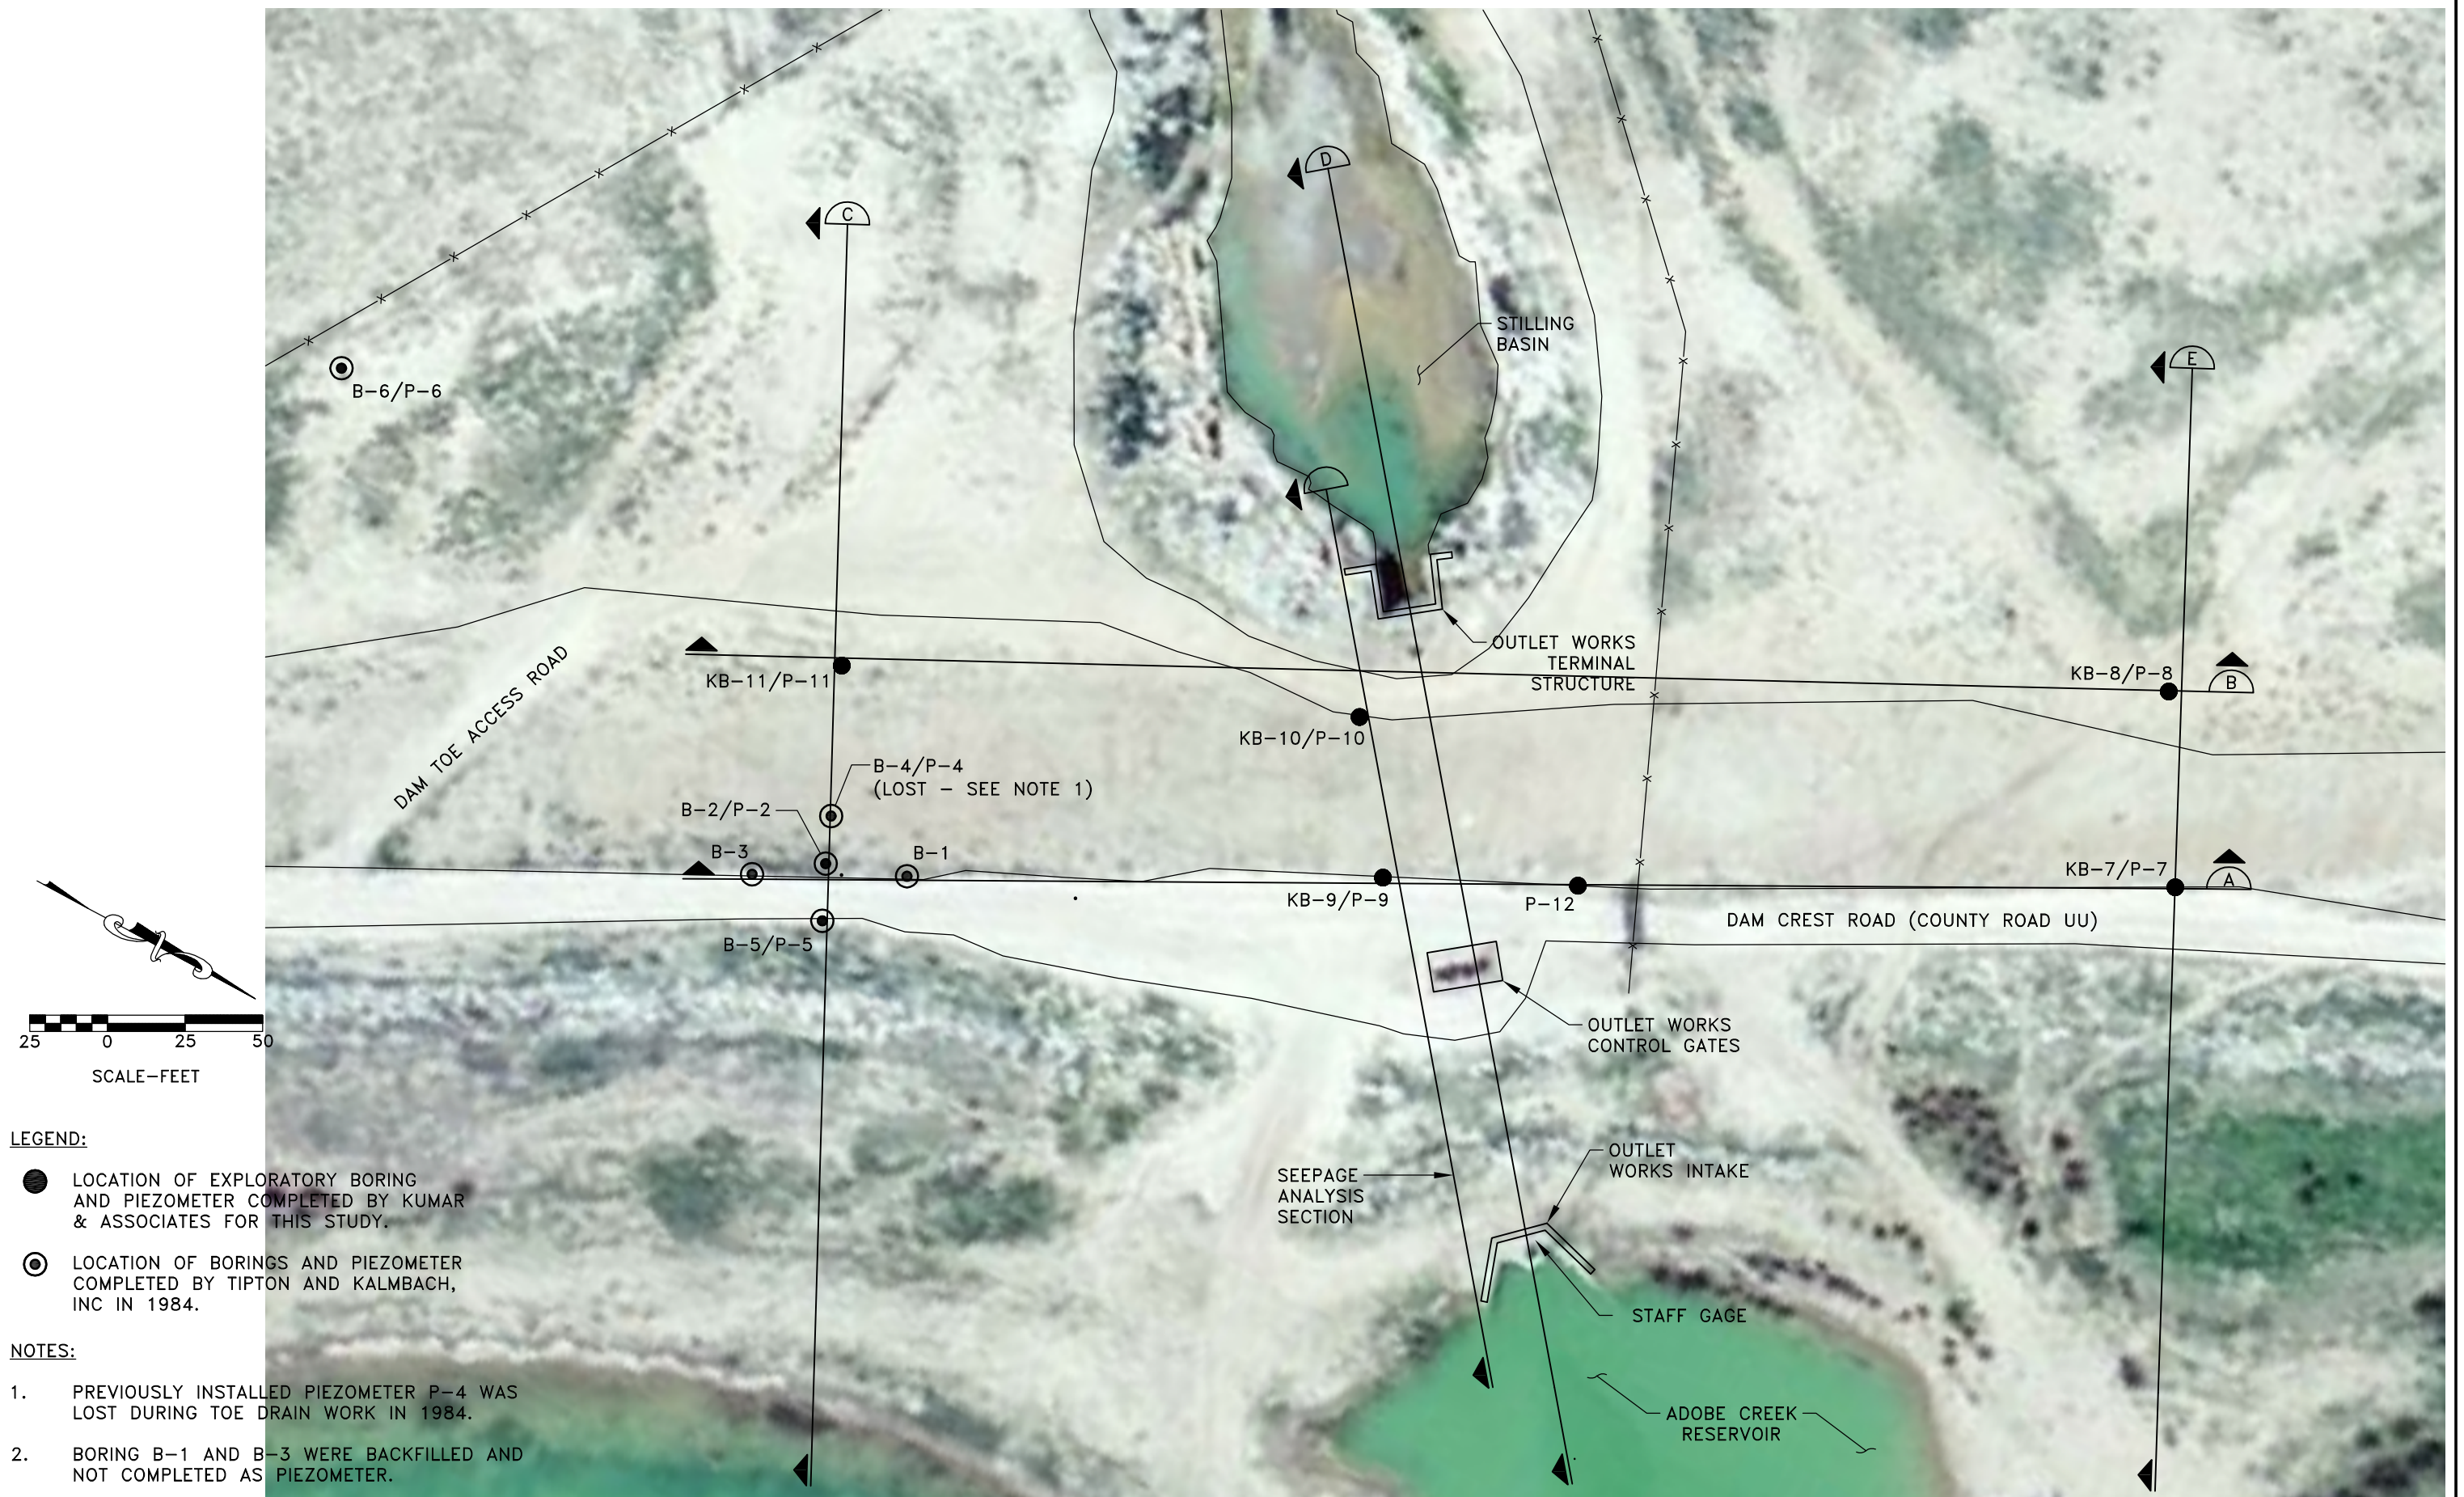
General: A subsurface exploration program consisting of 6 exploratory borings was performed from November 14 to 16, 2016. The locations of the exploratory borings are shown on Fig. 1. Three borings (KB-7, KB-9 and KB-12) were completed along the downstream edge of the dam

Following exploration, the borings were completed as six permanent piezometers, P-7 to P-12, as shown on Fig. 1. Well completion logs for each piezometer are presented on Fig. 5. The piezometers will be used to supplement water level monitoring in existing piezometers P-2, P-3 and P-6 (which were completed as piezometers in Exploratory Borings 2, 3 and 6 by Tipton and Kalmbach). The locations of the pre-existing piezometers are also shown on Fig. 1.

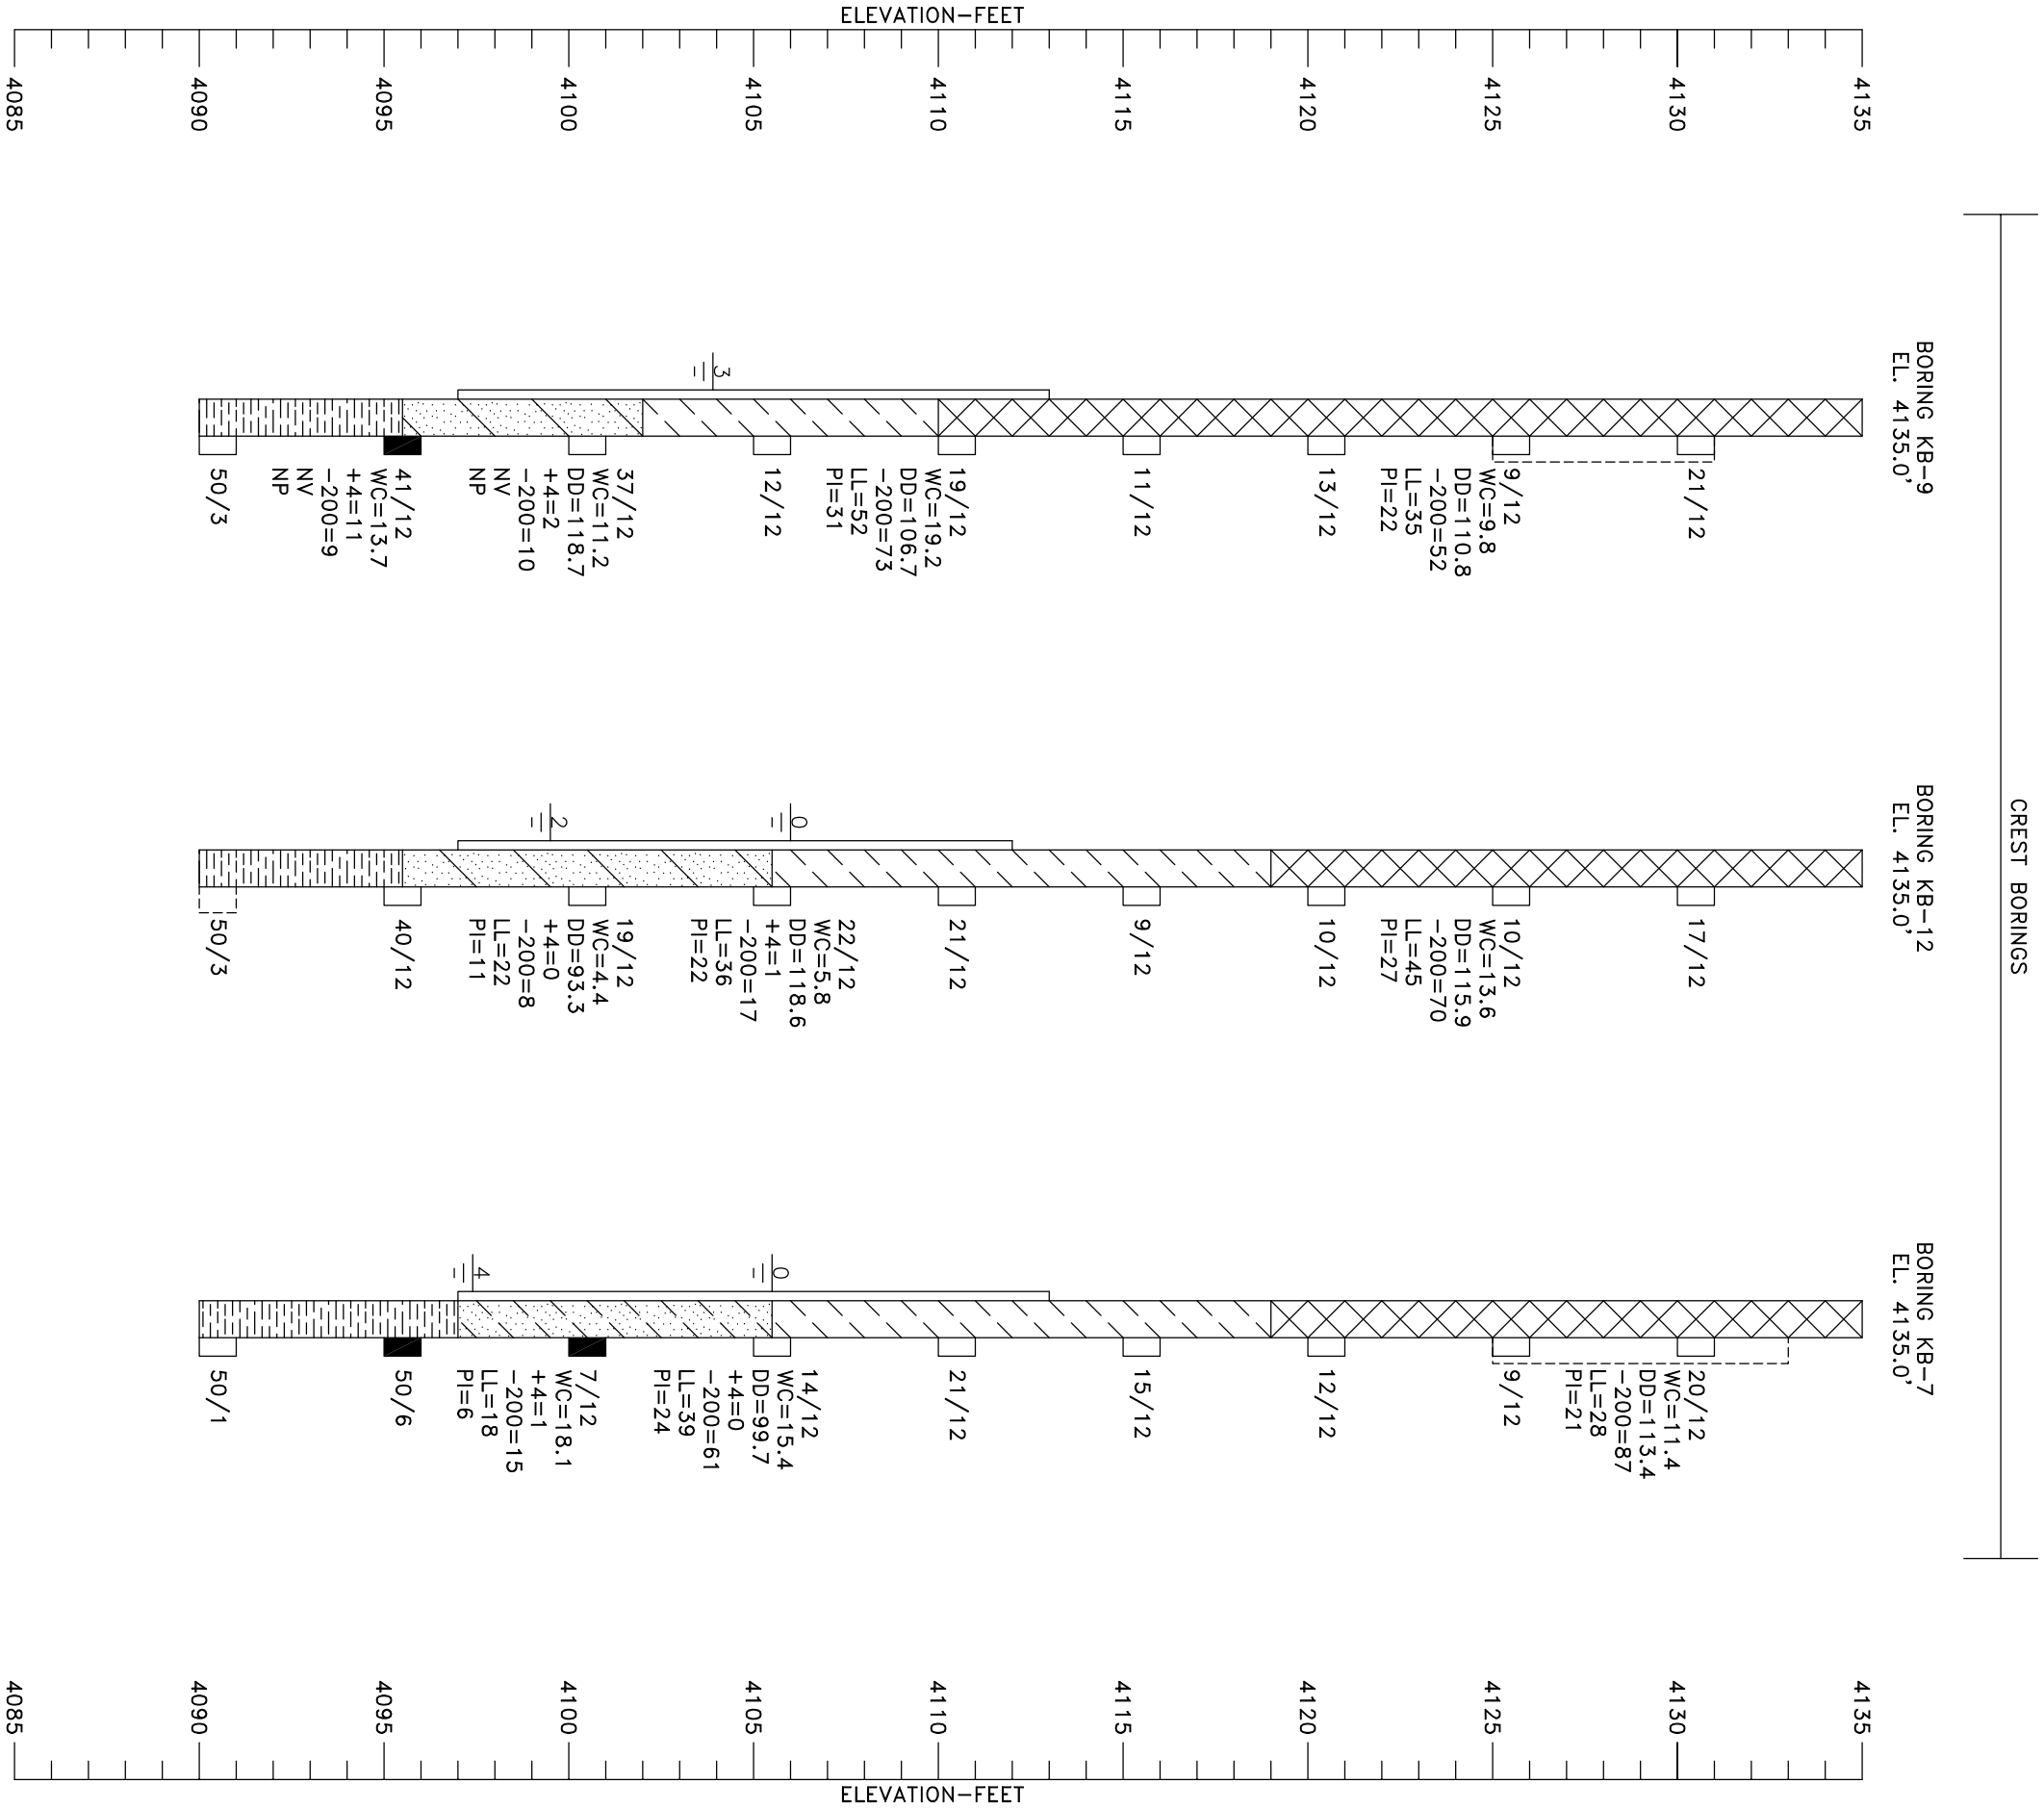
Fig. 2

LOGS OF EXPLORATORY BORINGS

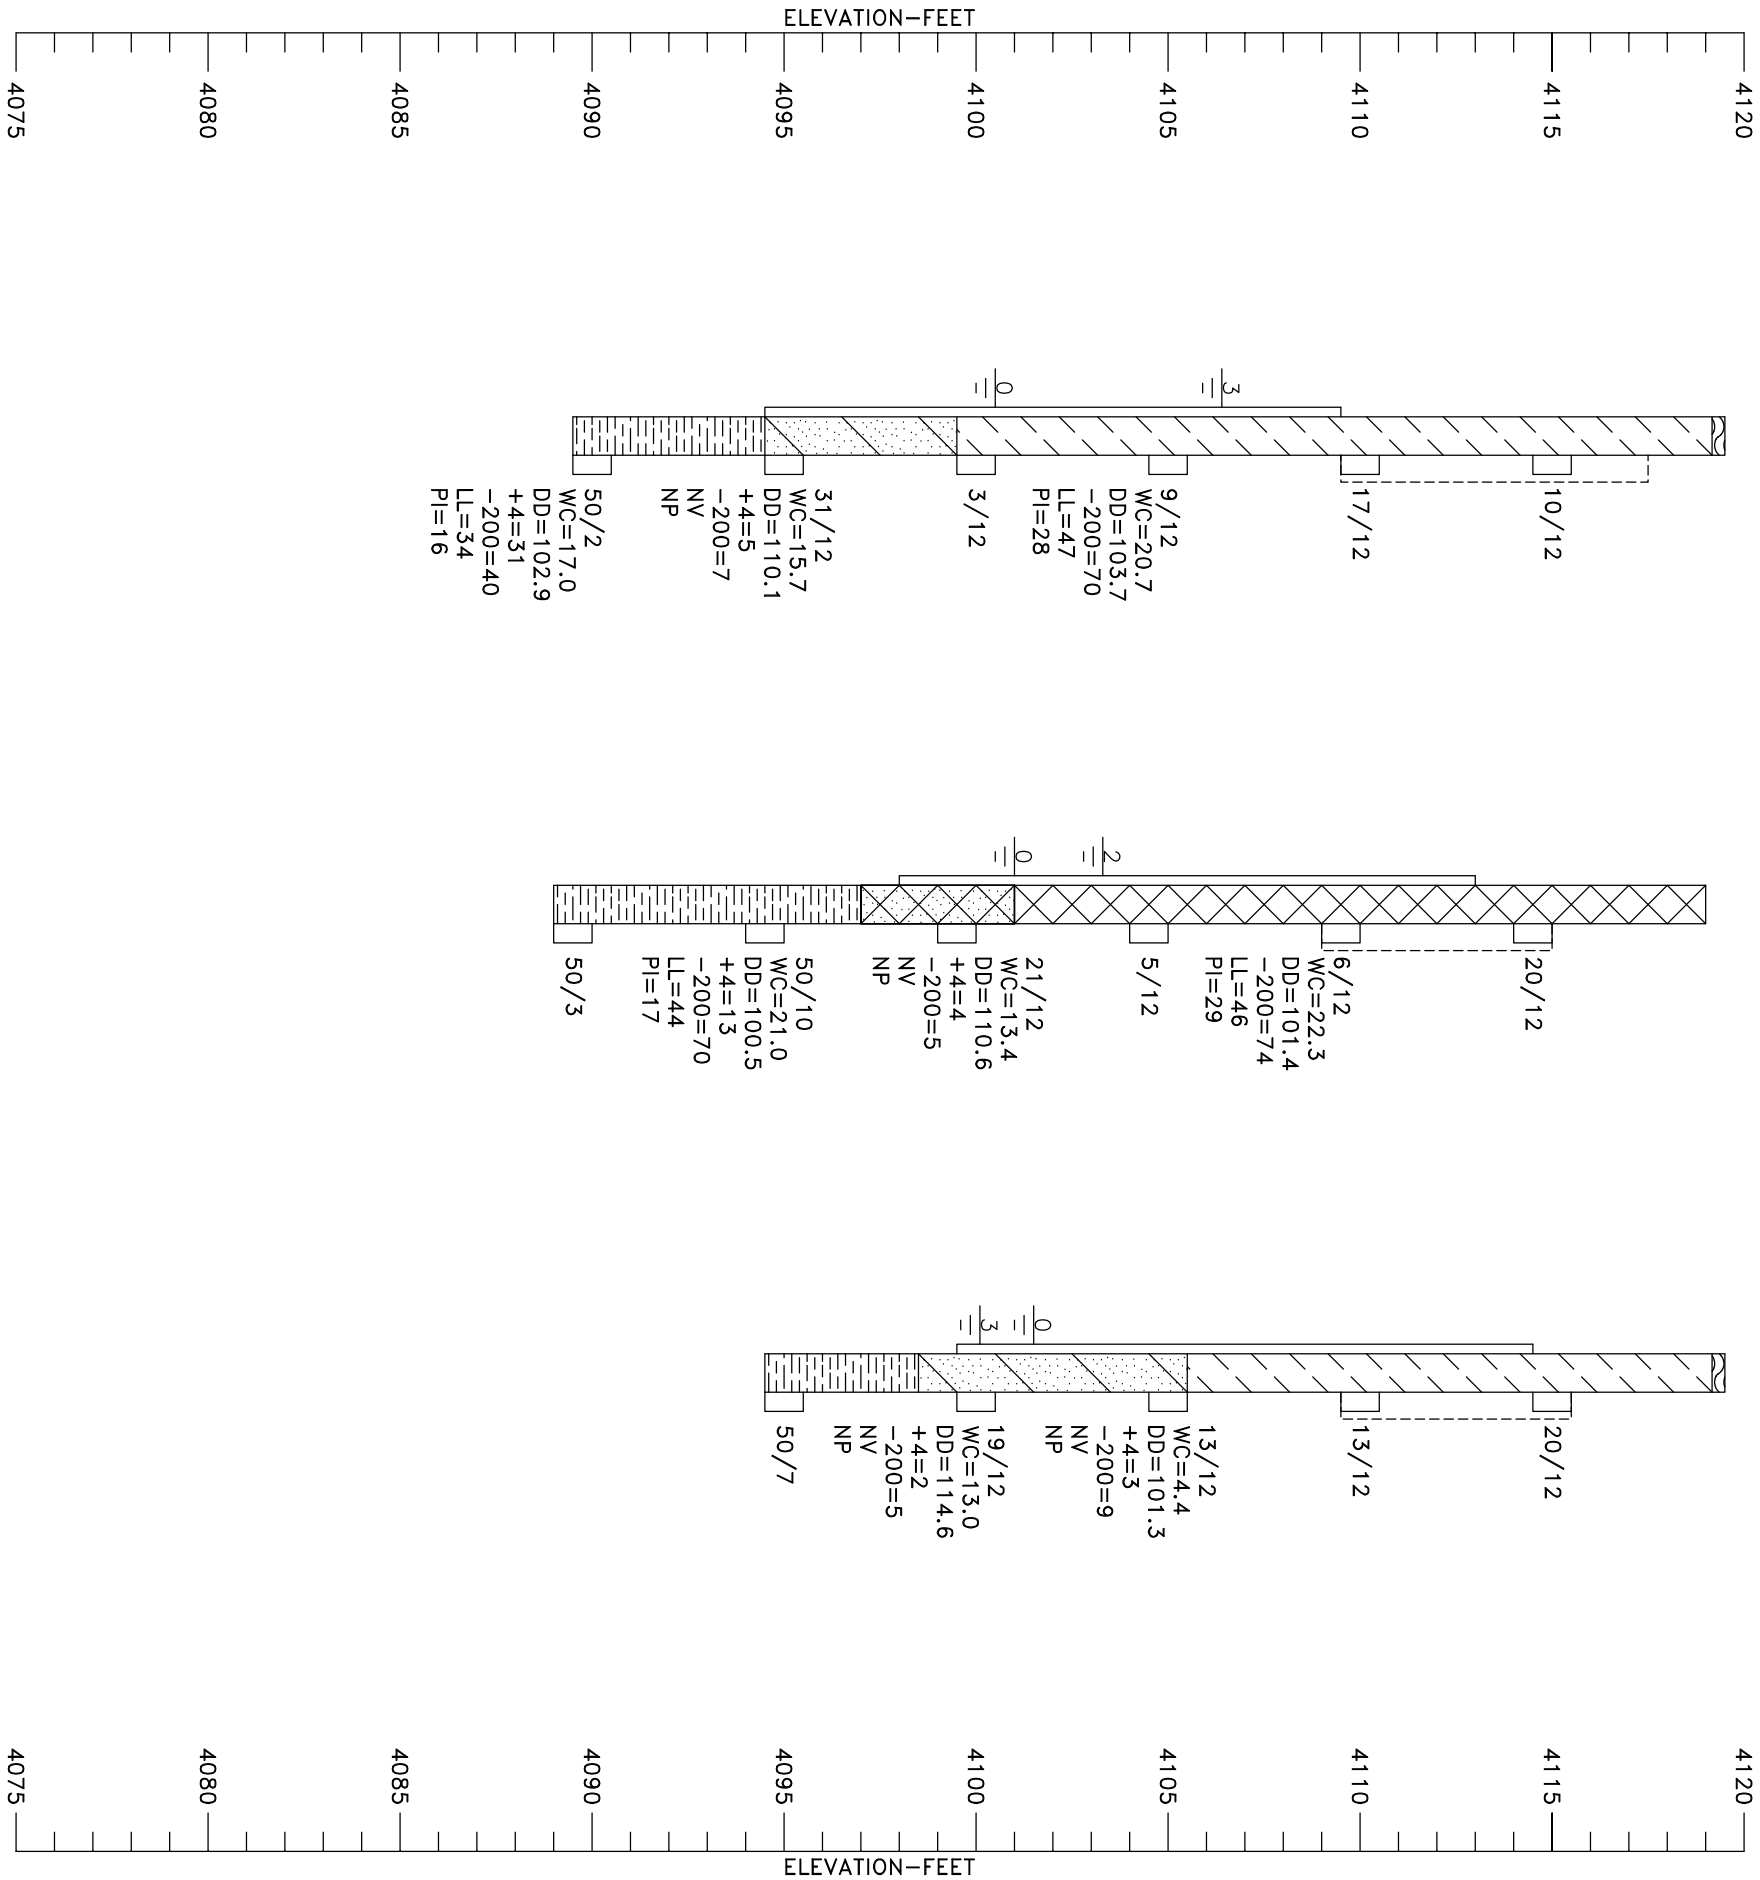
Fig. 3

LOGS OF EXPLORATORY BORINGS

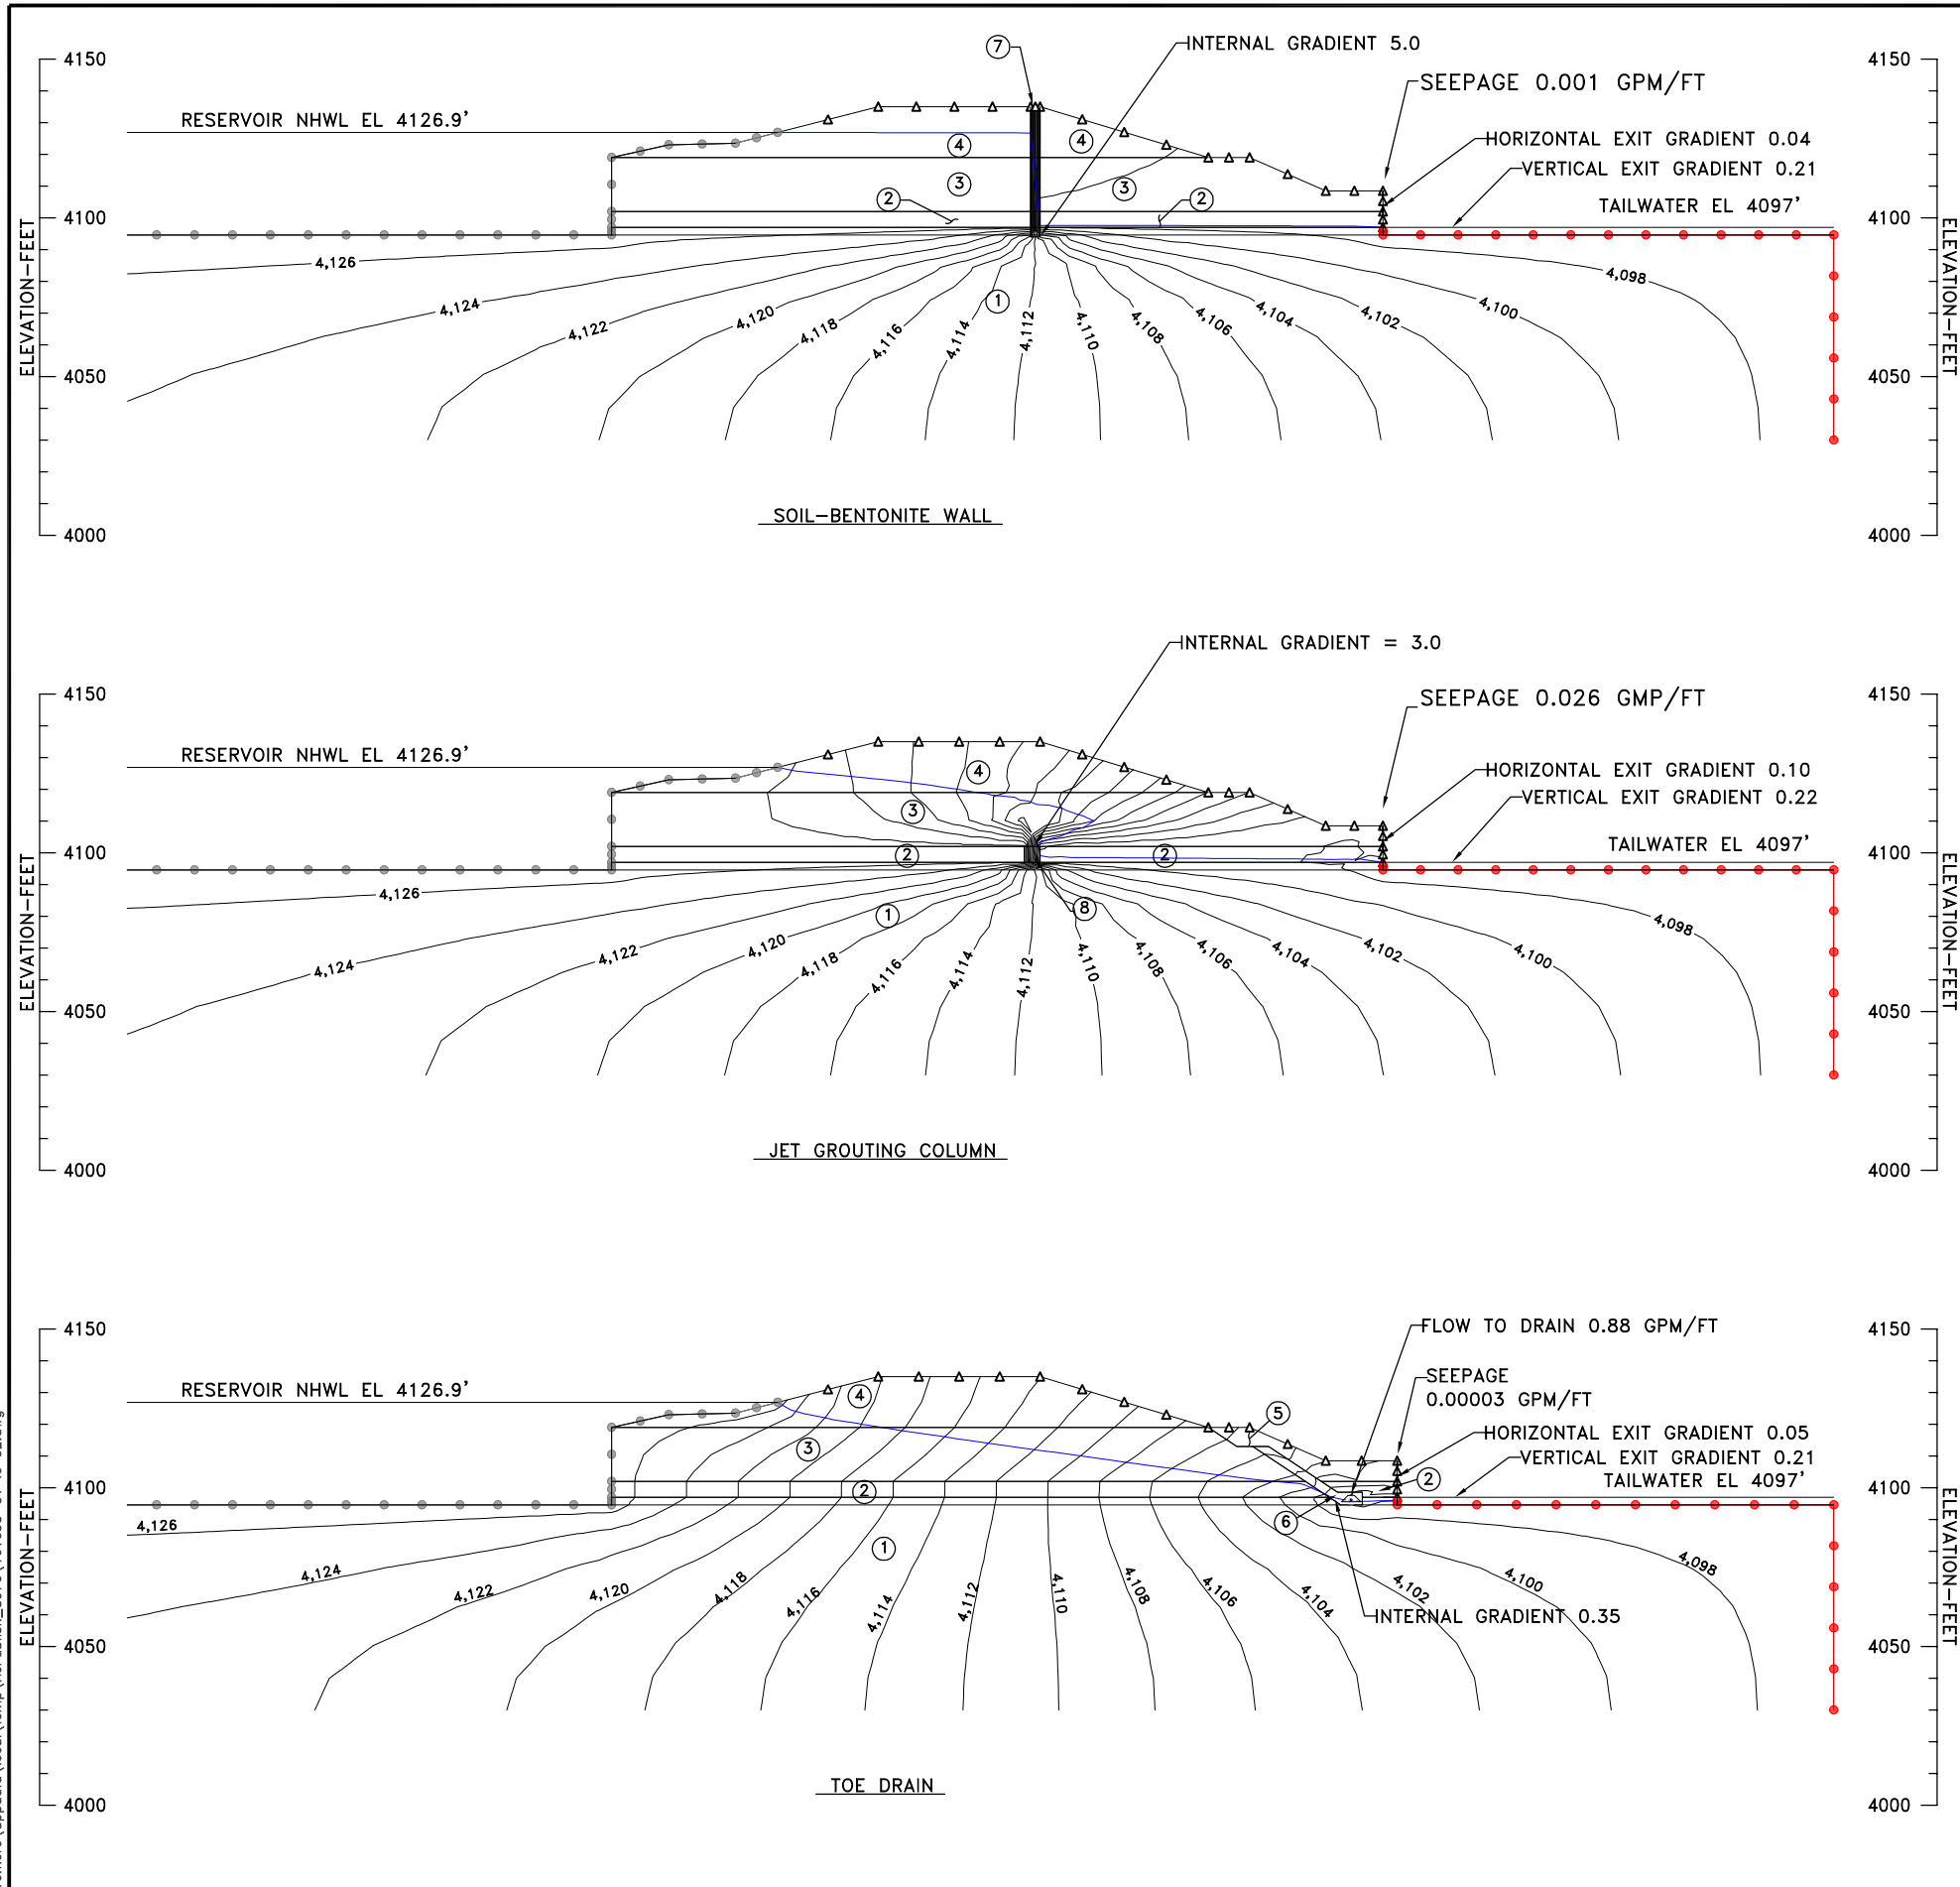
The location of the seepage analysis section used in the analysis is shown on Fig. 1, and the modeled section is presented on Fig. 14. We assumed that the critical seepage condition occurs when the reservoir is at the normal high water level Elevation 4126.9 feet and the outlet conduit is closed or allowing only a small release of water into the downstream channel, corresponding to a downstream tailwater at Elevation 4097 feet. The section shows a seepage path along the left side of the outlet conduit, but we would expect seepage flows to primarily occur through the alluvial sand to the left and right of the outlet conduit. Seepage flowing around the left and right wing walls would encounter the alluvial sand layer bank slopes, and predominantly flow through the alluvial sand, and to a significantly lesser extent through the clayey embankment, clay soil and claystone bedrock, until exiting at the left and right side of the end walls for the outlet terminal structure.
