**CONSTRUCTION COMPLETION REPORT**  
**WEST RESERVOIR NO. 1 OUTLET WORKS**  
**REHABILITATION PROJECT**  
**DELTA COUNTY, COLORADO**

Submitted to  
**West Reservoir & Ditch Company**  
708 1250 Road  
Delta, CO 81416

Submitted by  
**RJH Consultants, Inc.**  
9800 Mt. Pyramid Court, Suite 330  
Englewood, Colorado 80112  
303-225-4611  
[www.rjh-consultants.com](http://www.rjh-consultants.com)

December 2016  
Project 13129

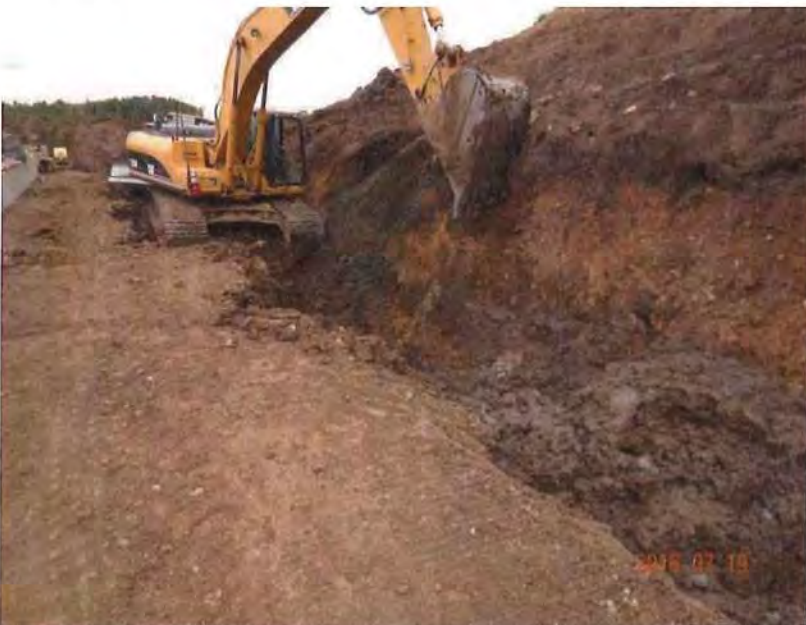
Photo 4 – Excavation of the dewatering trench on the north side of the excavation. Note width of excavation and excavation of the existing embankment to create a slope.

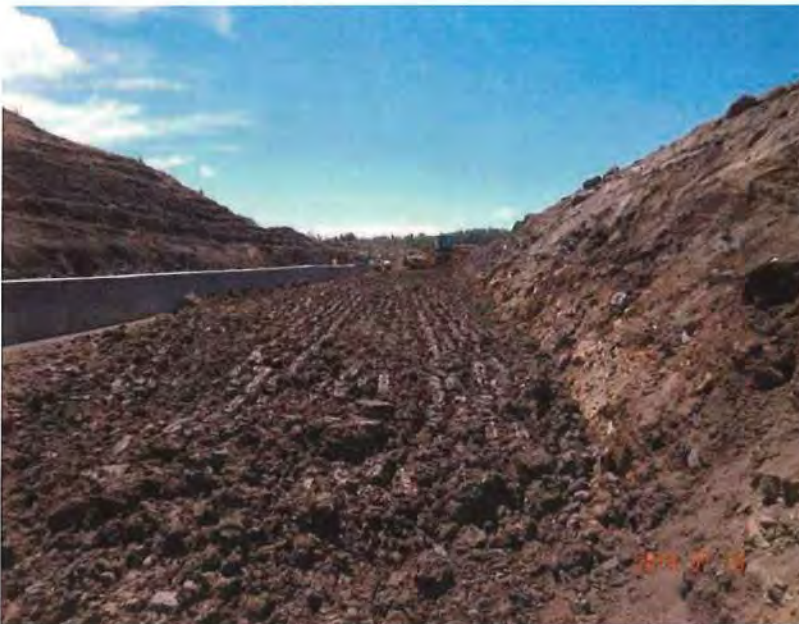
Photo 6 – Completed embankment fill to about Elevation 8740. Note slope of existing embankment (right side of photograph).

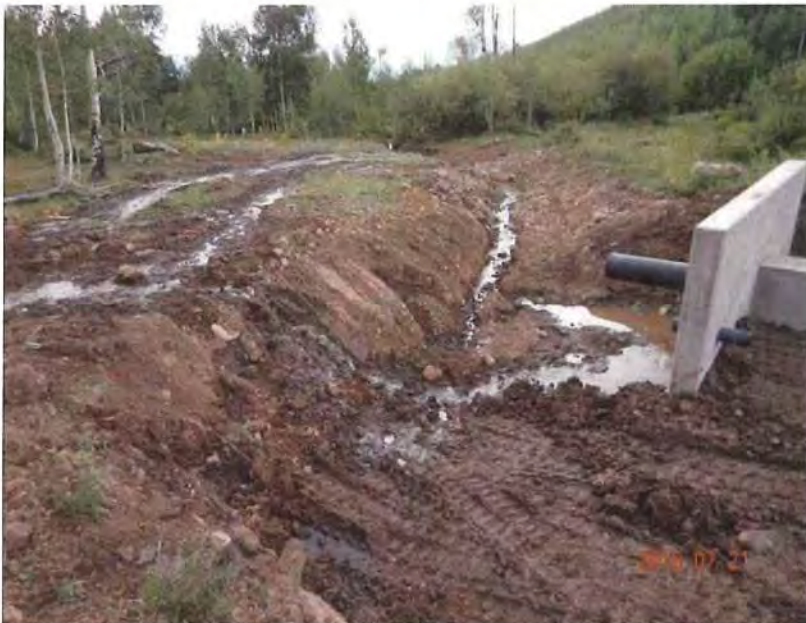
Photo 1 – Water flowing around downstream headwall.

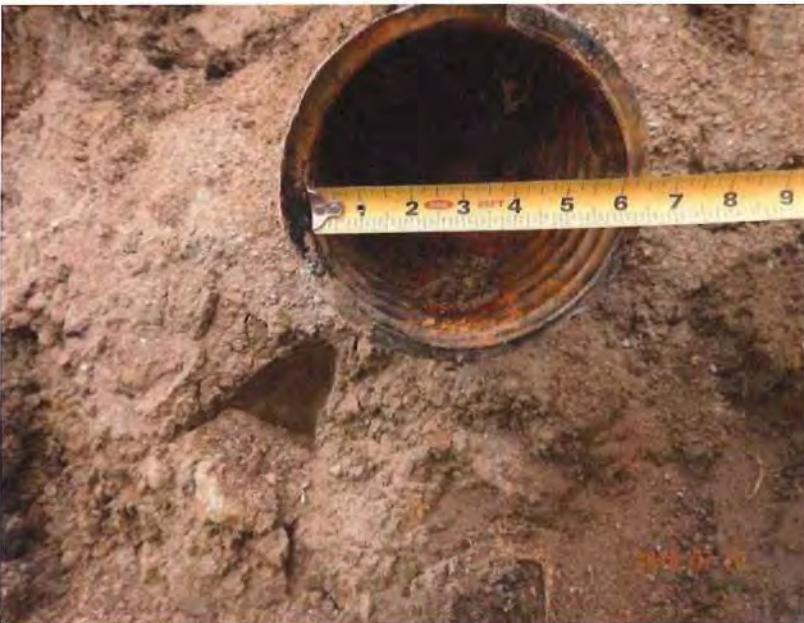
Photo 4 – Existing toe drain pipe exposed on the north side of the excavation.

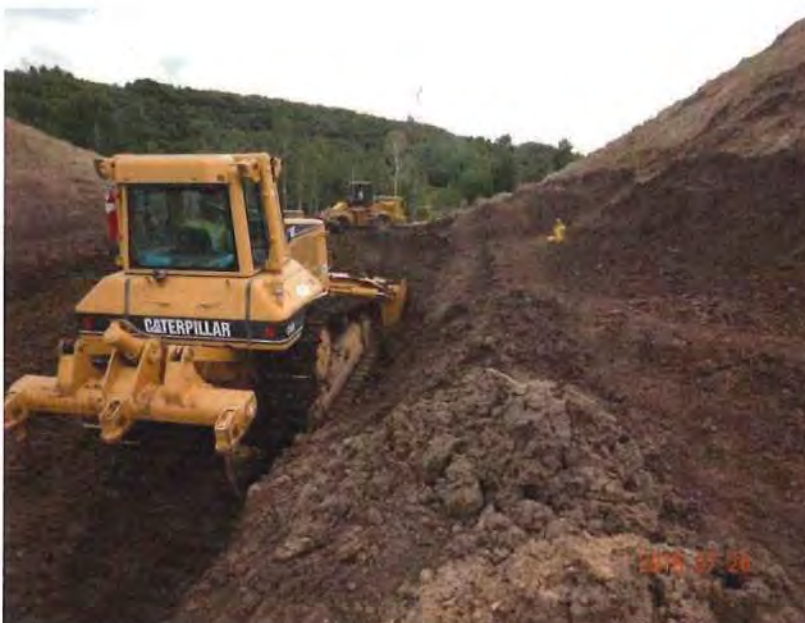
Photo 3 – Cutting existing embankment at new fill contact.

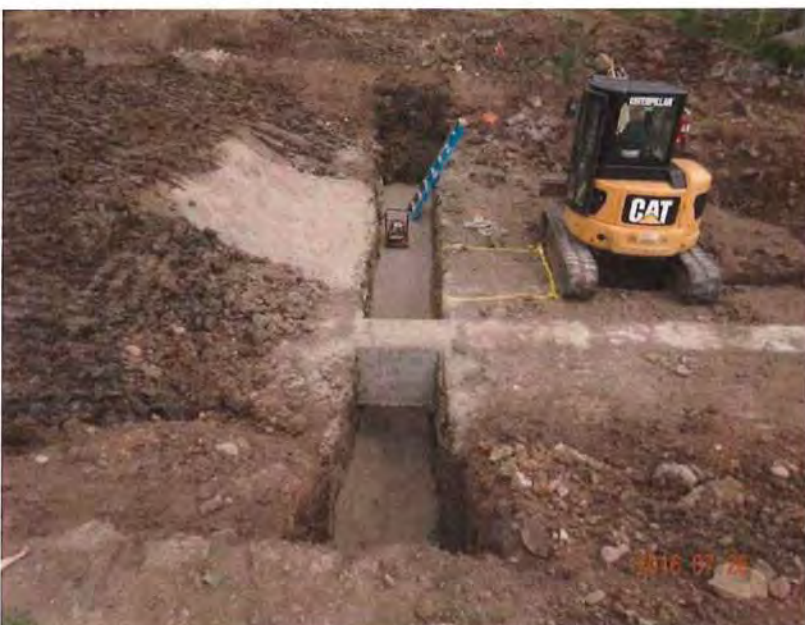
Photo 4 – Filter collar construction (near Station 2+95).

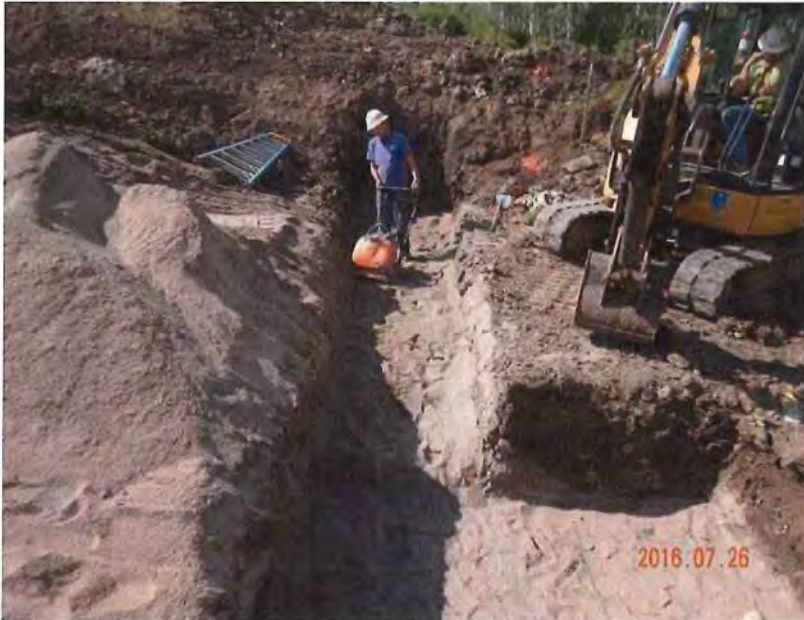
Photo 5 – Compacting filter sand for the filter collar.

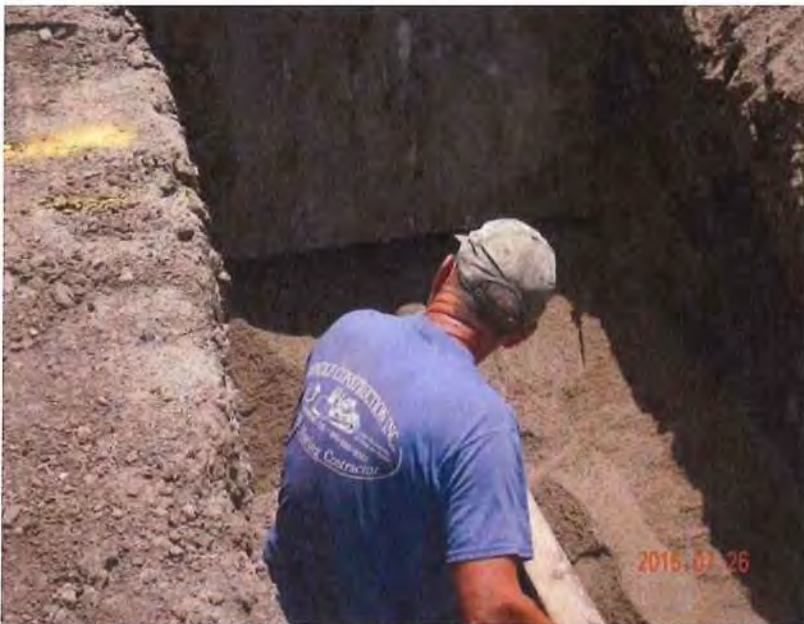
Photo 6 – Compacting filter sand beneath the conduit encasement.

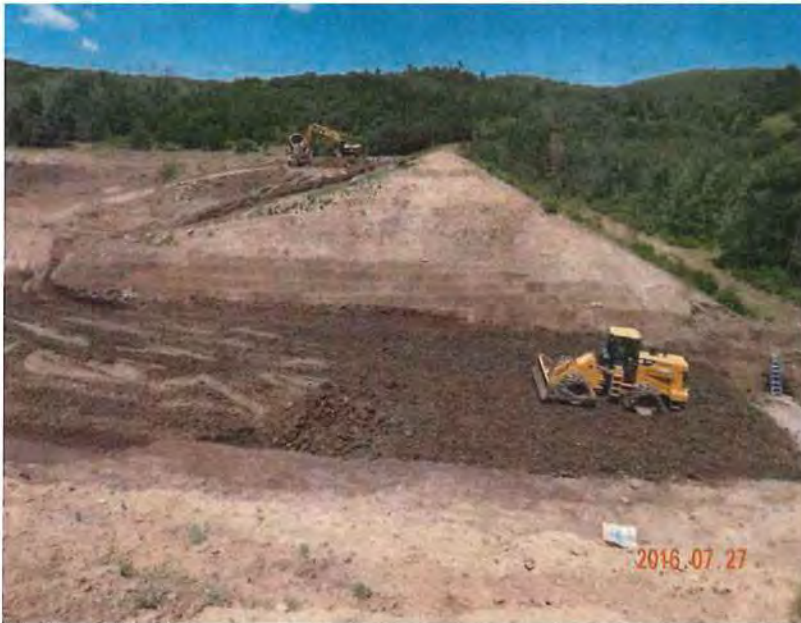
Photo 1 – Placing common fill for the embankment.

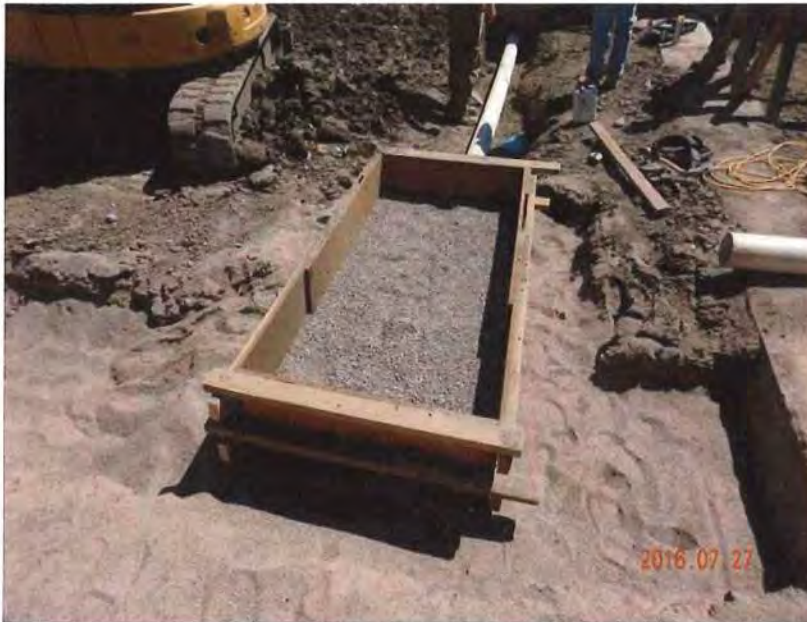
Photo 3 – Forms used to contain filter gravel.

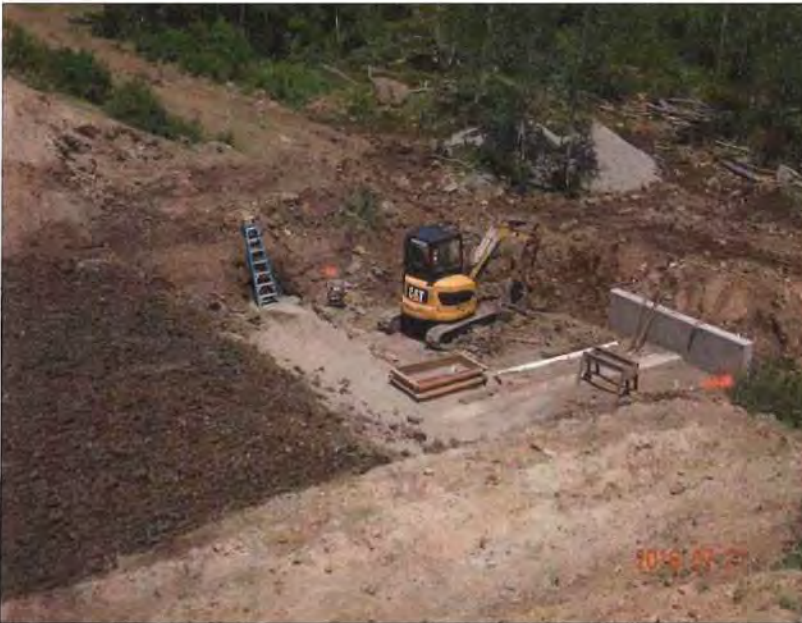
Photo 4 – Filter collar to about Elevation 8738.

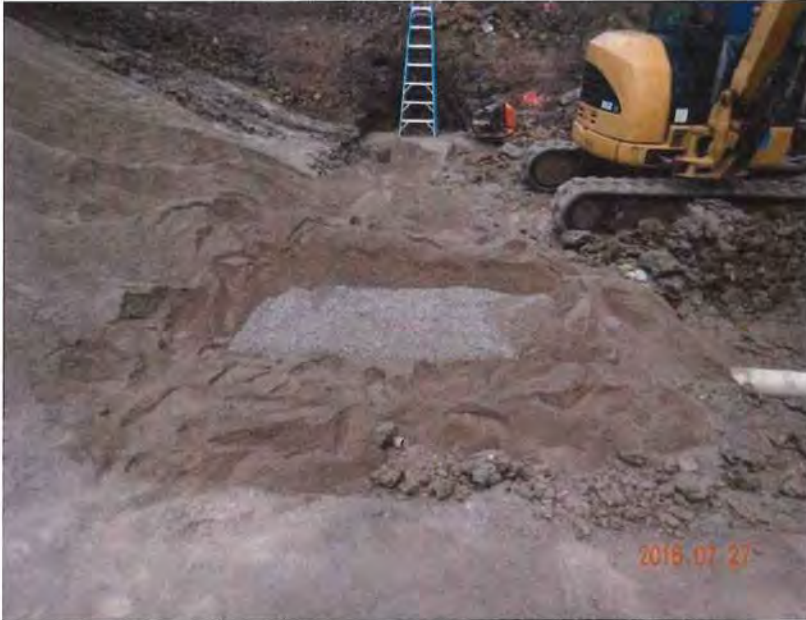
Photo 5 – Filter collar with forms removed.

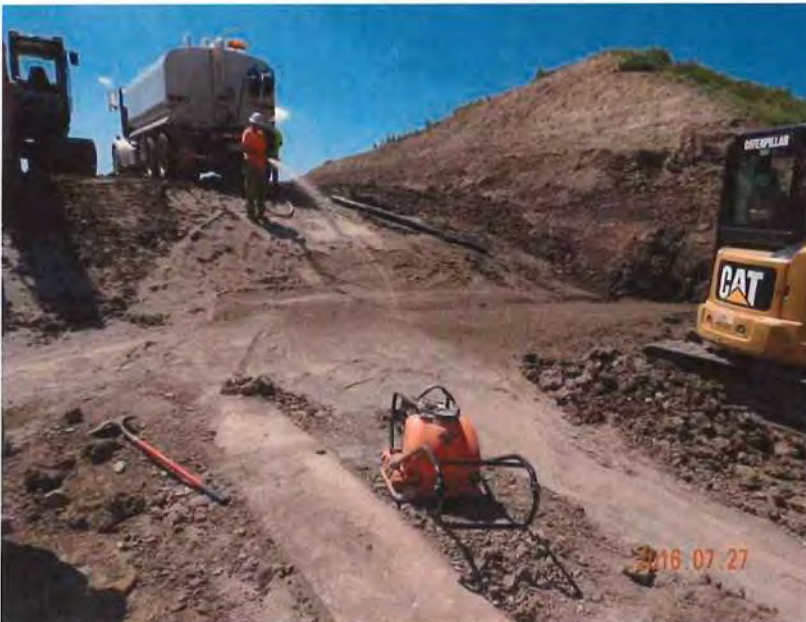
1. The sand should be placed in a saturated or at least wet condition. I said the existing sand was placed at stockpile moisture. Garrett asked that the existing filter be saturated once sand and gravel placement was finished today. I agreed.
2. Garrett asked that the sand be wet for the next phase of placement (when the filter collar is re-excavated and placed to Elevation 8745). I said I will make this request to Rundle.

Photo 6 – Spraying water on the partially completed filter collar.

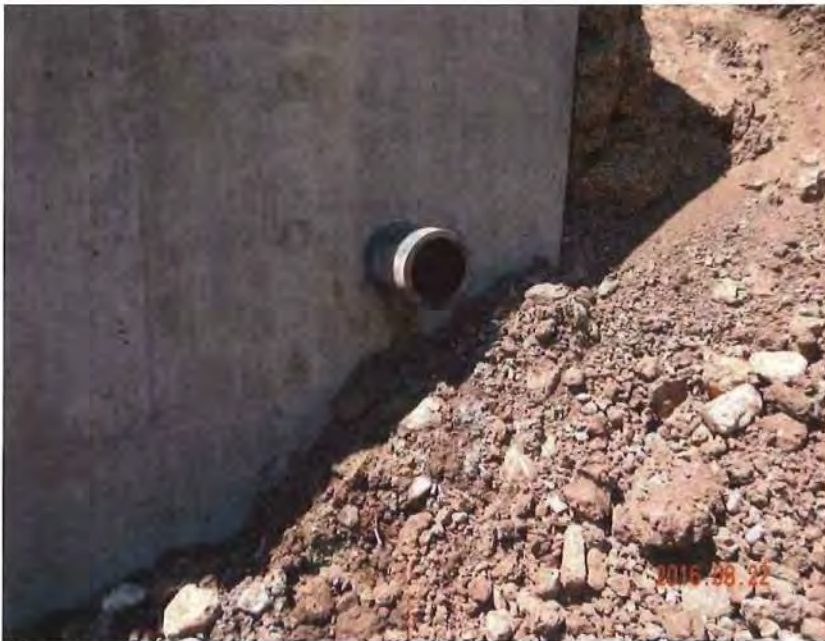
I observed a small amount (about ¼ cup per minute) of water trickling from the filter collar drain pipe. Water is flowing from the pipe with no water in the reservoir. Photo 5

Photo 3 – Flow from the sand collar drain pipe.

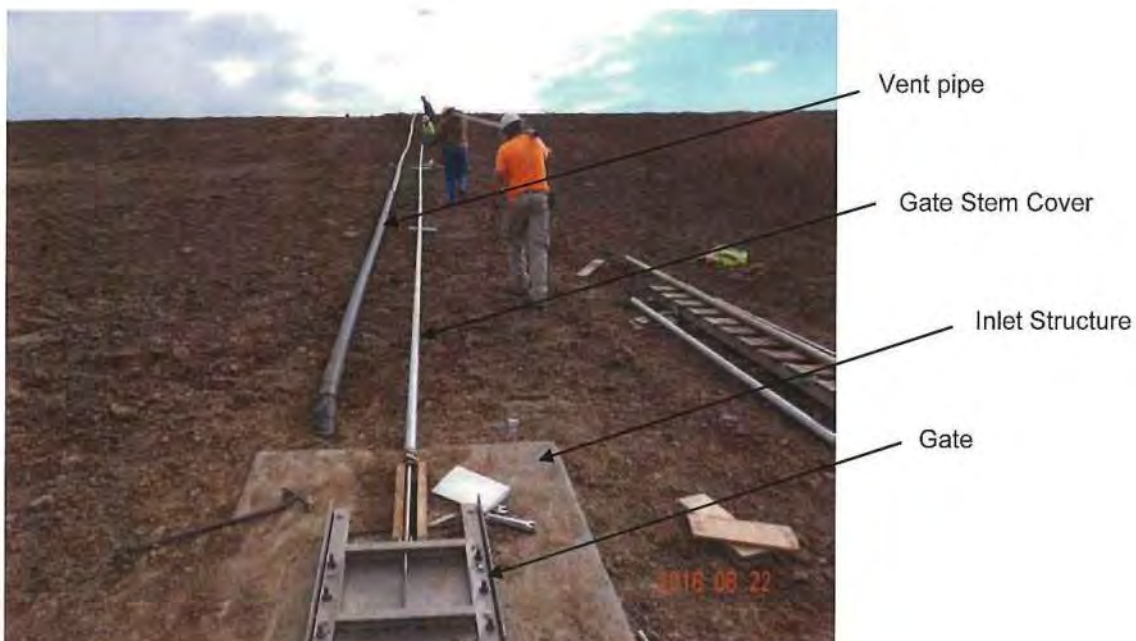
1. Placed the 4-inch diameter vent pipe from the inlet structure to the dam crest. Photo 6.

1. Placed the gate stem and 4-inch diameter gate stem cover from the inlet structure to near the dam crest. The stem and cover stopped below the crest until the handwheel pedestal is placed. Photo 6.

Photo 4 – Vent pipe and gate stem/stem cover on the upstream slope.

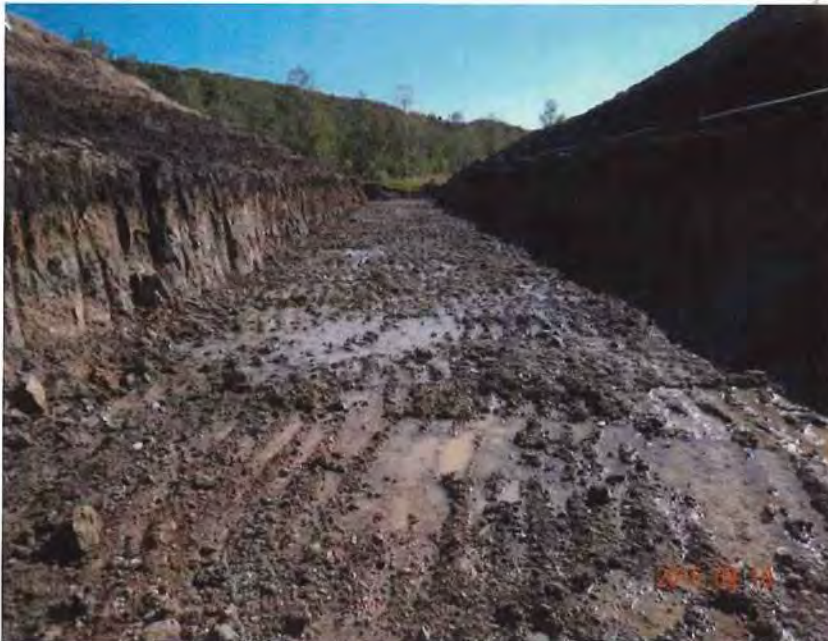
Photo 1 – Bottom of excavation looking downstream. Note the standing water.

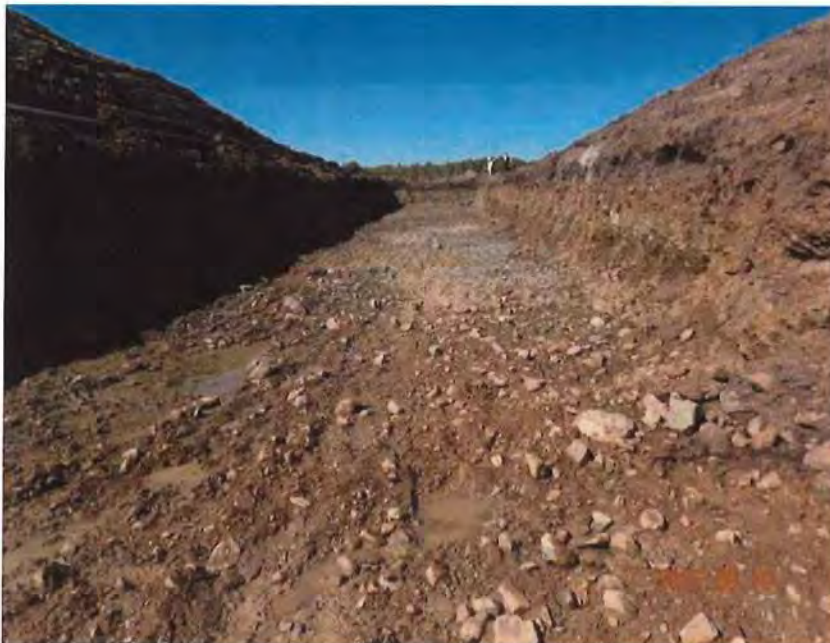
Photo 2 – Bottom of the excavation looking upstream.

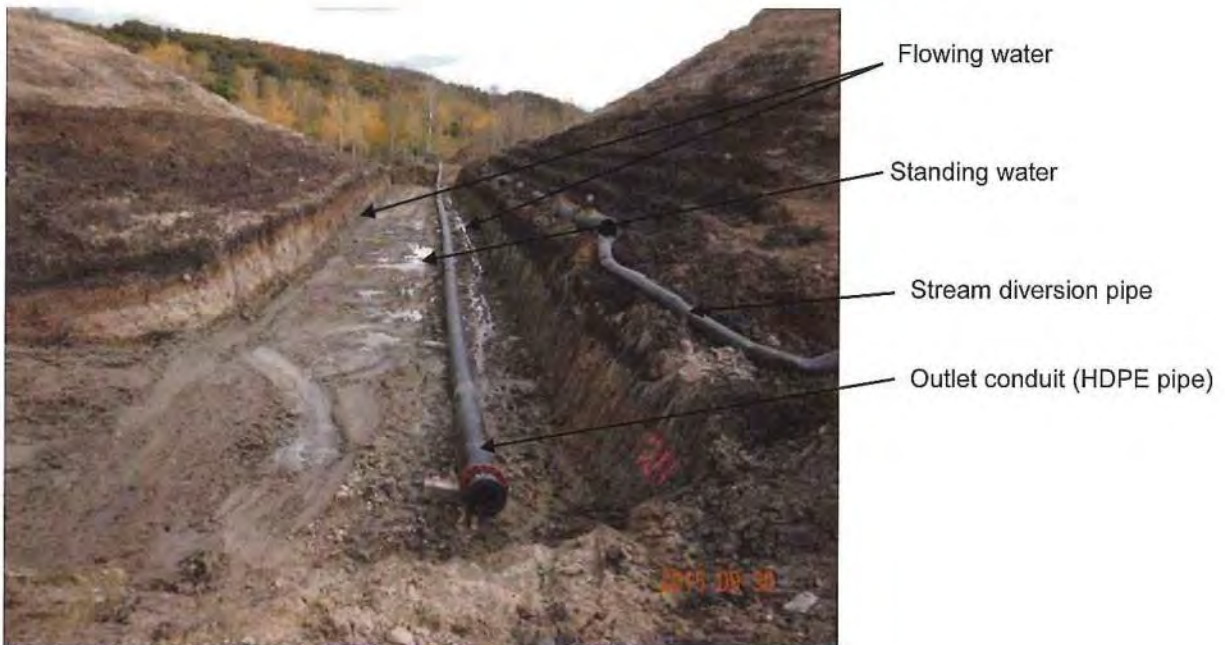
Photo 1 – Outlet works excavation.

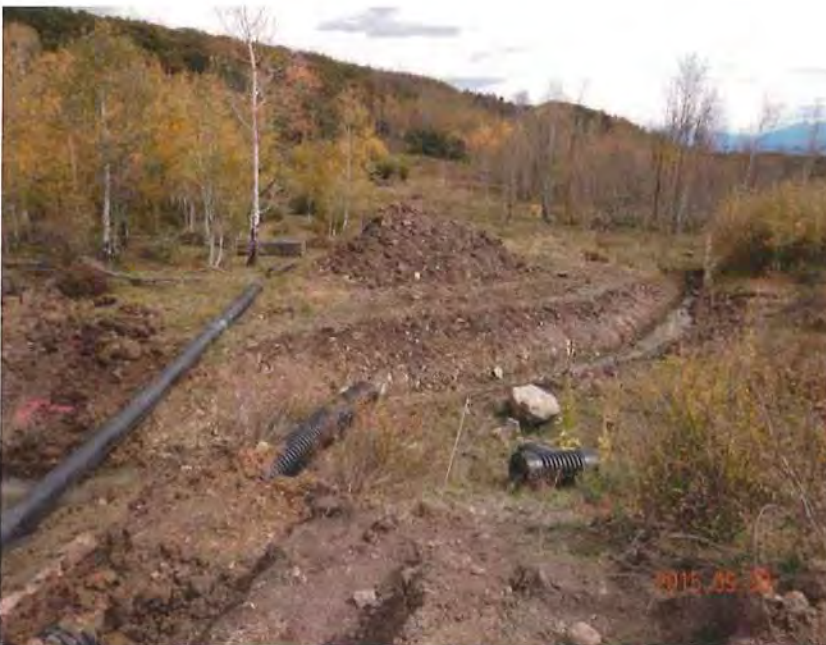
Photo 2 – Channel excavation downstream of dam (to Jay Creek).

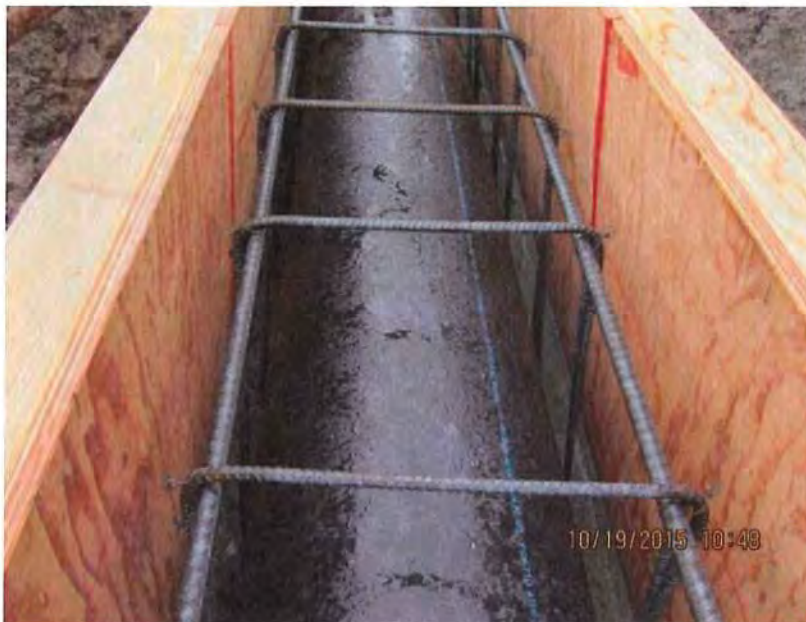
Photo 3 - Reinforcing steel for the outlet works encasement.

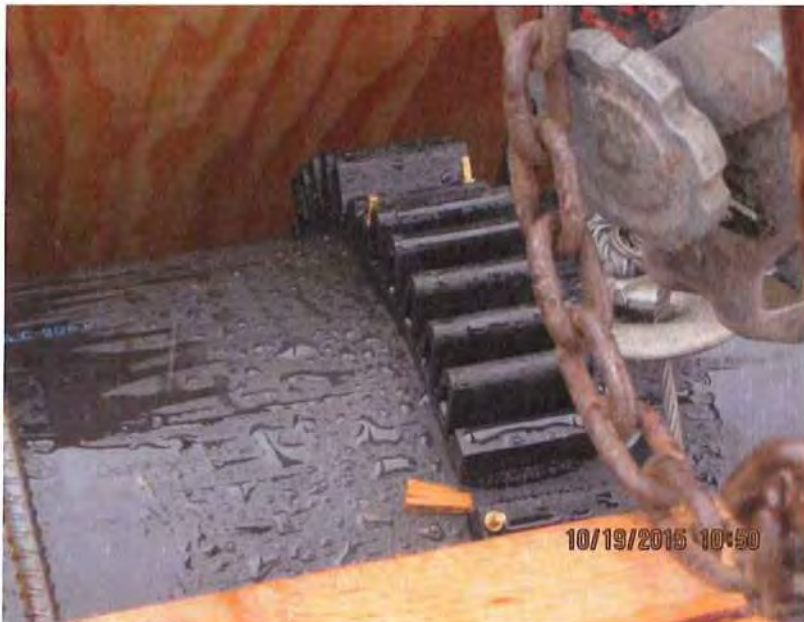
Photo 4 – Exterior band attached to HDPE pipe.

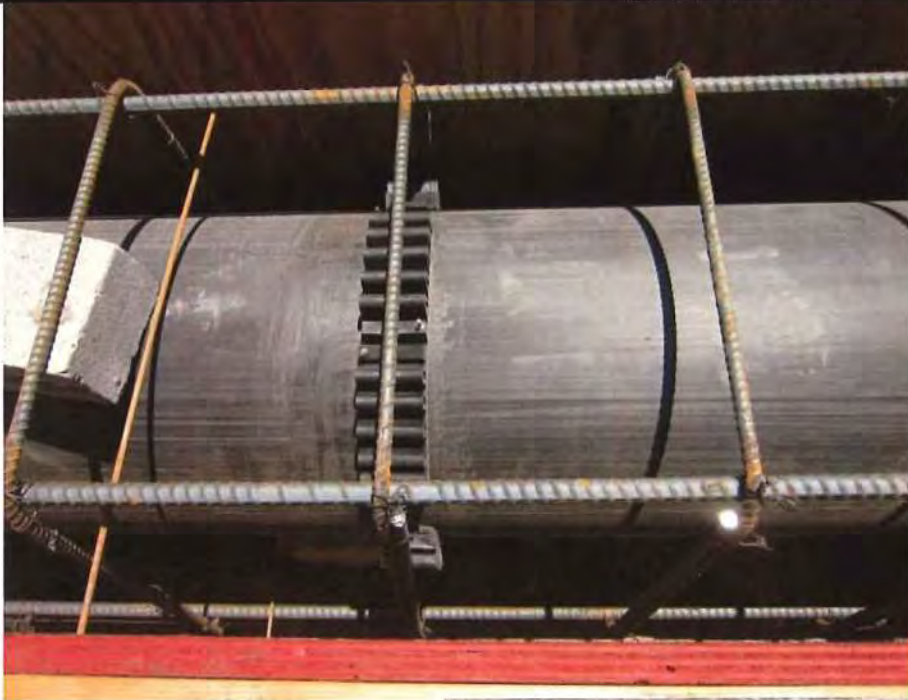
Close-up of outlet pipe, rebar cage, concrete forms, and exterior band to prevent lateral displacement of pipe.

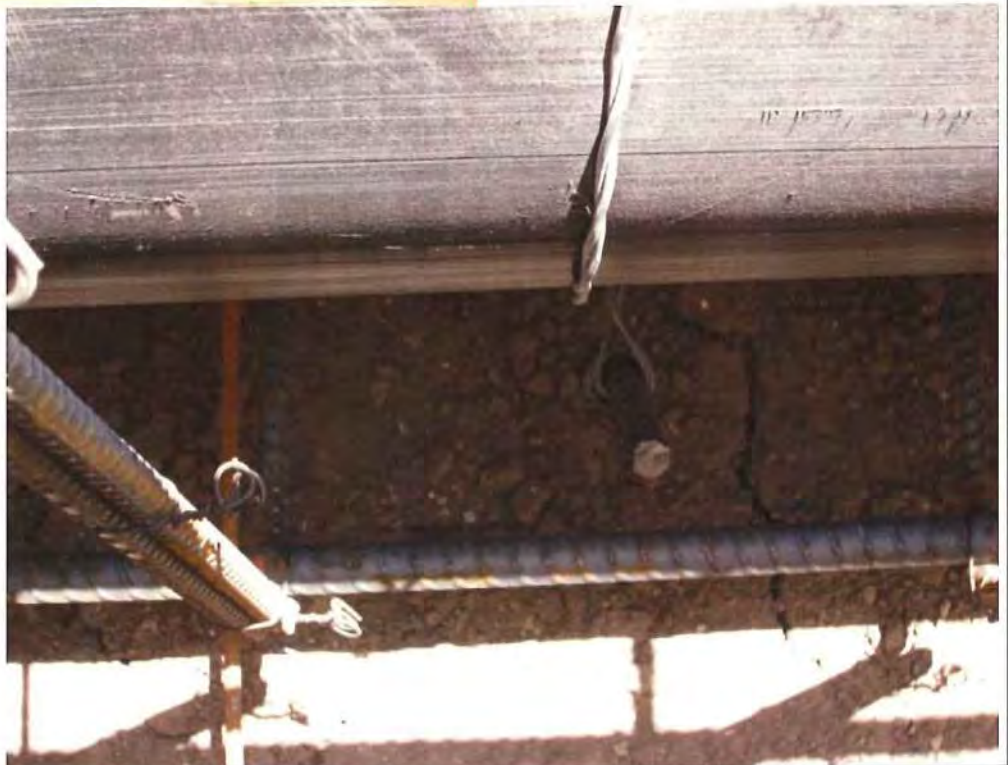
Close-up of wire tie and rebar to prevent floatation of the outlet pipe during concrete placement.

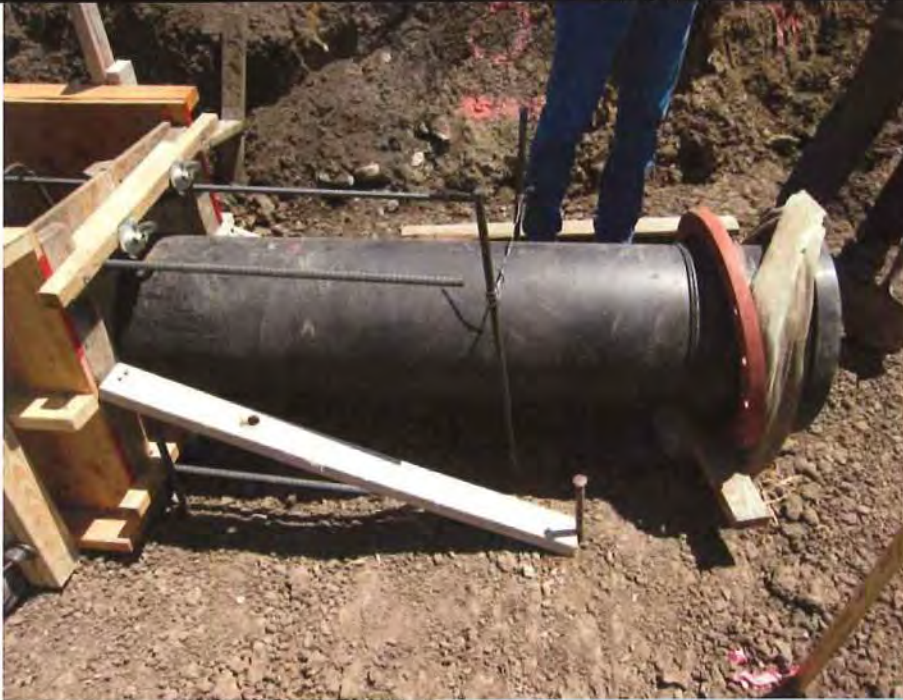
Upstream end of outlet pipe with flanged end for connection to intake structure. Concrete encasement of this section of pipe will occur at a later date.

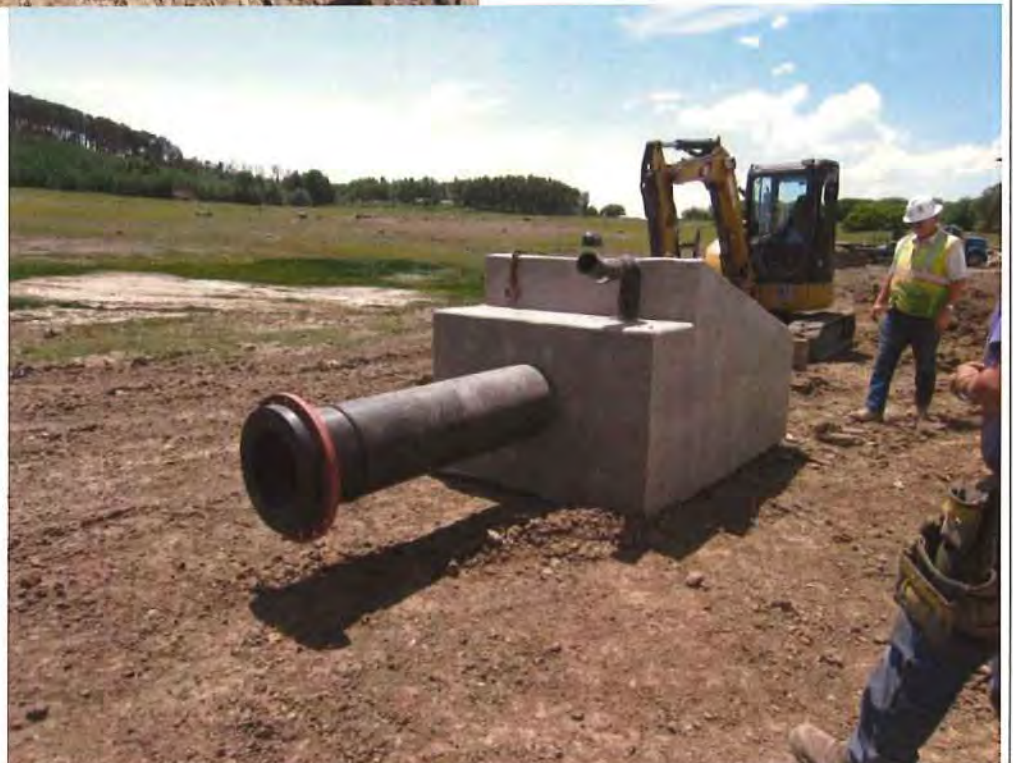
Flanged end on precast intake structure.

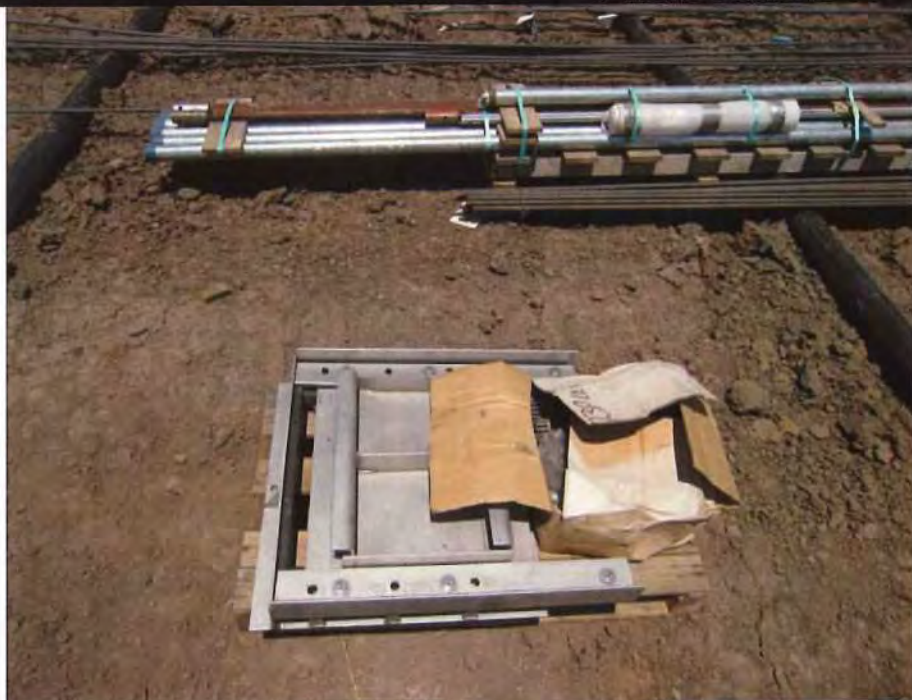
Outlet valve with stem and stem casing in background.

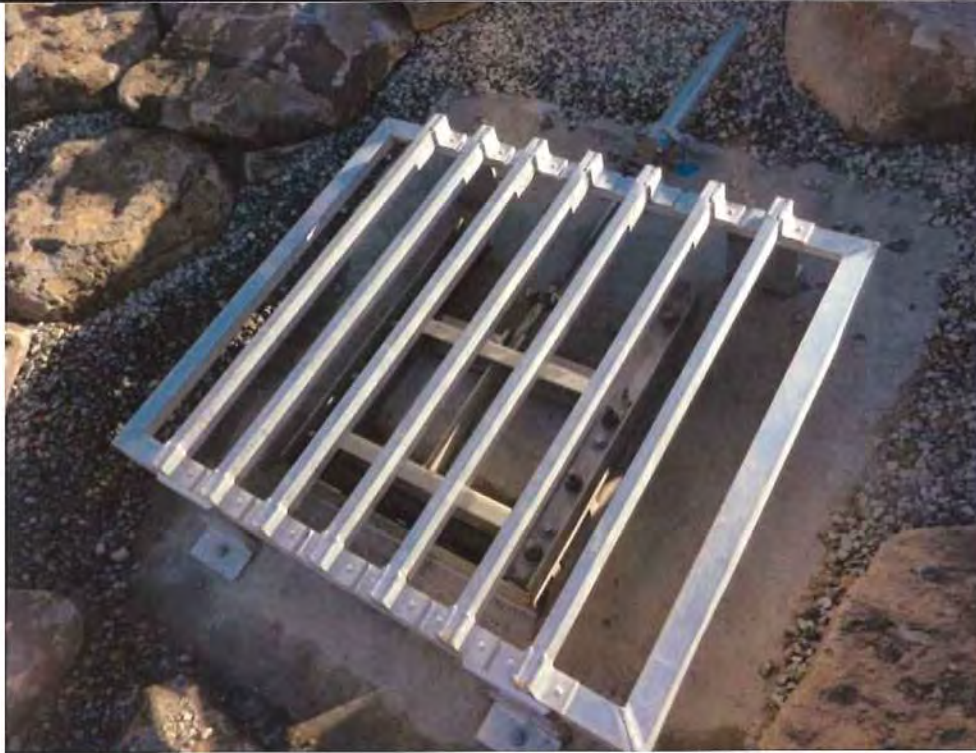
Aluminum trash rack on outlet gate.

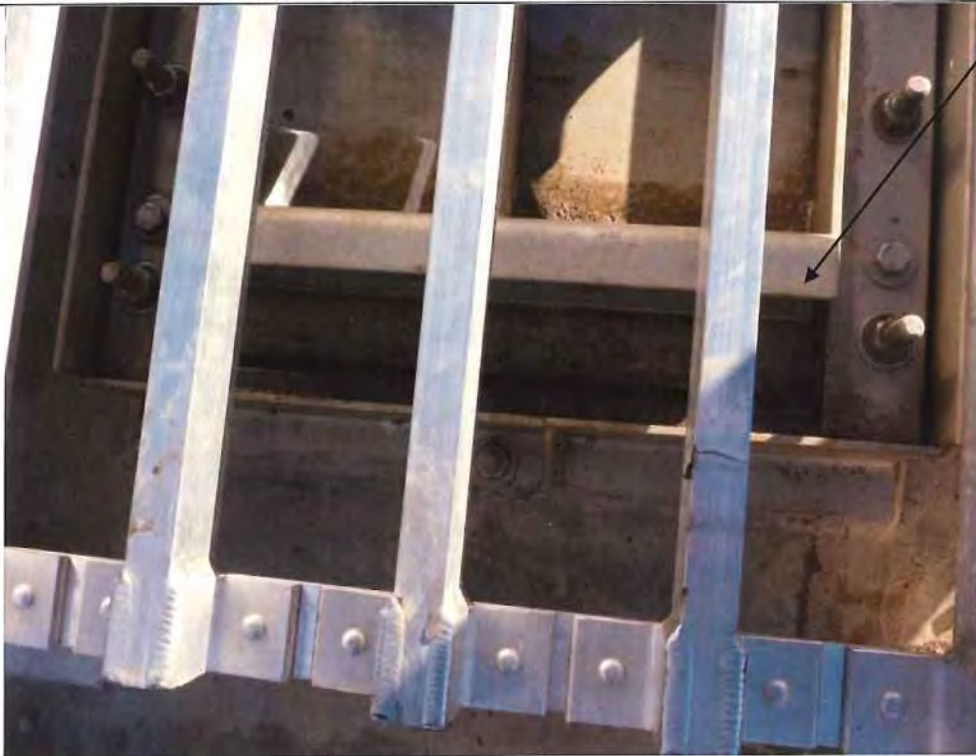
Right corner (looking downstream) of gate closes barely sooner than left side, gate appears to seal adequately.

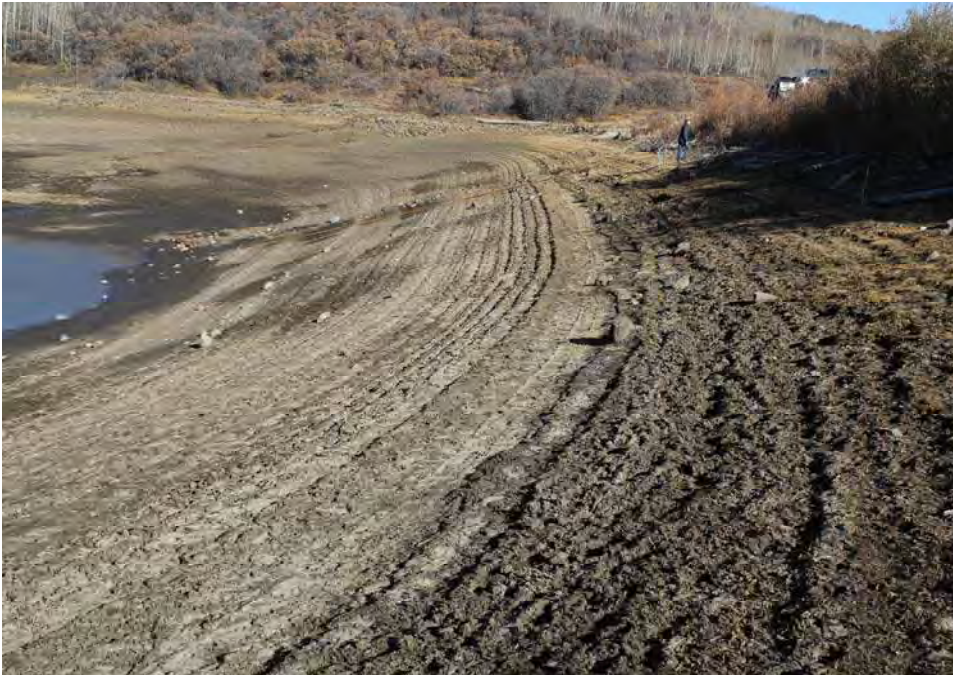
**Photograph 1:** Upstream slope prior to the start of excavation.

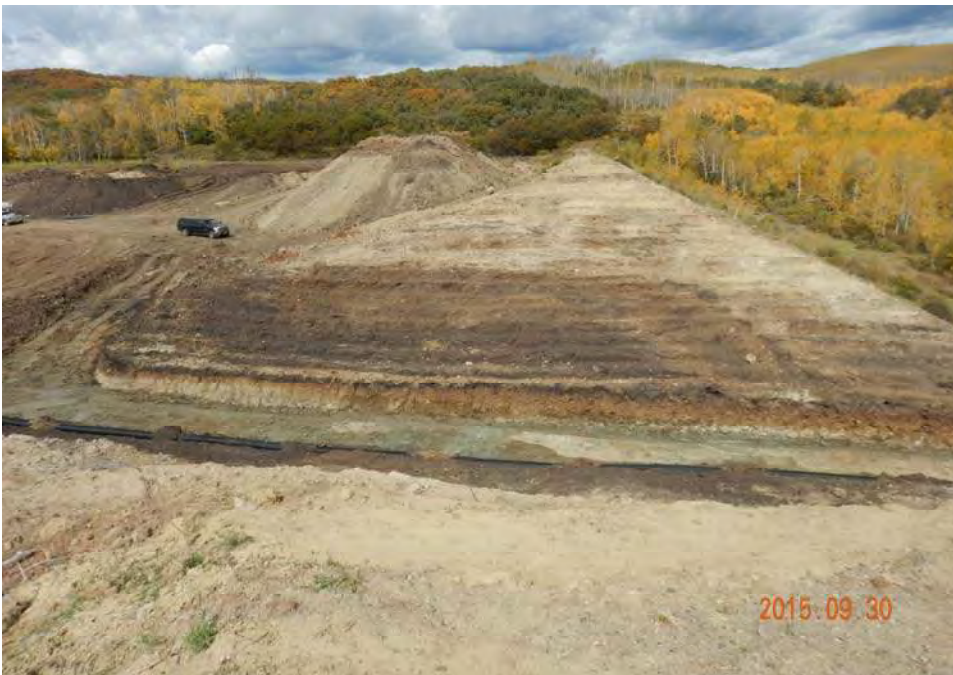
**Photograph 2:** Completed excavation above the outlet works.

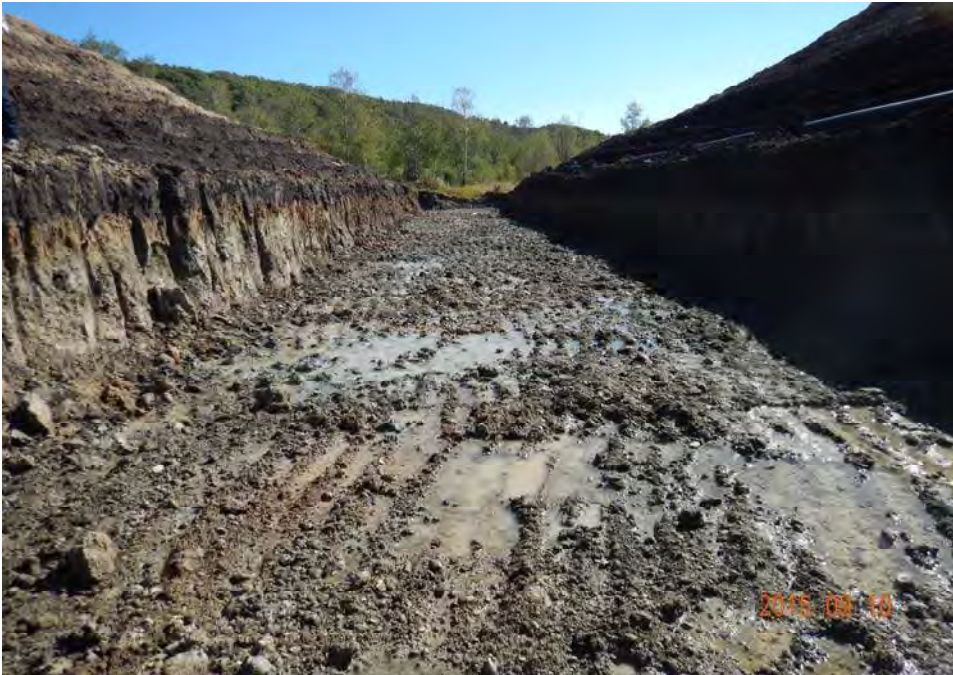
**Photograph 3:** Bottom of excavation without effective dewatering.

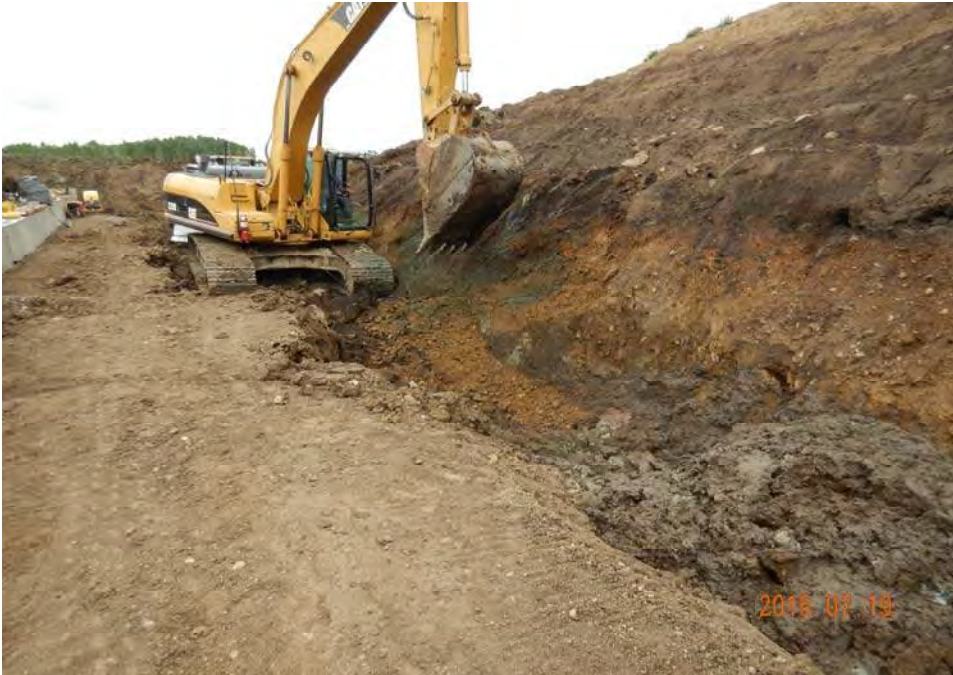
**Photograph 7:** Excavating the dewatering trench on the left side of the working platform prior to placing common fill for the embankment.

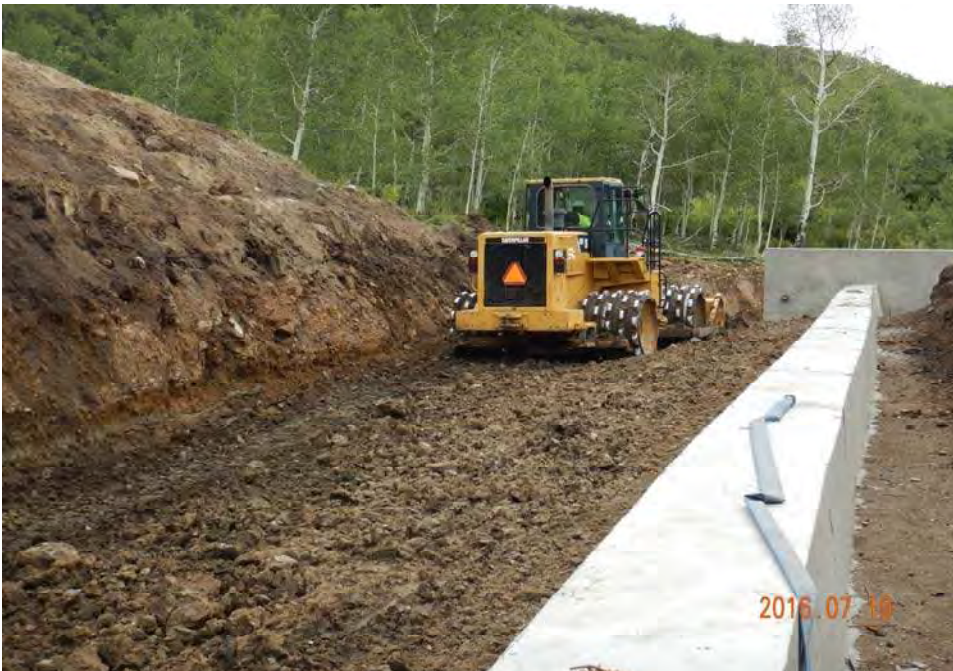
**Photograph 8:** CAT 815 compacting common fill for the embankment.

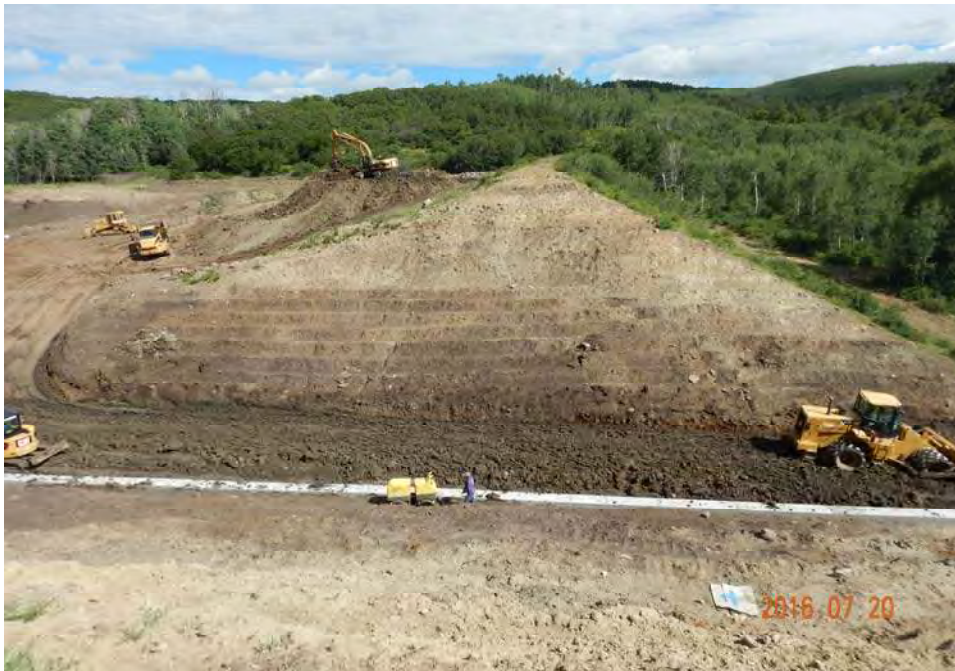
**Photograph 10:** Placing common fill for the embankment.

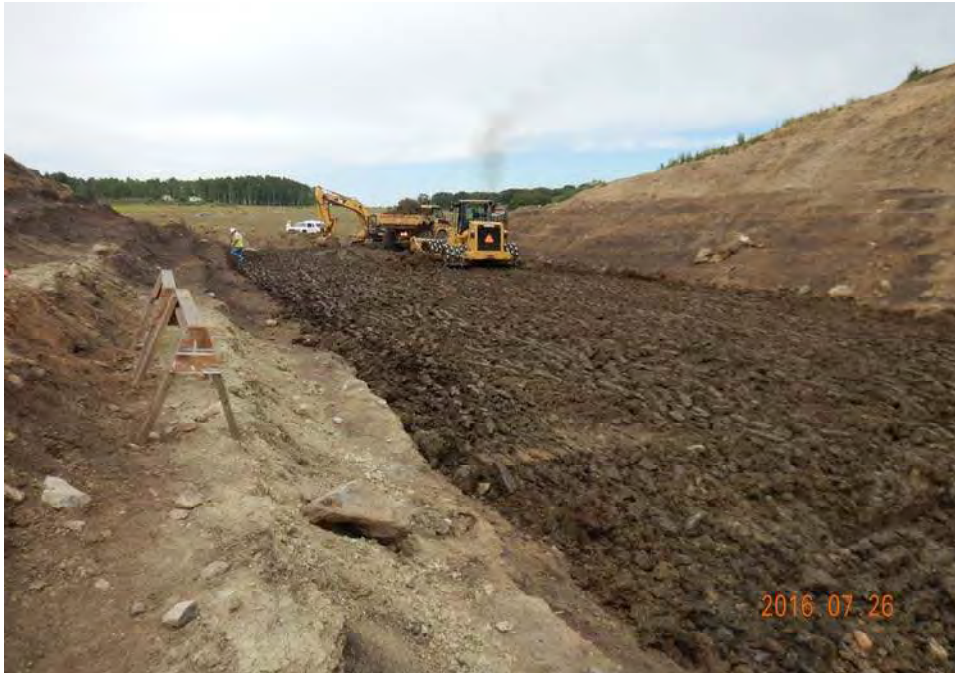
**Photograph 11:** Placing common fill for the embankment.

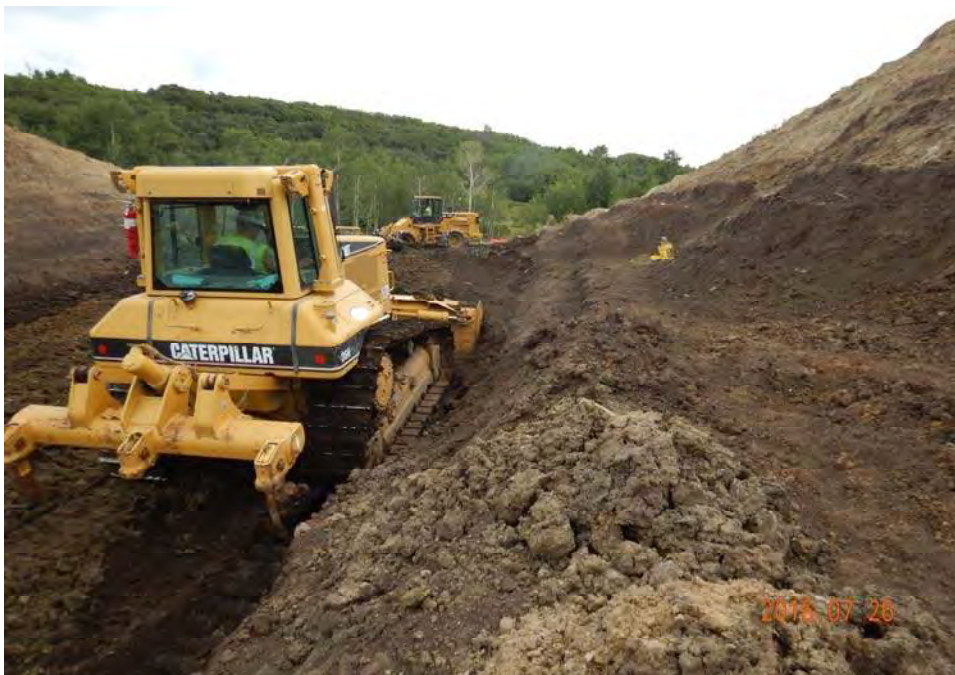
**Photograph 12:** Cutting the existing slope back to fresh material and eliminating steep slopes.

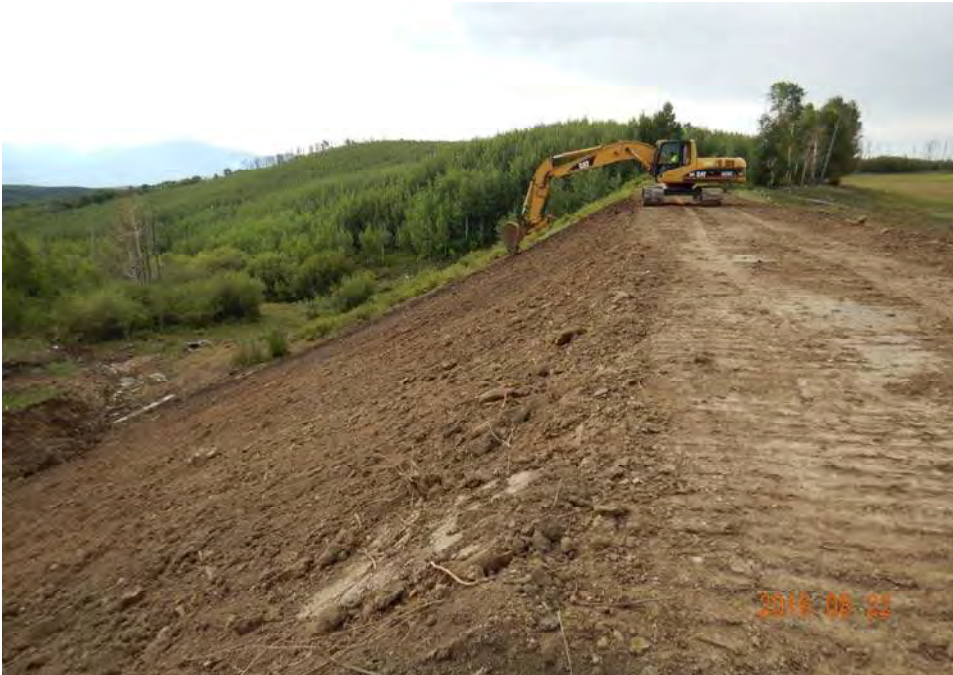
**Photograph 13:** Placing topsoil on the downstream slope.
