**CONSTRUCTION COMPLETION REPORT**  
**WEST RESERVOIR NO. 1 OUTLET WORKS**  
**REHABILITATION PROJECT**  
**DELTA COUNTY, COLORADO**

Submitted to  
**West Reservoir & Ditch Company**  
708 1250 Road  
Delta, CO 81416

Submitted by  
**RJH Consultants, Inc.**  
9800 Mt. Pyramid Court, Suite 330  
Englewood, Colorado 80112  
303-225-4611  
[www.rjh-consultants.com](http://www.rjh-consultants.com)

December 2016  
Project 13129

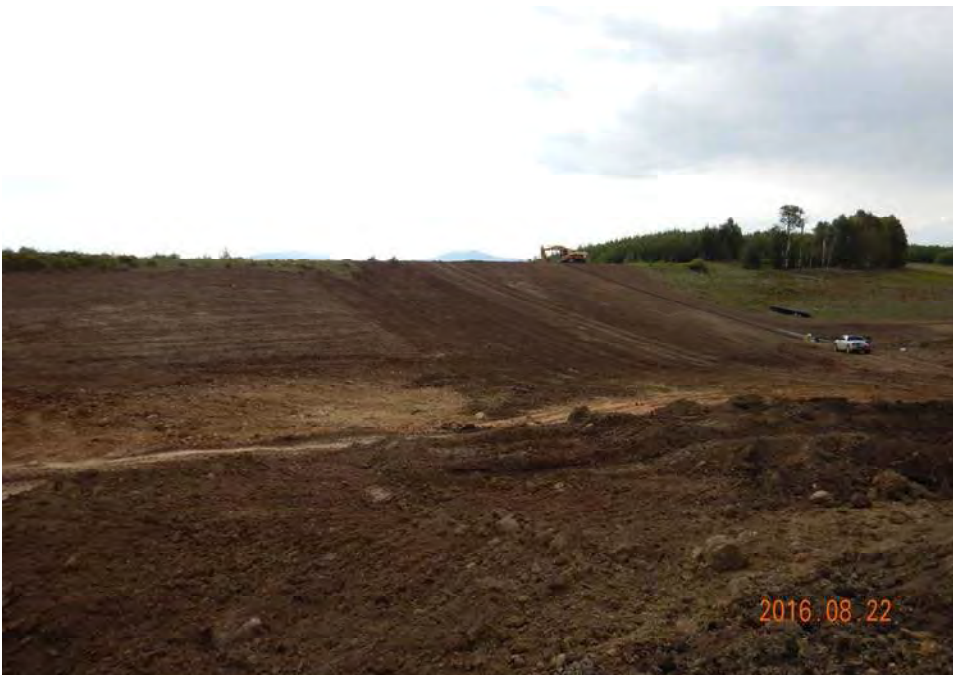
**Photograph 14:** Finished embankment, upstream slope.

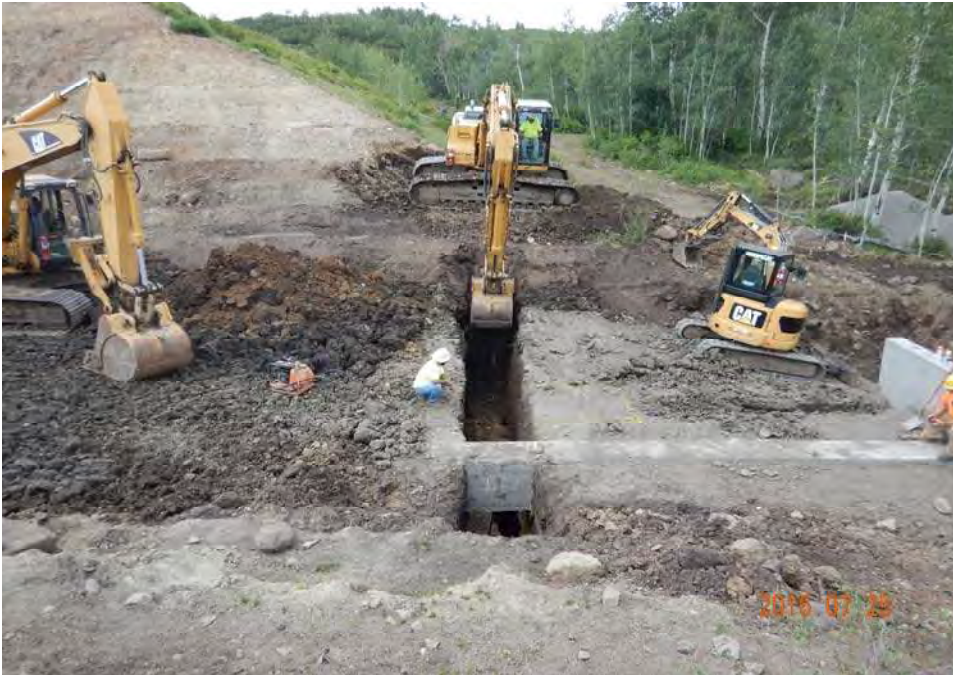
**Photograph 15:** Excavating the trench for the filter collar.

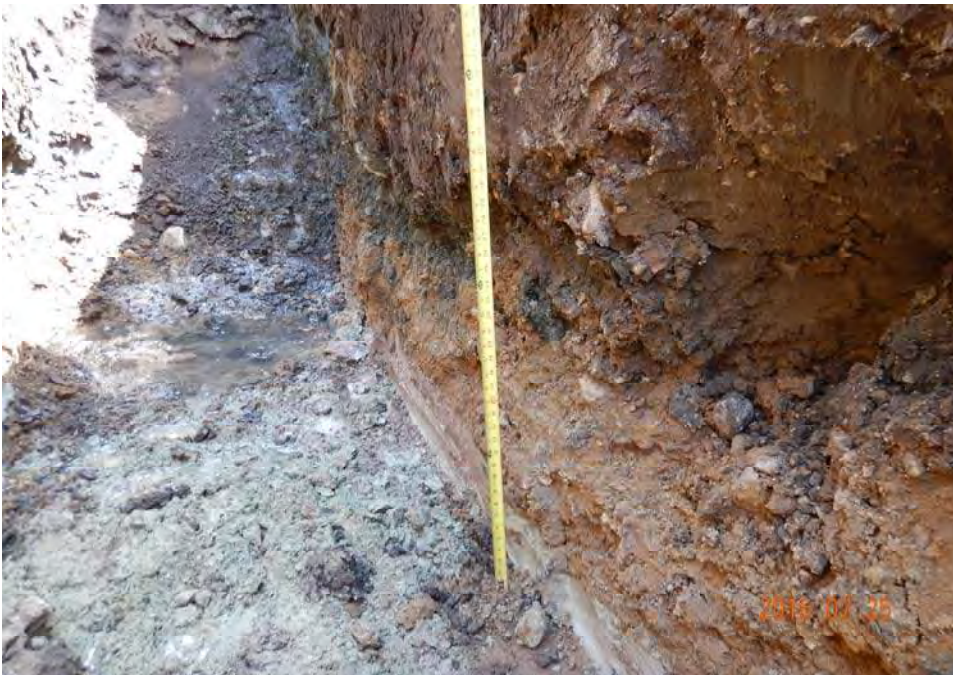
**Photograph 16:** Filter collar overlap between existing material and new fill.

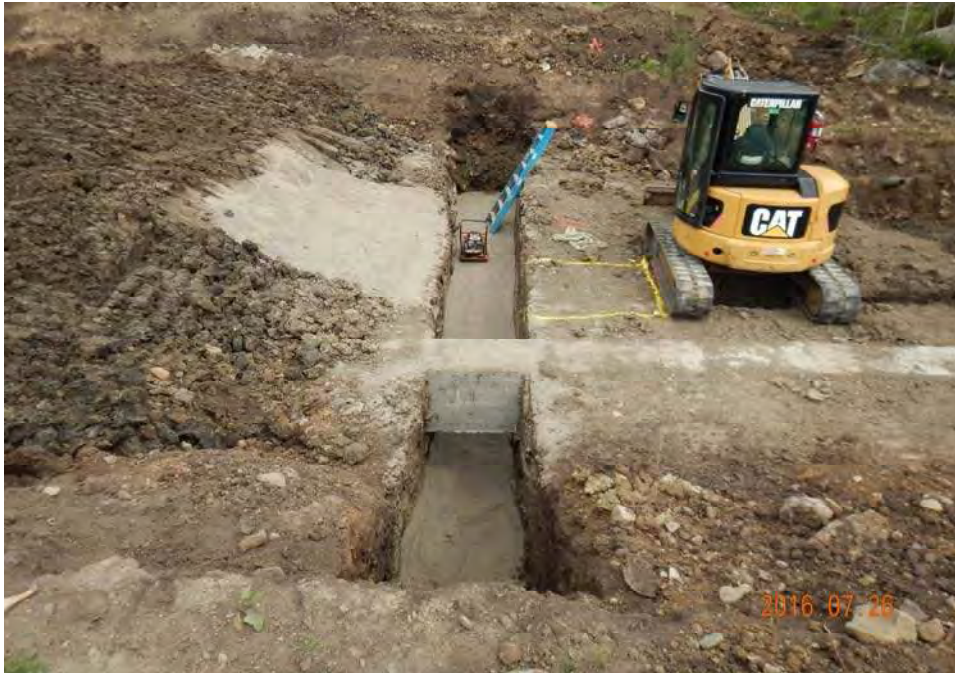
**Photograph 17:** Placing sand for the filter collar.

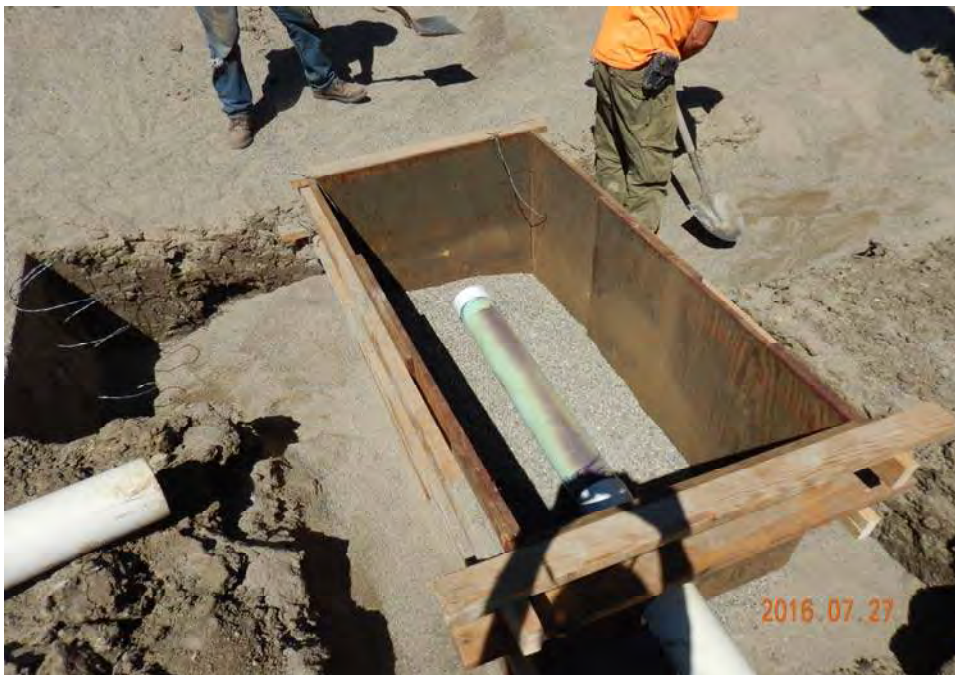
**Photograph 18:** Forms used to separate the filter sand and filter gravel for the filter collar drain pipe.

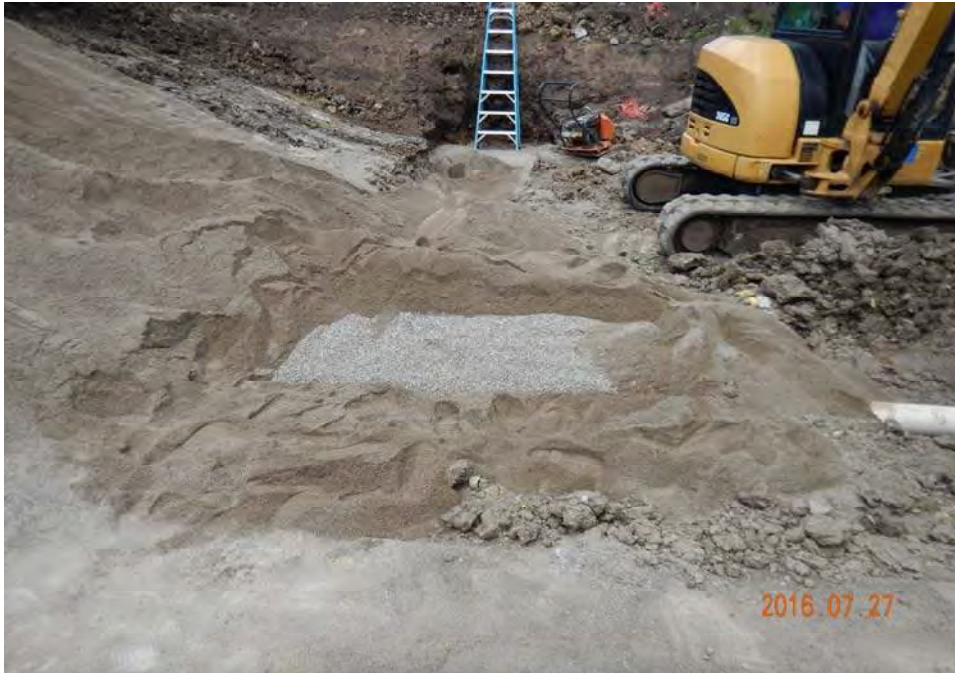
**Photograph 19:** Filter sand and filter gravel with forms removed.

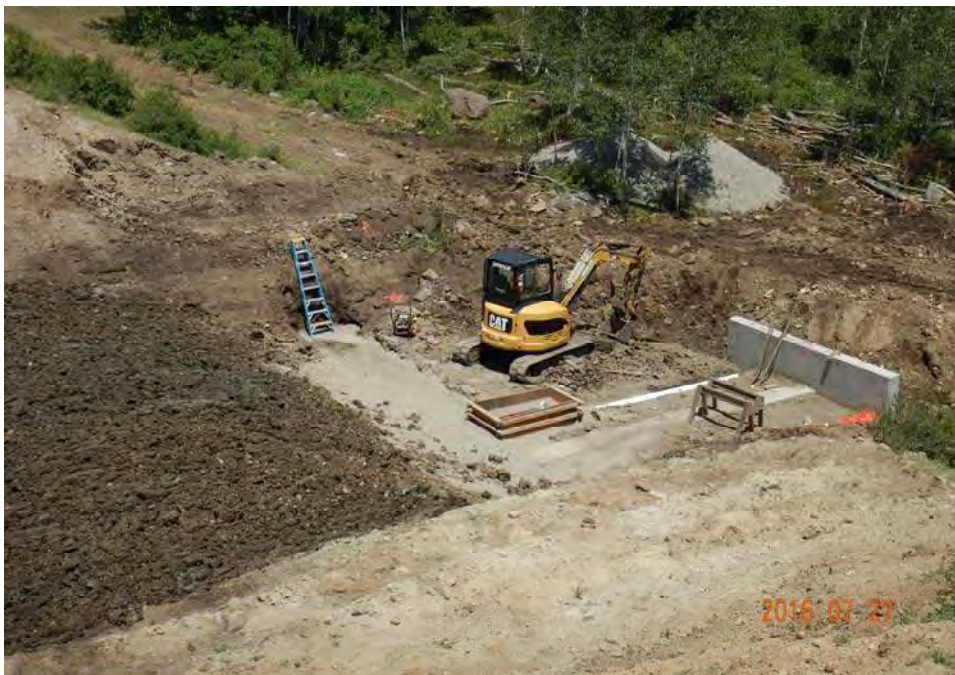
**Photograph 20:** General view of the filter collar.

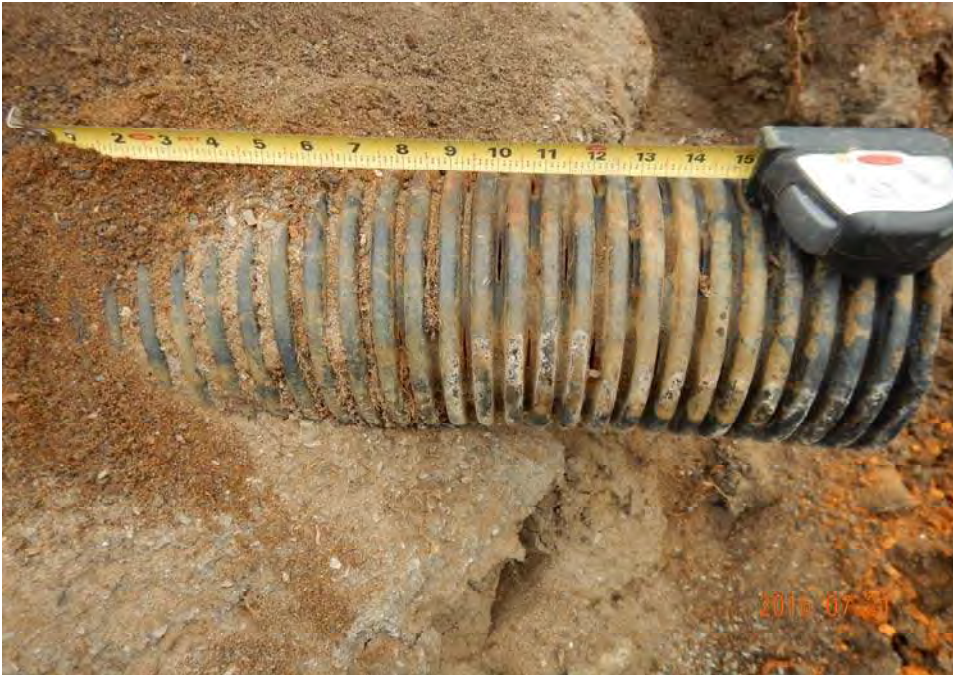
**Photograph 21:** Existing embankment toe drain pipe on the left side of the energy dissipation structure (not part of this construction).

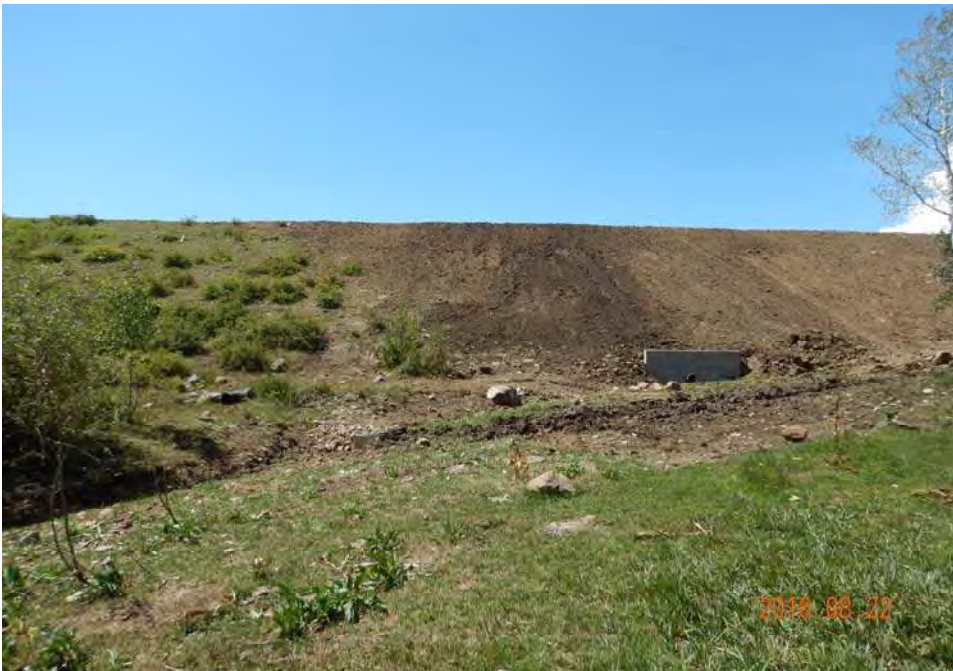
**Photograph 22:** Completed downstream slope.

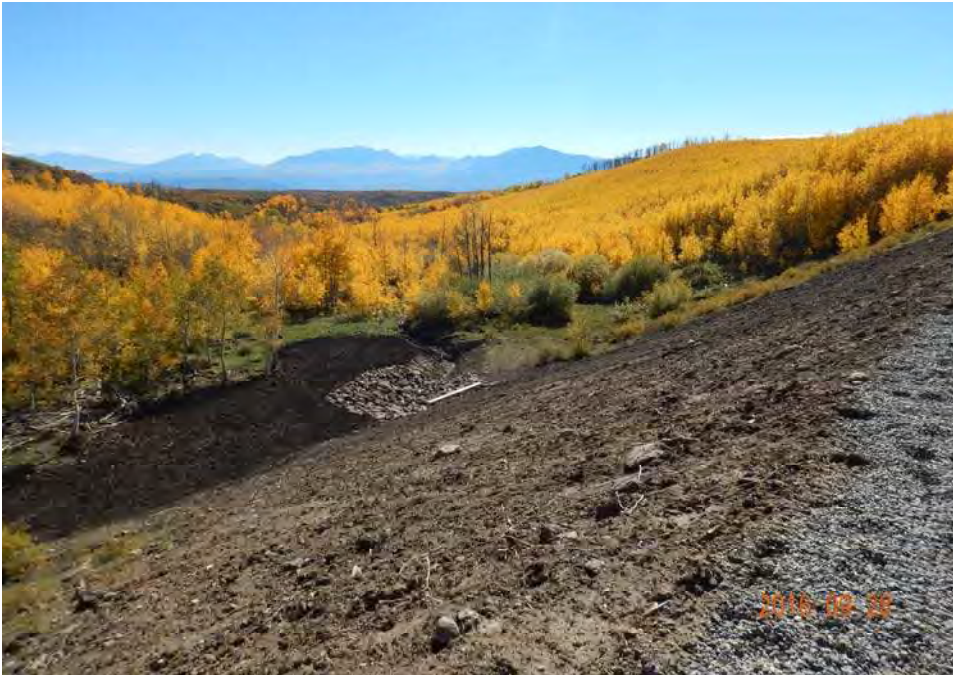
**Photograph 23:** Completed downstream slope and discharge channel.

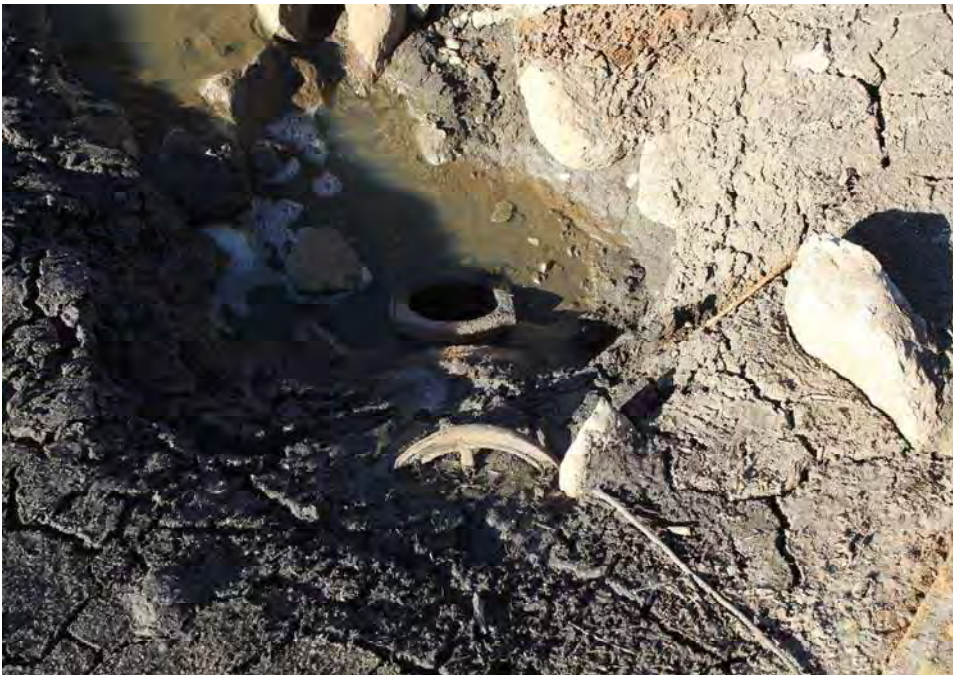
**Photograph 24:** Existing valve on upstream end (outlet works inlet).

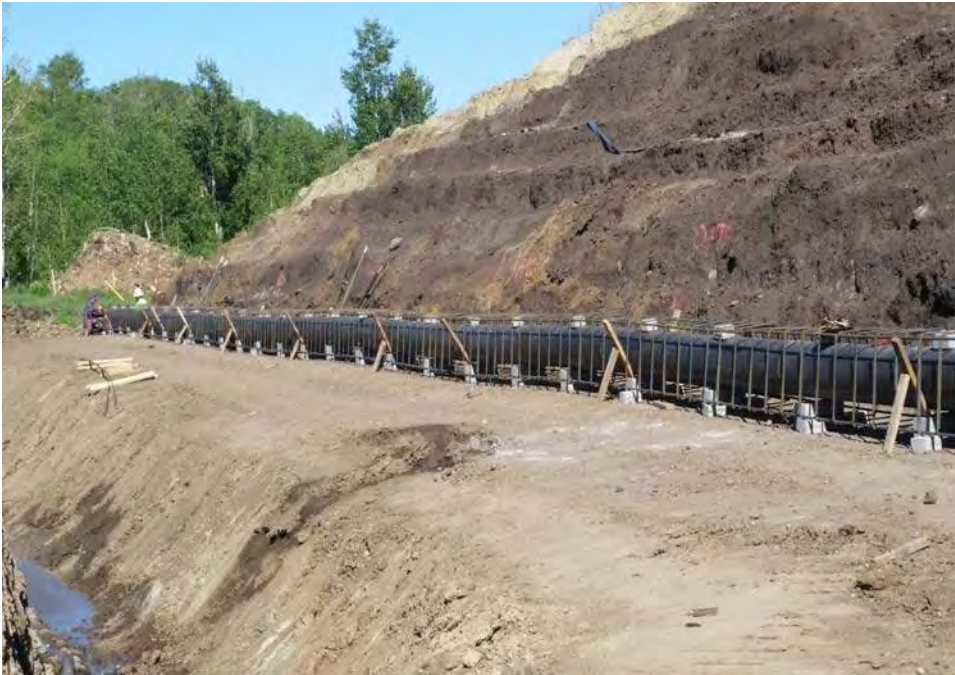
**Photograph 25:** HDPE conduit and encasement reinforcing steel in place.

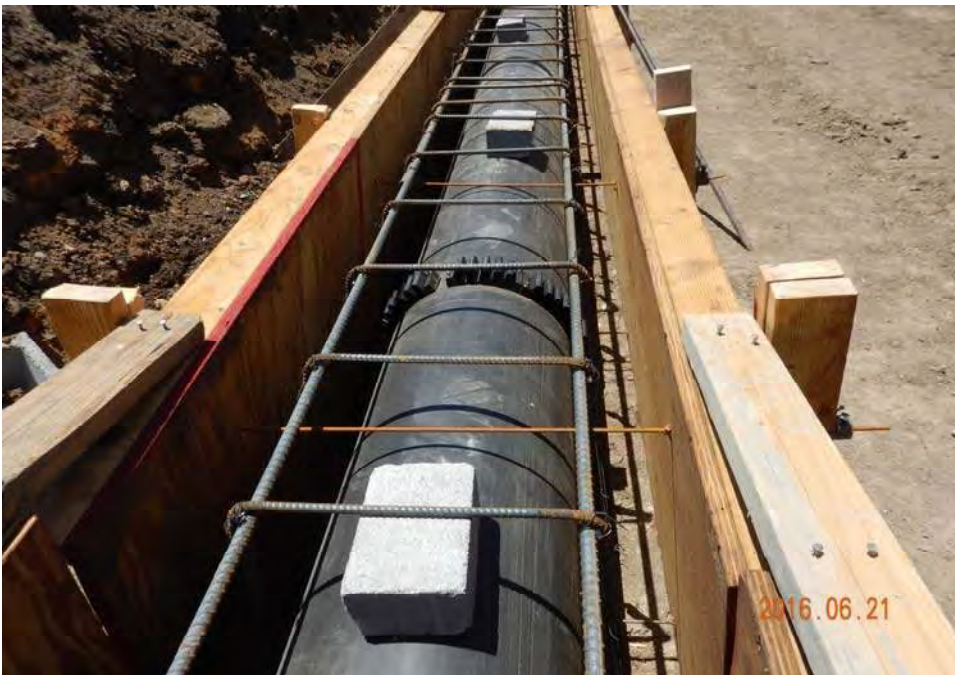
**Photograph 26:** Outlet conduit prior to concrete placement. Note the exterior band welded to the HDPE conduit.

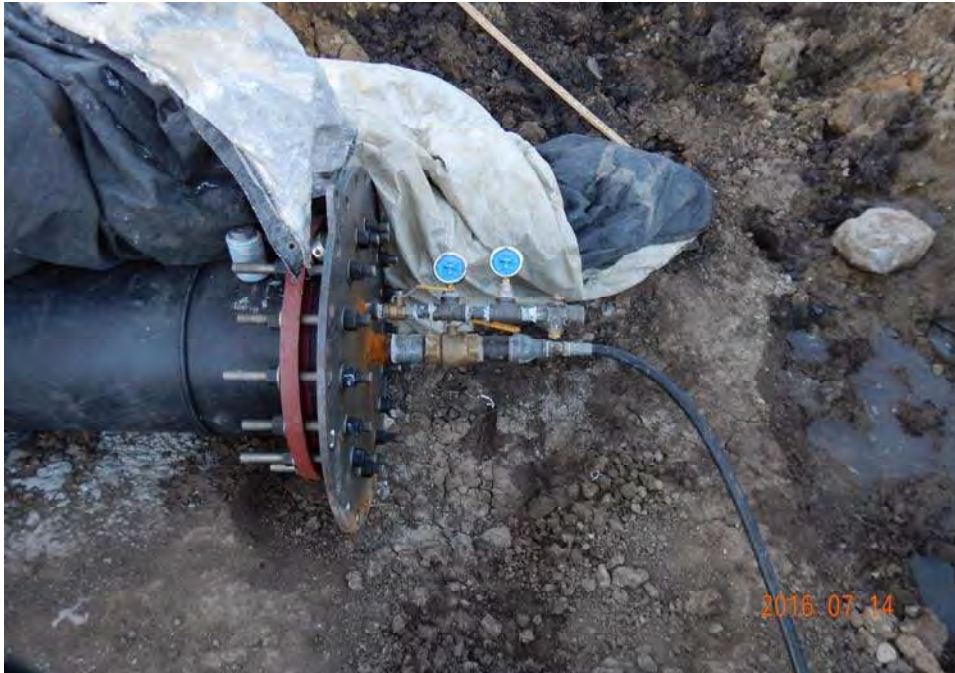
**Photograph 29:** Conduit pressure test apparatus (valves and pressure gauges).

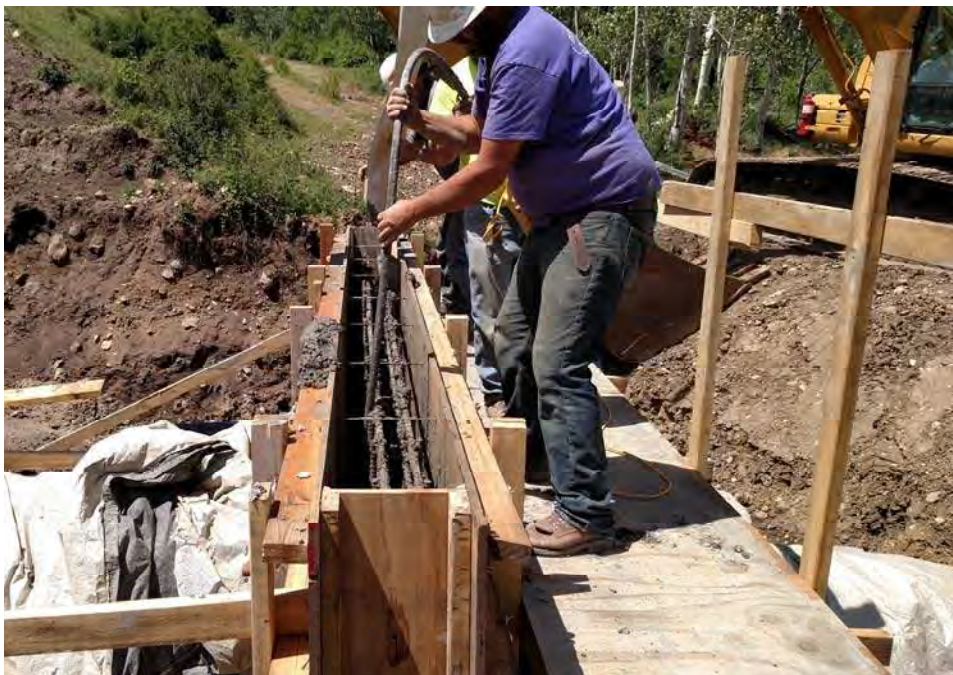
**Photograph 30:** Placing concrete for the downstream headwall.

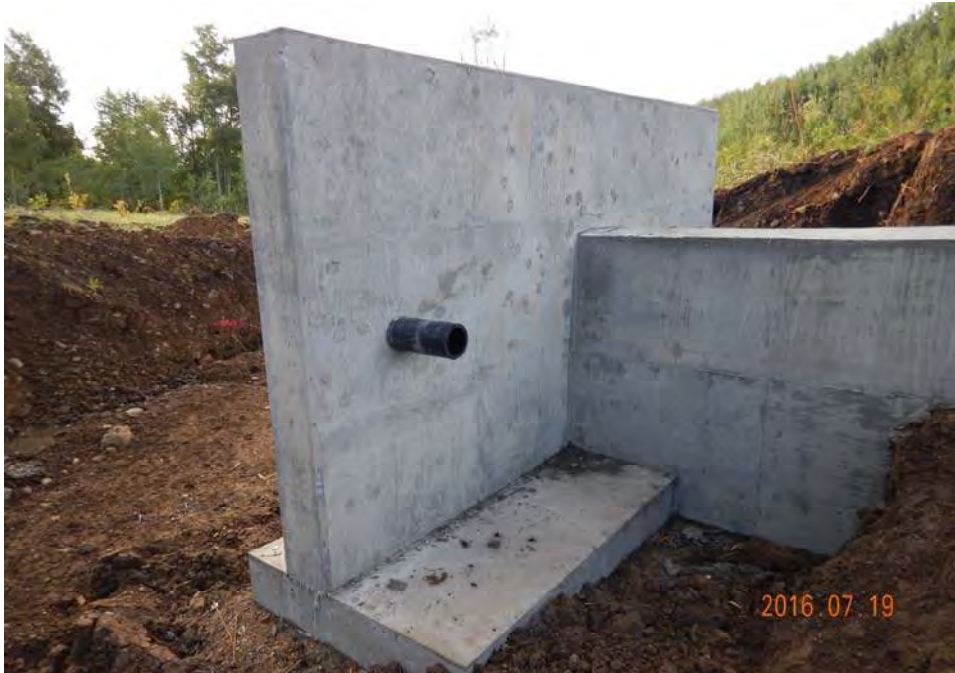
**Photograph 31:** Downstream headwall, upstream side.

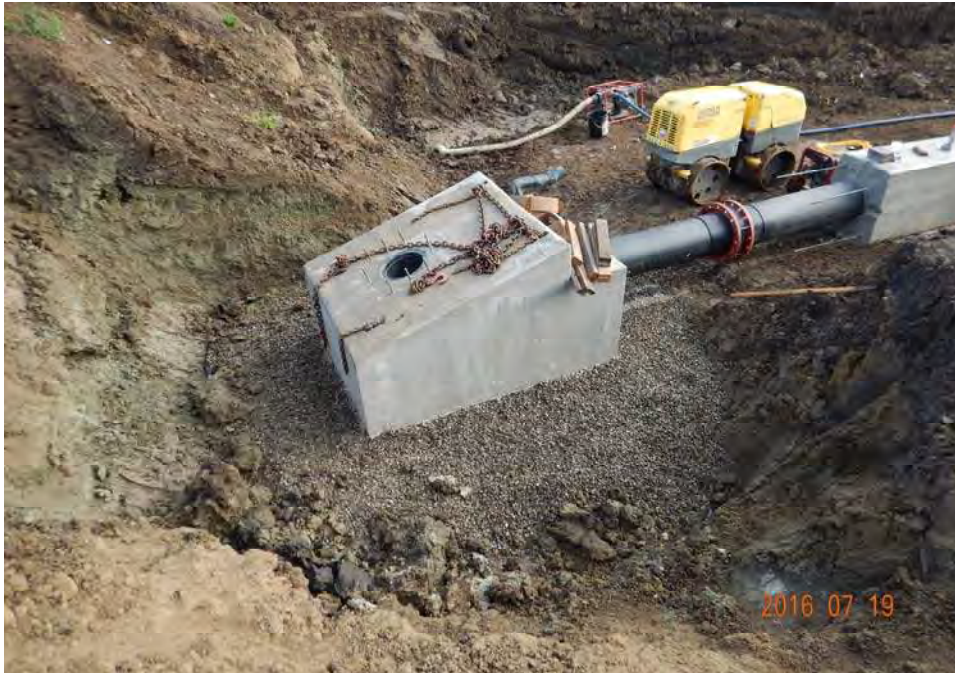
**Photograph 33:** Precast inlet structure in-place. Note the flange connection downstream of the structure.

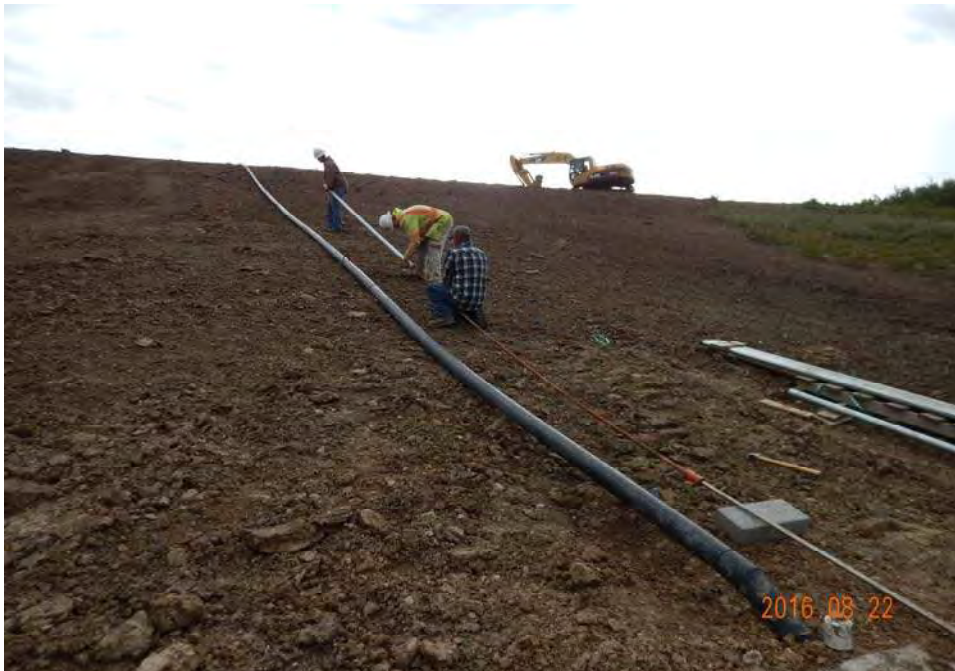
**Photograph 34:** Placing gate stem and stem cover on the upstream slope.

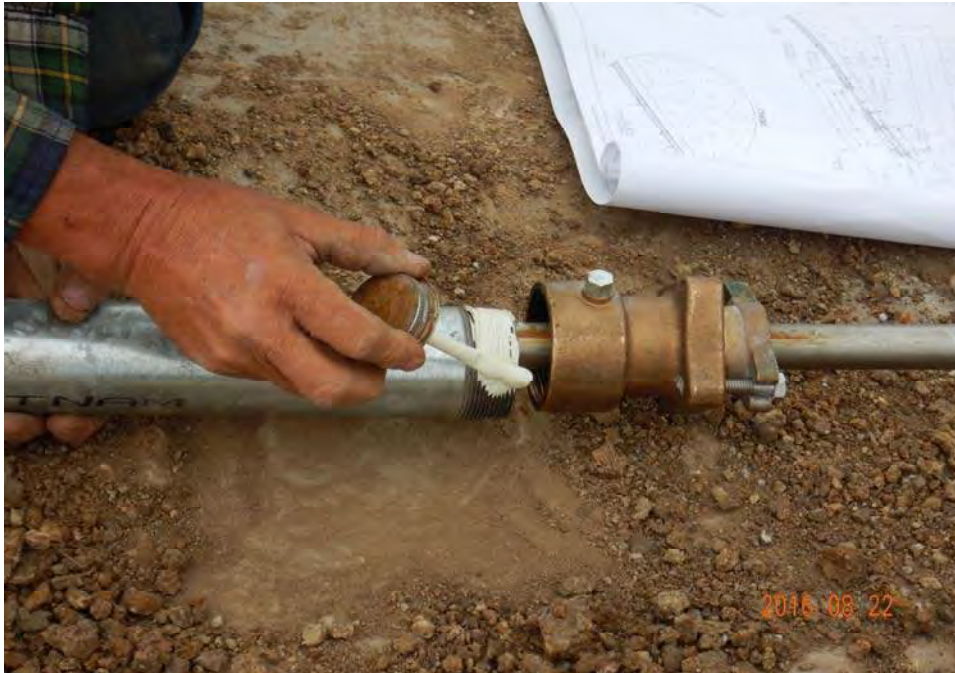
**Photograph 35:** Placing pipe joint compound to seal the gate stem cover at the inlet structure.

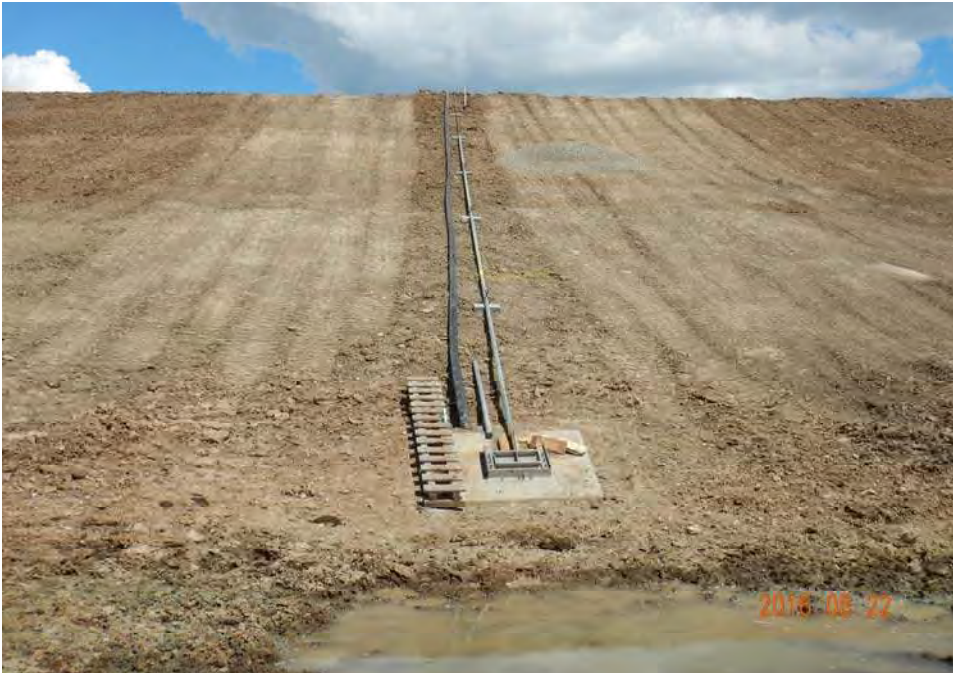
**Photograph 37:** Gate stem cover and vent pipe on the upstream slope.

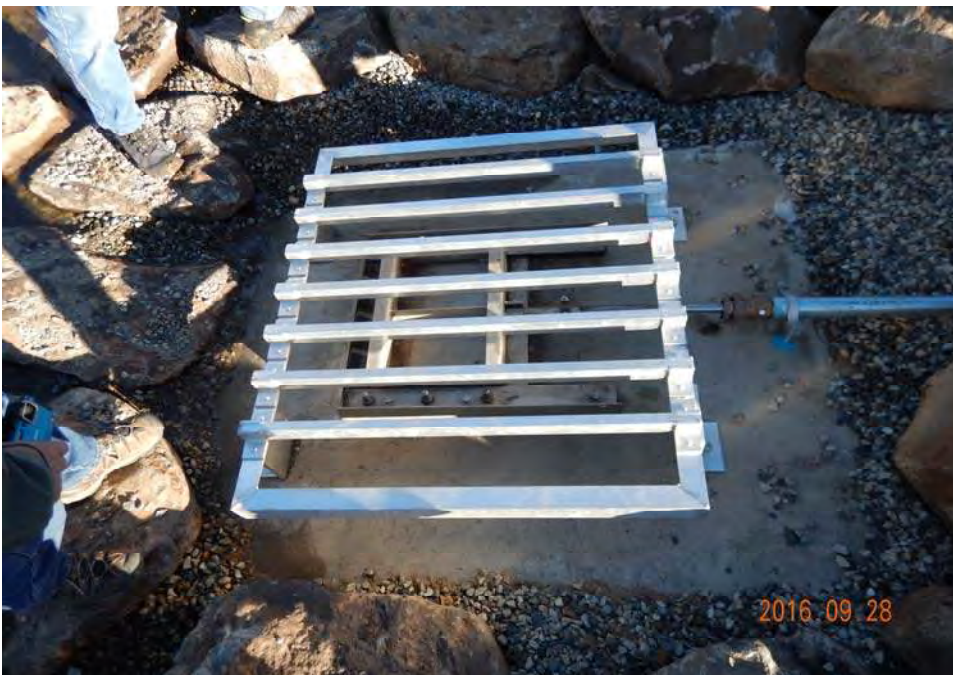
**Photograph 38:** Inlet trash rack and gate.

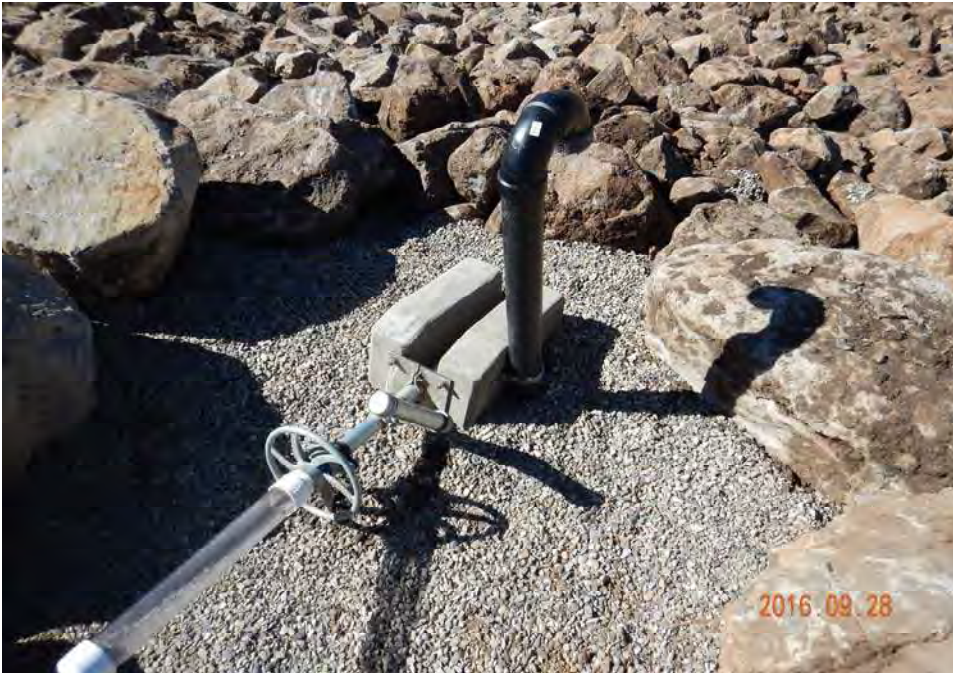
**Photograph 39:** Hand wheel pedestal on the dam crest. Note the vent pipe, stem cover and fill tube for the stem cover.

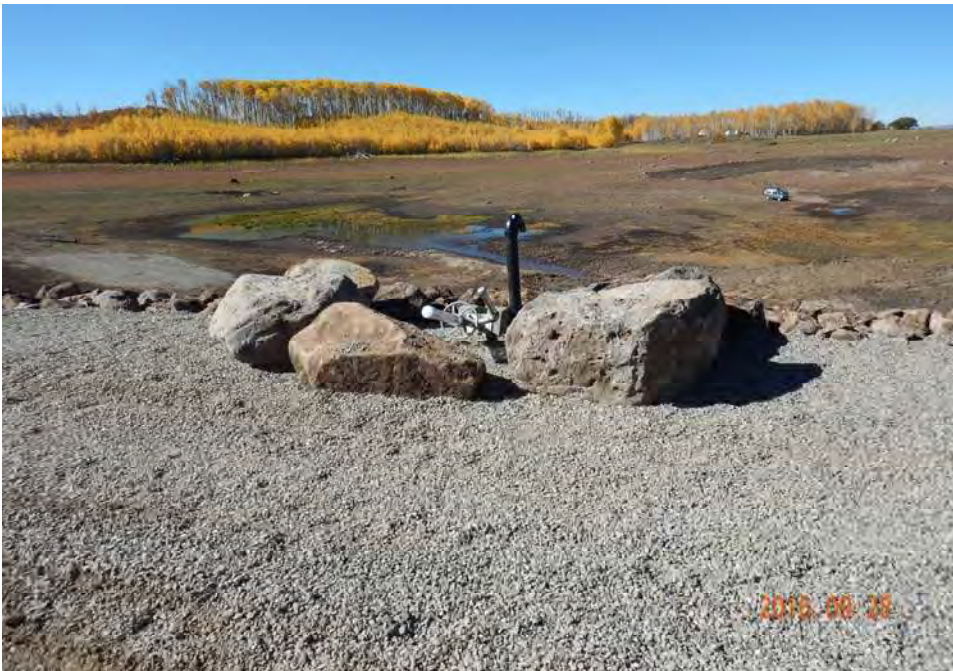
**Photograph 40:** Boulders placed around the hand wheel pedestal for protection.

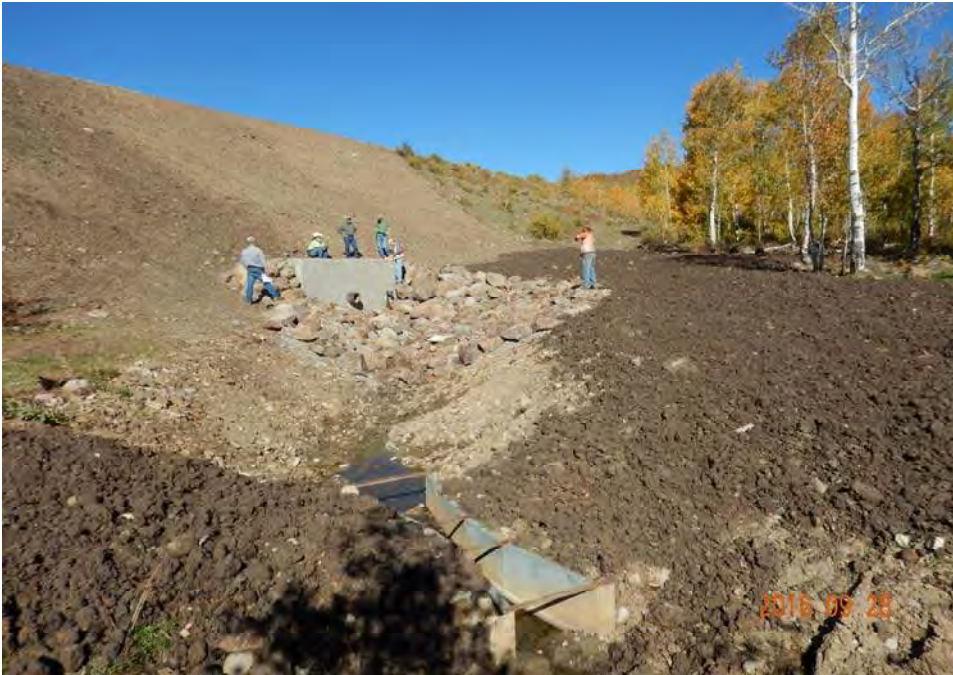
**Photograph 41:** Downstream headwall, discharge channel, and Parshall flume.

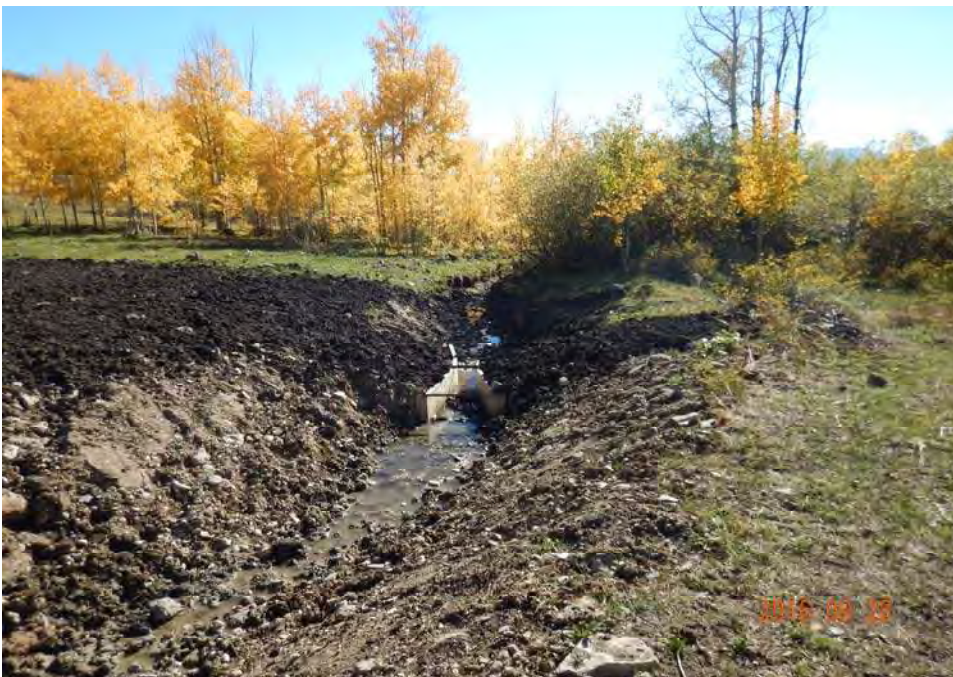
**Photograph 42:** Parshall flume in the discharge channel.

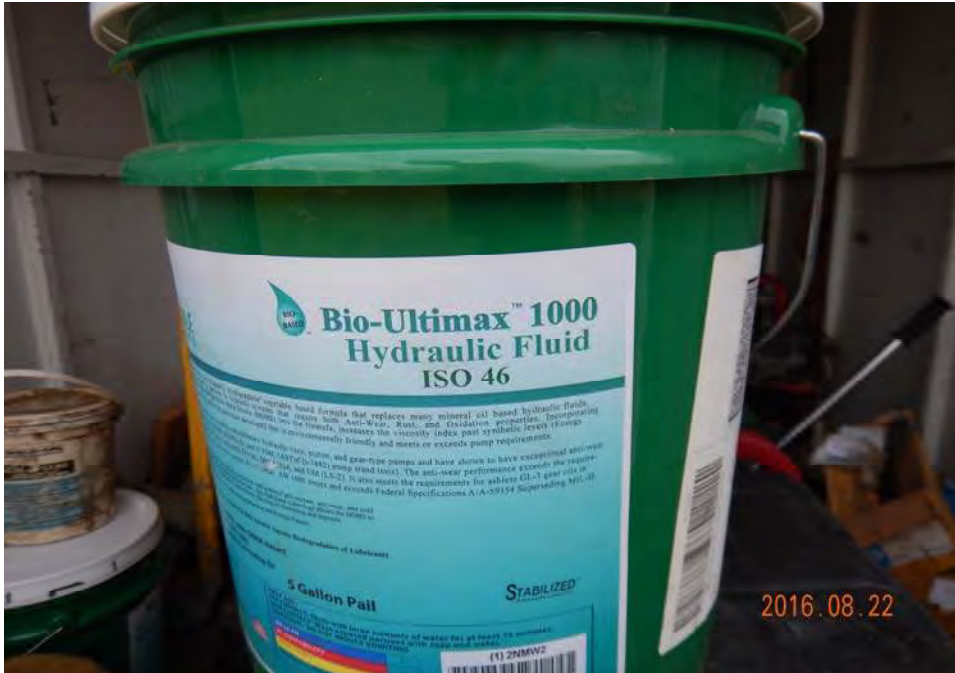
Photograph 43: Hydraulic fluid used for the gate.

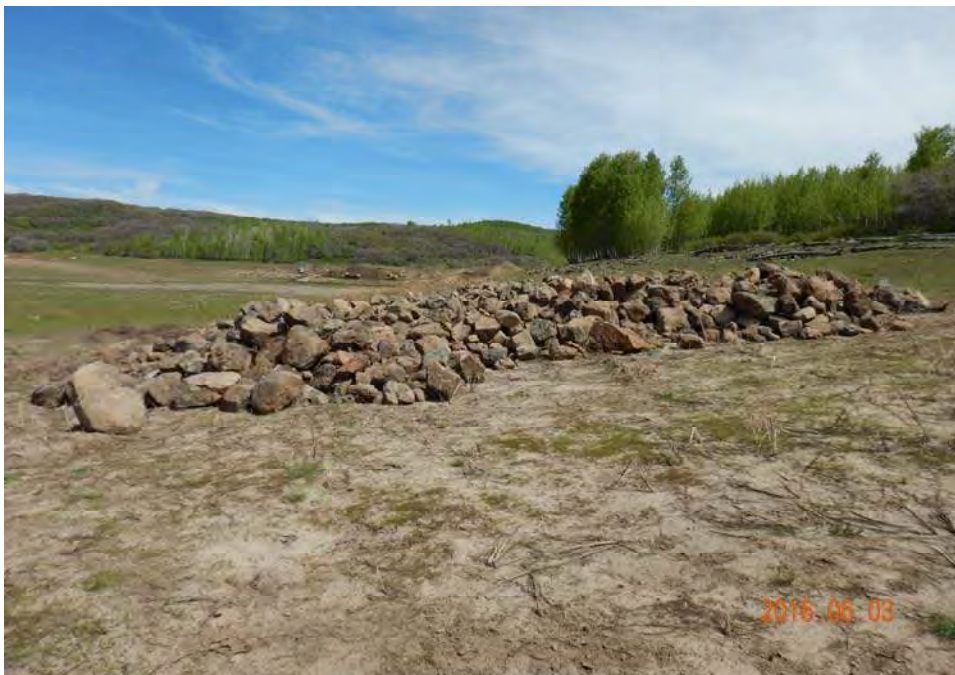
Photograph 44: Riprap stockpile from on-site materials.

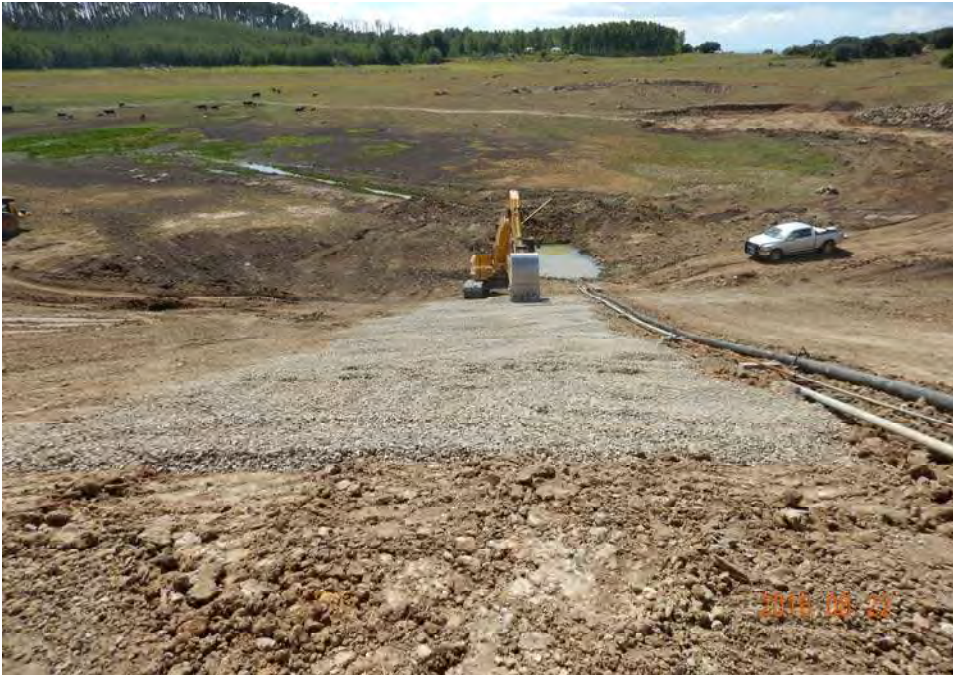
**Photograph 45:** Placing riprap bedding on the upstream slope.

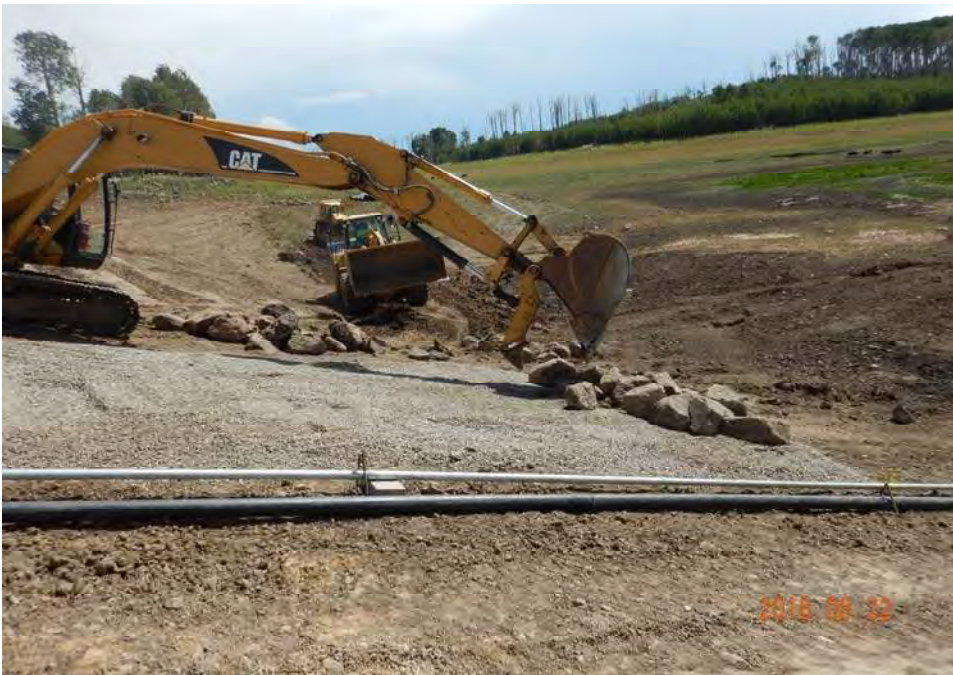
**Photograph 46:** Placing riprap on the upstream slope.

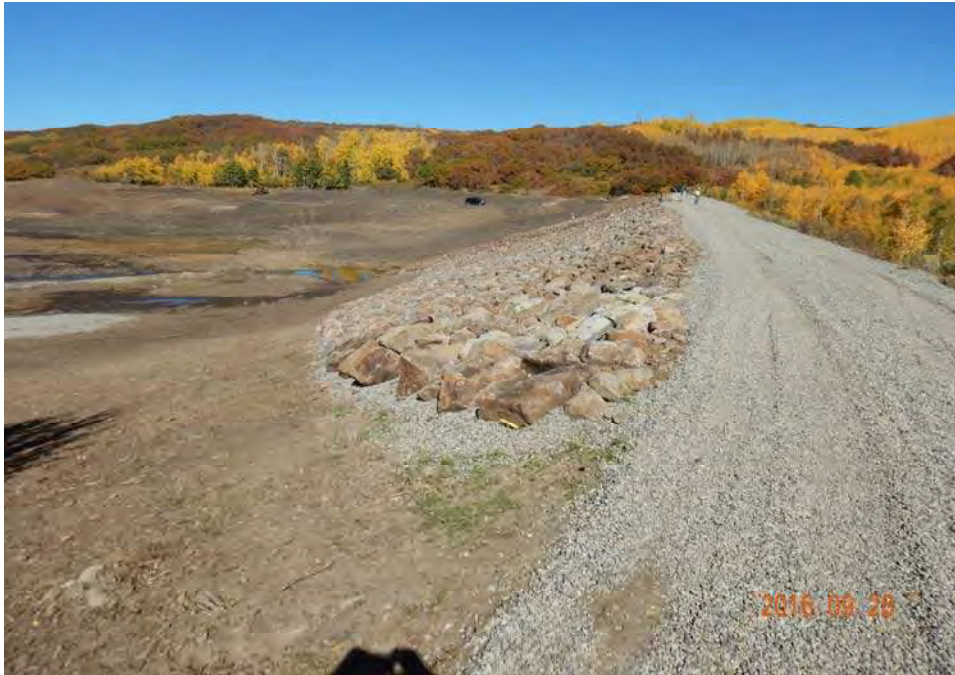
**Photograph 47:** Riprap on the upstream slope from the right abutment.

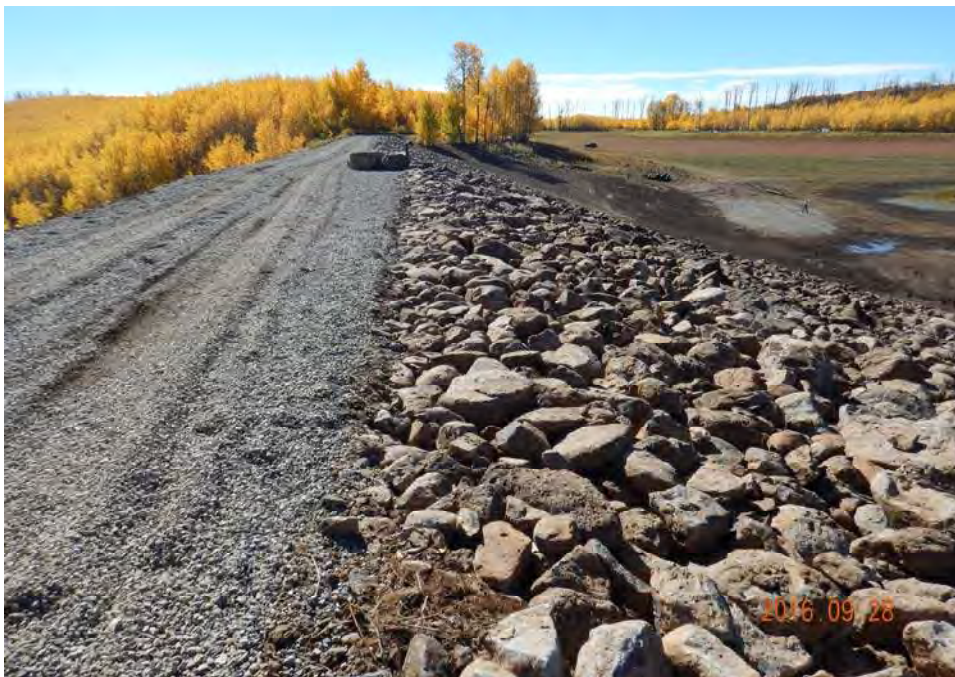
**Photograph 48:** Riprap on the upstream, slope from the left abutment.

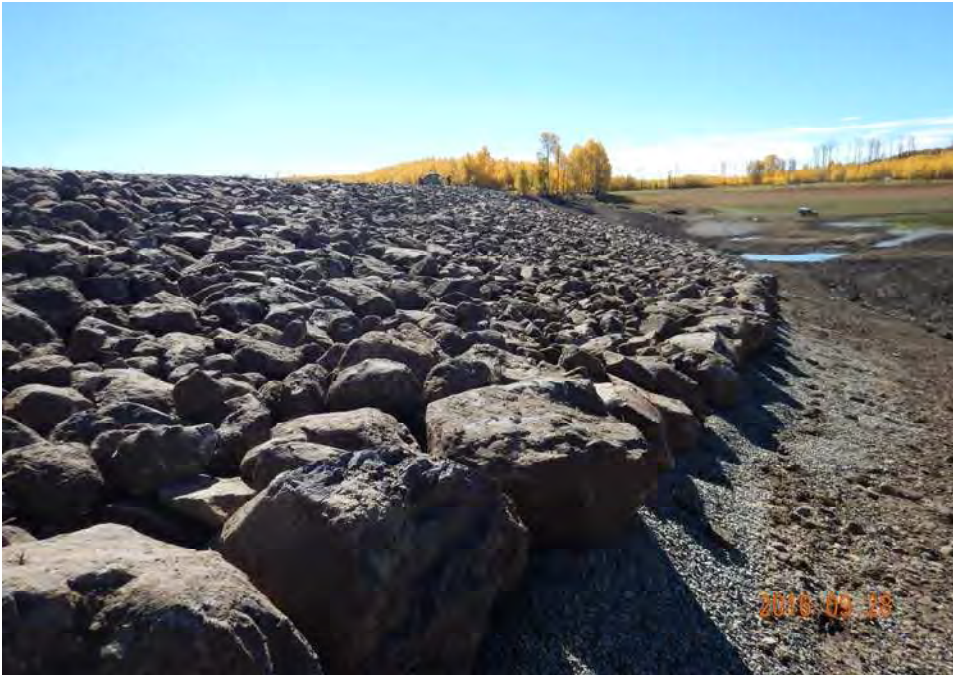
**Photograph 49:** Toe of riprap on the upstream slope. Note large rocks on the toe.

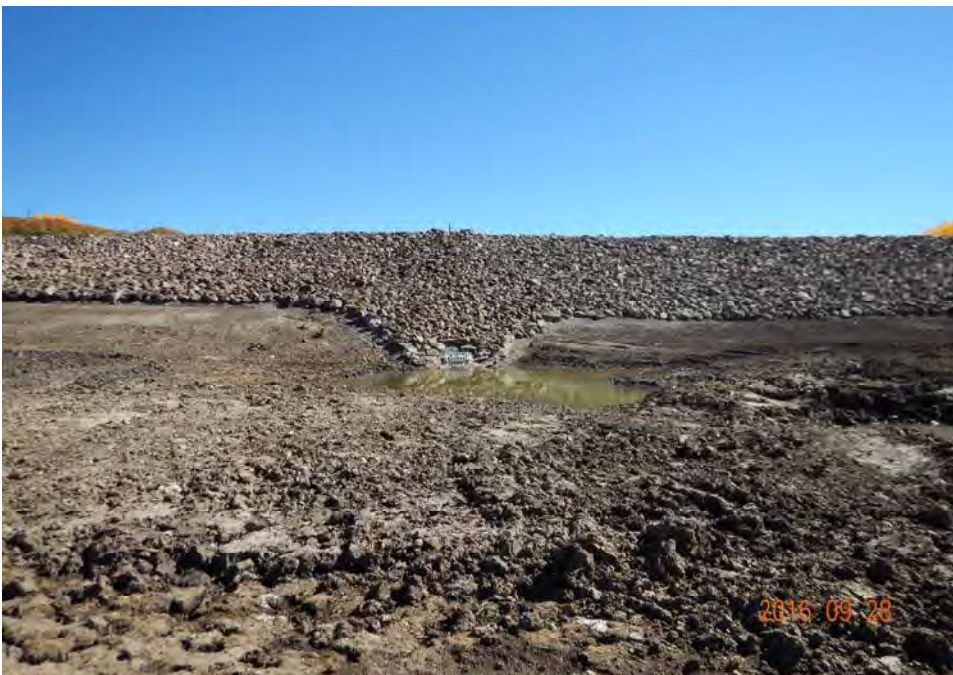
**Photograph 50:** Upstream slope. Note riprap around the inlet structure.
