FINAL REPORT

UPPER PLATTE AND BEAVER / DEUEL AND SNYDER FEASIBILITY STUDY

PRELIMINARY DESIGN REPORT

The Upper Platte & Beaver Canal Company
P.O. Box 205
Brush, Colorado 80723

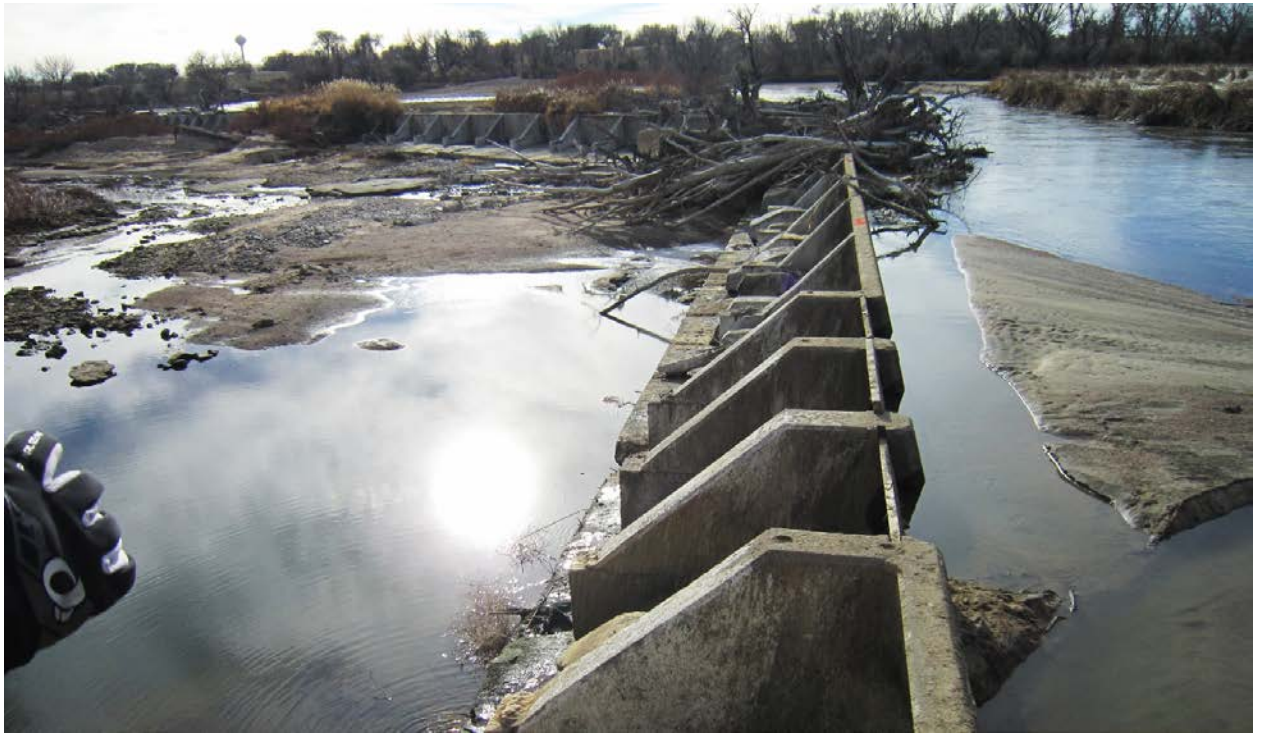
Photo No. 1 North Buttress Section. View of taken from left (north) abutment, looking south. There is significant reservoir sedimentation upstream of the dam, and woody debris on the crest from previous flood events.

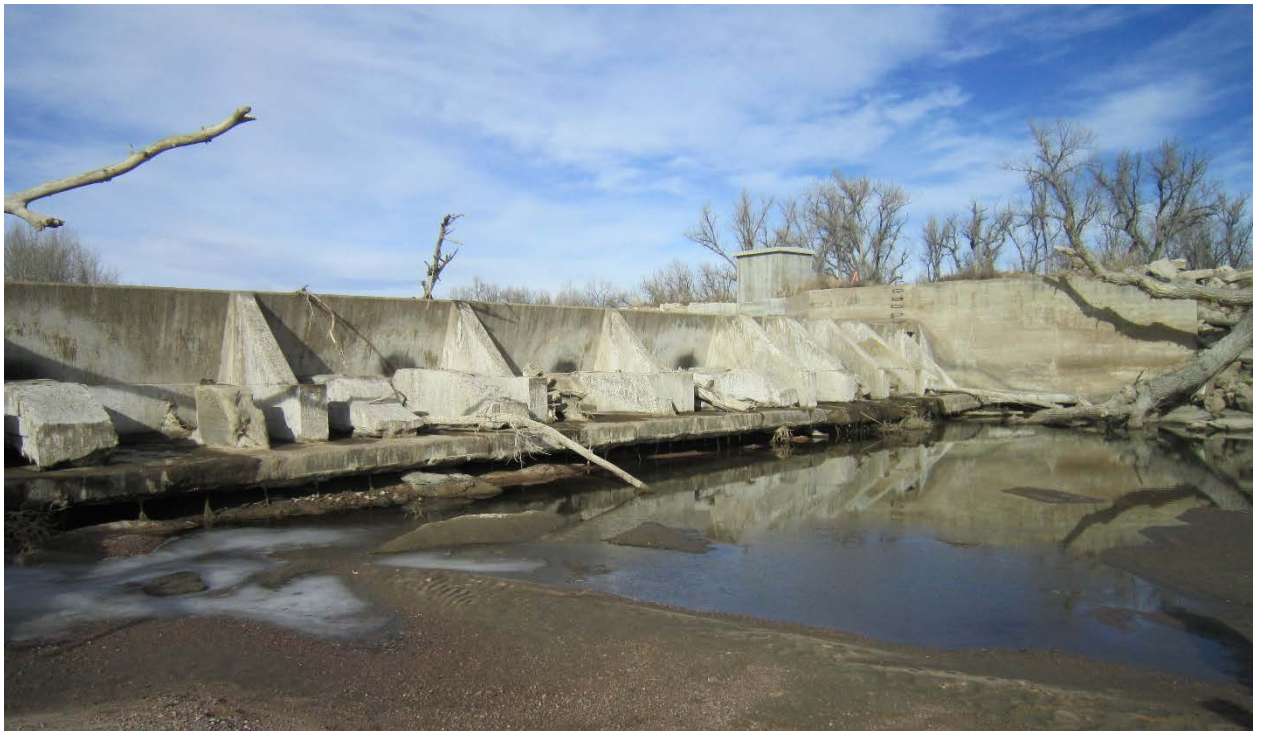
Photo No. 2 North Buttress Section. View of the upstream slab and buttresses, taken from the downstream channel.

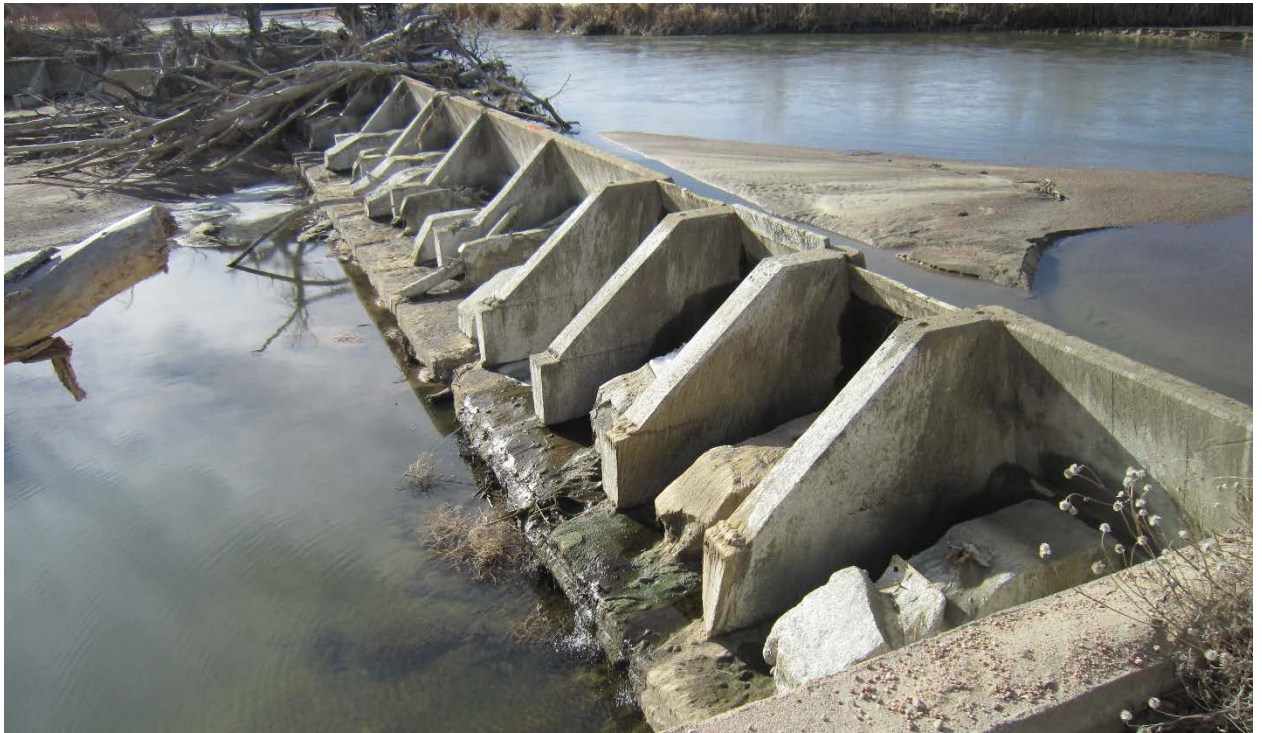
Photo No. 3 North section looking upstream towards north abutment.

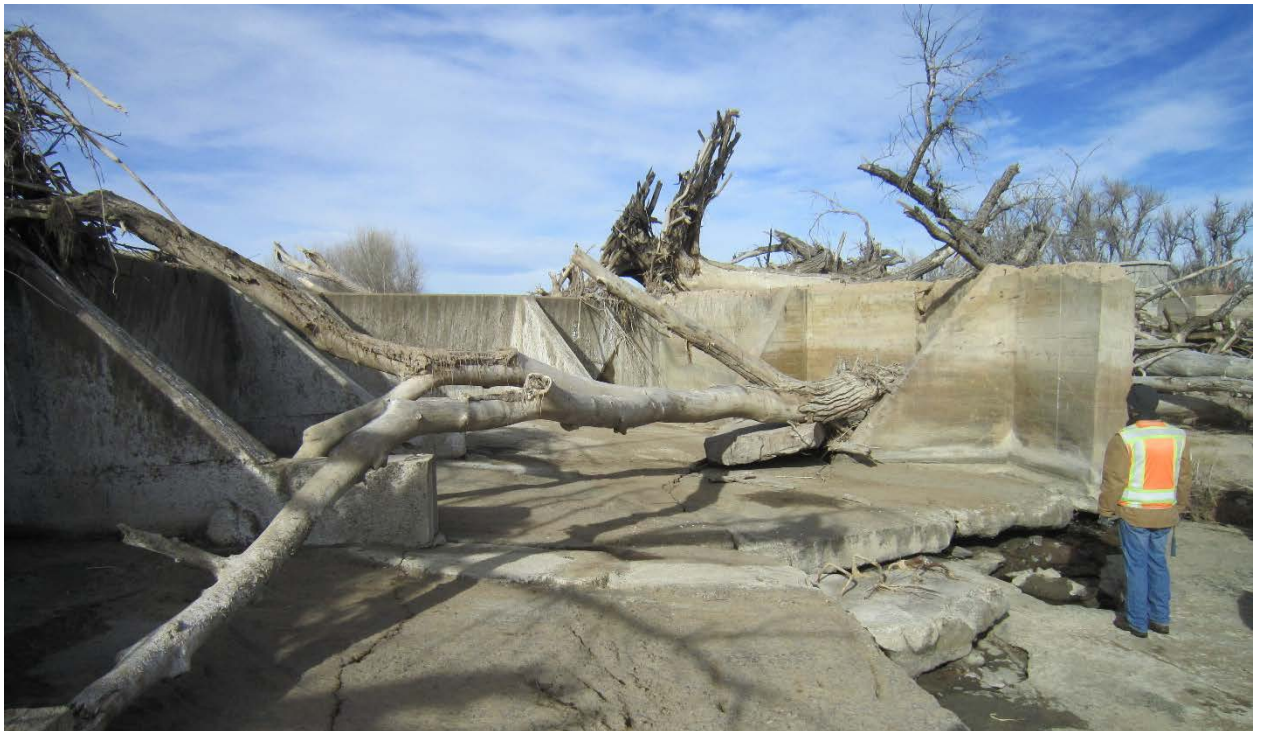
The inspection of the transition section was performed from the area downstream of the structure, as shown in [Figure 2](#), [Photo No. 4](#) and [Photo No. 16](#). Based on the visual observations from the site visit, the transition section is considered to be in satisfactory to poor condition. Although there are areas of concrete where deterioration has developed (i.e., along the top of the buttresses and vertical walls and base of the buttresses as shown in [Photo No. 16](#) and [Photo No. 17](#)), it is not considered to be sufficient to reduce the structural capacity.

The poor condition rating is primarily due to the undermining erosion visible beneath the concrete base slab, as shown in [Photo No. 4](#) and [Photo No. 16](#). The undermining needs to be repaired to restore the kinematic stability. The repair should include construction of a cutoff wall at the downstream toe of the base slab to provide protection against undermining erosion.

Photo No. 4 Transition Section. View looking northwest into the transition section of the dam.

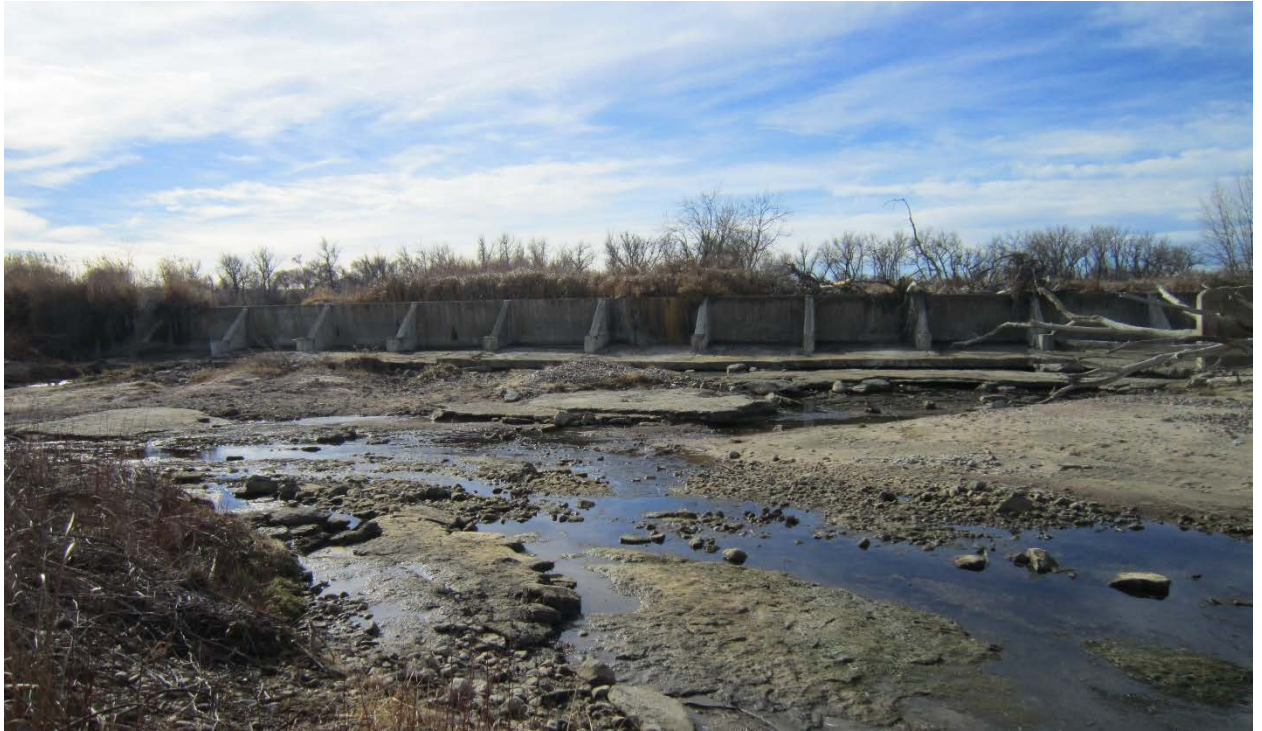
The inspection of the central buttress section was performed from the downstream river channel, and the downstream concrete slab where accessible, as shown in [Photo No. 5](#) through [Photo No. 8](#). The central buttress section was considered to be unsatisfactory condition due to the following observations:

Photo No. 5 Diagonal Section. View looking at the downstream side of the diagonal section, taken near Sta. 11+00.

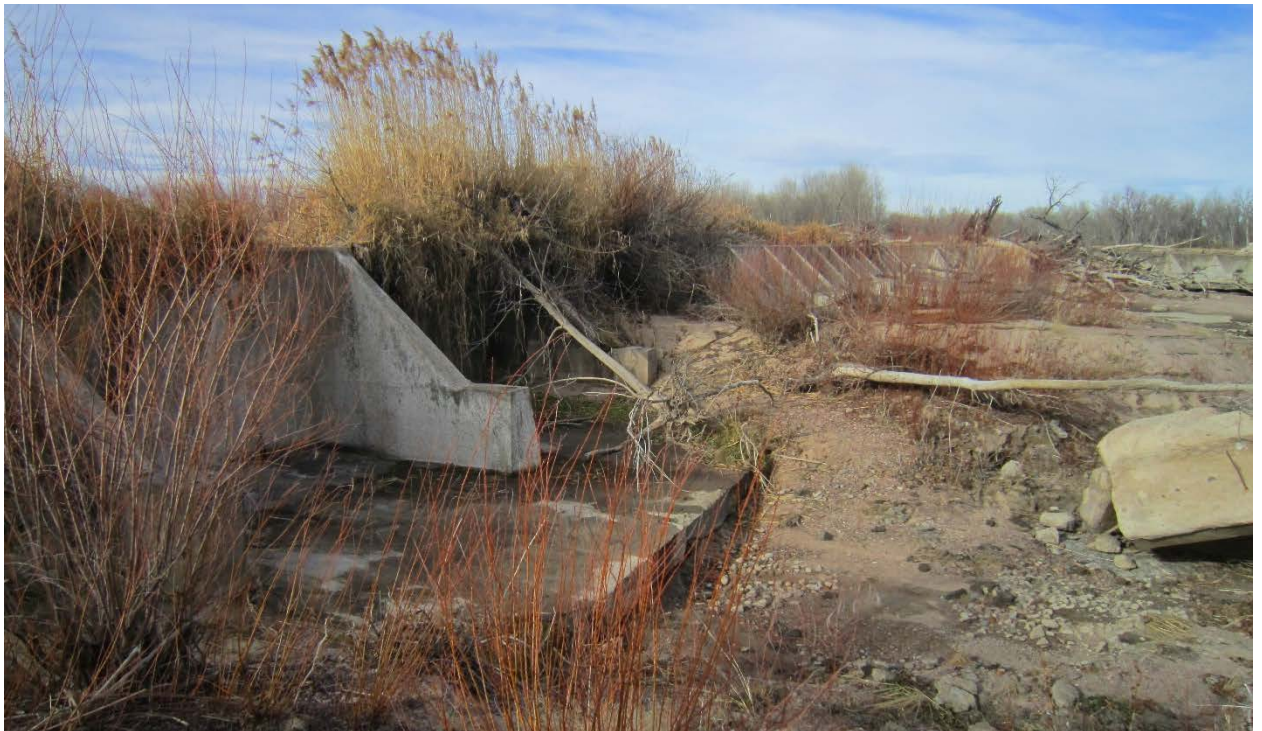
Photo No. 6 Diagonal Section. View looking northwest, toward approximately Sta. 10+00.

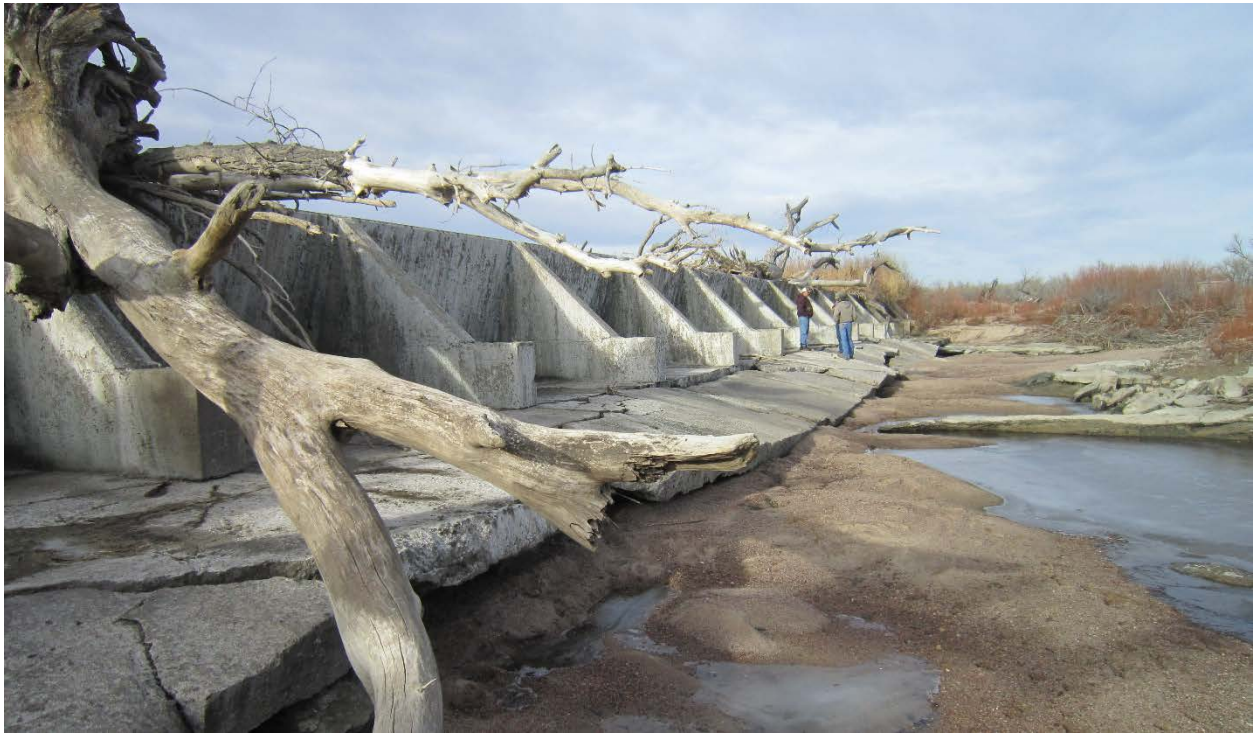
Photo No. 7 Diagonal Section. View taken from downstream channel area, looking toward approximate Sta. 6+00.

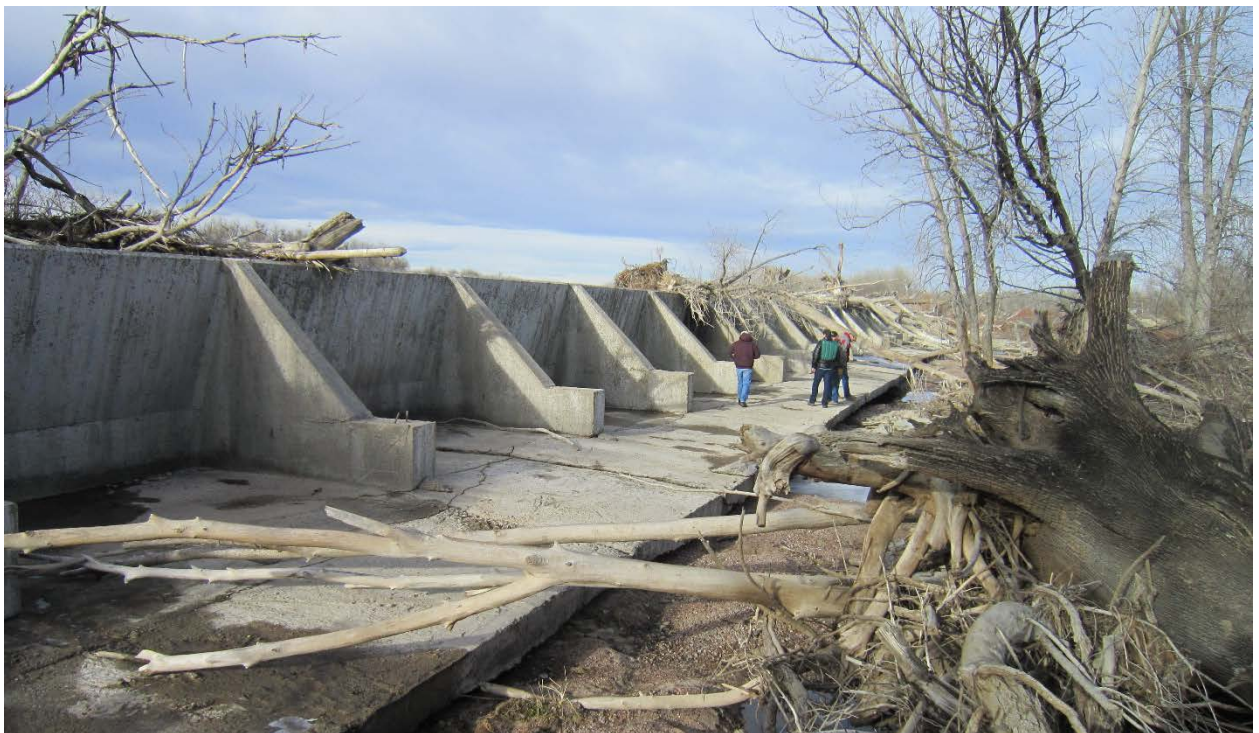
Photo No. 8 Diagonal Section. View taken from downstream channel area, looking towards approximate Sta. 5+00.

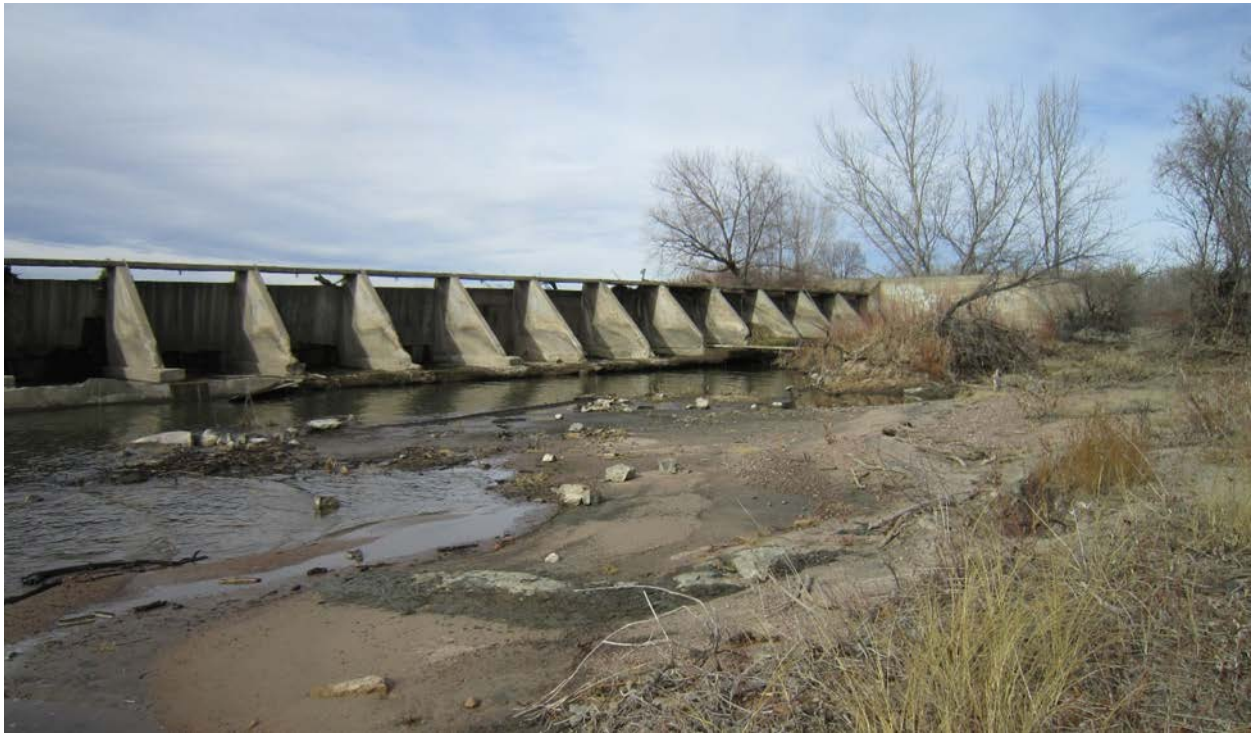
The inspection of the south buttress section was performed from the crest of the structure and the downstream channel. [Photo No. 9](#) shows a view of the south buttress section from the downstream river channel. [Photo No. 22](#) through [Photo No. 25](#) show the general condition of the structure. Based on observations taken during the site visit the south buttress section is considered to be poor to unsatisfactory condition, due to the reasons listed below:

Photo No. 9 South Section. View looking upstream at the south buttress section.

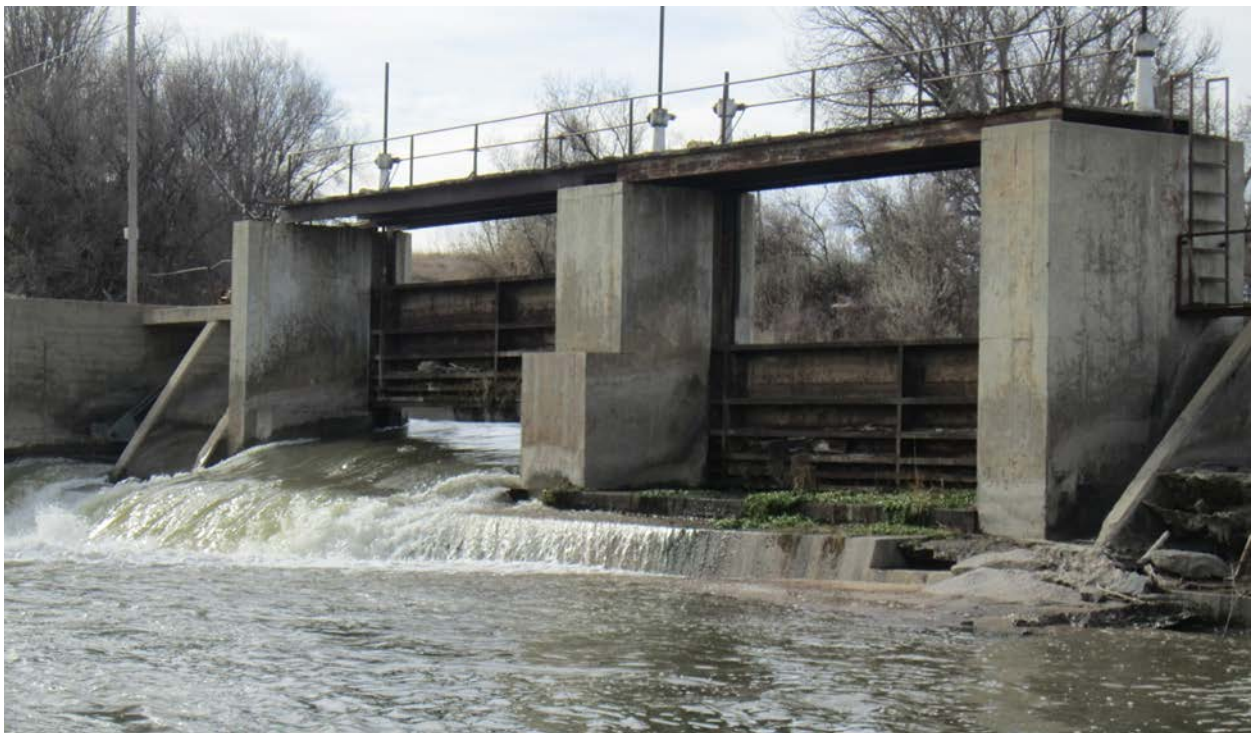
The inspection of the spillway drop gate structure was performed from the crest of the structure, and the downstream river channel, as shown in [Photo No. 10](#) and [Photo No. 11](#). The drop gate structure appears to be in satisfactory condition.

Photo No. 10 South Section. View from downstream channel looking upstream at the spillway slide gate structure.

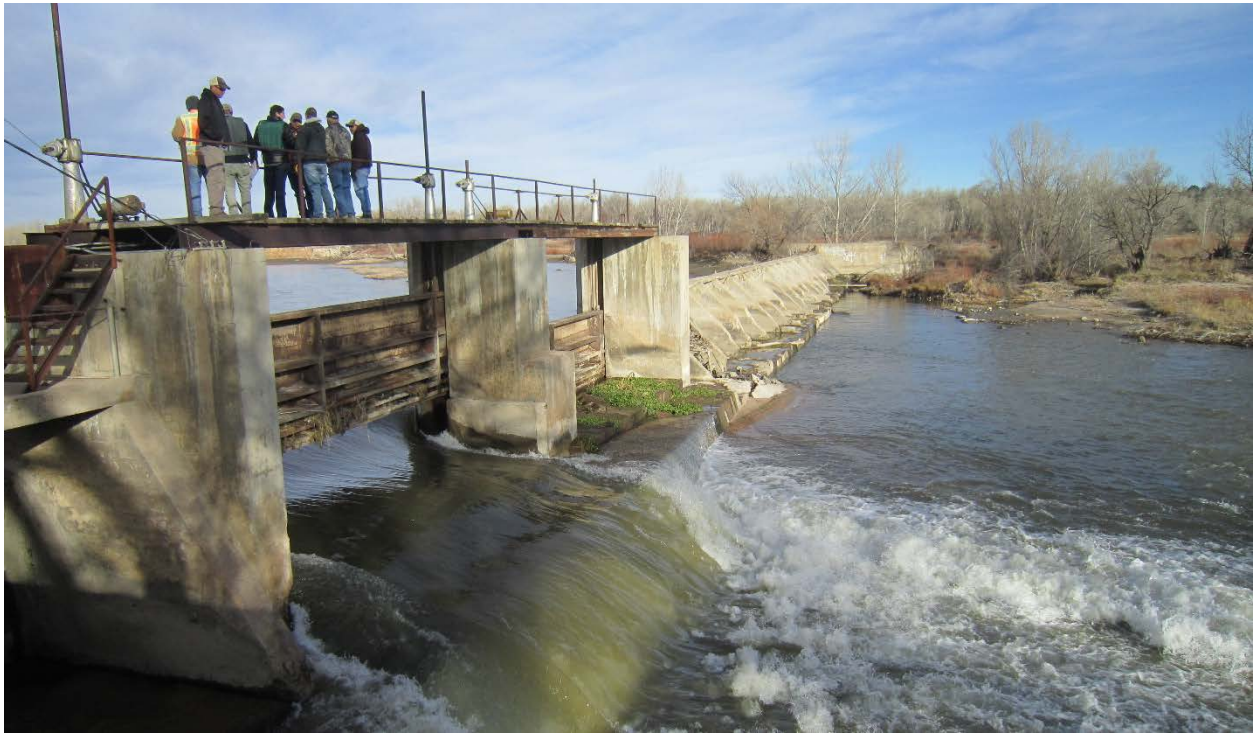
Photo No. 11 South Section. Looking at the spillway drop gate structure and the south buttress section, taken from the downstream right (south) abutment.

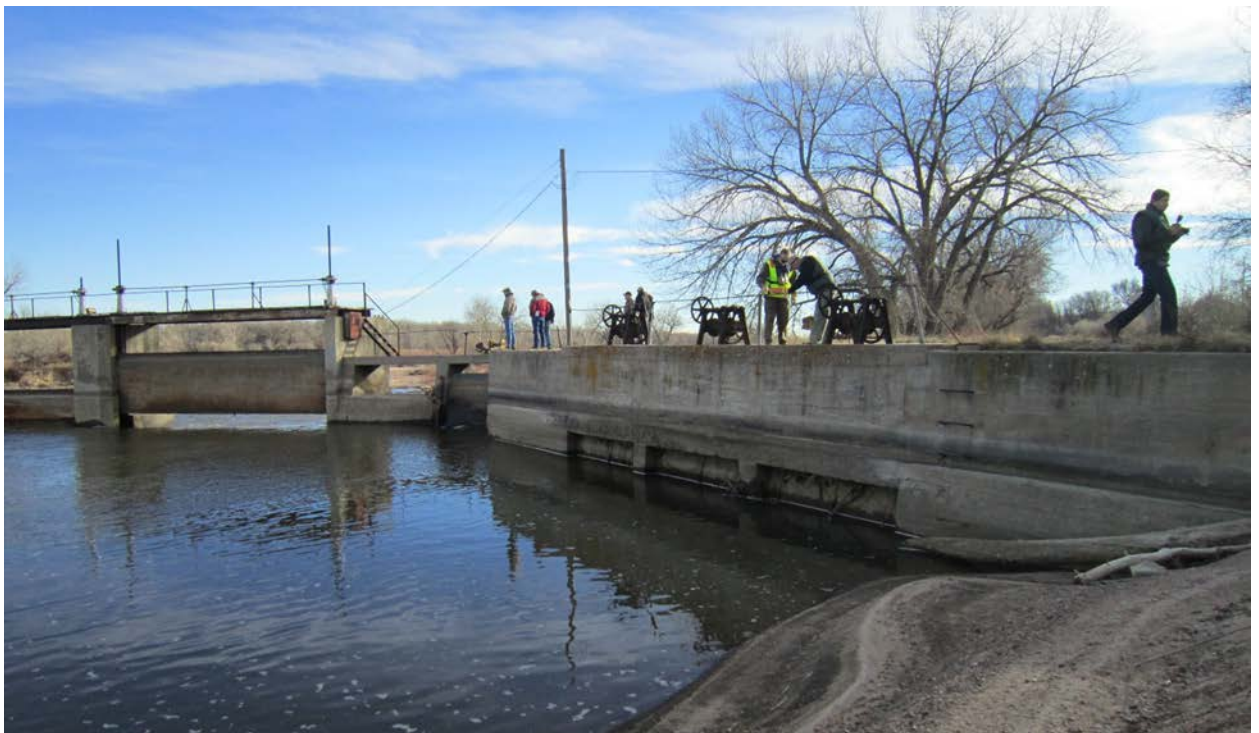
The inspection of the intake structure was performed from the crest of the structure, and both the upstream and downstream areas on the right (south) abutment, as shown in [Photo No. 12](#). The intake has no visual signs of deterioration or deficiencies and was considered to be in good to satisfactory condition.

Photo No. 12 South Section. Upstream face to the Duel & Snyder canal intake structure

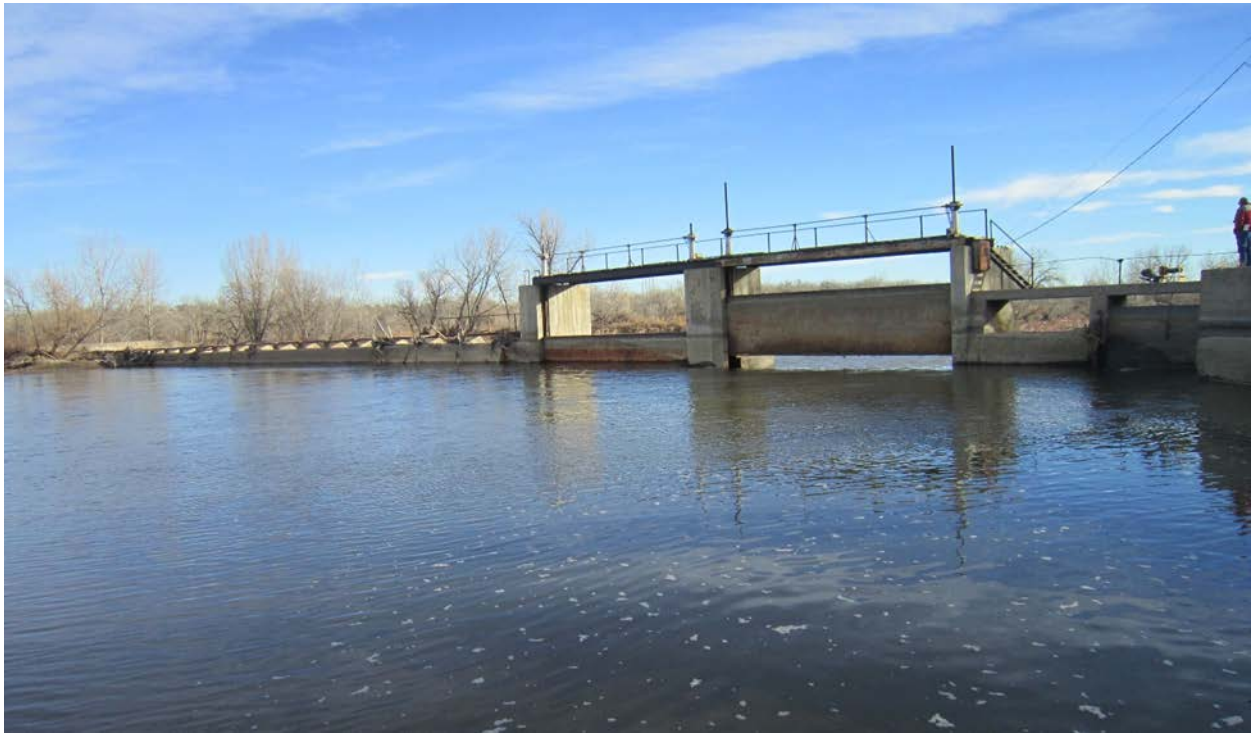
Photo No. 13 South Section. View looking downstream from abutment at the upstream face of the spillway drop gate structure.

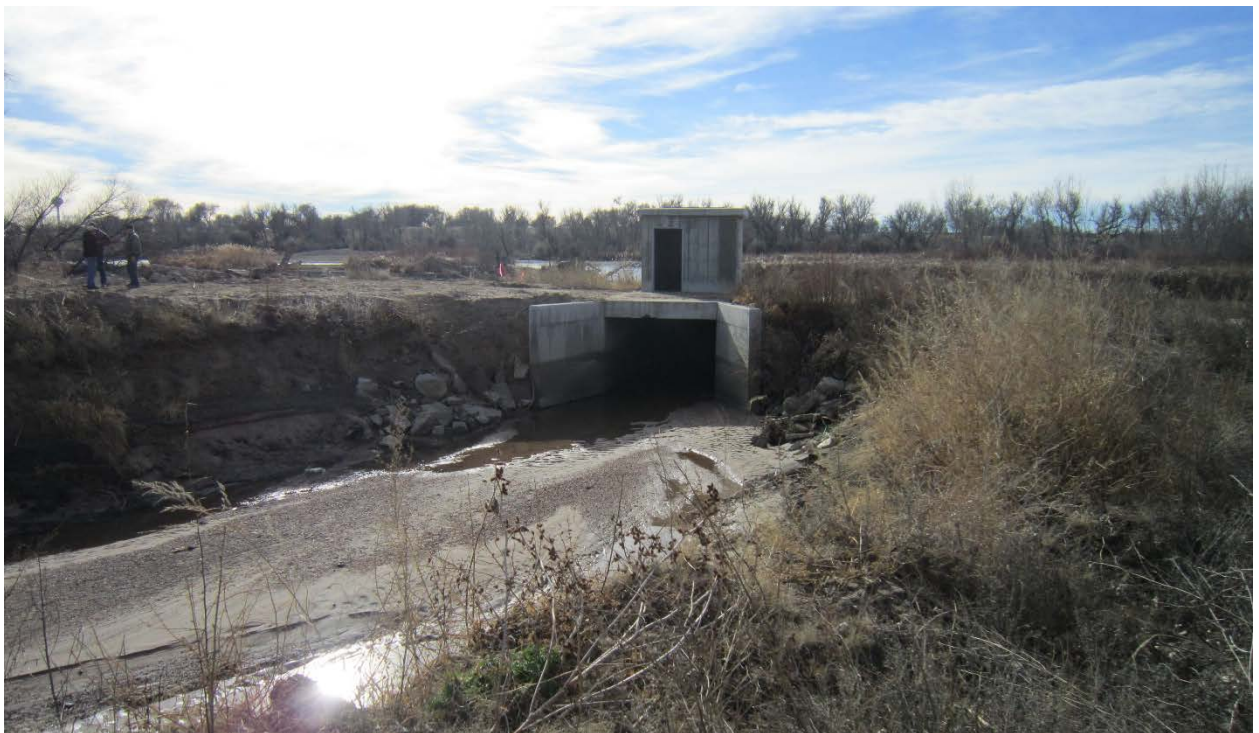
The inspection of the intake structure to the Upper Platte and Beaver Canal was performed from crest of the structure and the downstream area adjacent to canal. The structure is shown in [Photo No. 14](#).

Photo No. 14 North Section. View of the Upper Platte and Beaver Canal intake structures, taken from the canal, just downstream of the structure..

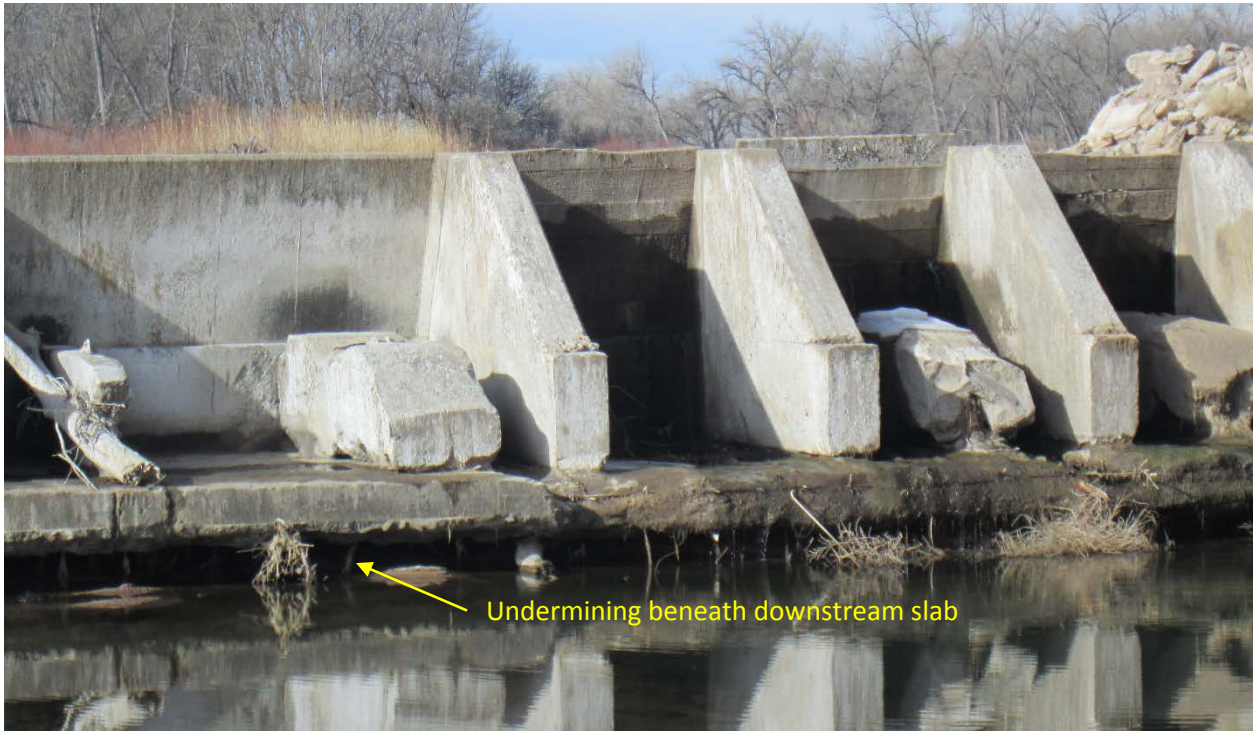
Photo No. 15 North Section. Closer view of the north buttress section, taken from the downstream channel.. Note, undermining (erosion) beneath the downstream slab.

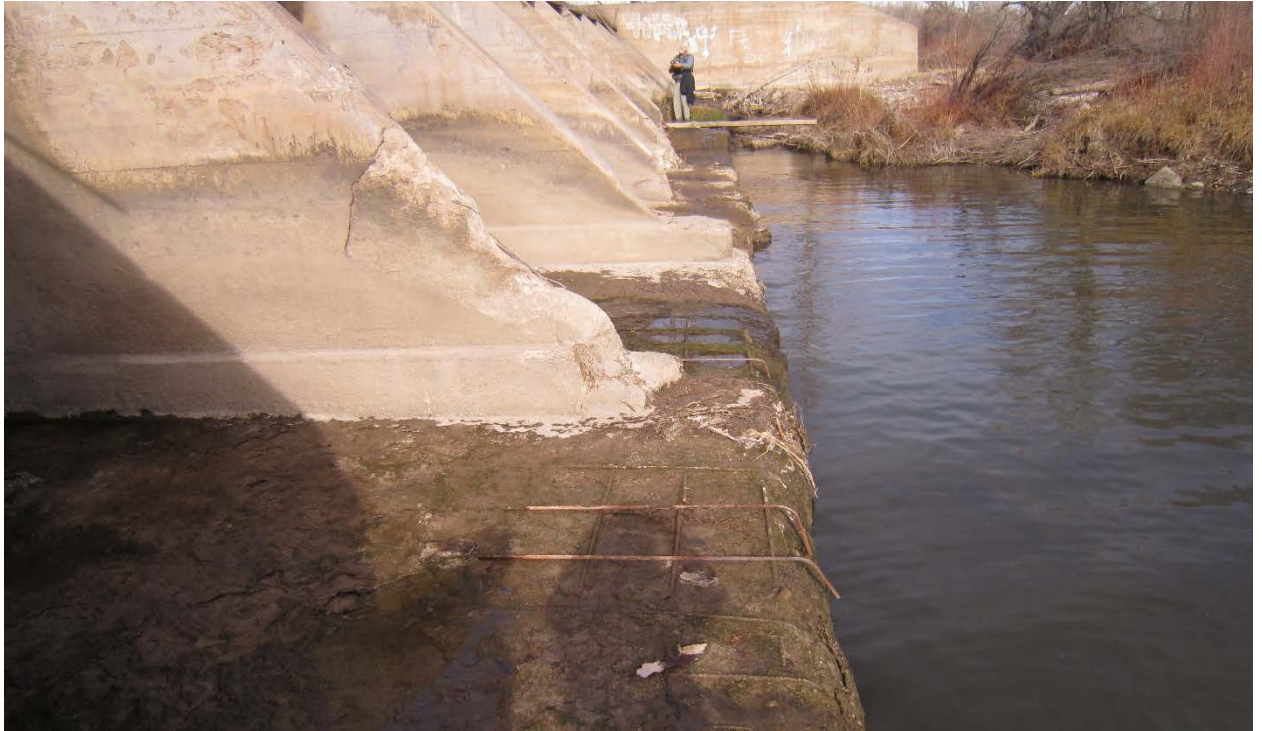
Photo No. 25 South Section. View showing exposed reinforcement in bottom slab of the south buttress section.

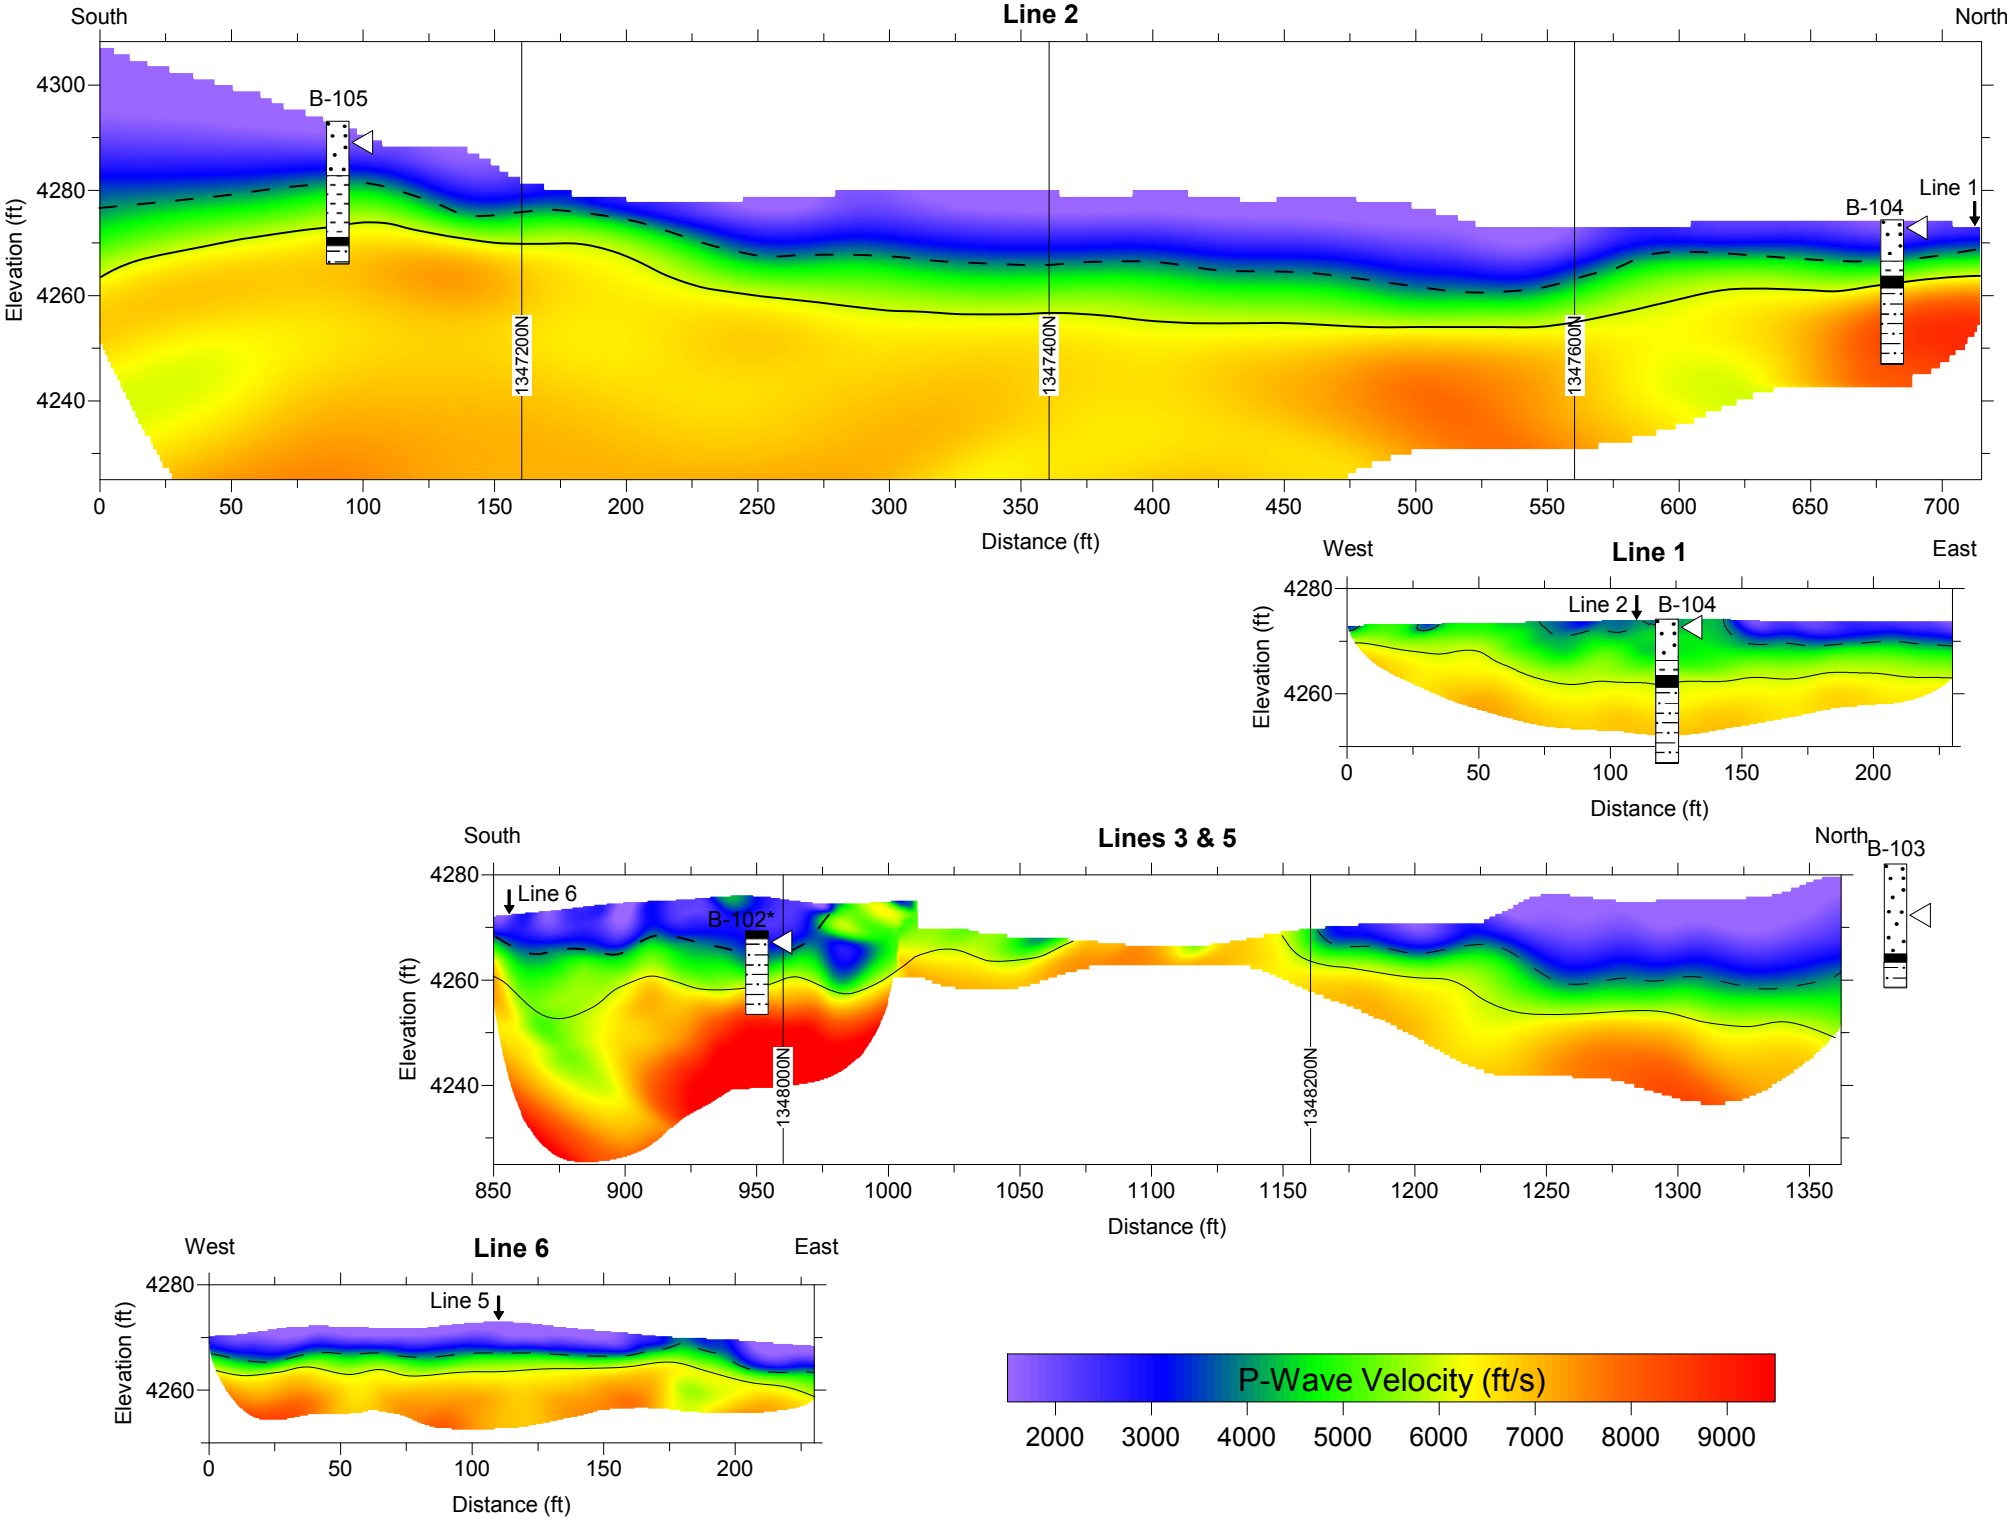
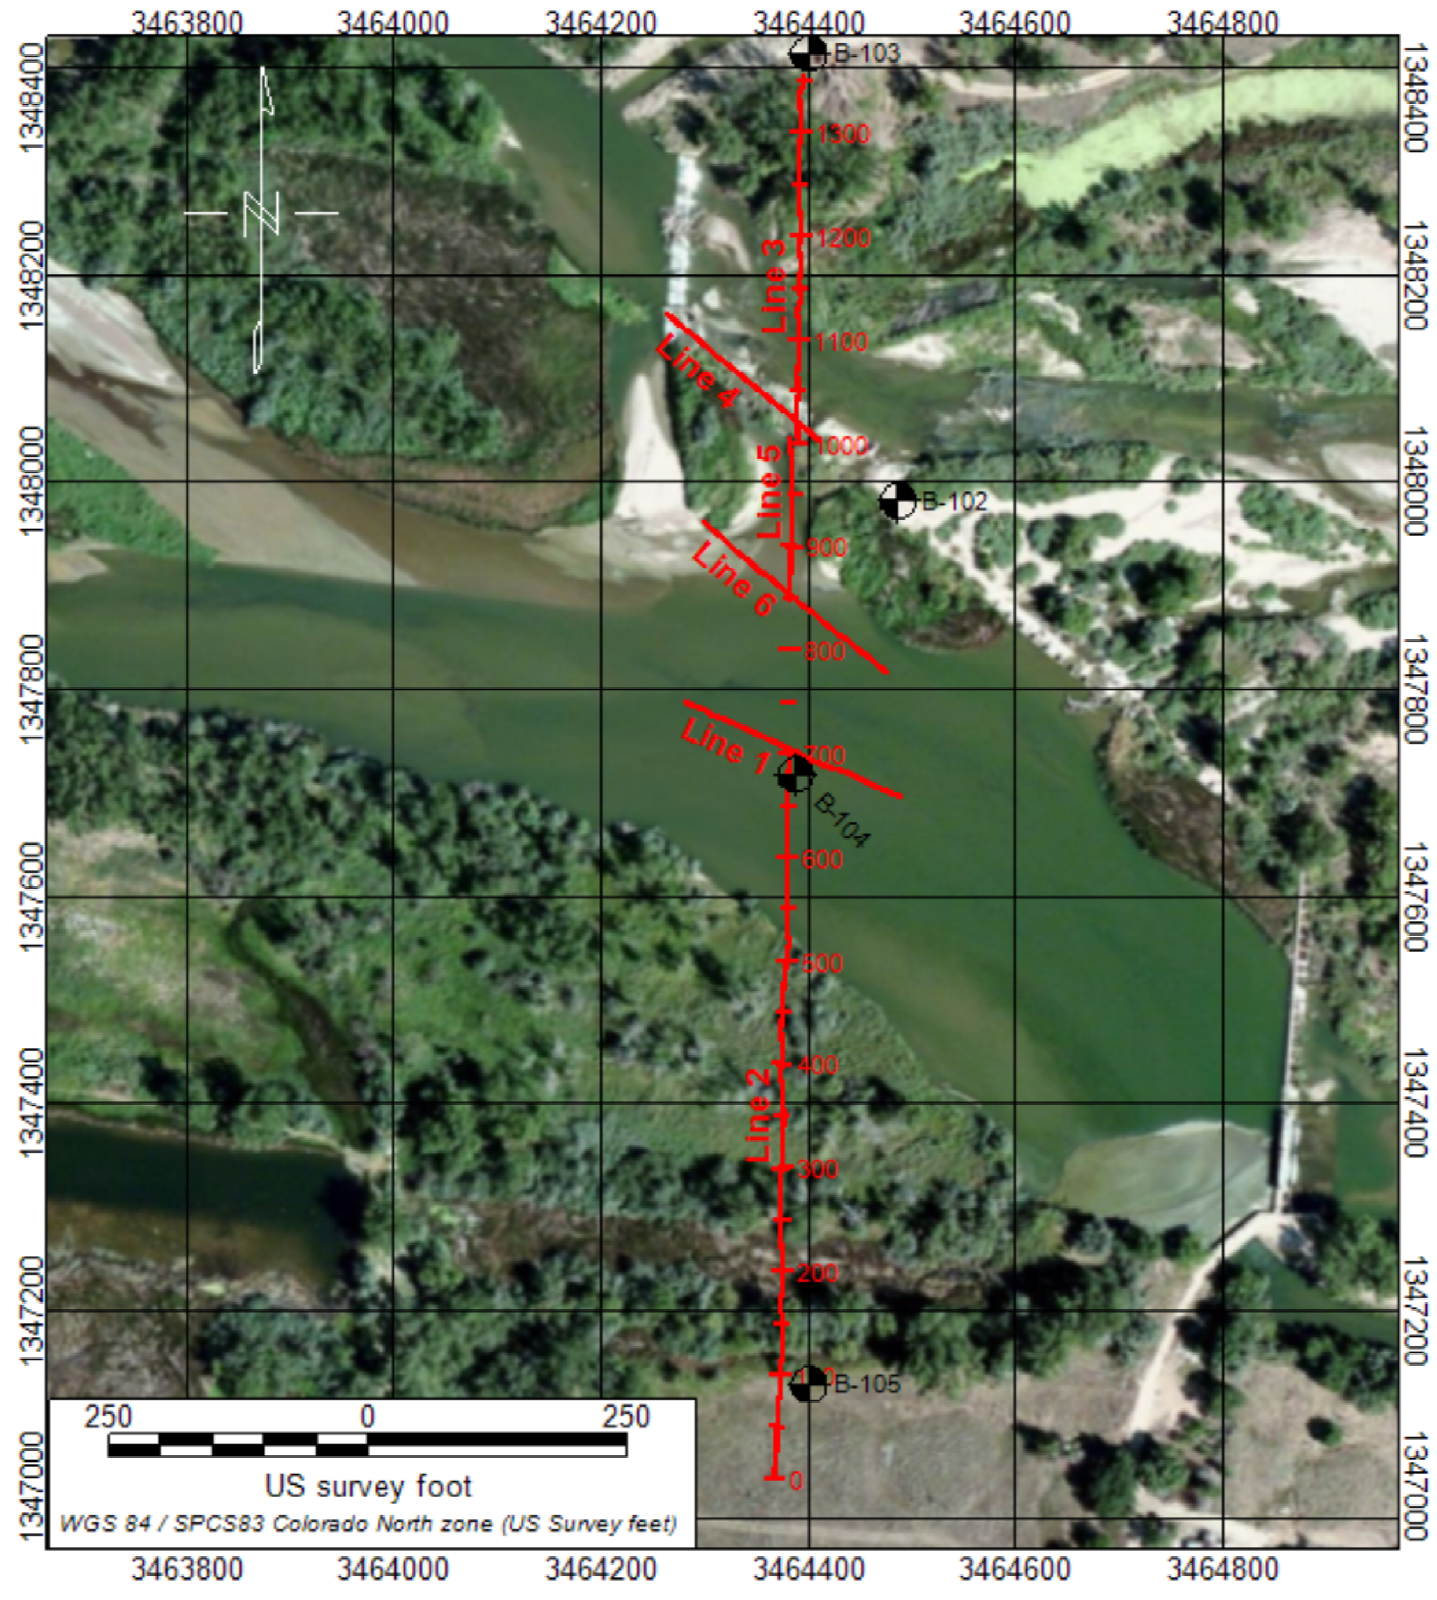
The 2D interpretive geophysical results for the SRT lines are presented in Figure 4 at the end of this report; the figure is 11x17 inches. The Vp profiles are presented with ‘cool’ colors (e.g., blue) representing lower velocity values and ‘warm’ colors (e.g., red) representing higher velocity values. The horizontal (distance) and vertical (elevation) dimensions (as measured by GPS) are shown in feet, at 2x vertical exaggeration. In the lower left corner of the figure is a location map showing the seismic lines (red; see also Figure 2). Note that no results are presented from Line 4, as the SRT data from this line proved to be unusable. This is most likely because this line was collected on top of a cement slab on the downstream side of the dam. Although MASW can often image through concrete slabs, SRT often cannot.

Lithologic logs from the boreholes, provided to Olson by RJH, are overlain on the profiles at their approximate horizontally-projected positions along each line. Elevation data for the boreholes were provided by TZA. The borehole log for B-101 is not included on the seismic profile, as the borehole was drilled too far away from the seismic line for the borehole log to be of any correlative/interpretive use. The projected location of B-102 is included on the profile of Lines 3 and 5. As noted on Figure 4, the borehole is located approximately 100 feet off-line.

*Borehole B-102 is located approximately 100 ft east of Line 5.
