FINAL REPORT

UPPER PLATTE AND BEAVER / DEUEL AND SNYDER FEASIBILITY STUDY

PRELIMINARY DESIGN REPORT

The Upper Platte & Beaver Canal Company
P.O. Box 205
Brush, Colorado 80723

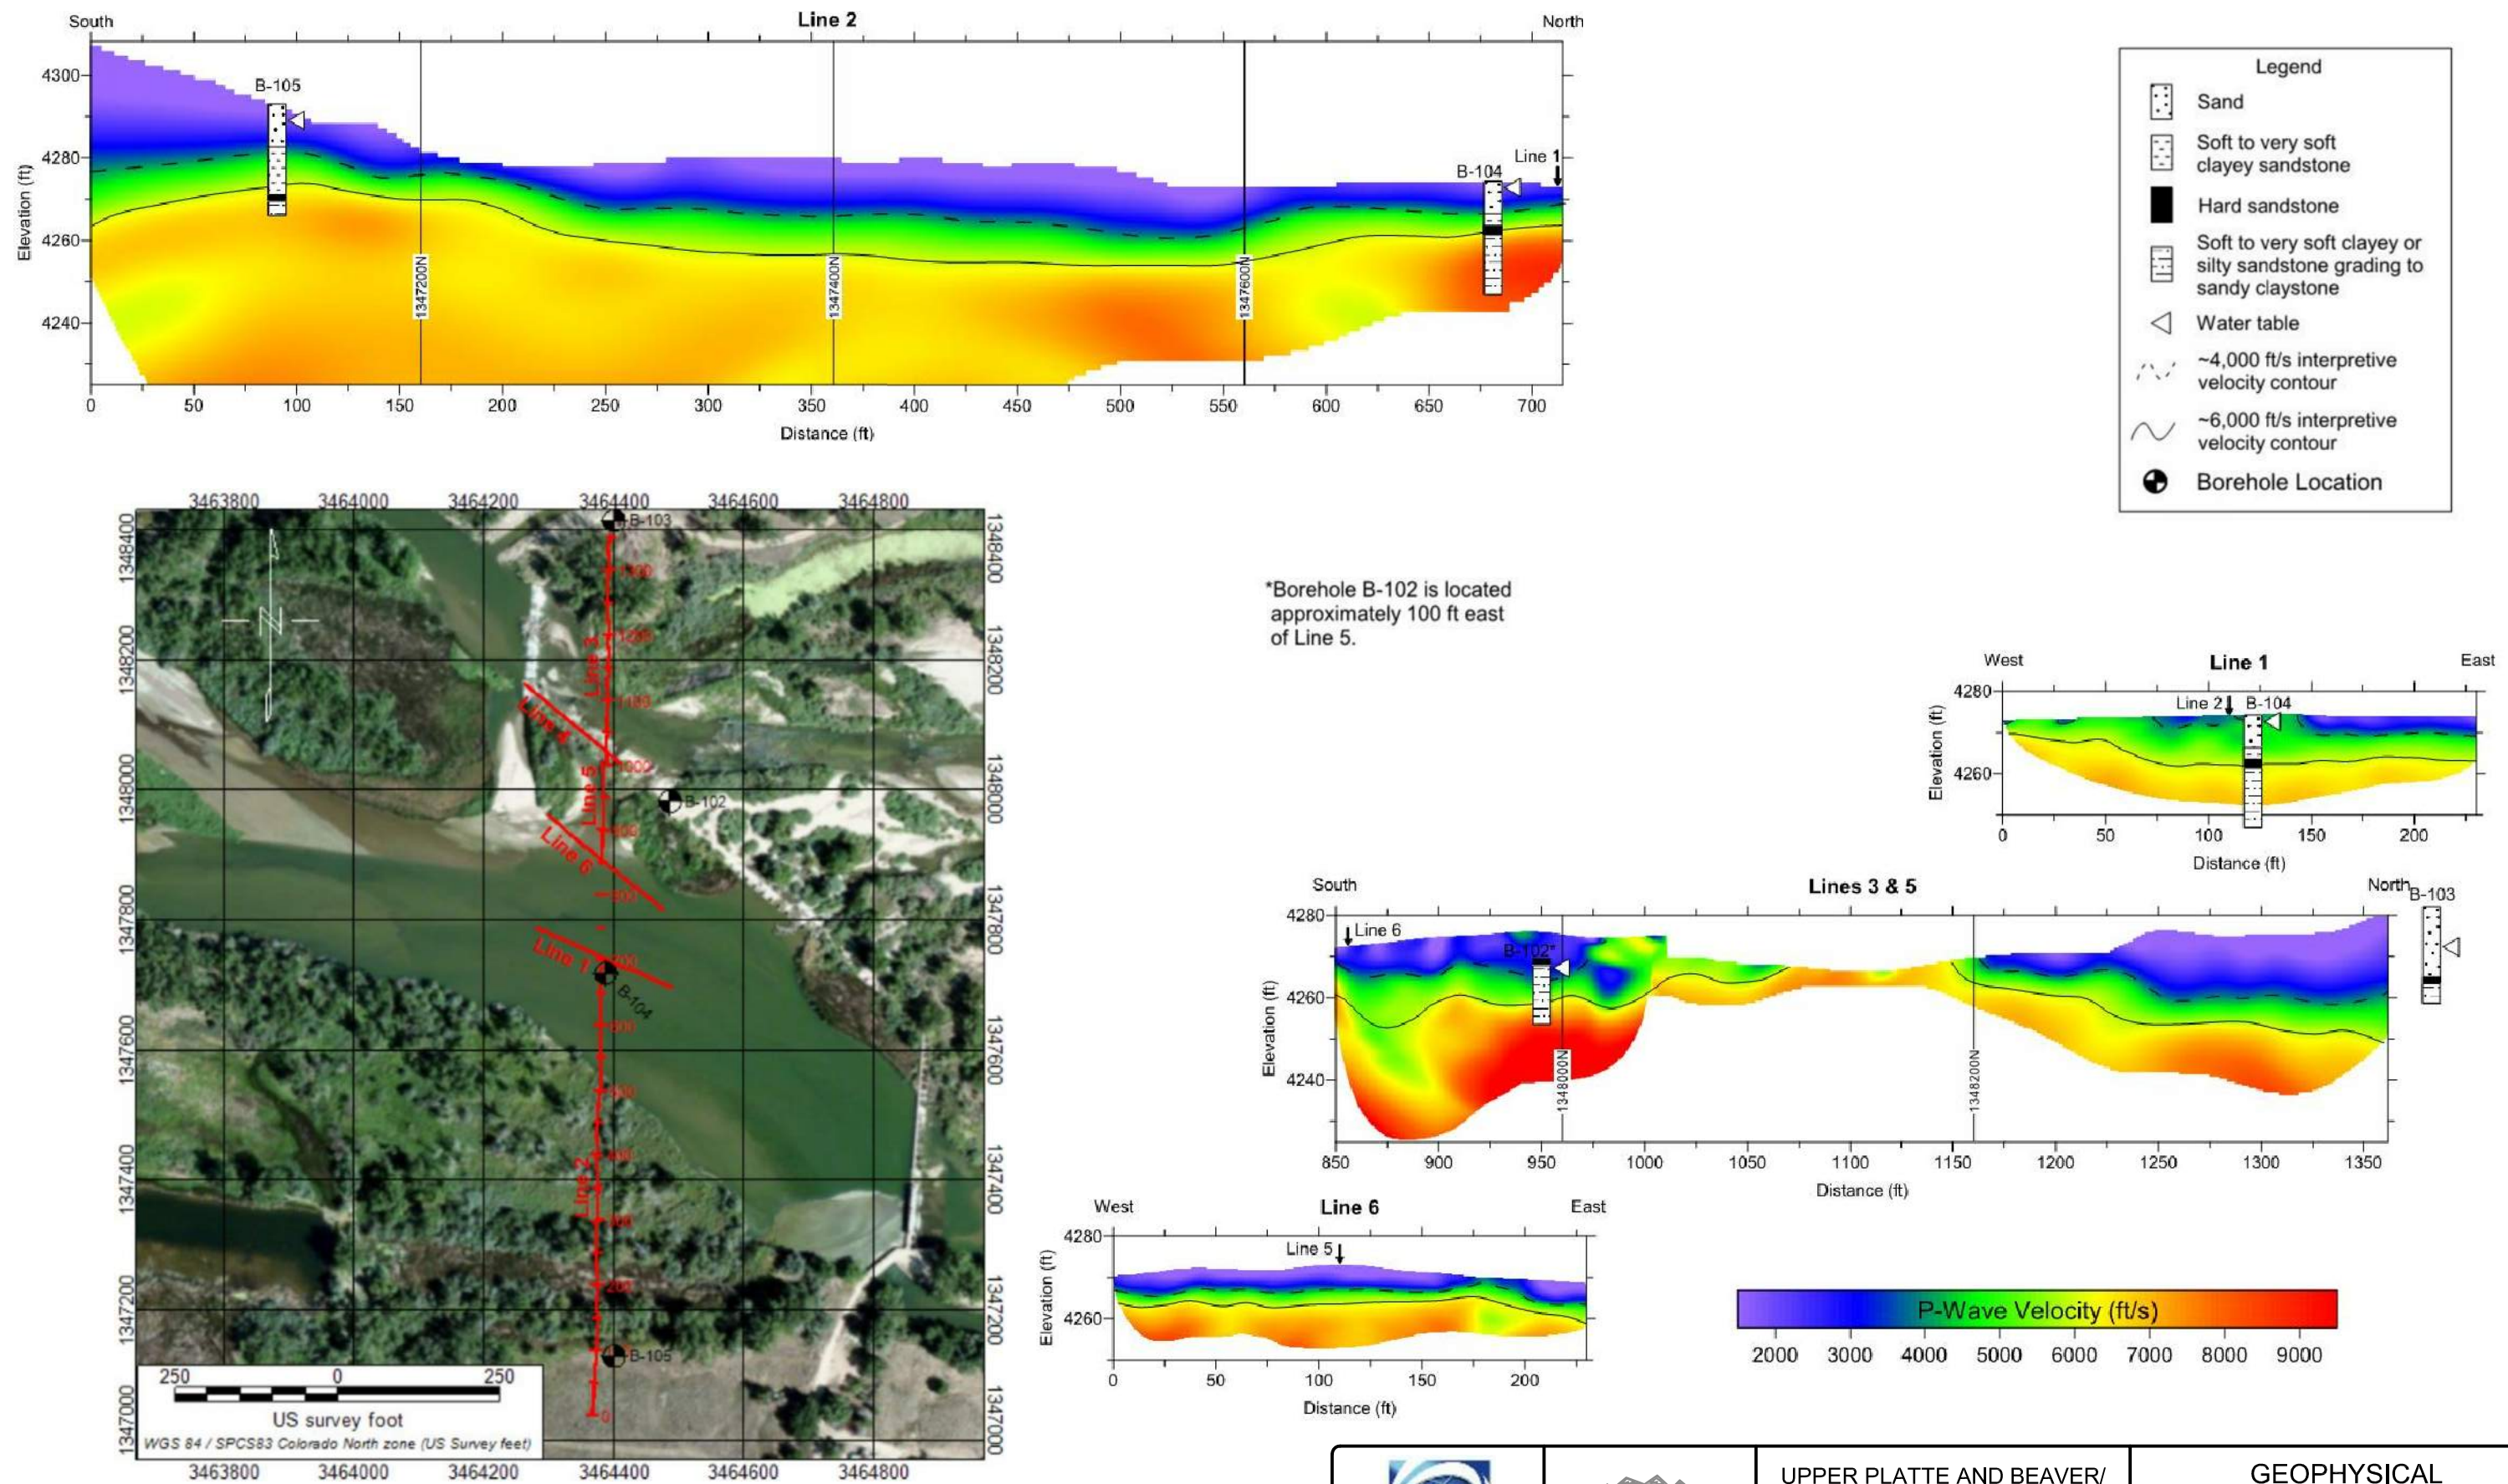
The investigation consisted of six seismic lines totaling 1,860 linear feet. The orientation of the seismic lines is shown on Figure 3.2. Seismic energy was produced using a sledge hammer striking a plastic strike plate on the ground. Seismic data was processed using the multichannel analysis of surface waves (MASW) method and the Seismic Refraction Tomography (SRT) method. The MASW method produced inconclusive results and were not reported. The SRT method produced usable results that were correlated with logs from boreholes B-102 through B-105 to produce velocity profiles along the survey lines, as shown on Figure 3.2. No results are presented for line 4 on Figure 3.2 because the SRT data from this line was unusable. The profiles display lower velocities with a blue color and high velocities with a red color. In general, based on the seismic data, the top of bedrock is relatively flat across the valley bottom. The geophysical investigation report by Olson is provided in Appendix C.

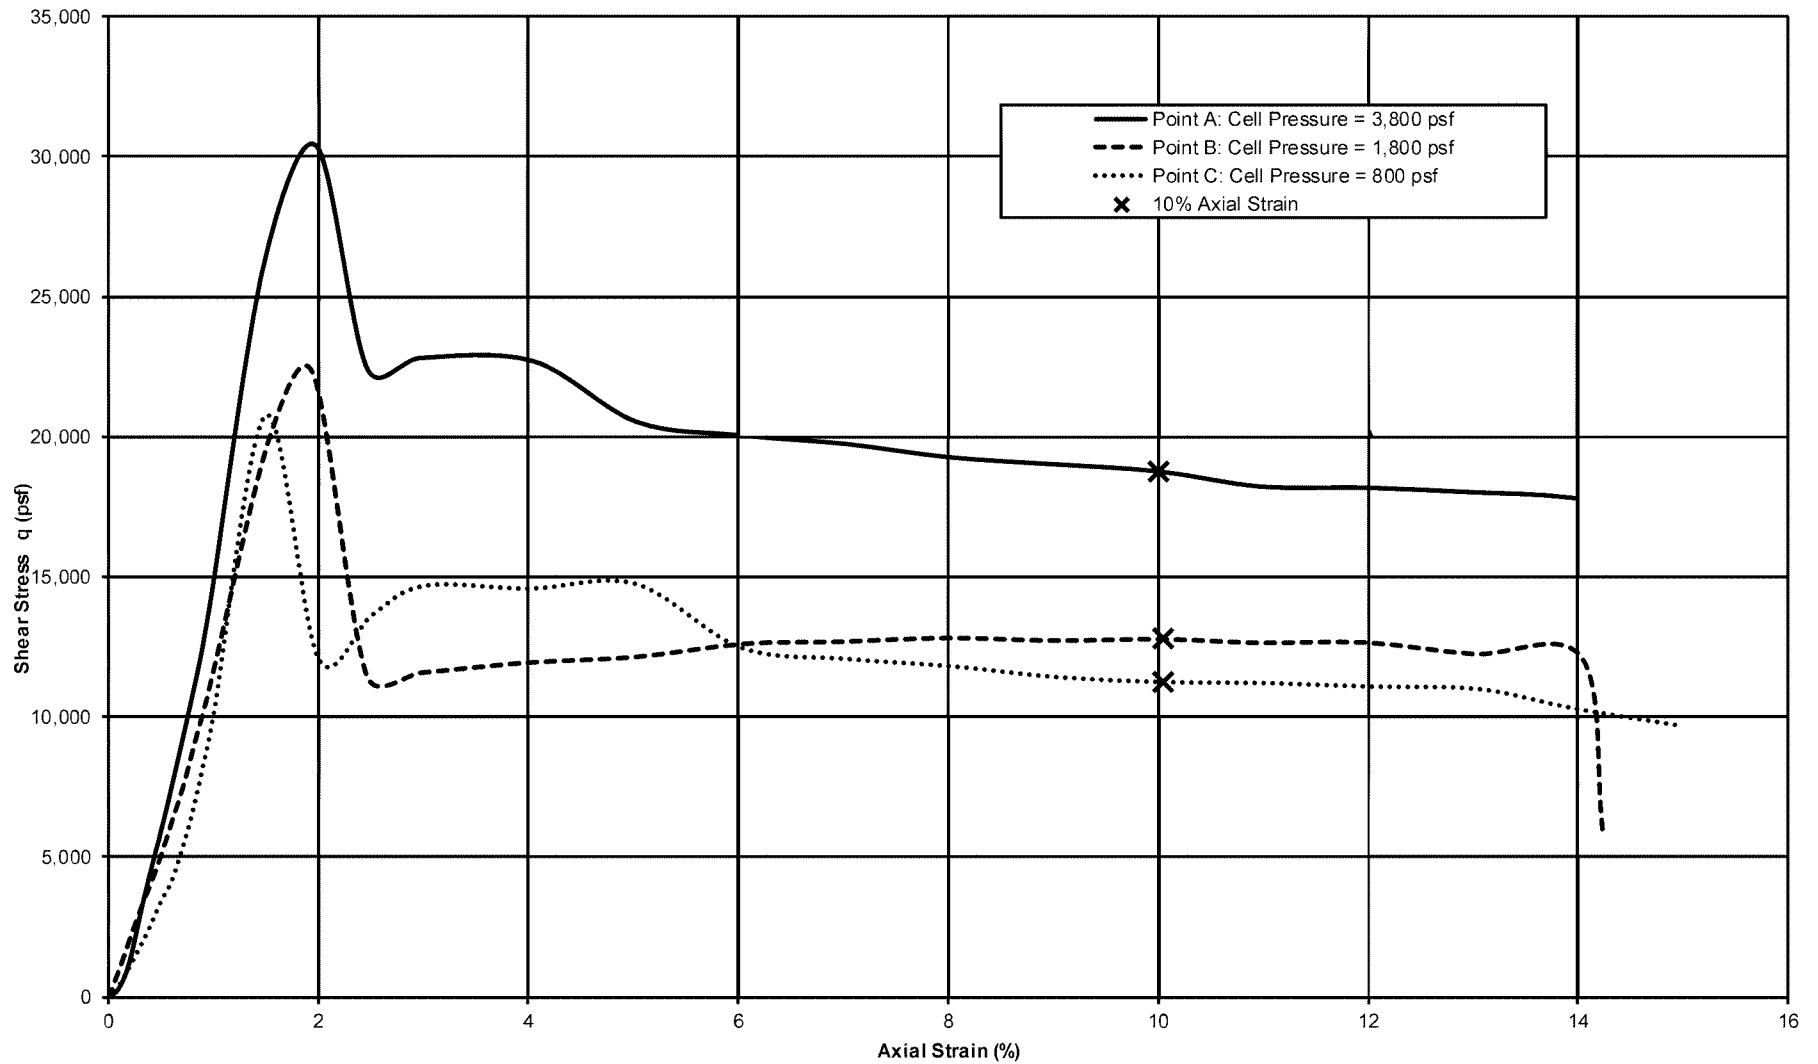
Figure 5.1

Three consolidated undrained triaxial shear strength tests were performed on samples of sandy claystone at confining stresses of 800, 1,800, and 3,800 psf. As shown on Figure 5.1, the samples have a high peak strength and break in a brittle manner as would be expected for intact rock. As strain continues, the samples developed a softened strength, which is considered to be representative to the inter-particle strength along a joint or bedding plain. The shear strengths at 10 percent strain were selected as representative of the softened strength and were used to develop the drained and undrained strength envelopes shown on Figures 5.2 and 5.3. The drained strength was an effective friction angle of 39 degrees with 0 psf of effective cohesion. The undrained strength was a friction angle of 69 degrees with 8,800 psf of cohesion.

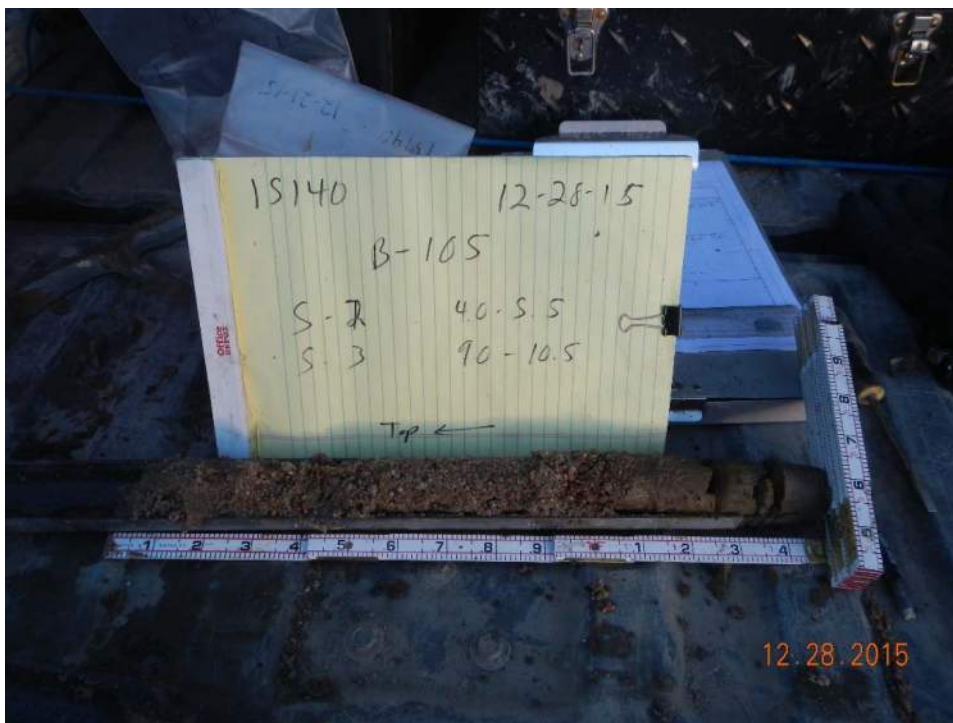
Photograph 3: Alluvium bedrock contact from boring B-105. Bedrock consists of intensely weathered soft rock.

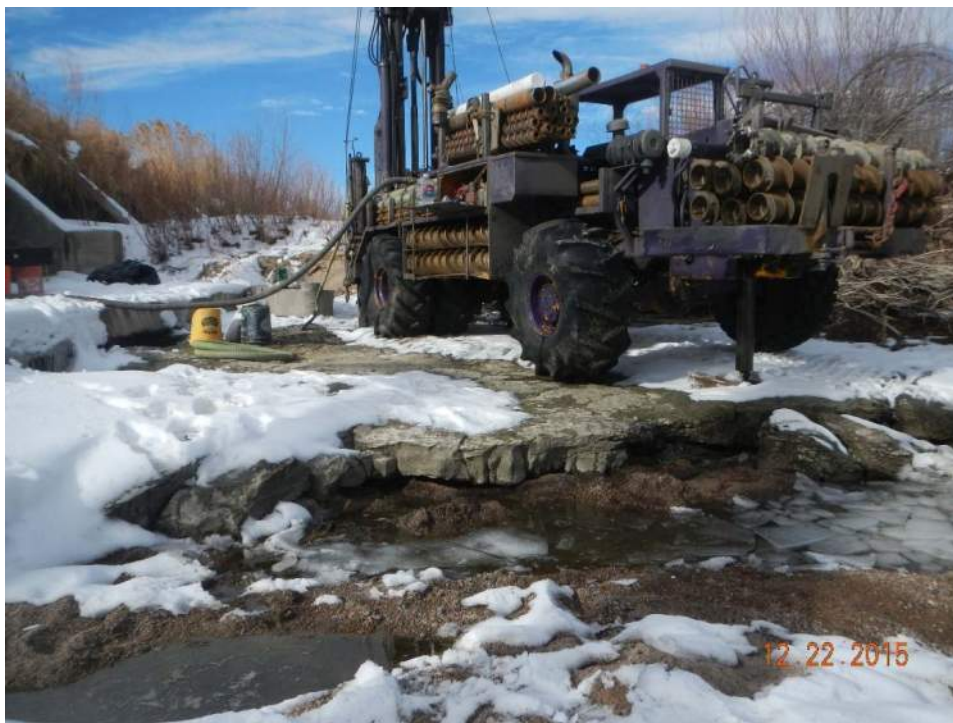
Photograph 4: Hard sandstone outcrop at boring B-102 is about 1 foot thick. The underlying soft rock is not visible in this photograph.

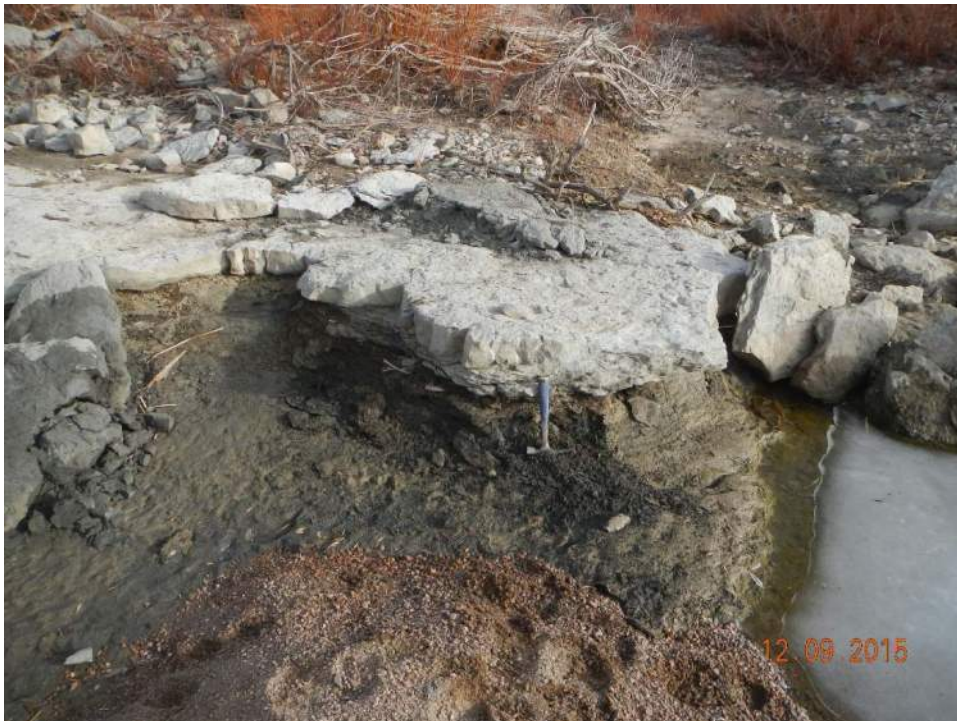
Photograph 5: Looking east at an outcrop of hard sandstone overlying soft rock located at the downstream toe of the existing structure.

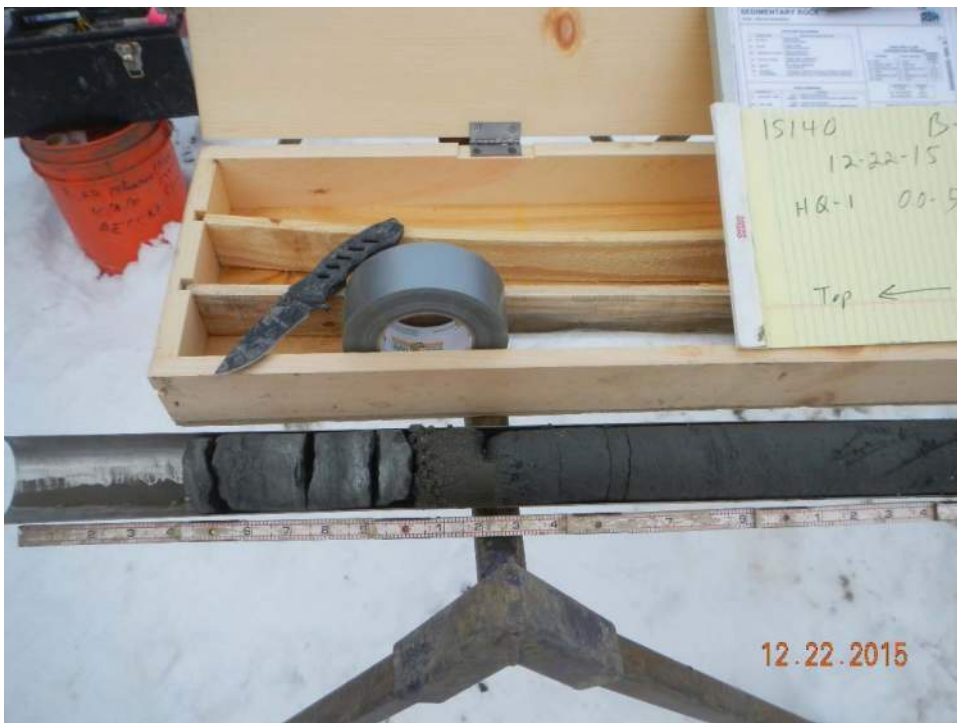
Photograph 6: Typical core sample of hard sandstone (left) with soft rock below (right). Soft rock is easily gauged with a knife, note marks on core at right of photograph.

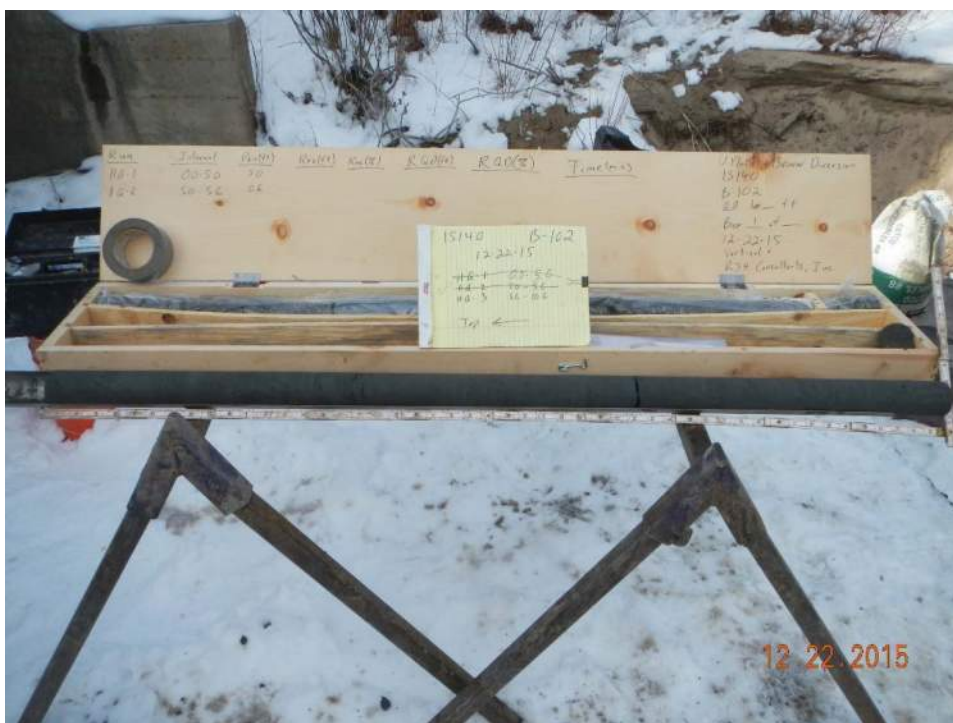
Photograph 7: Typical core sample of soft rock between about 5 and 10 feet below the hard sandstone. Note minimal fractures and no discoloration due to weathering.

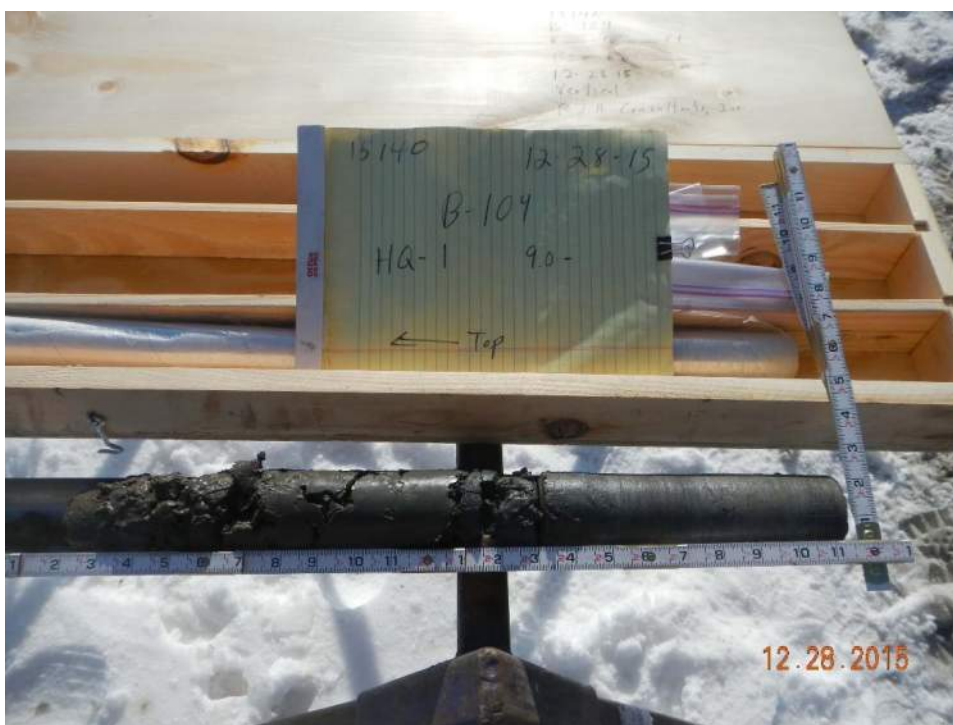
Photograph 8: Soft rock (left) above hard sandstone (right) in boring B-104.
