## Hallenbeck No. 1 Reservoir Downstream Slope Repair Project

### Final Construction Report

C – 0356F

February, 2017

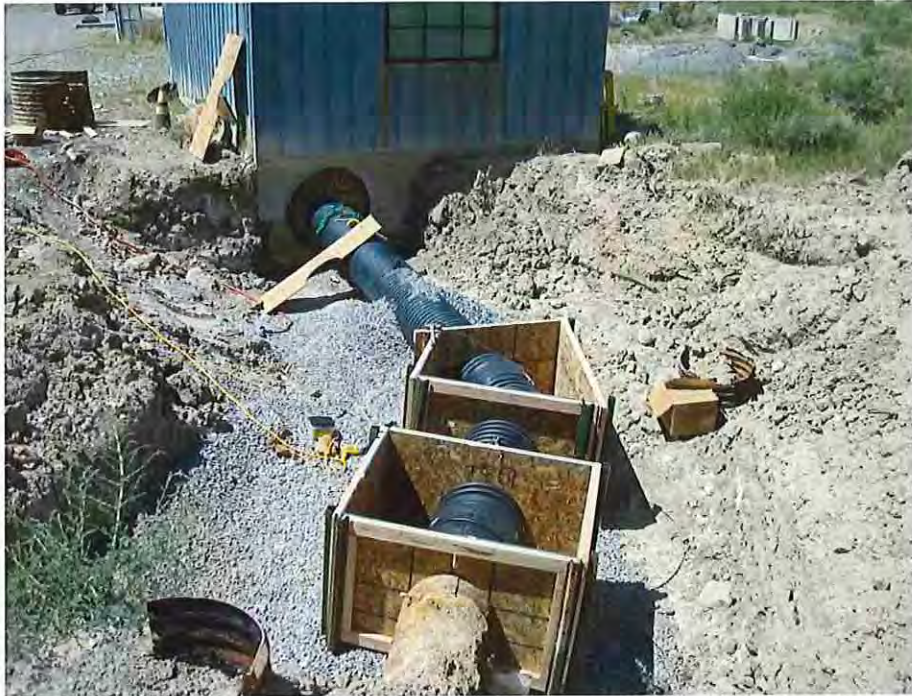
Photo #1: August 10, 2016 – Installation of new 18" dia. HDPE Corrugated pipe for the reservoirs low-level outlet pipe. The wood form boards are for the concrete thrust-blocks. Work completed by the City of Grand Junction.

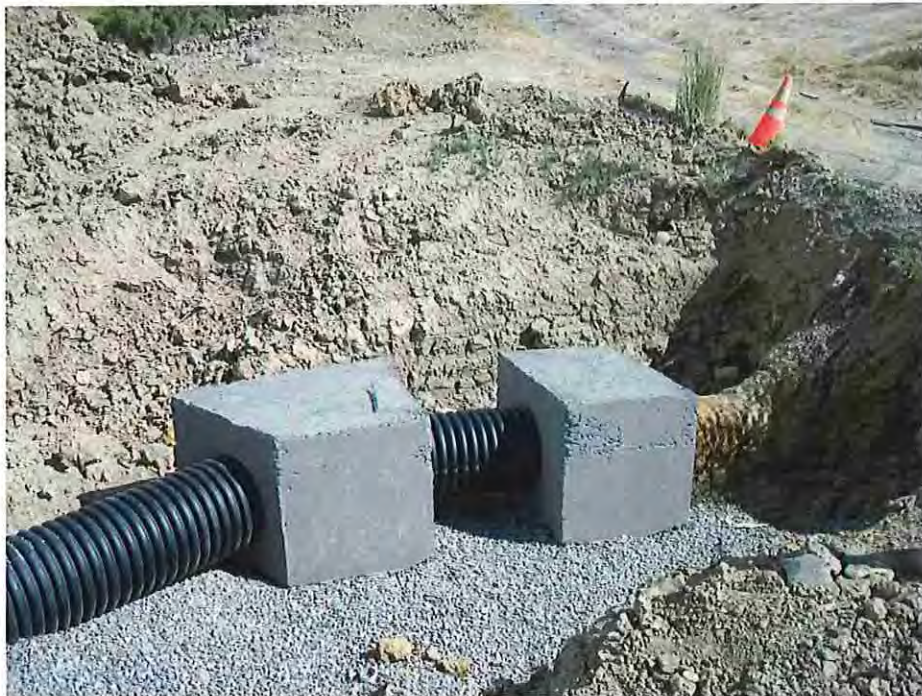
Photo #2: August 17, 2016 – Thrust-blocks poured and backfill operations ready to start. New HDPE pipe was bedded in  $\frac{3}{4}$ " minus pipe bedding rock. Backfill material came from the borrow site within the reservoir pool area. Walk behind sheeps-foot roller was used to compact backfill material. Work completed by the City of Grand Junction.

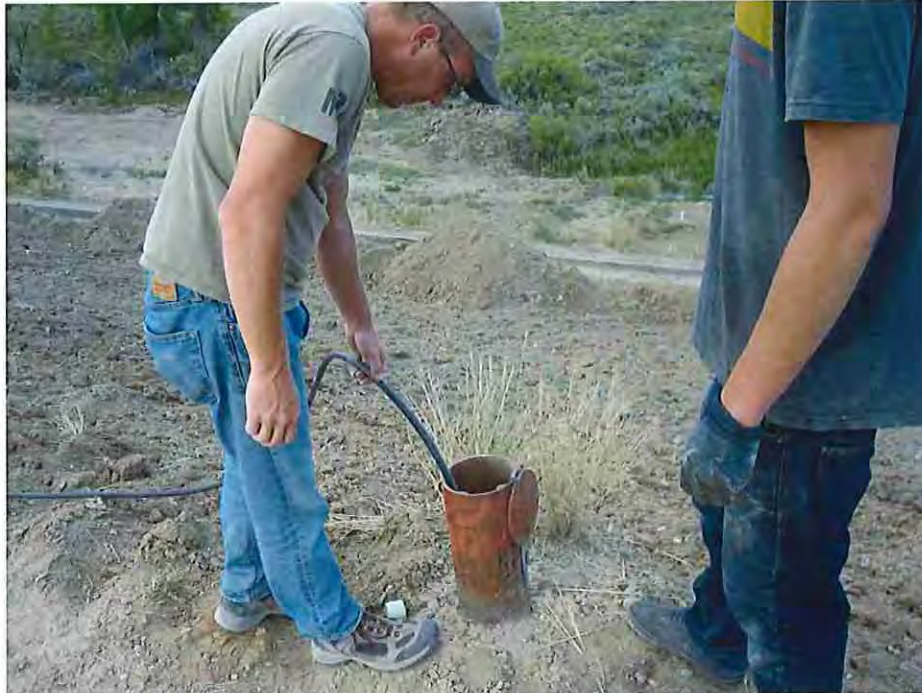
Photo #3: September 3, 2016 – Subcontractor, Huddleston-Berry Engineering, abandoning the dams old piezometers using a cement-bentonite grout.

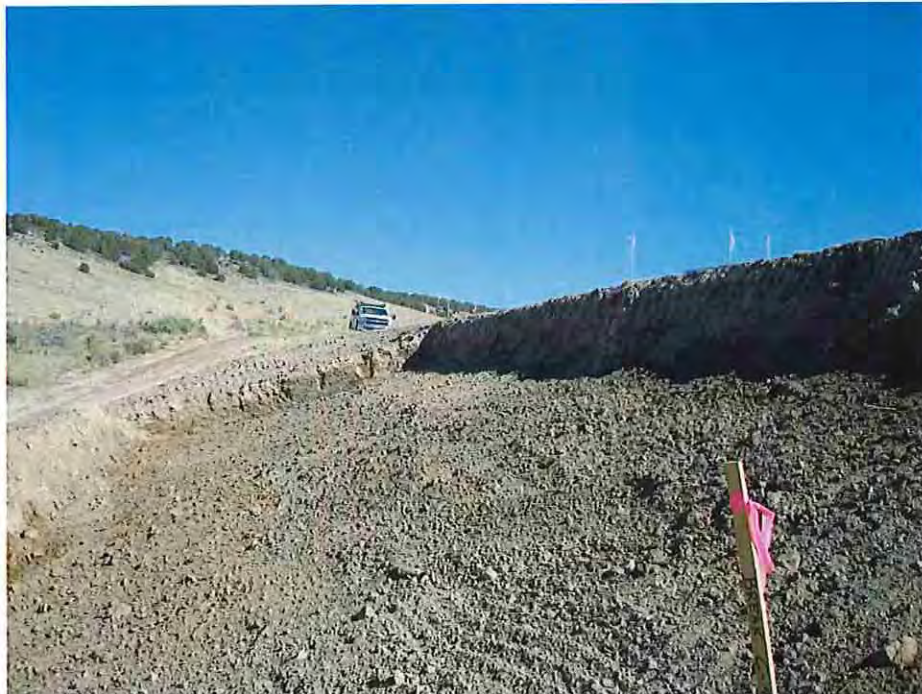
Photo #4: September 8, 2016 – Photo showing the over-excavation completed at the north end of the dam to accommodate the filter sand layer and the embankment fill. The same was done at the south end of the dam as well. This was done so the new embankment fill would tie into the existing dam grades at each end.

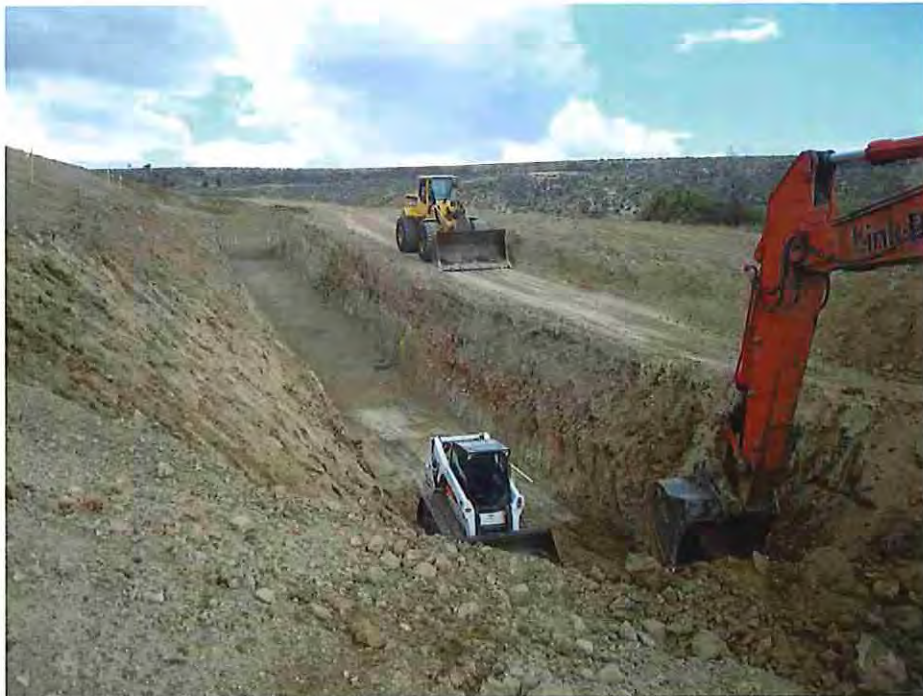
Photo #6: September 14, 2016 – Excavation begins on the south toe-drain.

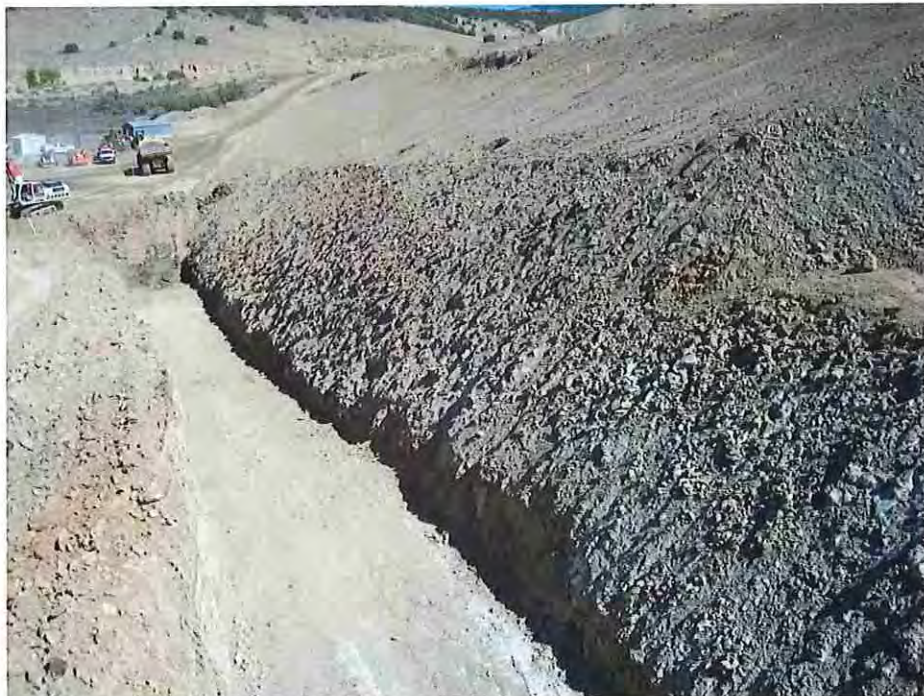
Photo #8: September 15, 2016 – Photo showing the south toe-drain excavation looking north along the dam face.

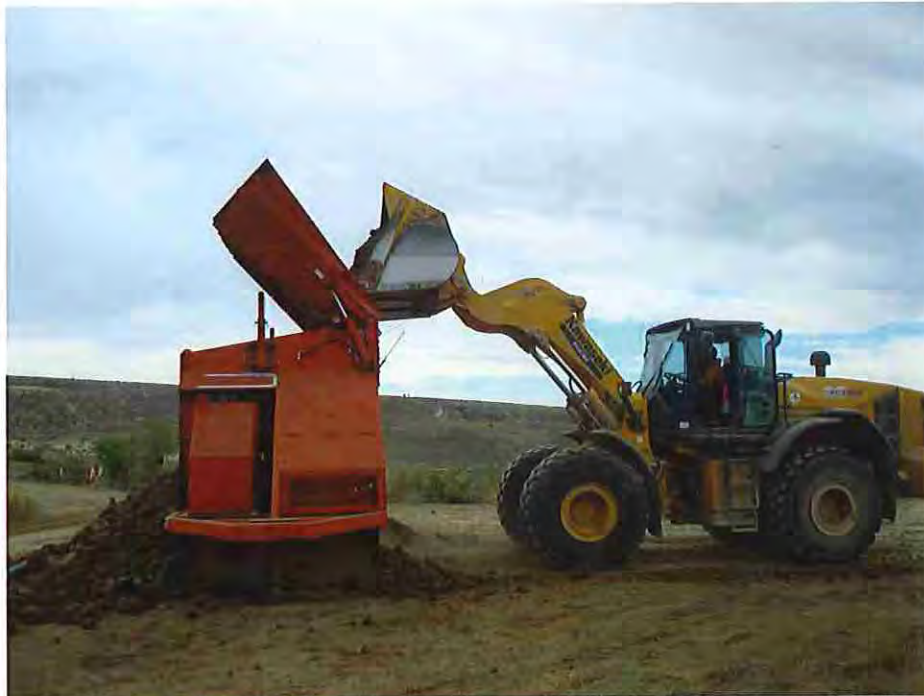
Photo #10: September 21, 2016 – Contractor processing the proposed embankment fill to get rid of rocks that are larger than 4-inches per specification.

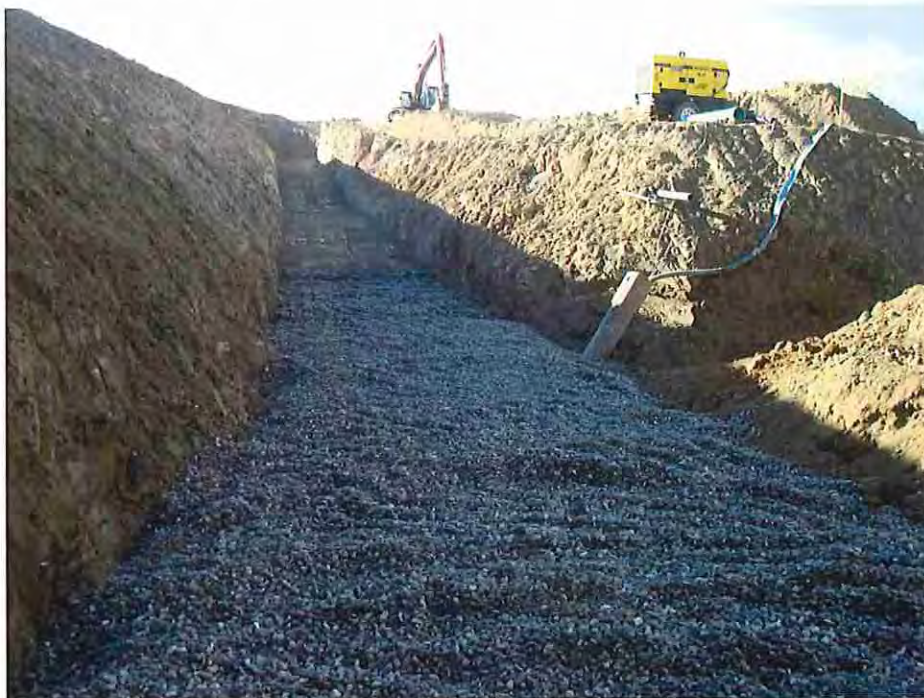
Photo #12: September 22, 2016 – Photo showing completion of the rock stabilization zone with the contractor's bypass pumping equipment set up. Filter sand would be placed on top of this stabilization rock.

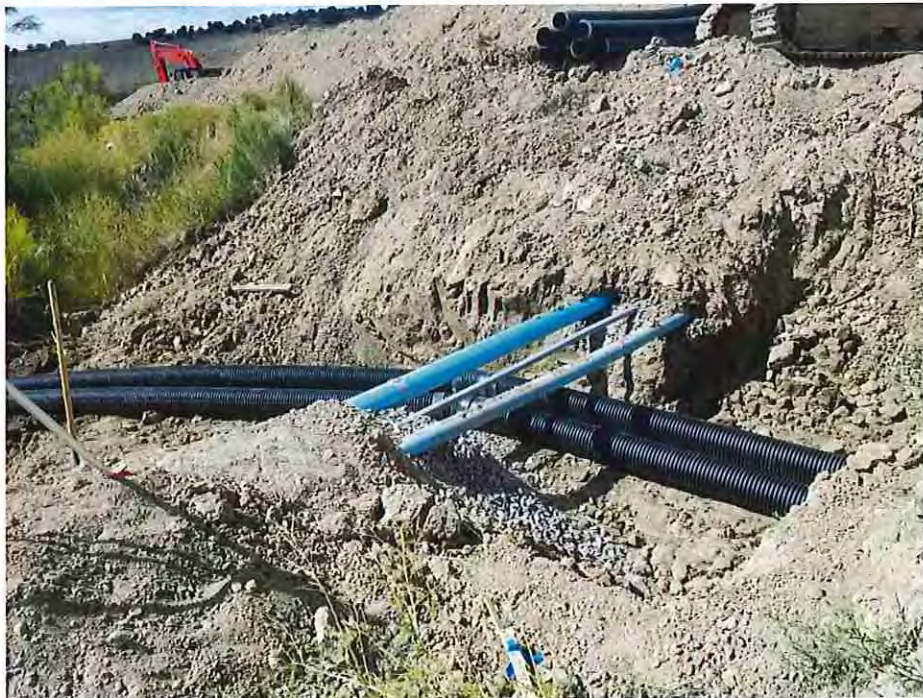
Photo #14: September 22, 2016 – North and south toe-drain outfall pipes daylighting out into the drainage. Pipes shown above the toe-drain pipes are the City's 4-inch domestic water supply line, the future 6-inch domestic water supply line and a 2-inch electrical conduit.

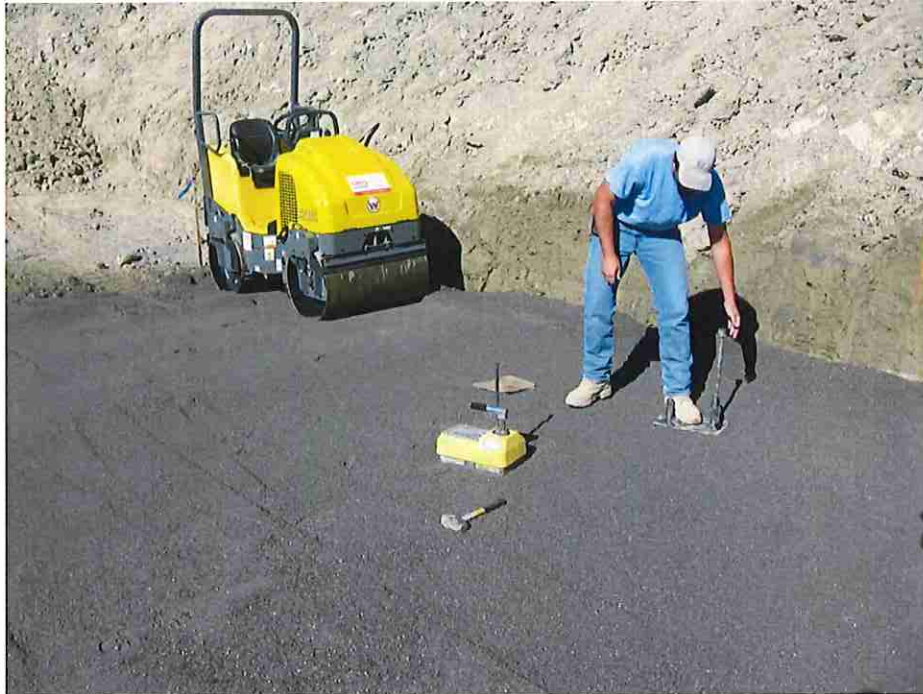
Photo #15: September 27, 2016 – Contractor's quality control subcontractor performing compaction/density tests on the filter sand. A smooth drum roller and the application of clean water was used to compact the filter sand.

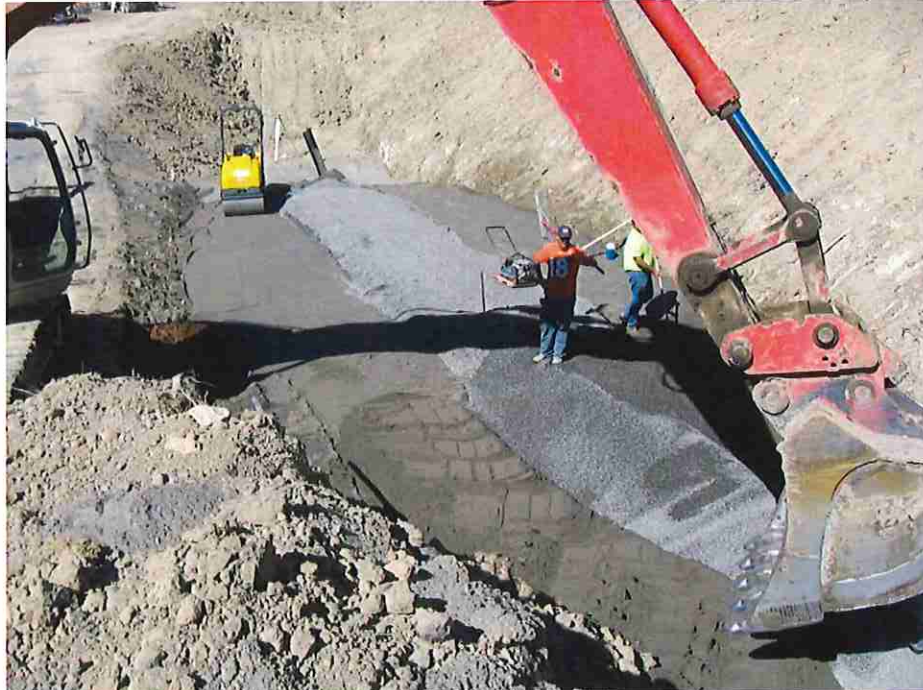
Photo #16: September 27, 2016 – Photo shows the south toe-drain being installed. Filter sand and drain gravel encapsulate the 8-inch diameter HDPE toe-drain pipe. The toe-drain pipe can be seen in this photo to the right of the smooth drum roller.

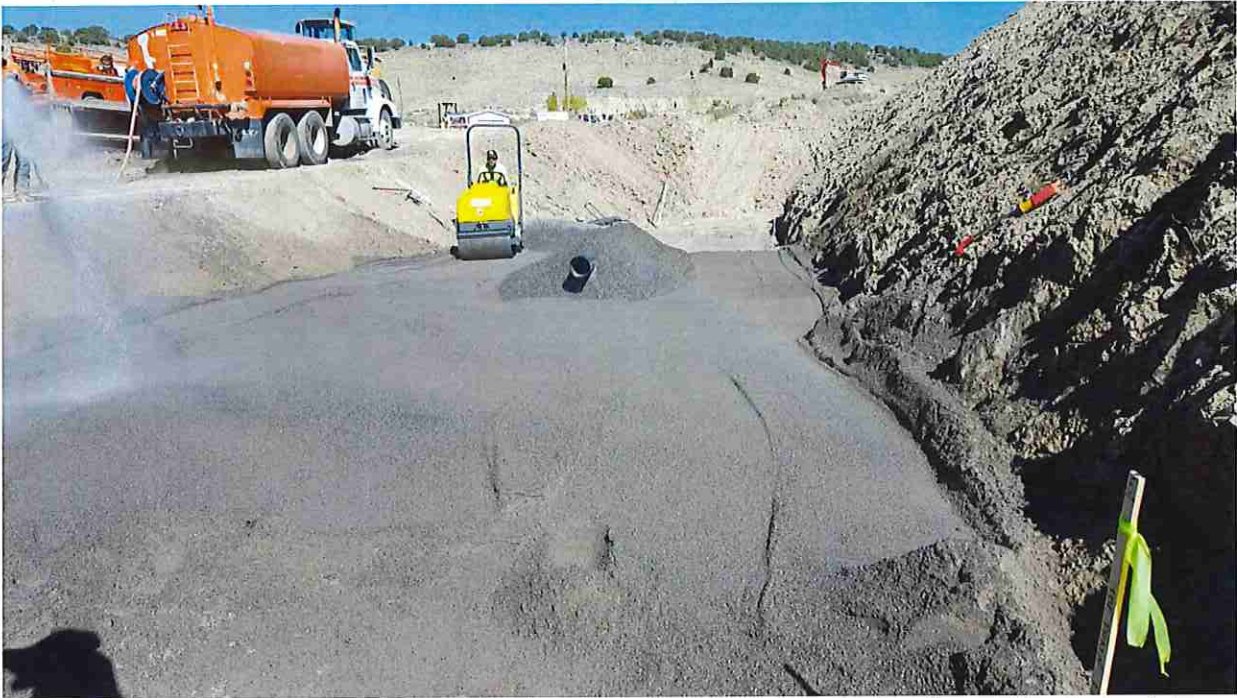
Photo #17: September 27, 2016 – Photo shows the contractor's operations for installing the toe-drain. Water is being applied to the filter sand to keep it wet while the smooth drum roller compacts the sand. Drain gravel is surrounding the pipe.

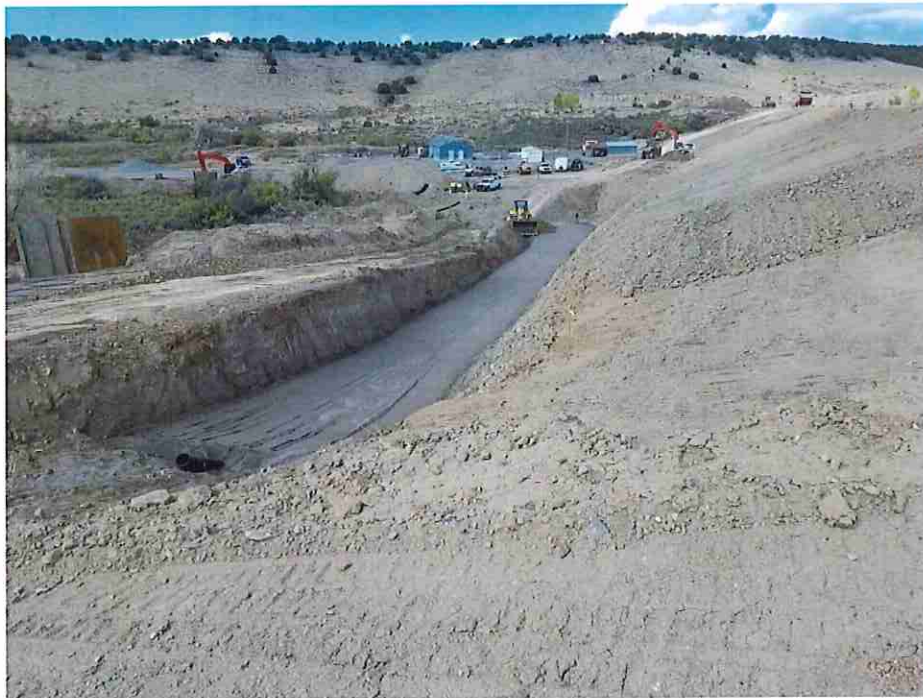
Photo #18: September 30, 2016 – South toe-drain pipe installed and encapsulated in the filter sand and drain gravel. Ready for embankment fill to be placed on top of the filter sand.

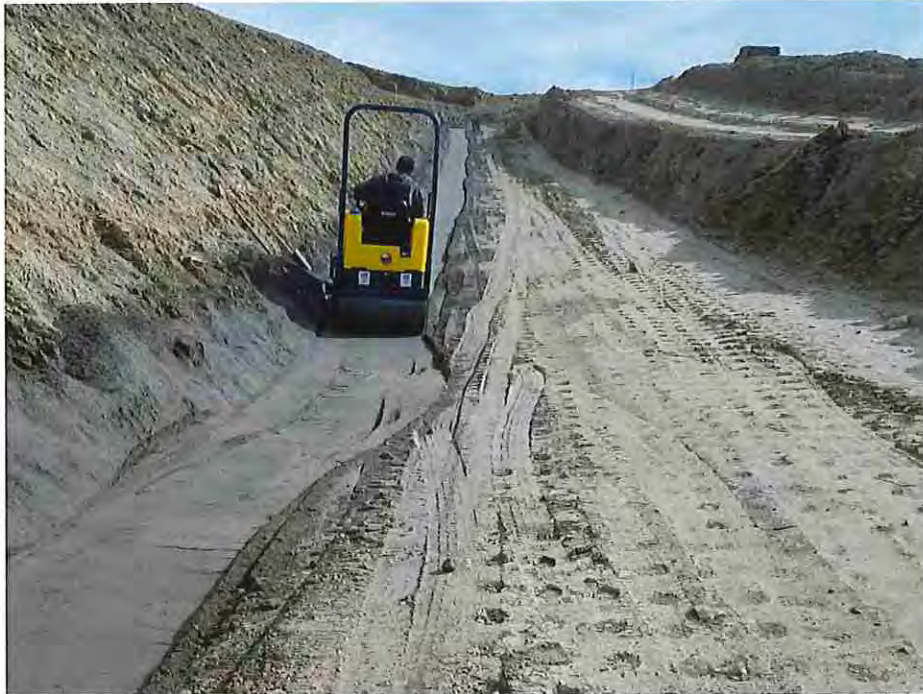
Photo #19: October 3, 2016 – Photos shows the smooth drum roller compacting the filter sand chimney drain, while to the right of the filter sand the embankment fill is being compacted using a large sheep's-foot roller compactor. Indentations from the sheep's-foot roller can be seen in the embankment fill.

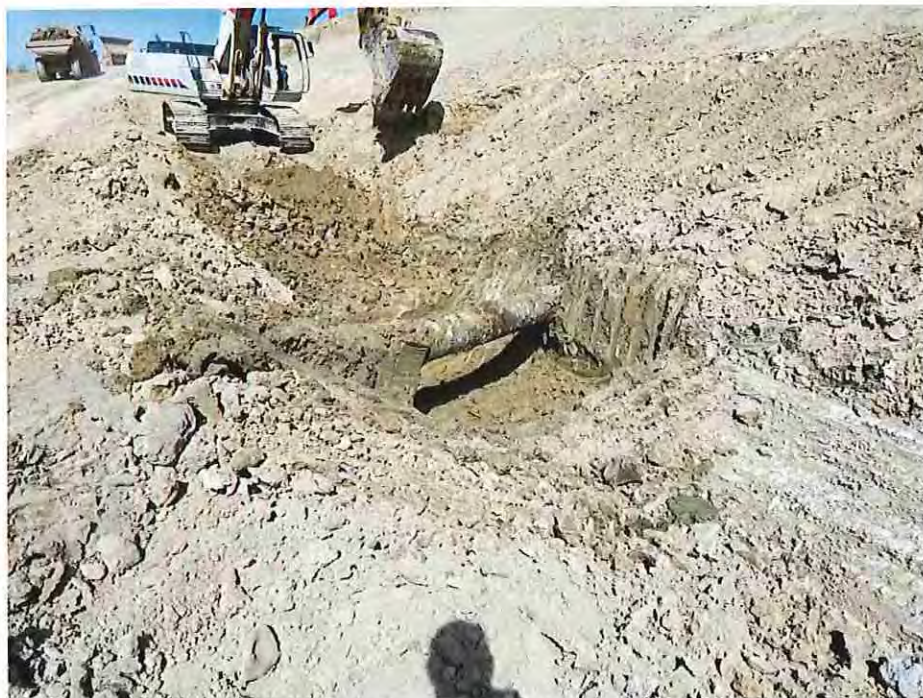
Photo #20: October 5, 2016 – Excavation of the north toe-drain. This photo shows the contractor excavating around the reservoir's low-level outlet pipe. The toe-drain would be installed underneath the low-level outlet pipe. Installation details are shown in the As-Built construction plans.

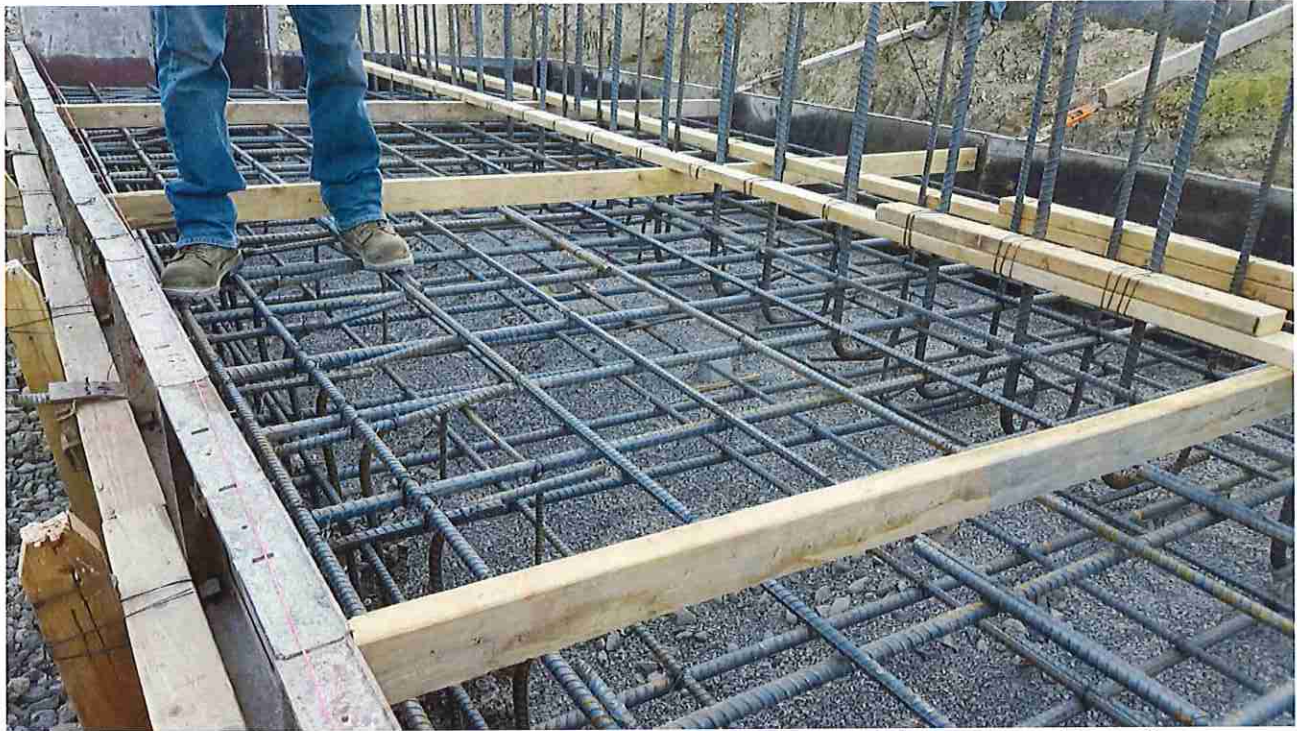
Photo #21: October 10, 2016 – Steel reinforcement for the footer of the concrete retaining wall.

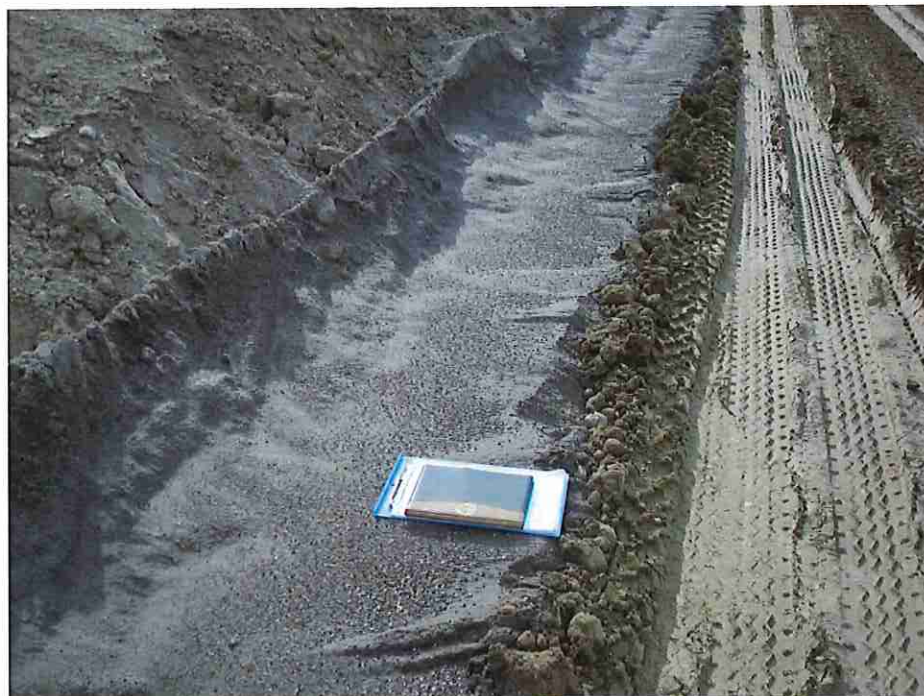
Photo #22: October 17, 2016 – Photo showing the 3-ft wide filter sand chimney and the embankment fill to the right.

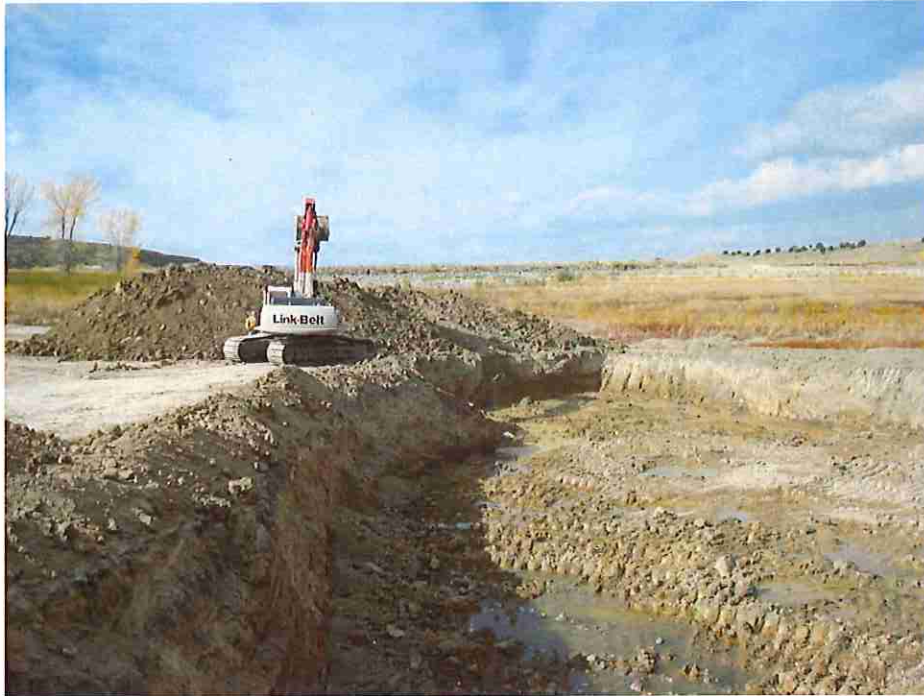
Photo #23: October 17, 2016 – Photo showing the borrow area within the reservoir pool area. The borrow area was towards the south end of the reservoir.

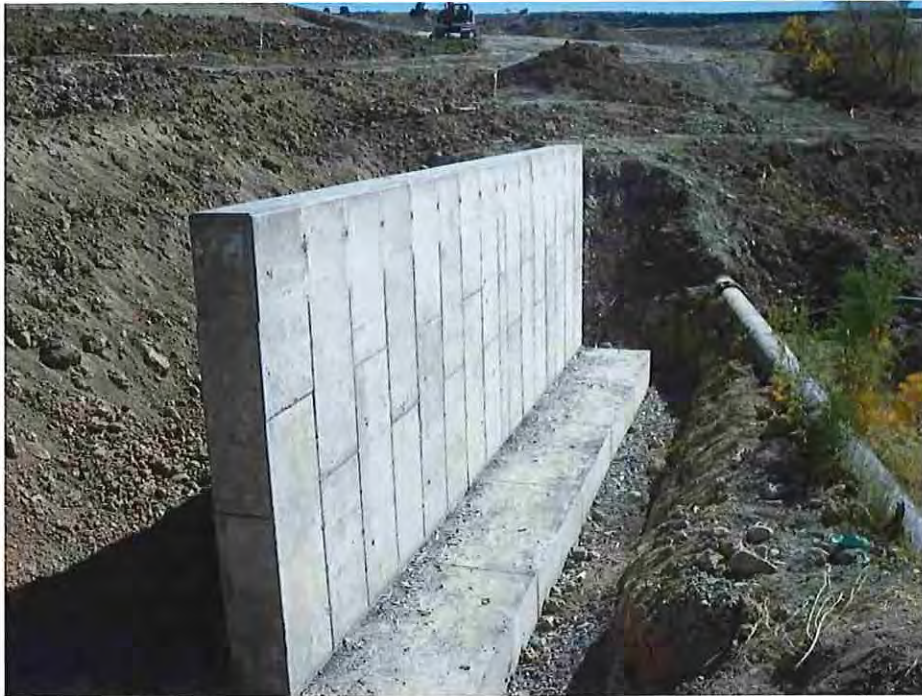
Photo #27: October 20, 2016 – Completed concrete retaining wall. Embankment fill will be placed and compacted around the wall.

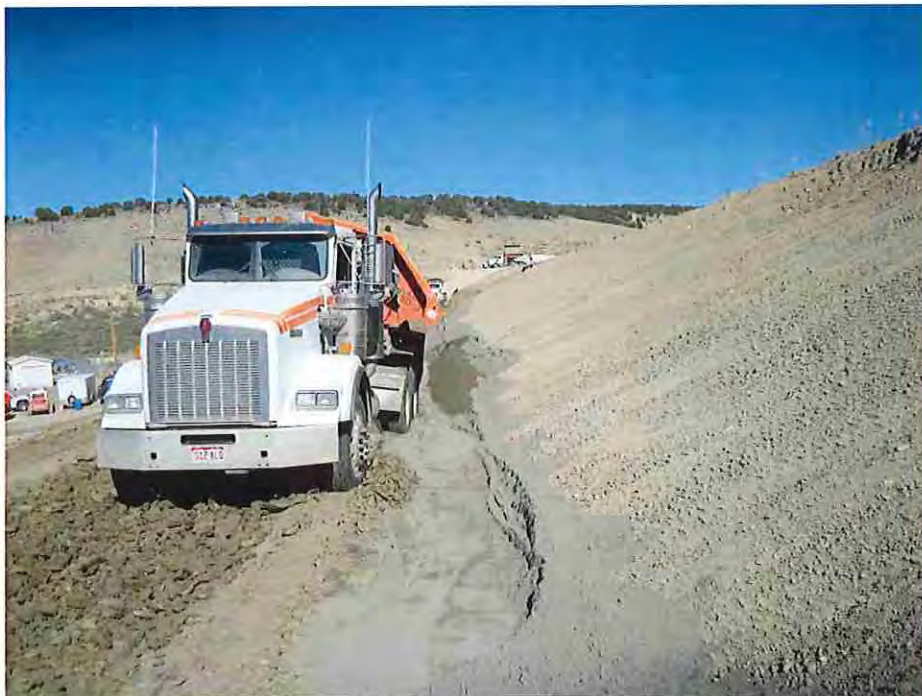
Photo #28: October 21, 2016 – Photo shows contractor's method for placing the filter sand. Side dump trailers were used to place the filter sand. The contractor then used a grader to level the filter sand and then the smooth drum roller compactor would compact the filter sand. A water truck was used to keep the sand wet.

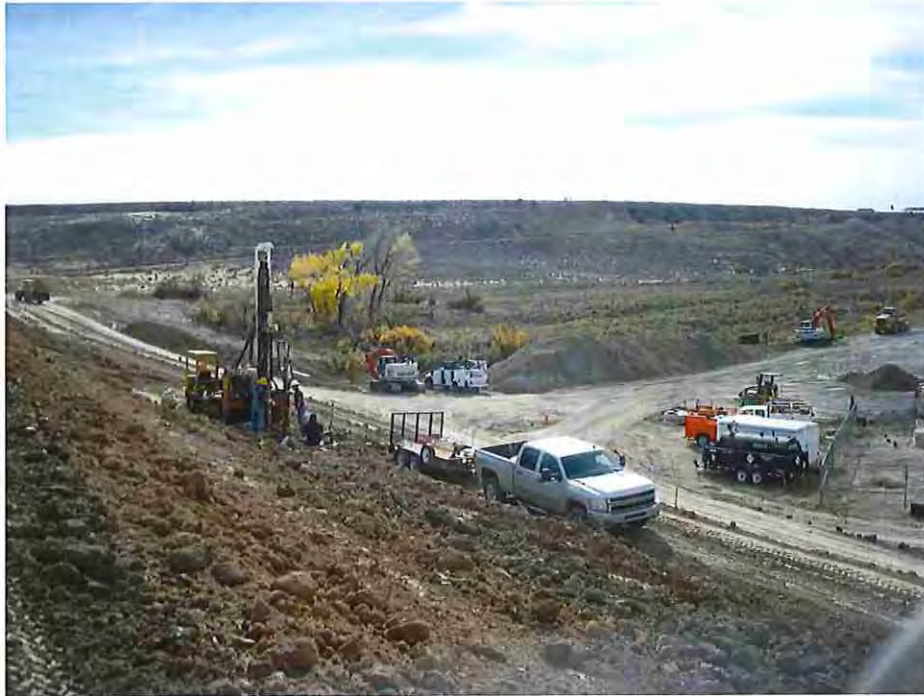
Photo #31: October 28, 2016 – Subcontractor installing the new piezometers along the downstream face of the dam.

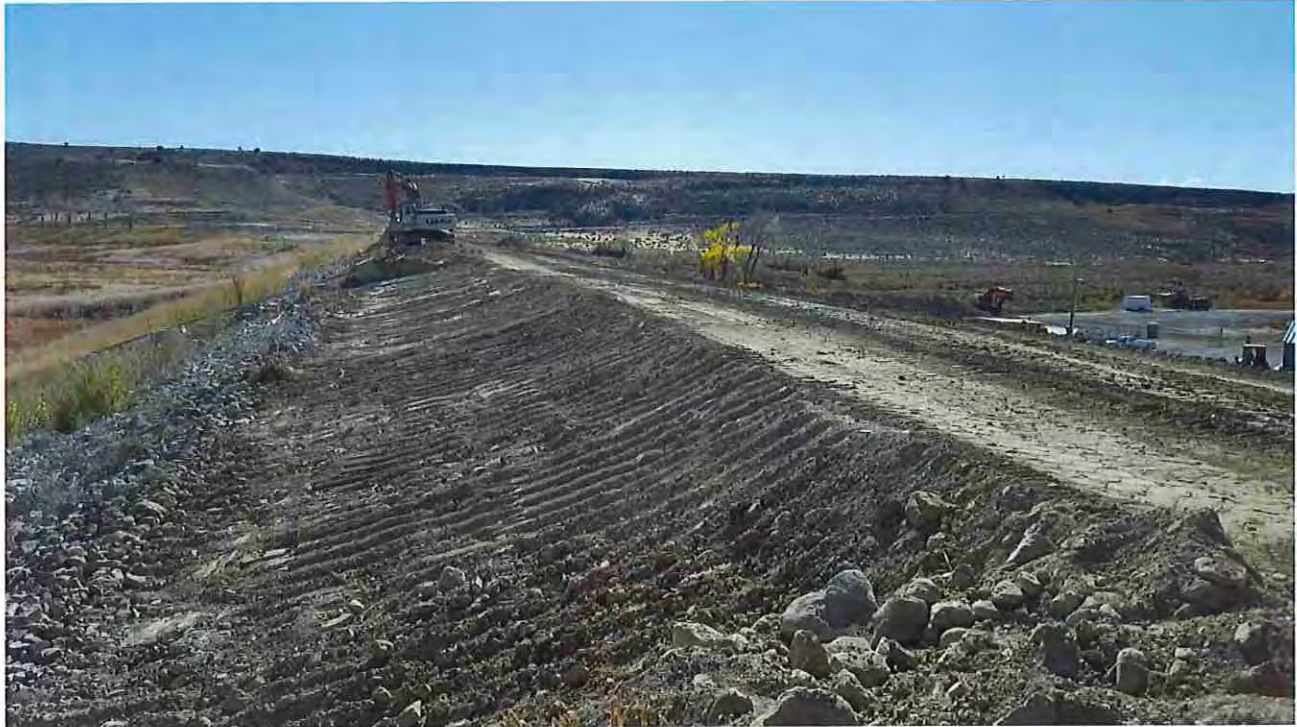
Photo #32: November 2, 2016 – Contractor stripping and prepping the upstream face of the dam crest for the placement of drain gravel and riprap.

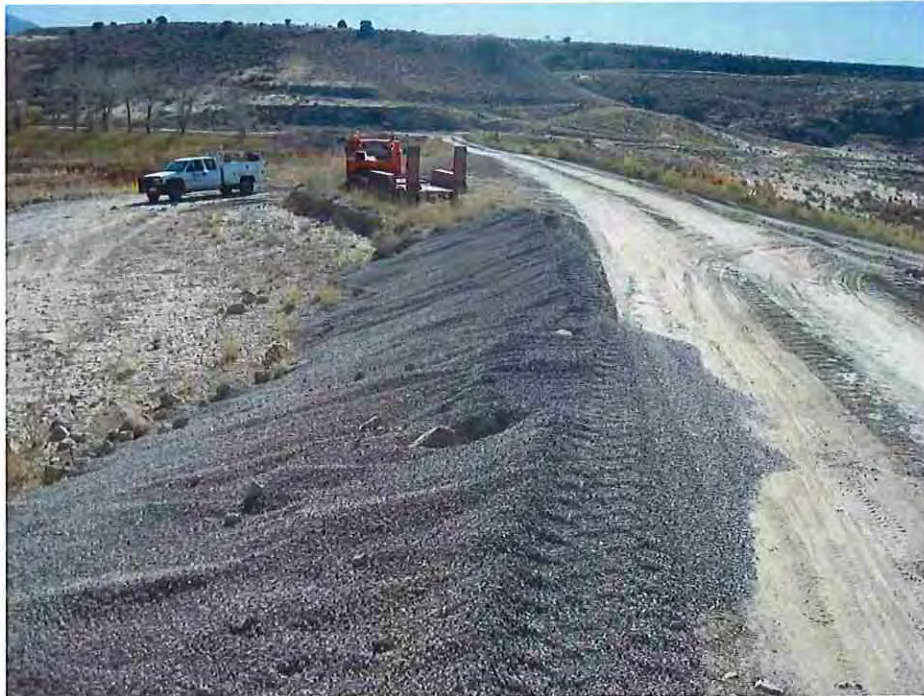
Photo #33: November 15, 2016 – Drain gravel placement along the upstream face of the dam. Riprap protection will be placed on top of the drain gravel.

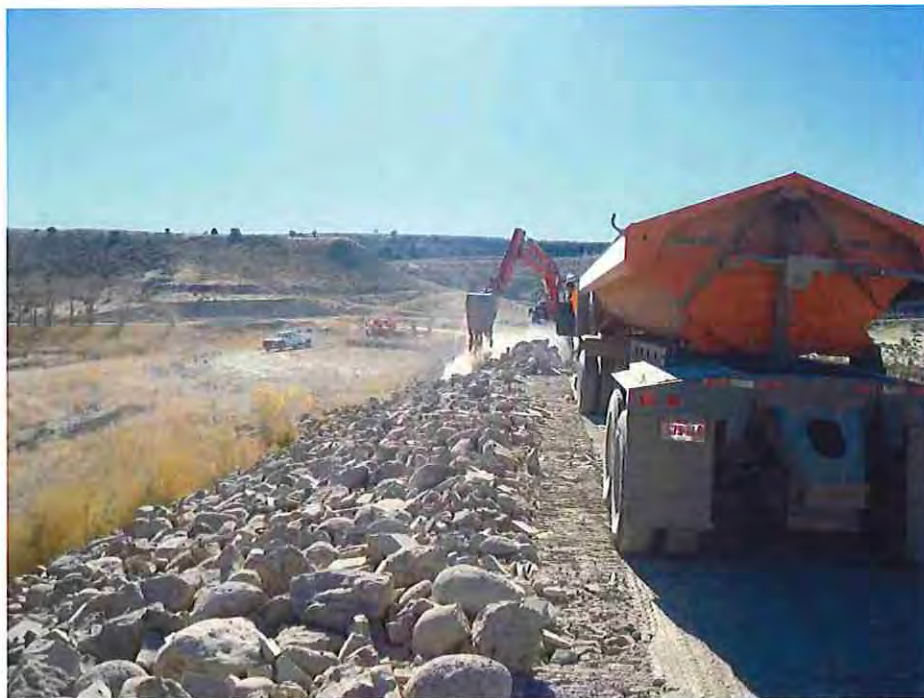
Photo #34: November 15, 2016 – Riprap placement along the upstream face of the dam.

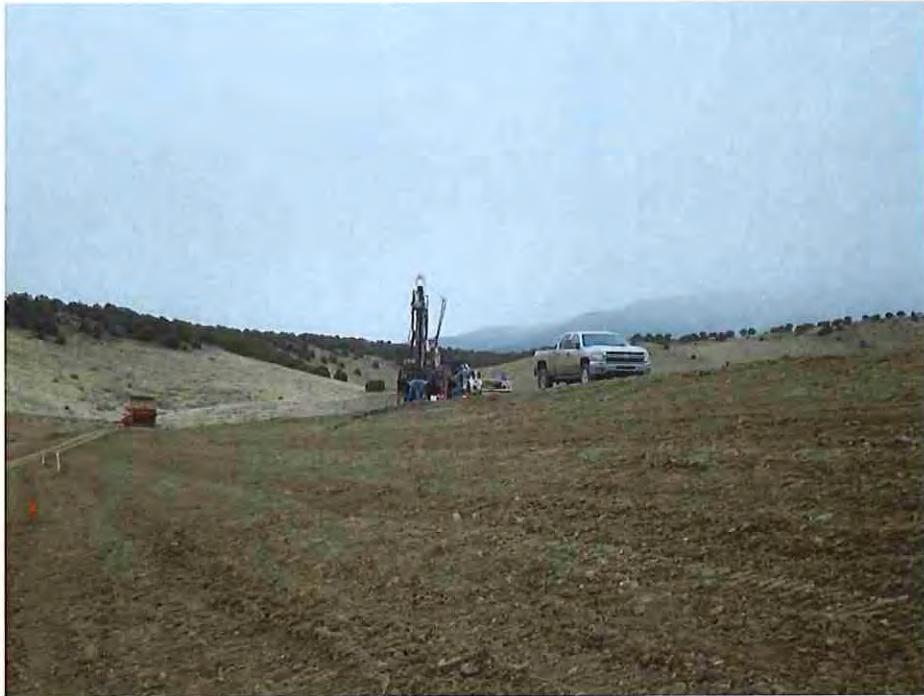
Photo #35: November 28, 2016 – Subcontractor installing the new piezometers along the crest of the dam.

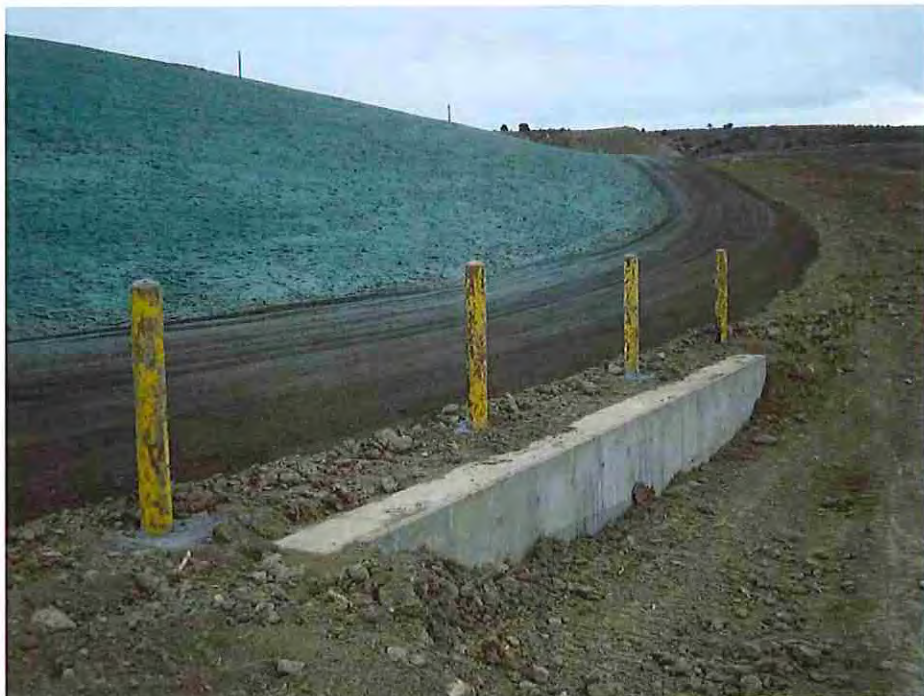
Photo #36: December 15, 2016 – Photo shows the completed retaining wall, pipe bollards, recycled asphalt millings placed on the dam service roads, and seed, fertilizer, mulching operations. Photo is looking south.

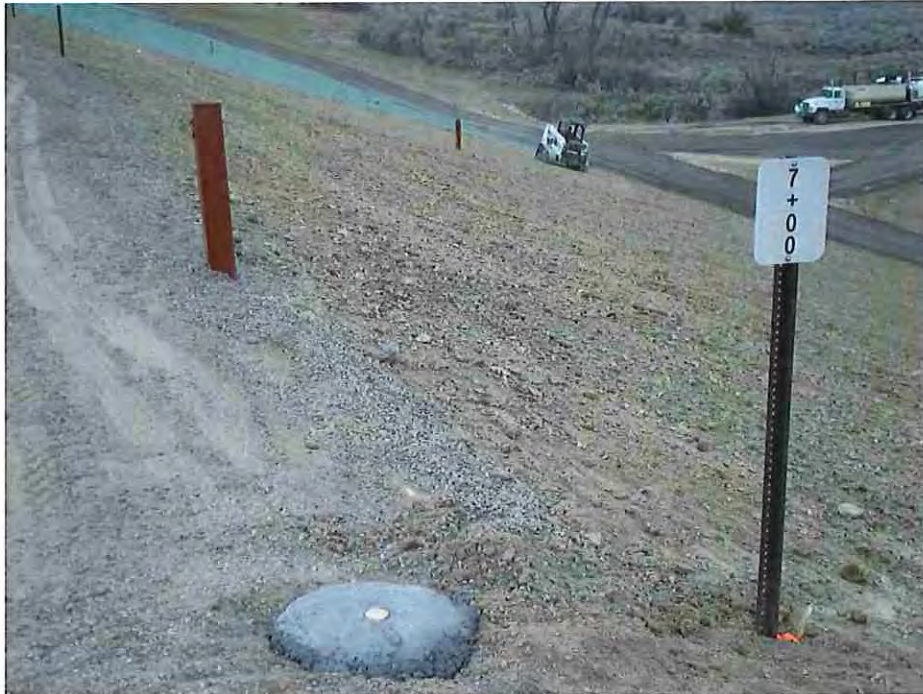
Photo #37: December 15, 2016 – Photo shows the installed piezometers, dam crest station markers, movement monuments set in concrete, and the seeding, fertilizing, mulching operations.

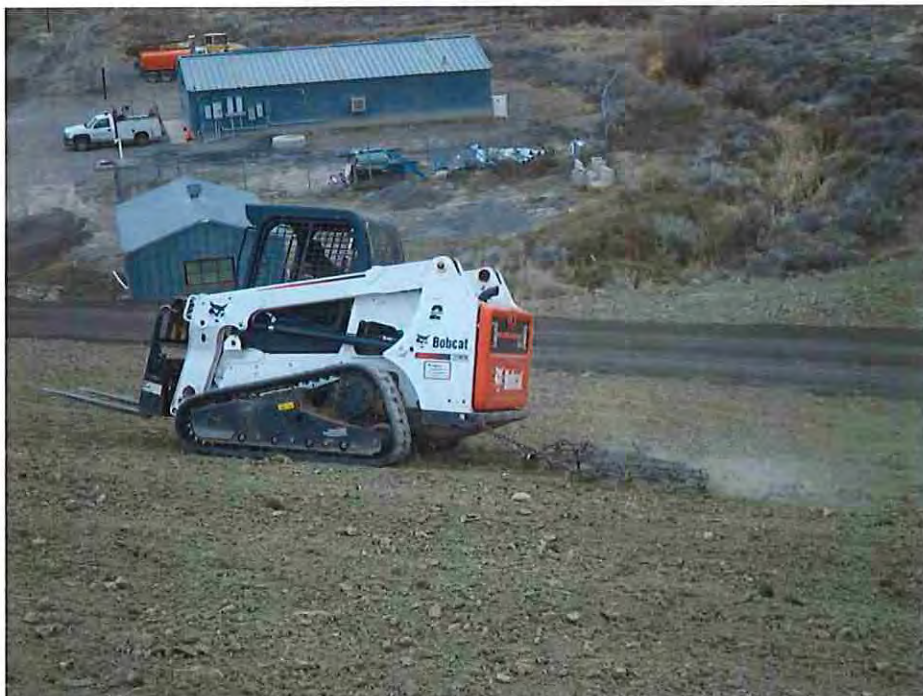
Photo #38: December 15, 2016 – Subcontractor raking the downstream dam face prior to broadcasting native seed, fertilizing and applying mulching.

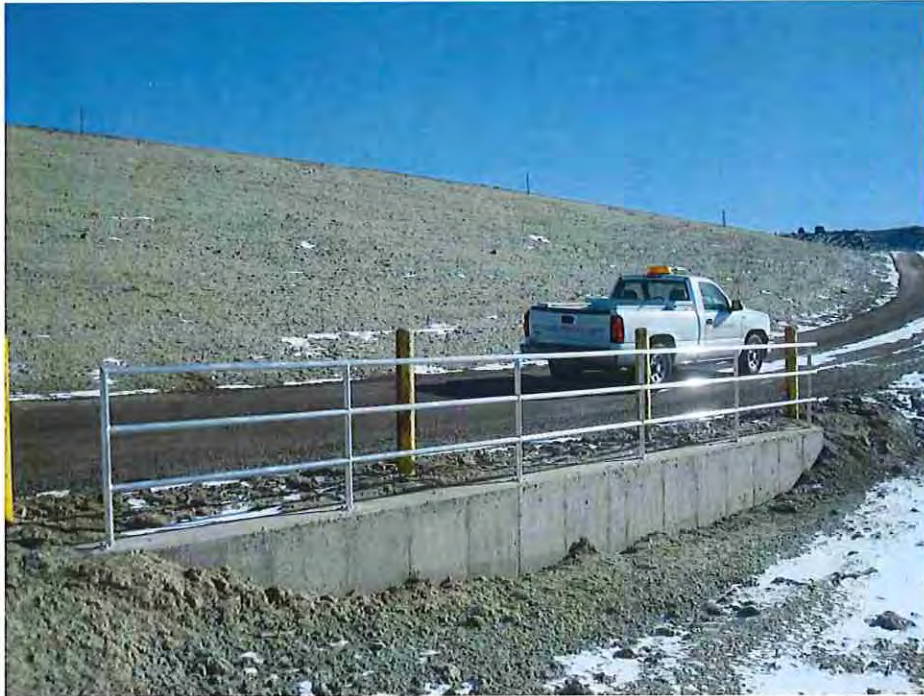
Photo #39: December 27, 2016 – Aluminum hand railing installed along the top of the retaining wall.

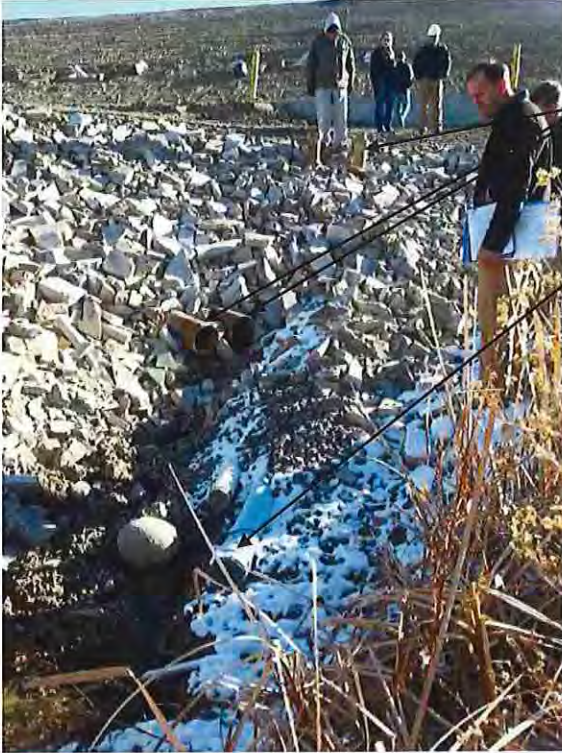
- Toe drain pipe discharge points.
- Valve on water line downstream of toe.
- Water line valve box drain discharge.

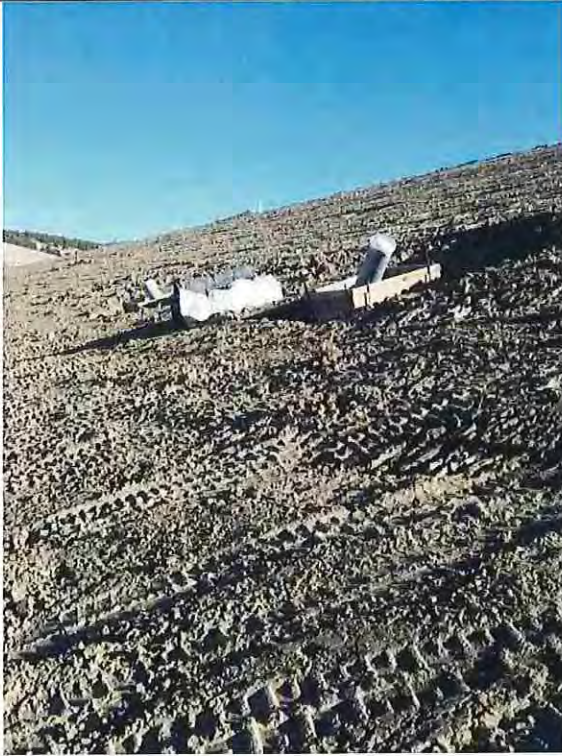
Toe drain cleanout risers at maximum dam section.

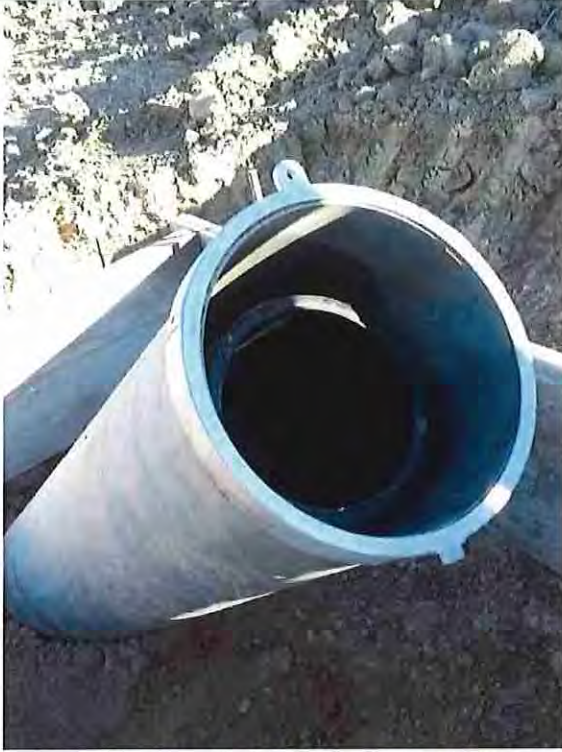
Left toe drain cleanout riser at left (south) end of dam. Similar cleanout is located on the slope at the right (north) end of the dam.

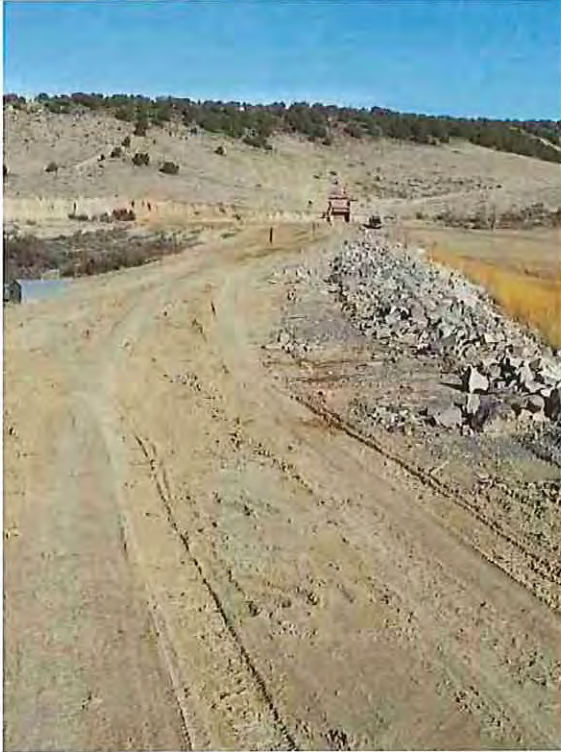
Dam crest from left end. Final grading for drainage and crest surfacing has not been completed.

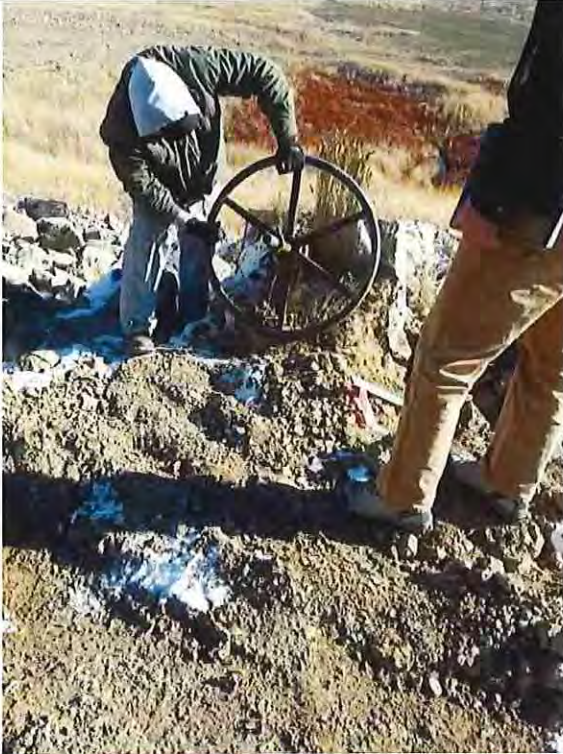
Outlet gate operator on dam crest.
