Design Report Swede Lake Dam Rehabilitation Boulder County, Colorado

Water Division 1, Water District 5, C-2064
DAMID:050304

Project No. 110480

April 24, 2018

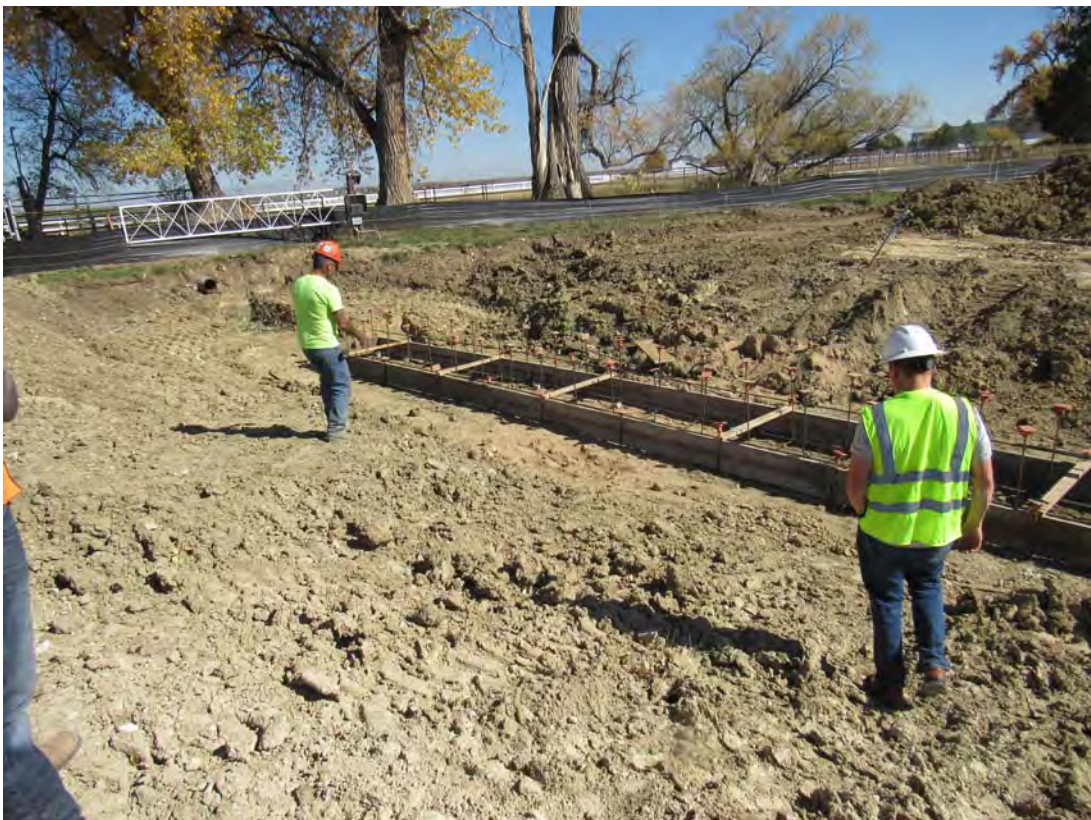
Photo 06 (10-18-2017) Irrigation outlet rebar

The base of the outlet easements and the outlet structures were formed and poured first. Then the two outlet pipes were placed and anchored to the base using metal belts and spacers between the pipe and base. The remainder of the outlet pipe encasement was formed and poured with battered sides. After the concrete set, the excavation was backfilled with compacted clay and the pipes were pressure tested. Both the primary outlet and the irrigation outlet passed the pressure tests. Photo 6 shows the formwork for the base of the outlet pipe encasement. Photos 9 and 10 show the outlet pipes strapped to the base of the encasement. Photo 11 shows the formwork of the irrigation outlet pipe before the remainder of the encasement was poured.

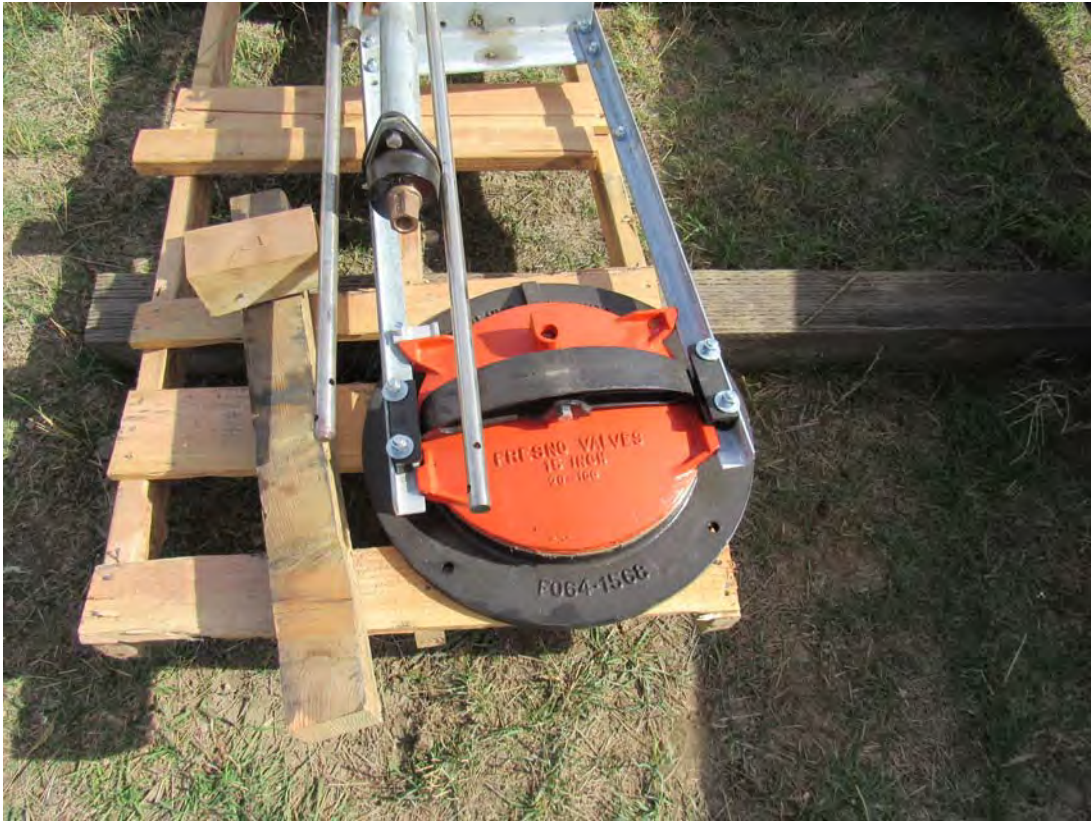
Photo 07 (10-24-2017) 15-inch heavy duty slide gate

for the walls. Lids with hatches were placed on top of the towers. Photos 7 and 8 show the heavy-duty sluice gates for the outlet works. Photo 13 shows the construction of the primary outlet tower.

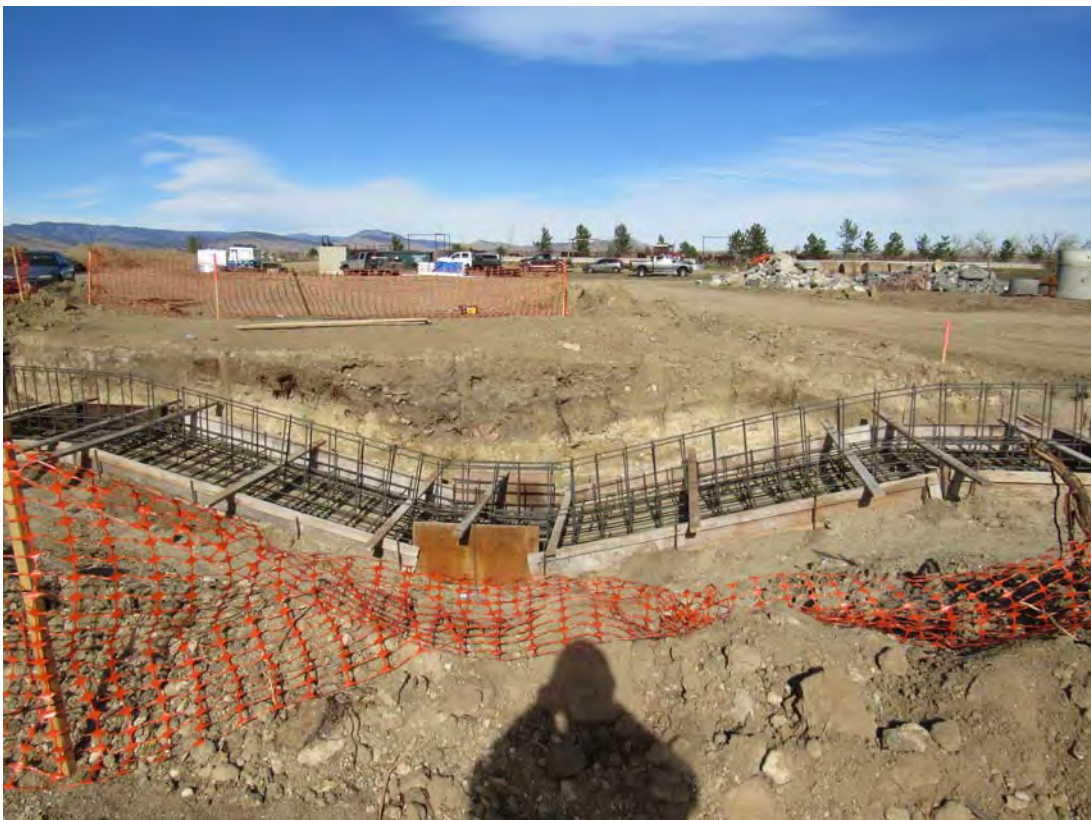
Photo 12 (11-20-2017) Spillway grade beam reinforcement

The cutoff wall was constructed per the drawings and specifications. Both sides of the cutoff wall were filled and compacted simultaneously. A spillway channel was constructed and armored with bedding. Riprap was placed just downstream of the cutoff wall, along the outside of the channel's bend. Photos 12 and 14 show the construction of the emergency spillway cutoff wall.

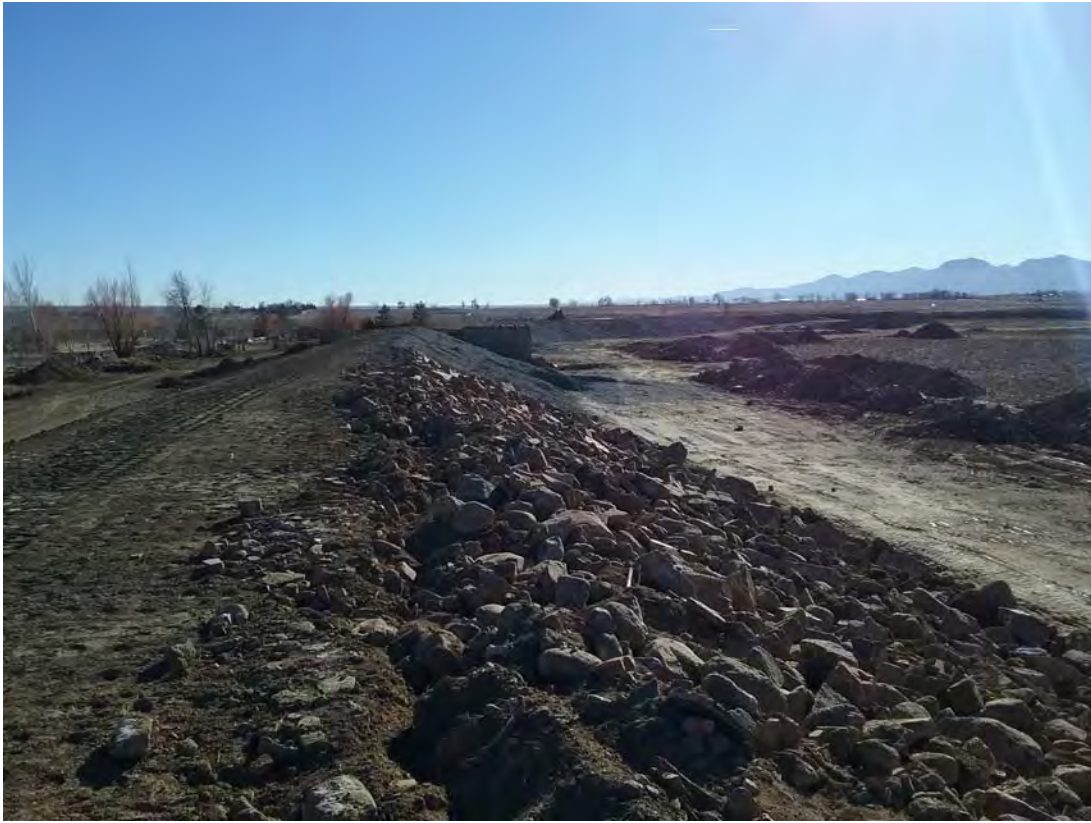
Photo 15 (01-02-2018) Bedding and riprap on upstream face

Existing riprap was removed and sorted through. The unwanted debris was separated and disposed of. The riprap was evaluated, and the portion that passed visual inspection was reused later in the project. The contractor placed 24-inch layer of riprap on top a 6-inch layer of bedding. Existing riprap that could be salvaged and reused was mixed in with imported Class 12 ($D_{50} = 12''$) riprap. Photo 15 shows the placement of bedding and riprap on the dam embankment.
