Water Supply Reserve Fund – Grant and Loan Program
Water Activity Summary Sheet
September 18-20, 2018
Agenda Item 12(a)

Applicant & Grantee: Surface Creek Ditch & Reservoir Company

Water Activity Name: Deep Ward Dam Repair Project

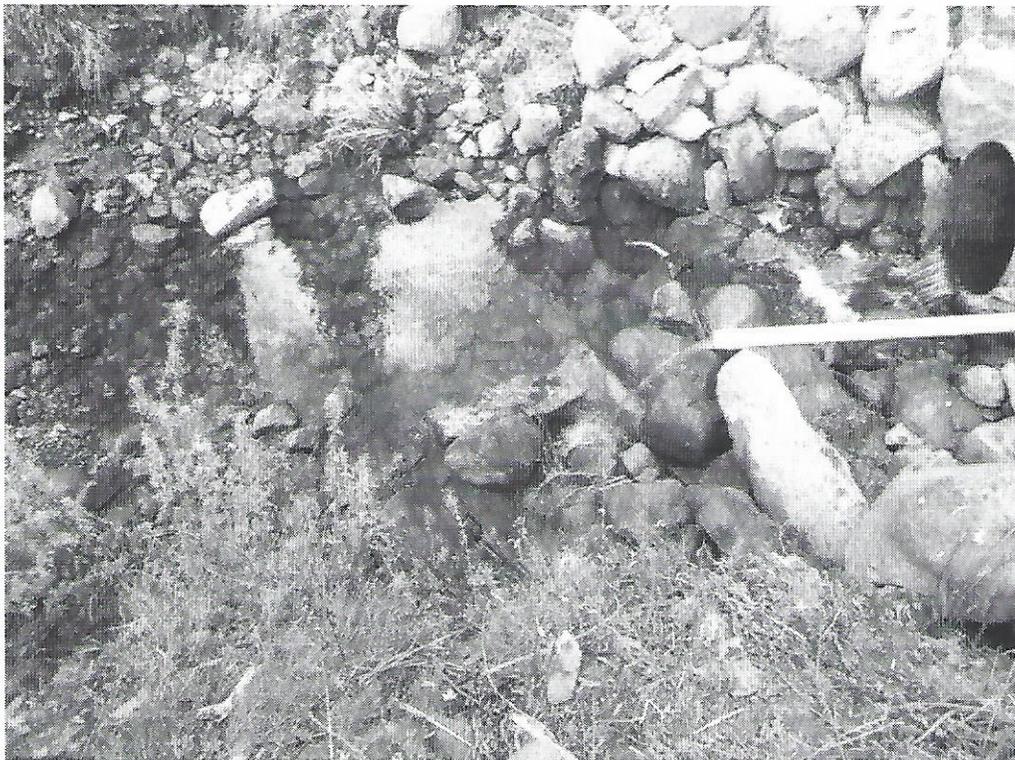
- One (1) tablet of BrightDyes Fluorescent FWT Red was dissolved in approximately 4.5 gallons of reservoir water (not quite full 5-gallon bucket)
- The dye was slowly introduced into the suspected void and seepage entry point (Photo 4).
- Dye dispersed in the reservoir, but was fairly contained to the area immediately adjacent to the intake structure (Photo 5).
- Visual monitoring of the seepage flow commenced at the downstream toe (Photo 6)
- Dye visually appeared in flow from the seepage collection pipe approximately 18-minutes after introduction into the upstream void (Photo 7).
- Dye was readily apparent after 20 minutes (Photos 8 & 9) and slowly dissipated over another 30-40 minutes.

Photos 8 & 9 View looking upstream and across at outlet pipe and seepage collection pipe with visibly dye;
Time approx. 20 minutes

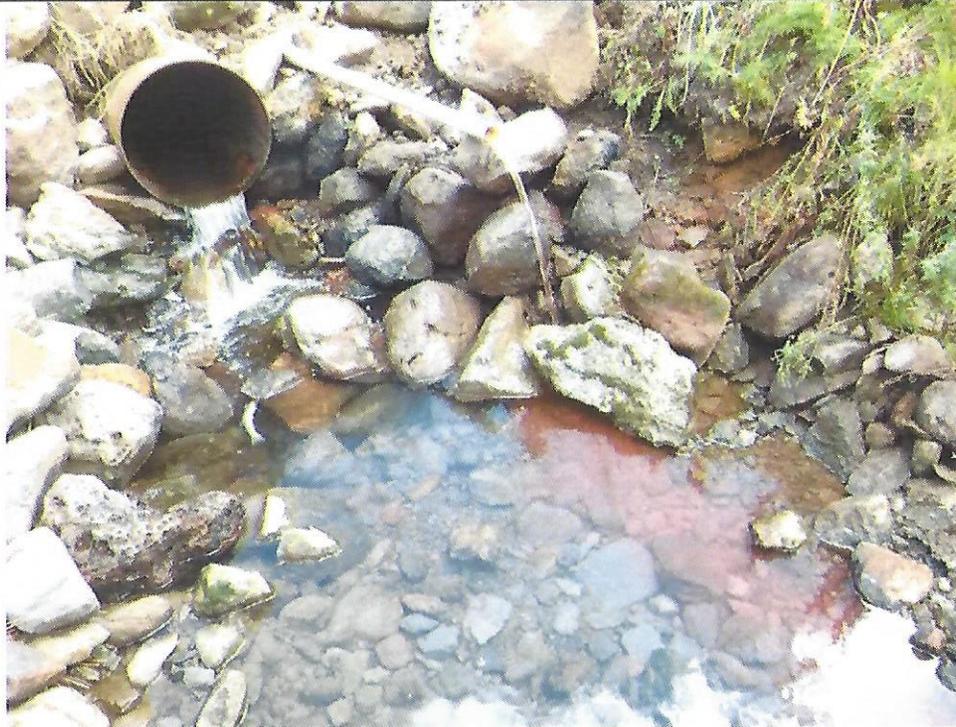
Photo supports well-defined concentrated exit point indicating possible erosion pipe formation (ADVERSE FACTOR).

The fact that the 1958 repairs left the pipe, concrete collars, and surrounding original soils/rocks/zones in place is concerning. The area surrounding the pipe/collars could be fairly large diameter rock in point to point contact "infilled" with more granular soils. This infilled granular material could be eroded at lower critical stress than the above breach repair fill (possible CL material), leaving a matrix of rock to form pipe and transmit seepage.
