# **FINAL CONSTRUCTION REPORT** for **MACFARLANE DAM** **REHABILITATION PROJECT**

**CONSTRUCTION FILE NO. C-1031B**  
**COLORADO DAM ID: 470202**  
**NID: CO-00997**  
**WATER DIVISION 6 – WATER DISTRICT 47**  
**JACKSON COUNTY, COLORADO**

## Executive Summary

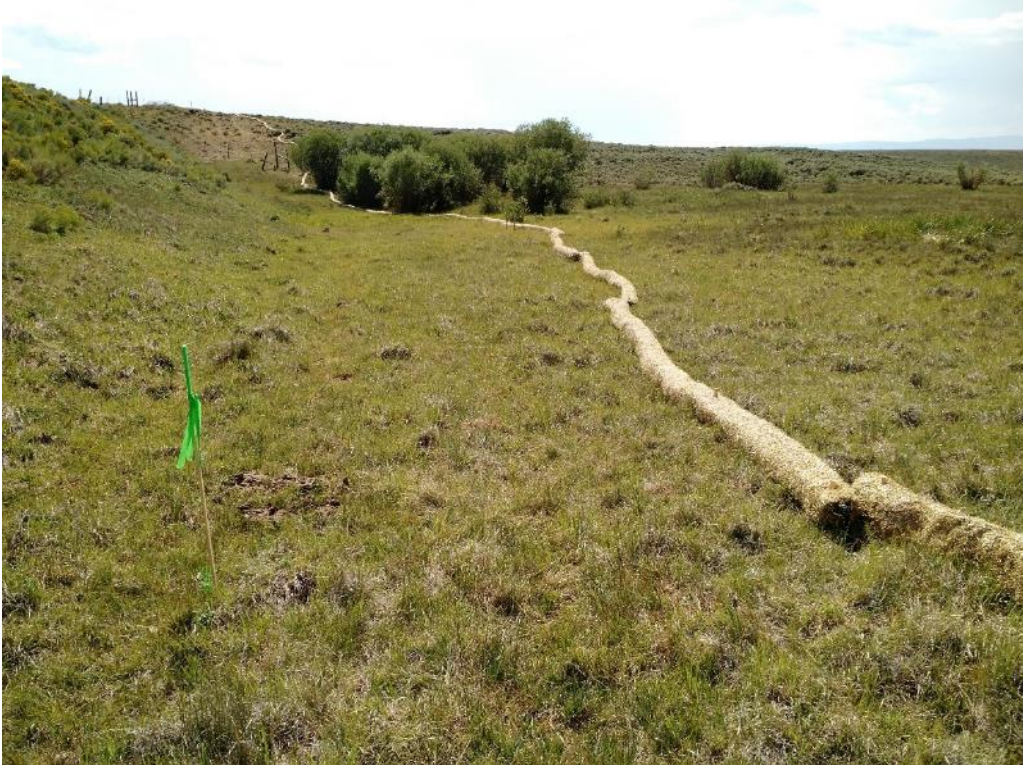
Photo 1. Erosion control wattles staked down at the toe of the North Embankment. View looking left along the toe of the North Embankment. August 1, 2017.

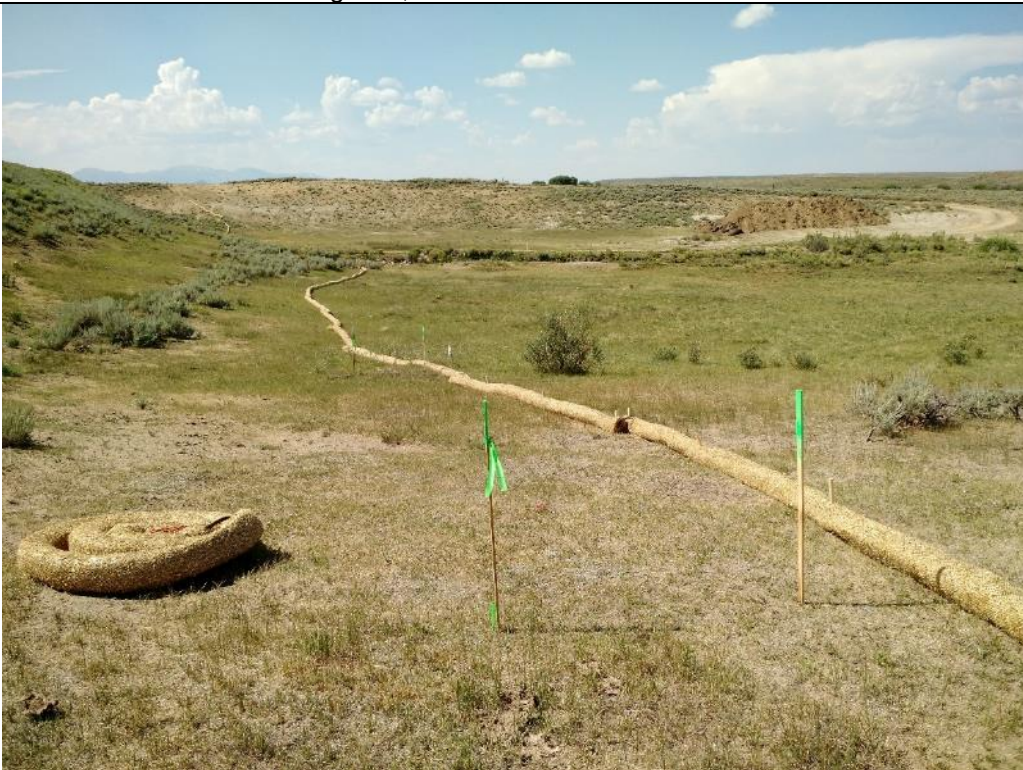
Photo 2. Erosion control wattles staked down at the toe of the Main Dam Embankment. View looking left along the toe of the Main Dam Embankment. August 1, 2017.

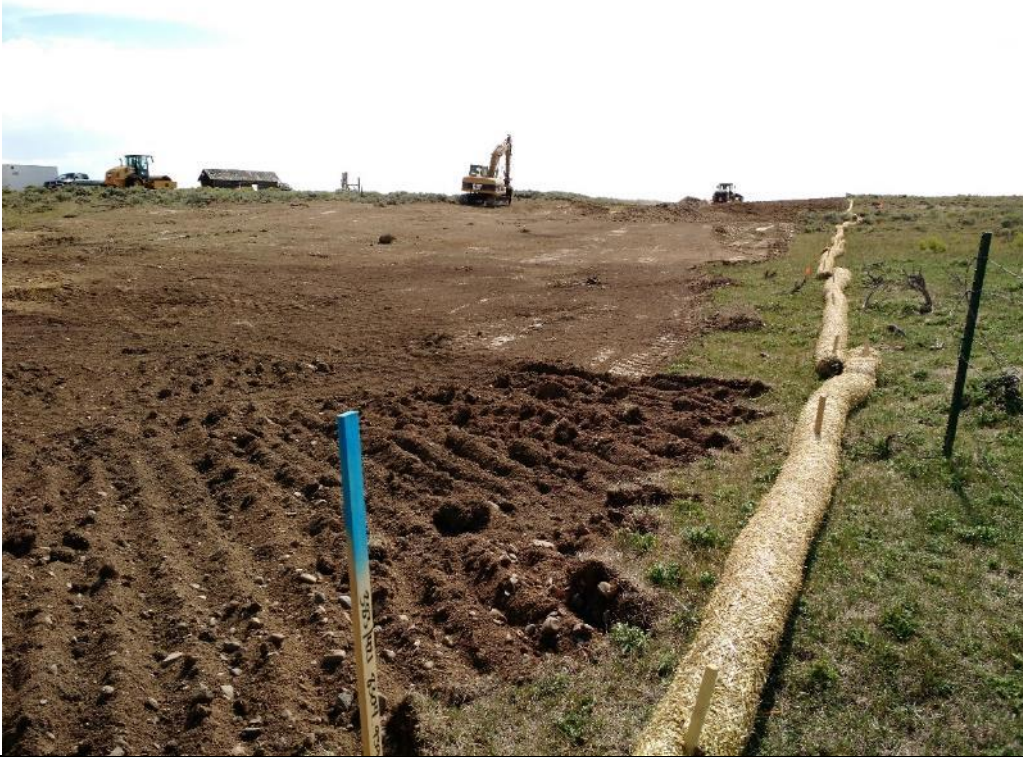
Photo 3. View looking upstream along the left side of the spillway channel at the clearing and grubbing work and the installed erosion control. Aug. 1, 2017.

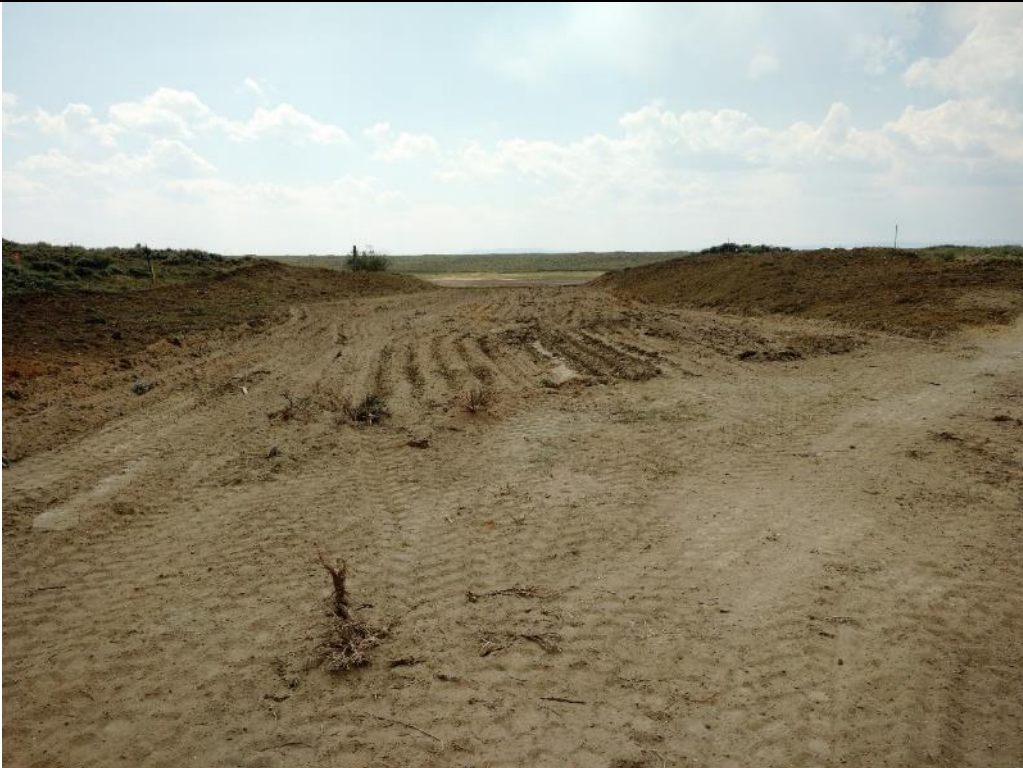
Photo 4. View looking upstream at the cleared and grubbed spillway from ES Station 2+75. Aug. 2, 2017.

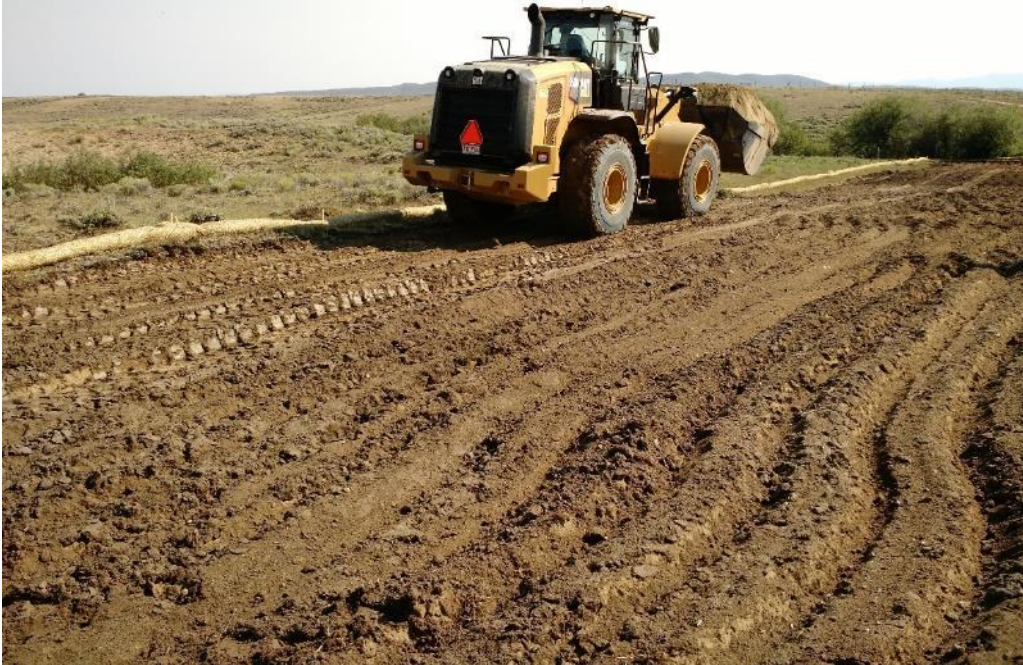
Photo 5. View of the spillway proof-rolling from approximate ES Stations 4+50 to 6+50. Aug. 3, 2017.

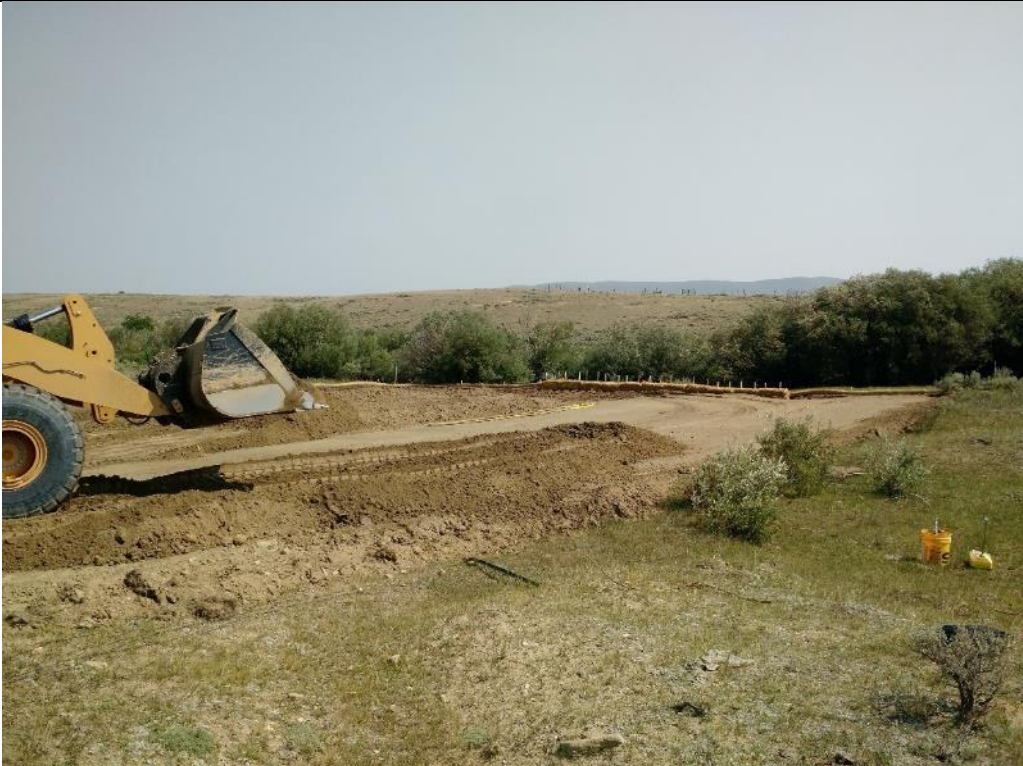
Photo 6. Placement of Embankment Fill for the first lift of the right spillway berm between ES Stations 5+50 and 6+50. Aug. 4, 2017.

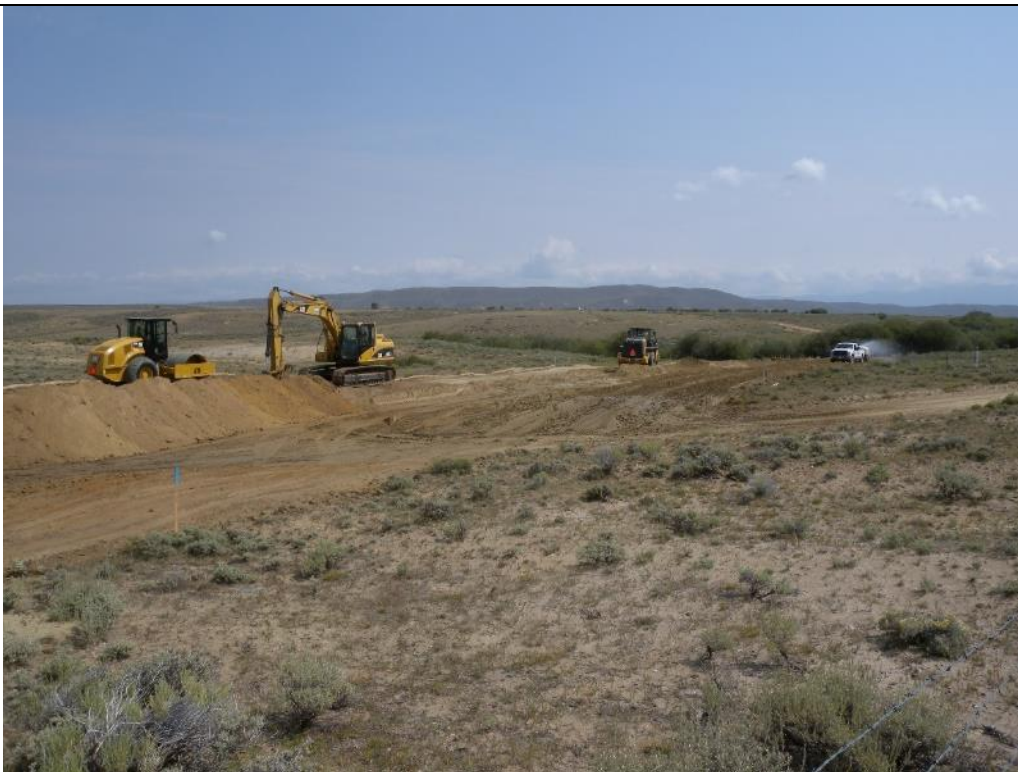
Photo 7. View looking downstream from ES Sta. 2+00 of soil placement and moisture conditioning on the left and right spillway berms. Aug. 7, 2017.

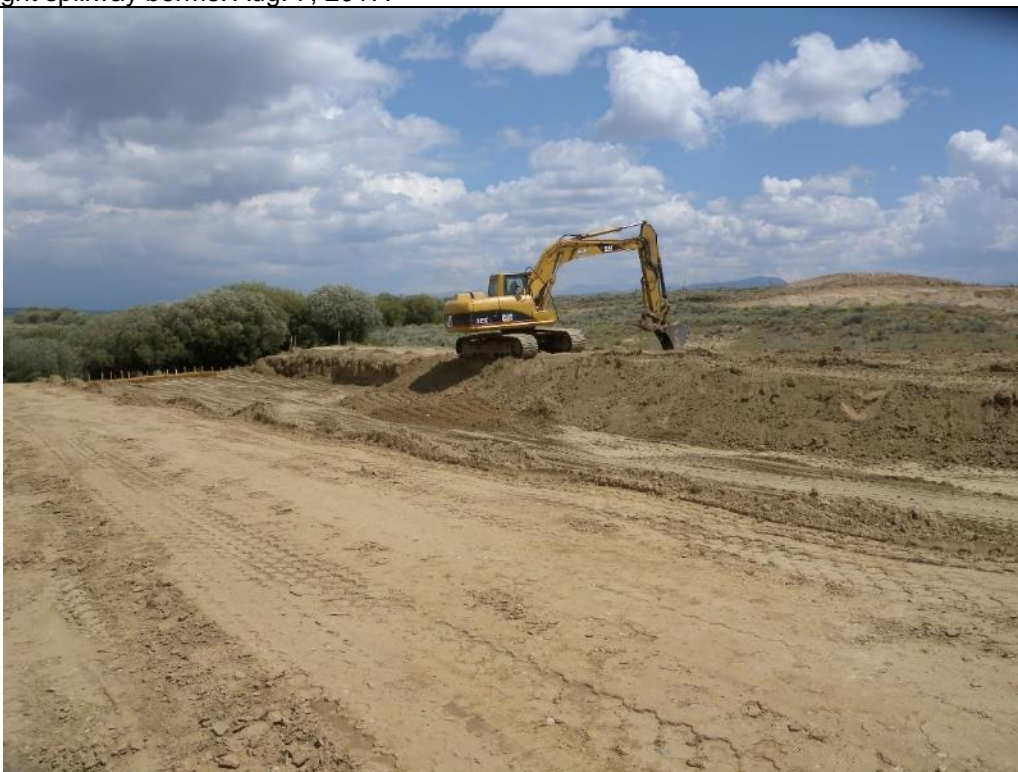
Photo 8. View from ES Sta. 5+00 looking right at the right spillway berm being shaped using the excavator. Aug. 9, 2017.

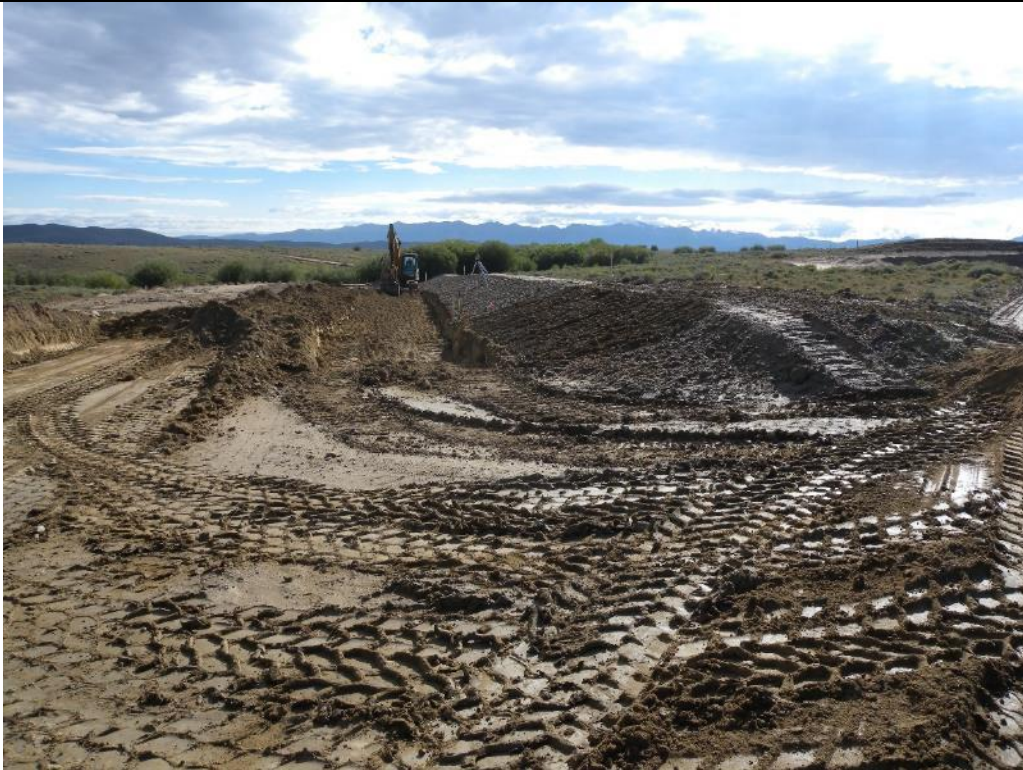
Photo 9. View from ES Sta. 3+00 looking downstream along the right spillway berm toe of RME shaping the right spillway berm. Aug. 10, 2017.

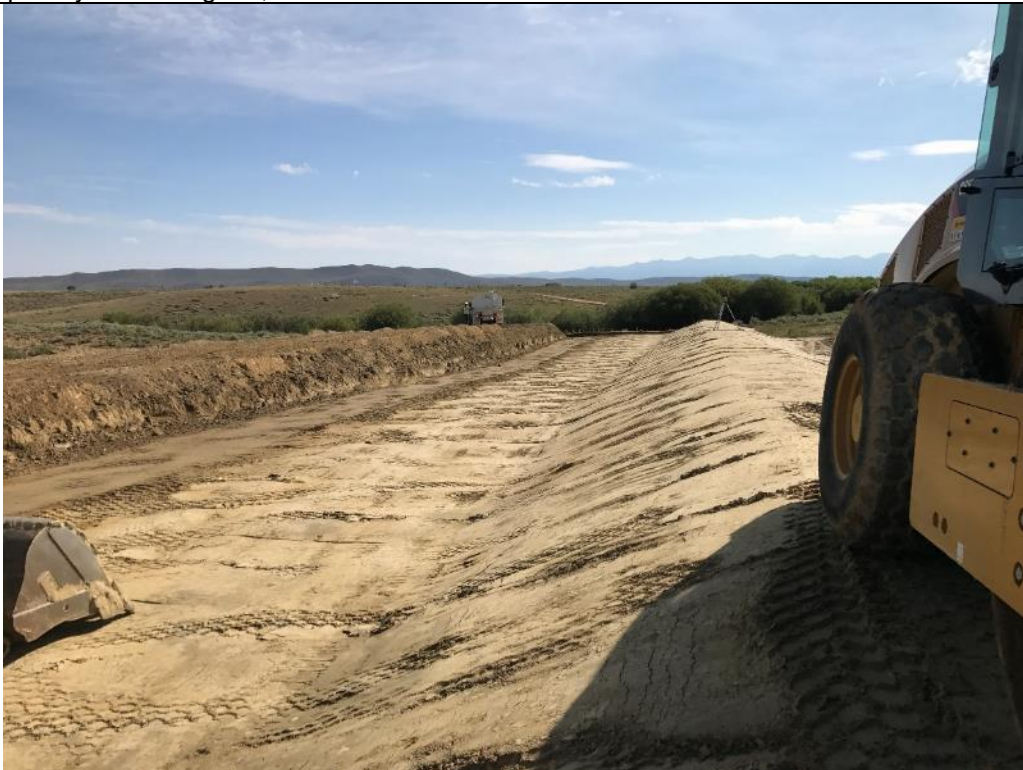
Photo 10. View from ES Sta. 3+00 looking downstream along the completed right spillway berm. Aug 11, 2017.

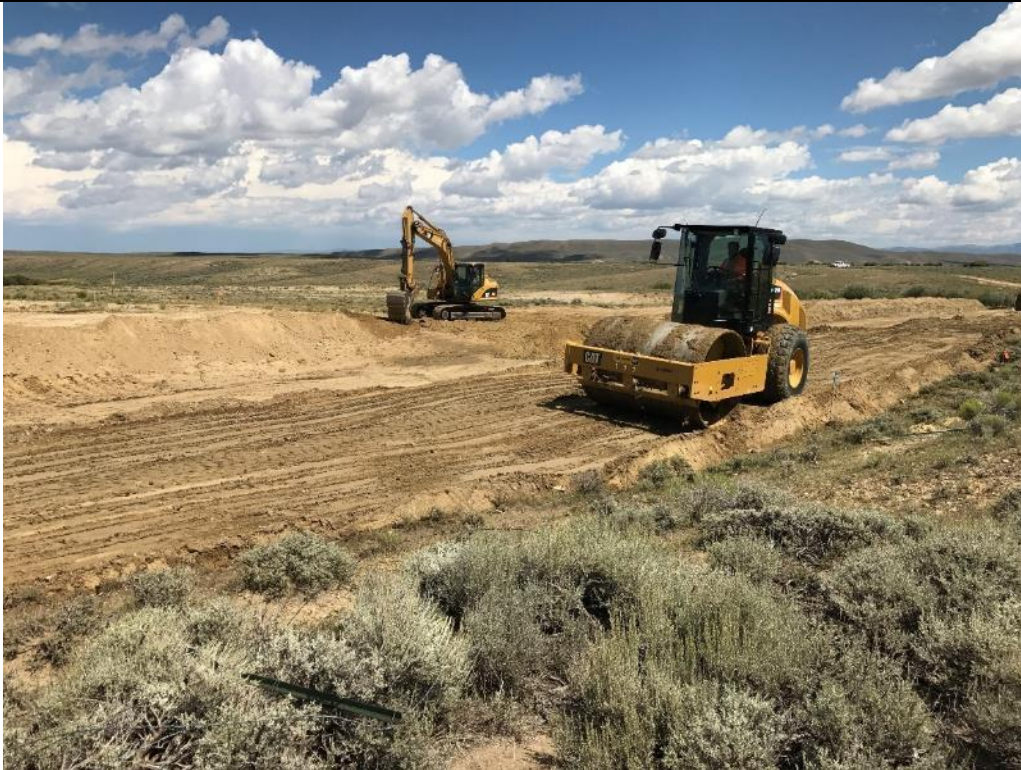
Photo 11. View of compaction of the right spillway berm from ES Sta. 1+00 to 3+00. Aug. 11, 2017.

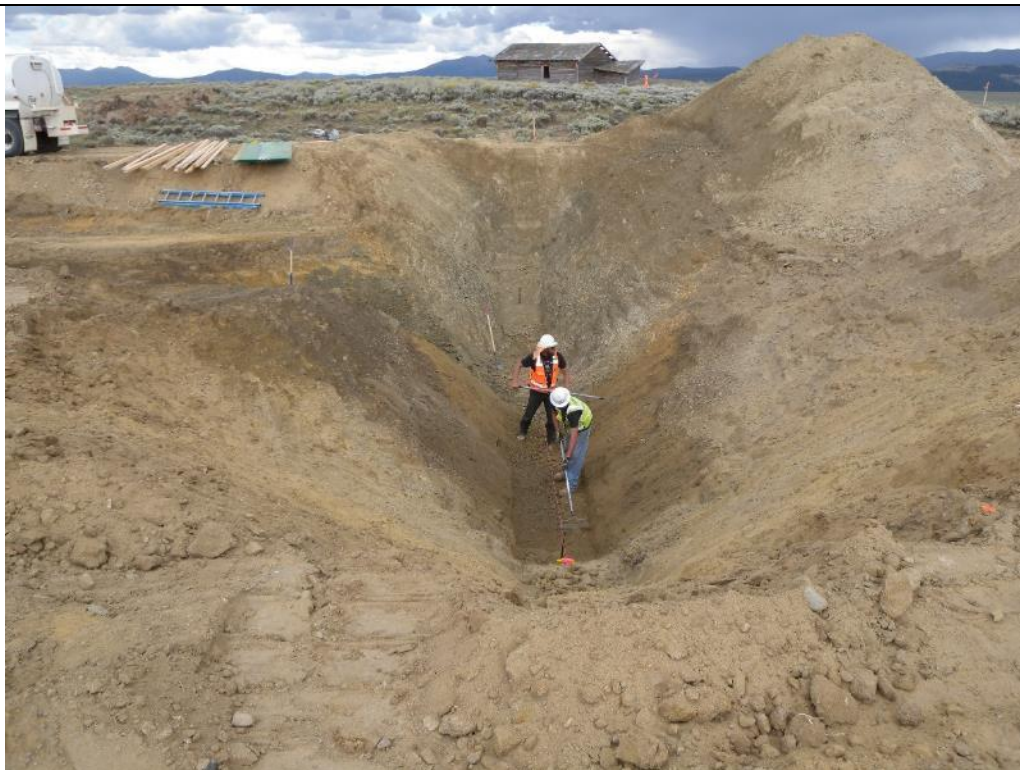
Photo 13. View looking right at the foundation preparation of the upstream cutoff spillway at ES Sta. 2+20. Aug. 14, 2017.

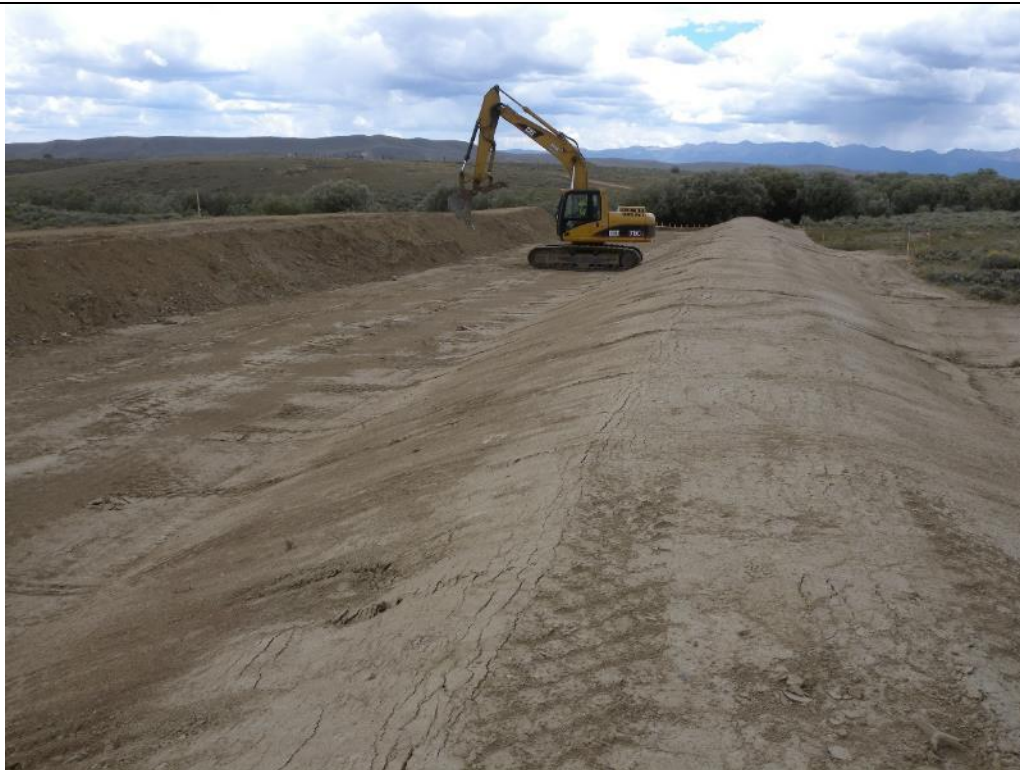
Photo 14. View looking downstream from ES Sta. 4+00 at the shaped and compacted right spillway berm and spillway discharge channel prior to excavation of the downstream cutoff wall at ES Sta. 5+20.

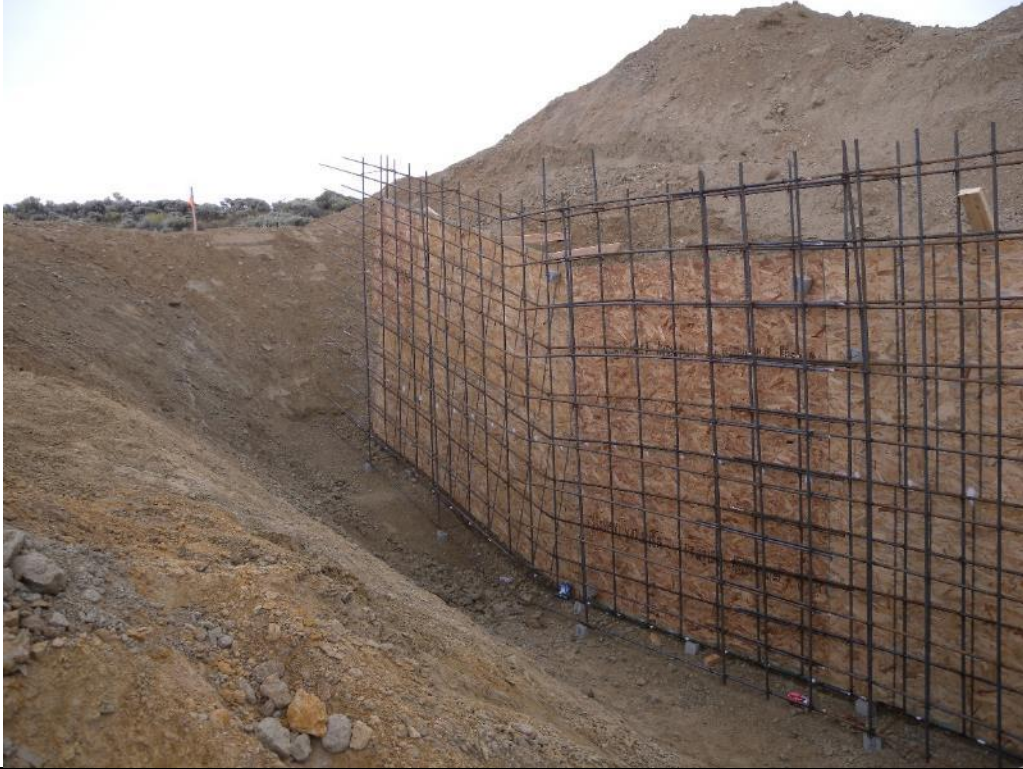
Photo 17. View of the formwork and rebar installation for the upstream spillway cutoff wall at ES Sta. 2+20. Aug. 16, 2017.

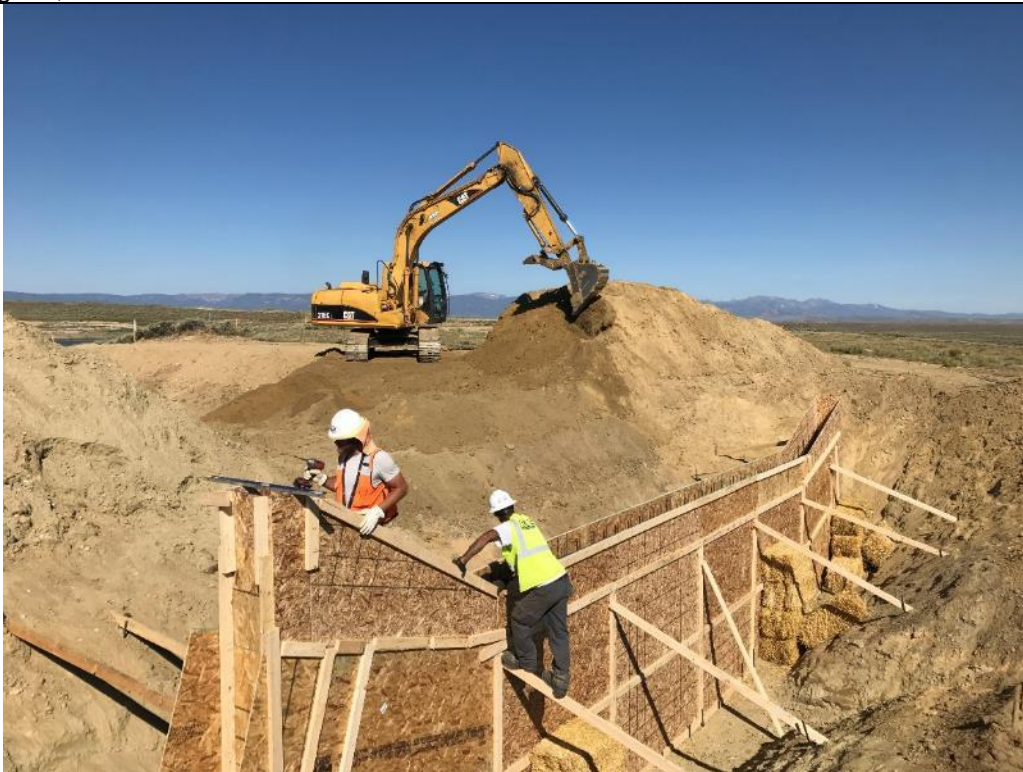
Photo 18. View of the completed formwork for the upstream spillway cutoff wall at ES Sta. 2+20. Aug. 18, 2017.

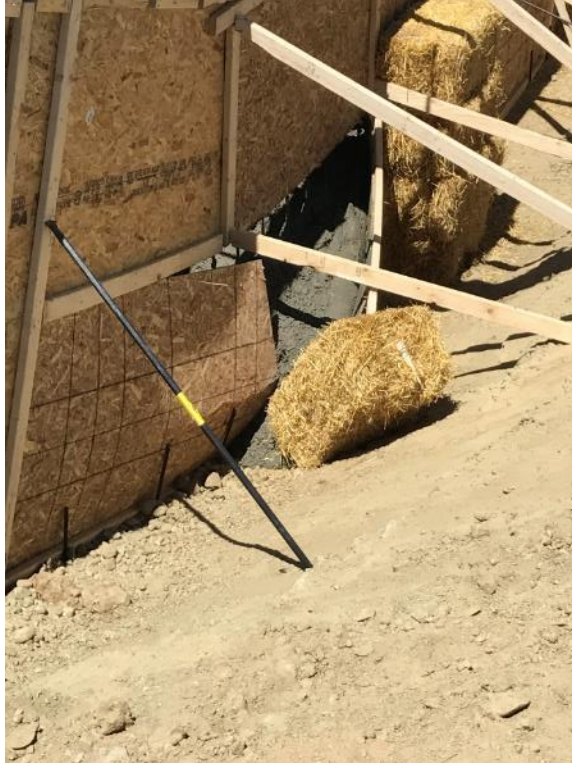
Photo 19. View looking at the form work blowout on the downstream side of the upstream spillway cutoff wall at ES Sta. 2+20. Aug. 18, 2017.

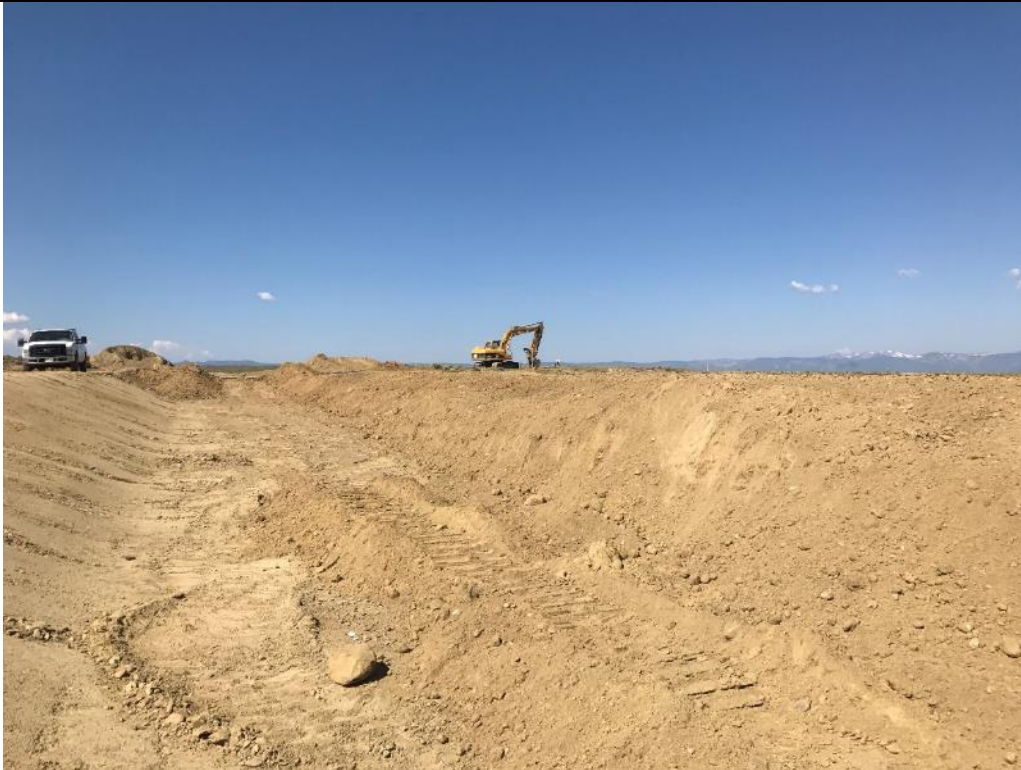
Photo 21. View looking upstream of the left spillway berm shaping and grading from ES Station 5+50. Aug. 22, 2017.

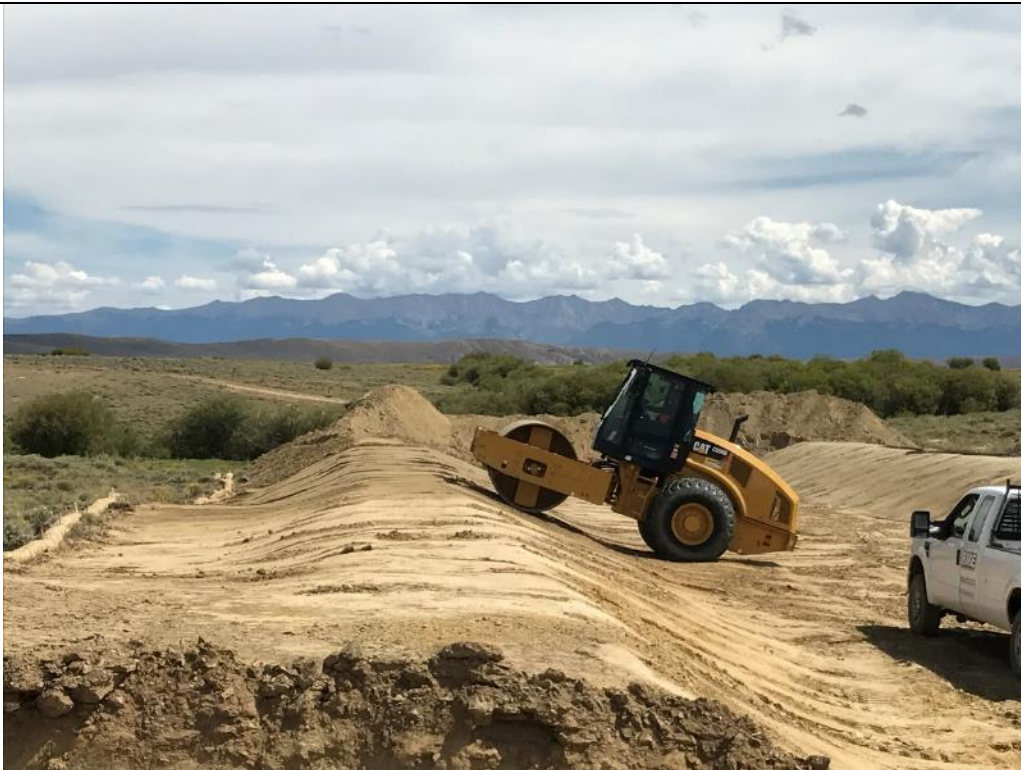
Photo 22. View looking downstream from ES Sta. 2+50 of the smooth drum rolling of the left downstream spillway berm. Aug. 24, 2017.

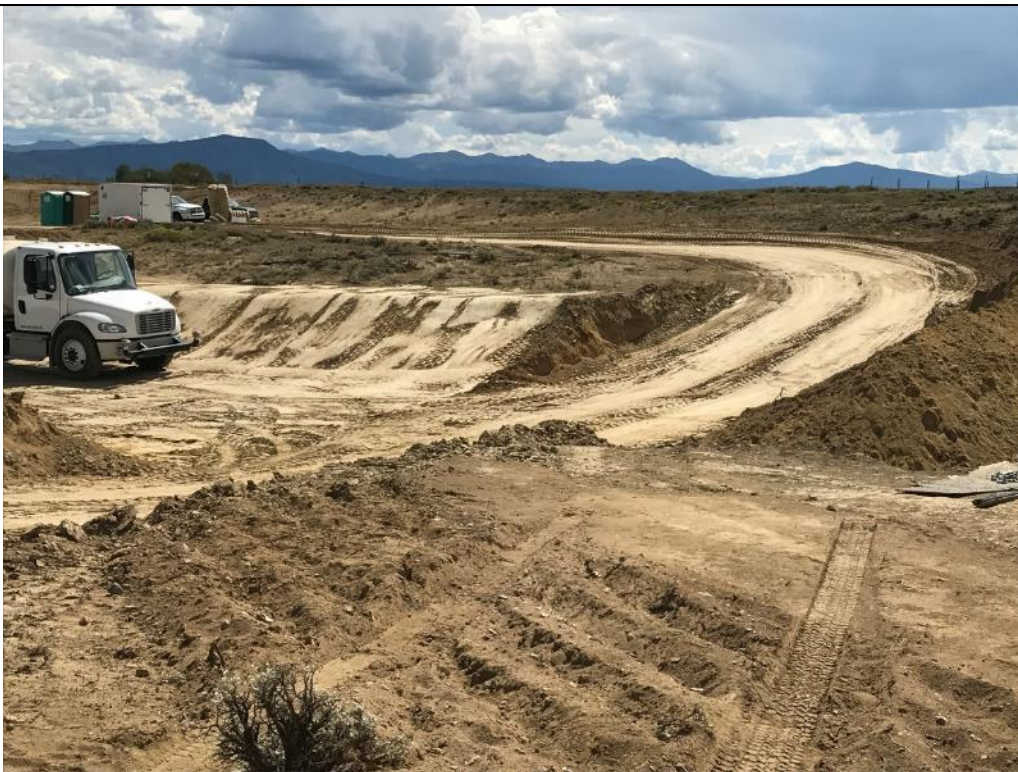
Photo 23. View looking from the left side of the spillway at the right spillway berm and new access road alignment through the spillway between the upstream and downstream cutoff walls. Aug. 24, 2017.

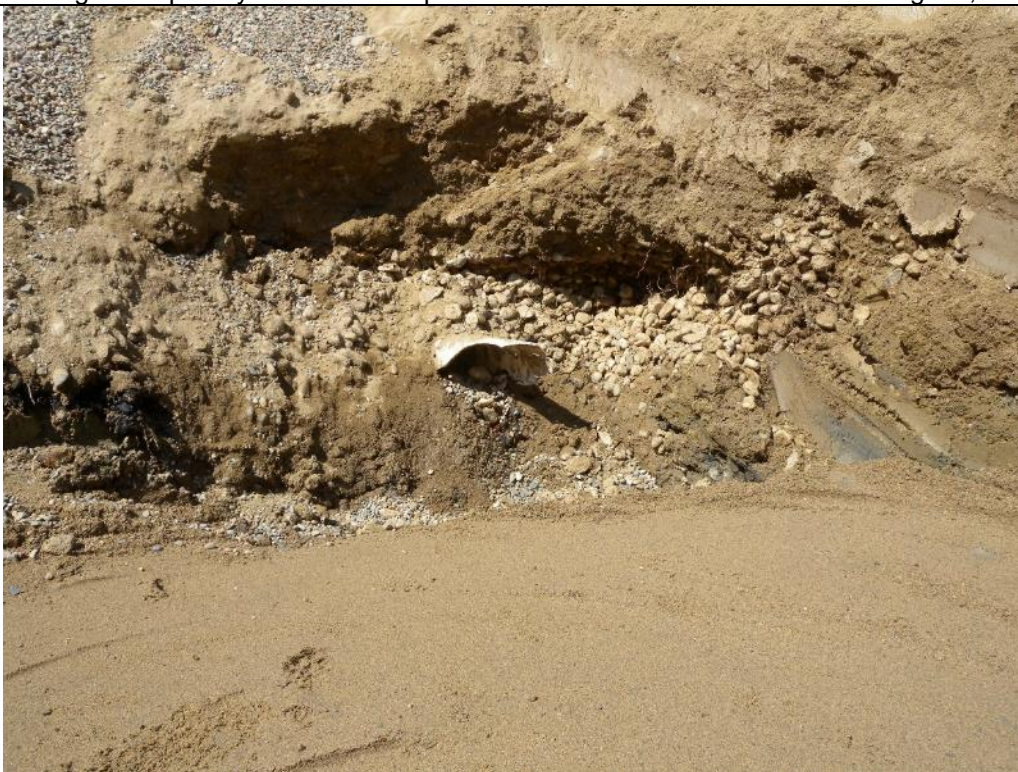
Photo 24. View looking left from approximate MTD Sta. 2+50 at the previous toe drain encountered during excavation of chimney drain. Aug. 28, 2017.

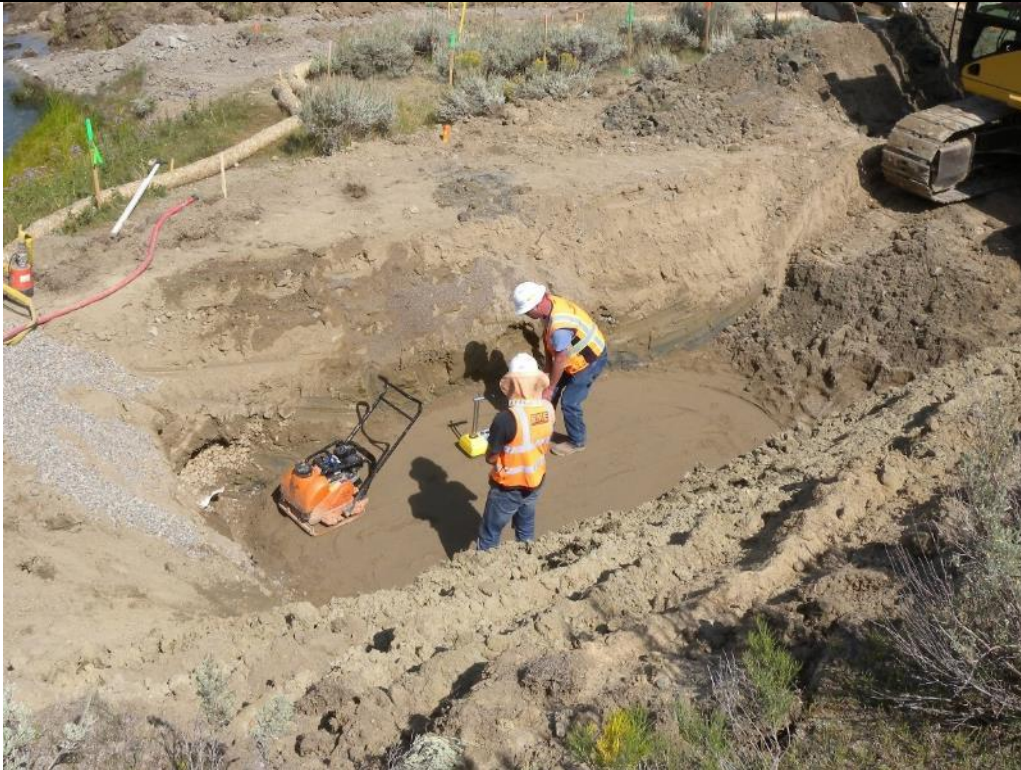
Photo 25. Representative view of the completed excavation and placement and compaction of Type A Filter Sand in the chimney drain at MTD Sta. 2+50 to 2+70. Aug. 28, 2017.

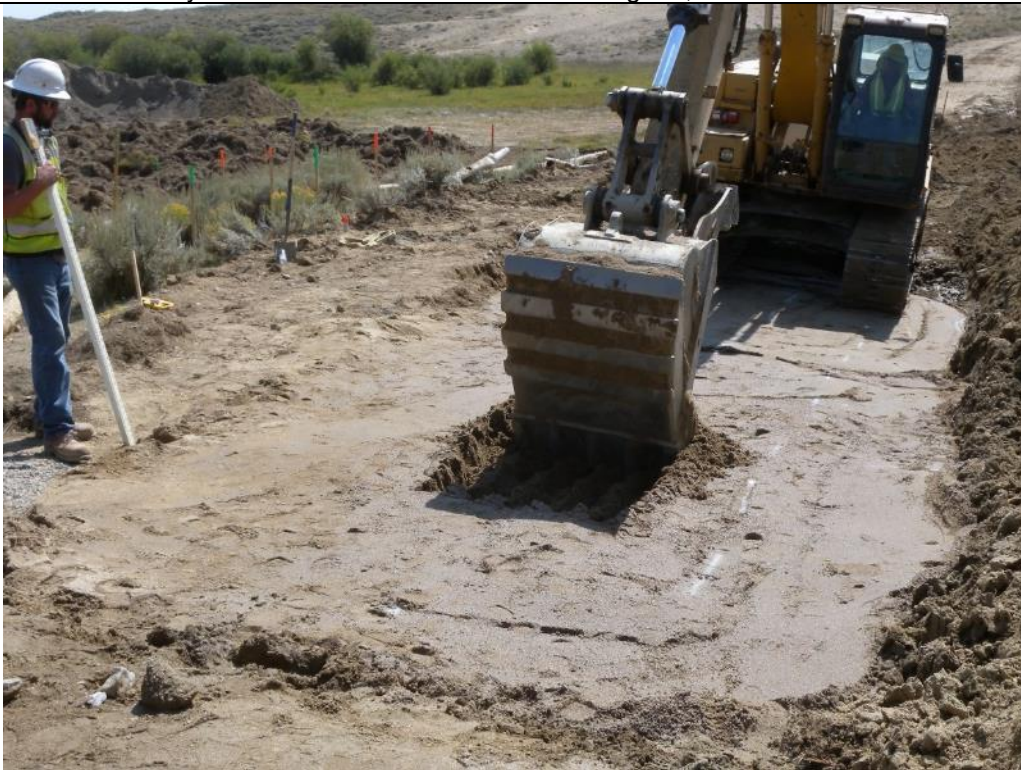
Photo 26. View looking right from MTD Sta. 2+45 at the compacted Type A Filter Sand and the start of the excavation for the Type B Gravel Drain for the chimney drain. Aug. 29, 2017.

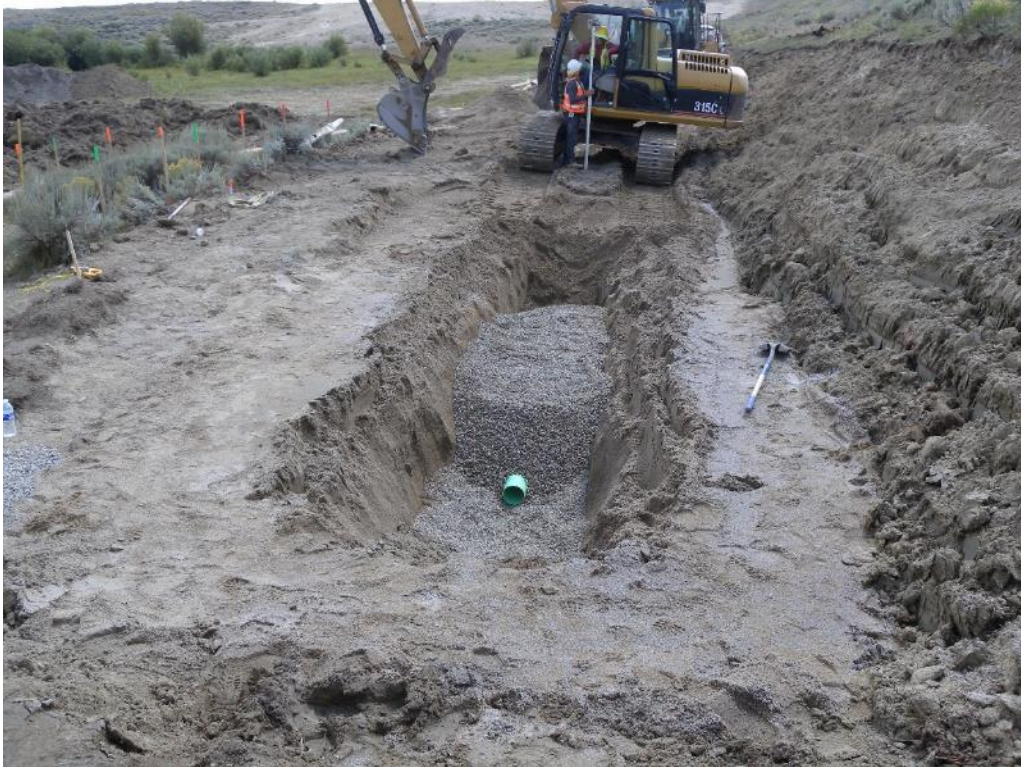
Photo 27. View looking right from MTD Sta. 2+50 and the first section of chimney drain and seepage collection pipe placed from MTD Sta. 2+55 to 2+70. Aug. 29, 2017.

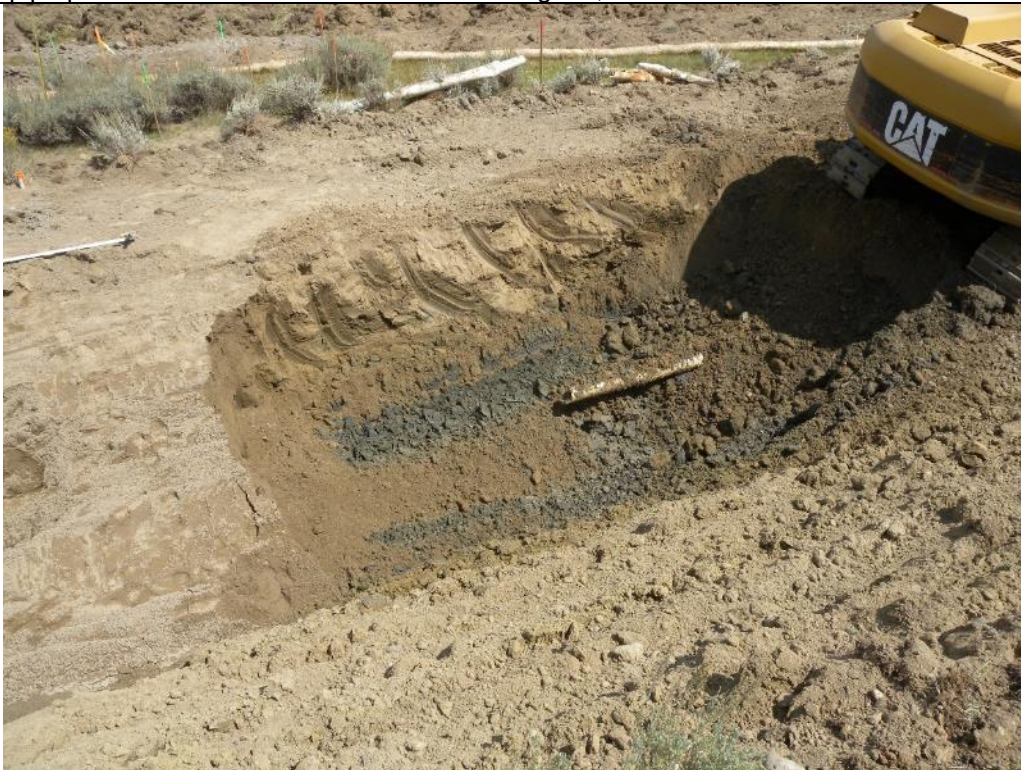
Photo 28. View looking downstream at the exposed, previous seepage collection system at approximate MTD Sta. 2+90. This pipe was removed during excavation of the chimney drain. Aug. 29, 2017.

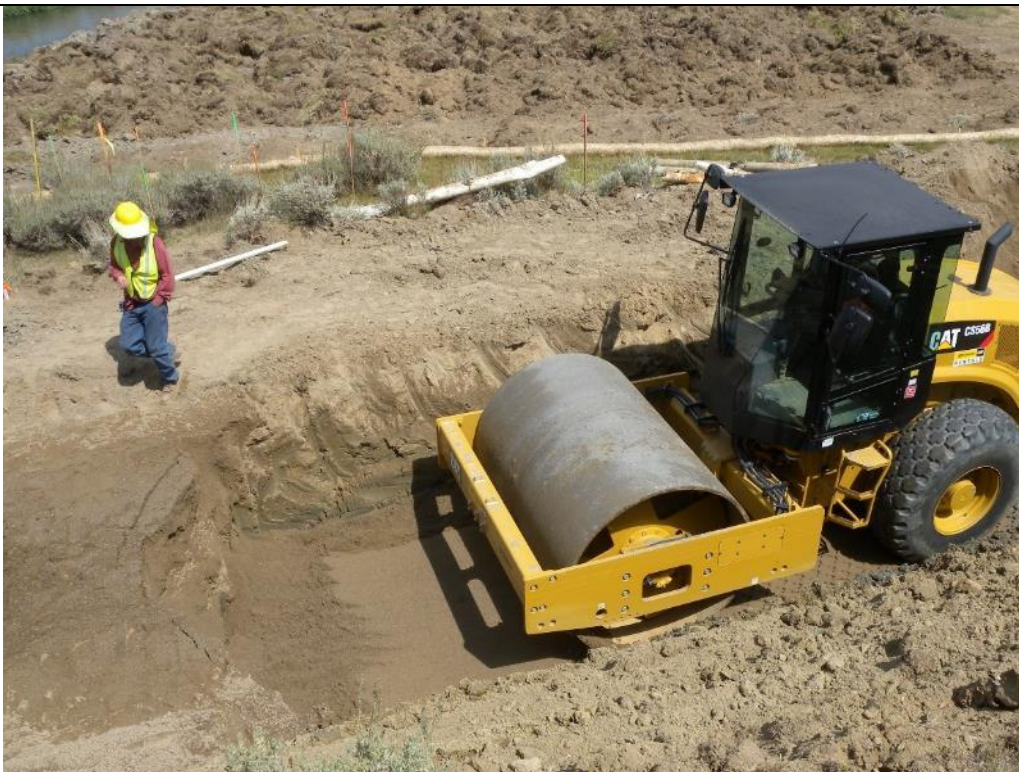
Photo 29. View looking downstream at the smooth drum roller compacting the Type A Filter Sand. Aug. 29, 2017.

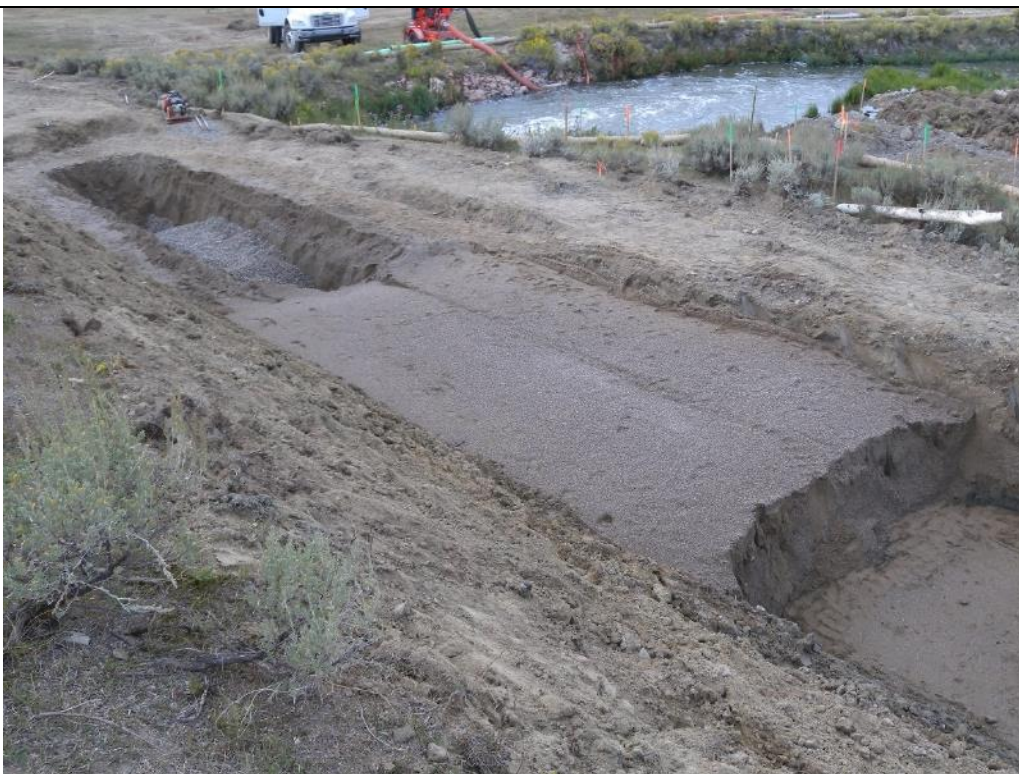
Photo 30. Representative view of the chimney drain installation work between MTD Sta. 2+55 and 3+20. Aug 29, 2017.

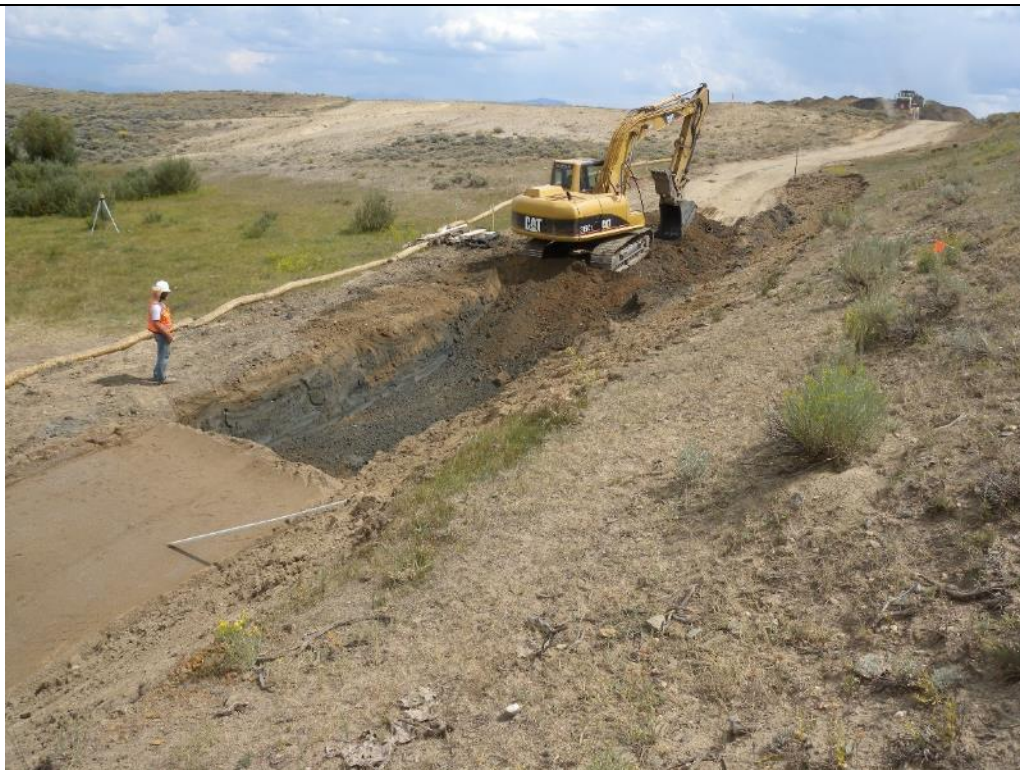
Photo 31. View looking right from MTD Sta. 3+50 at continued excavation into the Main Dam toe for the seepage collection system. The excavation is from MTD Sta. 4+00 to 4+30. Aug. 31, 2017.

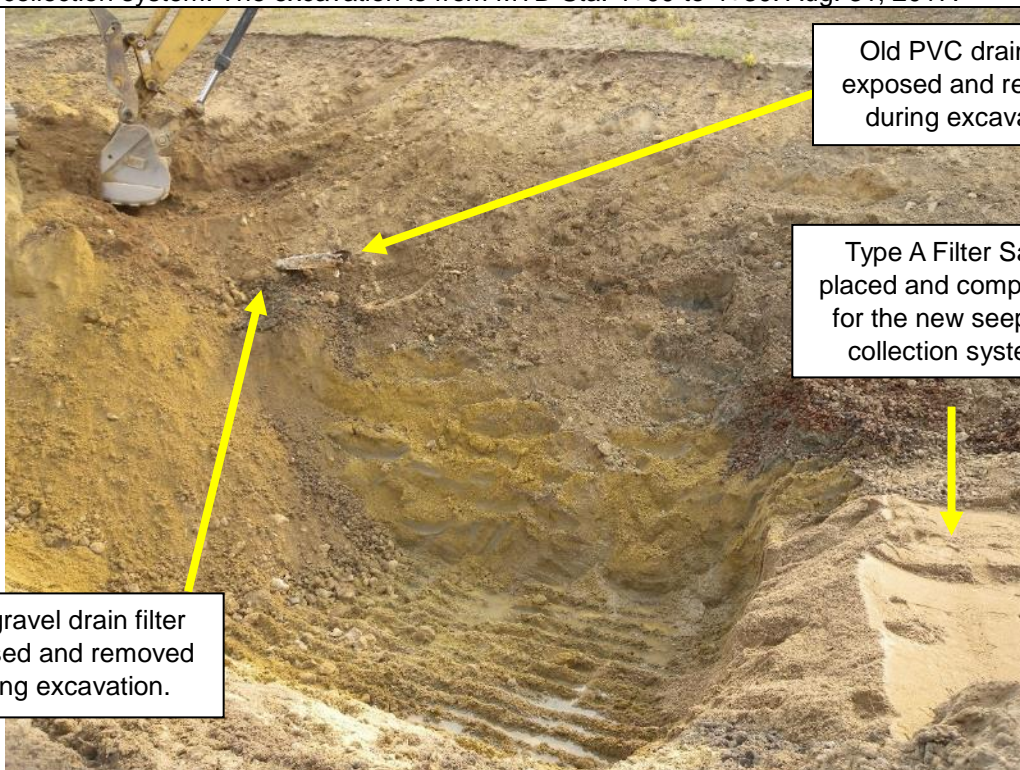
Photo 32. View looking upstream at the toe of the Main Dam during excavation and removal of the old drain line. Sept. 5, 2017.
