# **FINAL CONSTRUCTION REPORT** for **MACFARLANE DAM** **REHABILITATION PROJECT**

**CONSTRUCTION FILE NO. C-1031B**  
**COLORADO DAM ID: 470202**  
**NID: CO-00997**  
**WATER DIVISION 6 – WATER DISTRICT 47**  
**JACKSON COUNTY, COLORADO**

## Executive Summary

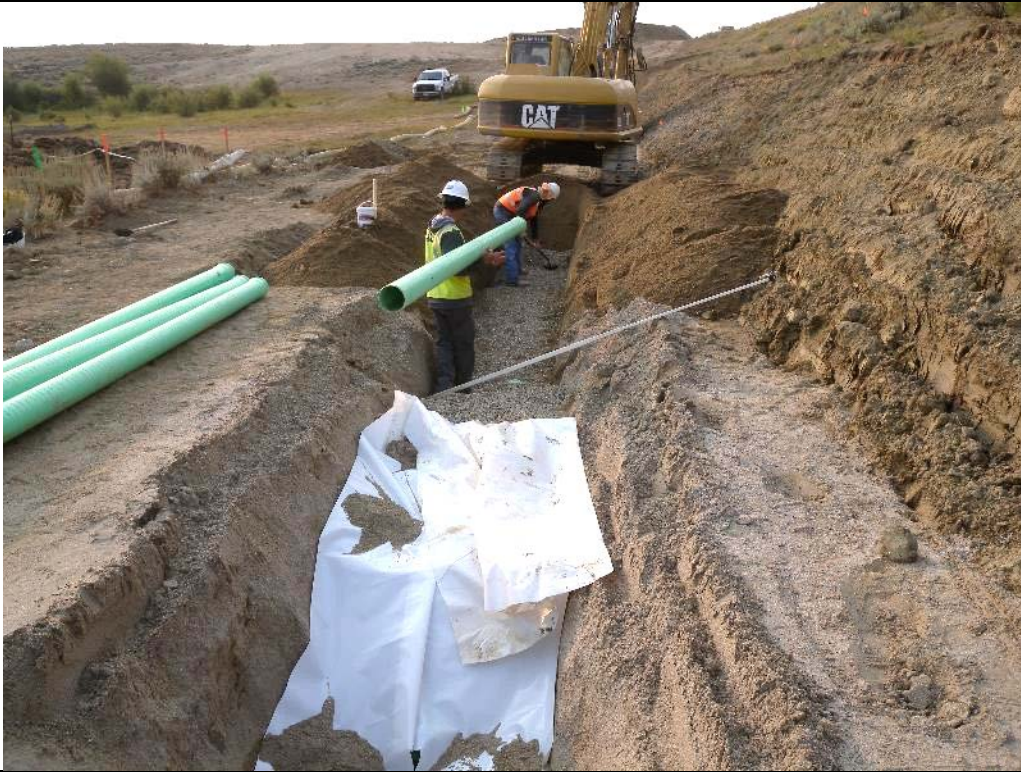
Photo 33. View looking right from MTD Sta. 2+50 at the start of placement of the slotted drain pipe. The excavator was used to dig into the compacted layer of Type A Filter Sand, Type B Gravel Drain was placed at the bottom of the excavation to the invert of the slotted drain pipe and the drain pipe was then added and buried with 1-foot of Type B Gravel Drain. Sept. 7, 2017.

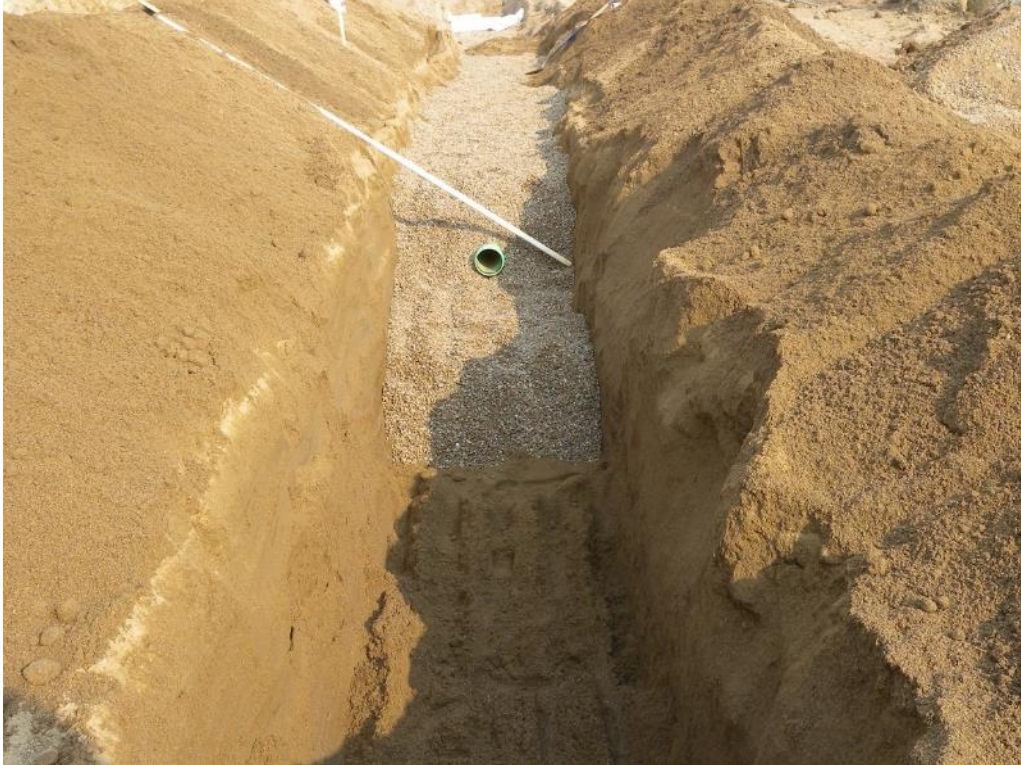
Photo 34. Representative view of the installation of the Type B Gravel Drain surrounding the slotted drain pipe. Sept. 7, 2017.

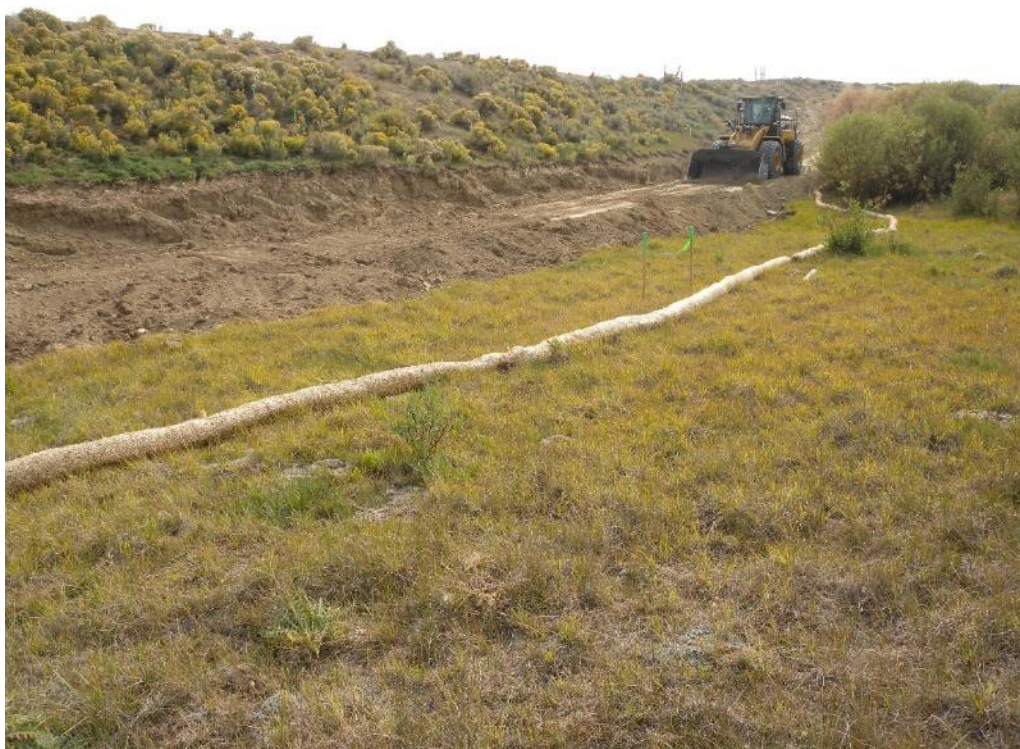
Photo 35. View looking upstream and left from approximate Sta. 4+50 at the foundation preparation work for the North Embankment Stability Berm, which included hauling and placing Embankment Fill along the North Embankment downstream toe. Sept 7, 2017.

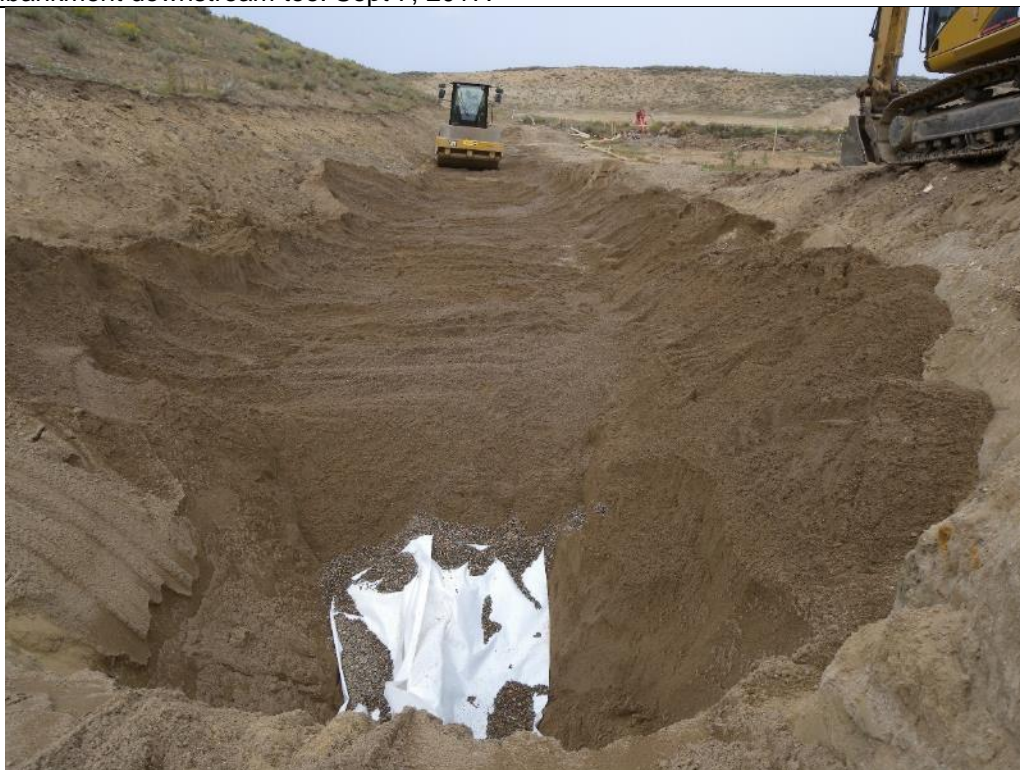
Photo 36. View looking left from approximate MTD Sta. 5+15 at the plastic cover over the location of where the Main Dam, Right Toe Drain clean-out will be located, and the compaction of a lift of Type A Filter Sand. Sept. 8, 2017.

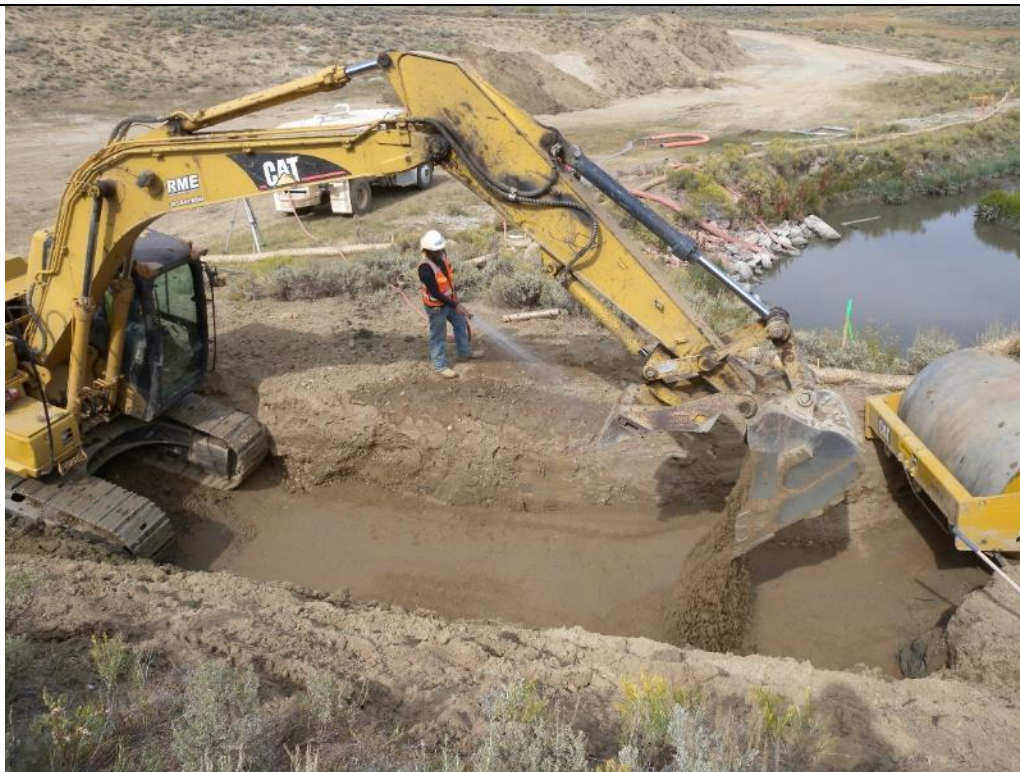
Photo 37. Looking downstream from approximate MTD Sta. 2+40 at the start of the seepage collection system for the left side of the Main Dam. Representative work included excavation into the toe of the Main Dam, removal of the old toe drain pipe, and placement, moisture conditioning and compaction of Type A Filter Sand shown above. Sept. 8, 2017.

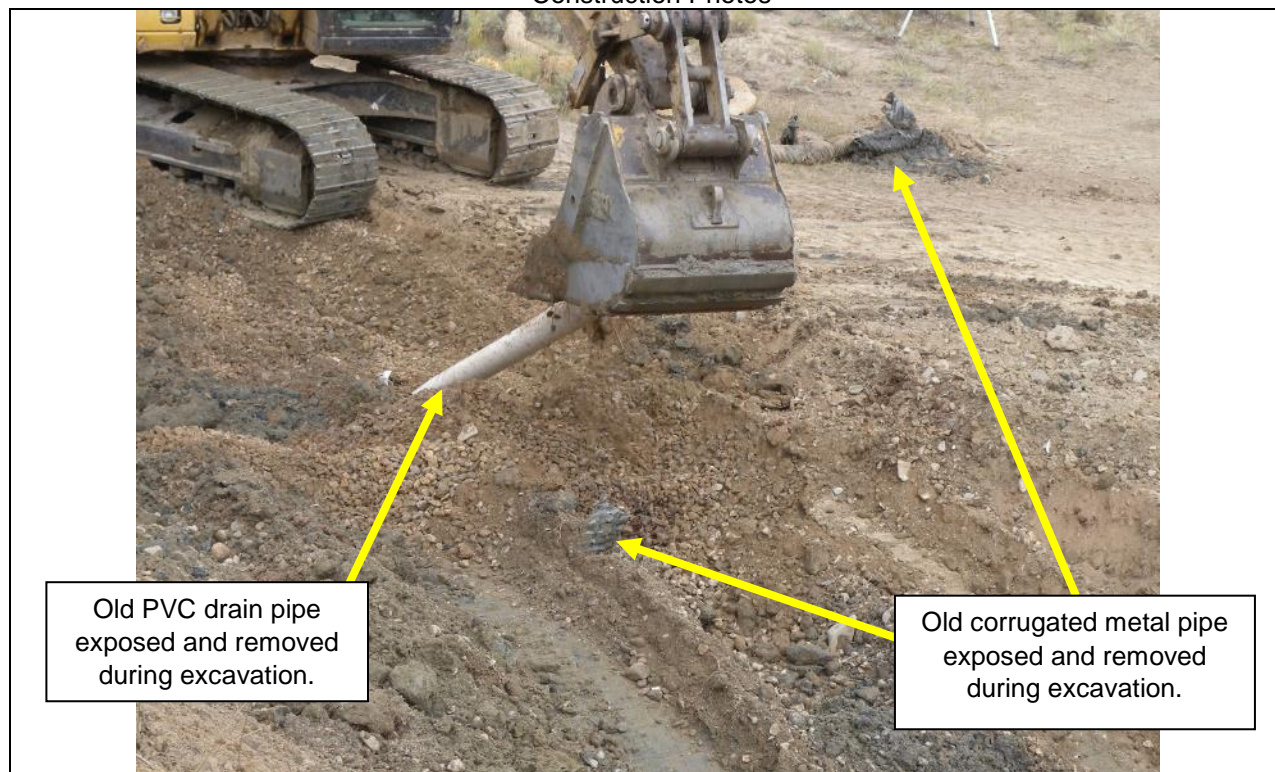
Photo 39. View looking left and downstream at the excavation of the left side of the Main Dam toe near MTD Sta. 1+25 at the installation of the seepage collection system. Note that two types of previously installed slotted drain pipe were removed, a white PVC and a corrugated metal pipe. Sept. 11, 2017.

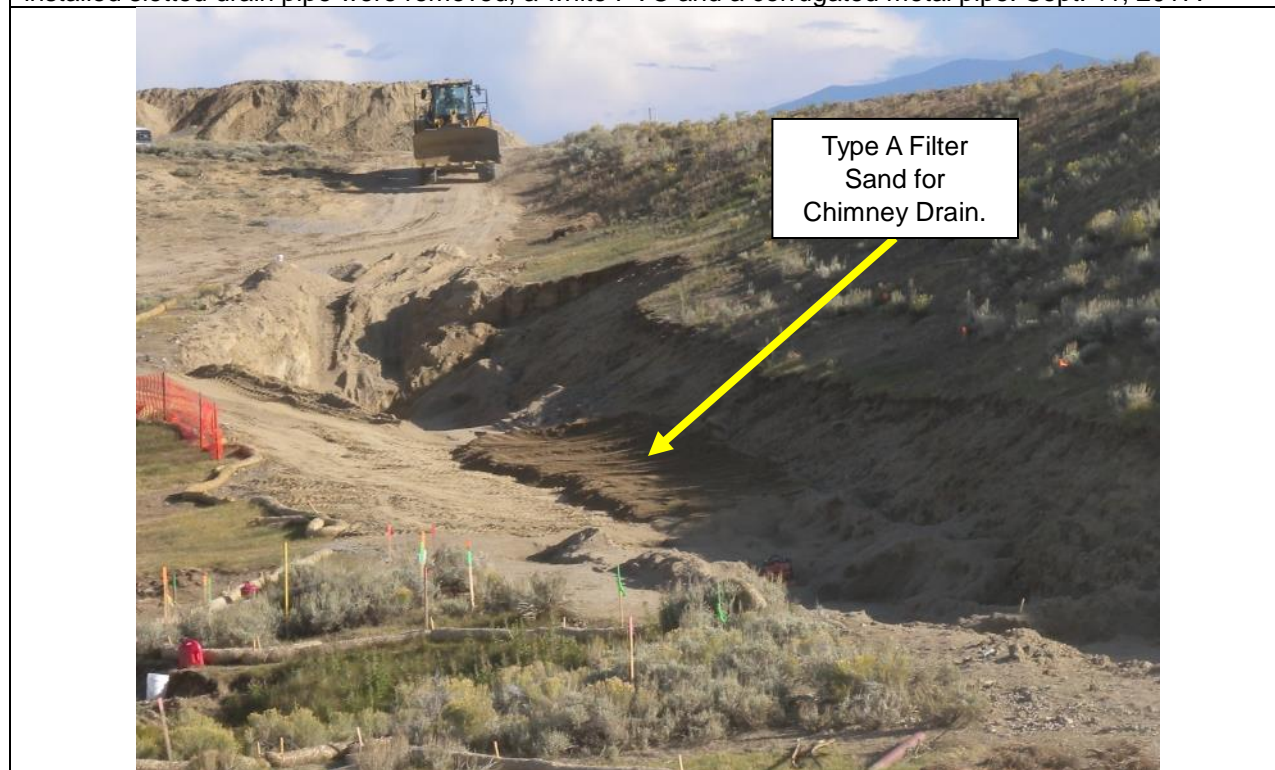
Photo 40. View looking right at the first lift of Type A Filter Sand that represents the start of the chimney drain from MTD Sta. 3+00 to 4+50. Sept. 12, 2017.

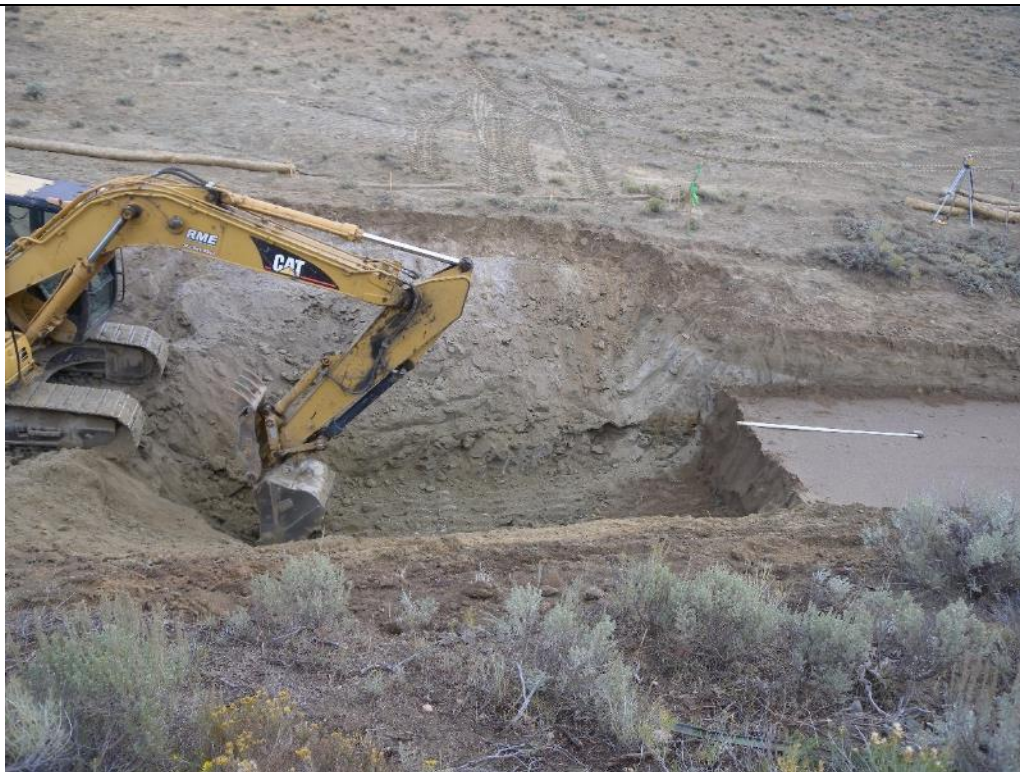
Photo 41. View looking downstream at the excavation from MTD Sta. 0+35 to 0+50. The excavator shown above was trying to cut into a rapidly rising layer of sandstone/claystone bedrock that appeared near MTD Sta. 0+35. It was decided after discussions with the SEO, Kumar and Wheeler to end the toe drain at MTD Sta. 0+50 instead of 0+00 and place the toe drain cleanout at MTD Sta. 0+45. Sep. 13, 2017.

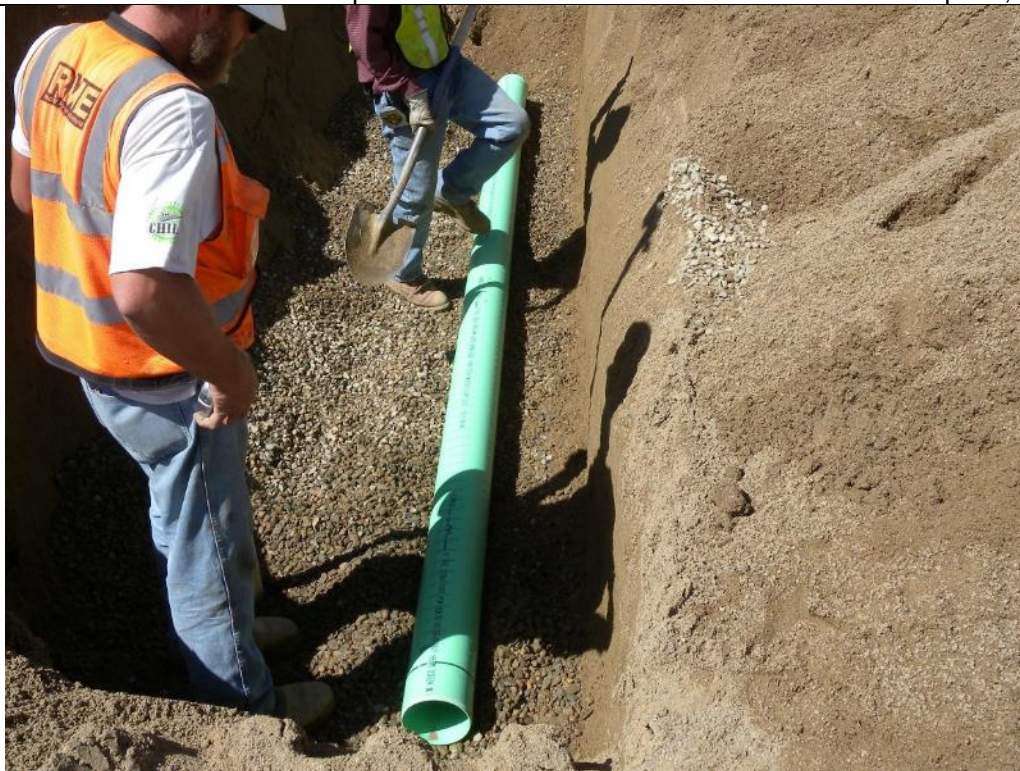
Photo 42. View looking left from MTD Sta. 2+45 at the placement of the first section of slotted drain pipe for the left side of the Main Dam seepage collection system from MTD Sta. 2+40 to 2+26. Sept. 13, 2017

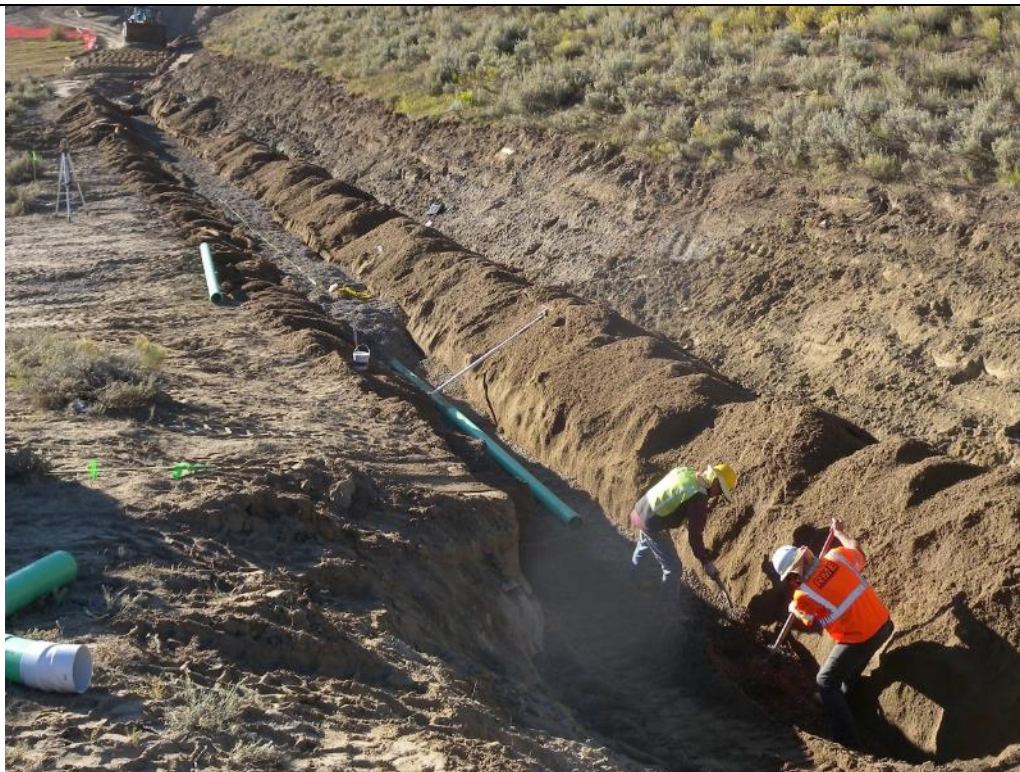
Photo 43. View looking right from approximate MTD Sta. 0+50 at a representative view of the Main Dam, right Chimney Drain installation and placement of the Embankment Fill Lift from MTD Sta. 3+00 to 4+00. Sept. 14, 2017.

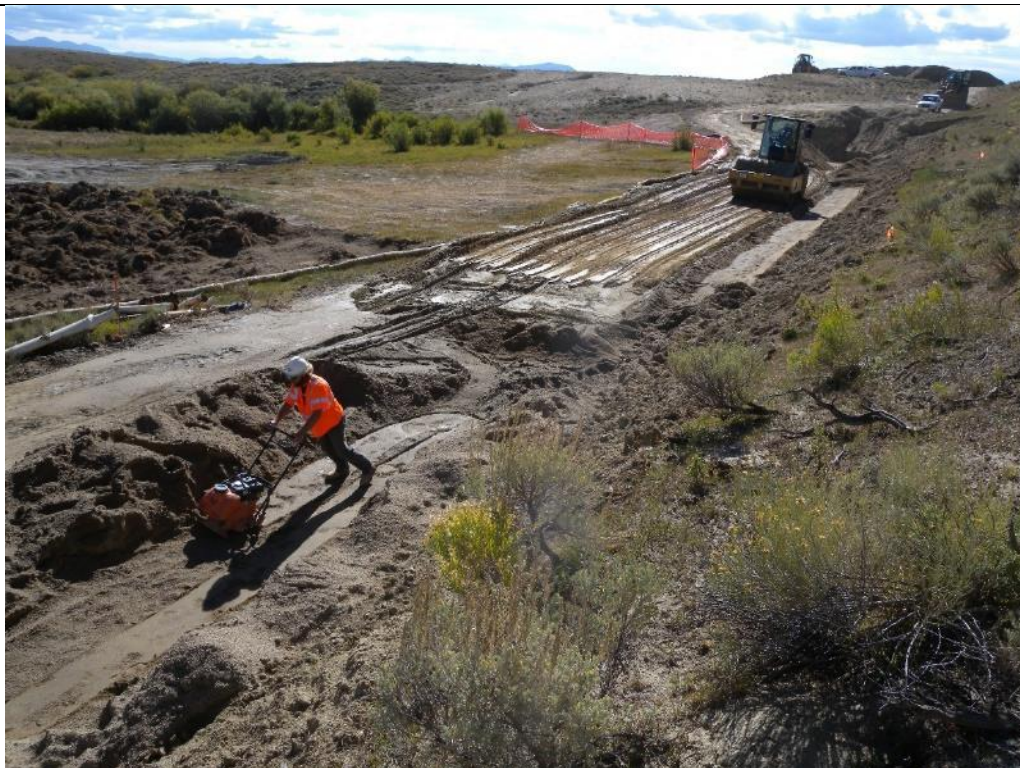
Photo 44. View looking right along the toe of the Main Dam at the compaction of the first layer of Type A Filter Sand covering the Type B Gravel Drain on the left side of the dam, and the chimney drain and start of stability berm on the right side of the Main Dam. Sept. 14, 2017.

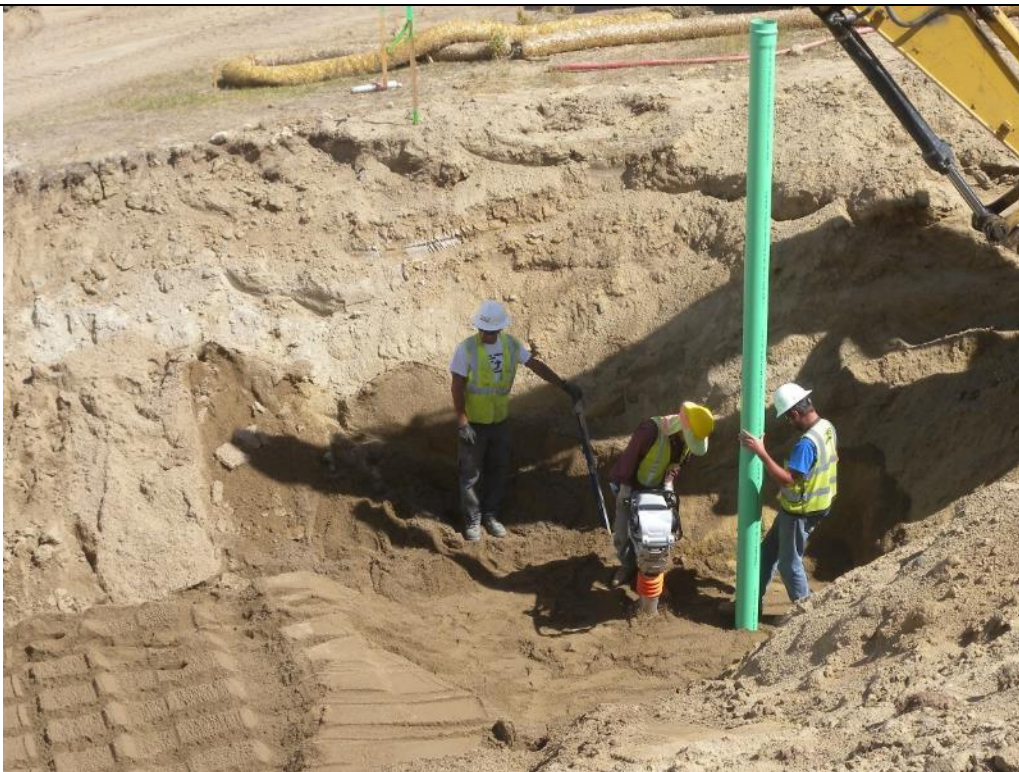
Photo 45. View from MTD Sta. 5+05 looking downstream at toe drain cleanout and special compaction of the Type A Filter Sand around the cleanout riser pipe. Sept. 14, 2017.

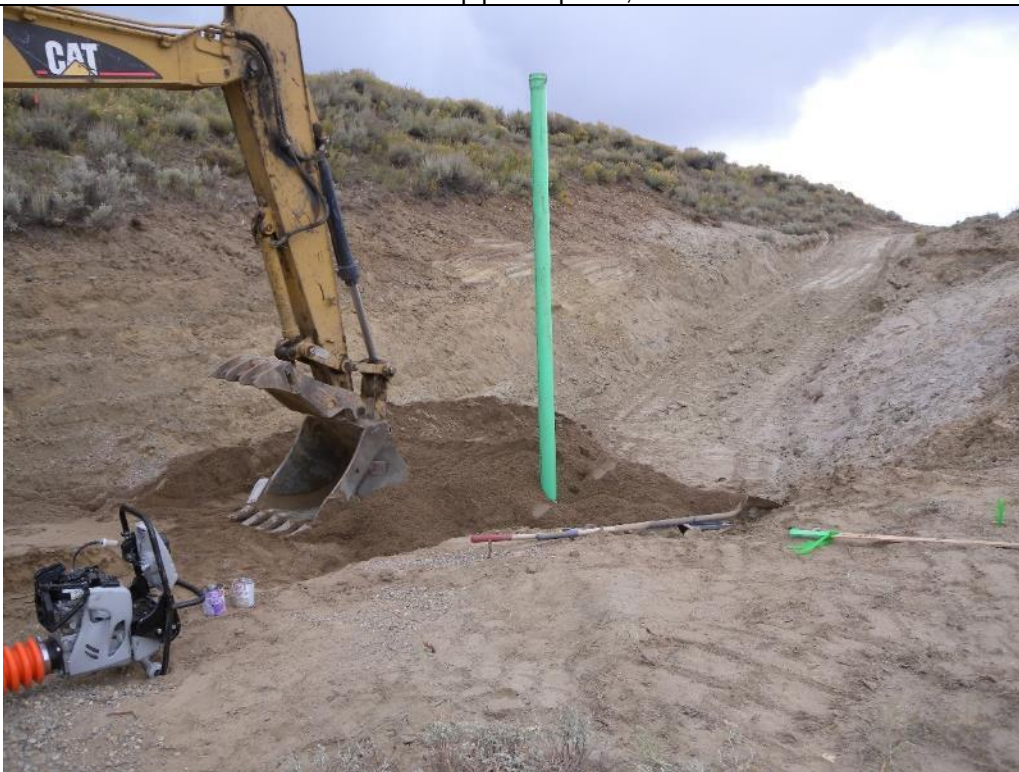
Photo 46. View from MTD Sta. 0+60 looking upstream at toe drain cleanout and placement of the Type A Filter Sand around the cleanout riser pipe. Sept. 14, 2017.

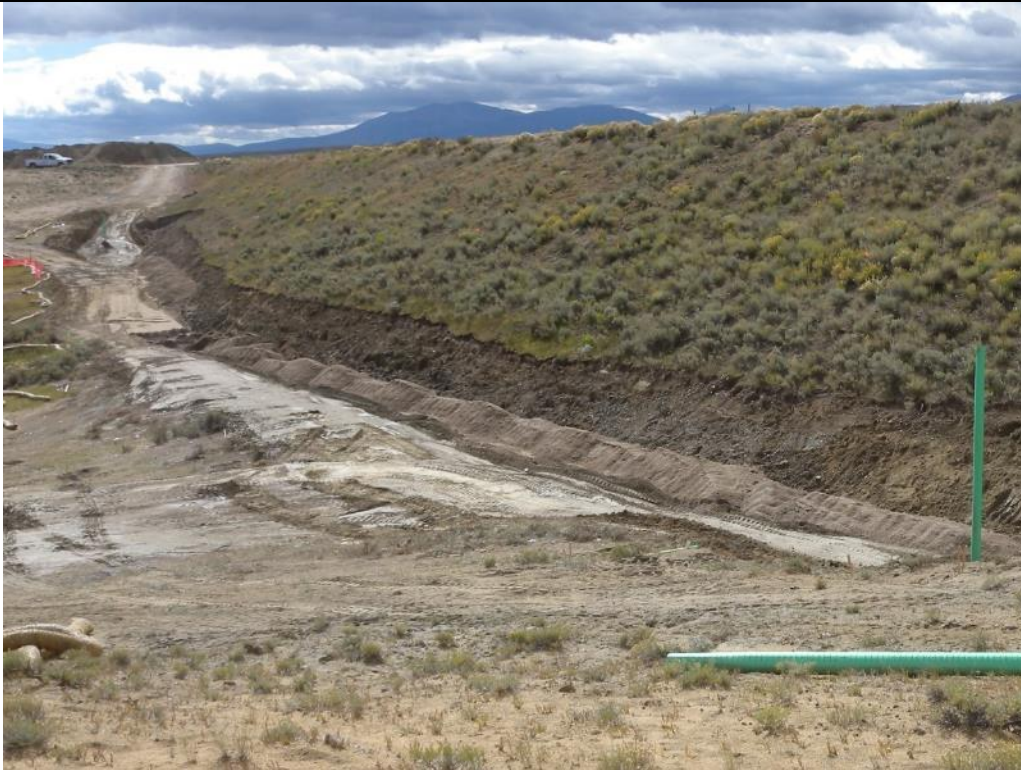
Photo 47. View looking right from the left abutment of the Main Dam at the continuation of the chimney drain and stability berm on the left and right side of the Main Dam outlet works. Note that the toe drain pipe sections at the location of the outlet works were left open. Sept. 15, 2017.

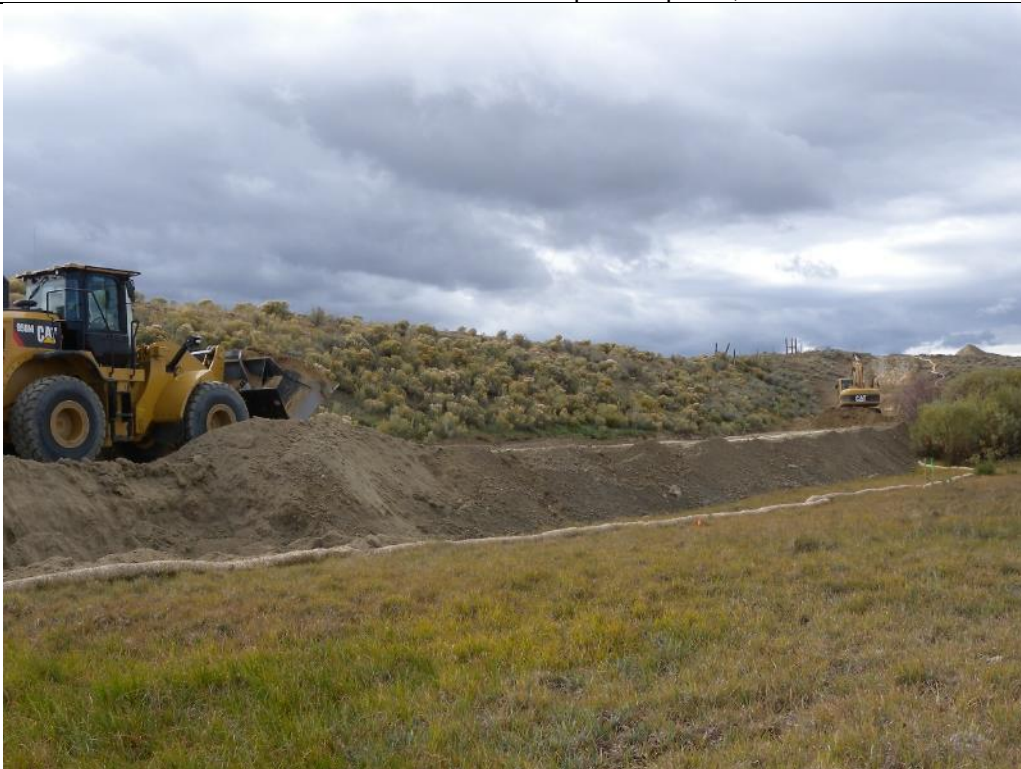
Photo 48. View looking left and upstream at the base of the North Embankment Stability Berm which was first constructed as shown above so the seepage collection system could then be constructed within the base of the berm. Shown above is the start of the excavation at NTD Sta. 0+00 and hauling of Type A Filter Sand for the placement of the seepage collection system Sept. 15, 2017.

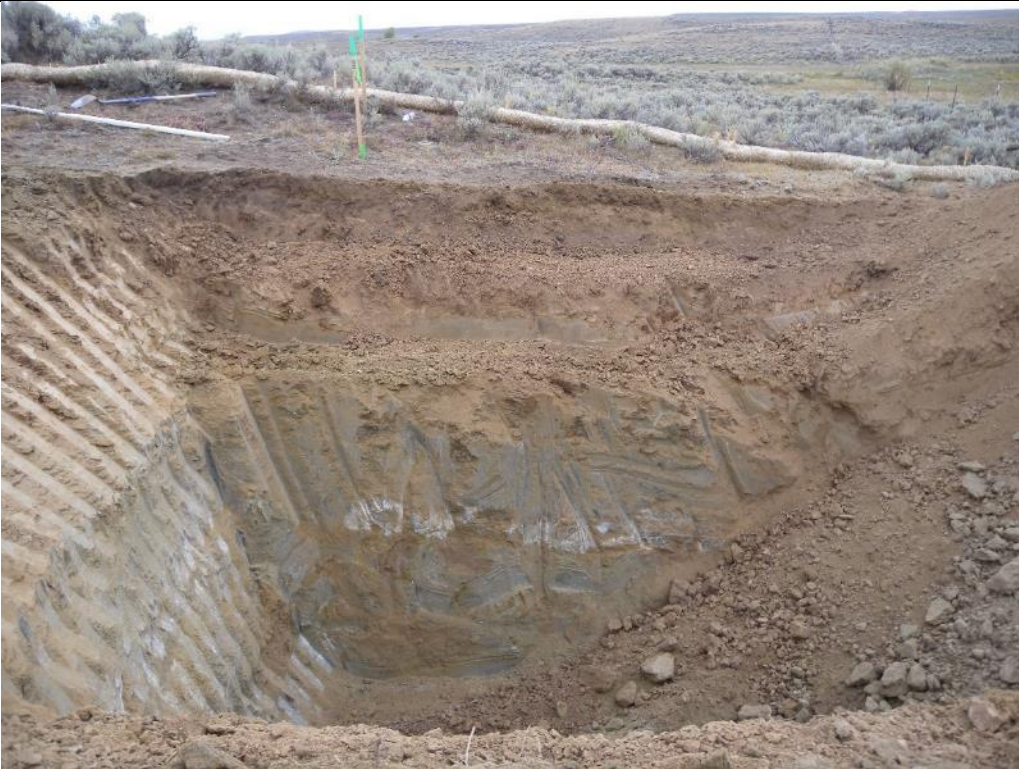
Photo 49. View looking downstream from NTD Sta. 0+00 at the excavation down to the base of the seepage collection system at the left toe drain cleanout. Sept. 15, 2017.

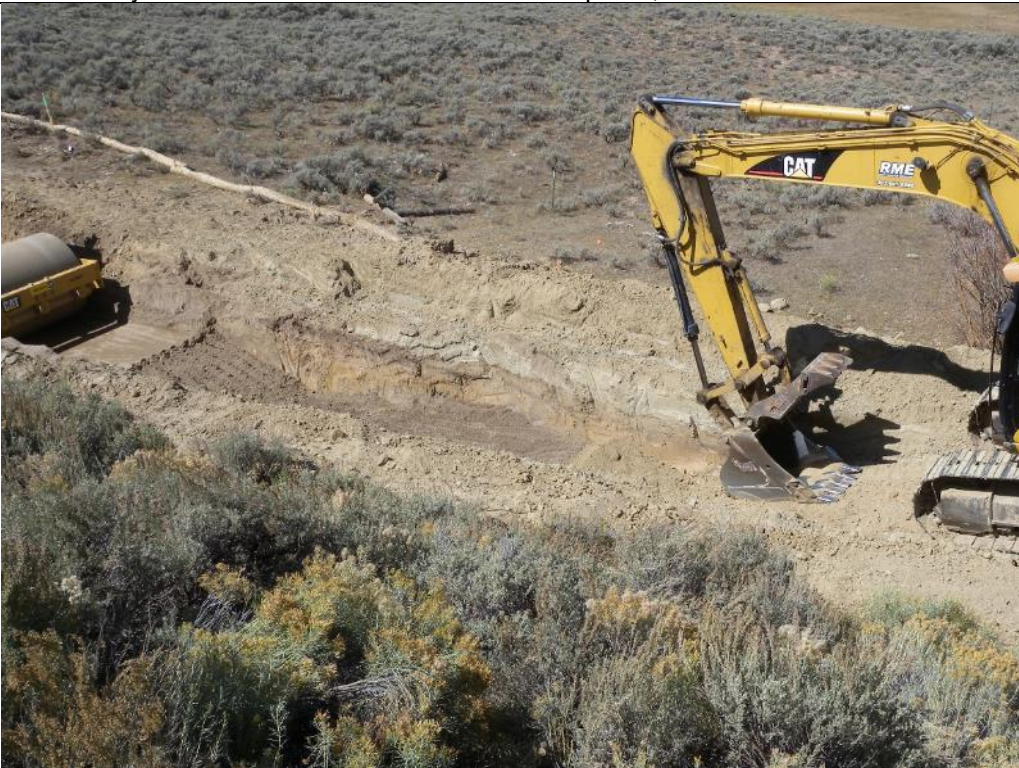
Photo 50. View of the excavation of the stability berm and installation and compaction of the Type A Filter Sand in the North Dam chimney drain near NTD Sta. 0+00 to 0+80. Sept. 19, 2017.

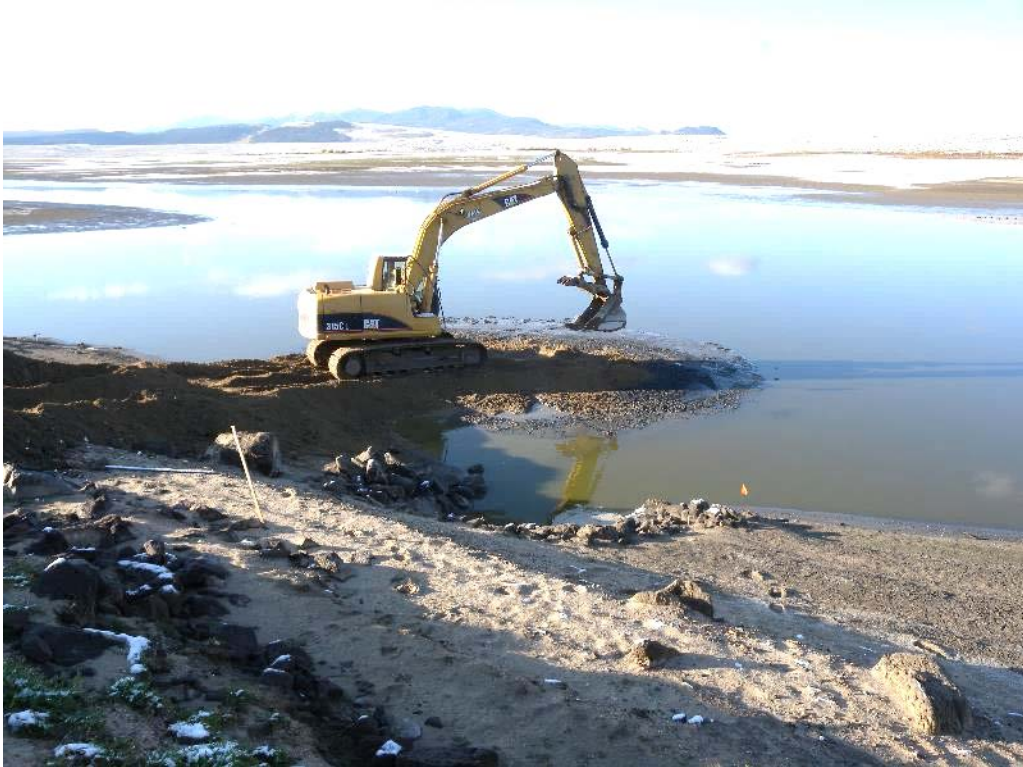
Photo 51. View looking upstream from Sta. 9+90 at the start of the coffer dam construction. Sept. 20, 2017.

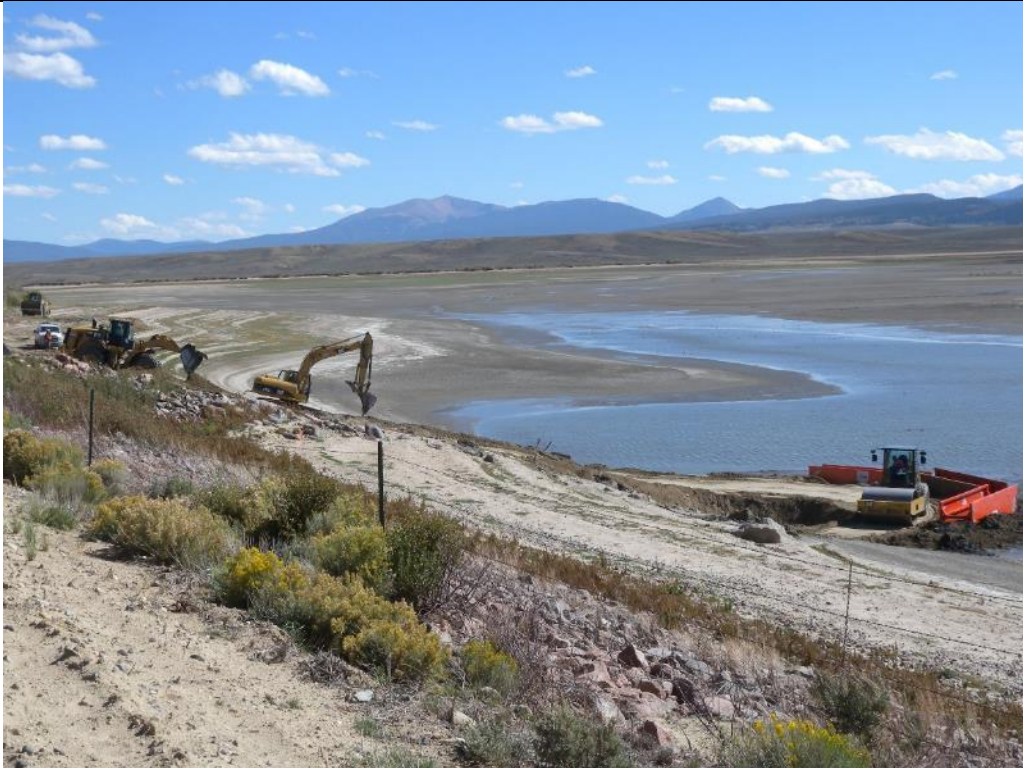
Photo 52. View looking upstream from Sta. 10+50 at the trench boxes and work on the coffer dam as well as construction of the temporary access road and platforms for the dewatering pumps on the upstream side of the reservoir. Sept. 20, 2017.

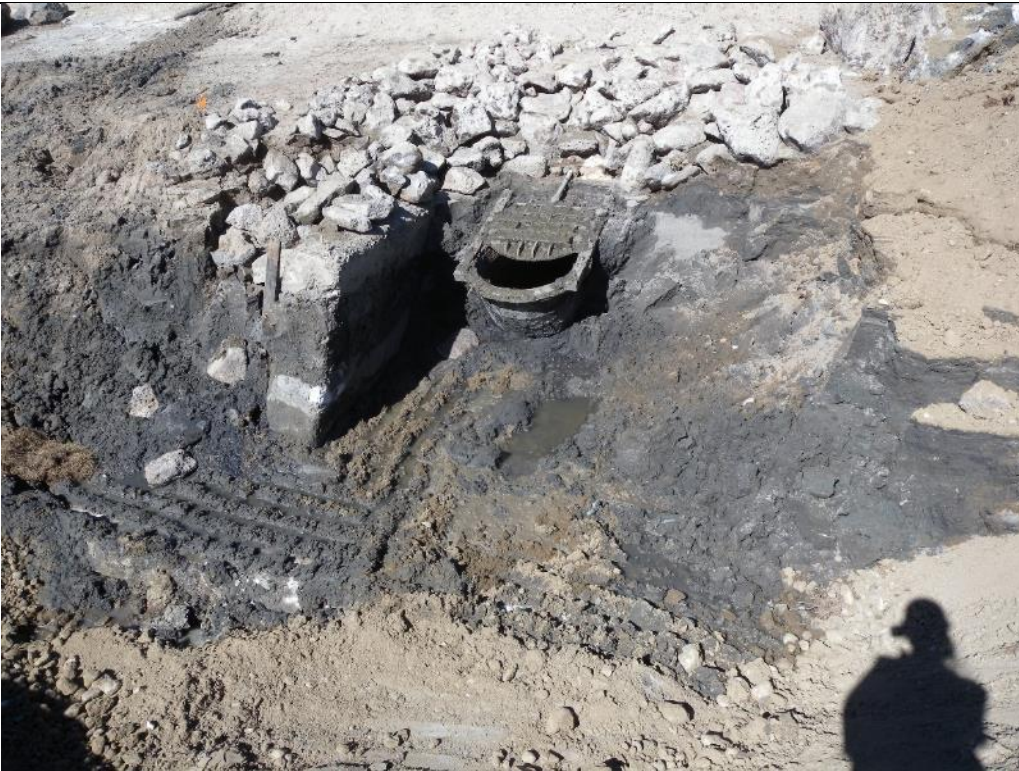
Photo 53. View looking downstream from the top of the coffer dam at the dewatered outlet inlet. Sept. 20, 2017.

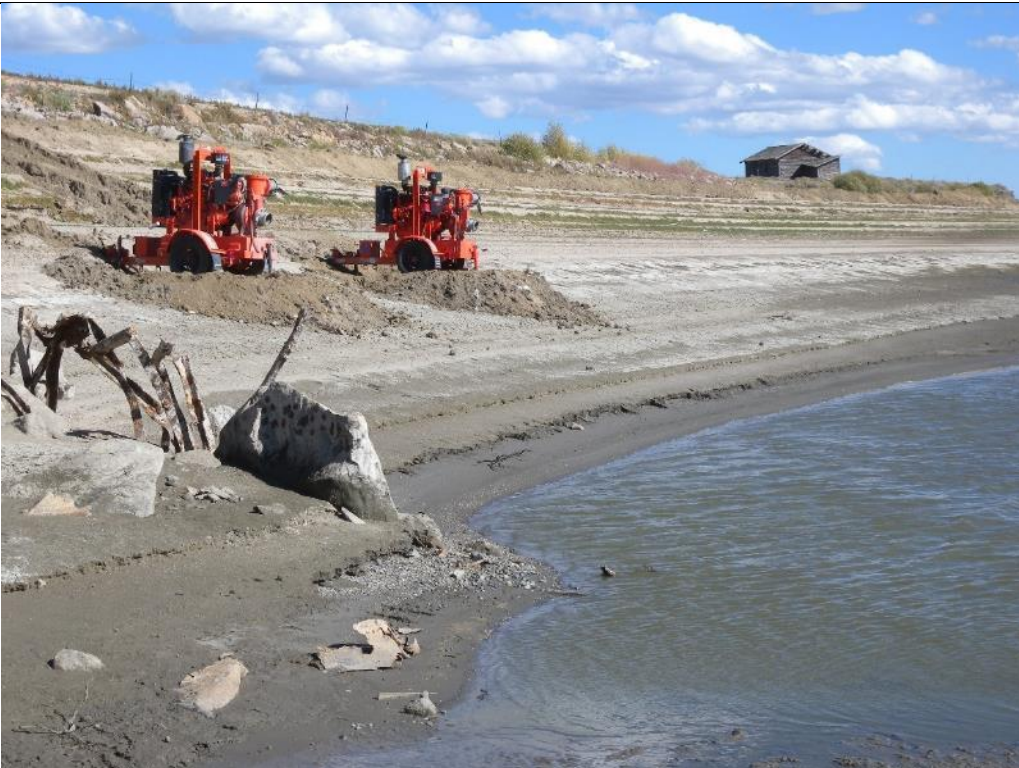
Photo 54. View looking right from the top of the coffer dam at the two reservoir dewatering pumps placed on the upstream side of the Main Dam Embankment near Sta. 11+00. Sept. 20, 2017.

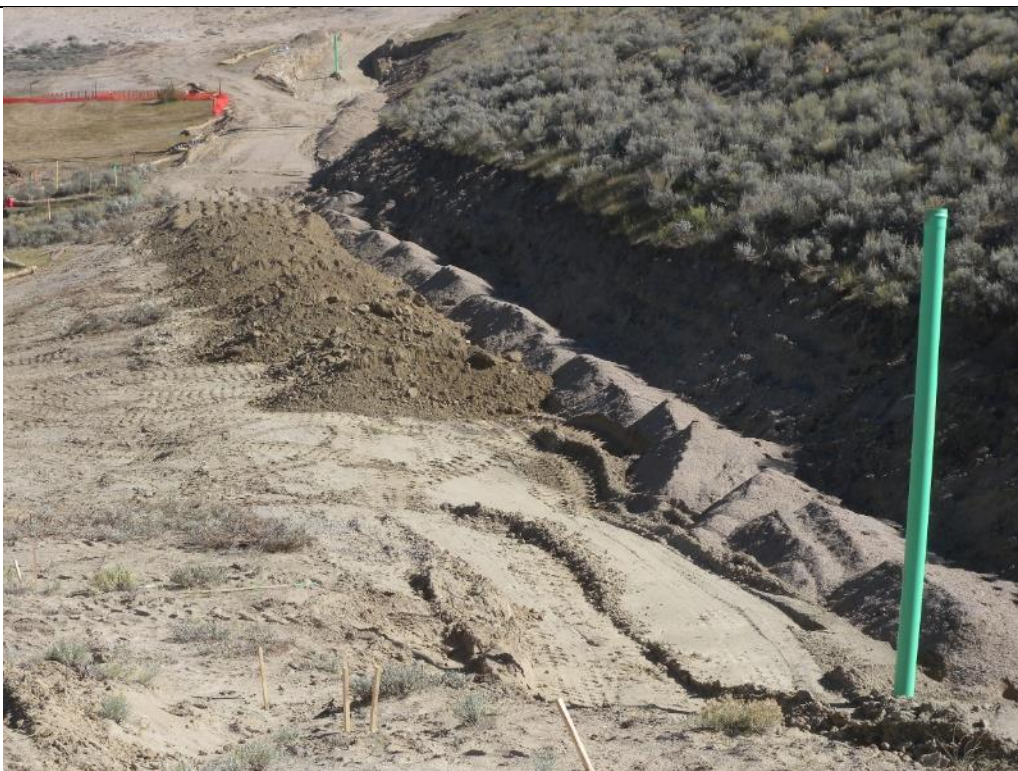
Photo 55. View looking right from approximate MTD Sta 0+00 at the Work in progress on the Main Dam which included placement of the chimney drain and lifts of Embankment Fill from MTD Sta 0+50 to 2+00. Sept 21, 2017.

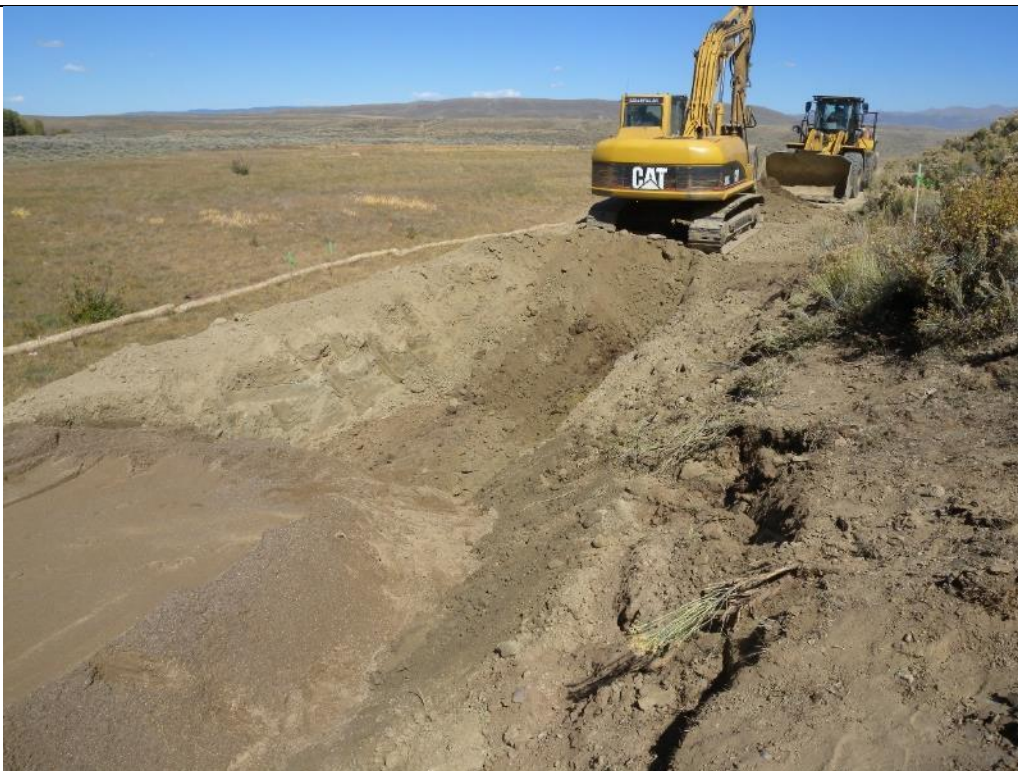
Photo 56. View looking right and downstream at NTD Sta. 1+50 to 1+75 at the excavation into the stability berm and construction of the Type A Filter Sand layer of the seepage collection system. Sept. 21, 2017.

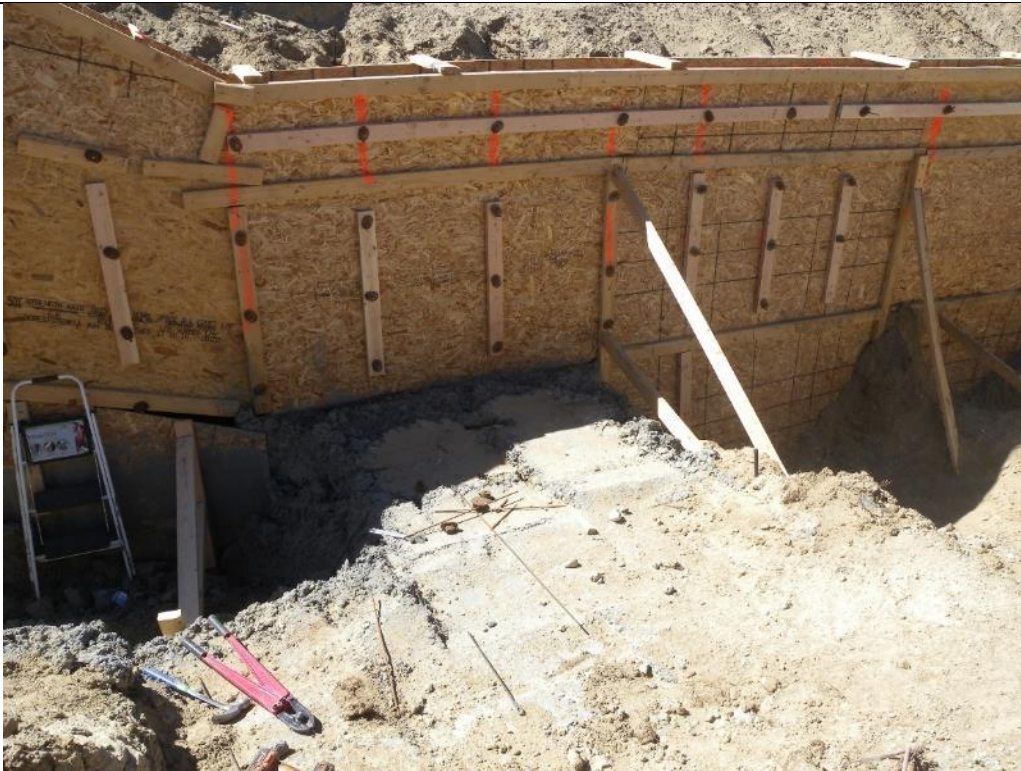
Photo 57. Representative view of the work completed by the concrete crew who added form ties and additional support to the upstream spillway cutoff wall at ES Sta. 2+20. Sept. 22, 2017.

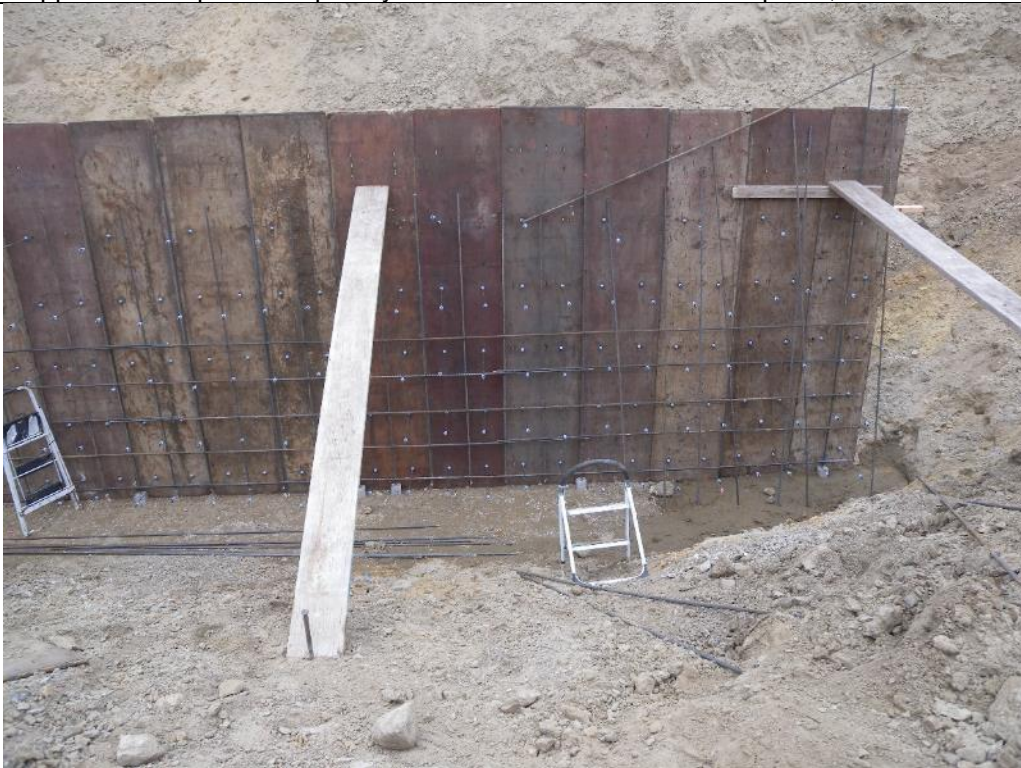
Photo 58. View of the formwork and rebar installation for the downstream spillway cutoff wall located at ES Station 5+20. Sept. 22, 2017.

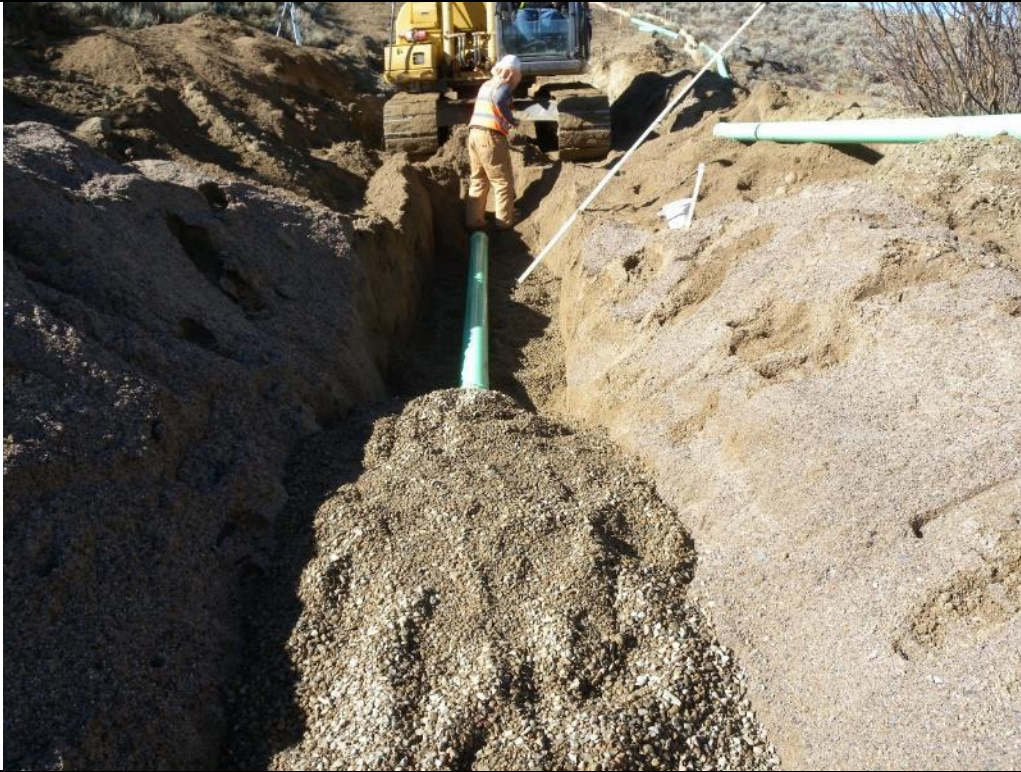
Photo 59. View looking left from NTD Sta. 0+80 at the installation of the slotted drain pipe and Type B Gravel Drain. Sept. 25, 2017.
