# **FINAL CONSTRUCTION REPORT** for **MACFARLANE DAM** **REHABILITATION PROJECT**

**CONSTRUCTION FILE NO. C-1031B**  
**COLORADO DAM ID: 470202**  
**NID: CO-00997**  
**WATER DIVISION 6 – WATER DISTRICT 47**  
**JACKSON COUNTY, COLORADO**

## Executive Summary

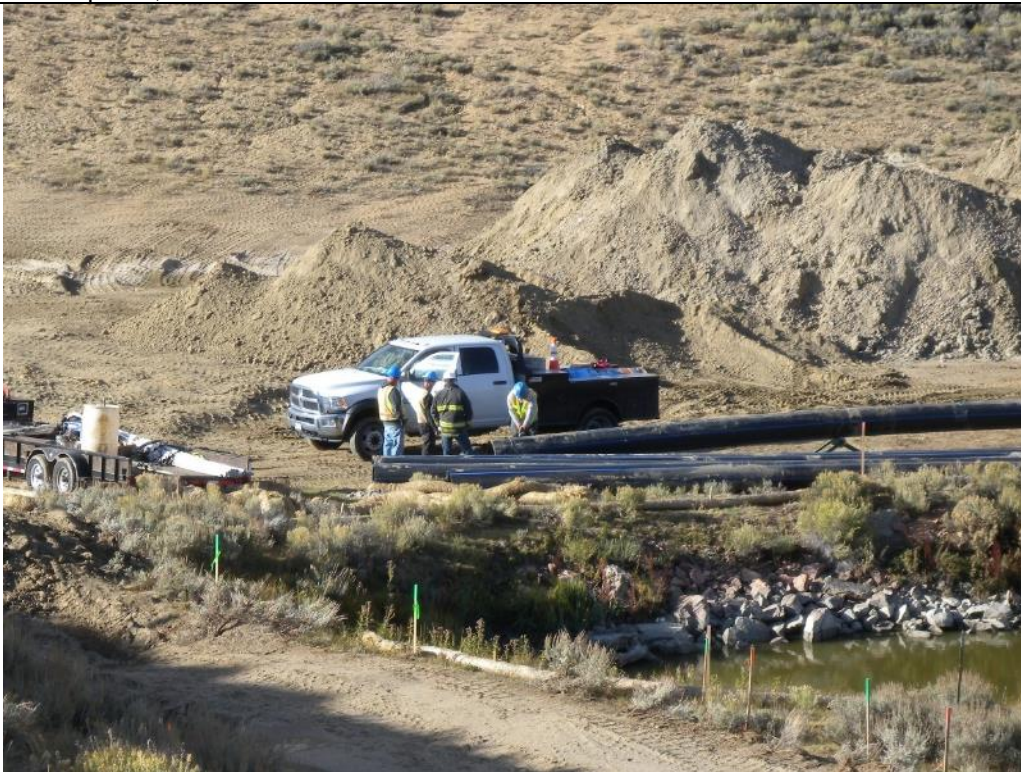
Photo 60. C&L arrived on-site and began setting up their operations in the staging and stockpile area to the left of the outlet works. Sept. 25, 2017.

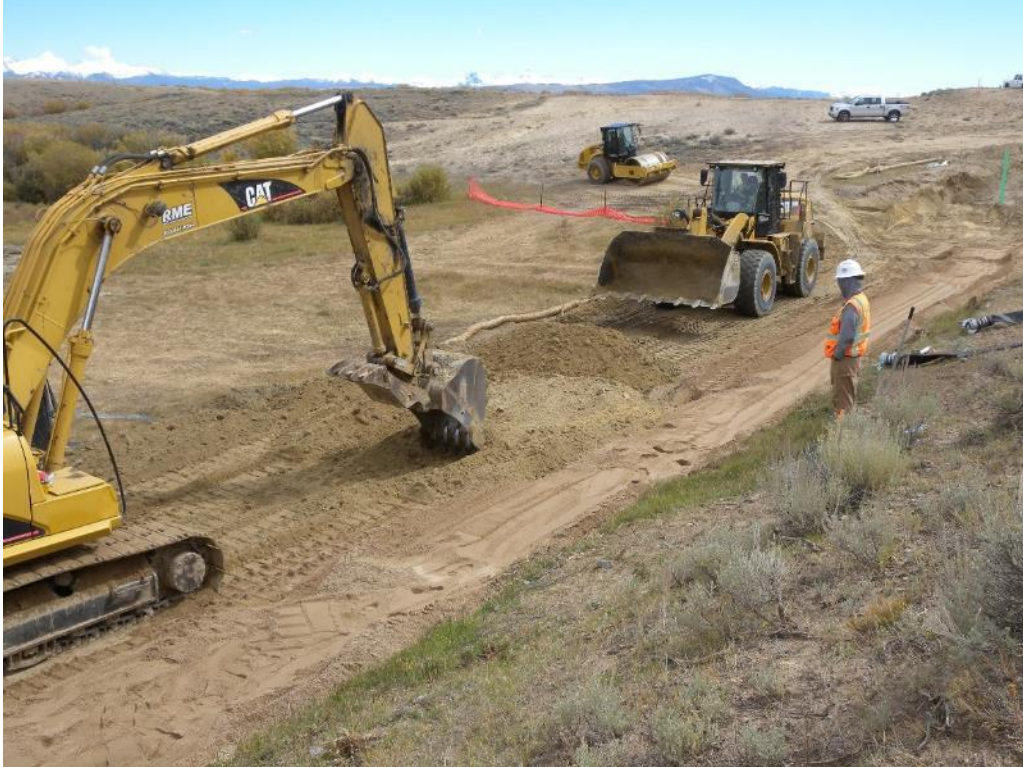
Photo 61. View looking downstream from approximate MTD Sta. 3+75 of the Embankment Fill placement in the Stability Berm. Sept. 26, 2017.

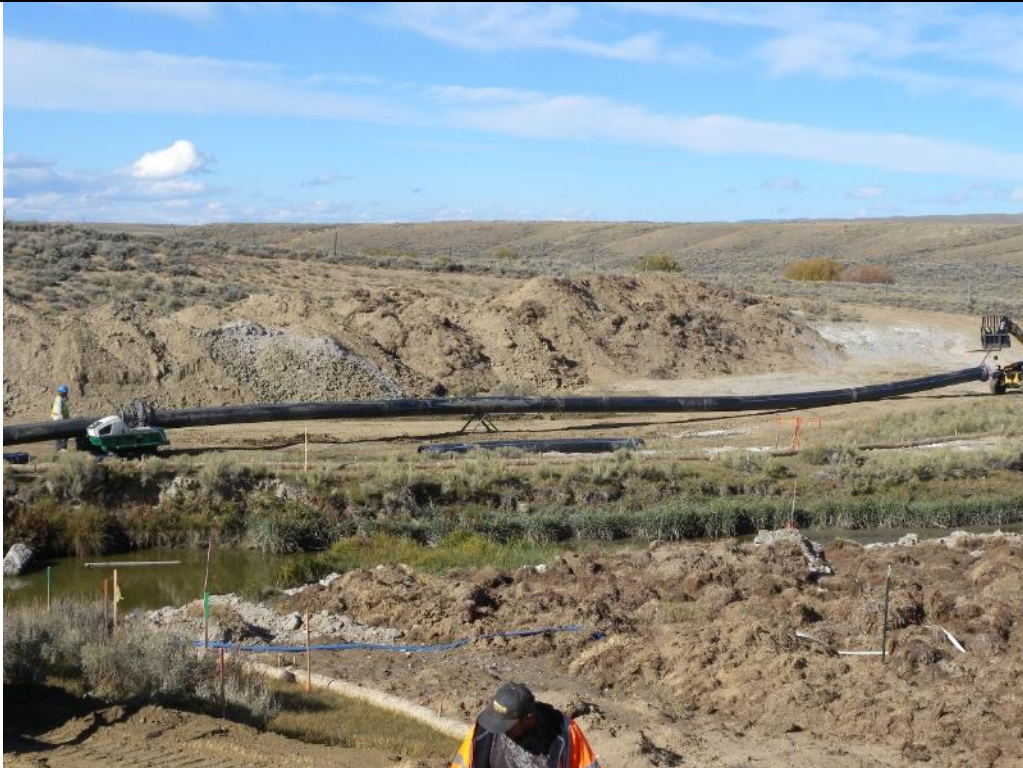
Photo 62. View of C&L fusing the 20-inch-diameter HDPE pipe. Sept. 26, 2017

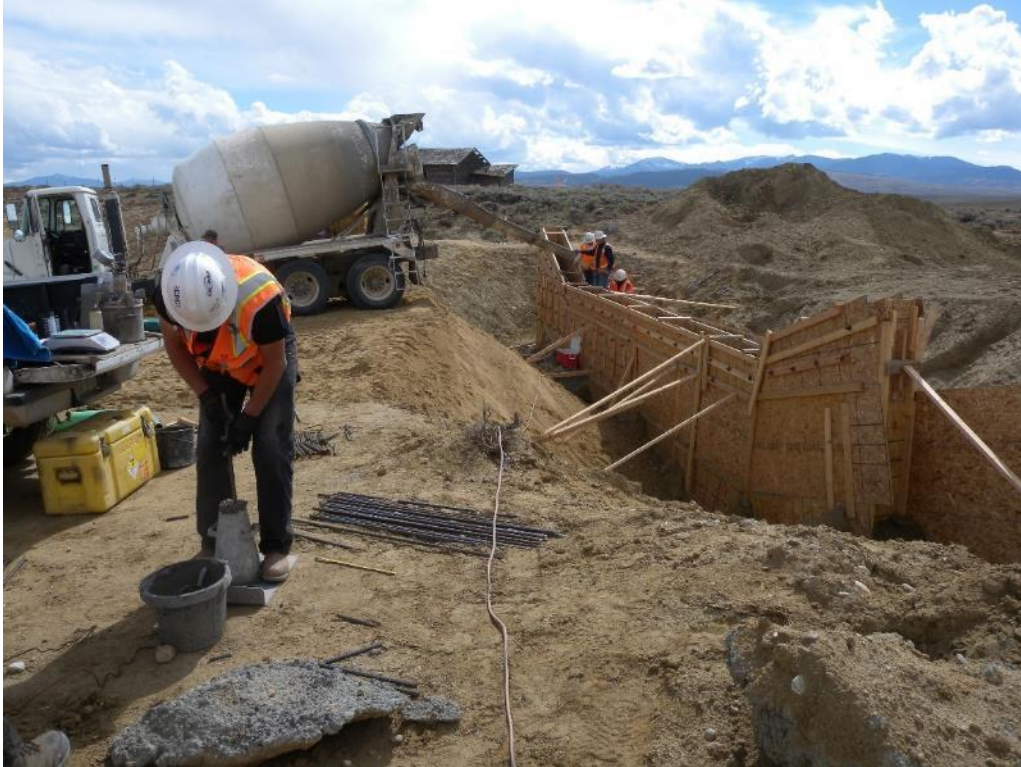
Photo 63. View of the concrete placement and concrete testing for the upstream spillway cutoff wall located at ES Sta. 2+20. Sept. 27, 2017

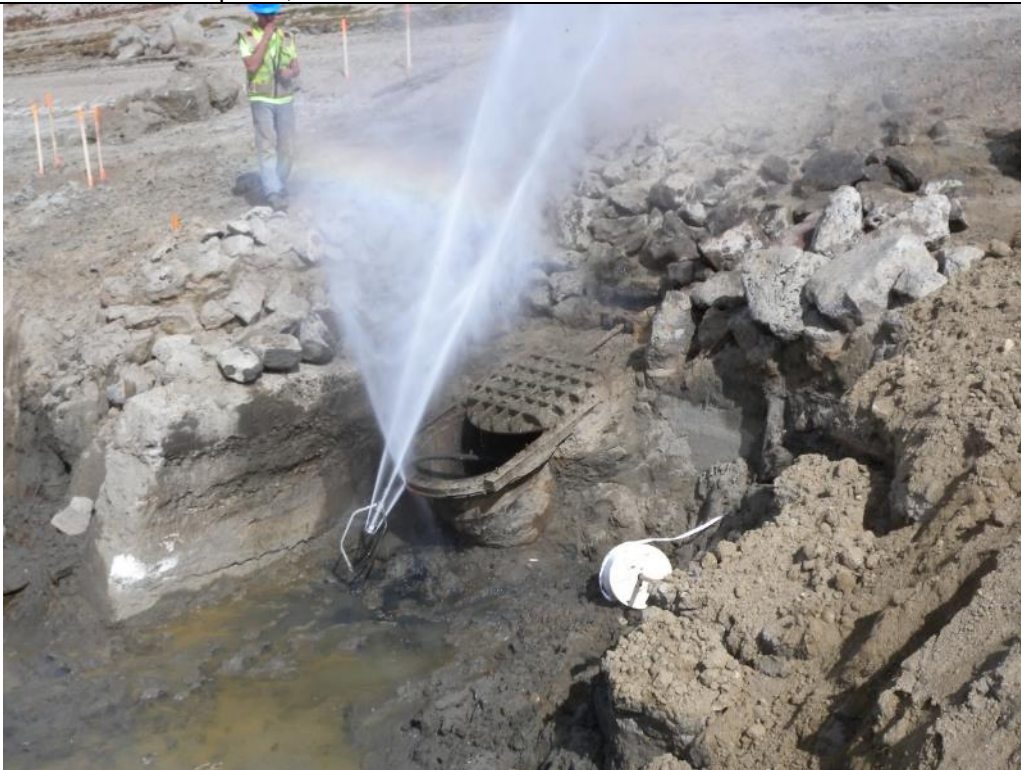
Photo 64. View of Snowbridge Inc. water jetting the outlet works conduit. Sept. 28, 2017

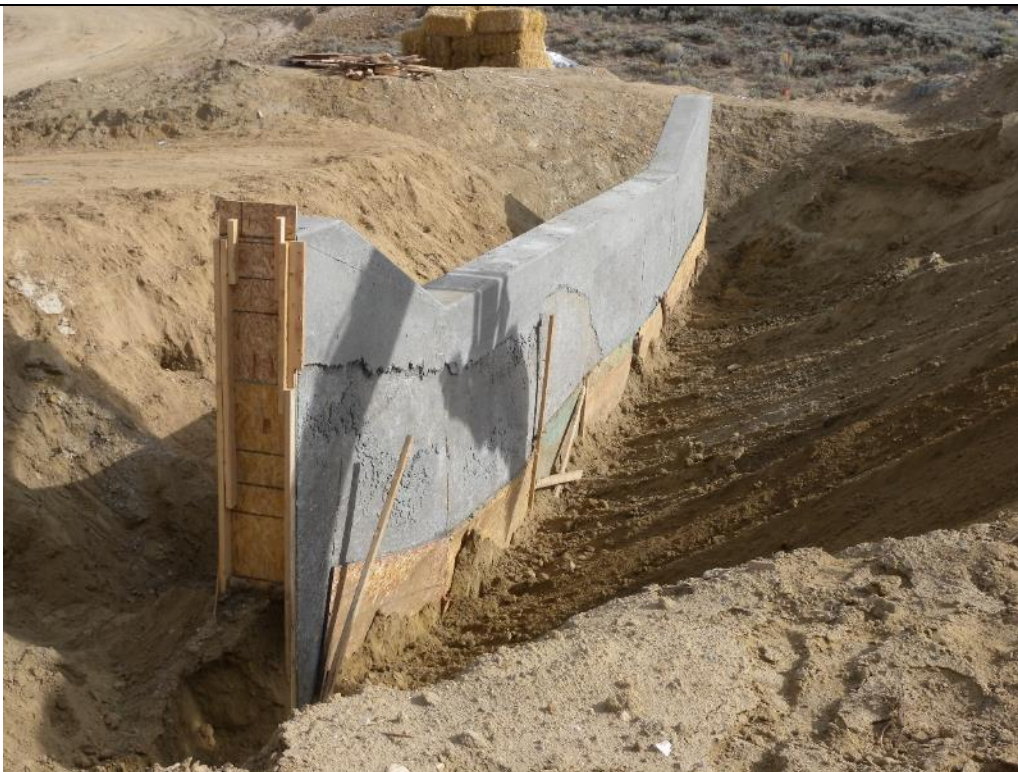
Photo 65. View looking at the upstream side of the upstream concrete cutoff wall after the forms were stripped. September 28, 2017.

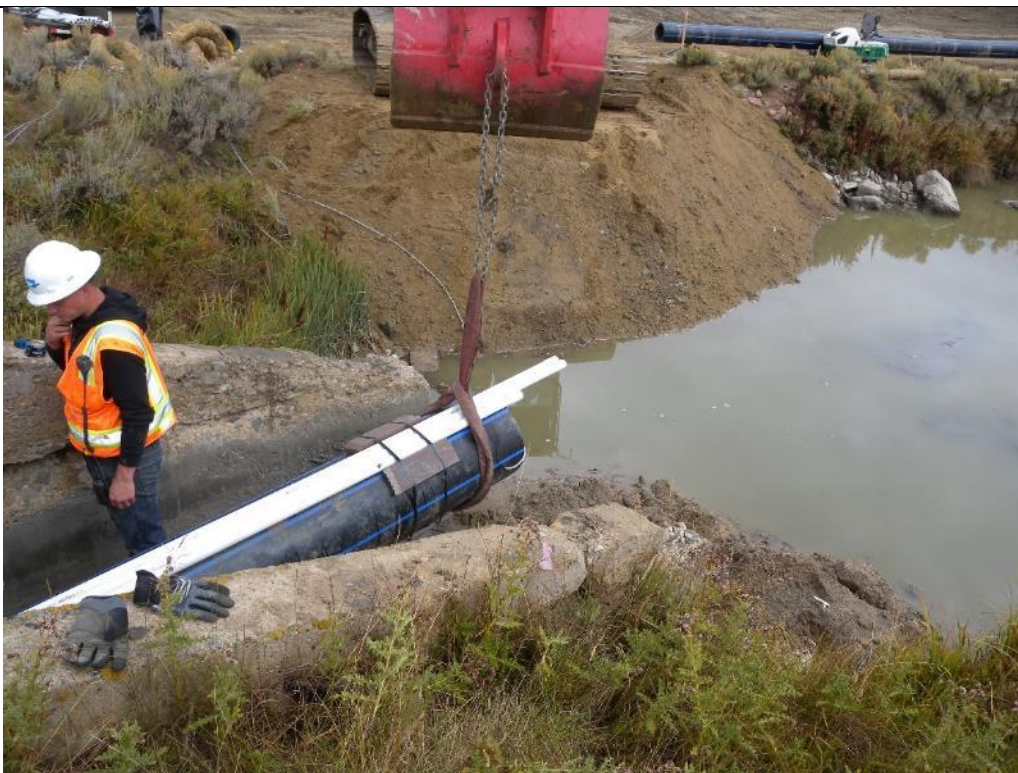
Photo 66. View of the 20-foot-long test section of HDPE pipe during the test pull which became stuck approximately 10-feet into the host pipe. Sept. 29, 2017.

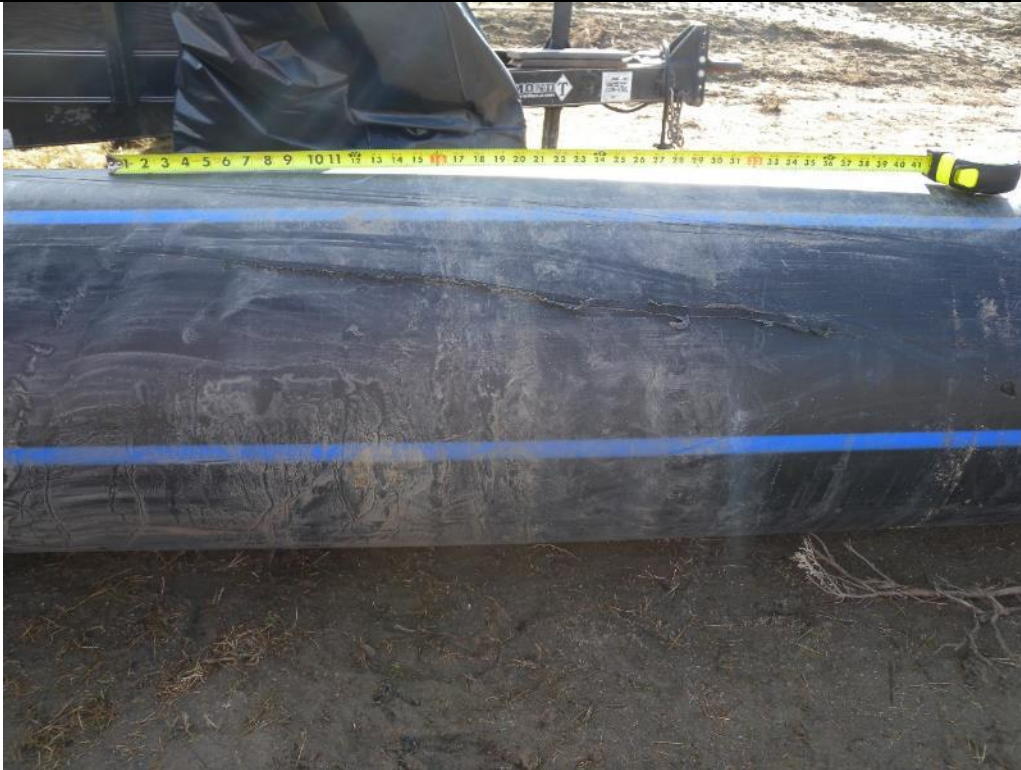
Photo 65. View of the test section after being pulled into the host pipe approximately 85 to 90 feet with no centralizers or grout tubes attached. Note the scratches around the exterior of the pipe. This bare test pull was also abandoned because the test section became stuck on an unknown obstacle approximately 90 feet up the host pipe from the downstream end. Sept. 29, 2017.

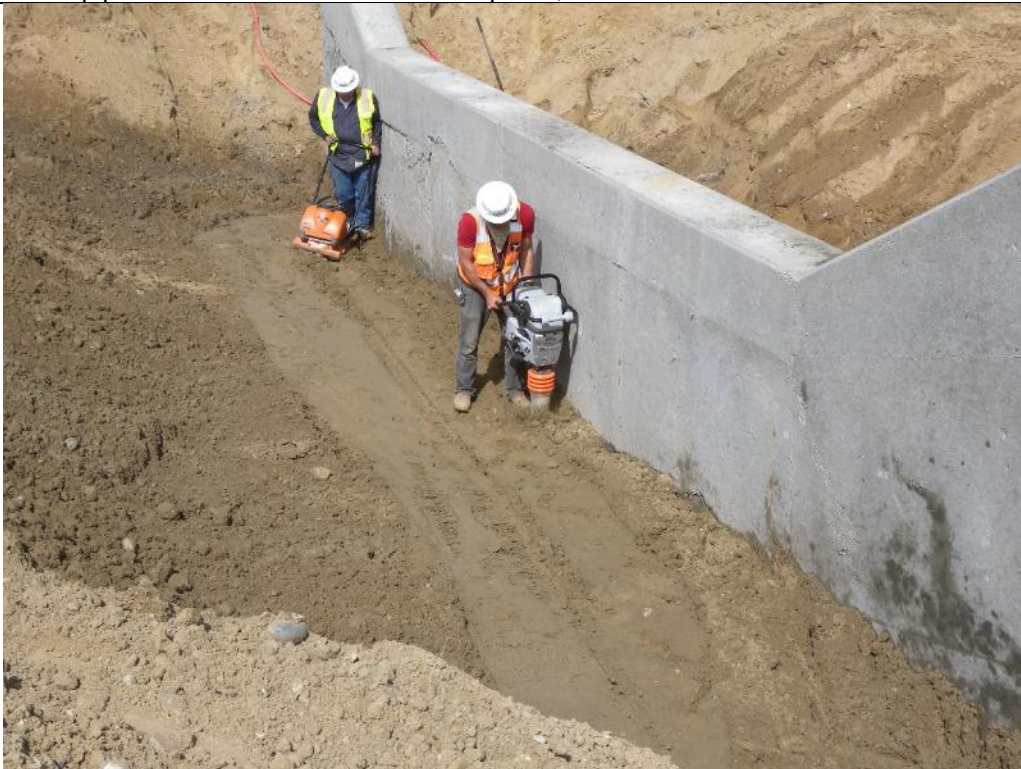
Photo 66. View of the special compaction around the upstream spillway cutoff wall during the backfilling process. Sept. 30, 2017.

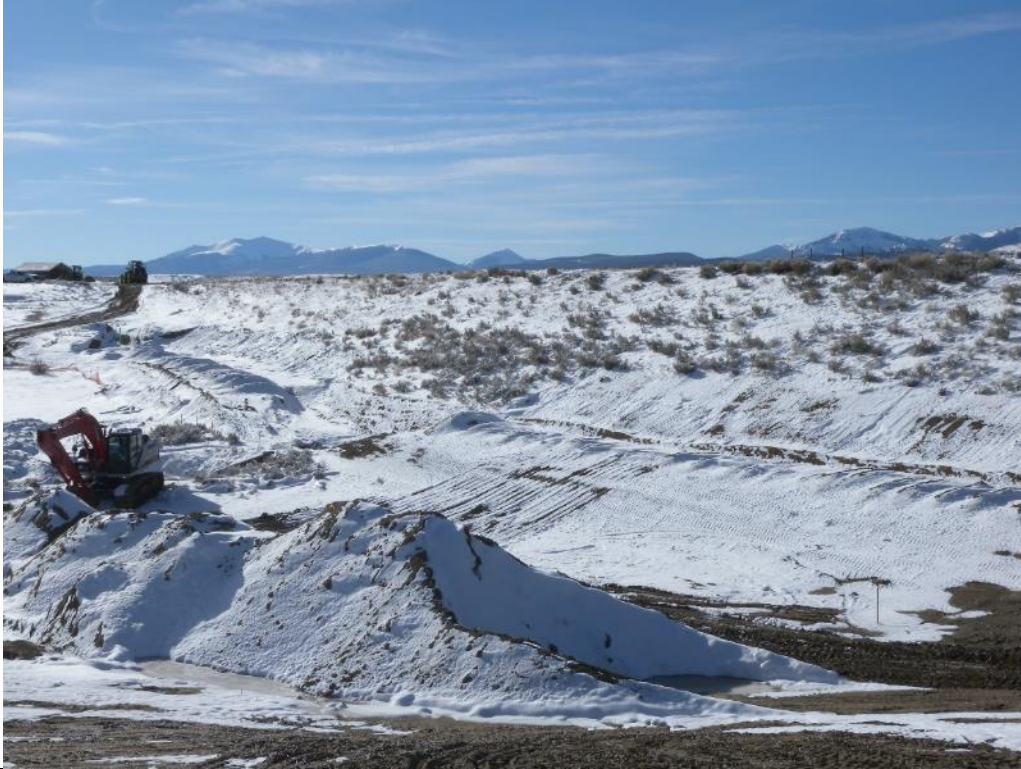
Photo 67. View looking right from the top of the Staging and Stock Pile Area looking at the Main Dam covered in snow from the second snow storm which occurred overnight Sunday October 8 into Monday October 9. Oct. 10, 2017.

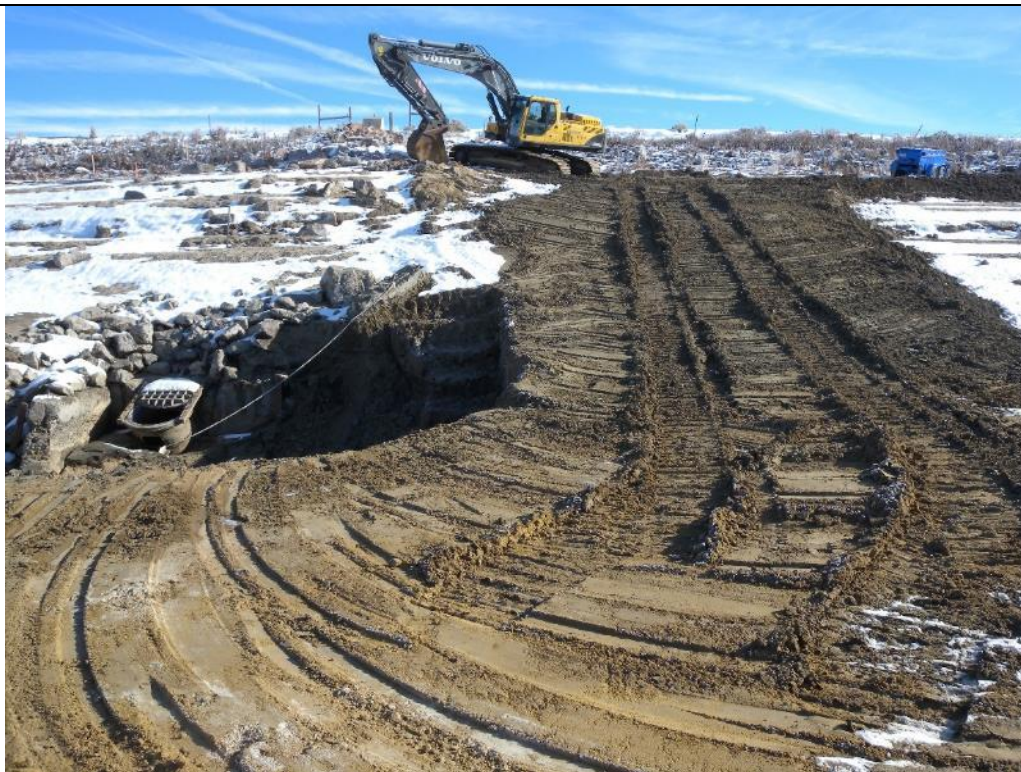
Photo 68. View of the top of the re-constructed coffer dam. The original coffer dam was washed out following the rising reservoir levels associated with the snow storm from October 1. Oct. 10, 2017.

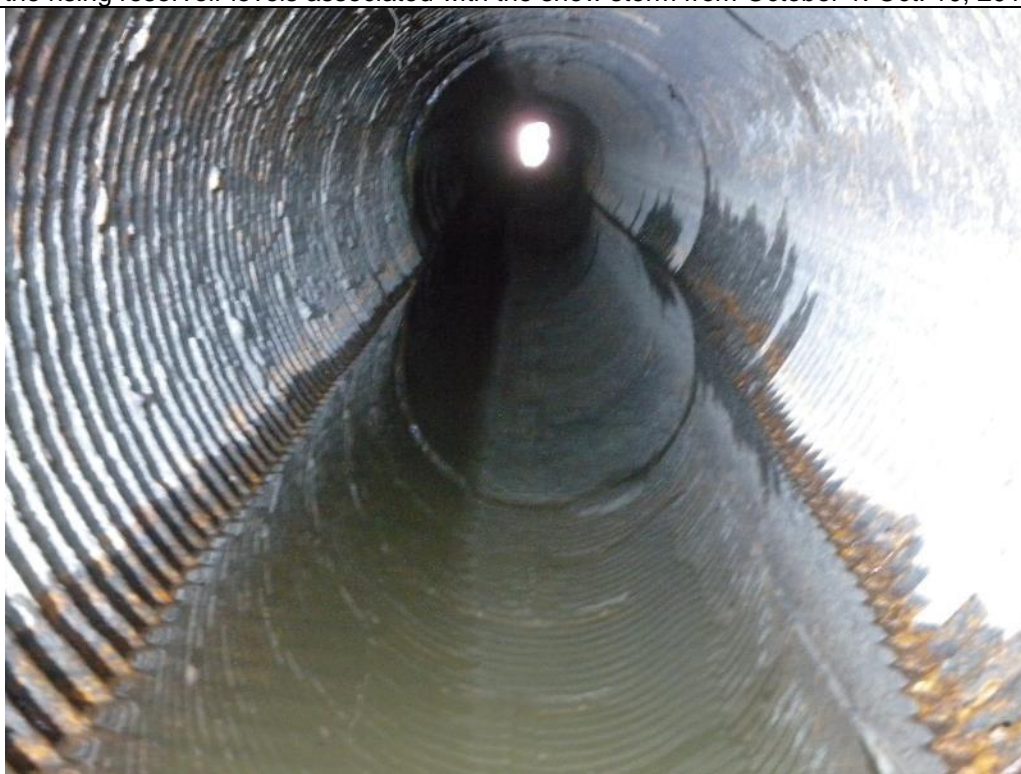
Photo 69. View looking upstream from the downstream end of the outlet works conduit at ponded water in the conduit due to overtopping of the coffer dam. The approximate depth of water was in excess of 4 inches in some areas. Oct. 10, 2017.

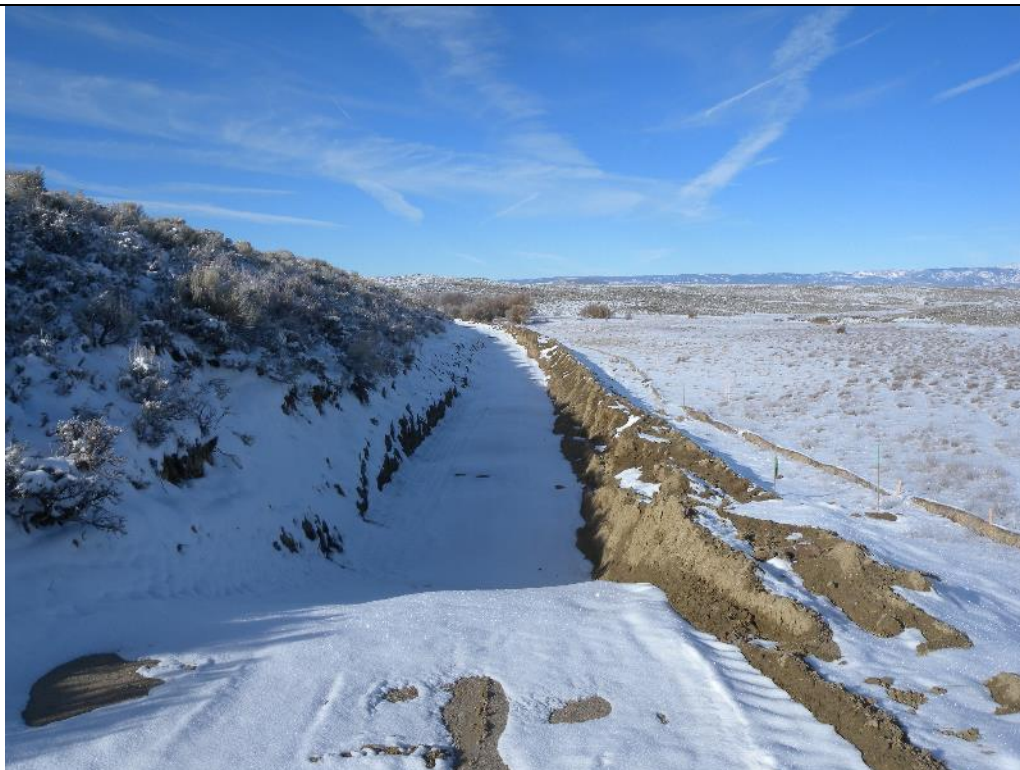
Photo 70. View looking left at the North Embankment seepage collection system from NTD Sta. -0+10. Snow is currently covering the top layer of Type A Filter Sand. Oct. 10, 2017.

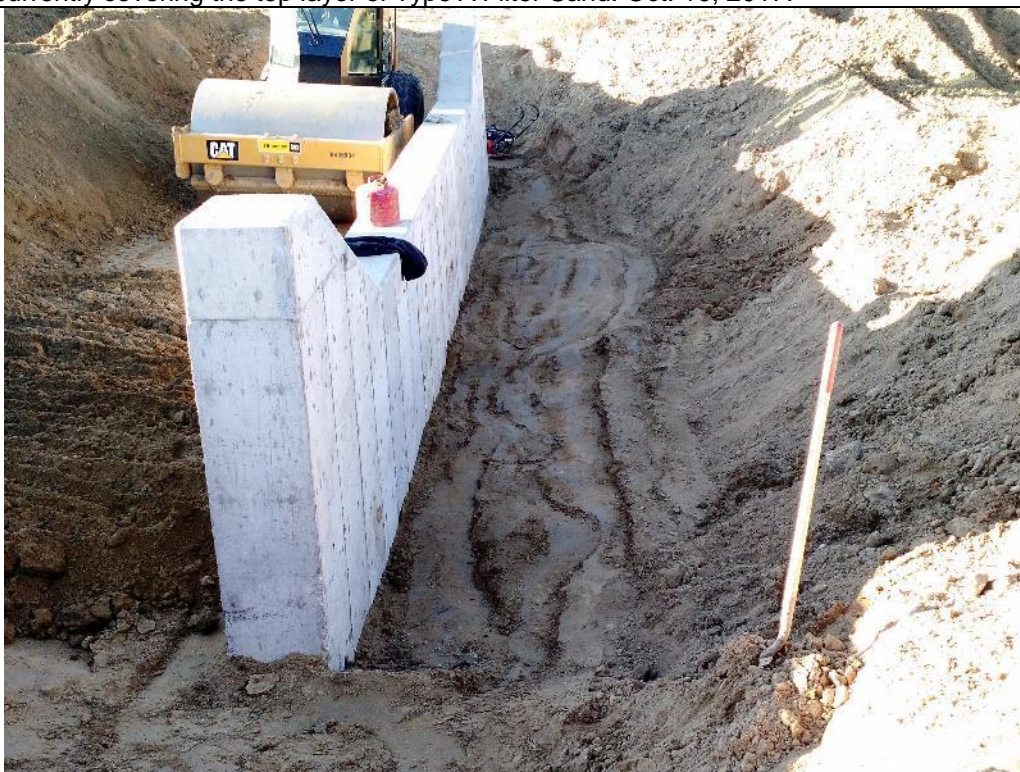
Photo 71. View looking left at upstream side of the downstream Spillway cutoff wall. RME used the roller to compact the majority of the lift and the Jumping Jack to compact along the cutoff wall. Oct. 11, 2017.

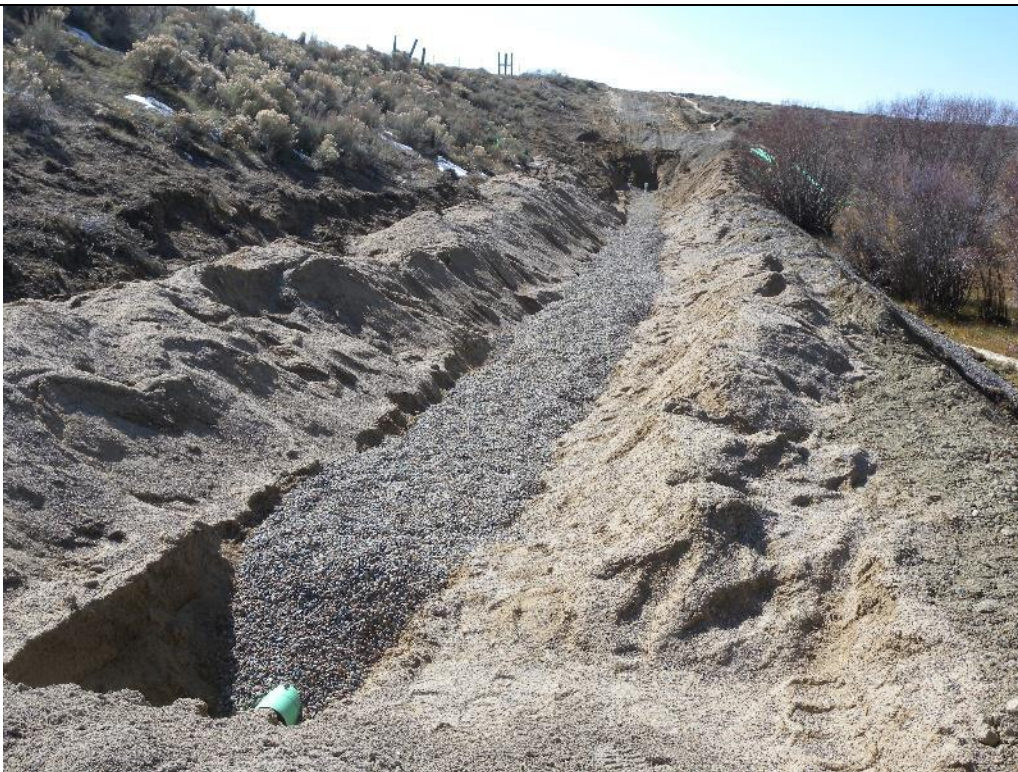
Photo 72. View looking left from NTD Sta. 1+85 at the installation of the slotted drain pipe and toe drain cleanout for the left side of the North Dam seepage collection system. Oct. 13, 2017.

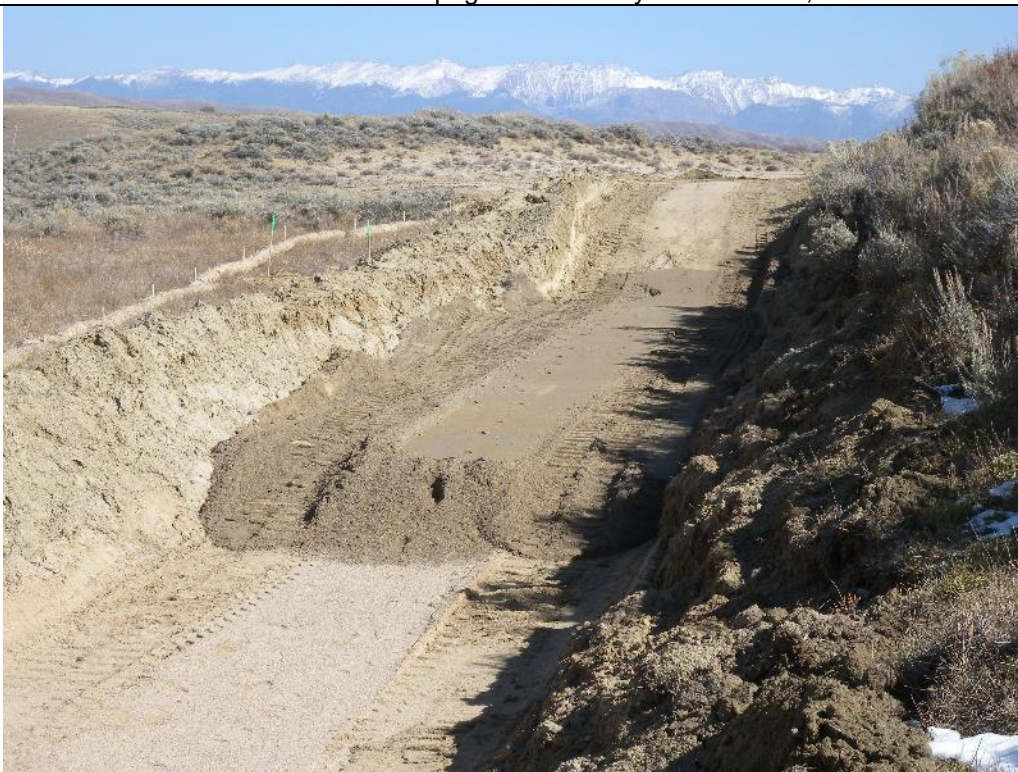
Photo 73. View looking right from approximate NTD Sta. 4+25 at the short lift of Type A Filter Sand placed from approximate NTD Sta. 4+50 to 5+10. Oct. 13, 2017.

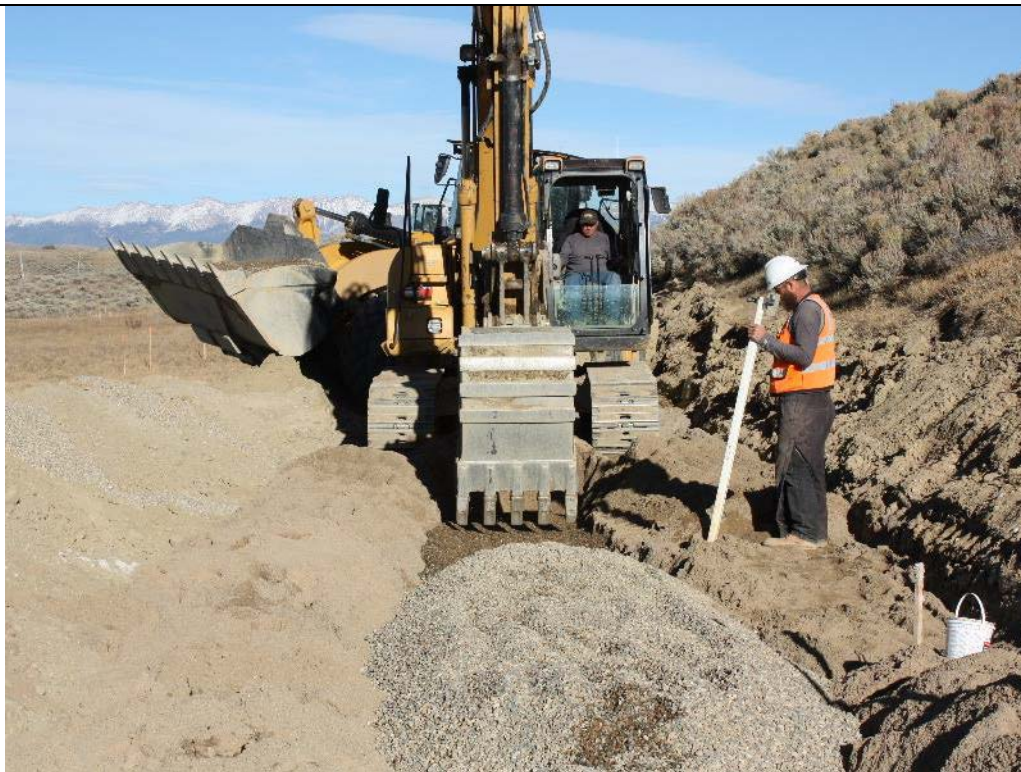
Photo 74. View of the method to install the toe drain on the North Embankment due to restricted access by construction equipment. The excavator used the bucket to obtain Type B Gravel Drain from the loader and place it into the trench and surround the slotted drain pipe. Oct. 16, 2017.

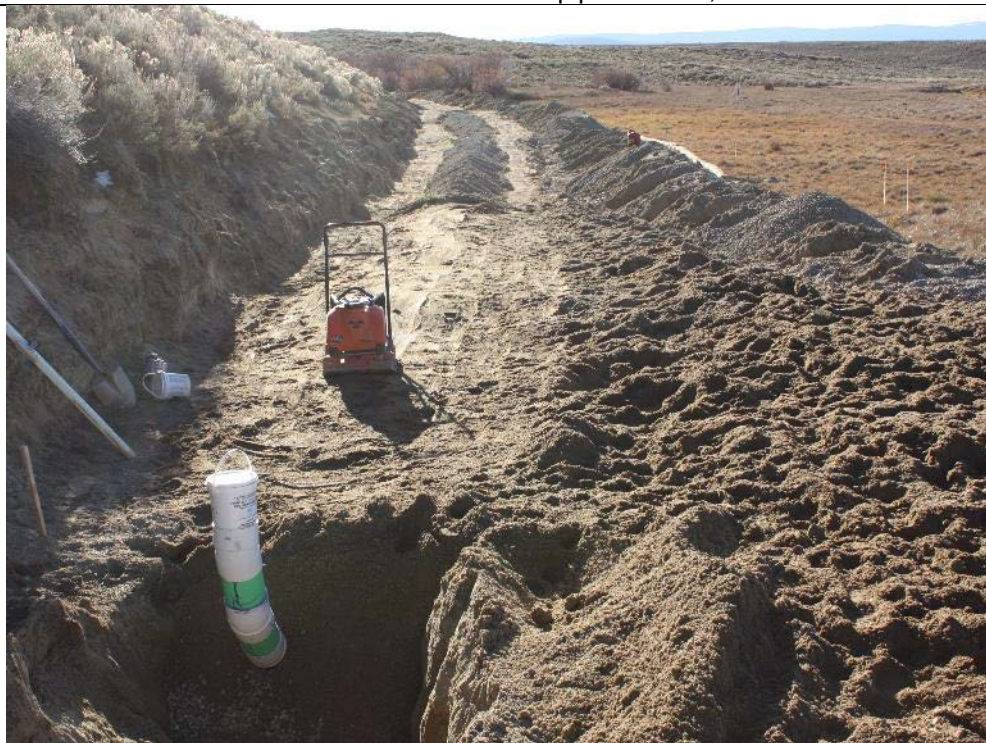
Photo 75. View looking left from NTD Sta. 5+15 at work on the North Dam Seepage Collection System including installing the slotted drain pipe, Type B Gravel drain in the Type A Filter Sand, and the Toe Drain cleanout. From approximate NTD Sta. 3+34 to 4+50, the Type A Filter Sand layer stopped at a lower elevation than elsewhere along the seepage collection system, which meant that RME had mound the Type B gravel over the slotted pipe for the required 1-foot of coverage. Oct. 17, 2017.

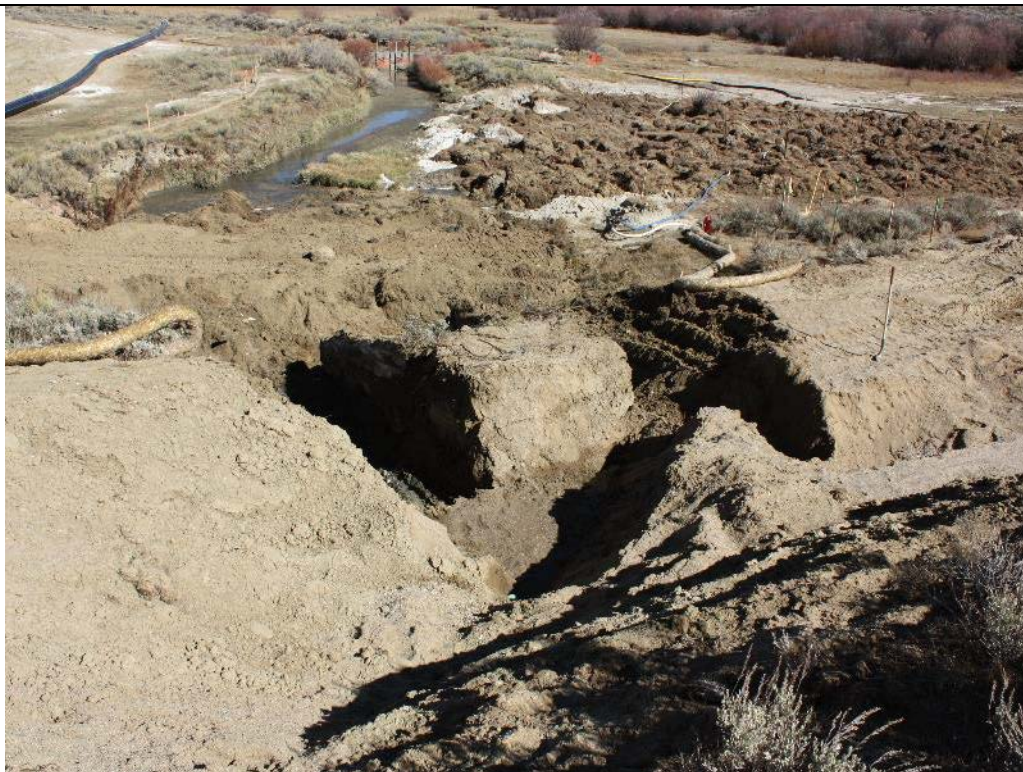
Photo 76. View looking downstream at the excavation around the existing outlet works headwall for the filter collar, which included the removal of the old toe drain discharge pipes, and the temporarily filled in section of the outlet plunge pool required for construction access. Oct. 17, 2017.

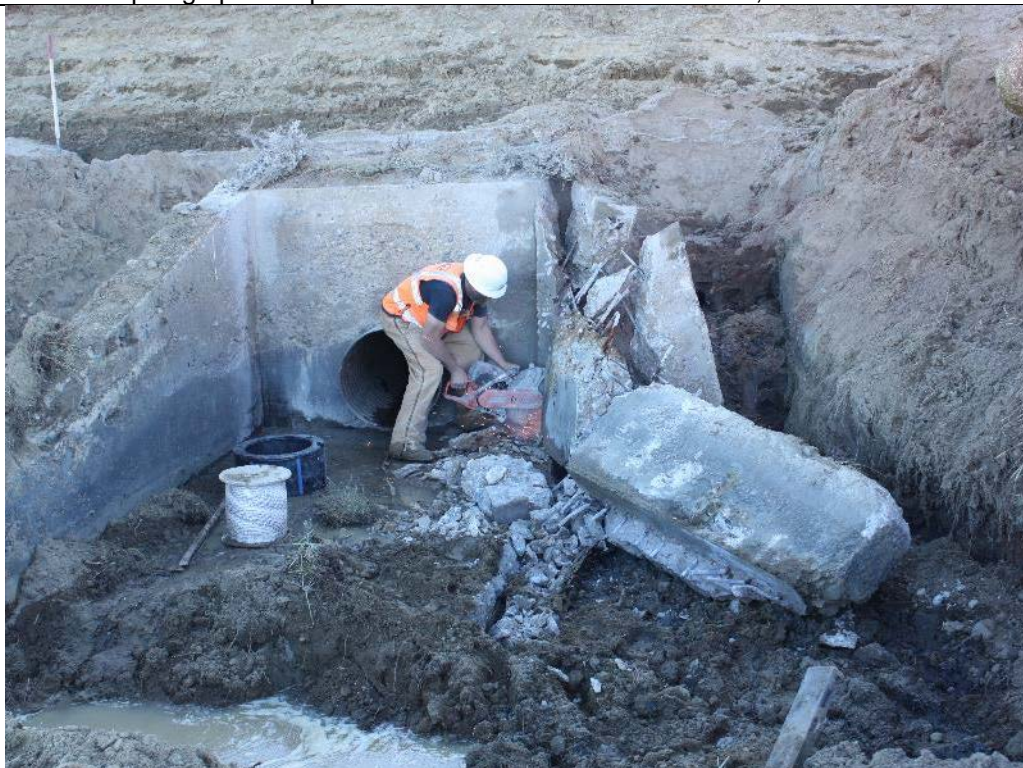
Photo 77. View looking upstream from the temporarily filled in outlet plunge pool at the demolition of the existing outlet structure wing walls. Oct. 17, 2017.

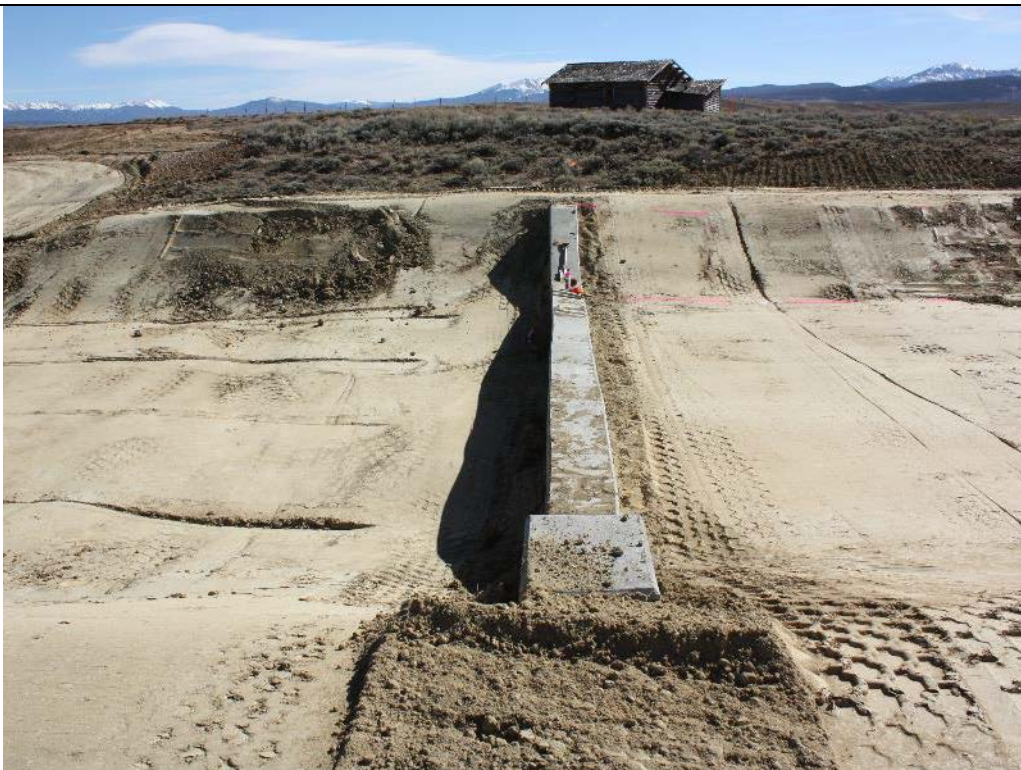
Photo 78. View looking right across the upstream spillway cutoff wall which has been backfilled. Oct. 17, 2017.

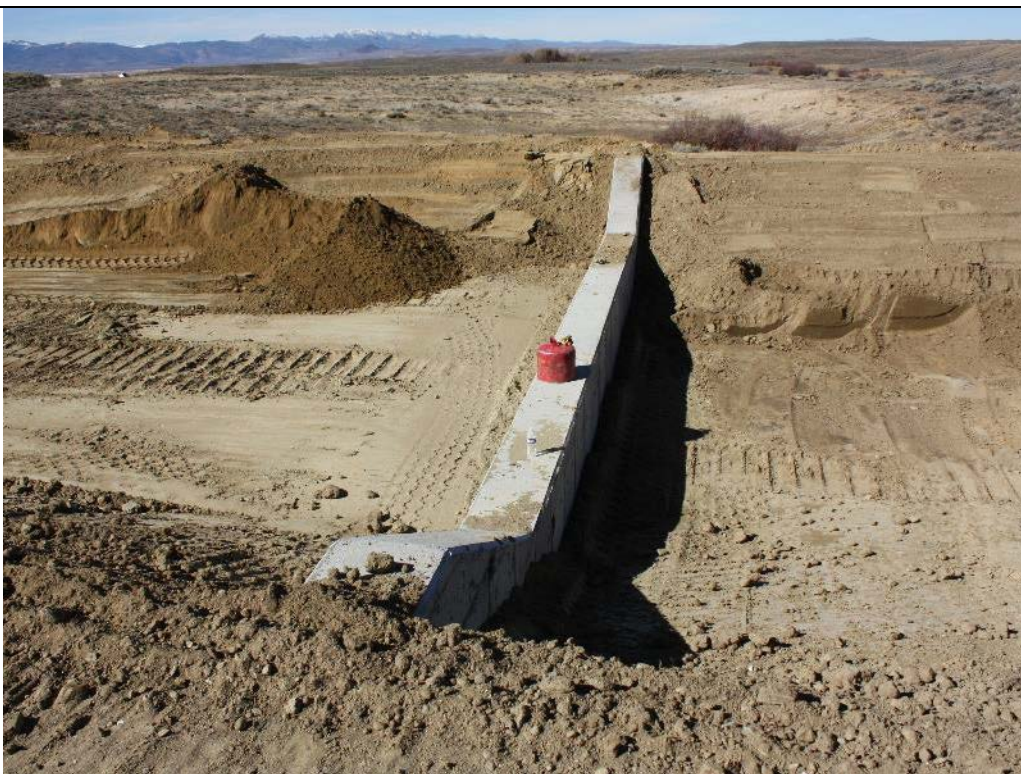
Photo 79. View looking left across the downstream spillway cutoff wall which has been backfilled. Oct. 17, 2017.

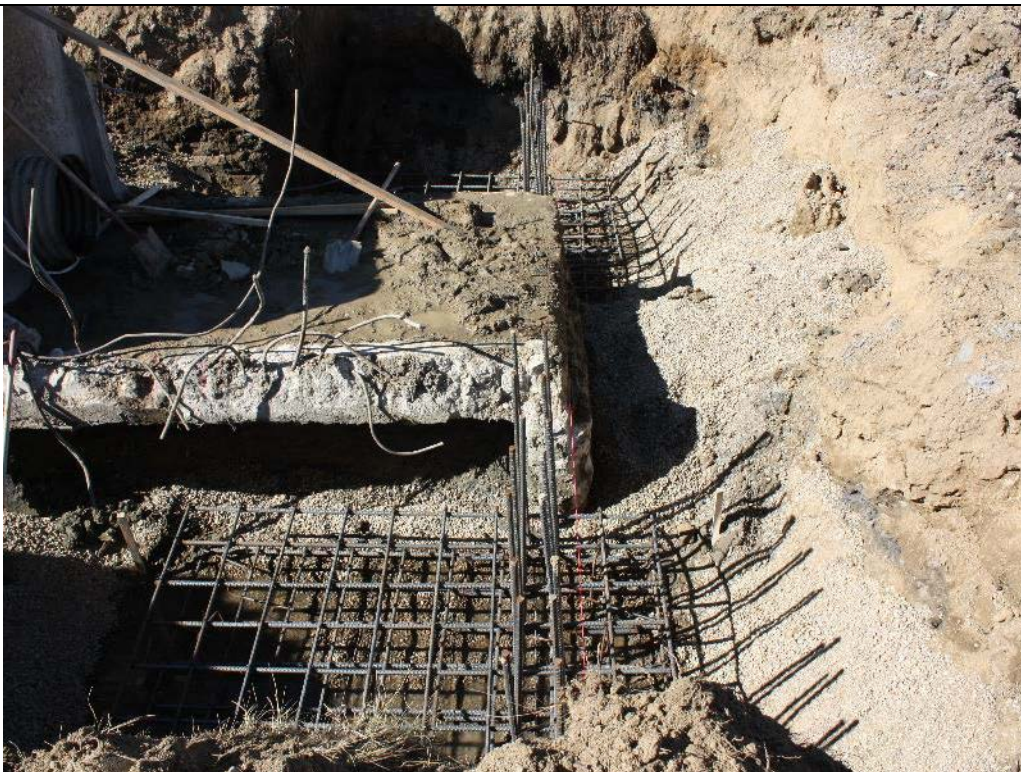
Photo 76. View looking left across the outlet works terminal structure at the left and right wingwall foundation rebar and head wall risers which were tied and in-place prior to the concrete bank pour.

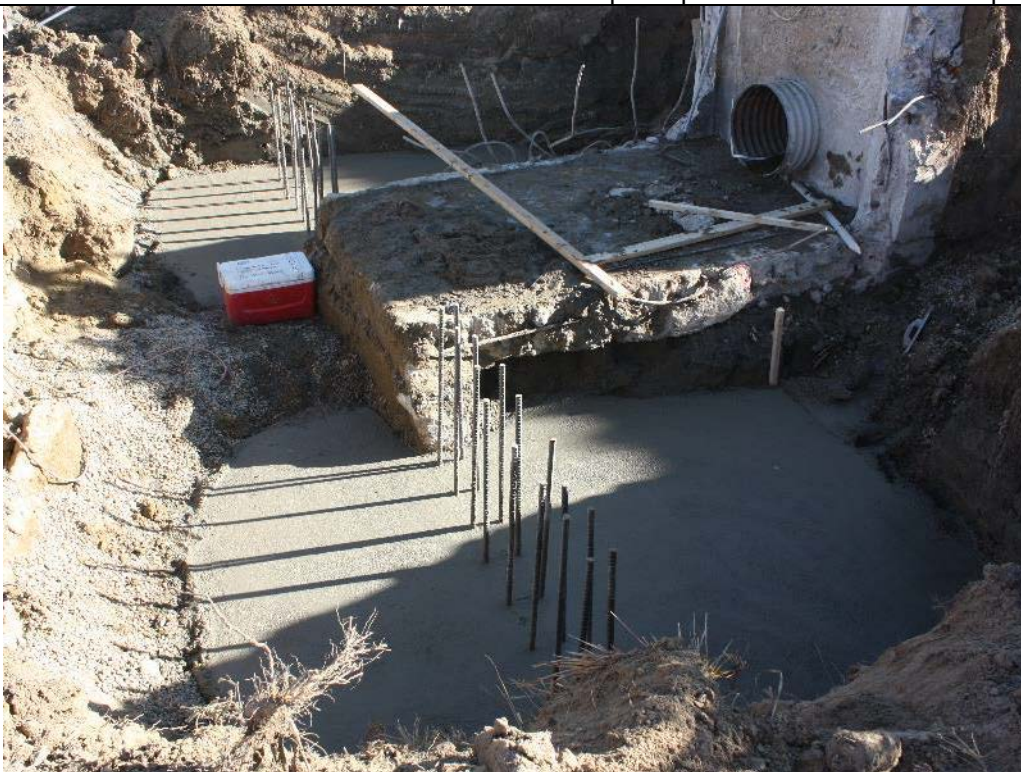
Photo 77. View looking right at the trowel finished surface of the bank poured left and right wingwall foundations. Note the test cylinders which are curing in the red cooler at the base of the old outlet works terminal structure. Oct. 18, 2017.

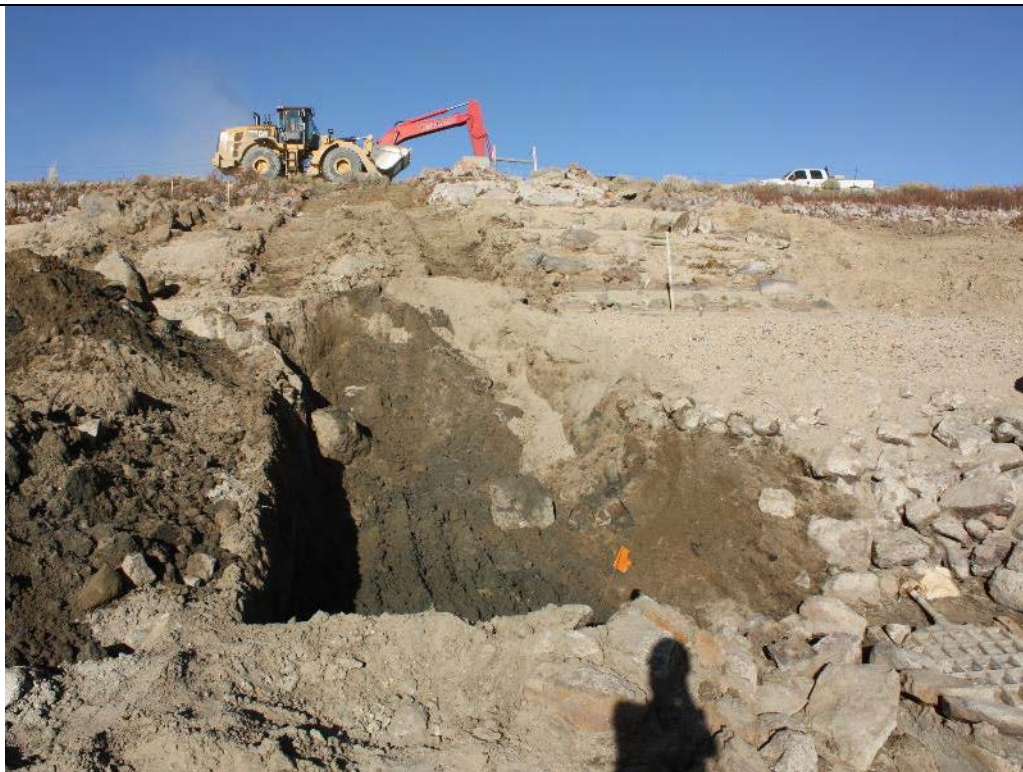
Photo 76. View looking upstream along the upstream slope from the coffer dam at the start of the excavation for the Air Vent encasement wall. Oct. 18, 2017.

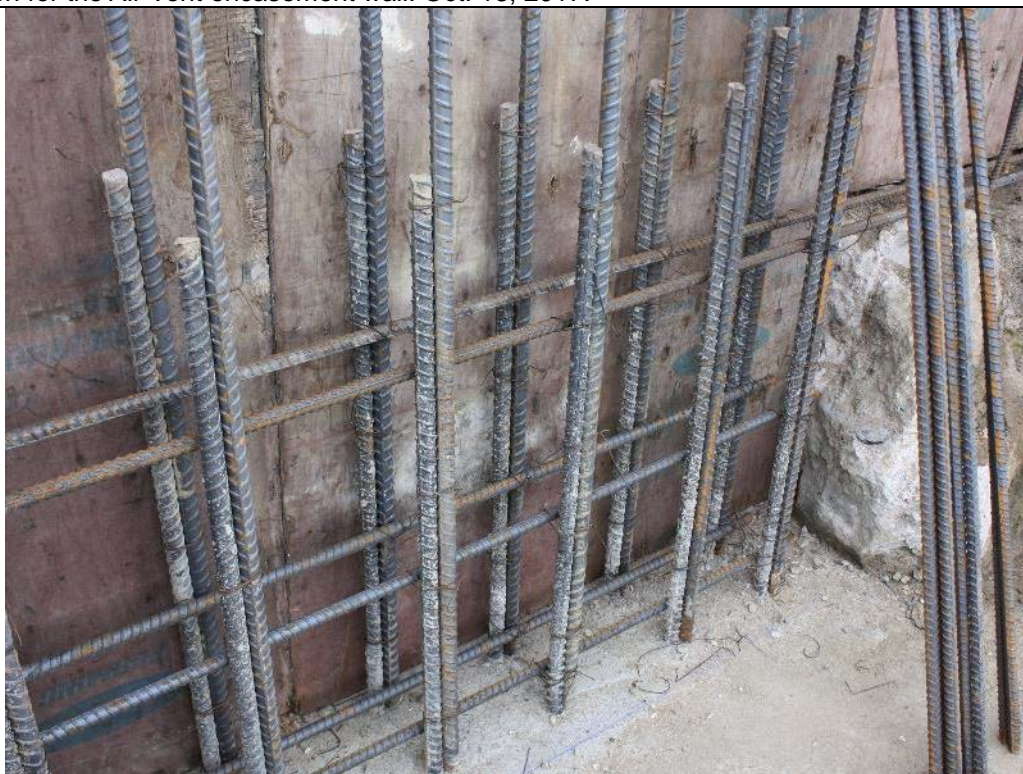
Photo 77. View looking down at the #8 rebar rising from within the wing wall foundation which was then tied to the vertical #8 rebar for the new outlet works terminal structure headwall. Oct. 19, 2017.

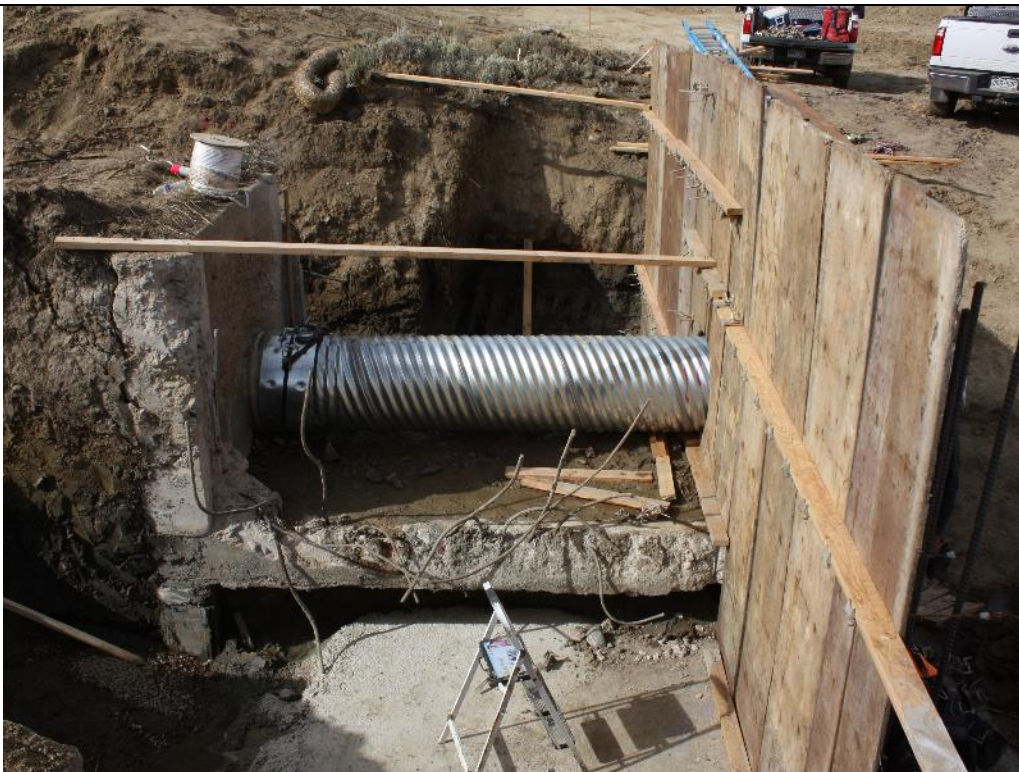
Photo 76. View looking left from approximate MTD Sta. 2+60 at the CMP extension and downstream side of the headwall form.
