# **FINAL CONSTRUCTION REPORT** for **MACFARLANE DAM** **REHABILITATION PROJECT**

**CONSTRUCTION FILE NO. C-1031B**  
**COLORADO DAM ID: 470202**  
**NID: CO-00997**  
**WATER DIVISION 6 – WATER DISTRICT 47**  
**JACKSON COUNTY, COLORADO**

## Executive Summary

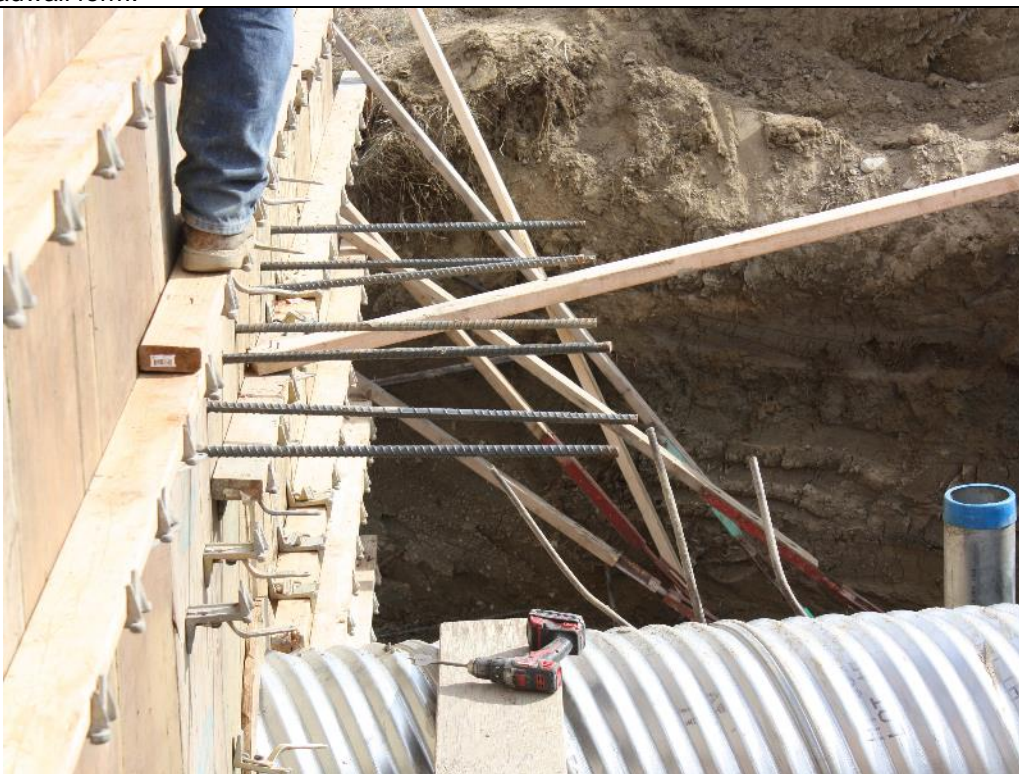
Photo 77. View looking right from behind the headwall form at the 90-degree-bend rebar which will exit from the new concrete headwall and attach into what will be the concrete encasement around the CMP extension. Oct. 20, 2017.

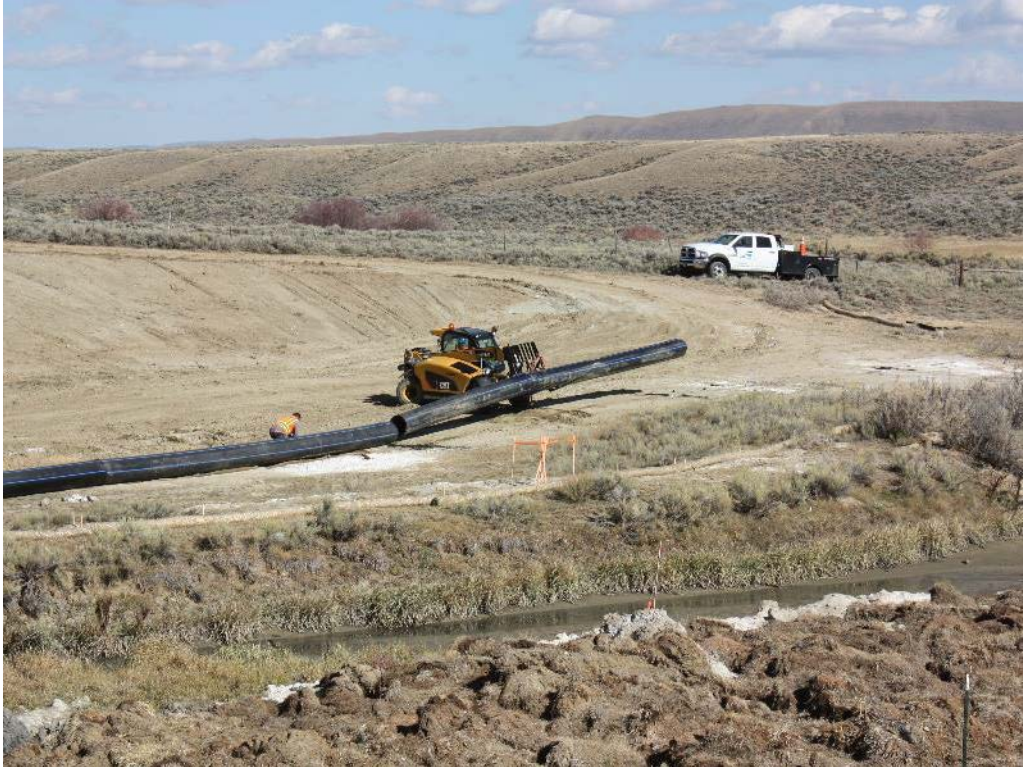
Photo 78. Photo of C&L cutting and removing the HDPE liner pipe from the Staging and Stock Pile Area. The HDPE pipe was loaded onto a trailer and removed from the site. Oct. 20, 2017.

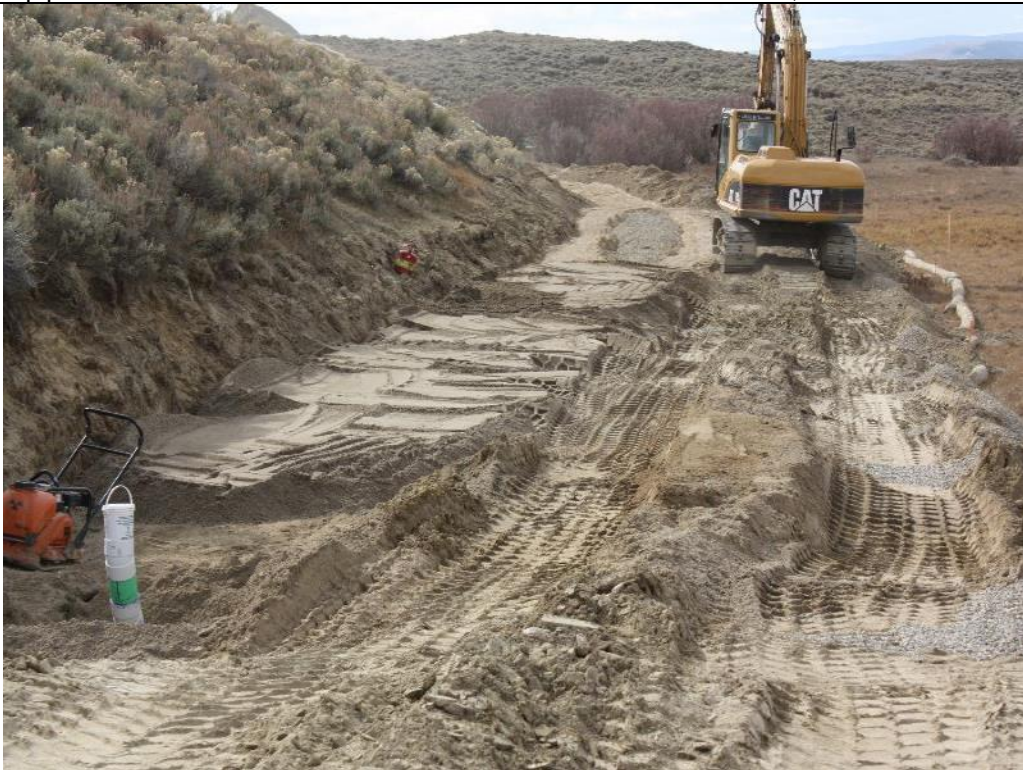
Photo 79. View looking left from NTD Sta. 5+15 at the top layer of Type A Filter Sand being placed and spread by the excavator which represents the top of sand layer for the North Dam Toe Drain. Oct. 20, 2017.

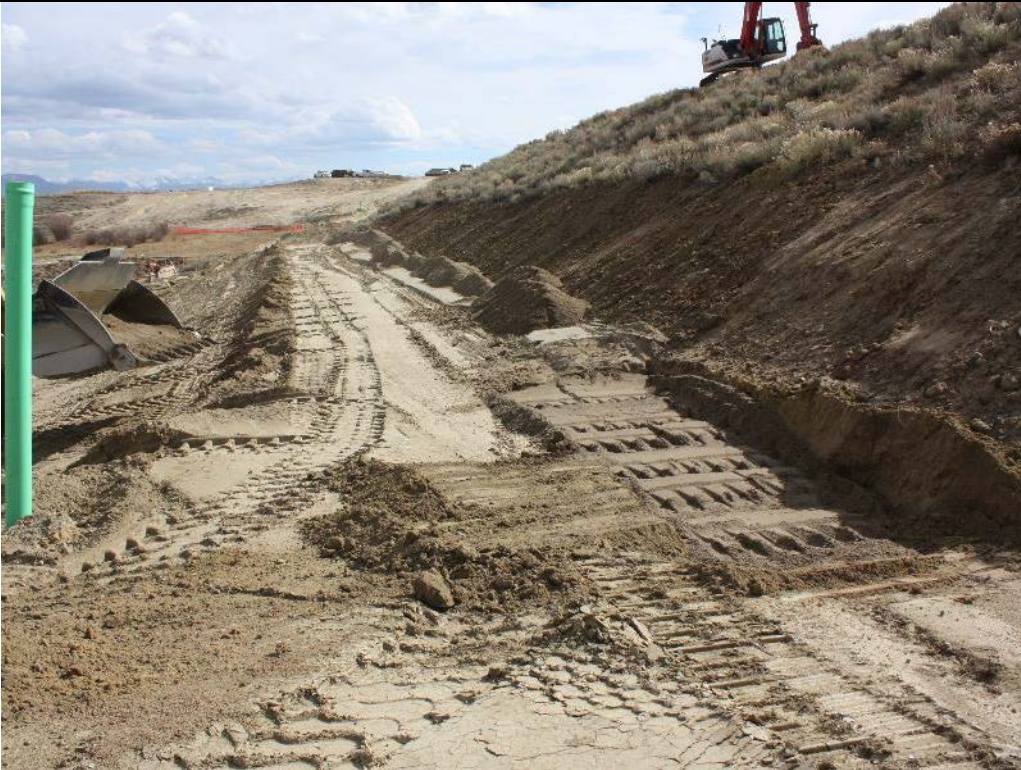
Photo 80. View looking right along the right side of the Main Dam seepage collection system from MTD Sta. 0+00 where the chimney drain and stability berm is still being constructed. Oct. 20, 2017.

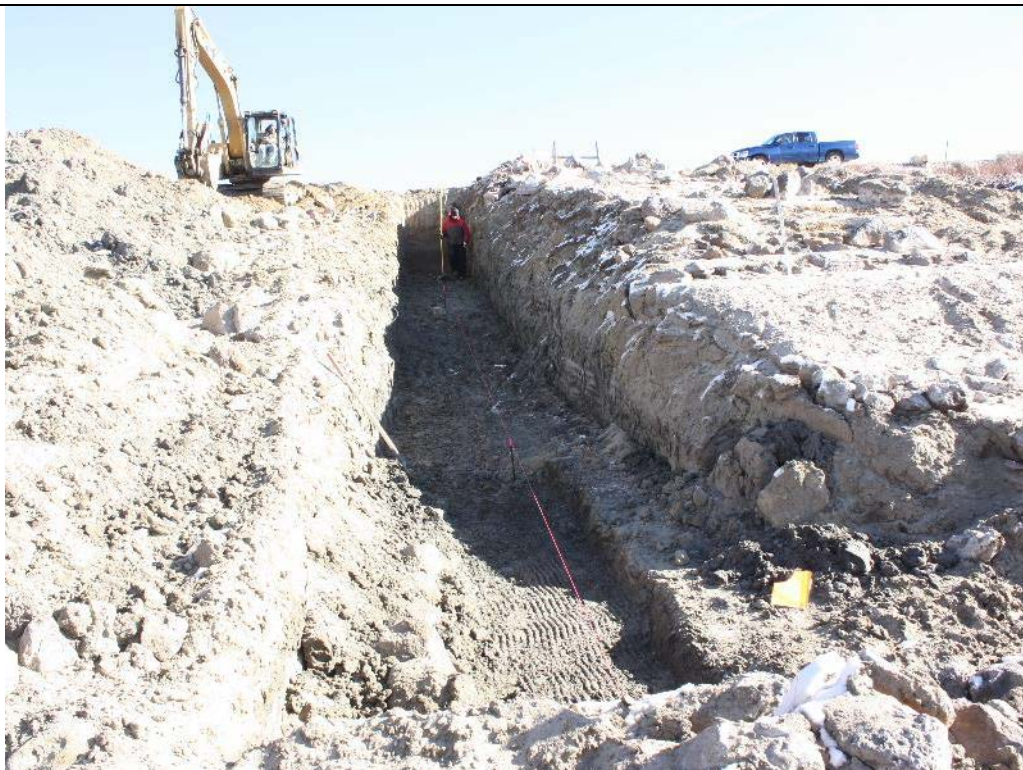
Photo 80. View looking downstream along the excavation for the Air Vent Encasement Wall and RME establishing the final required bottom grade. Oct. 22, 2017.

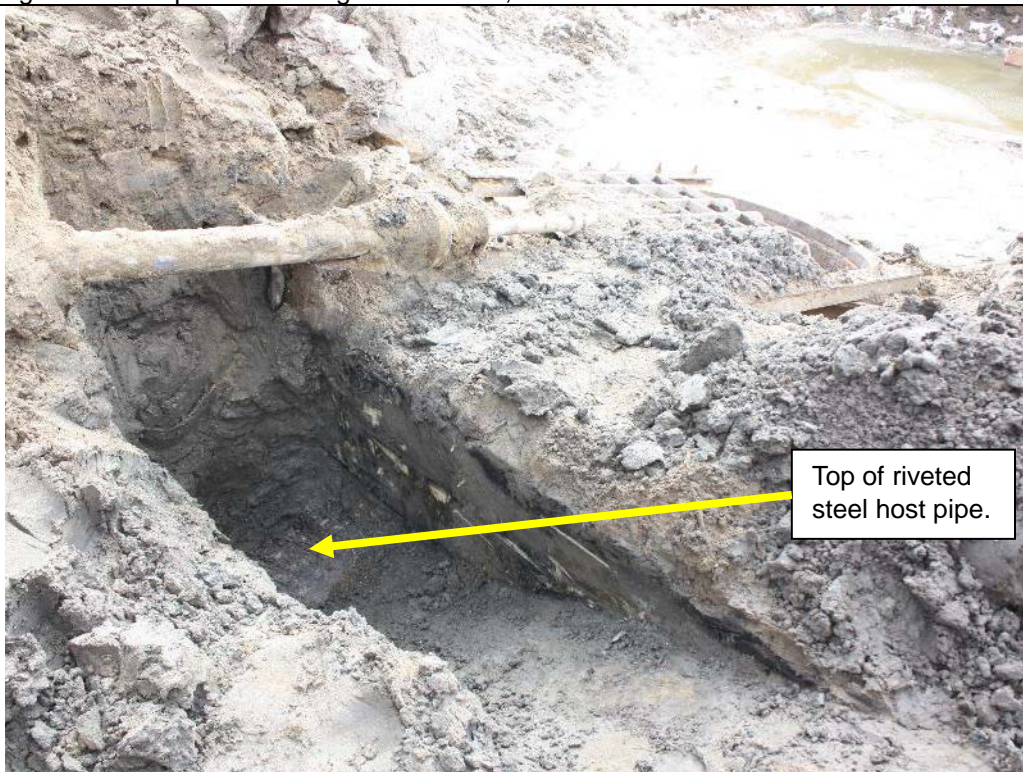
Photo 81. View looking upstream at the gate stem, slide gate, original outlet inlet headwall and excavation to the top of the riveted steel host pipe where the air vent connection was made. Oct. 22, 2017.

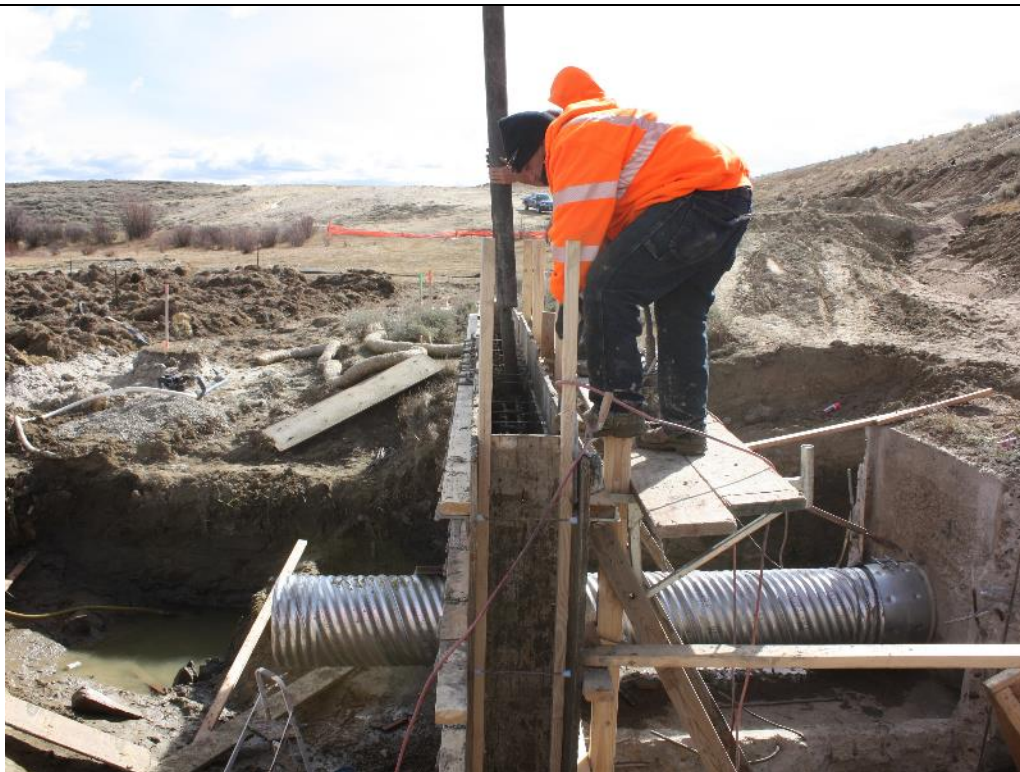
Photo 82. View looking right from the left side of the new outlet works terminal structure headwall at the concrete being placed from the pump truck. Oct. 23, 2017.

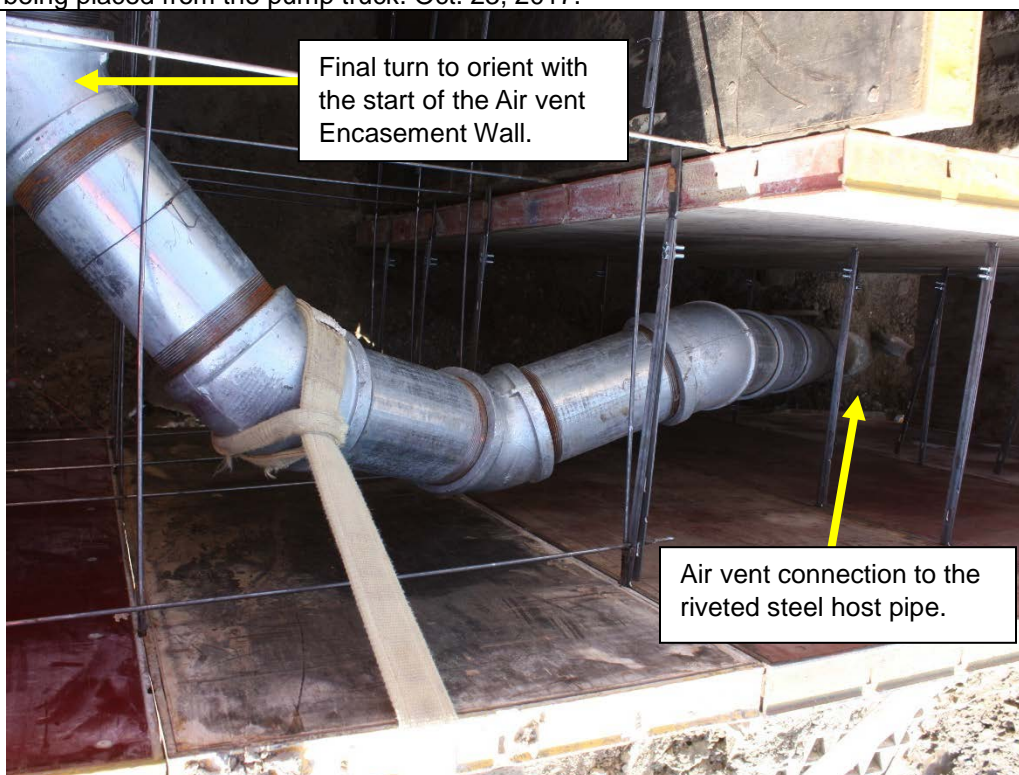
Photo 83. View looking down at the assembled air vent riser section of the air vent pipe in the anchor section of the Air Vent Encasement Wall. Oct. 23, 2017.

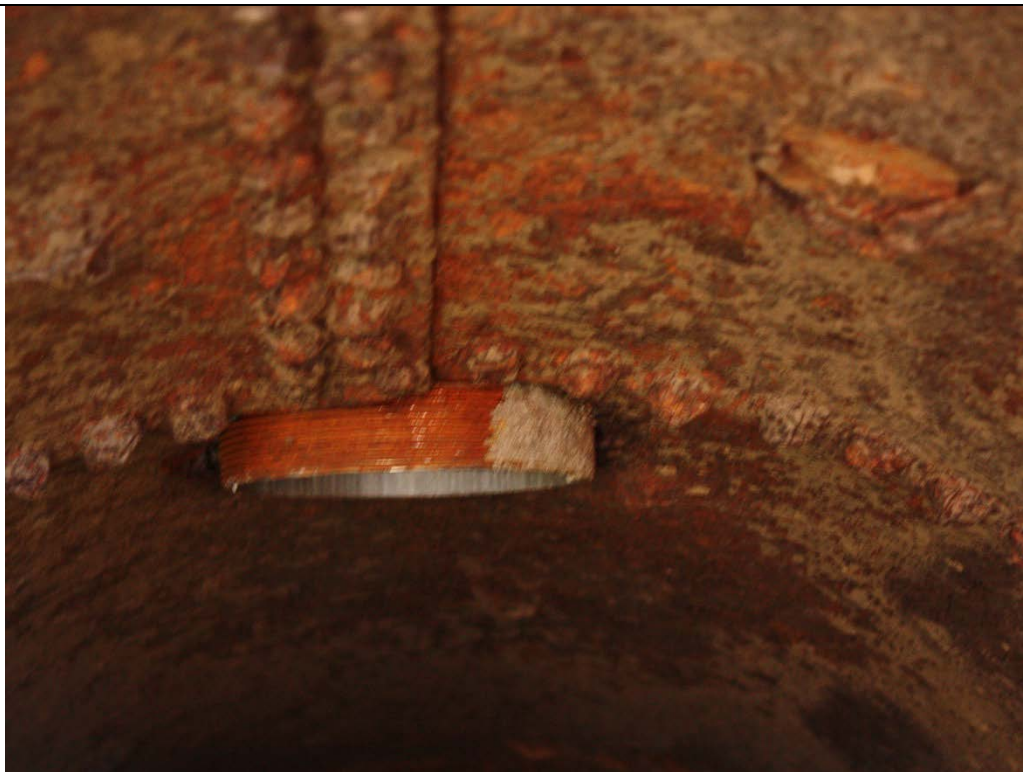
Photo 84. Close-up view of the Air Vent Pipe which was inserted into the original riveted steel outlet works conduit. Oct. 23, 2017.

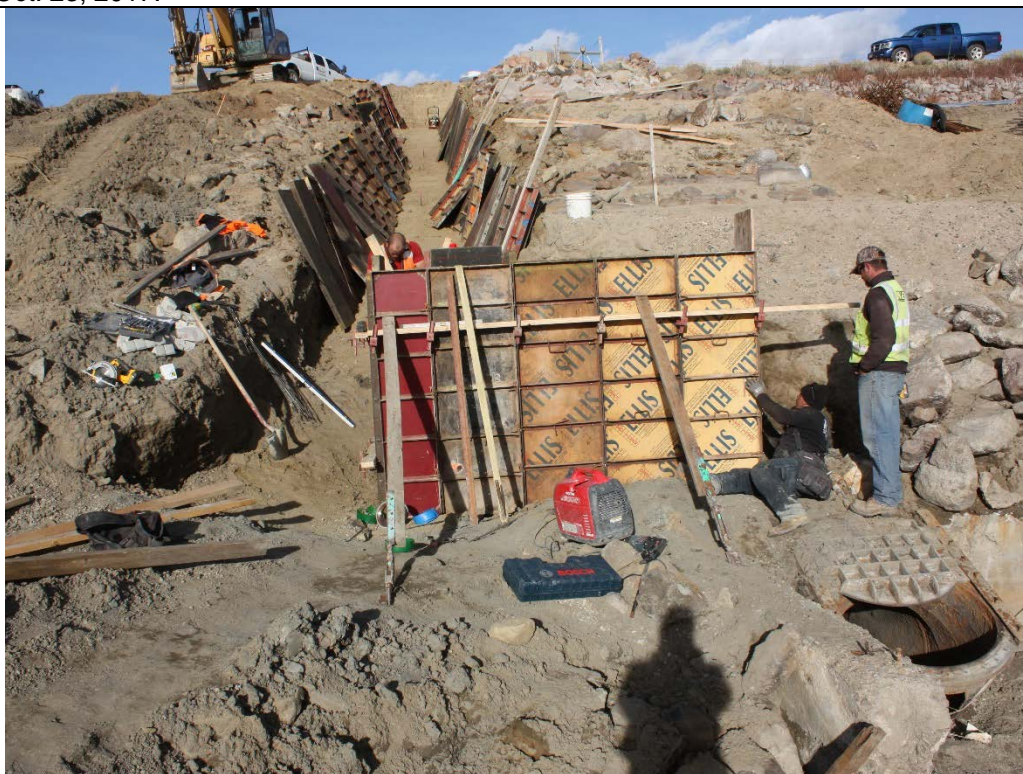
Photo 85. View from the coffer dam looking downstream at the riser section of the Air Vent encasement wall which extends from the attachment to the original riveted steel outlet works conduit to the start of the air vent pipe encasement wall. Oct. 23, 2017.

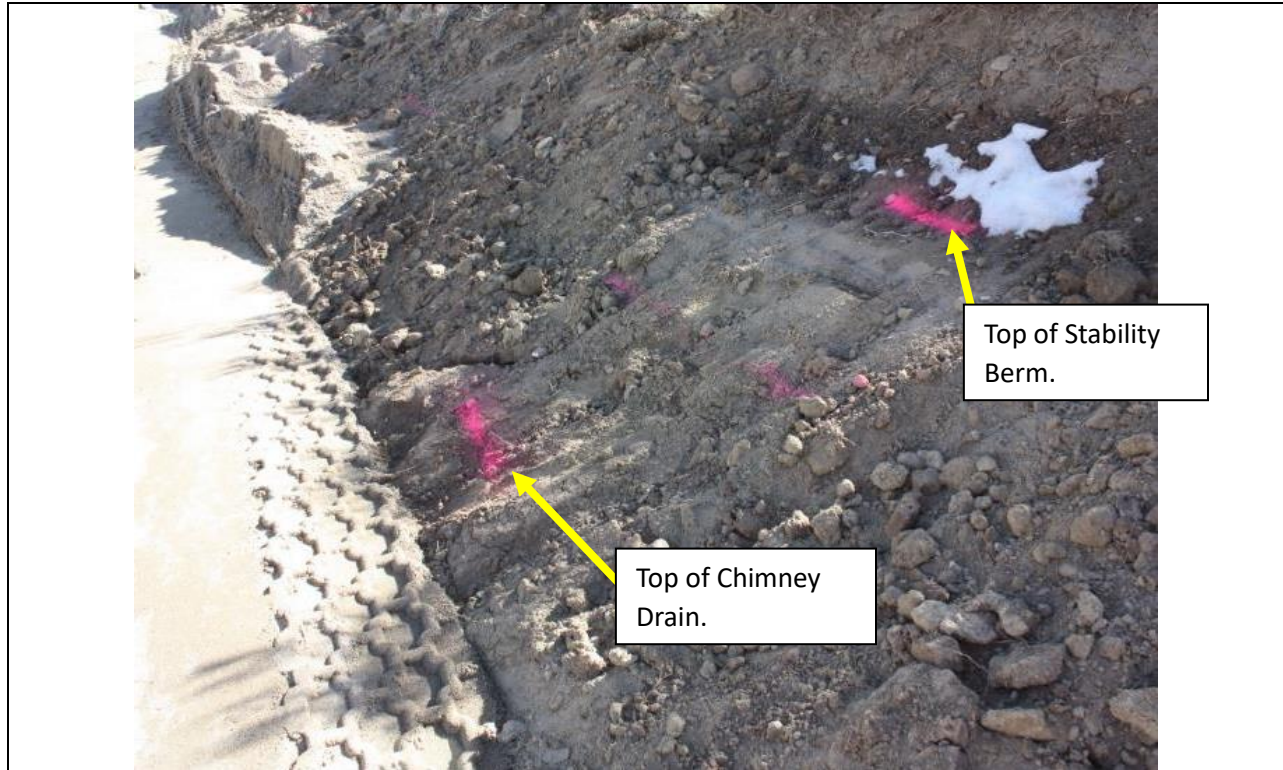
Photo 84. View of the Main Dam Stability Berm to the right of the outlet works which was approximately 2 feet below the final top of berm elevation. Oct. 24, 2014.

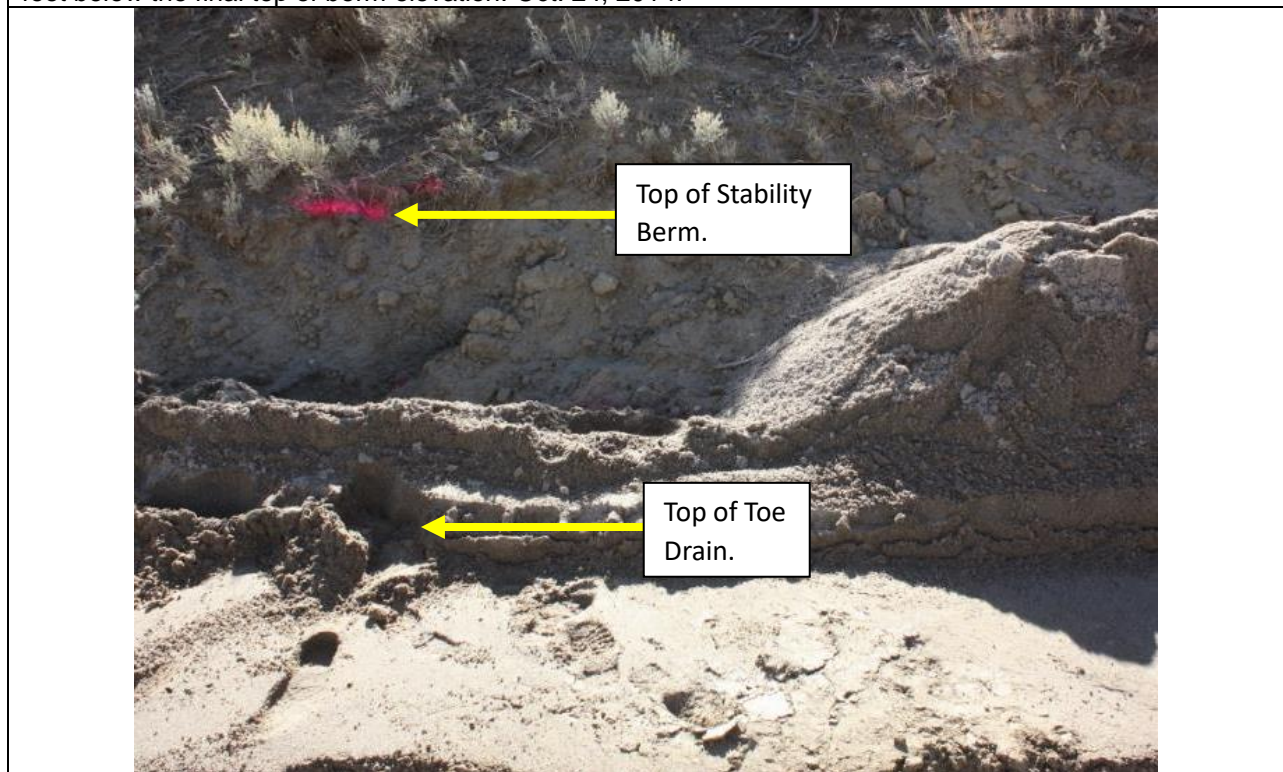
Photo 85. View at the North Embankment stability berm where the top of the Toe Drain two-stage filter was overbuilt, and the Type A Filter Sand was already at 2 feet below the top of berm elevation. As a result, no chimney drain was installed in this area. This was the case for the entire right side of the North Dam Toe Drain (NTD Sta. 1+85 to 5+10) except for NTD Sta. 3+00 to 4+50 which still needed additional Type A Filter Sand for the Chimney Drain. Oct. 24, 2017.

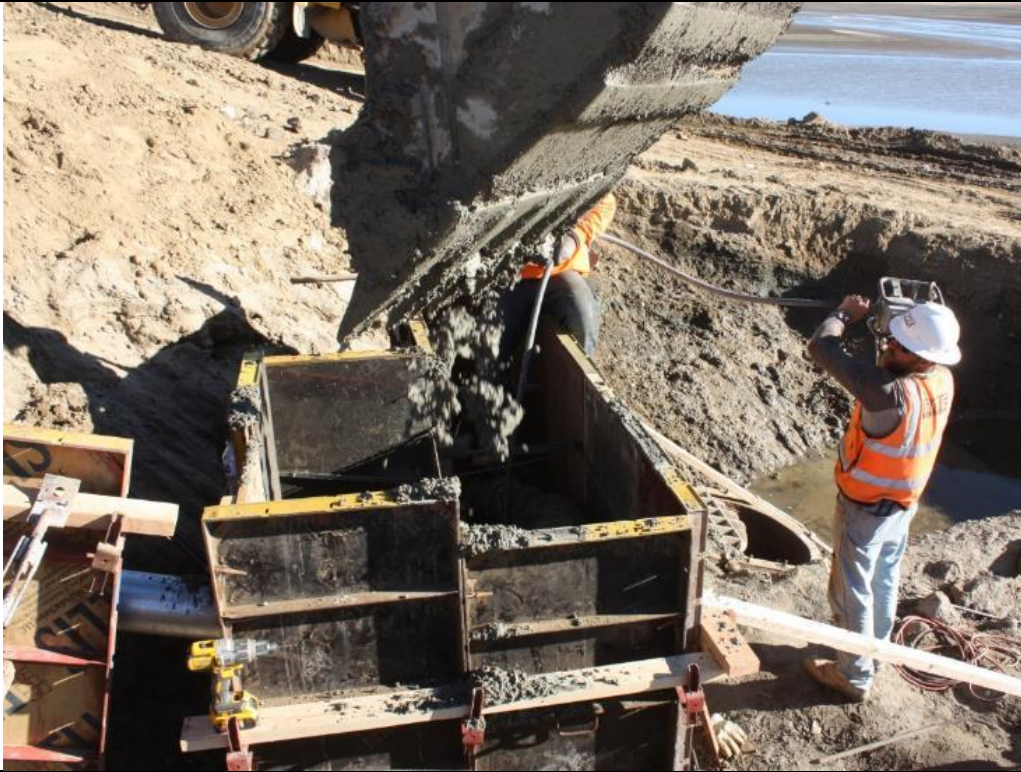
Photo 86. View of the concrete placement for the Air Vent Riser section and Air Vent Encasement Wall anchor section. Oct 24, 2017.

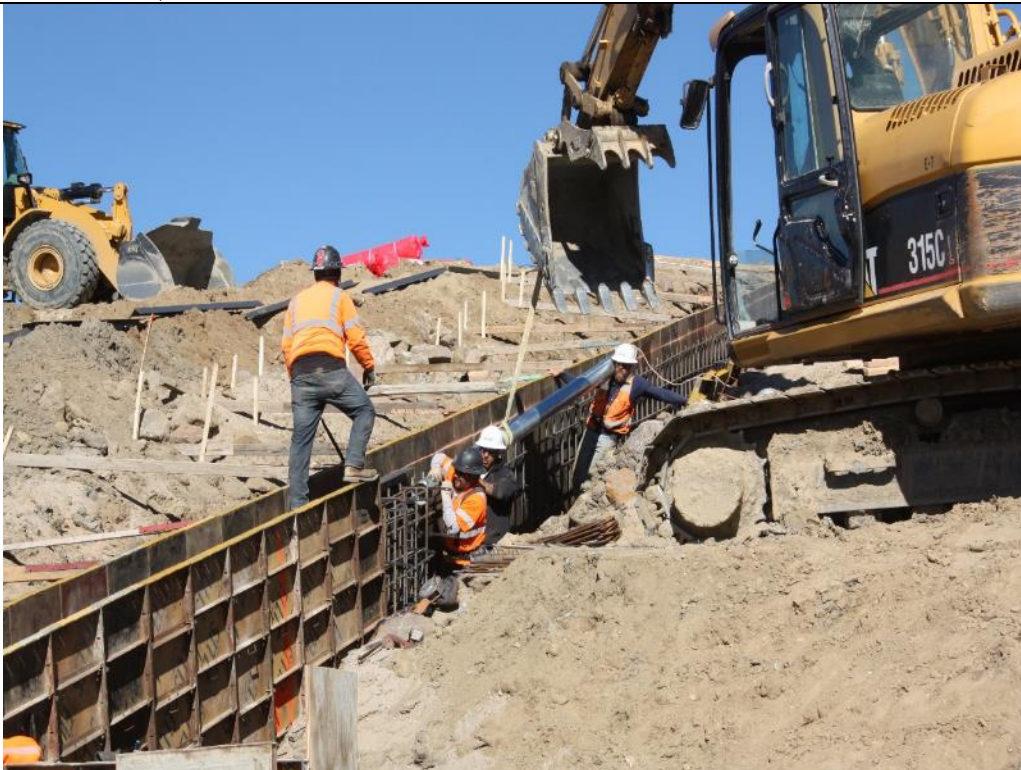
Photo 87. View looking downstream at the installation of the galvanized steel Air Vent pipe and partial rebar and formwork for the Air Vent Encasement Wall. Oct. 25, 2017.

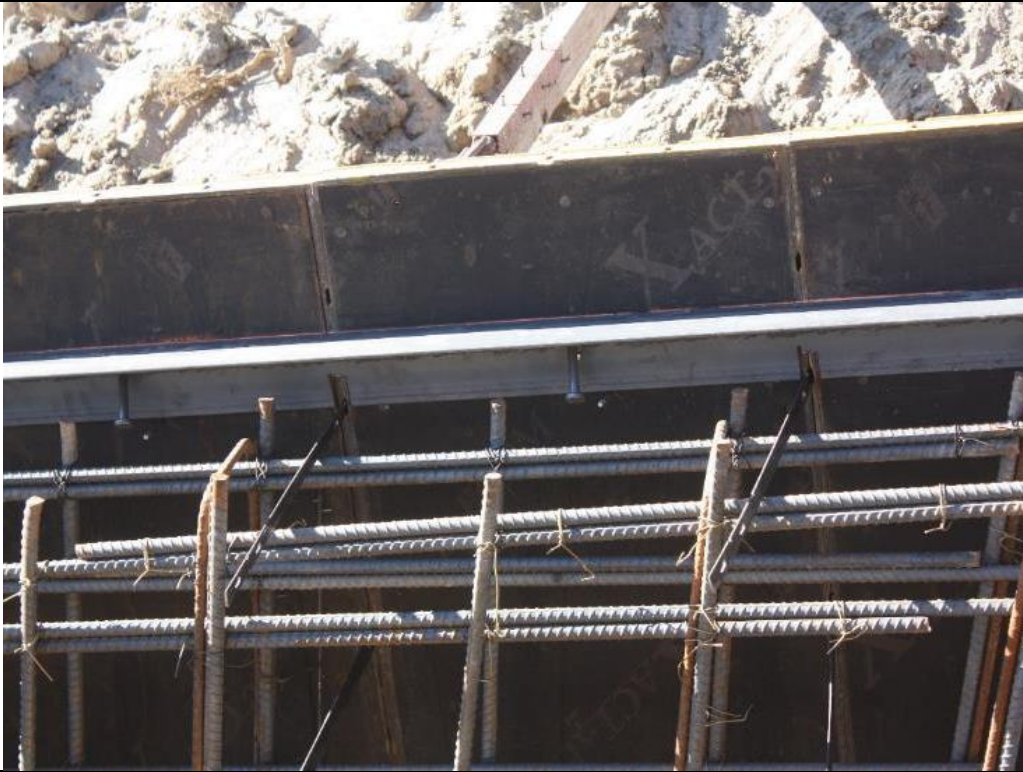
Photo 88. Close-up view of the angle iron, which to accommodate the form ties had a notch cut into the bottom portion. The angle iron was embedded into the concrete for the reservoir staff gage. Oct. 25, 2017.

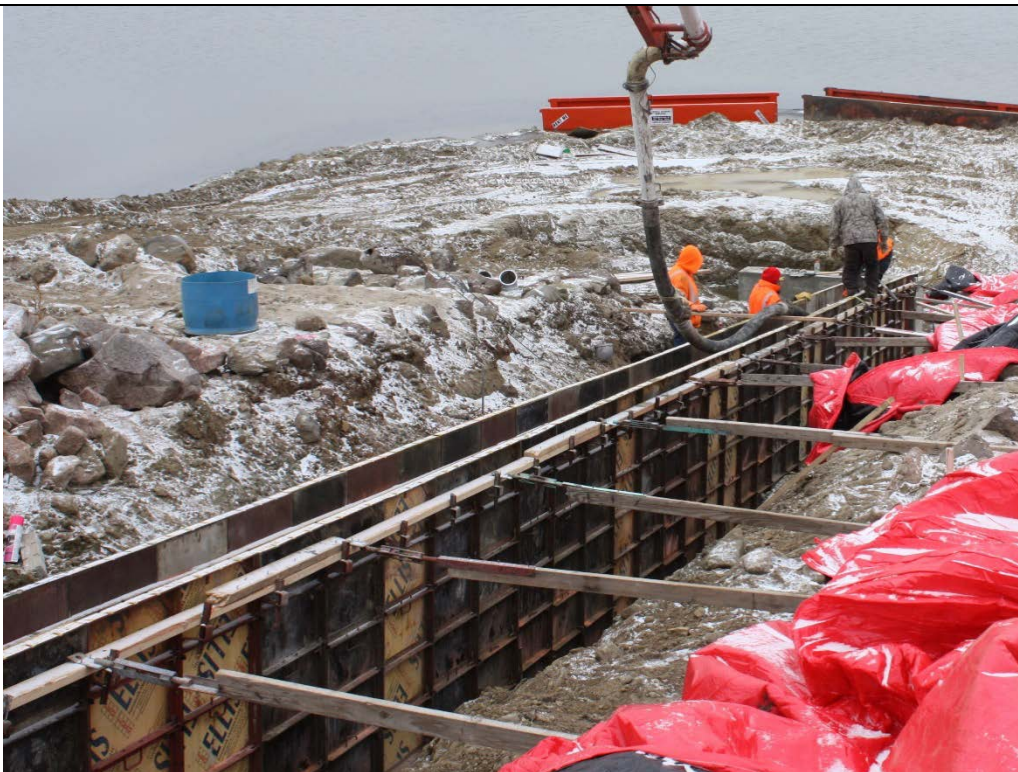
Photo 90. View looking upstream from near the dam crest at the placement of concrete by the pump truck into the Air Vent Encasement Wall. Oct. 30, 2017.

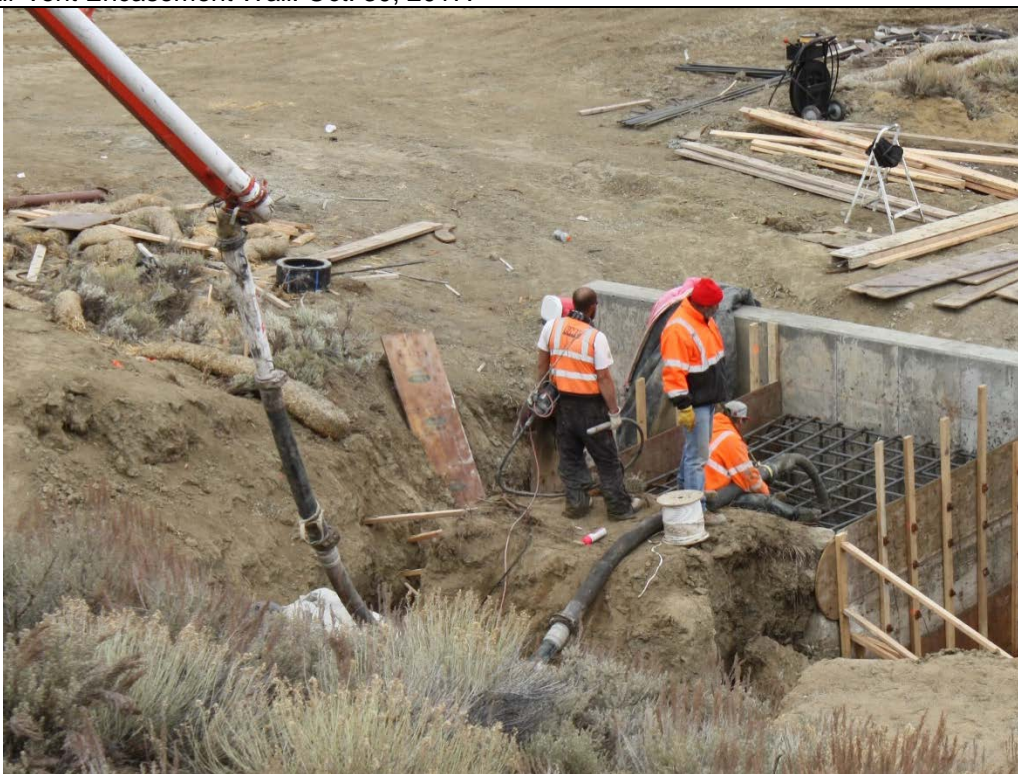
Photo 91. View looking downstream at the placement of concrete by the pump truck into the CMP outlet works conduit extension encasement section. Oct. 30, 2017.

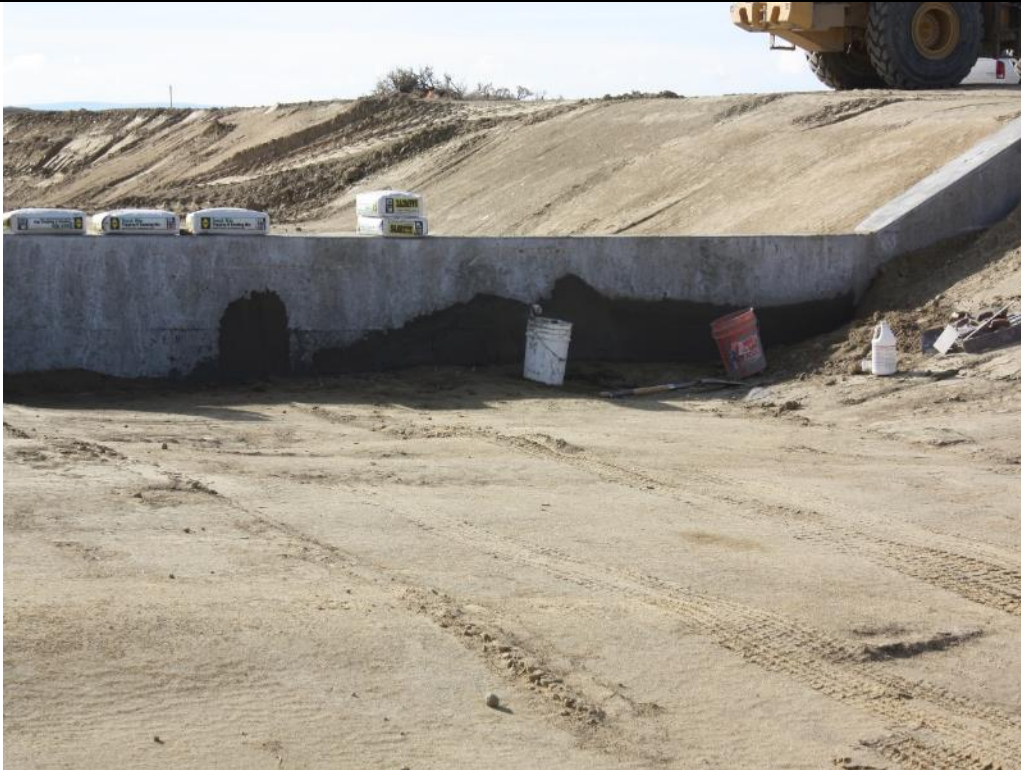
Photo 92. View looking upstream at the downstream side of the upstream spillway cutoff wall where RME patched the concrete from the initial partial concrete pour. Oct. 31, 2017.

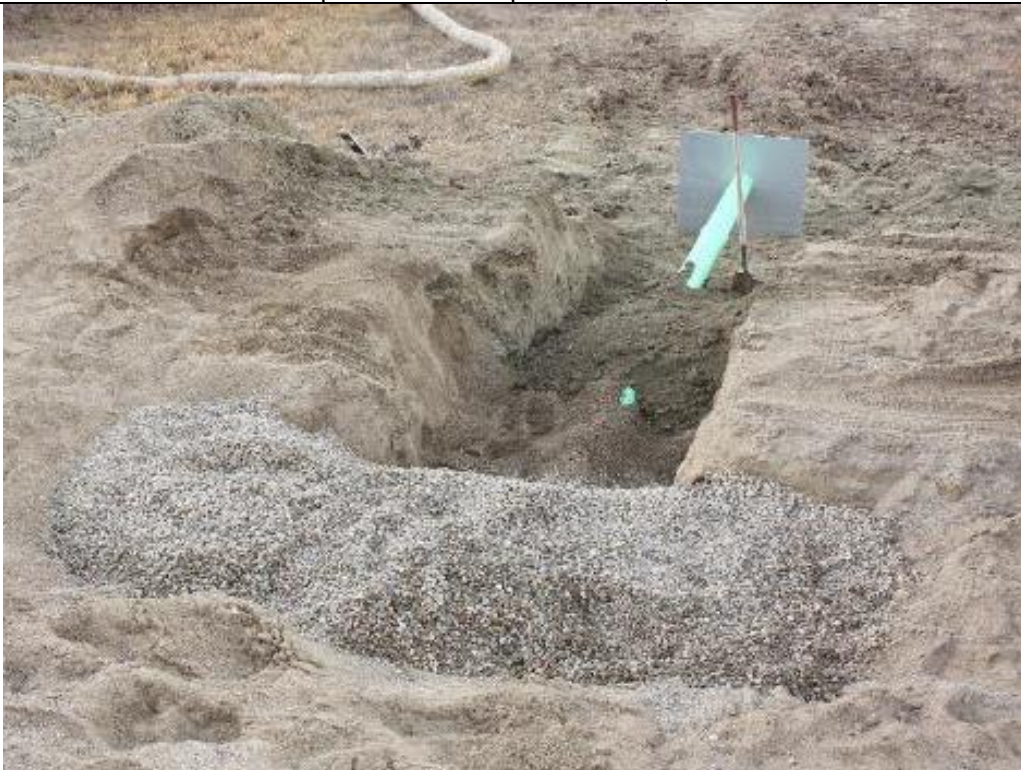
Photo 93. View looking downstream from NTD Sta. 1+75 at the North Embankment Toe Drain Outfall after installation of the discharge pipe and steel plate. Nov. 1, 2017.

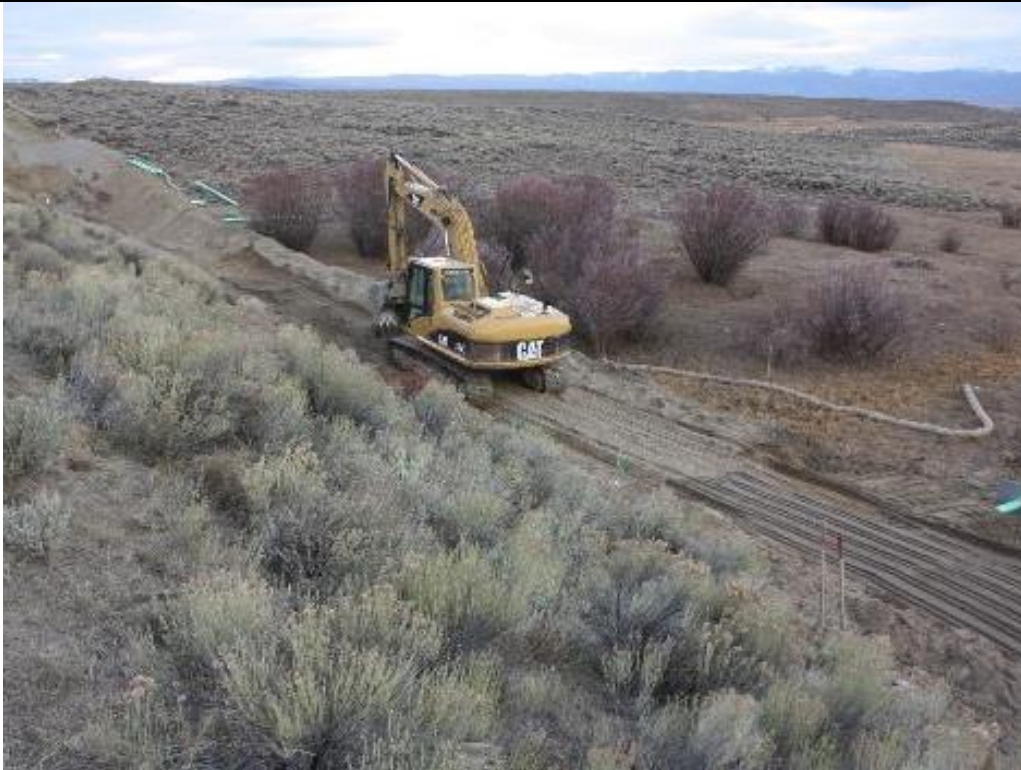
Photo 94. View looking left and downstream from approximate NTD Sta. 2+00 at the buried toe drain discharge pipe and galvanized steel plate, and the Work by RME to cover the Type B Gravel of the toe drain system. Nov. 1, 2017.

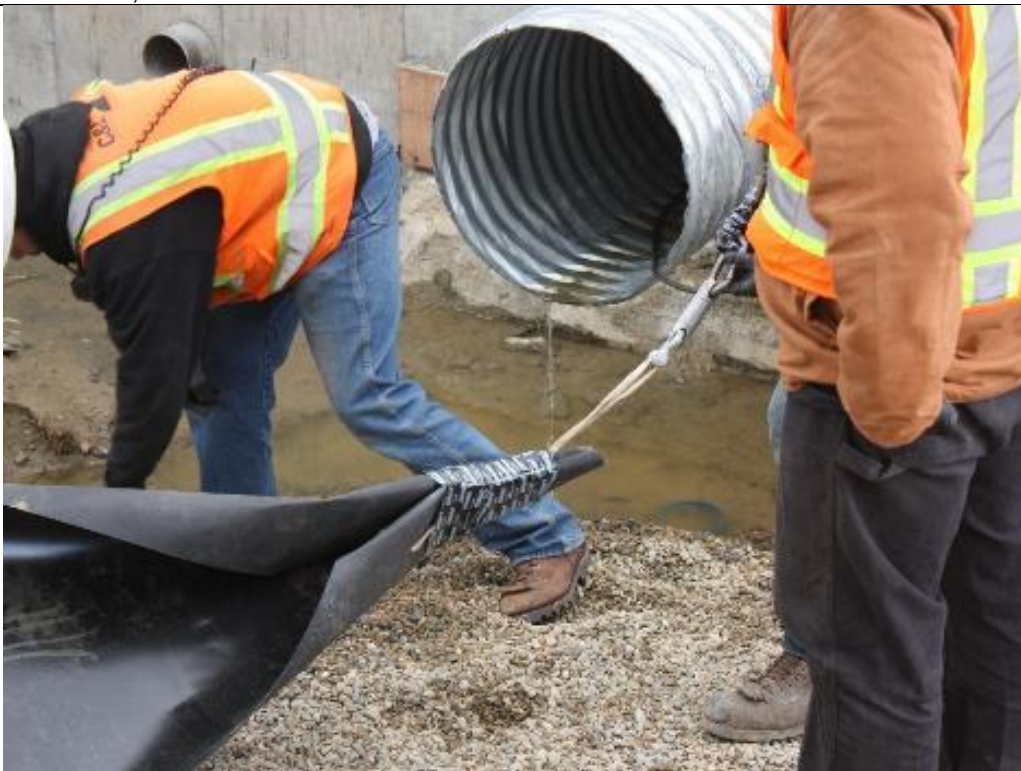
Photo 95. View of the protective liner which was pulled through the original outlet works conduit prior to pulling through the CIPP liner. This base material covered the bottom half of the host pipe and provided a smooth surface and protection for when the CIPP liner was subsequently pulled through the conduit. Nov. 1, 2017.

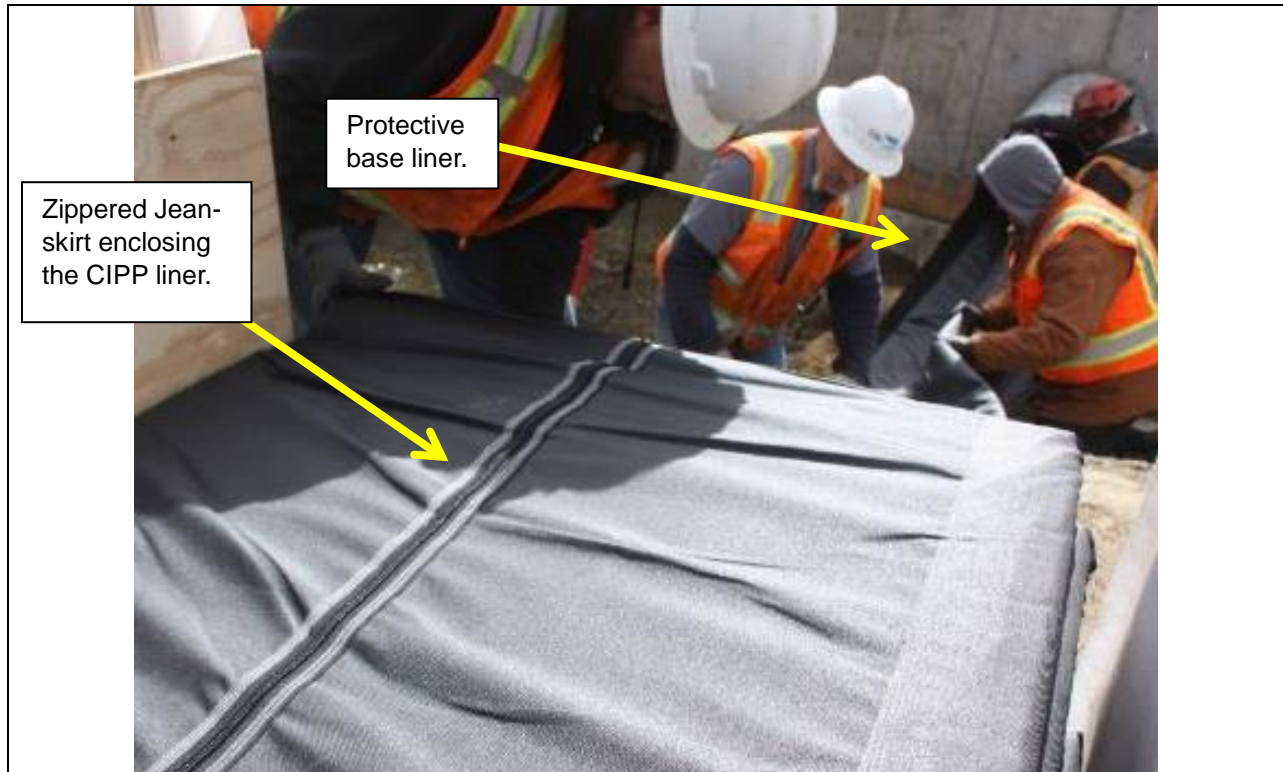
Photo 96. View looking at the CIPP liner being installed from the downstream end of the outlet works conduit. Note, a jean-skirt surrounds the CIPP liner for UV protection and to prevent over-expansion of the CIPP liner during inflation which was required for the upstream inlet transition section from 24 inches to 36 inches in diameter. Nov. 1, 2017.

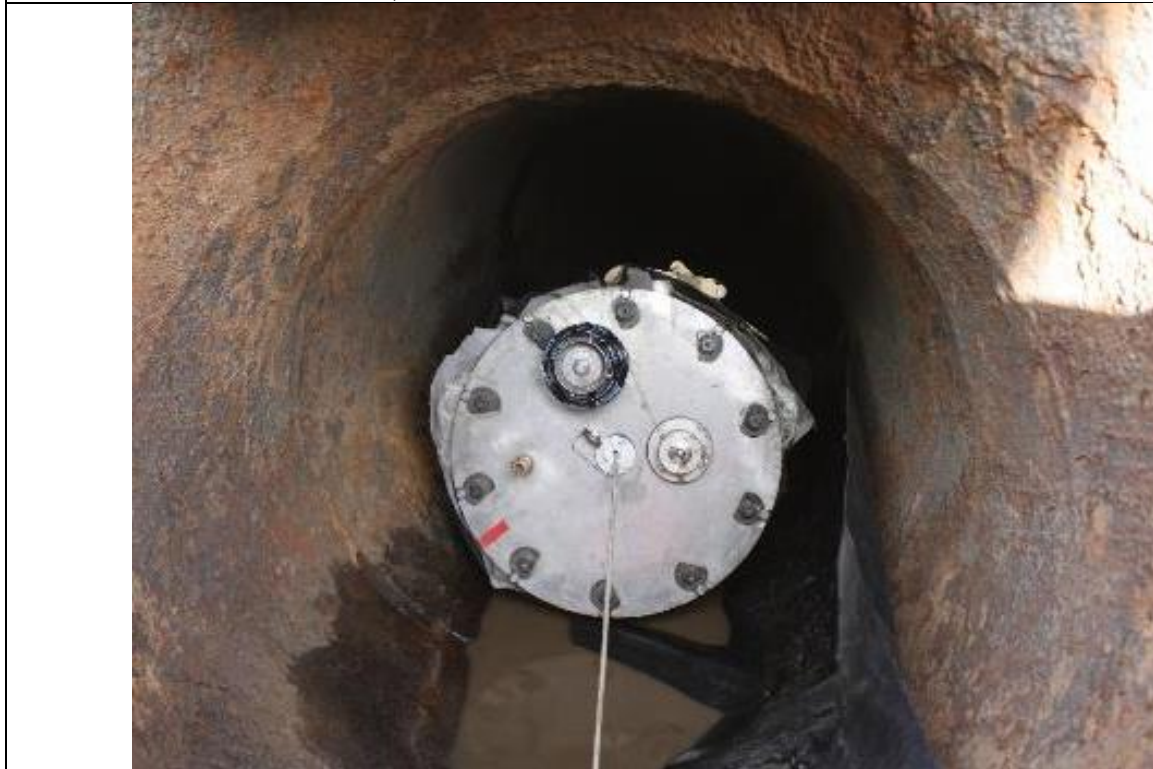
Photo 97. View looking downstream from the upstream inlet at the sealed upstream start of the CIPP liner. Nov. 1, 2017.

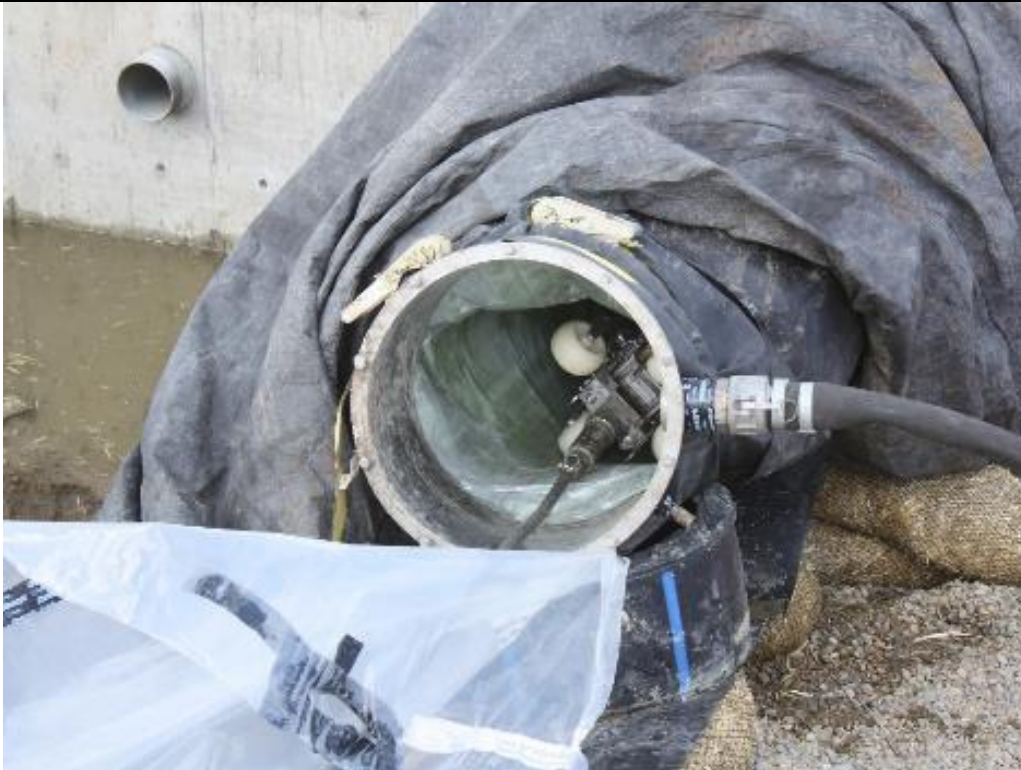
Photo 98. View looking upstream from the downstream end of the outlet works conduit at the roller device which houses the UV lamps and was now inserted into the partially inflated, downstream end of the pipe. Nov. 1, 2017.

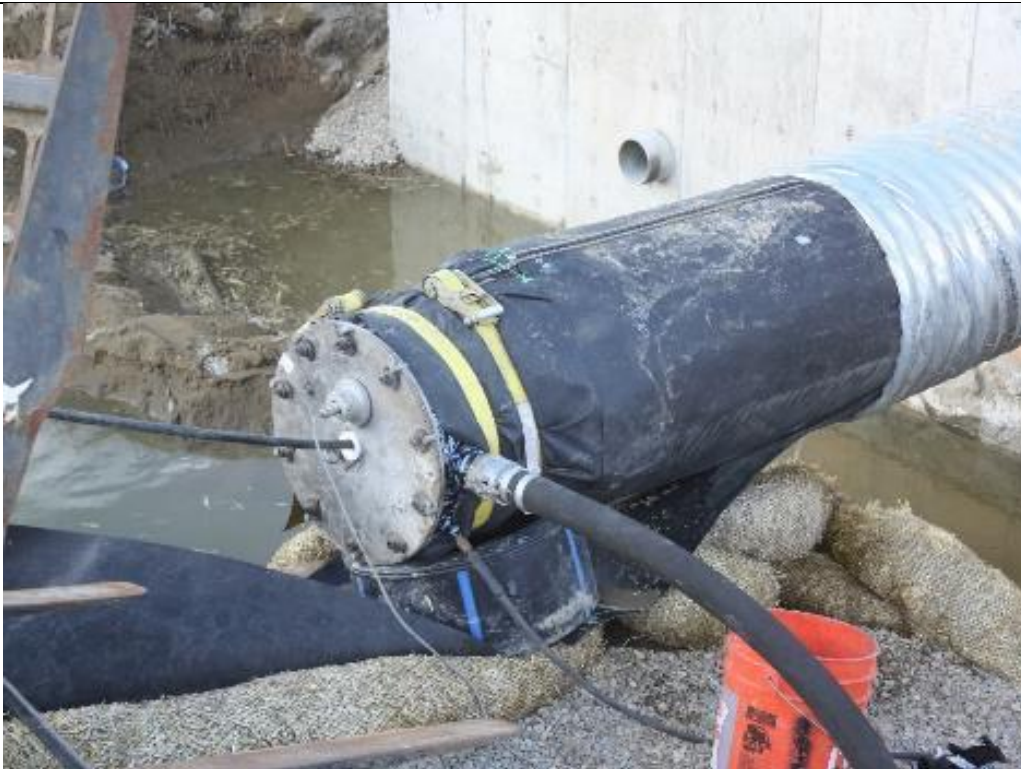
Photo 99. View looking right from the left side of the downstream end of the outlet conduit at the sealed end of the CIPP liner during inflation. C&L slowly raised the pressure within the CIPP liner to 450 mbar (6.2 psi) to expand the liner to fill the host pipe. Nov. 1, 2017.

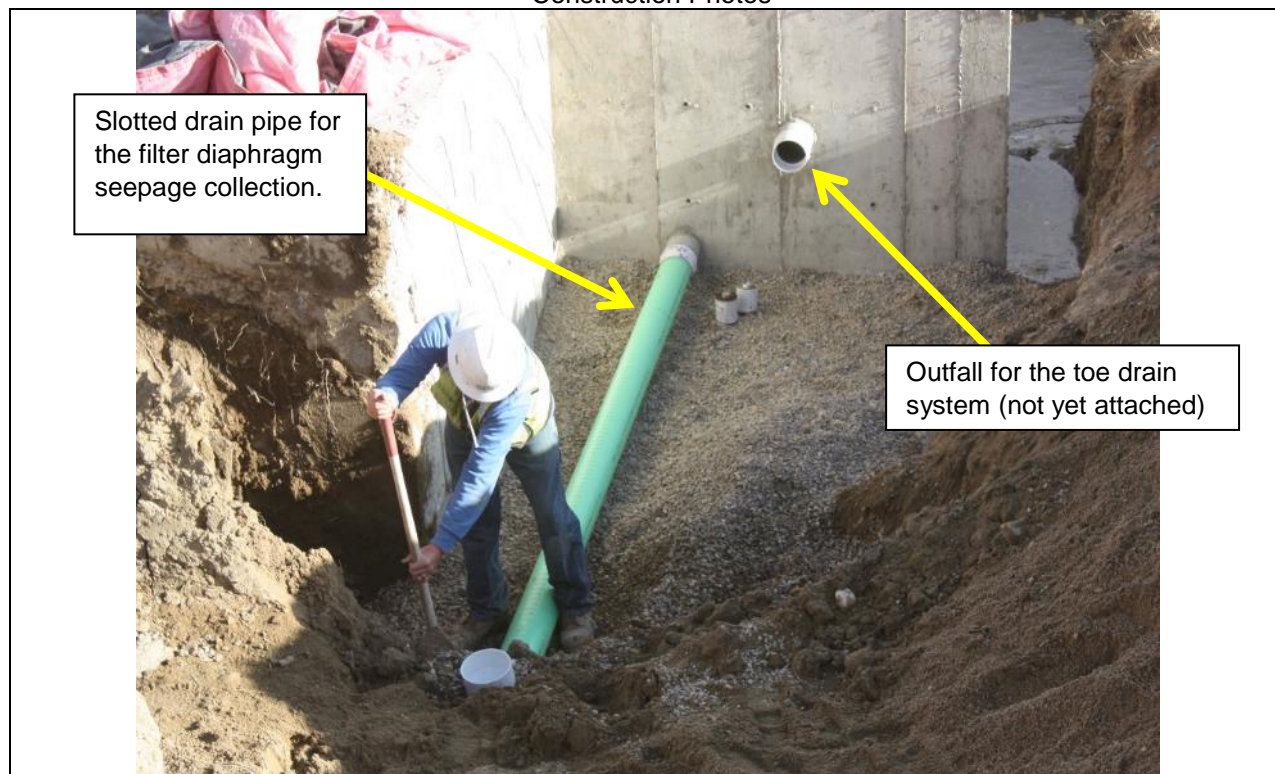
Photo 102. View looking downstream at the right side of the outlet works terminal structure headwall. The filter diaphragm slotted drain pipe was being installed and buried by Type B Gravel Drain. Nov. 2, 2017.
