# **FINAL CONSTRUCTION REPORT** for **MACFARLANE DAM** **REHABILITATION PROJECT**

**CONSTRUCTION FILE NO. C-1031B**  
**COLORADO DAM ID: 470202**  
**NID: CO-00997**  
**WATER DIVISION 6 – WATER DISTRICT 47**  
**JACKSON COUNTY, COLORADO**

## Executive Summary

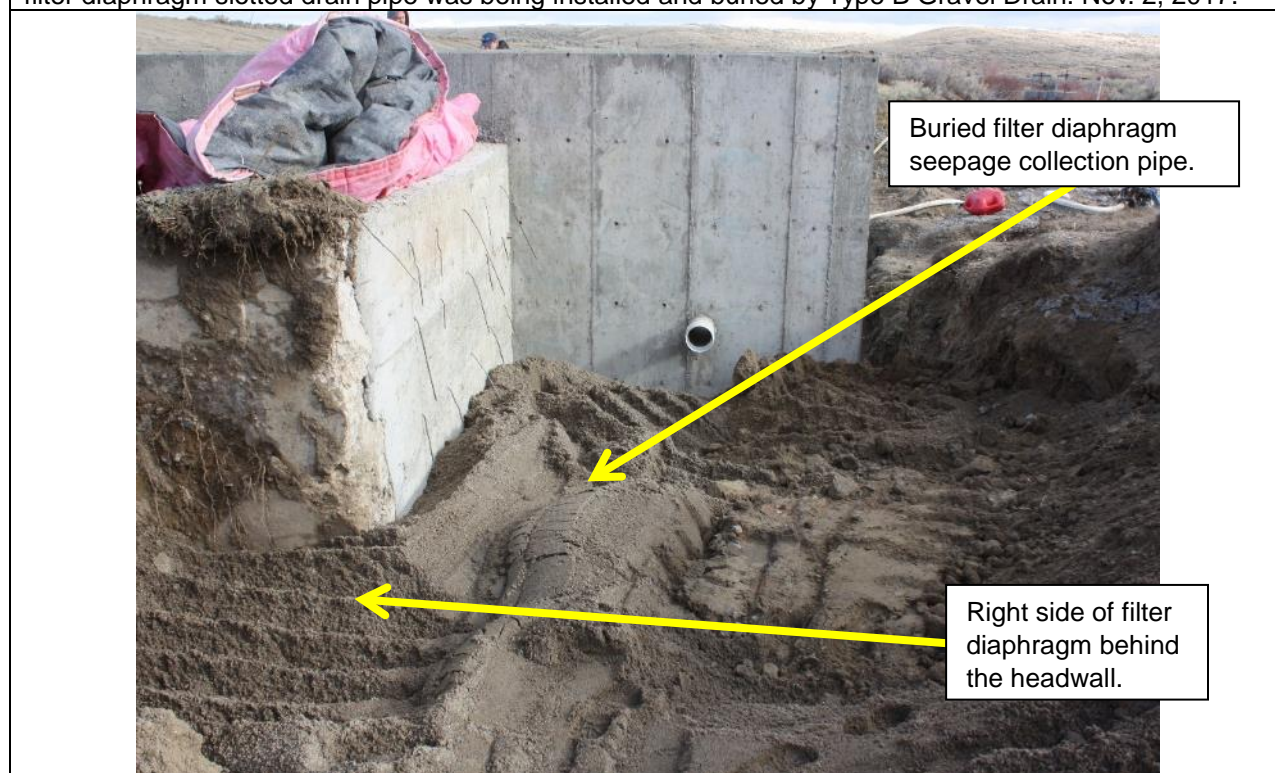
Photo 103. View looking downstream at the right side of the outlet works terminal structure headwall. The filter diaphragm slotted drain pipe was now buried by Type A Filter Sand, and the filter diaphragm was starting behind the old terminal structure headwall. Nov. 2, 2017.

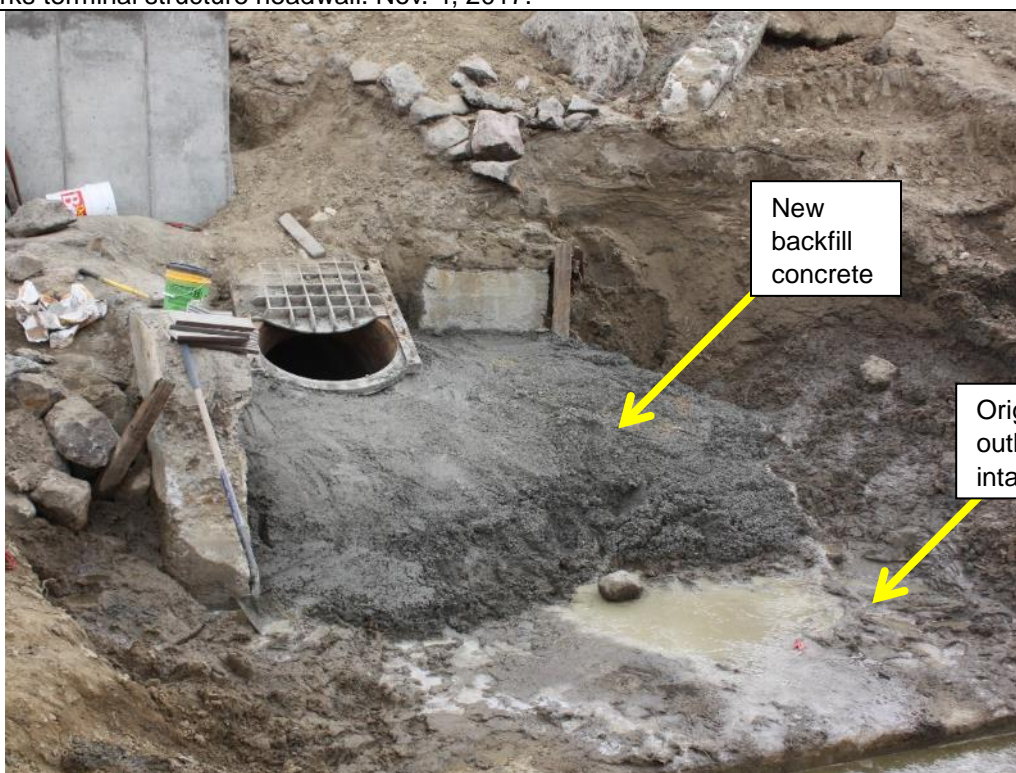
Photo 105. View looking downstream from the coffer dam at the concrete placed yesterday around the outlet conduit inlet. Nov. 4, 2017.

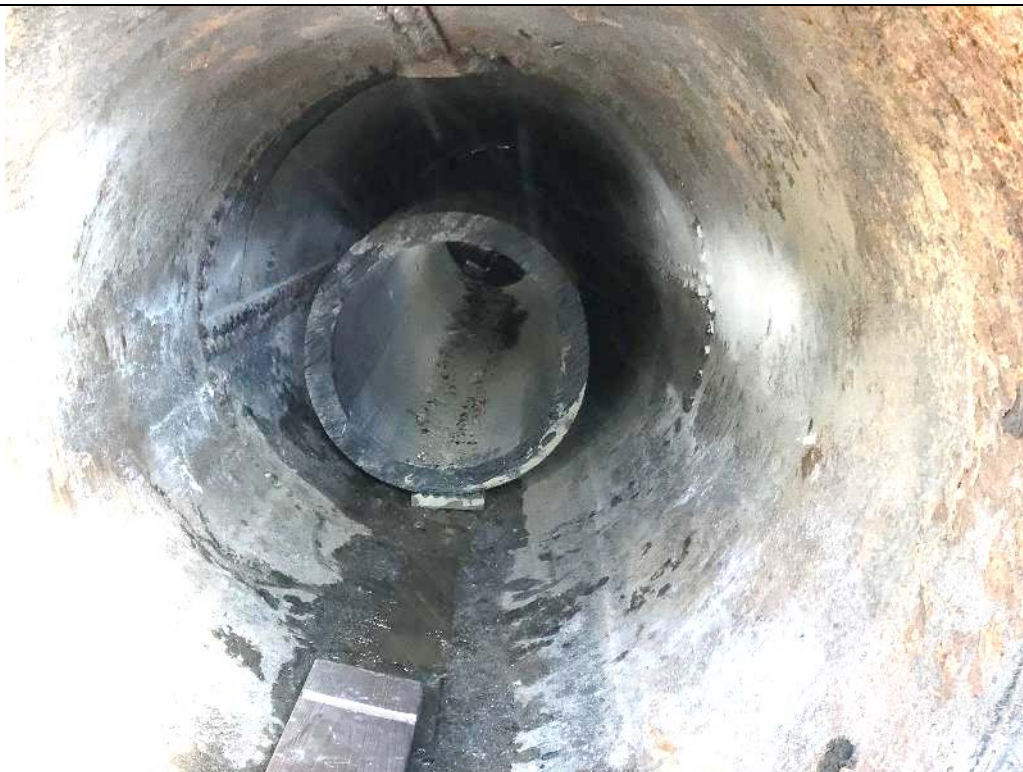
Photo 106. View looking downstream from the outlet works inlet where the HDPE liner section had been inserted into the CIPP liner at the riveted steel pipe diameter transition section. Decking was used to shim-up the base of the HDPE liner to achieve consistent annular space. Nov. 3, 2017.

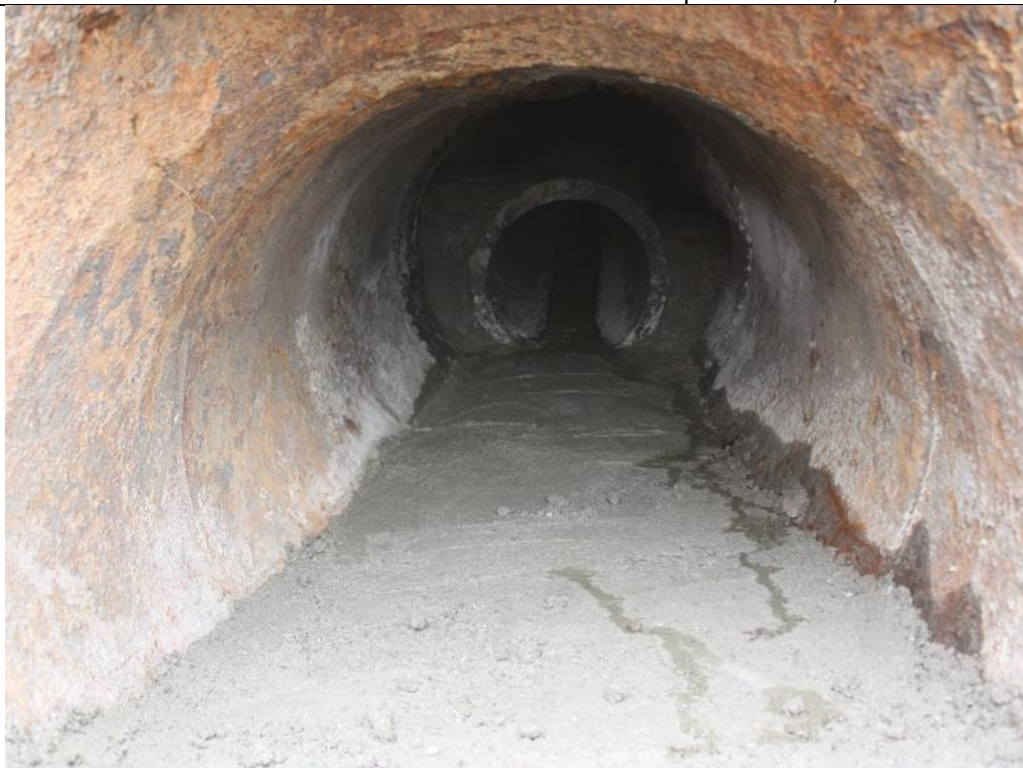
Photo 107. View looking downstream into the inlet of the outlet conduit at the original riveted steel host pipe transition section which had been filled in along the bottom up to the invert of the HDPE liner pipe with concrete. Nov. 4, 2017.

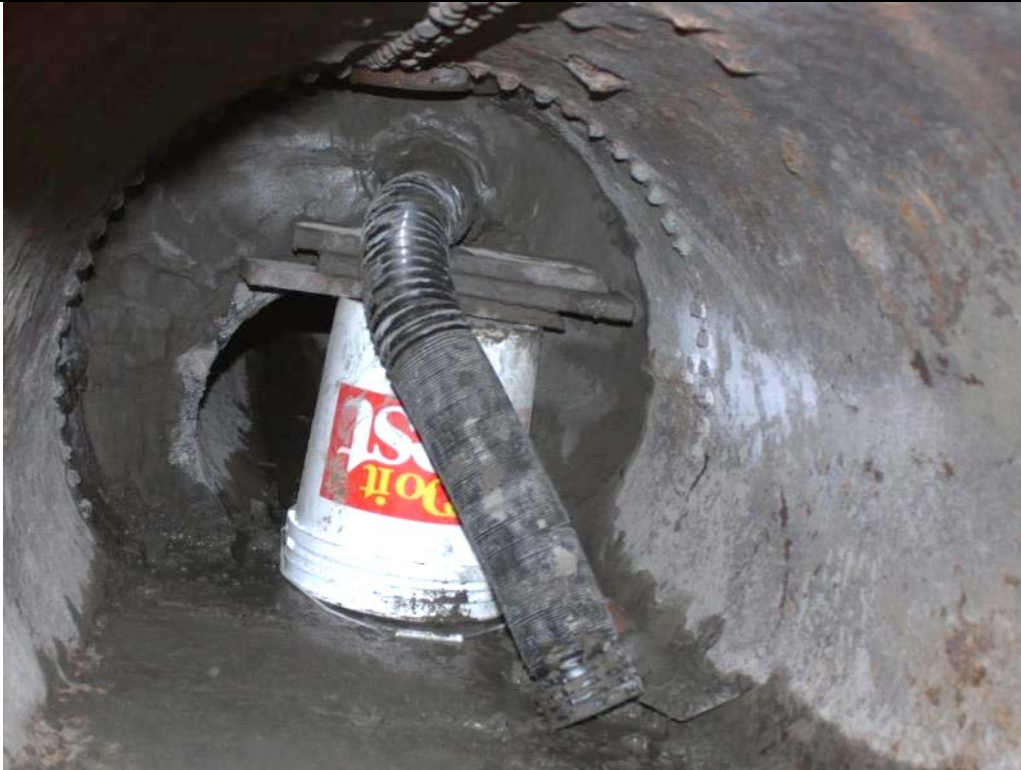
Photo 108. View looking downstream at the upper half of the bulkhead which was built after grouting the bottom half of the HDPE annular space. Note the 4-inch-diameter flexible hose was encased in the bulkhead and was used to finalize the annular space grouting once the bulkhead was set. Nov. 4, 2017.

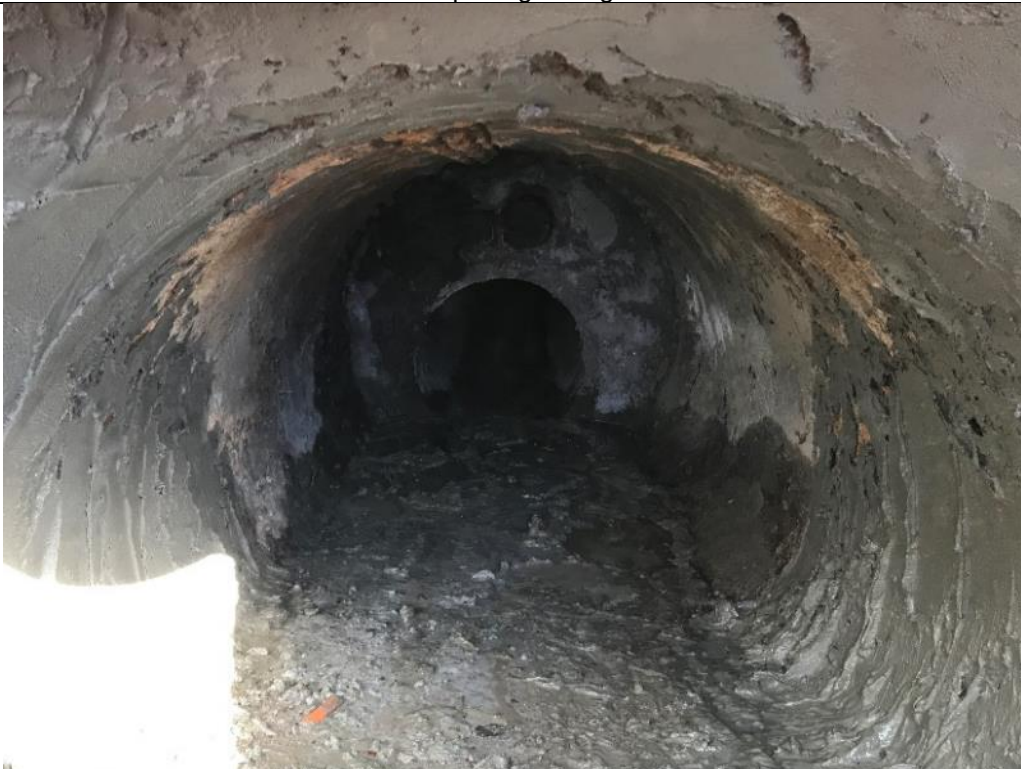
Photo 109. View looking downstream from the outlet conduit inlet gate at the non-shrink grout coating being installed in the invert and around the perimeter of the existing riveted steel outlet works pipe. Note, additional non-shrink grout was placed along the top of the existing riveted steel outlet works pipe after this picture was taken. Nov. 7, 2017.

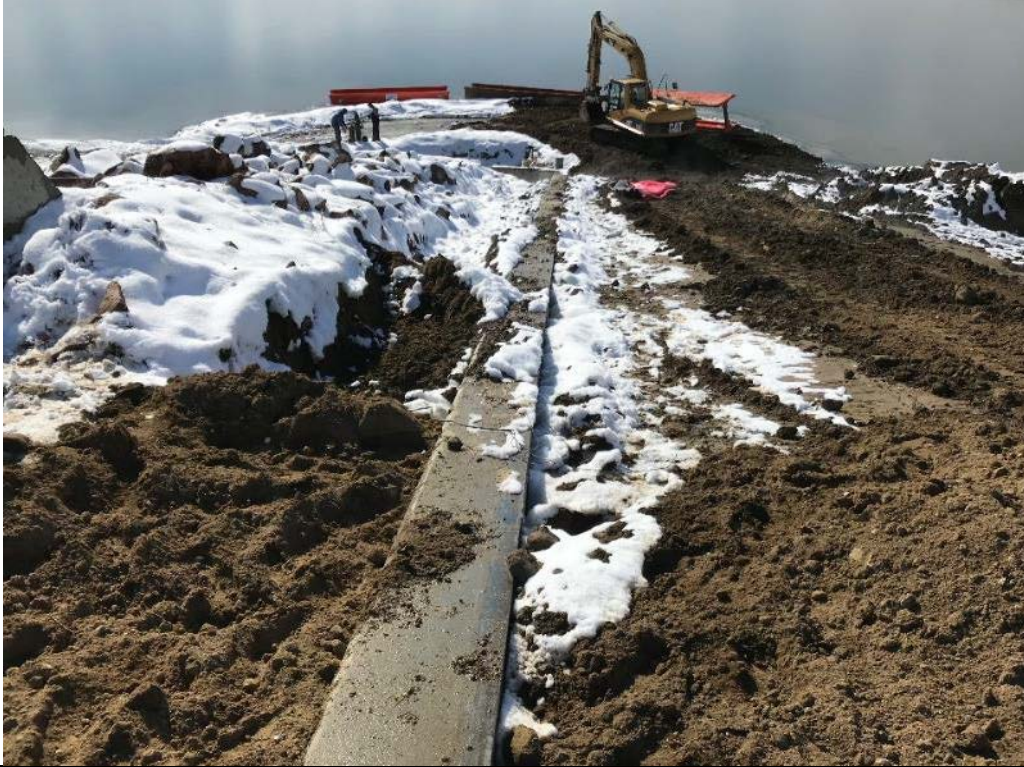
Photo 110. View looking down at the top of the air vent encasement wall containing the staff gage grade beam which had now been backfilled. RME completed the outlet works work and was preparing to start removing the cofferdam and begin re-filling the reservoir once permission to fill was granted by the Colorado Division of Water Resources. Nov. 7, 2017.

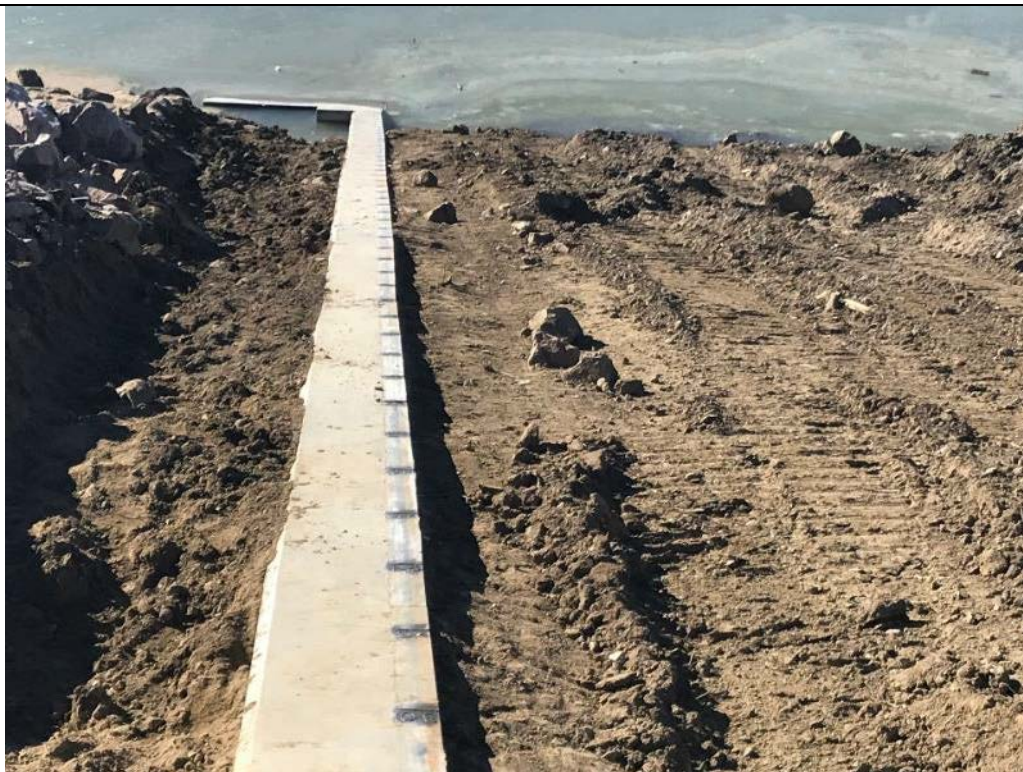
Photo 116. View looking down the air vent grade beam and staff gage. Note that the staff gage numbers are welded on the angle iron at 0.5-foot intervals. Note the additional grading and riprap that needs to be installed prior to completion. Nov. 13, 2017.

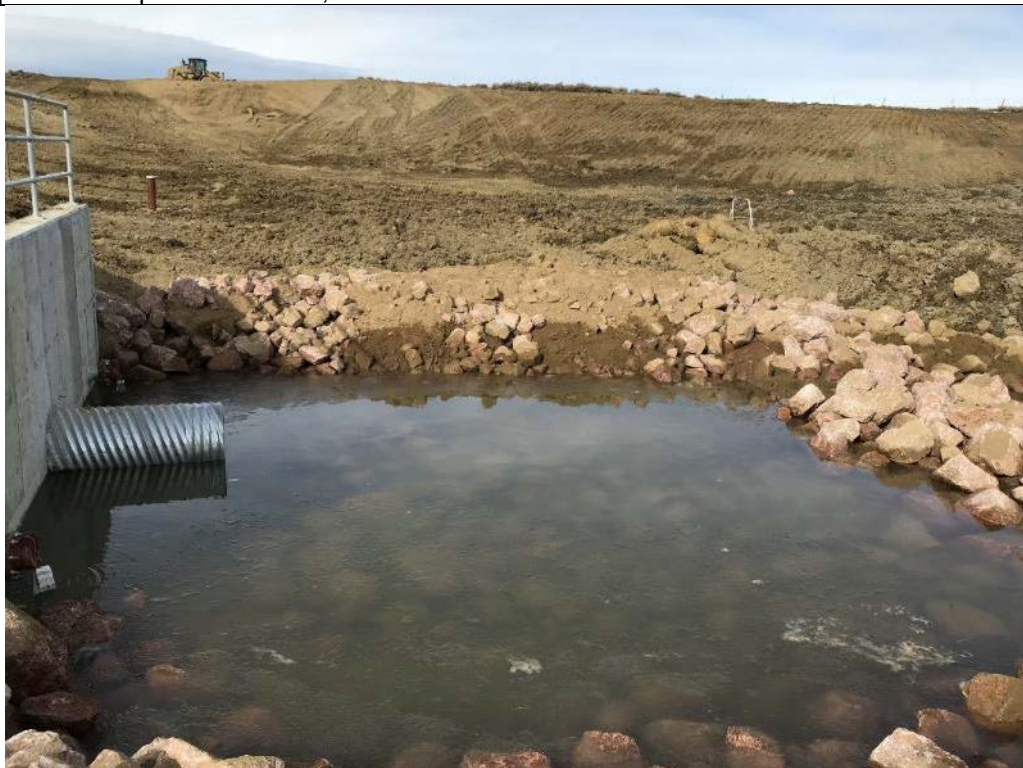
Photo 117. View looking left across the downstream terminal structure plunge pool. Note that the approximate invert elevation of the outlet pipe measured relative to the headwall is at Elevation 8281.2, which is 0.8 feet lower than the design elevation, and currently submerged by approximately 0.3 feet of water. The plunge pool was lowered in the spring of 2018. Nov. 14, 2017.

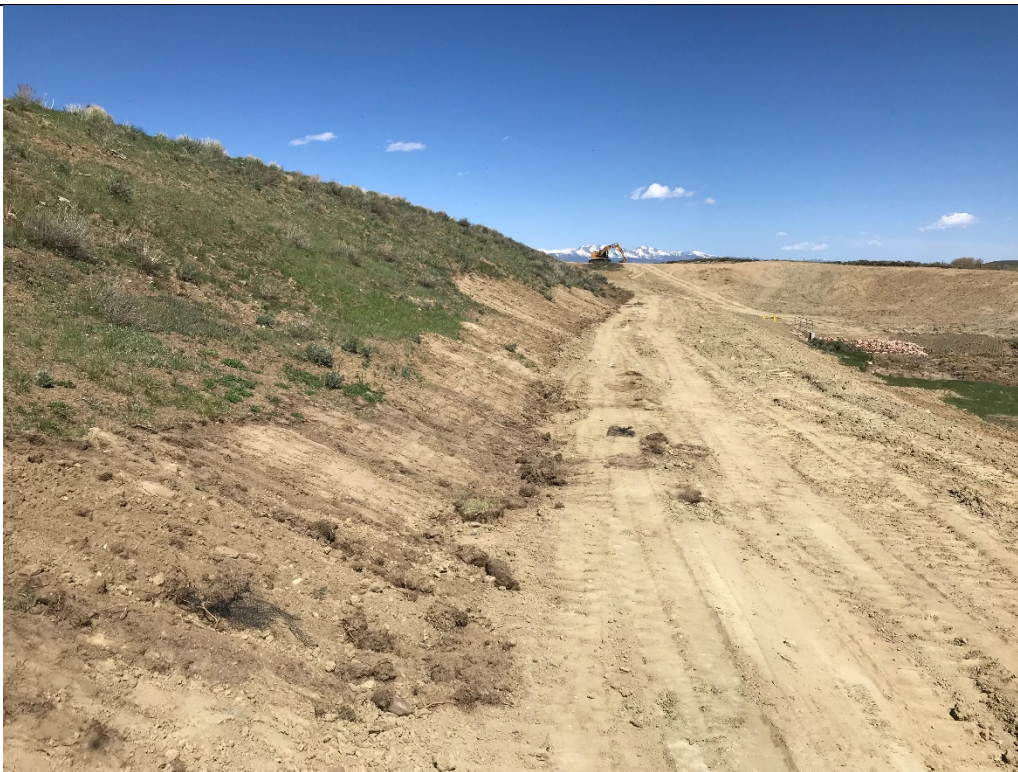
Photo 121. View looking left across the completed Main Dam Stability berm. Note that the berm and main dam slope transition was graded as per the SEO substantial completion comments. May 17, 2018.

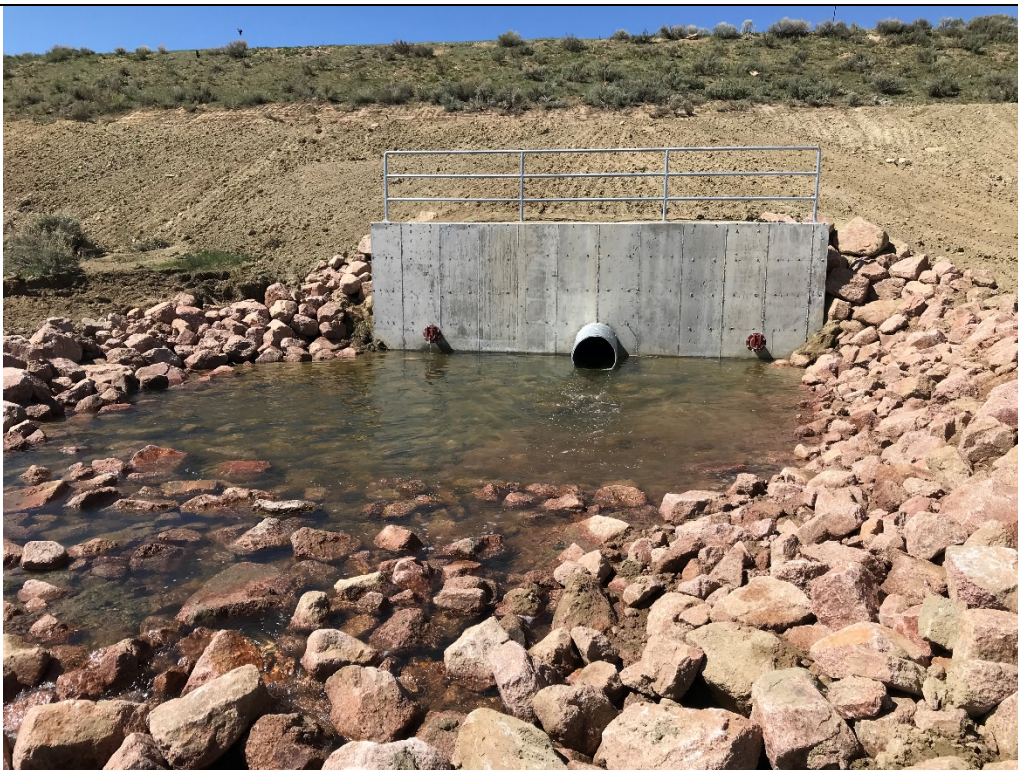
Photo 122. View of the terminal structure and plunge pool. Plunge pool was reworked and the water level lowered. Additional riprap armoring was installed on the right and left side of the headwall. May 17, 2018.

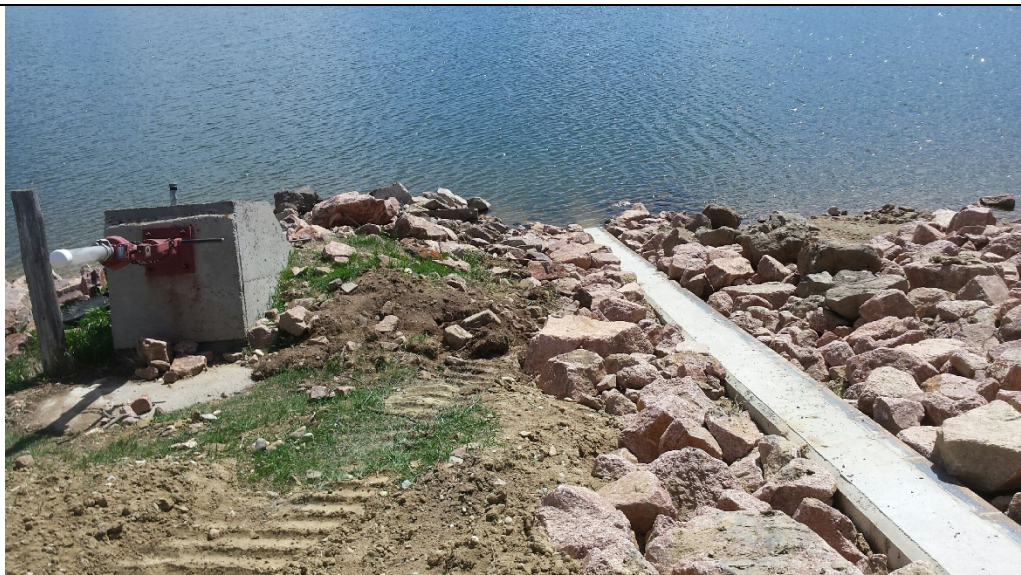
Photo 124. View of the air vent grade beam and staff gage. Note the riprap that was installed on both sides of the grade beam and the slope between the operator and grade beam was better graded. May 22, 2018.

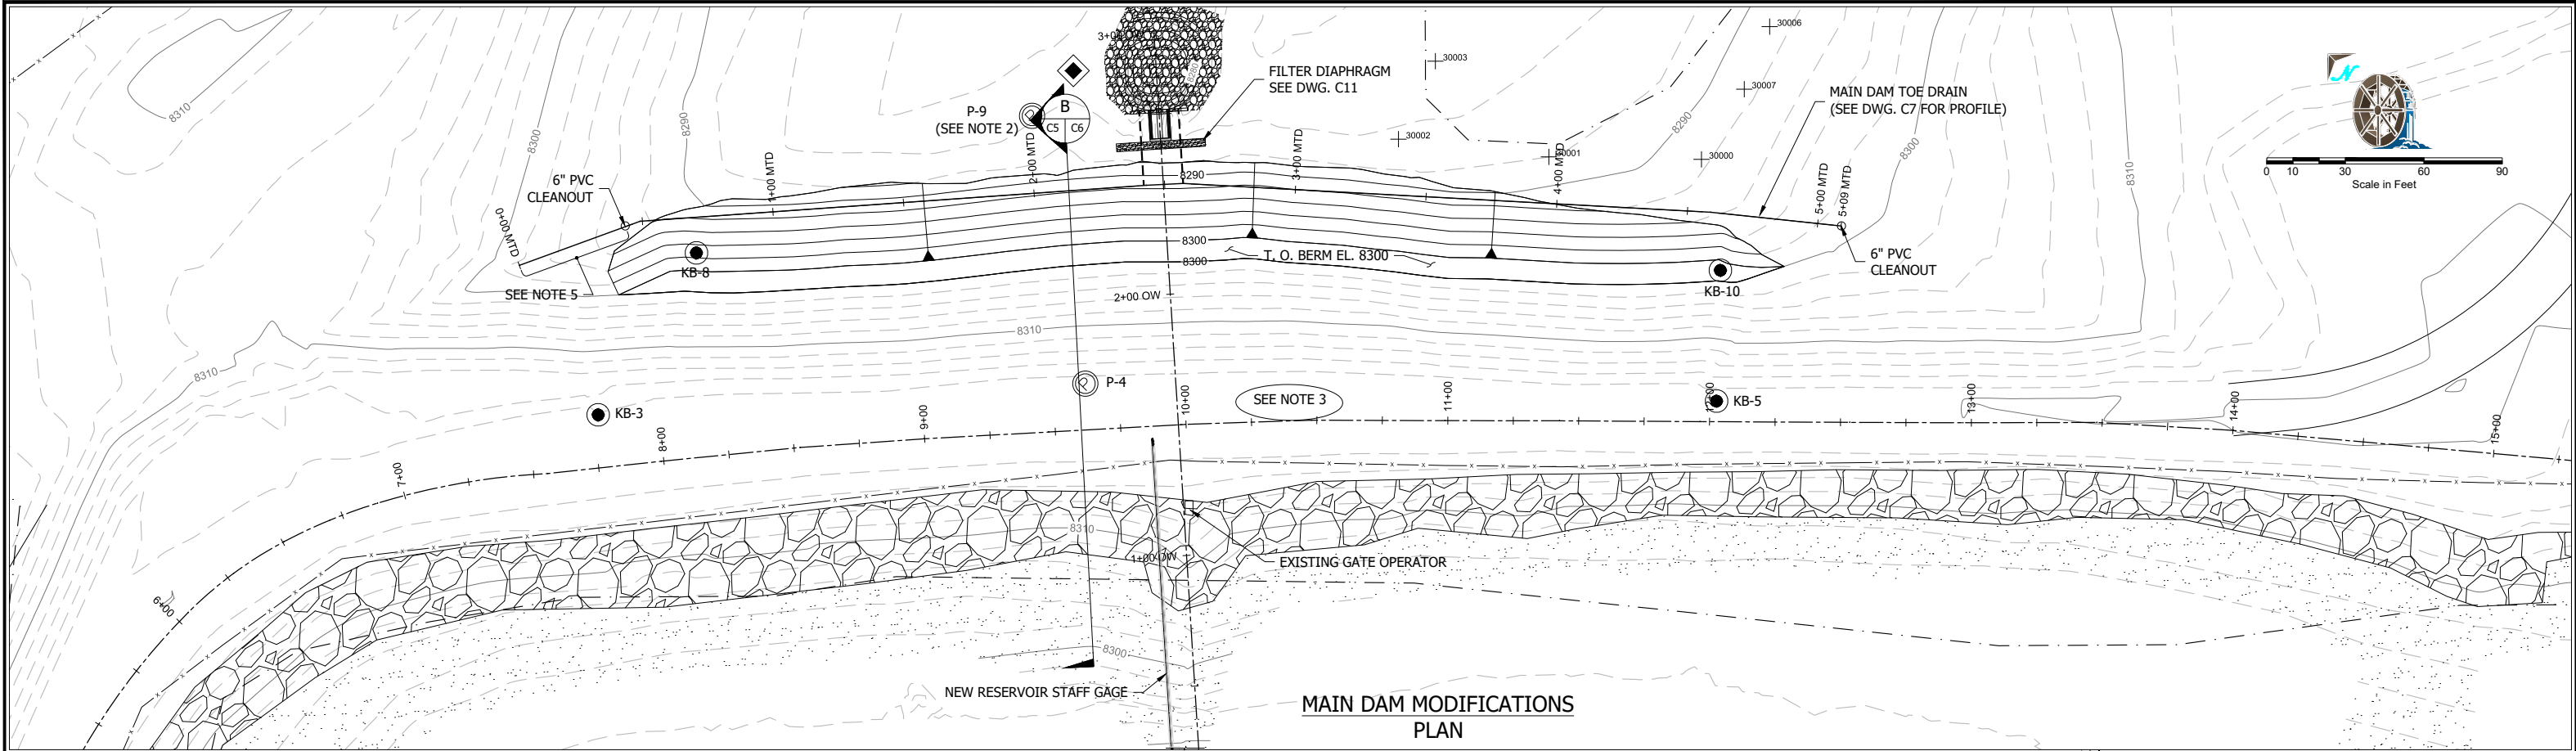
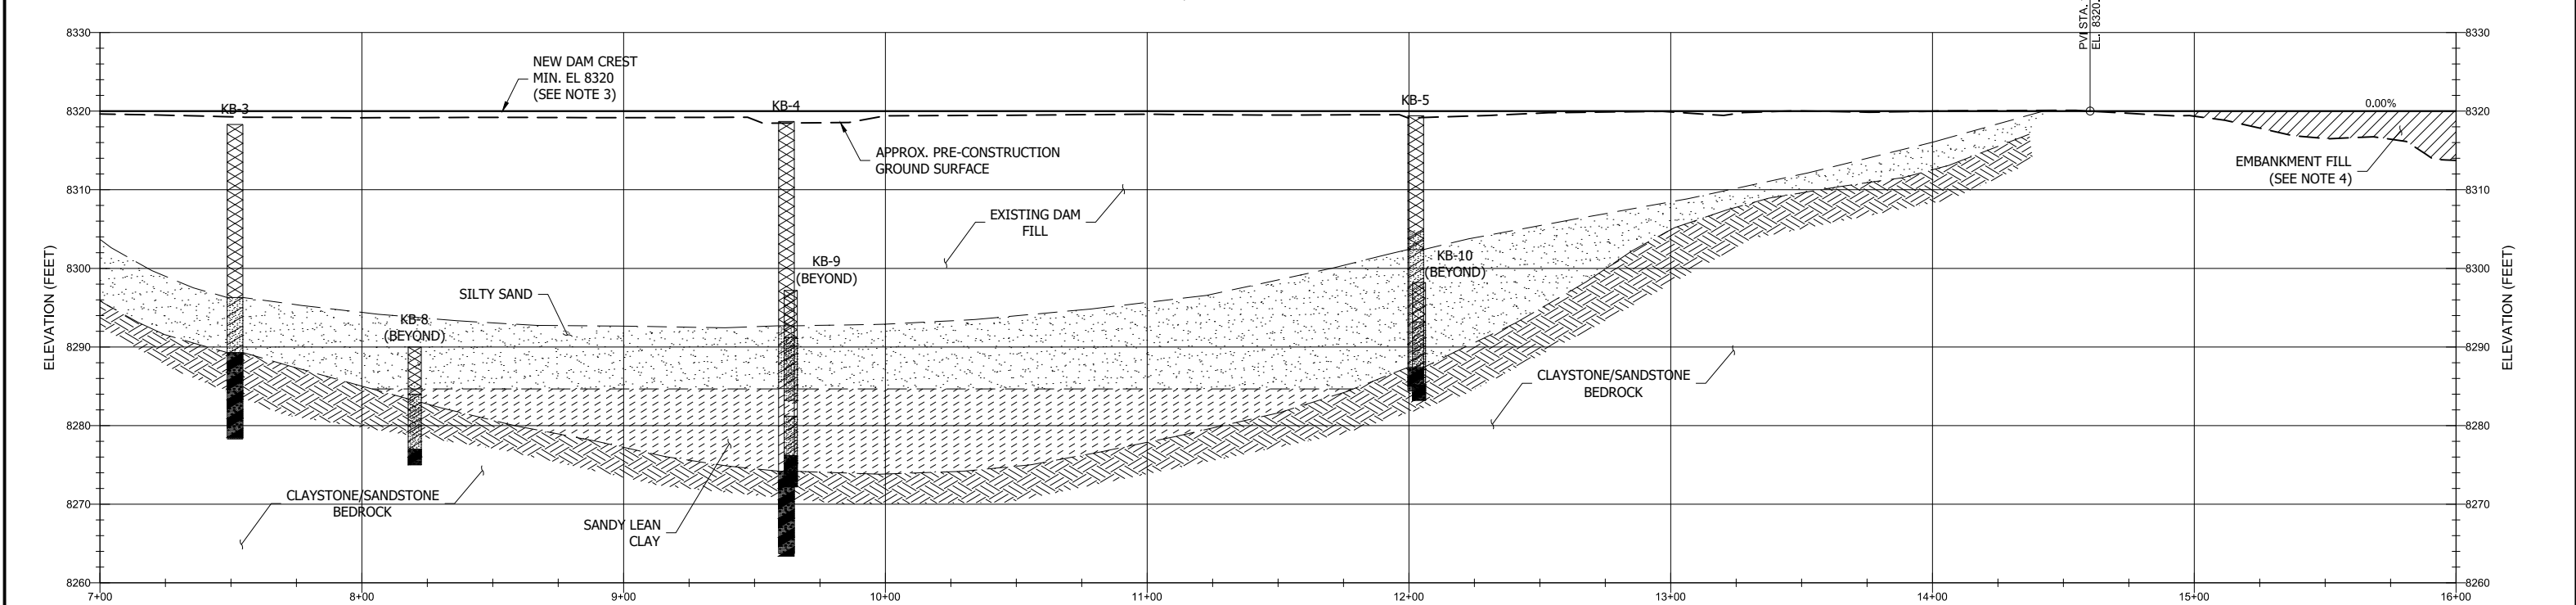
- NOTES:
- 1. SUBSURFACE STRATIGRAPHY IS APPROXIMATE.
  - 2. PIEZOMETER LOCATED IN KB-6 WAS REPLACED BY CONTRACTOR, SEE DWG C13 FOR DETAIL.
  - 3. FINAL BASE COURSE PLACED TO ELEV. 8320 NOT REQUIRED BY CONSTRUCTION CONTRACT. WORK WILL BE COMPLETED BY U.S. FISH & WILDLIFE SERVICE MAINTENANCE TEAM.

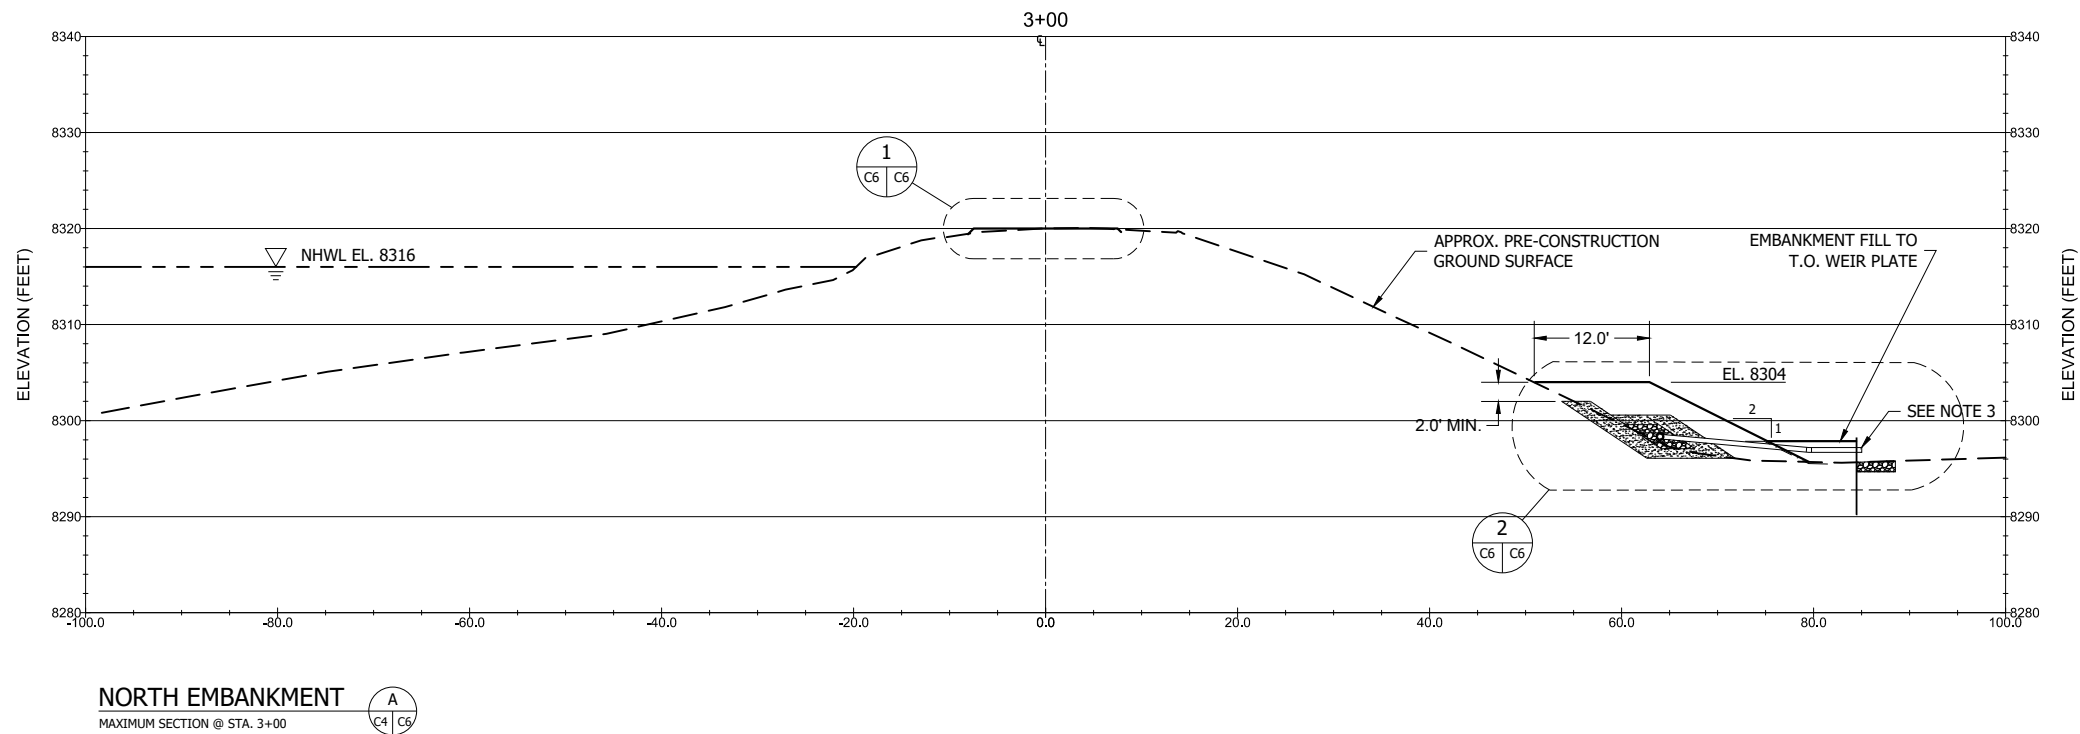
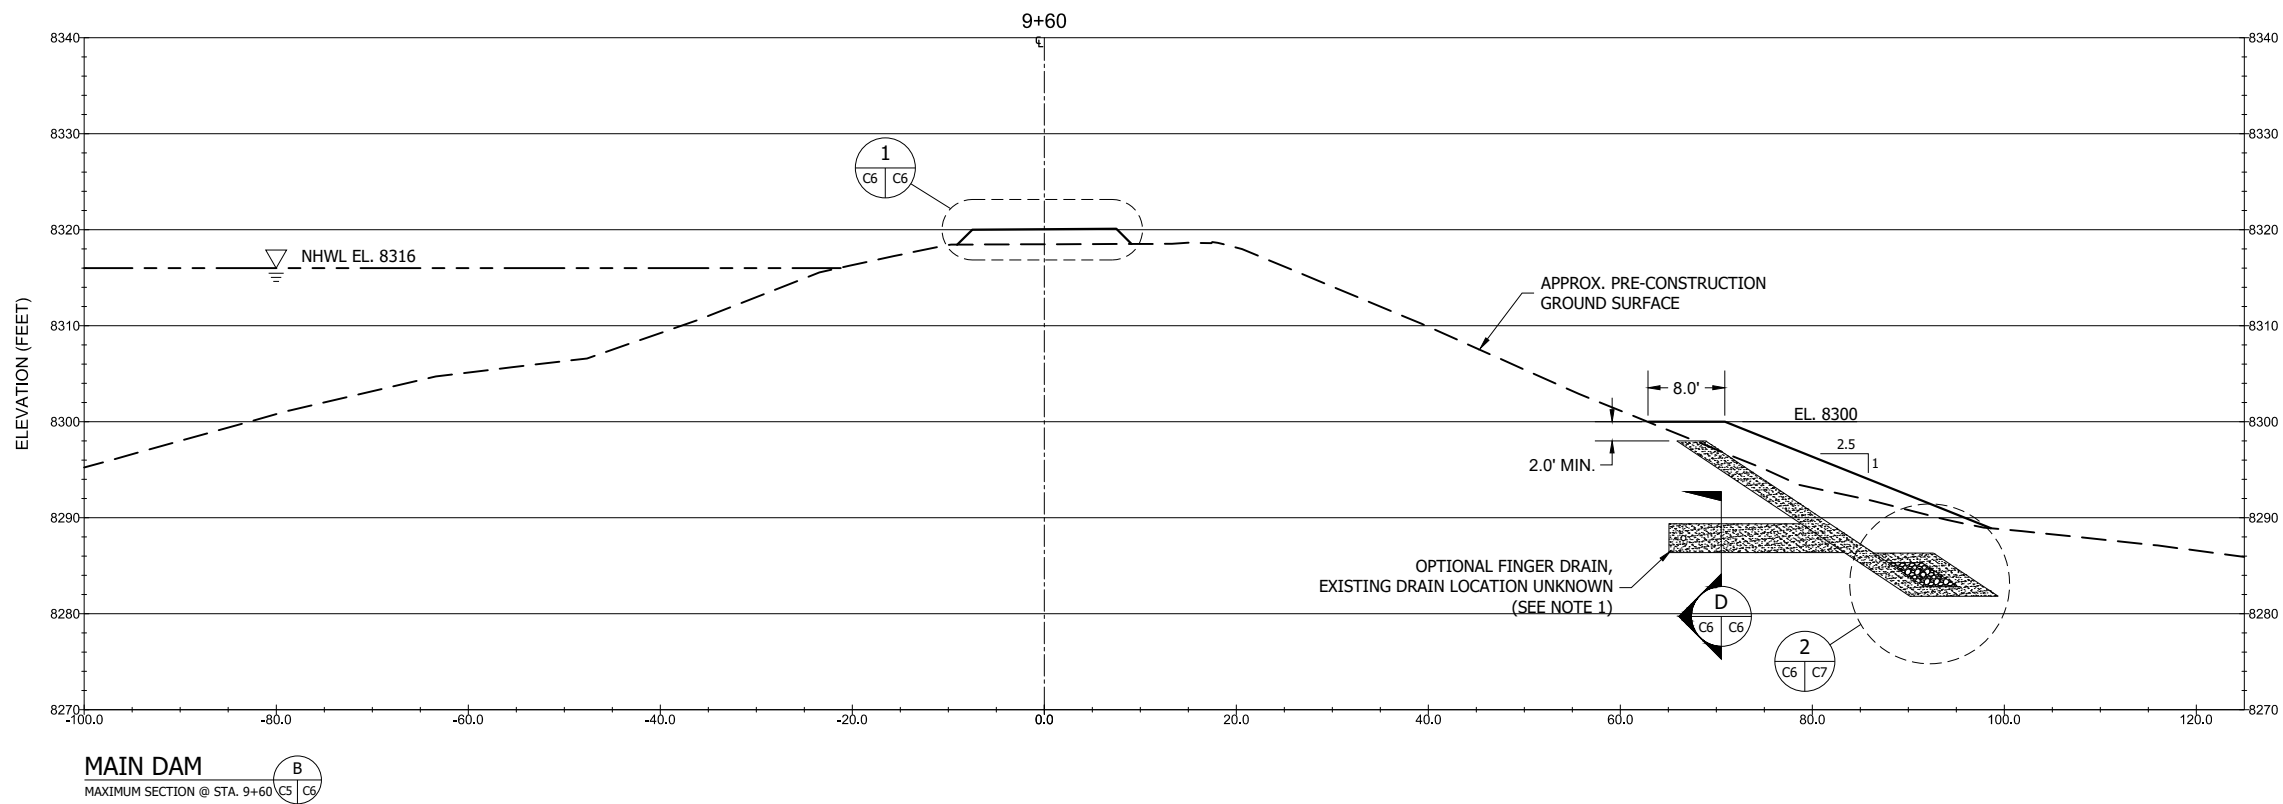
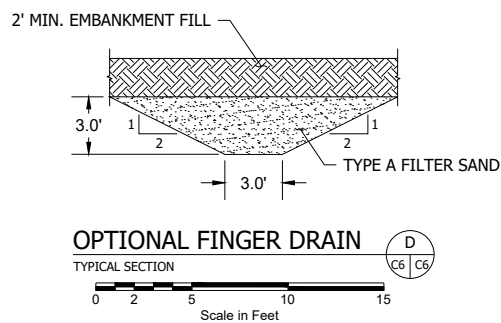
- NOTES:
- SUBSURFACE STRATIGRAPHY IS APPROXIMATE.
  - PIEZOMETER KB-9 WAS REPLACED BY CONTRACTOR. SEE DWG C14 FOR DETAIL.
  - FINAL BASE COURSE PLACED TO EL. 8320 NOT REQUIRED BY CONSTRUCTION CONTRACT. WORK WILL BE COMPLETED BY U.S. FISH & WILDLIFE SERVICE MAINTENANCE TEAM.
  - CONTRACTOR TO PLACE FILL TO CREST EL. 8320 IN LOW AREA BETWEEN SPILLWAY AND EXISTING DAM CREST.
  - FINGER DRAIN INSTALLED FROM 0+00 MTD TO CLEANOUT AT STA. 0+43 MTD.

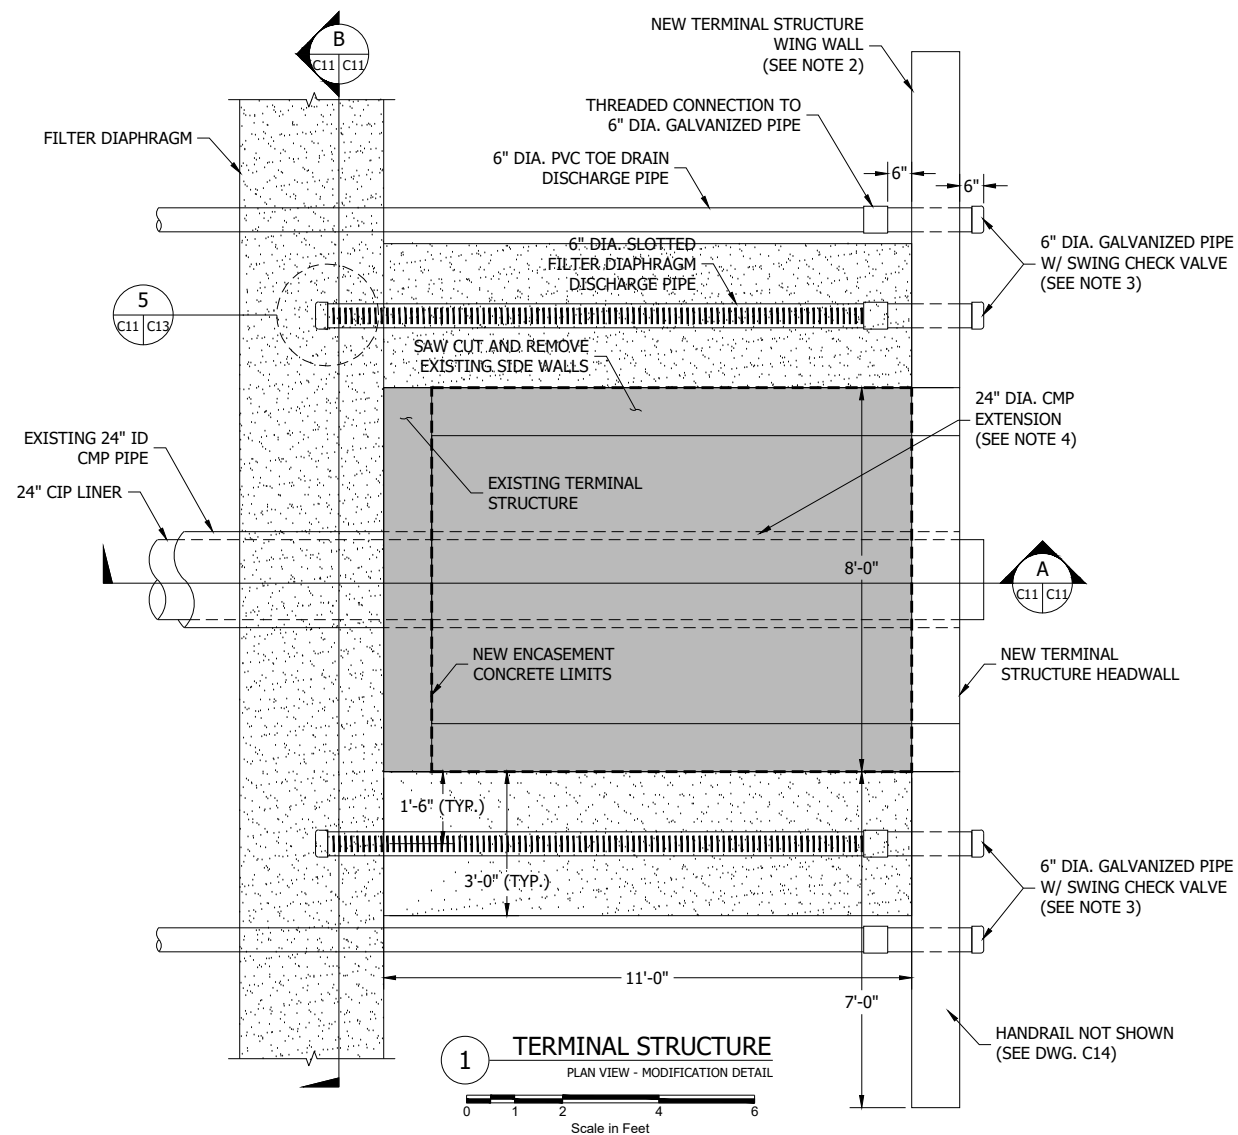
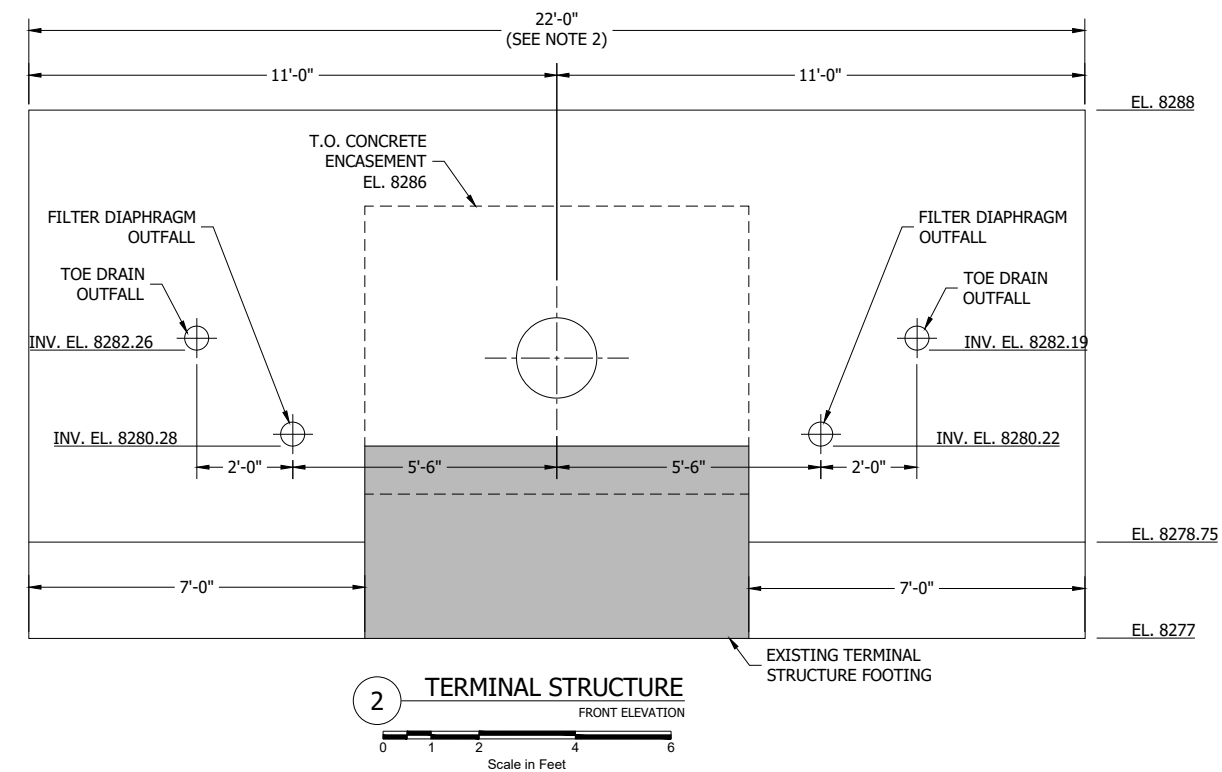
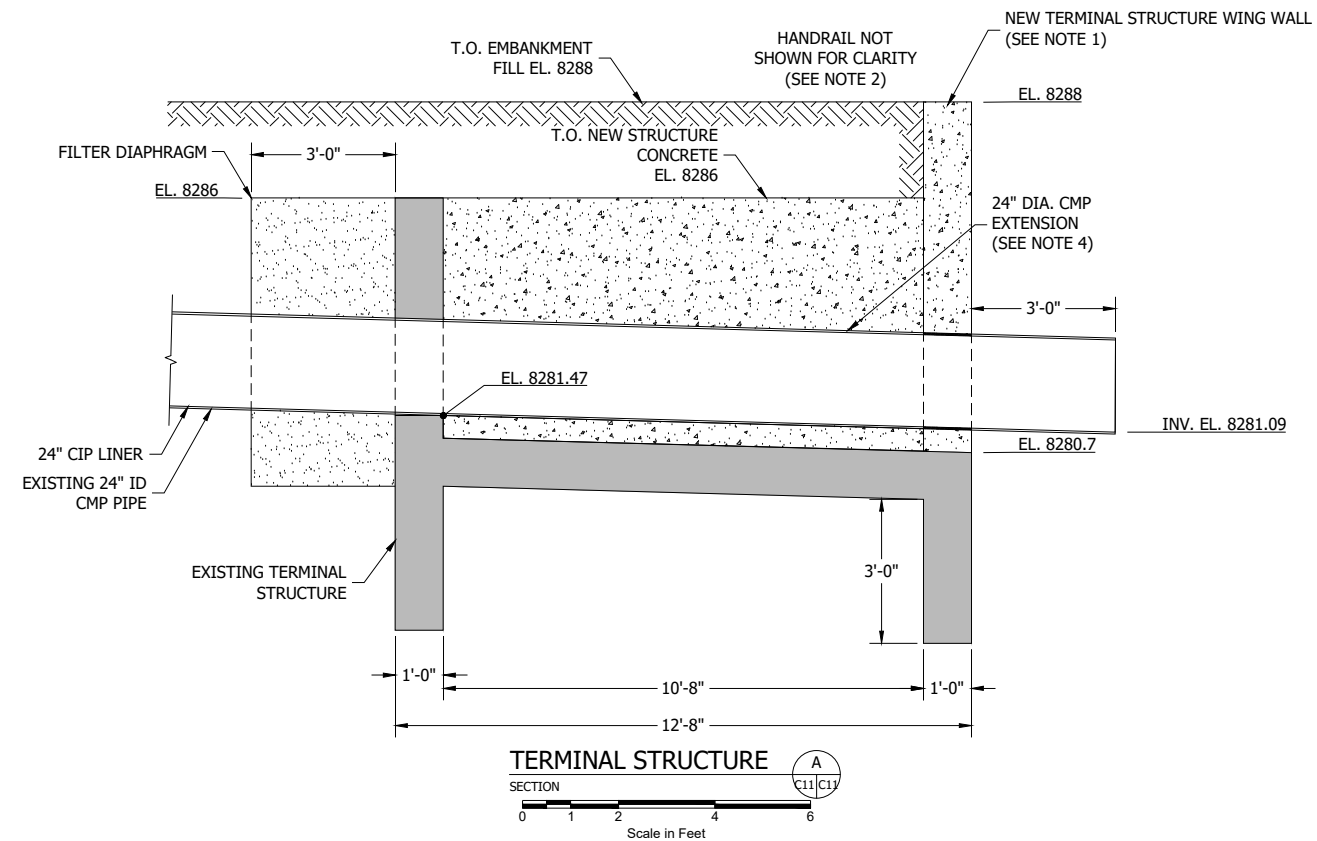
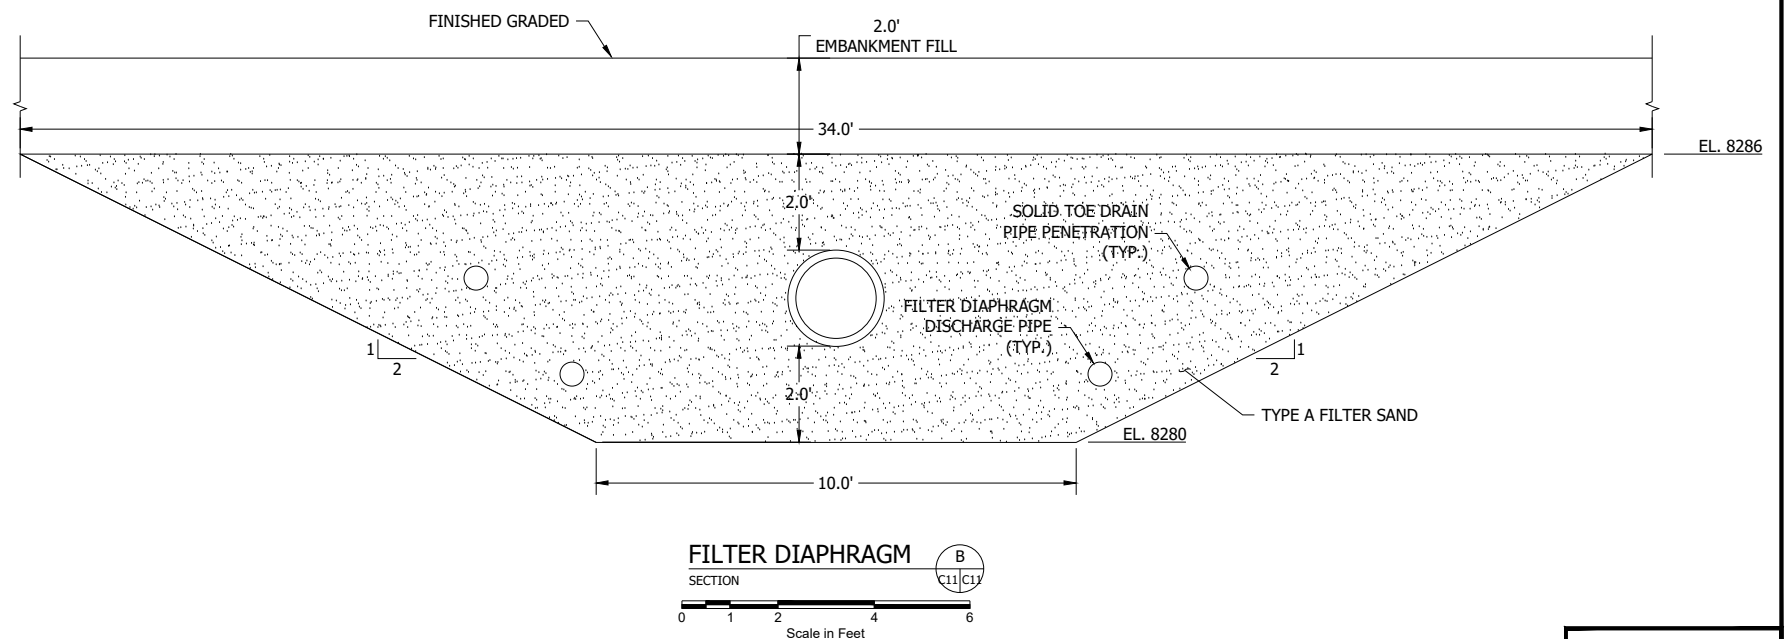
- NOTES**
- SEE S1 FOR REINFORCING DETAILS.
  - SEE C14 FOR HANDRAIL DETAILS.
  - INSTALL PLASTIC WAFER SWING CHECK VALVES TO GALVANIZED PIPE.
  - A 10-FOOT SECTION OF 24-INCH DIAMETER CMP WAS ADDED FROM THE END OF EXISTING TERMINAL STRUCTURE OUTLET THROUGH THE NEW TERMINAL STRUCTURE HEADWALL.
