# **FINAL CONSTRUCTION REPORT** for **MACFARLANE DAM** **REHABILITATION PROJECT**

**CONSTRUCTION FILE NO. C-1031B**  
**COLORADO DAM ID: 470202**  
**NID: CO-00997**  
**WATER DIVISION 6 – WATER DISTRICT 47**  
**JACKSON COUNTY, COLORADO**

## Executive Summary

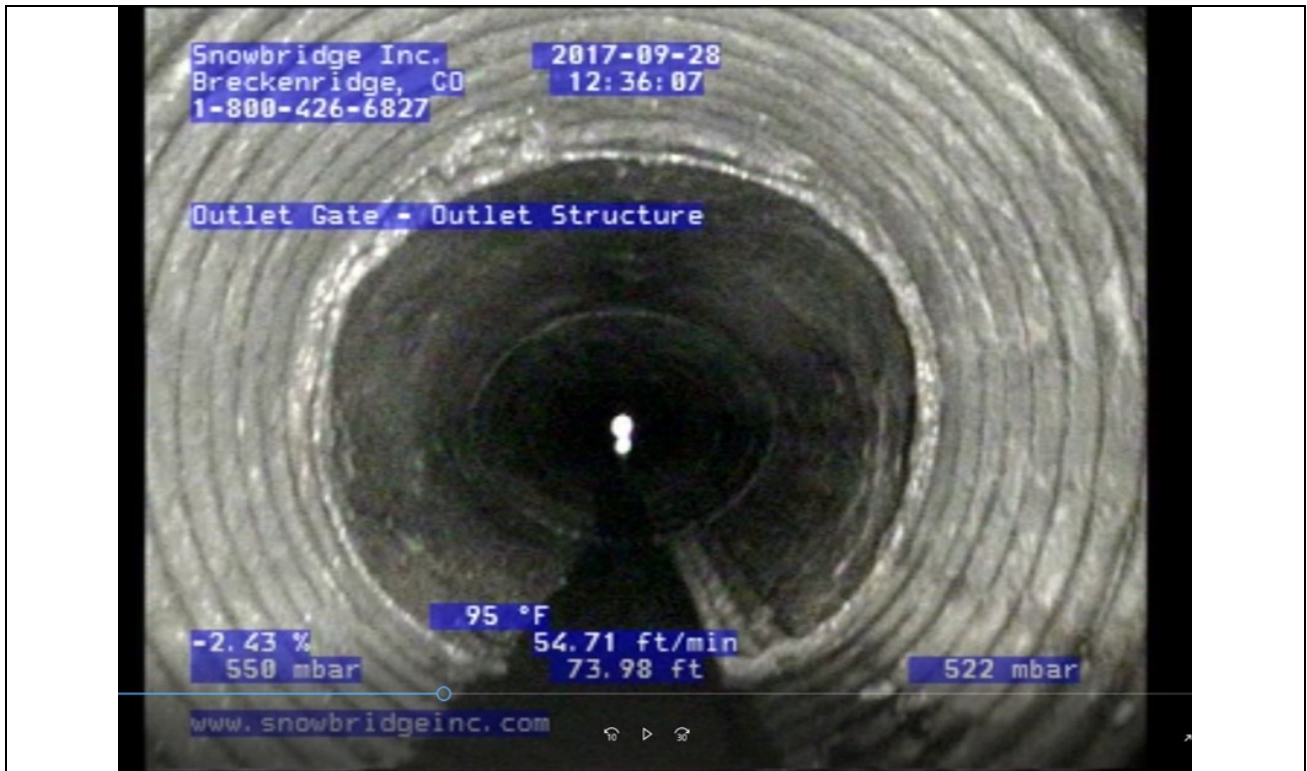
1. View looking upstream of the conduit at the transition between the CMP pipe and the riveted steel pipe. Note the squish in the pipe.

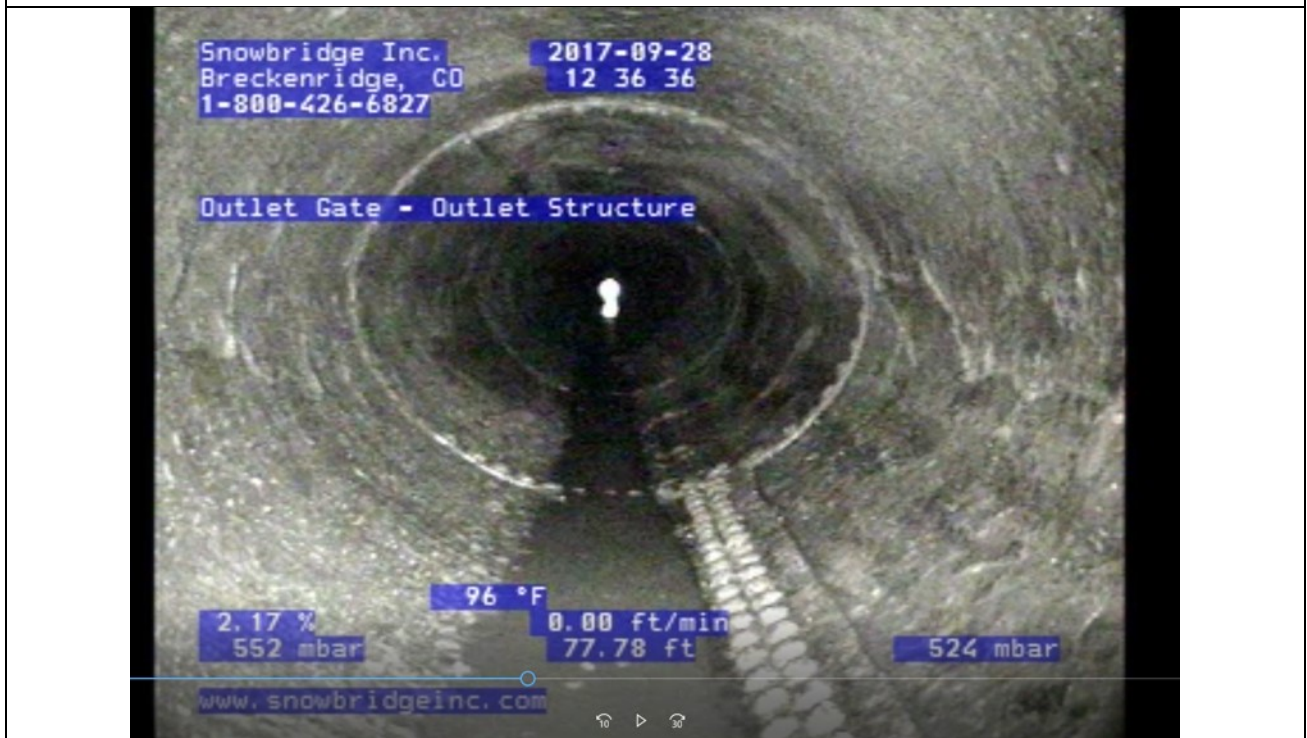
2. Close up view of the squished riveted steel pipe section located at the transition between the CMP pipe and the riveted steel pipe approximately 76 feet upstream of the outlet end of the discharge pipe.
