**Green Ditch Diversion Rehabilitation and Fish Passage Project**  
Final Report

April 12, 2018

Grant Recipient: The Green Ditch Company

Final Report Prepared by: Marianne Giolitto,  
City of Boulder Open Space and Mountain Parks Department

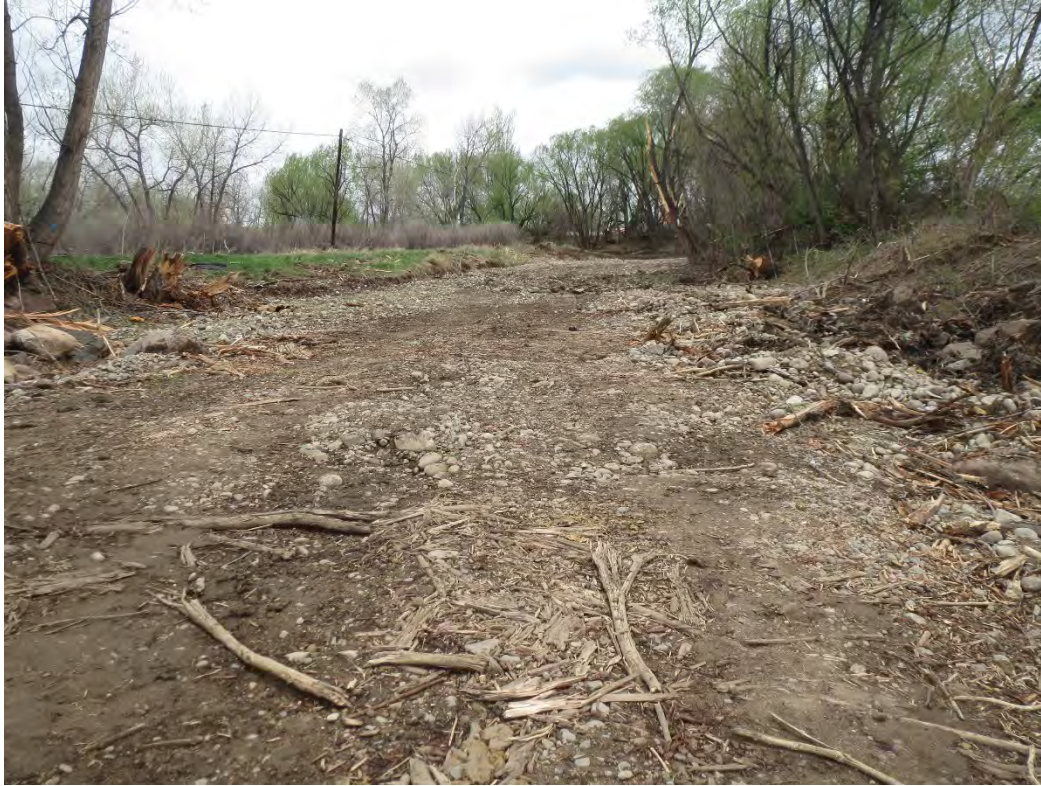
After installing a new headgate, the creek bed below the existing diversion dam was raised to eliminate the immediate drop in grade below the diversion dam (Photo 3). To protect the new creek bed as this section of the creek has the steepest grade, this work included the installation of two constructed riffles reinforced with boulder vanes set flush with the new grade of the creek (Photo 4). Based on consultation with Ficke, the creek's new grade was designed to eliminate any drops greater than approximately 0.3-0.4 feet to accommodate passage of most age classes of Boulder Creek fish (Photos 5 and 6).

***Photo 3. Raised creek bed. View looking downstream from the existing low head diversion dam.***

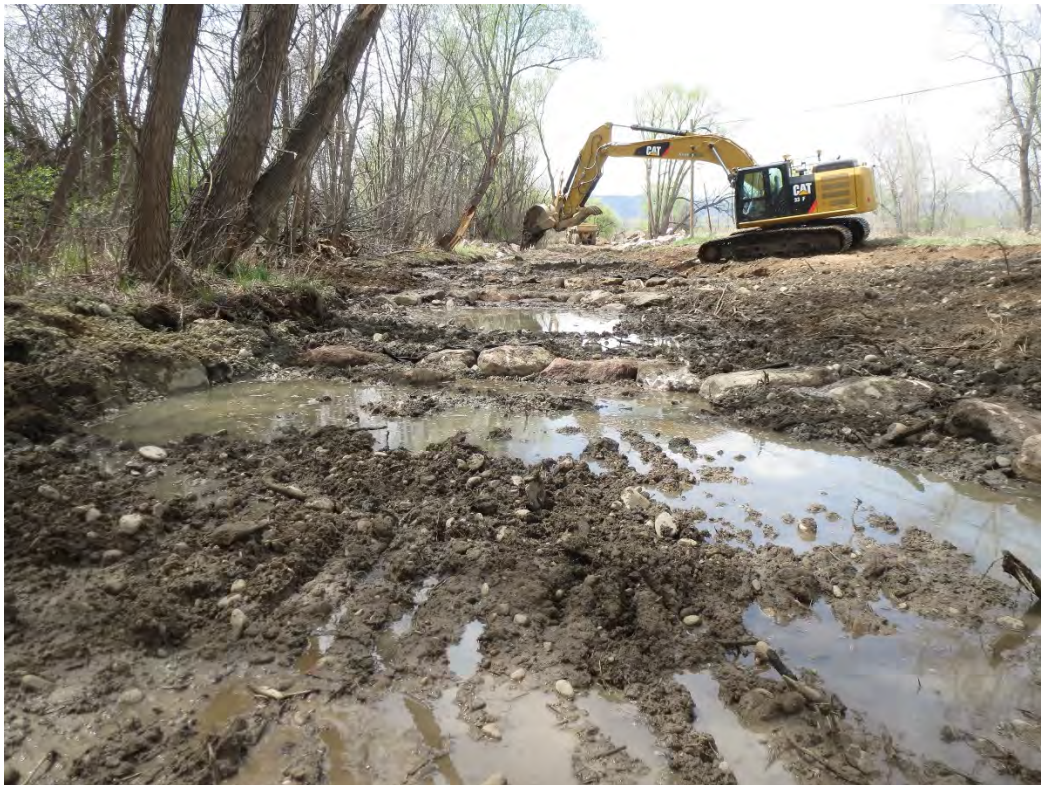
***Photo 4. Boulder vanes being installed in the constructed riffles immediately downstream of the existing low head diversion dam. View looking upstream from end of project reach.***

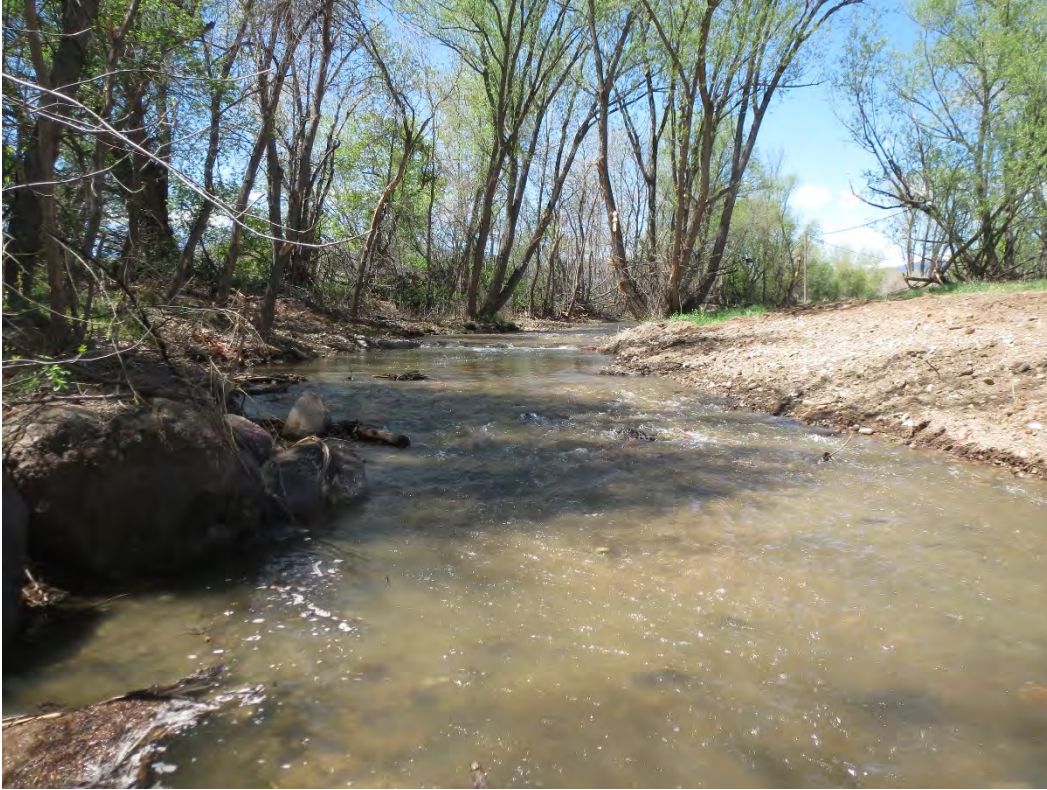
***Photo 5. Constructed riffle at low flow. View looking upstream from end of project reach.***

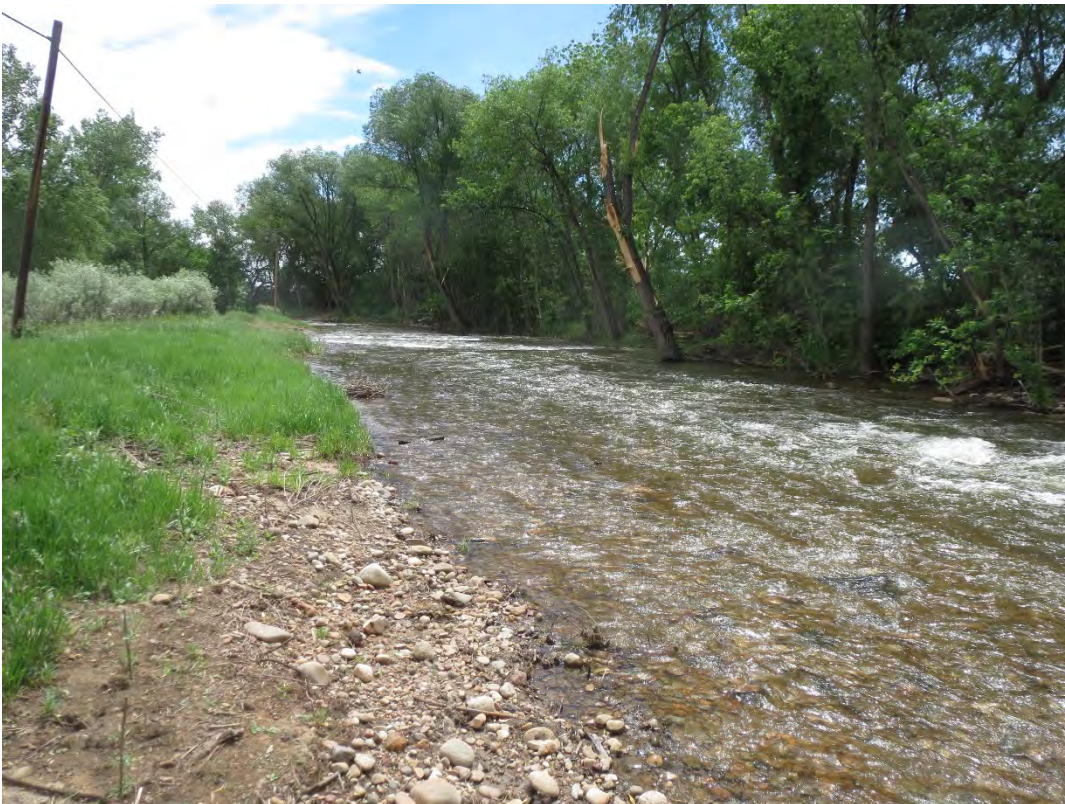
***Photo 6. Constructed riffle at low flow. View looking downstream from diversion point.***

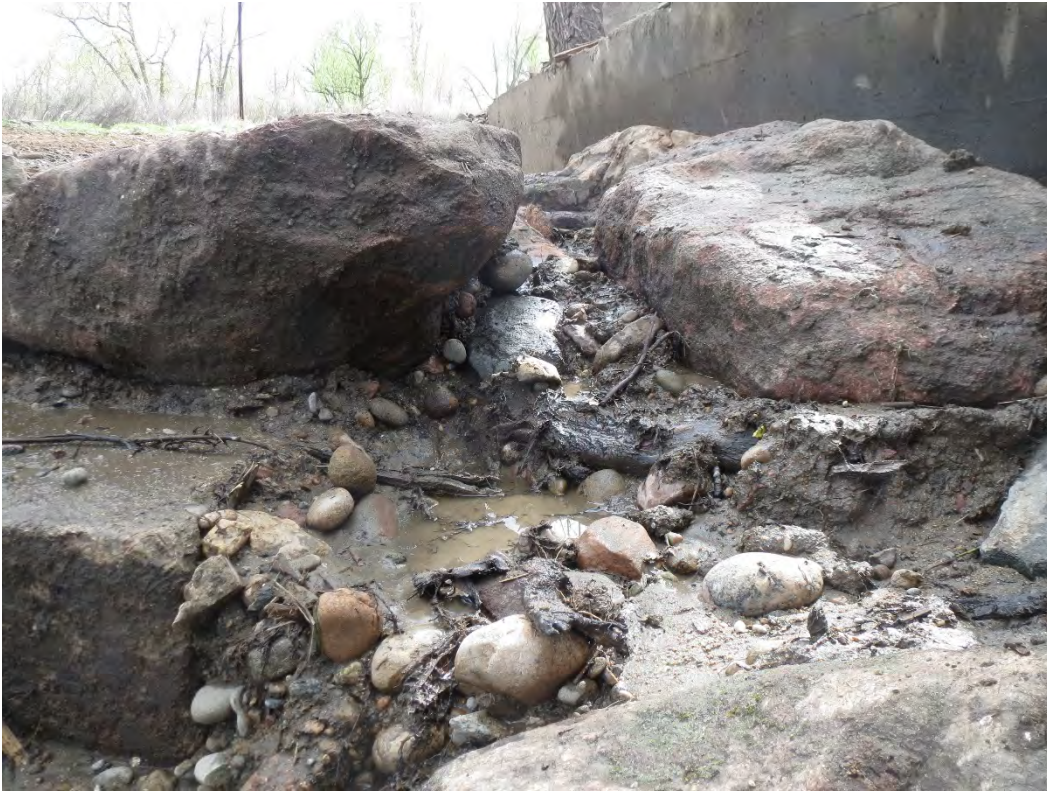
***Photo 8. Fish “escape path” in the rock cross vane adjacent to the new headgate.***

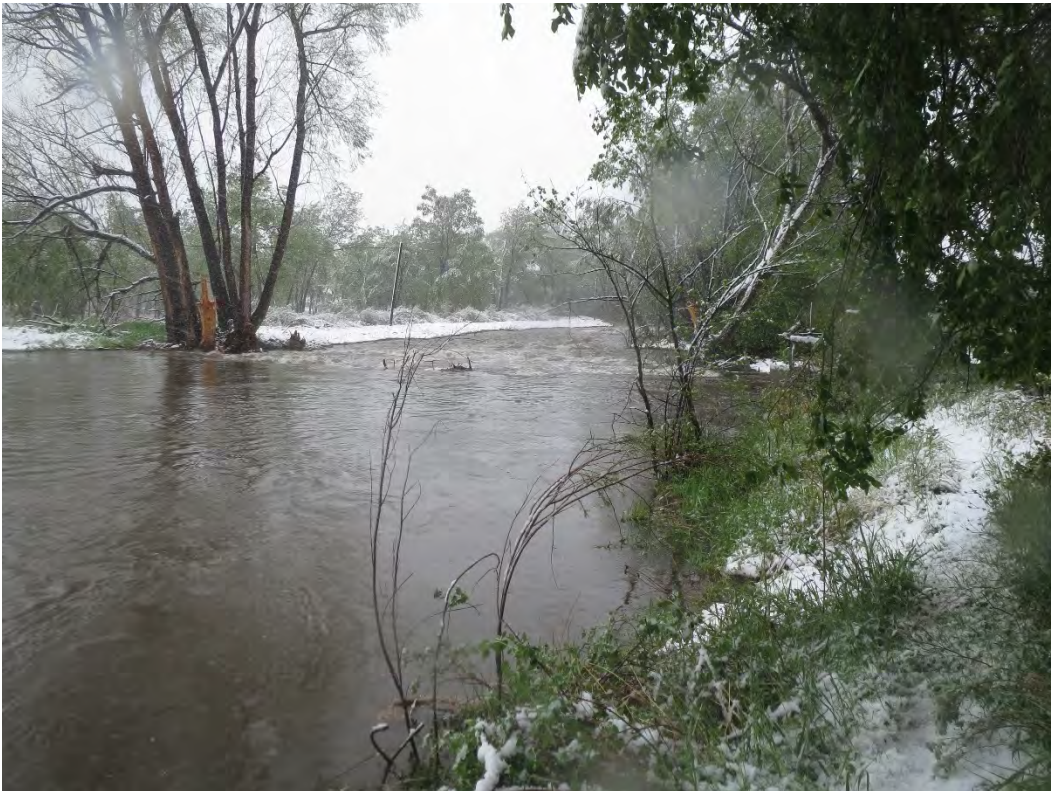
***Photo 9. Rock cross vane under high flow (approximately 500 cfs). View facing downstream.***

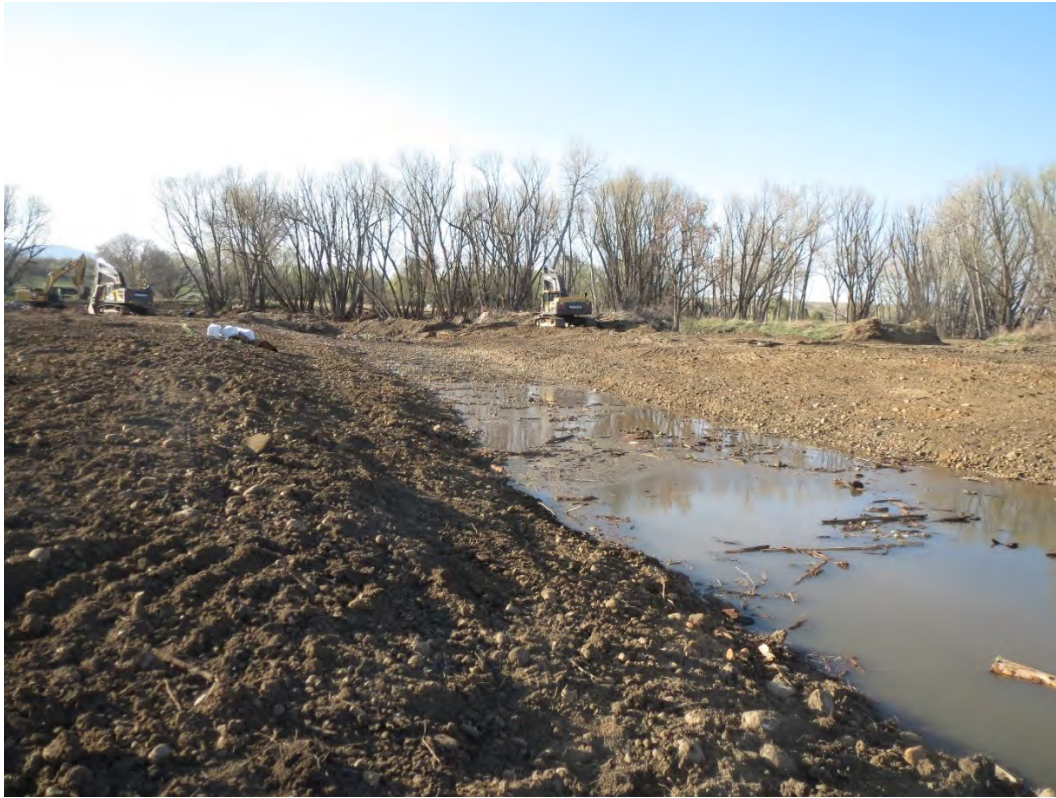
***Photo 11. New channel prior to water flowing in it. Inner berm and gently sloping banks to bankfull are clearly visible on the river right bank. View facing upstream.***

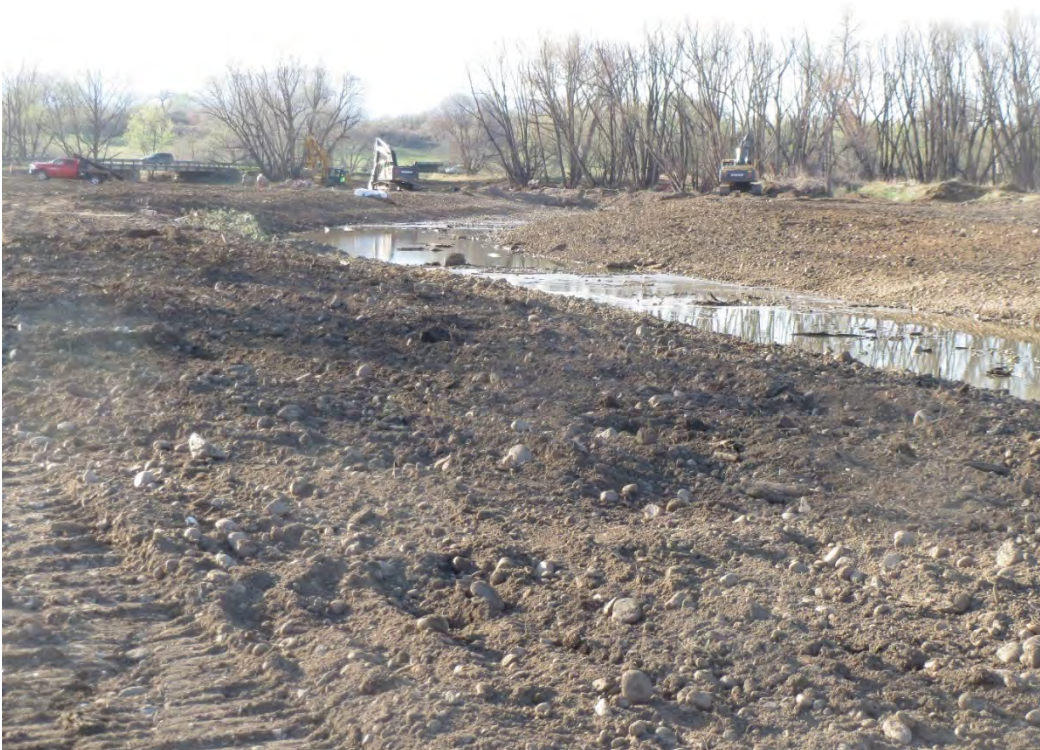
***Photo 12. Sinuosity is returned to the channel. View facing upstream.***

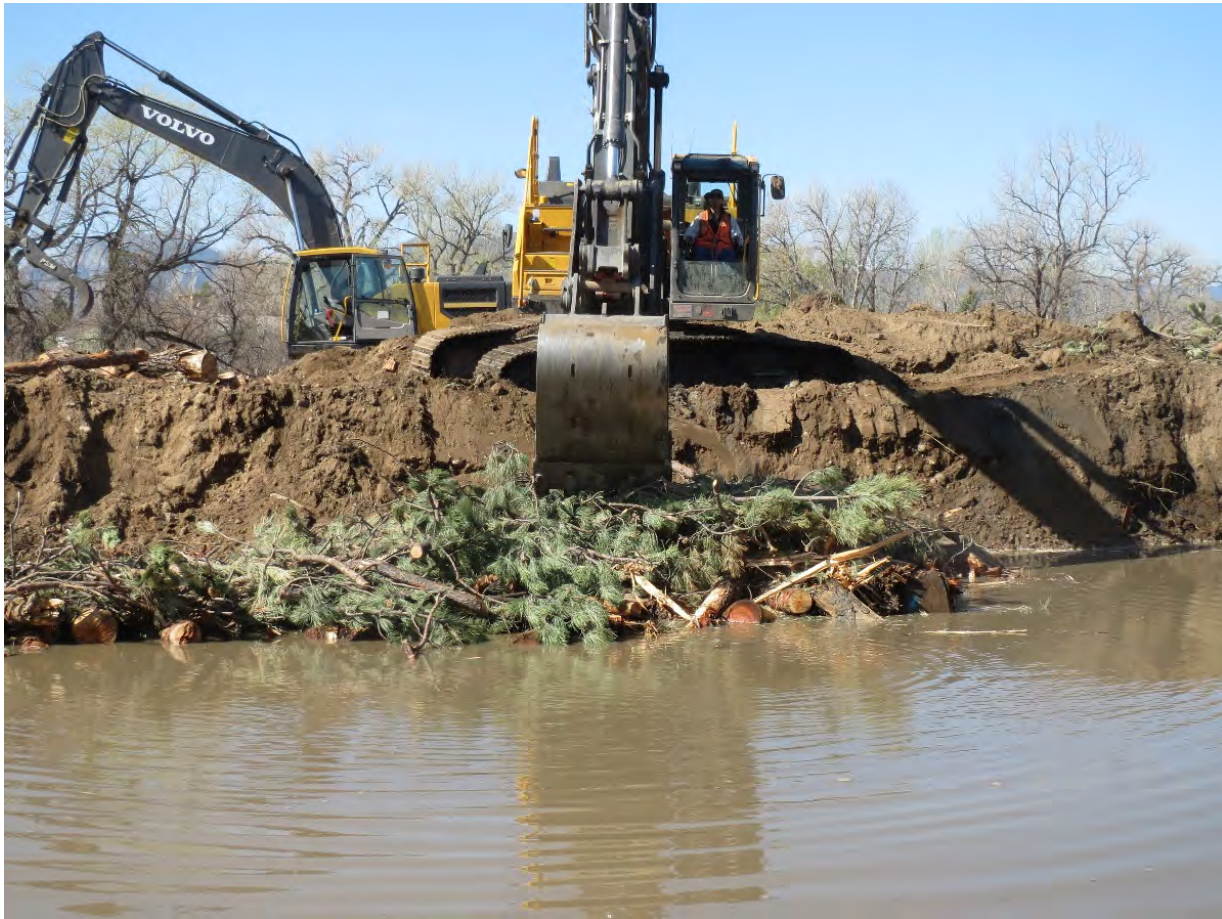
***Photo 13. Installing base of wood toe structure.***

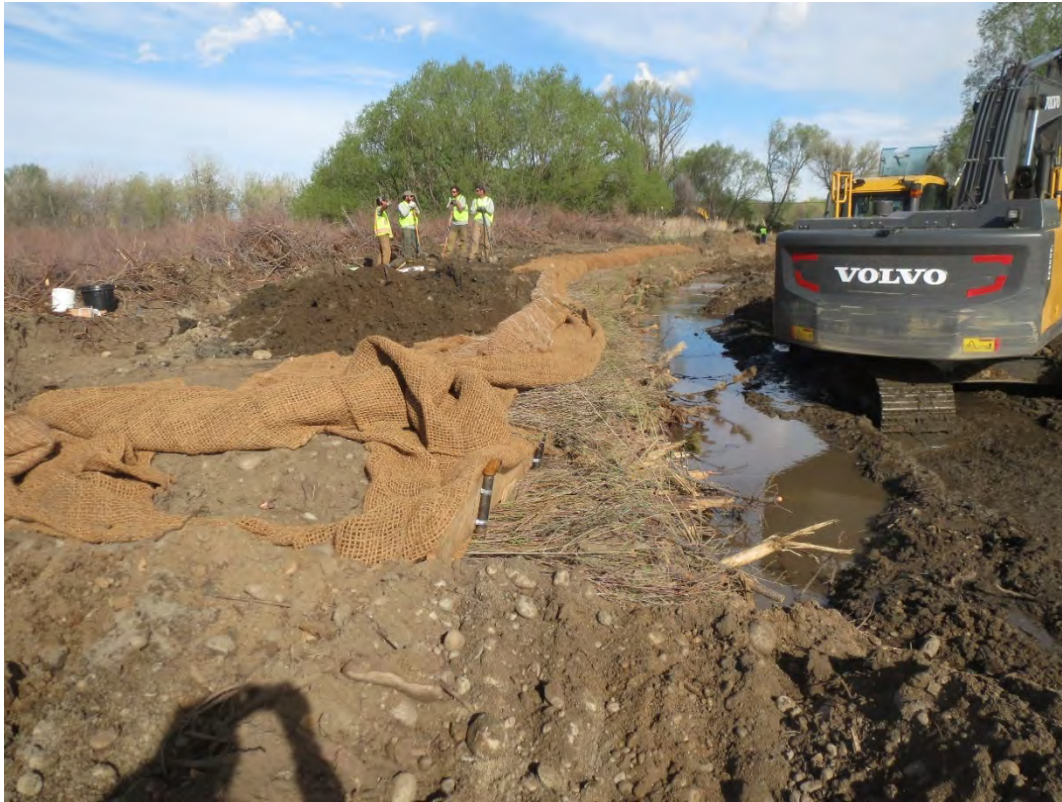
***Photo 14. Installing soil encapsulated lifts with live willow and cottonwood branches on top of wood toe structure.***

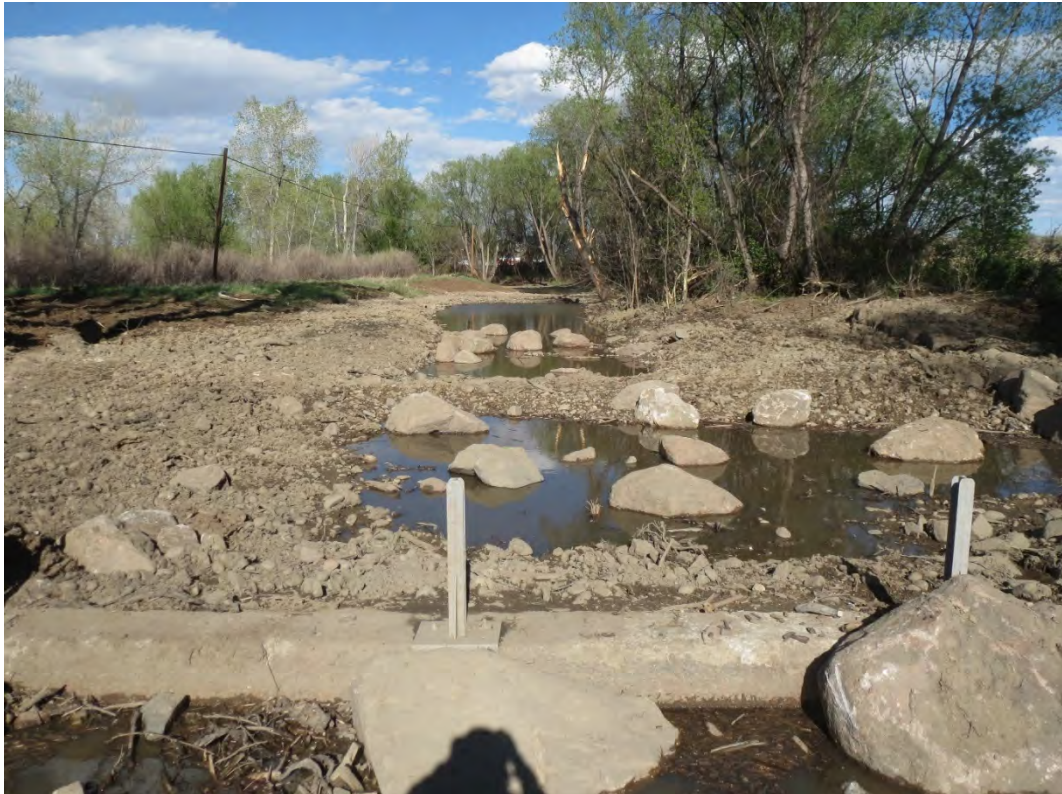
***Photo 15. Habitat boulders below the new point of diversion. View facing downstream.***

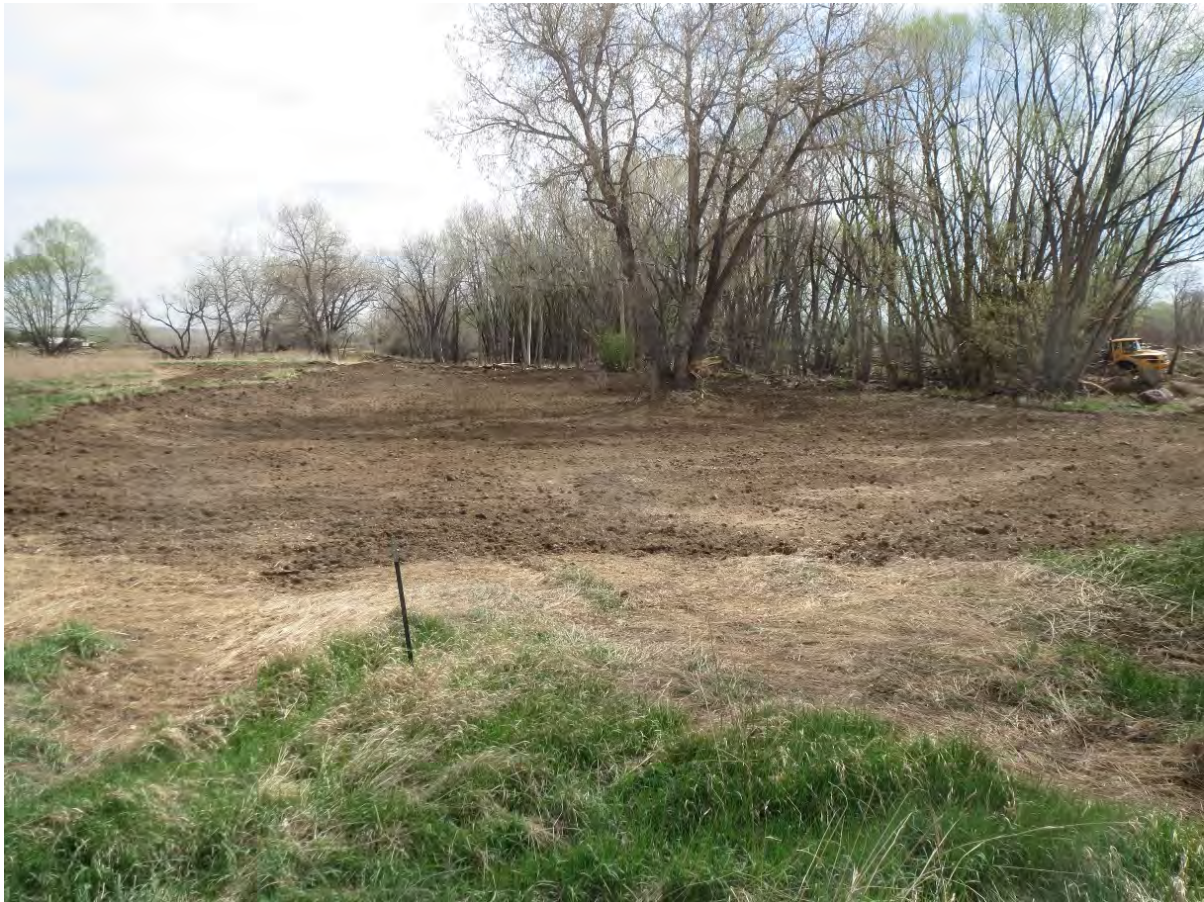
***Photo 16. Lowering of left floodplain. View facing east from 61<sup>st</sup> Street.***

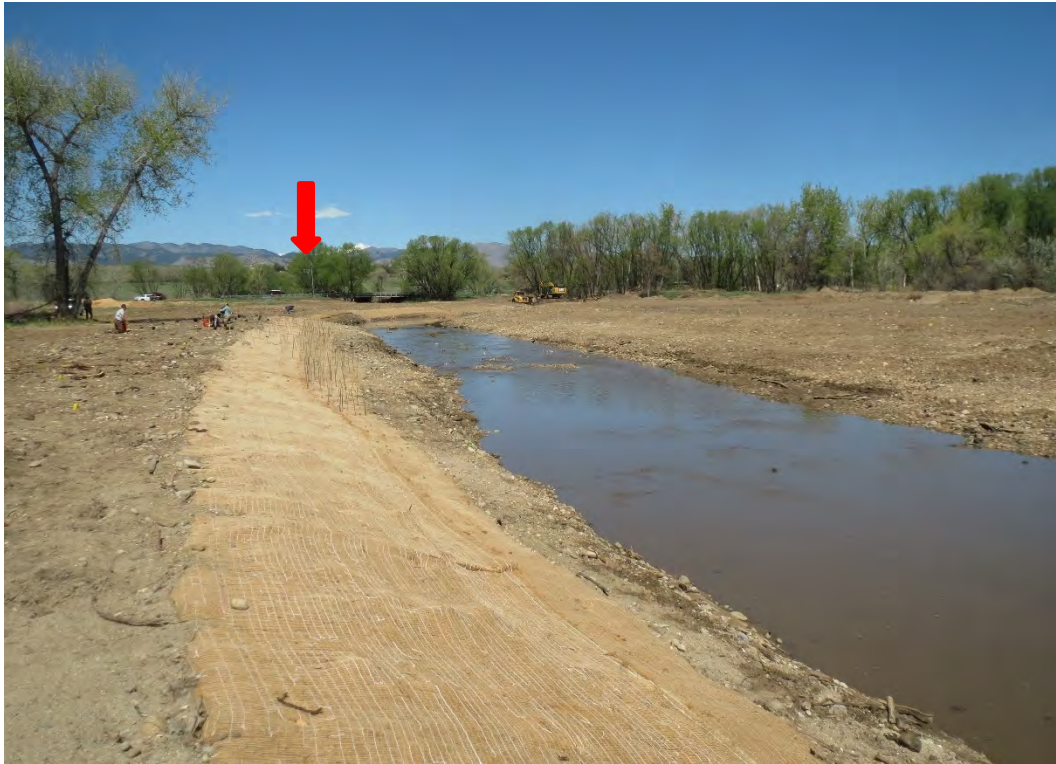
***Photo 17. New floodplain along creek. Note levee in background of the photo on the left bank. Prior to the project, the levee bordered the creek's left edge. Floodplain grading and relocation of the creek has expanded the floodplain. View facing downstream.***

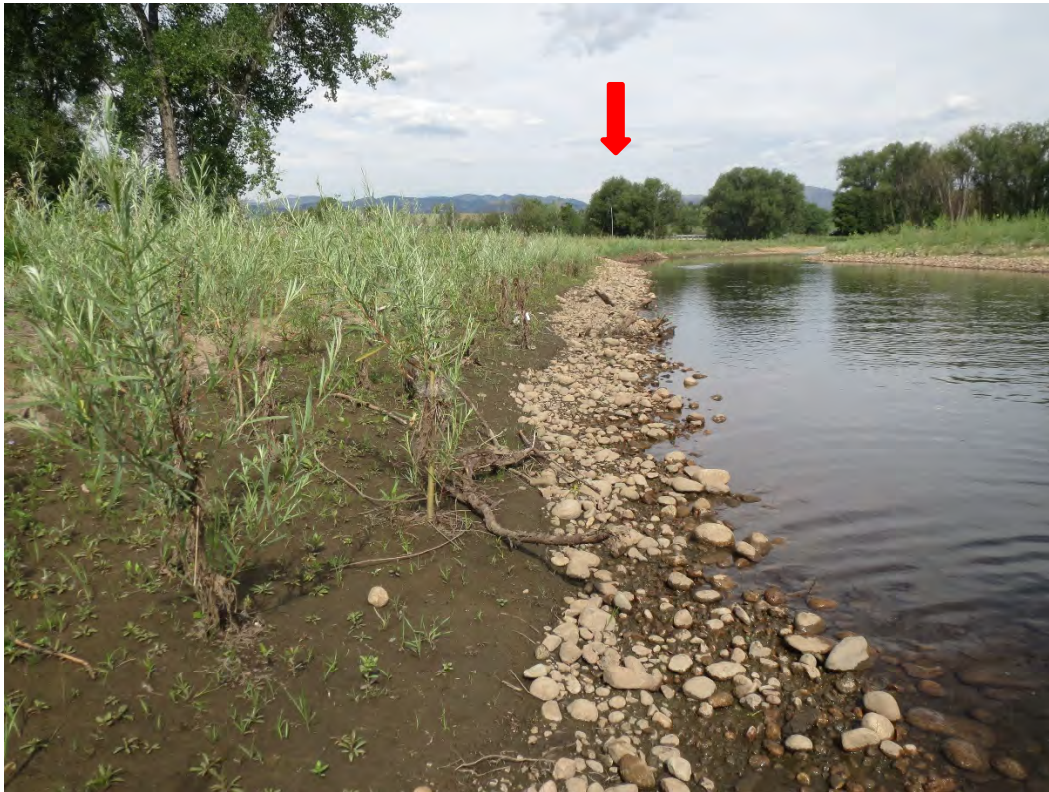
***Photo 18. Same willow stakes as shown in Photo 17 later in 2017. Red arrows point to the same tree in both photos.***

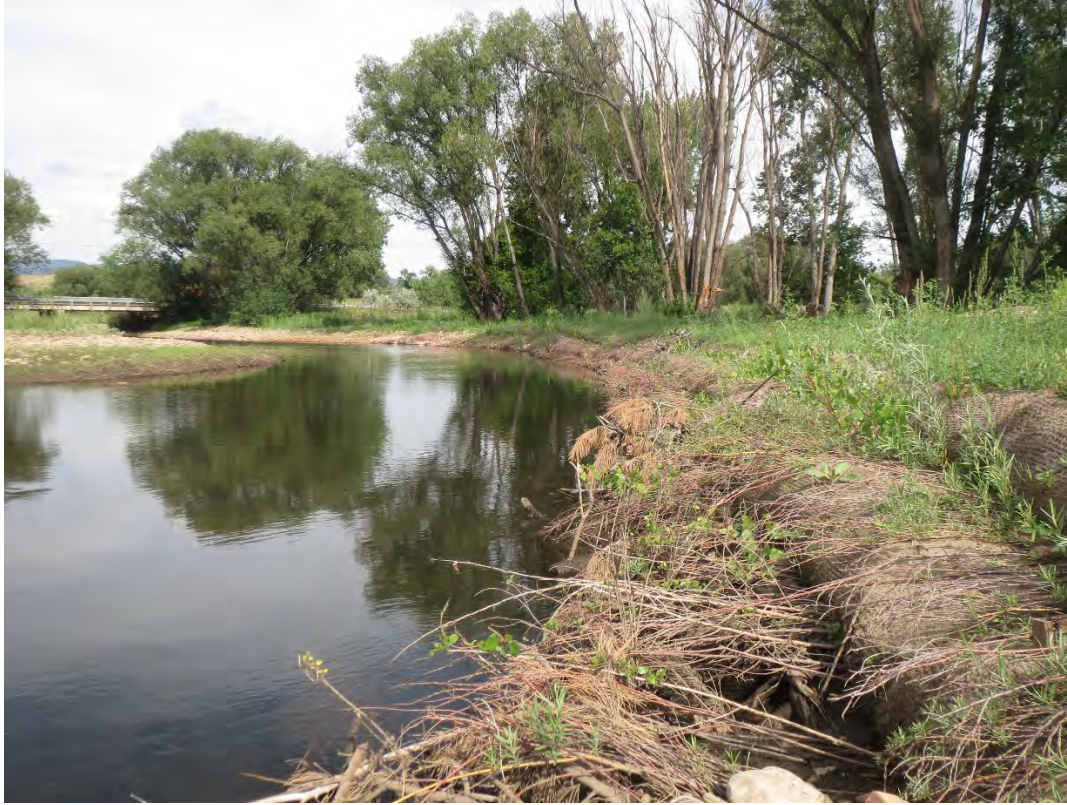
**Photo 19. Willow and cottonwood cuttings sprouting in the soil lifts above a wood toe structure. View facing upstream.**

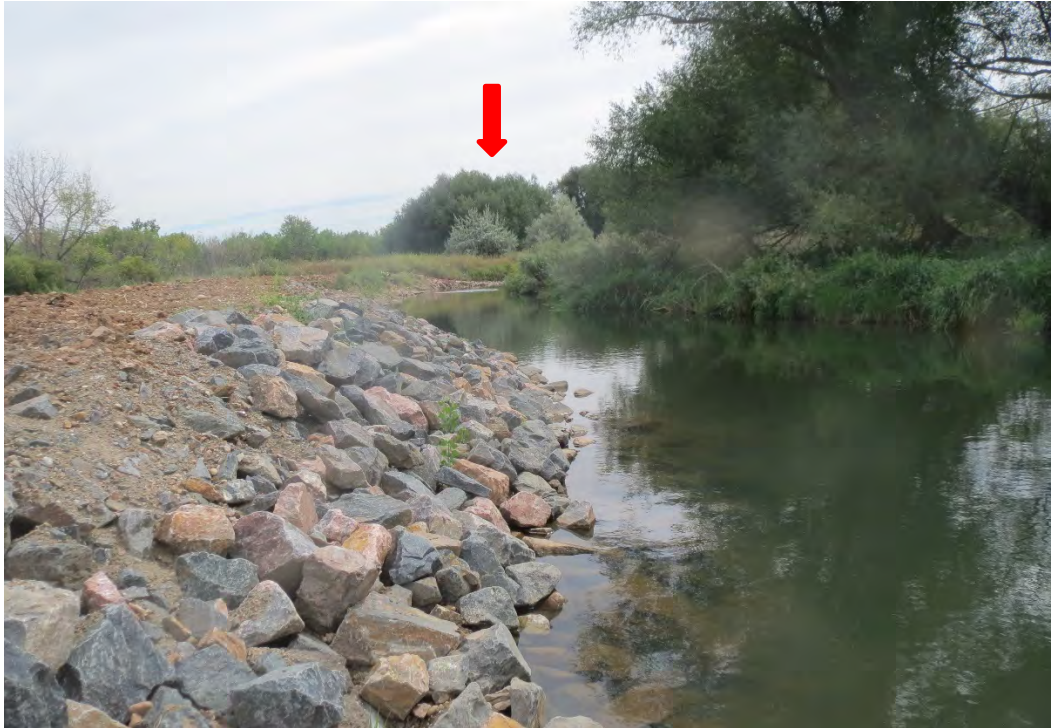
***Photo 20. Prior to restoration, the temporary riprap berm provides poor habitat. Creek dimensions created an entrenched channel. View facing downstream September 7, 2016.***

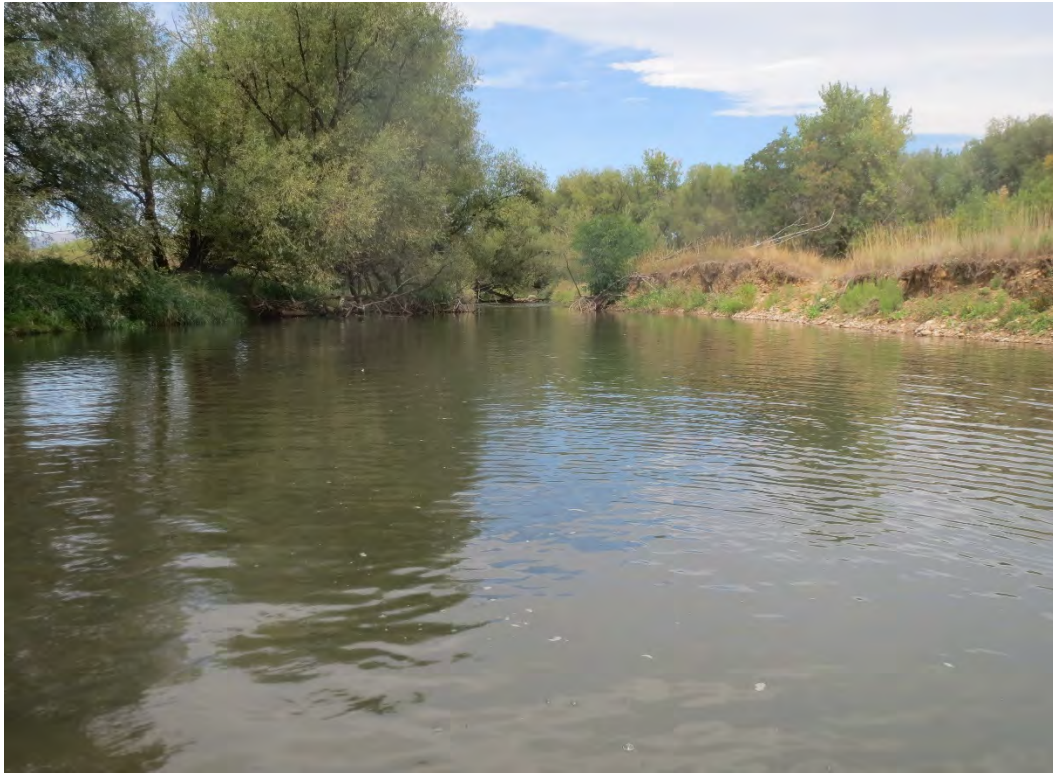
***Photo 32. Typical view of reach straightened during historic gravel mining operations. Note cut left bank. This reach was abandoned during restoration. View facing upstream September 7, 2016.***

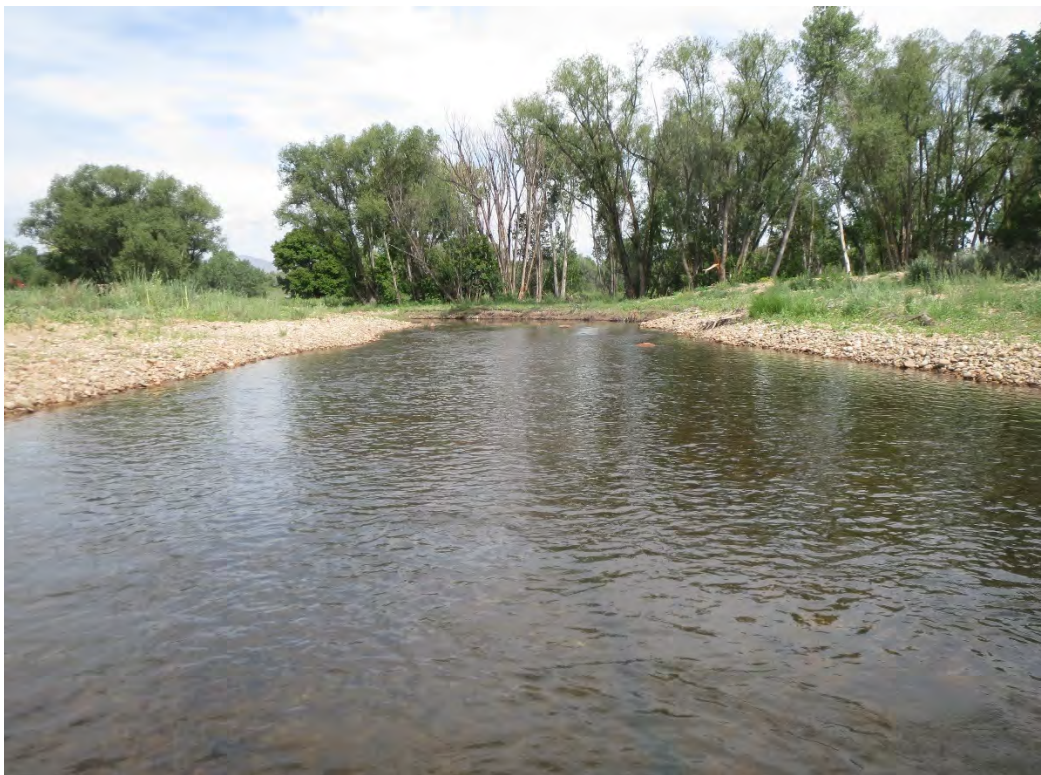
***Photo 33. Re-aligned reach constructed with a more stable plan view and dimension. Wood toe visible at bend in background. View facing upstream August 17, 2017.***

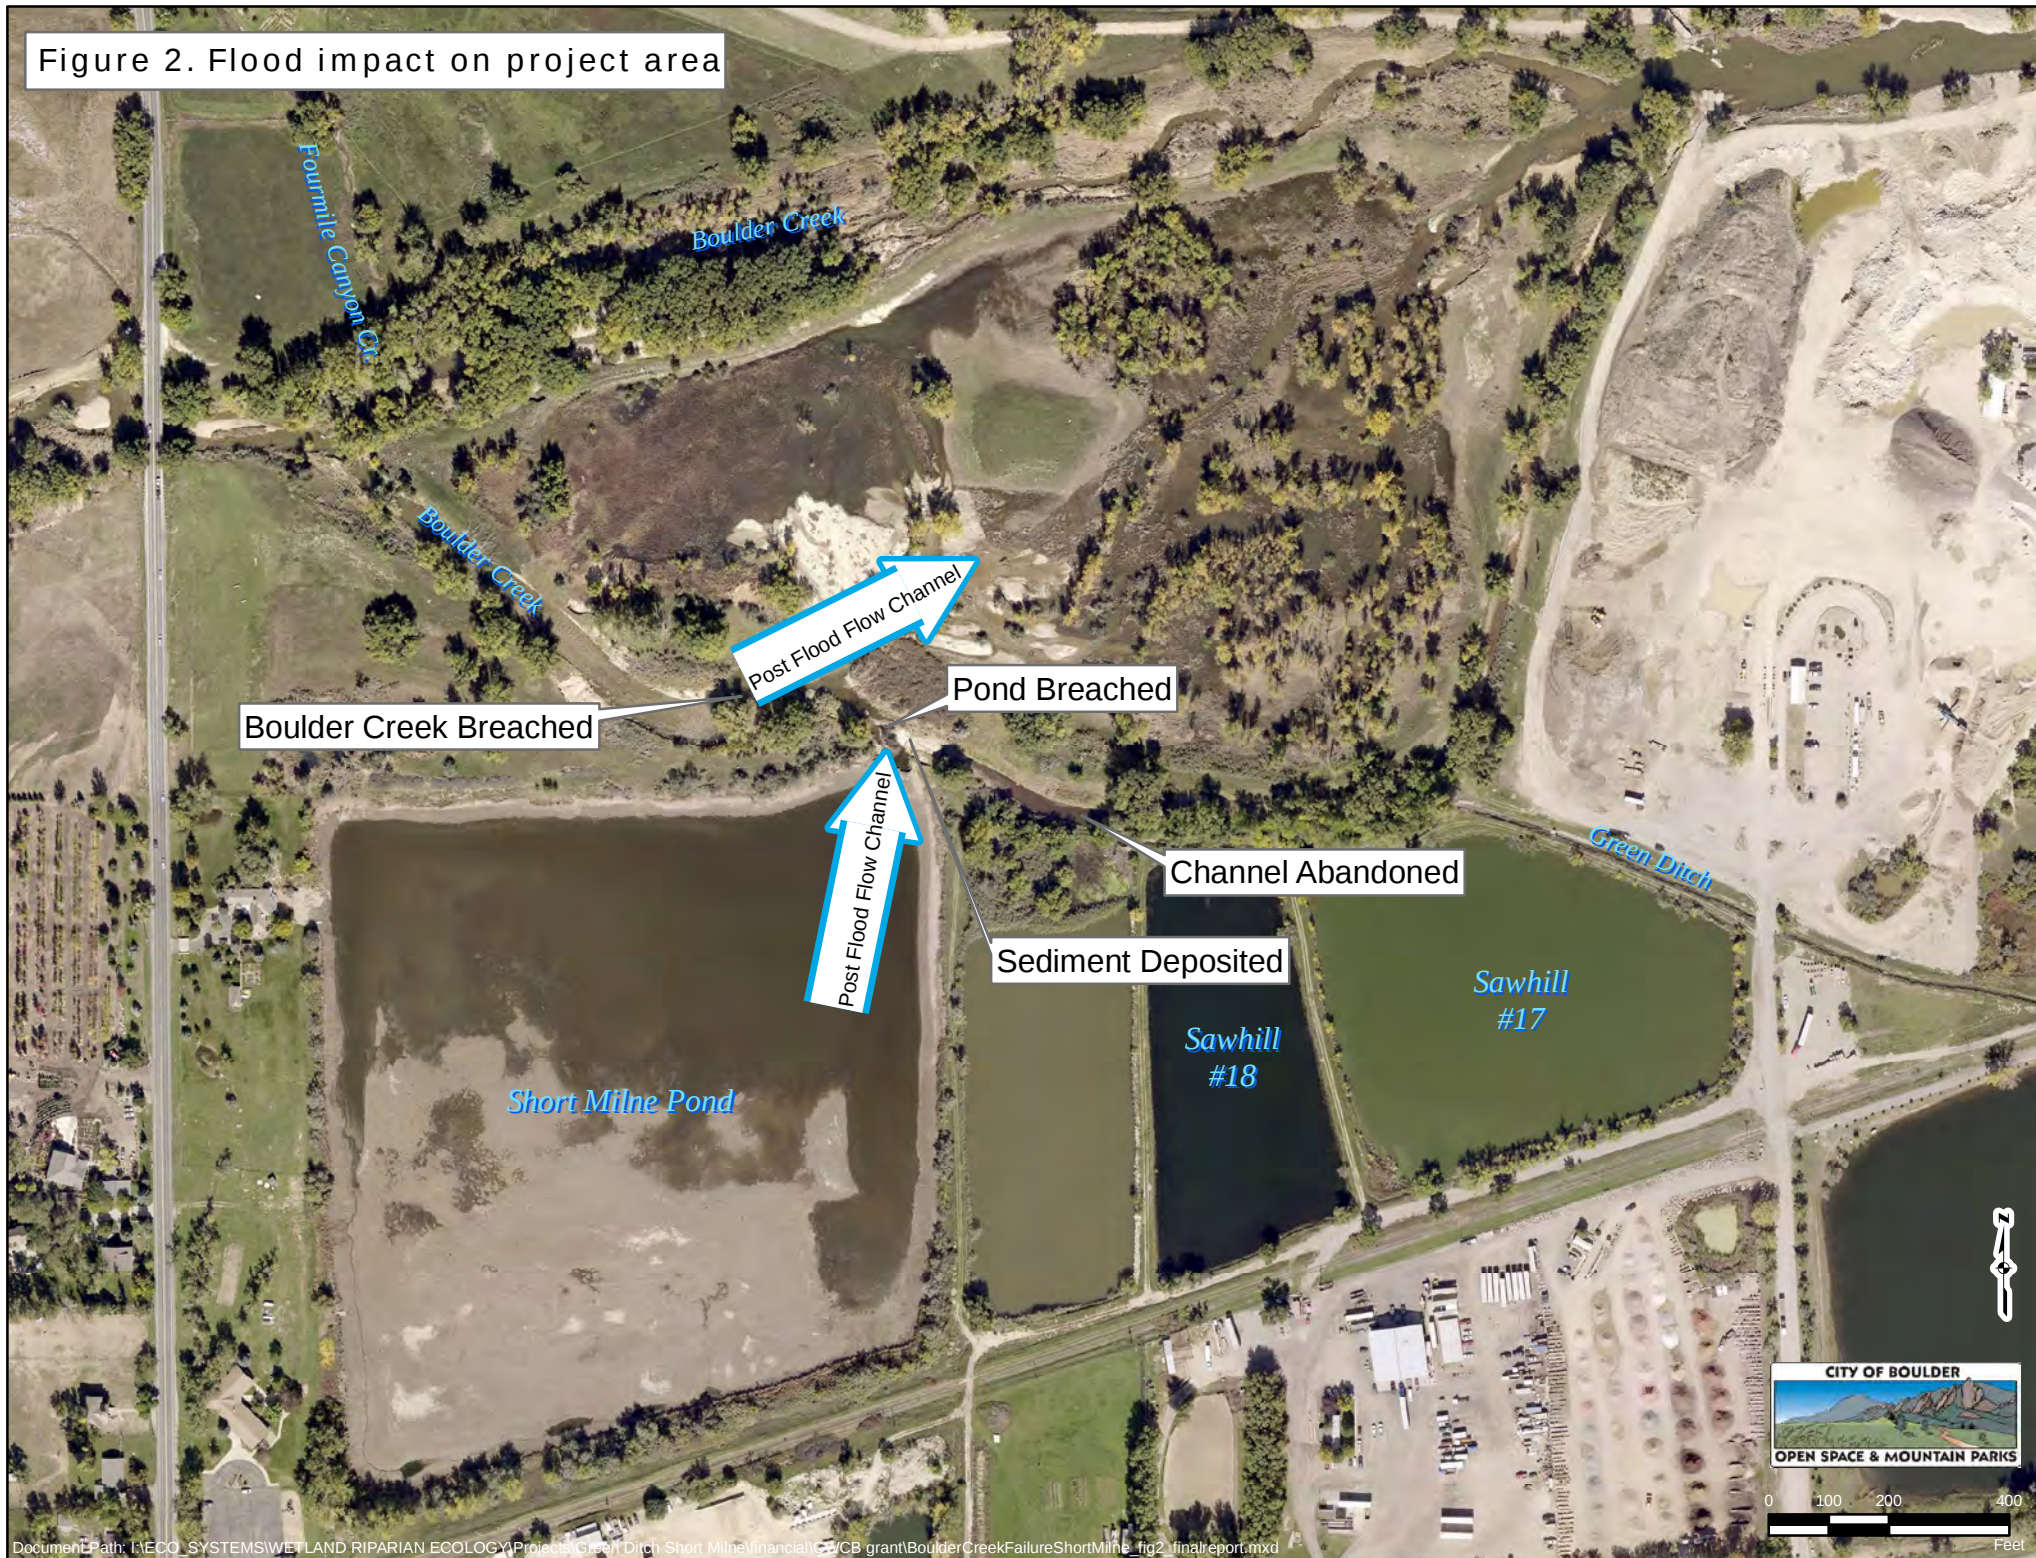
Figure 2. Flood impact on project area

The September 2013 flood event had a significant impact on Boulder Creek, particularly in the area immediately east of the city limits. In the Green Ditch Diversion Rehabilitation and Fish Passage project area (Figure 1), the flood altered Boulder Creek's path. During the flood, the Short Milne Pond, a former gravel pond, situated immediately south of Boulder Creek, breached its northeast corner, spilling sediment into Boulder Creek (Figure 2). This sediment plugged Boulder Creek forcing water in the creek to breach the creek's northern (left) bank diverting all its flow into a wetland (also a former gravel pit) to the north of the creek. While this change in creek path did not directly impact human infrastructure, it left the Green Ditch Company without the ability to divert its adjudicated water as Boulder Creek no longer flowed past the Green Ditch diversion point.
