# UPPER RIO GRANDE WATERSHED ASSESSMENT

FINAL December 2018

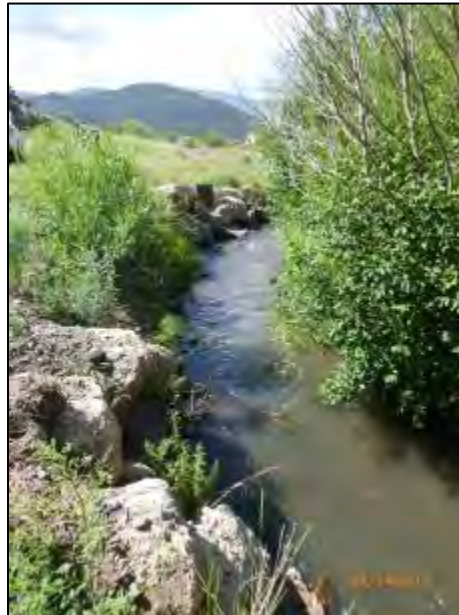
Photo 3. Impacts from road encroachment along trail.

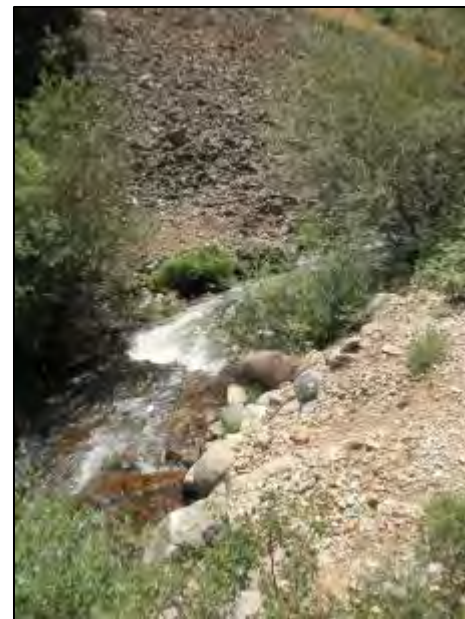
Photo 12. Impacts from road encroachment - looking downstream.

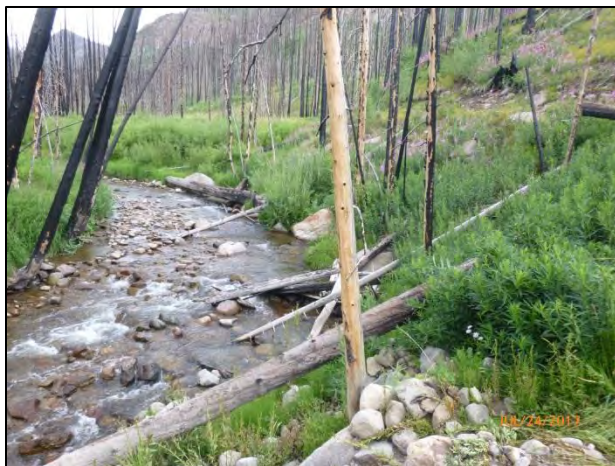
Photo 15. Impact Site No. 5, Hope Creek. Impacts from fire.

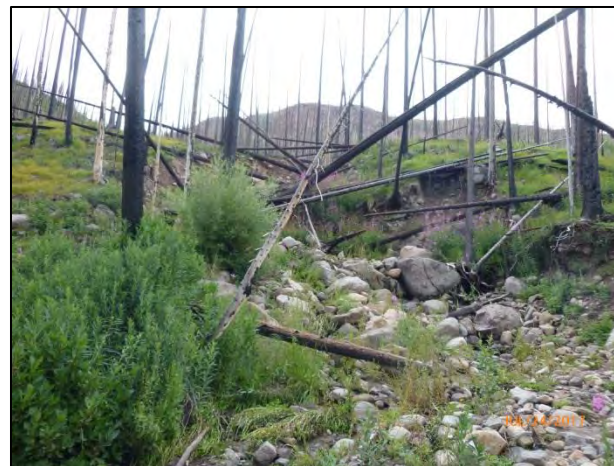
Photo 16. Evidence of erosion from fire; however, vegetation is established in gully to slow velocity and sediment to Hope Creek.

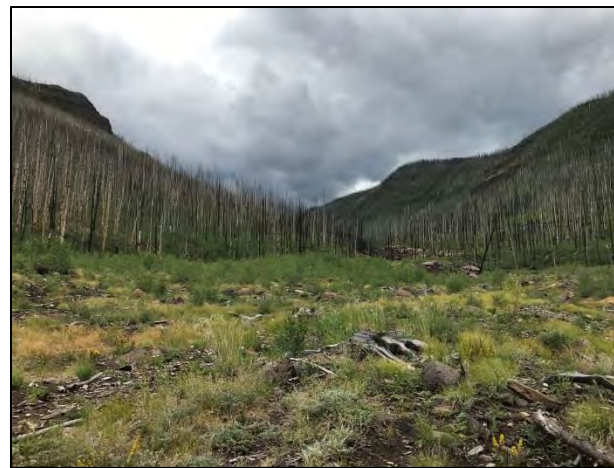
Photo 18. Trees were removed for safety concerns after fire. Note soils still effected by evidence of bare ground.

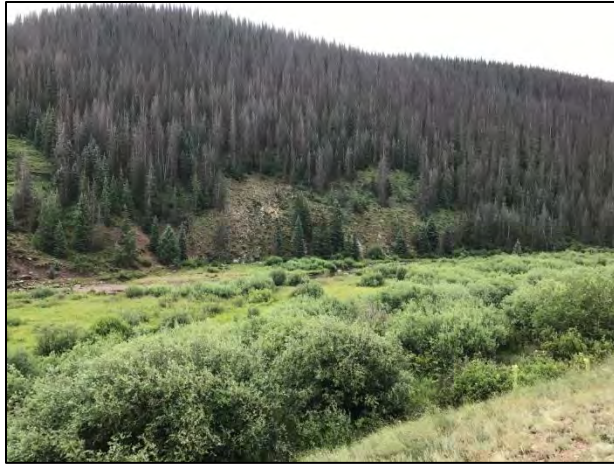
Photo 19. Impact Site No. 14, North Clear Creek.

Photo 20. Impacts include beetle kill, grazing, and road encroachment.

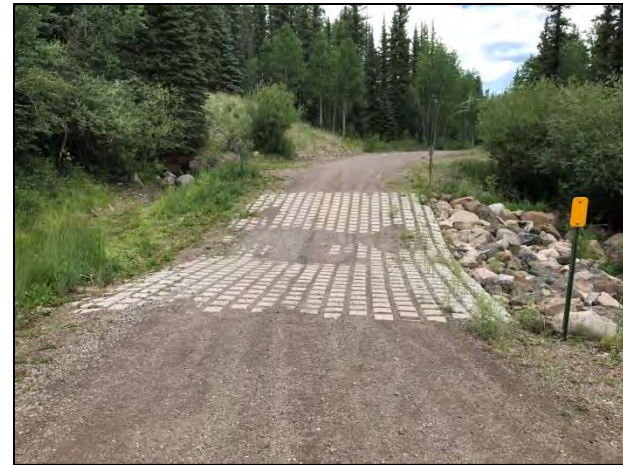
Photo 25. Impact Site No. A1, Fern Creek.

Photo 26. Impacts from road crossing and culvert.

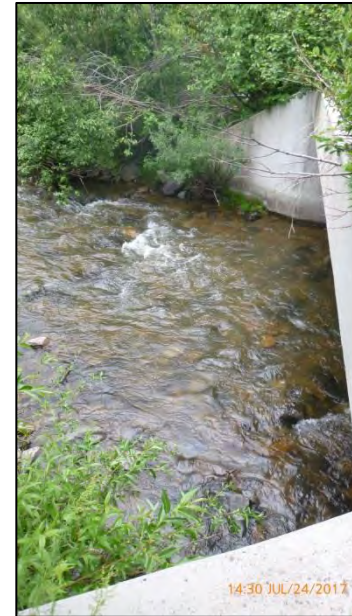
Photo 27. Impact Site No. A3, Pass Creek.

Photo 28. Road crossing at Pass Creek.

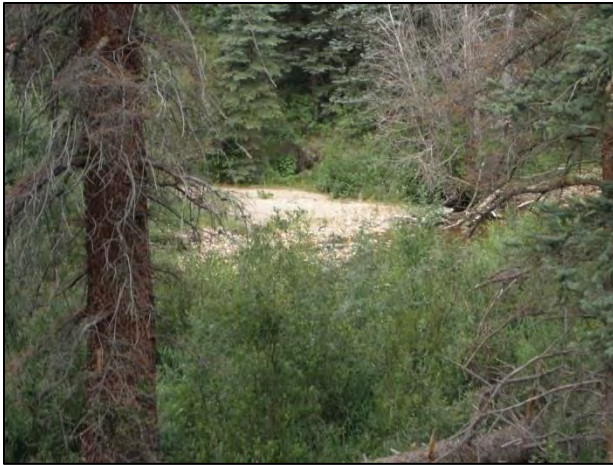
Photo 31. Impact Site No. A5, Miners Creek. Impacts from mining.

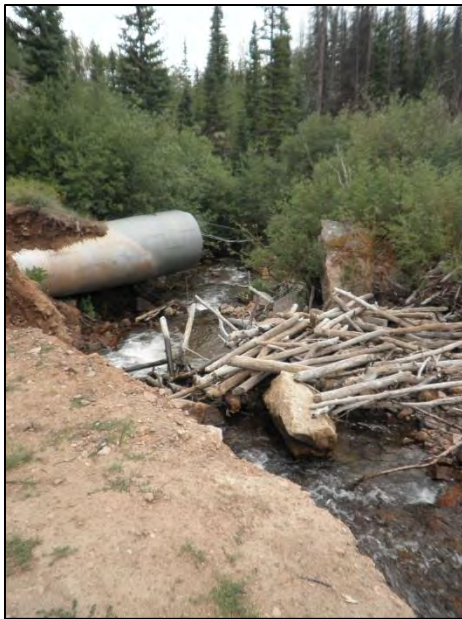
Photo 33. Impact Site No. A6, Rat Creek. Erosion impacts from culvert and road encroachment.

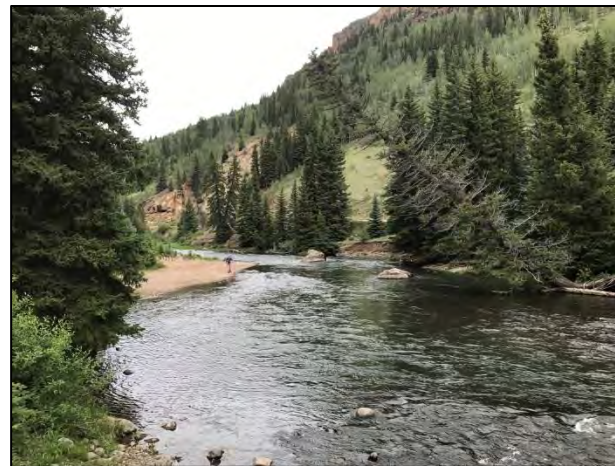
Photo 38. Impacts from road crossing and dispersed recreation.
