June 27, 2019

Re: Terrace Reservoir Outlet Inspection and Outlet Works Pipe Repair Concepts; D&A Job No. CG-0526.002.00

OUTLET WORKS TUNNEL AND 48-INCH DIAMETER PIPE INSPECTION

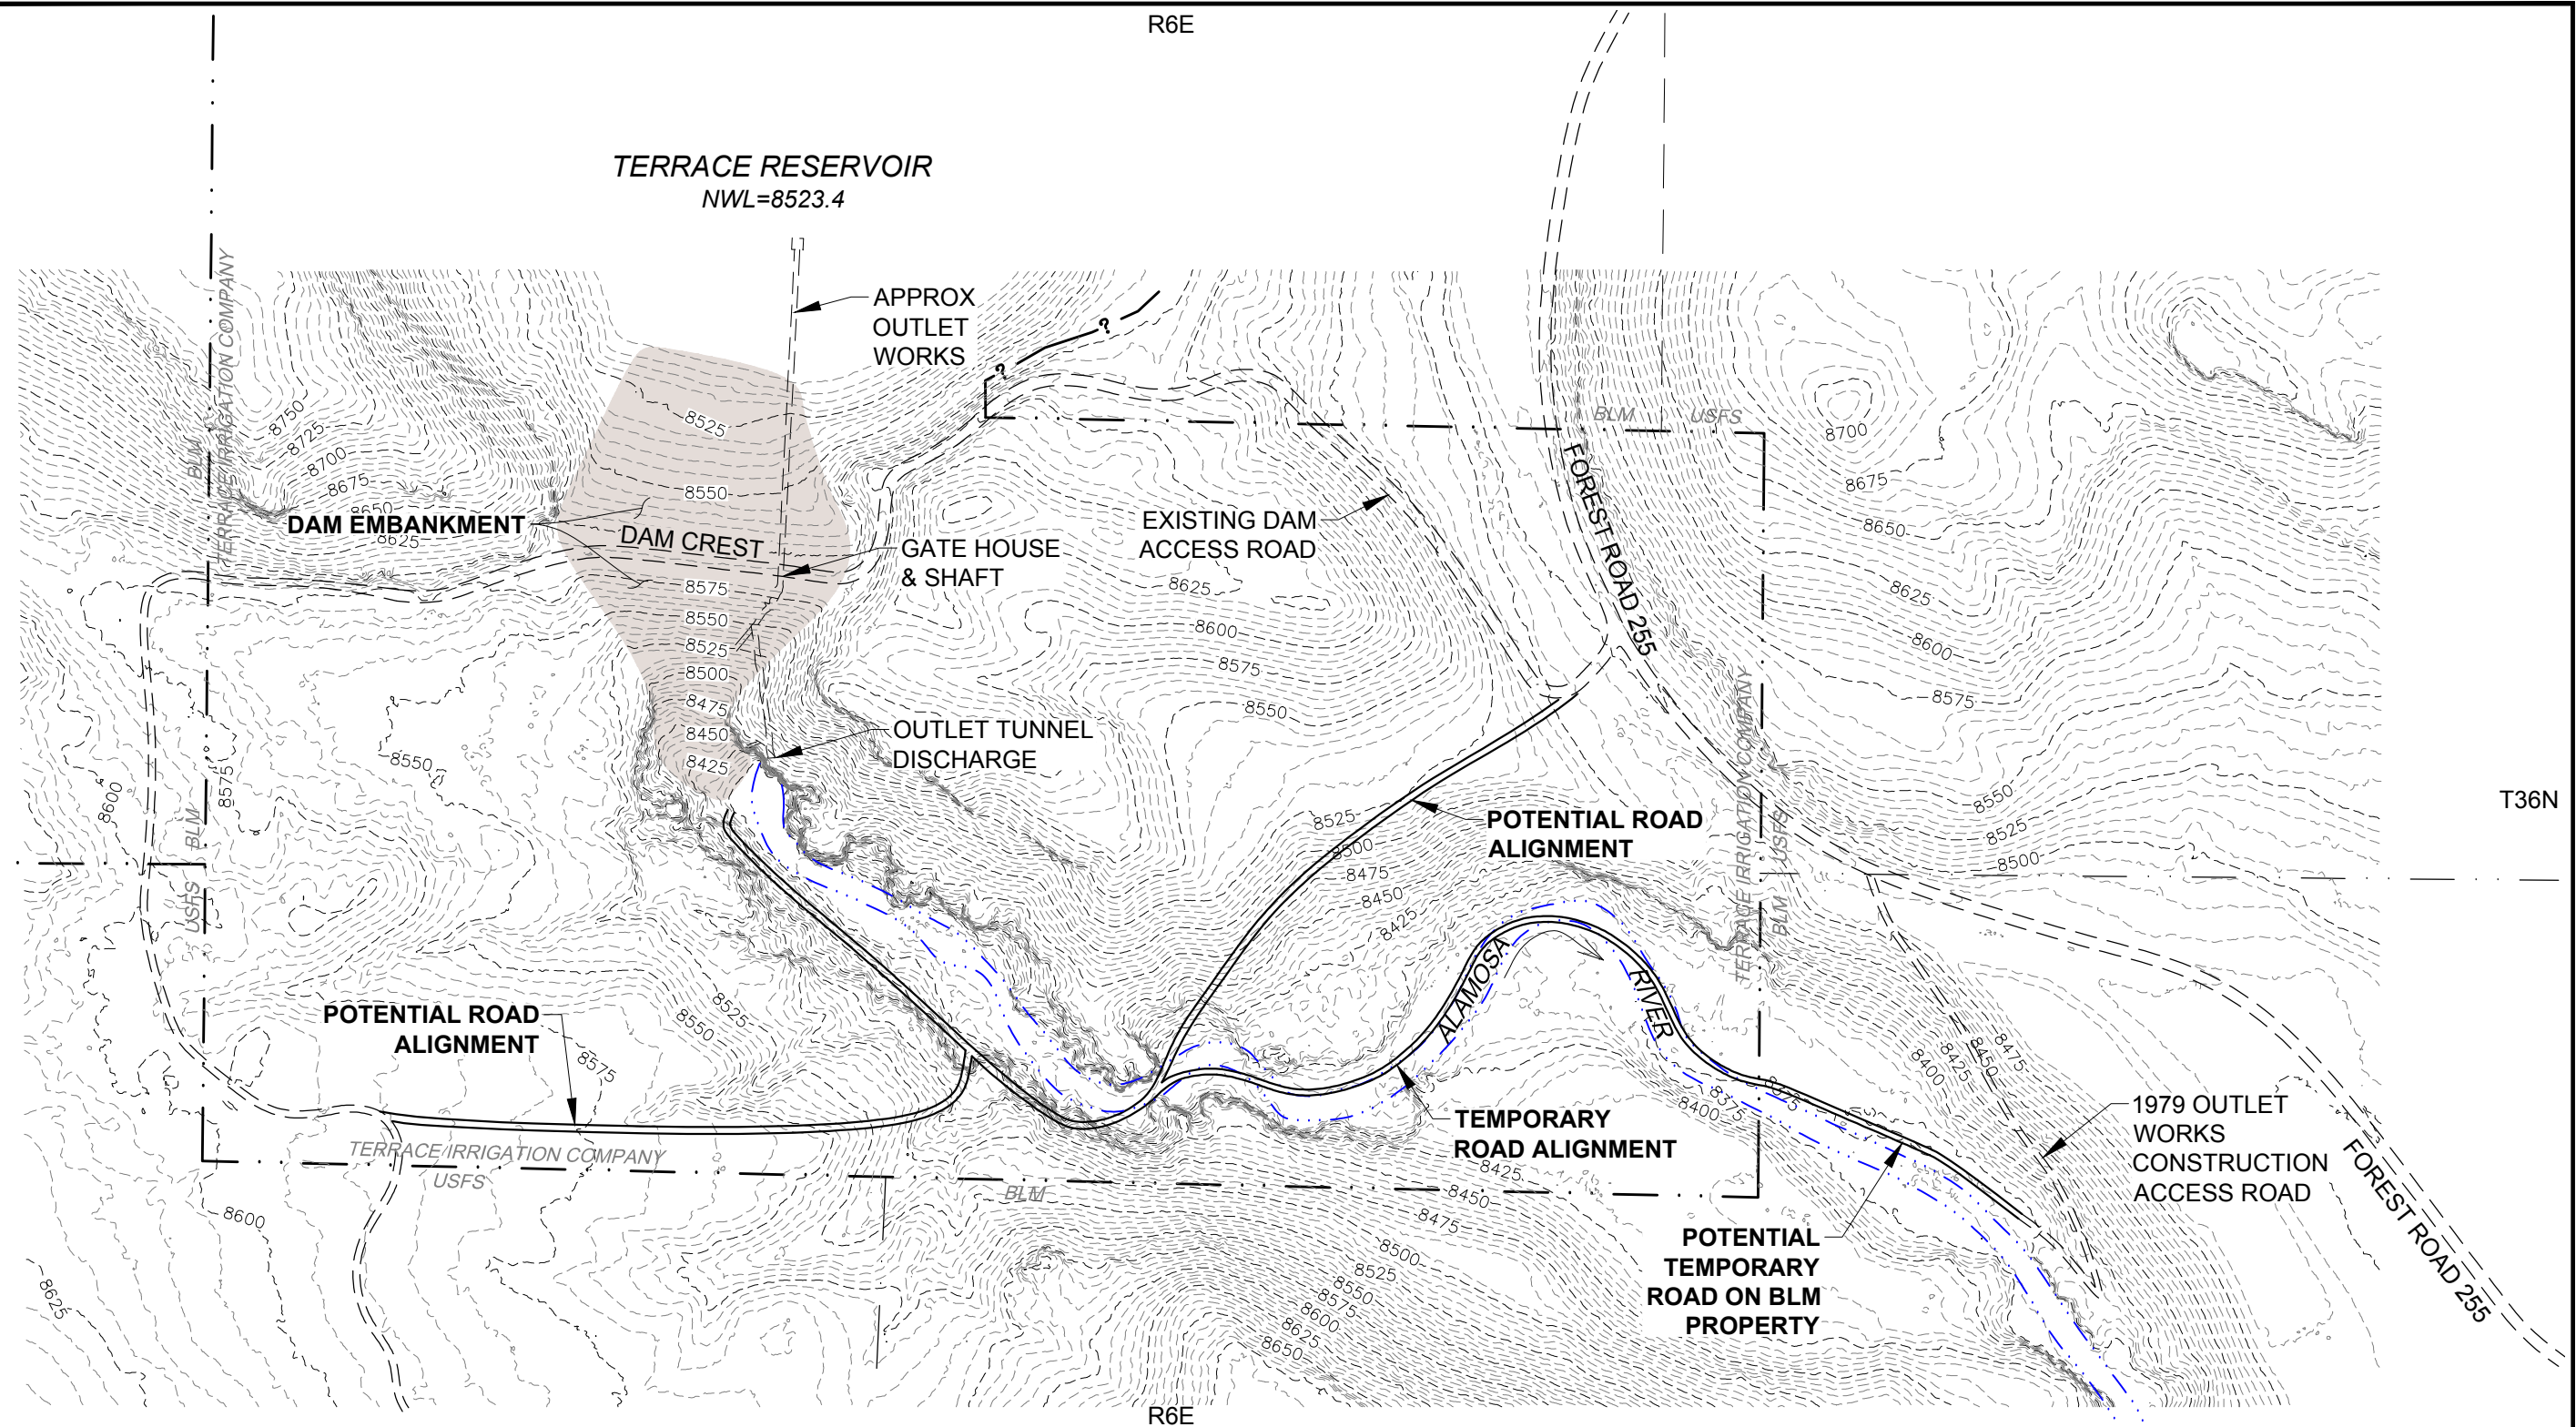
TERRACE IRRIGATION COMPANY	
OUTLET WORKS ACCESS ROADS	
DEERE & AULT	FIGURE NO.
CONSULTANTS, INC.	4
DATE: JUNE 2019	SCALE: AS NOTED

We developed a precursory review of potential permanent road alignments on Terrace Reservoir Irrigation property to the outlet works. Construction of a permanent road to the dam downstream to outlet works on company property would be difficult but valuable in providing future access and reduced construction costs for maintenance and repairs. Additionally, this would alleviate risks of obtaining permits and associated timing with the BLM. Potential routes are shown on **Figure 4**. Other routes may be identified with further field investigations.
