LOAN FEASIBILITY AND EVALUATION REPORT

QUEEN DAM

KIOWA COUNTY, COLORADO

March 2020

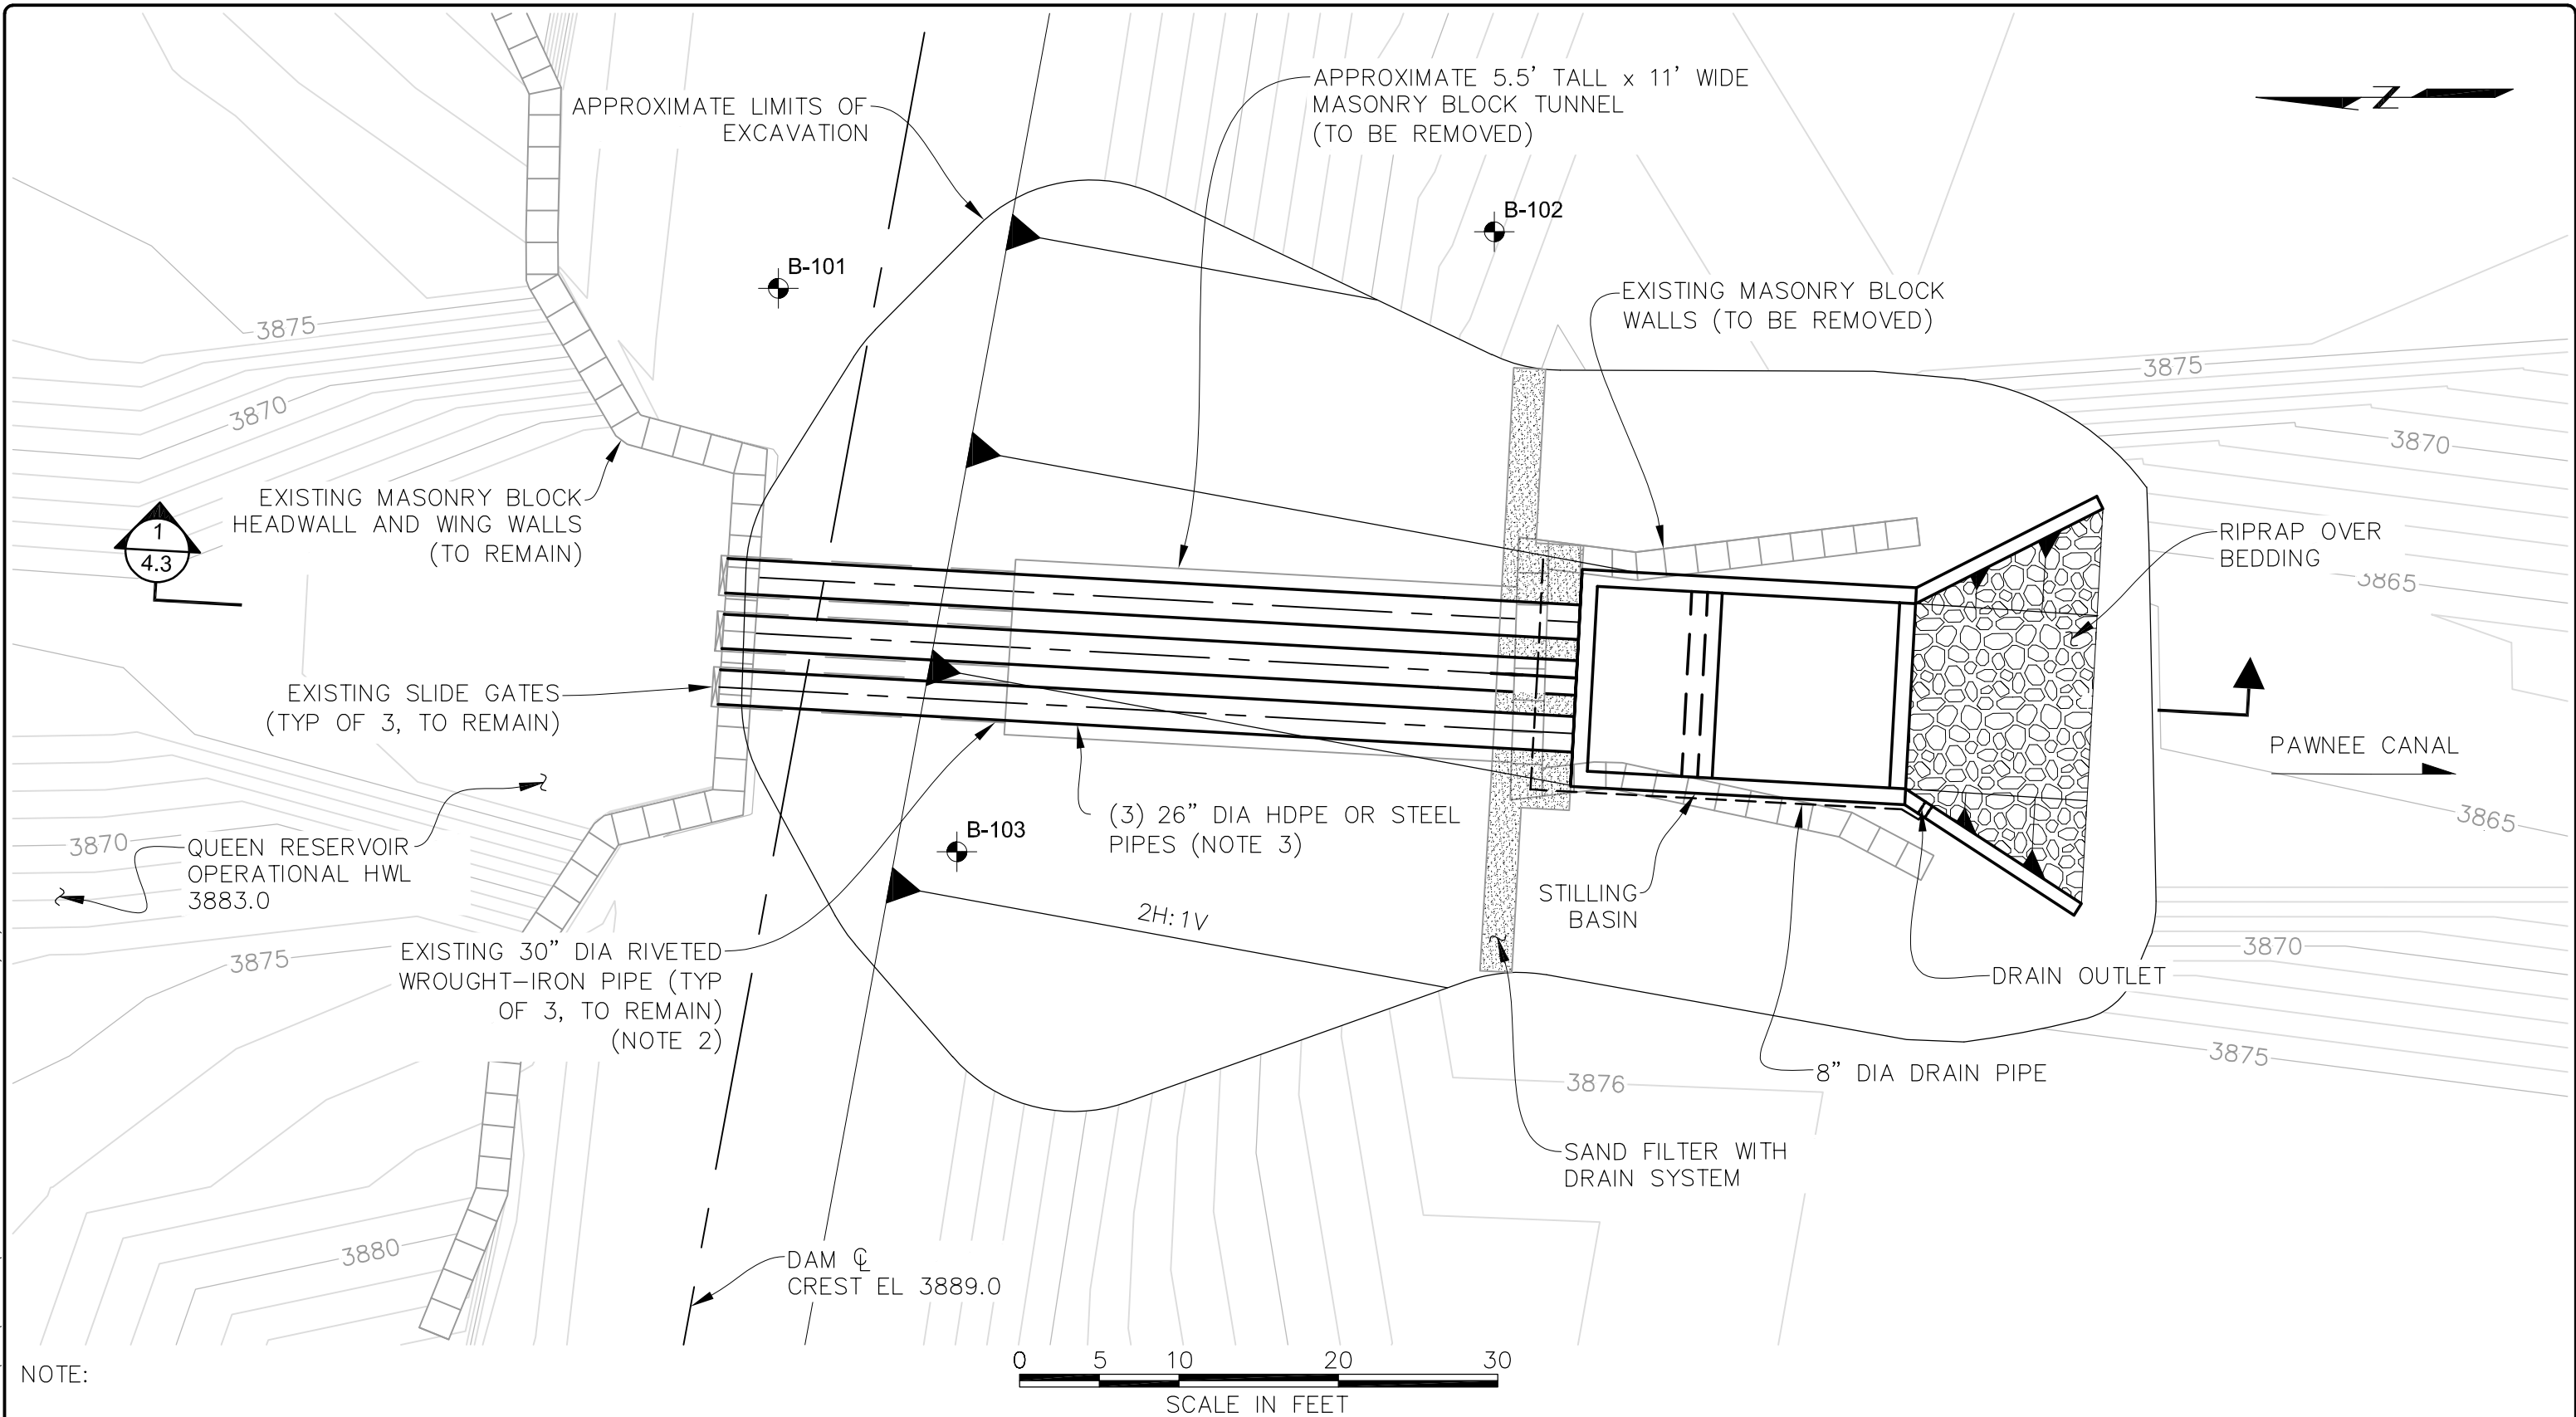
Figure 4.1

Wachob & Wachob, Inc. under contract to RJH performed a topographic survey of the embankment dam and appurtenant site features in January and February 2018. In addition, the survey recorded site features and boring locations. Two permanent survey control monuments were established downstream of the dam embankment and to the east and west of the discharge channel. The horizontal and vertical coordinate systems are Colorado State Plane South Zone (NAD83) and North American Vertical Datum of 1988 (NAVD88), respectively. Existing conditions and topography in the vicinity of the outlet works is shown on Figure 4.1.
