# Chambers Reservoir Slope Failure on the South-West reservoir slope

Field Inspection 4-25-17

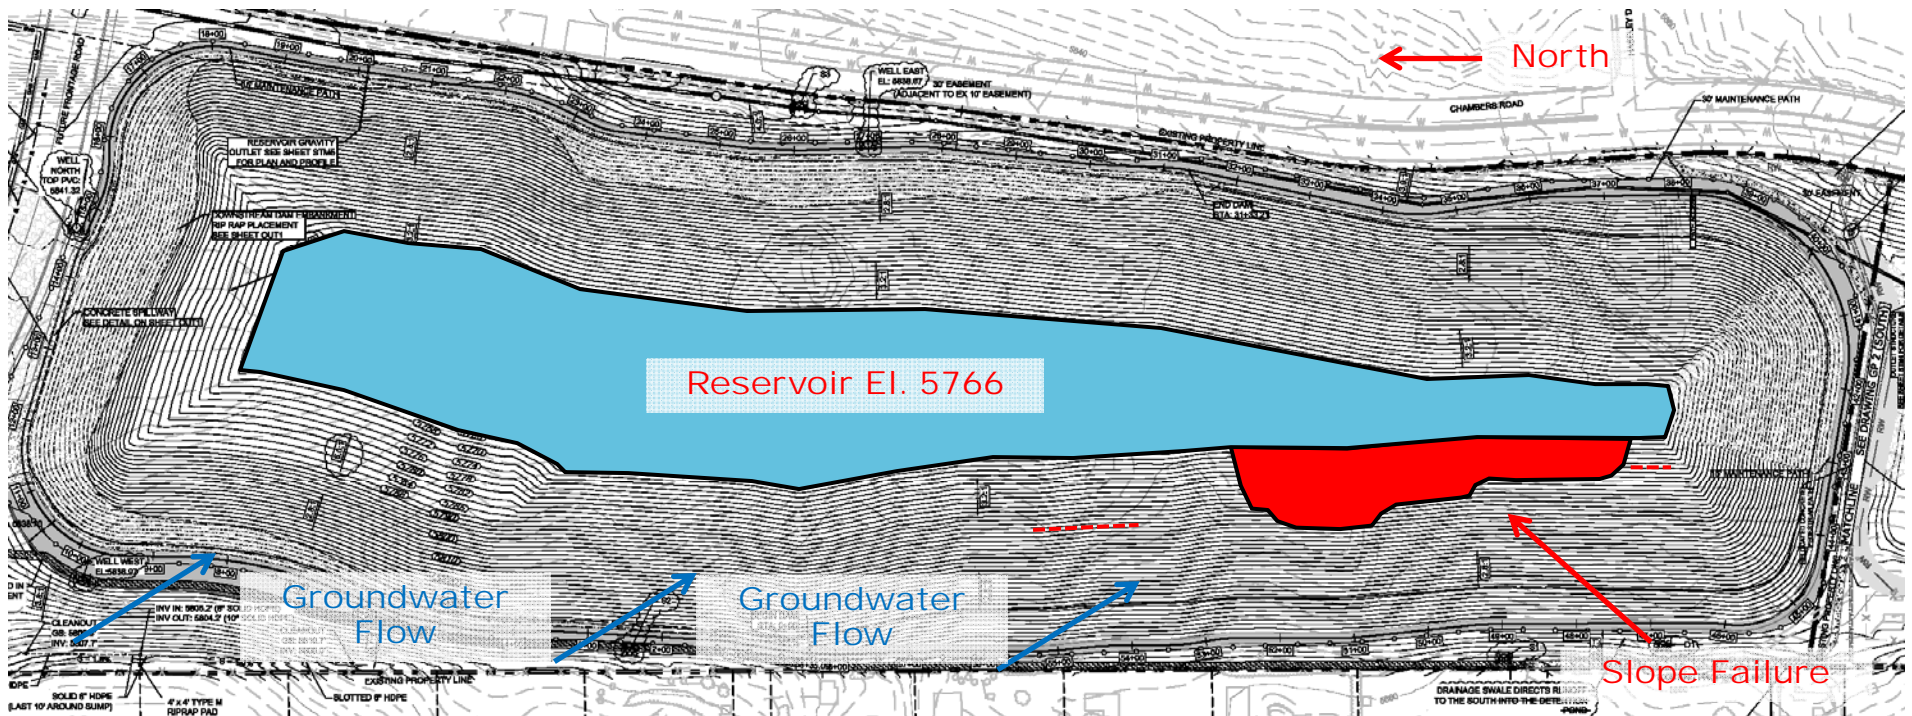
Direction of Regional Groundwater Flow: North-west to South-east

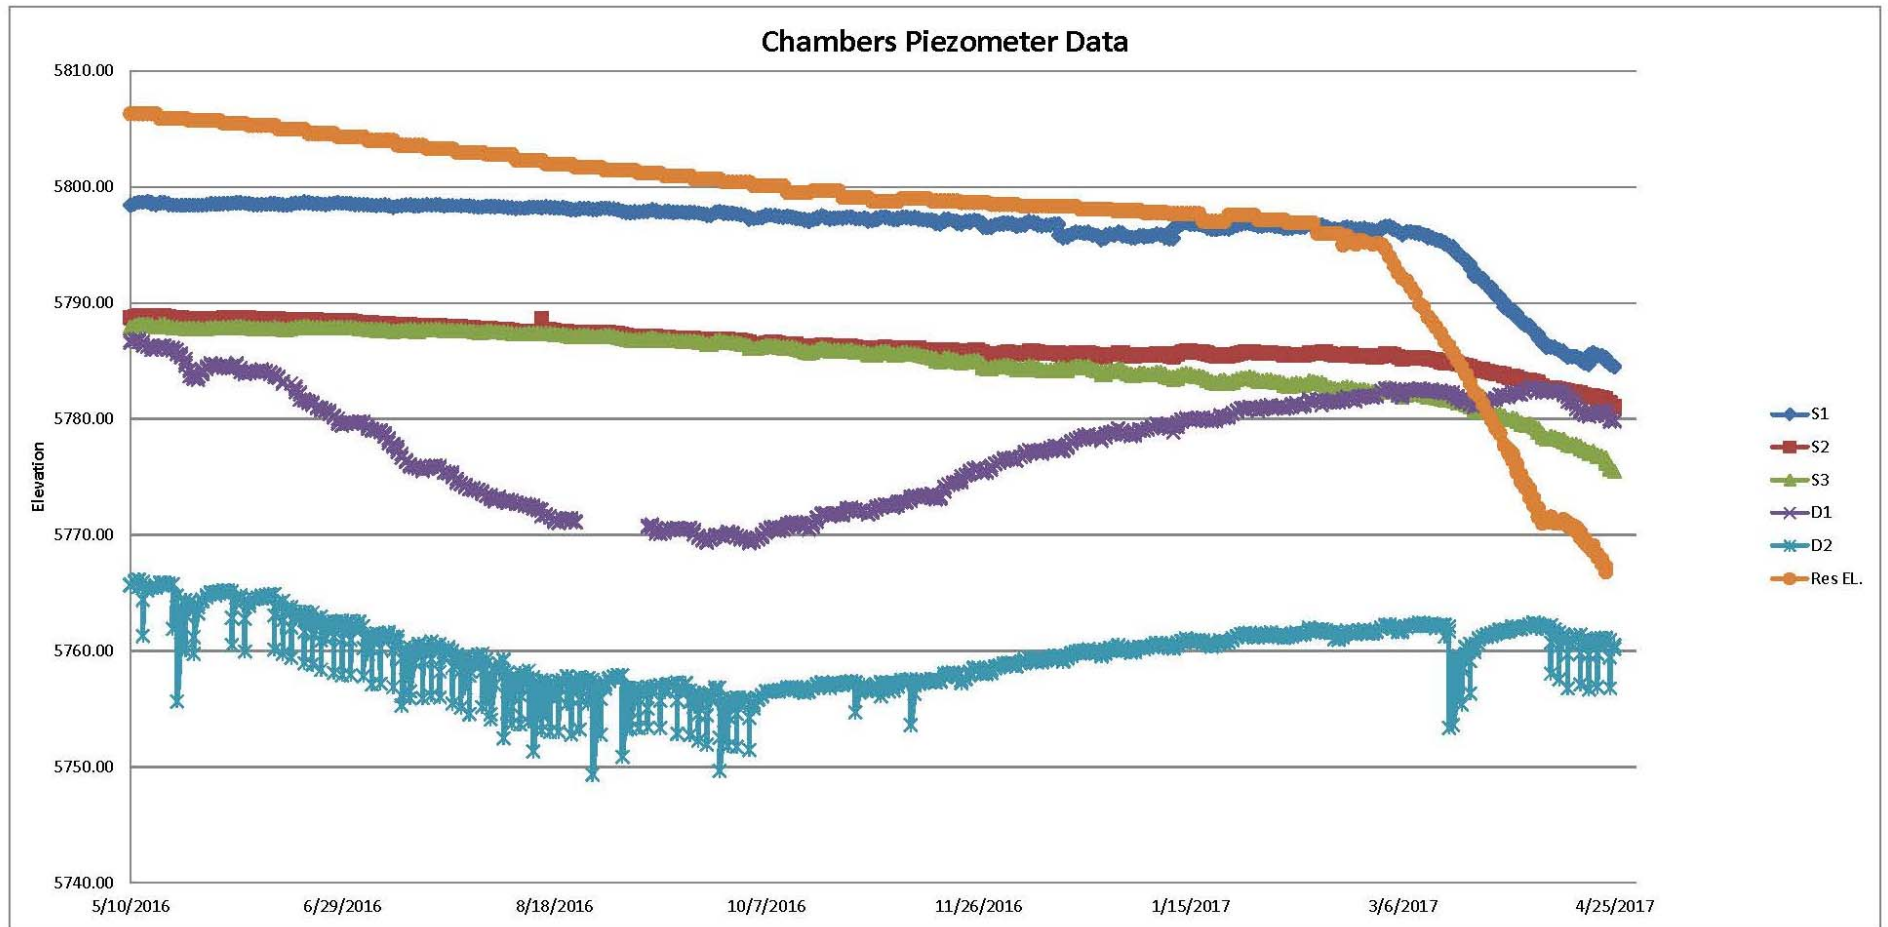
# Instrumentation

- Occurred ~March 25th or 26th, 2017
- Water observed flowing out from head scarp
  - High groundwater behind CCL
- Reservoir drawdown in March 2017
  - Rate of drawdown = 9 inches per day (El. 5796 – 5774)
  - Most rapid drawdown cycle (history of reservoir)
- March 25<sup>th</sup>, 2017
  - Groundwater El. = 5792 (piezometer S1)
  - Reservoir El. = 5781 (11 feet lower than S1)

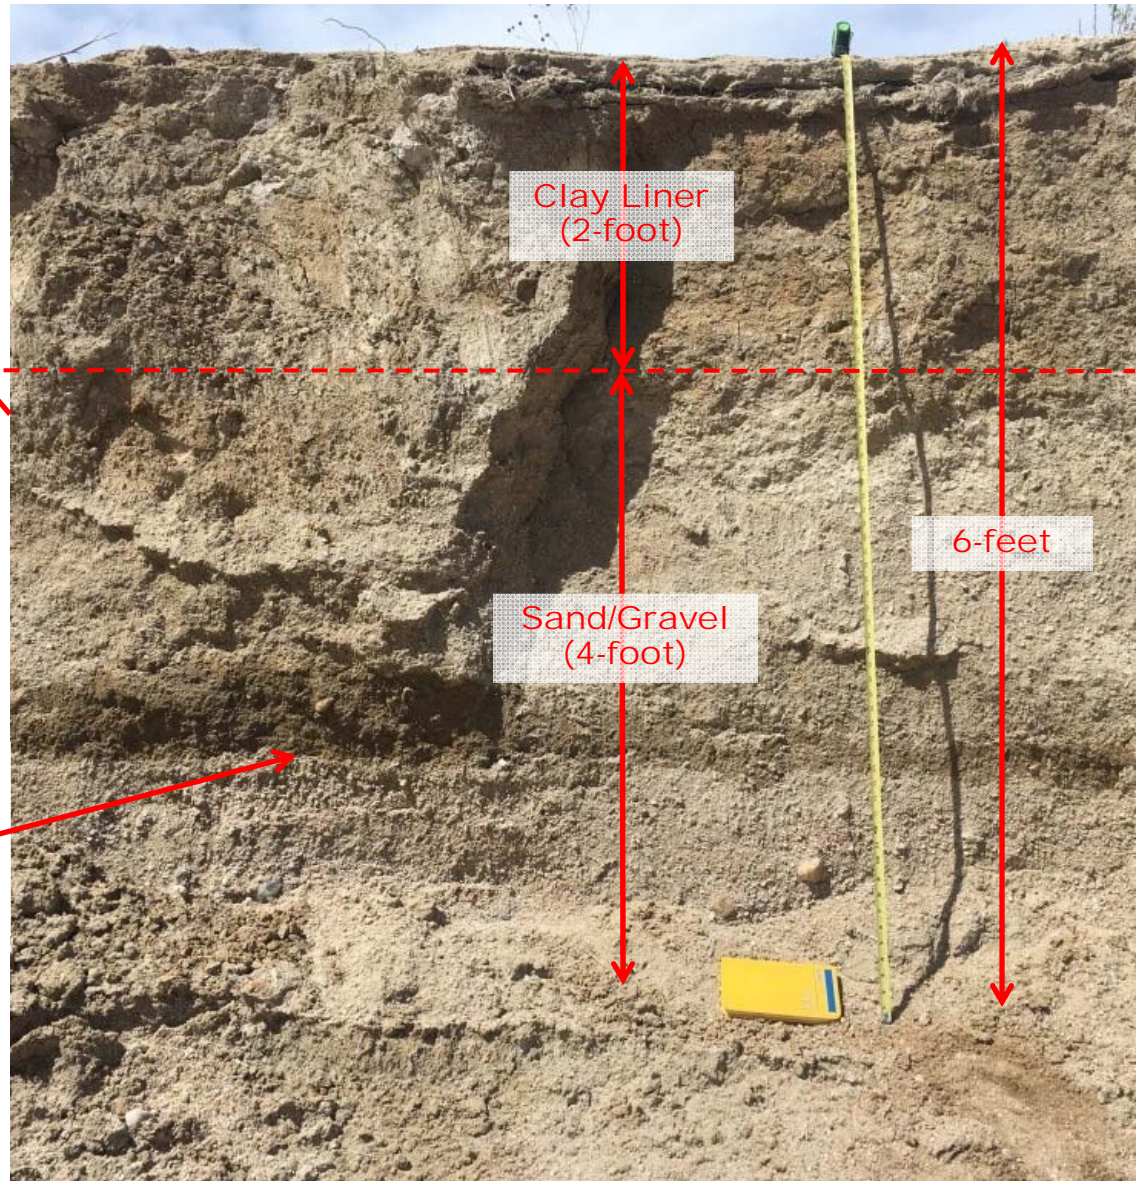
Seepage along  
gravelly  
sandy  
layers

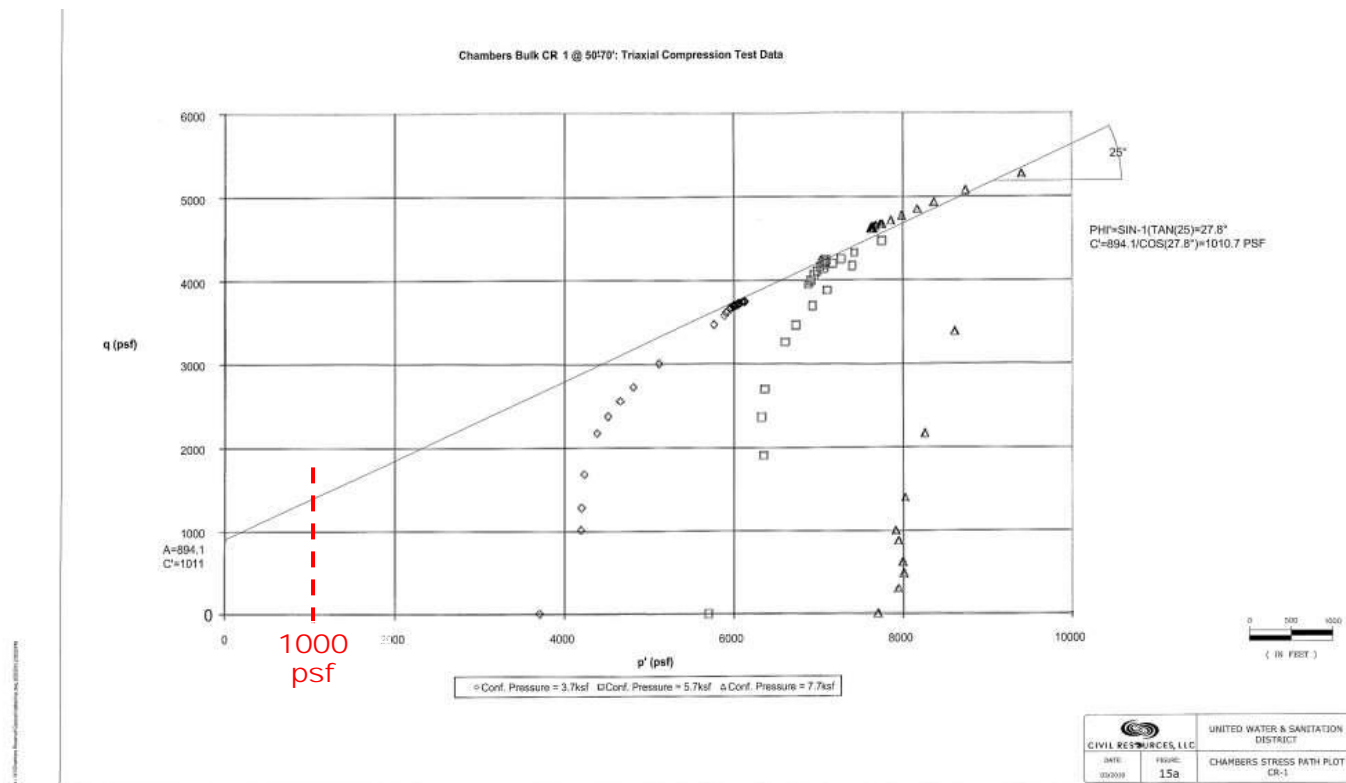
- Shear Strength Parameters
  - Triaxial testing performed at stresses exceeding the stress of the CCL (3,700psf to 7,700psf)
  - Triaxial test results may over-estimate strength of CCL (both drained and undrained).
