WARD LAKE DAM OUTLET REHABILITATION  
Construction File No. C-0888A  
Dam ID No. 400533

Final Construction Report  
December 22, 2020

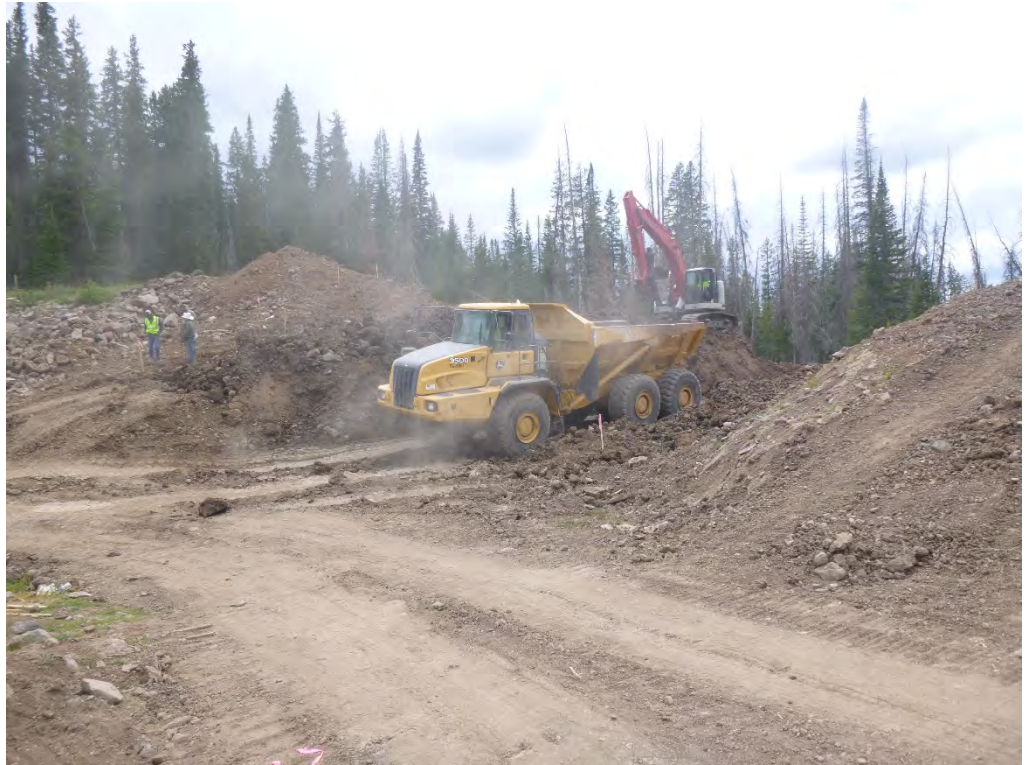
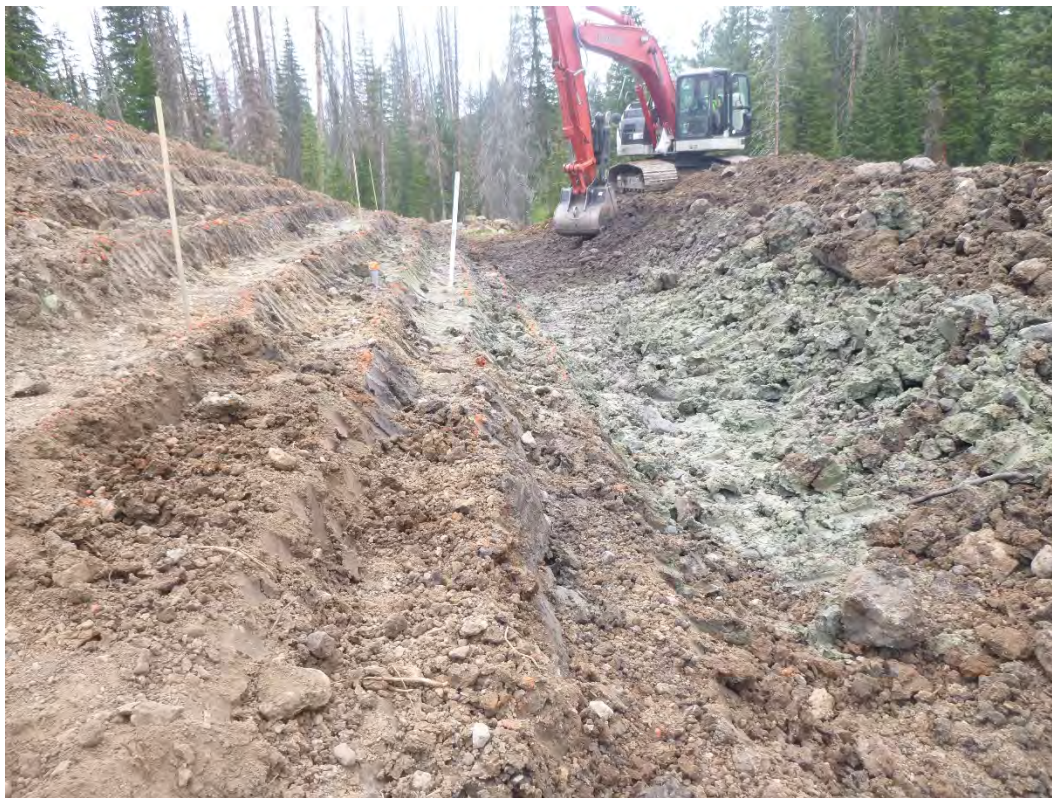
View looking downstream along  
left sideslope of breach with  
pre-formed benches. Blue clay  
can be seen in foreground.

Close-up of benched sideslope.

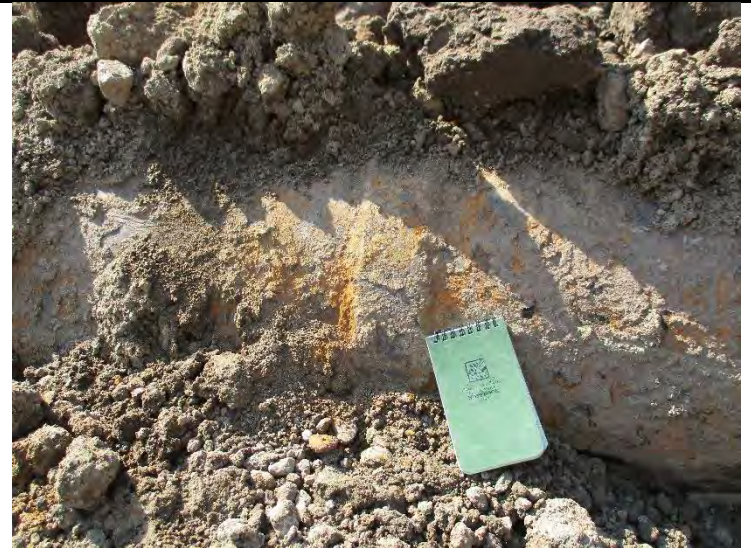
Photo 2. Old pipe joint

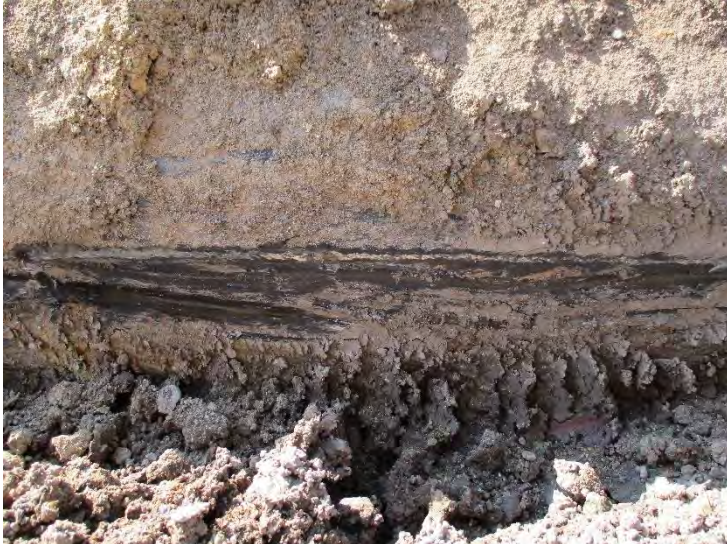
*Photo 3. Pipe is described as 1/4-inch thick, asbestos wrapped welded steel pipe with arc weld joints (reference C-0590 specifications) - photo shows outer material scraped away, revealing steel beneath*

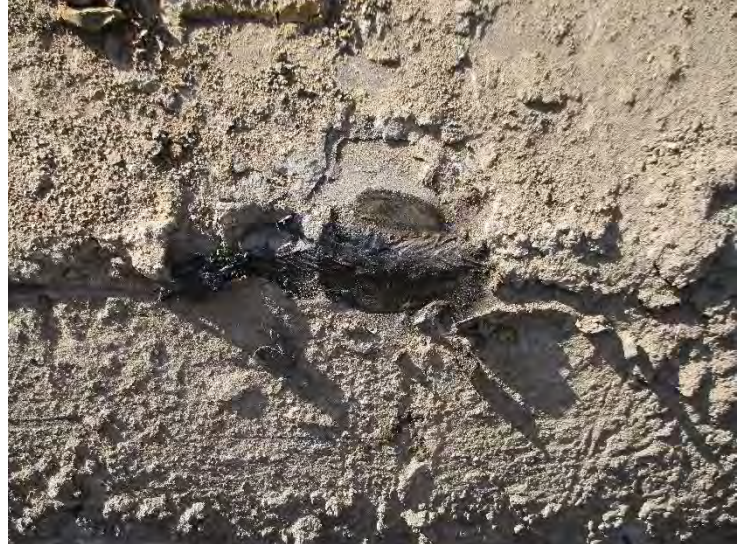
*Photo 4. Close-up view of old pipe exterior - seam along side of pipe appeared discontinuous - the section of pipe upstream likely was turned over, with the seam located beneath*

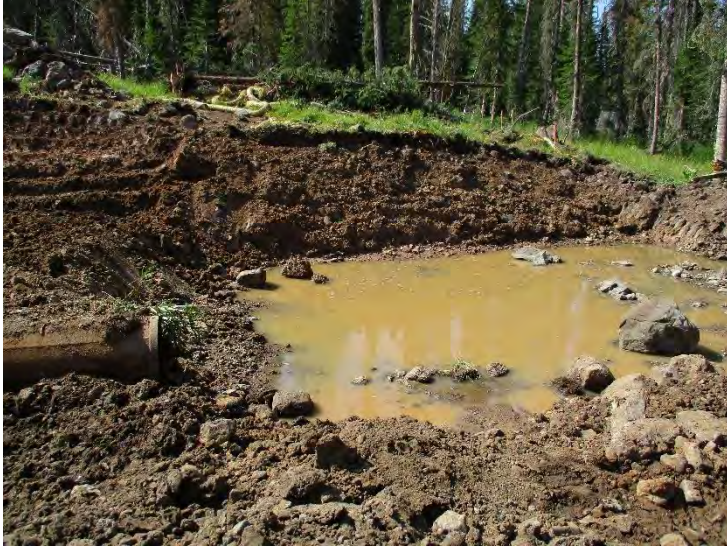
Photo 7. Stilling basin - terminal end of pipe (area to be dewatered)

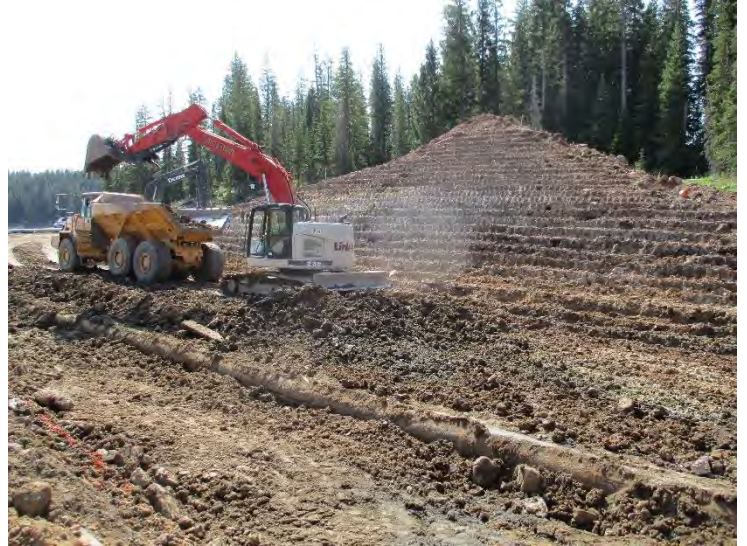
Photo 8. View of the old, exposed pipe, prior to removal

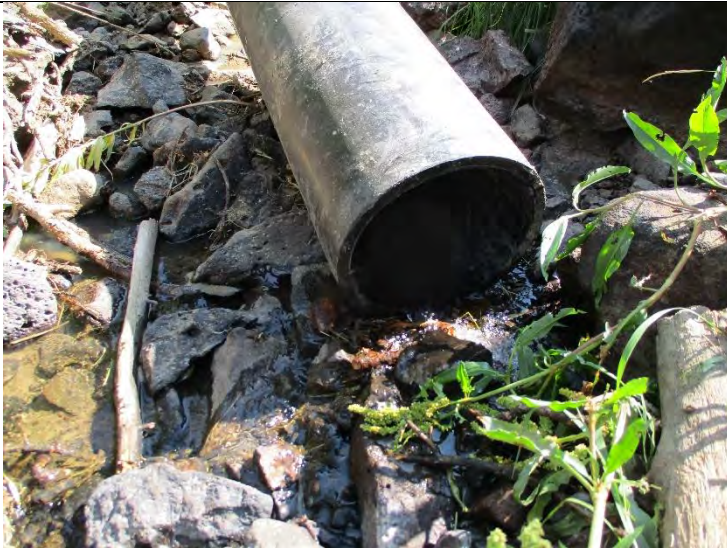
Photo 9. Flow depth of less than 0.5-inch conveyed by bypass pipe

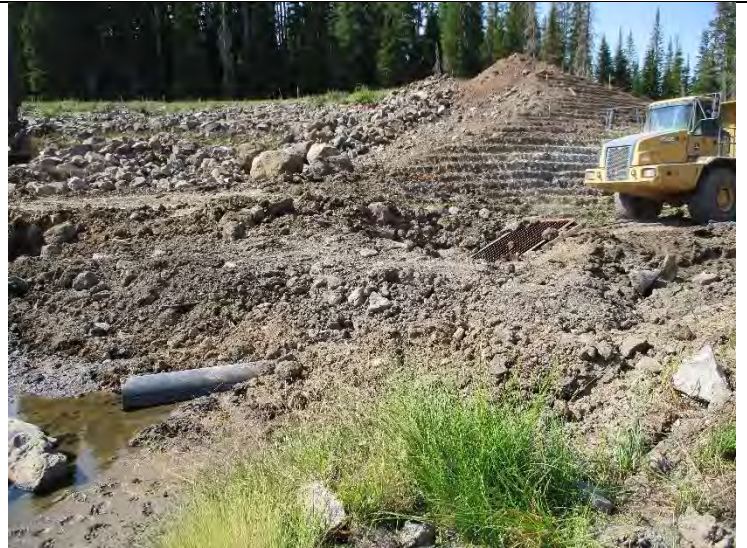
Photo 10. Bypass pipe inlet - old trash rack is visible in center right of photo

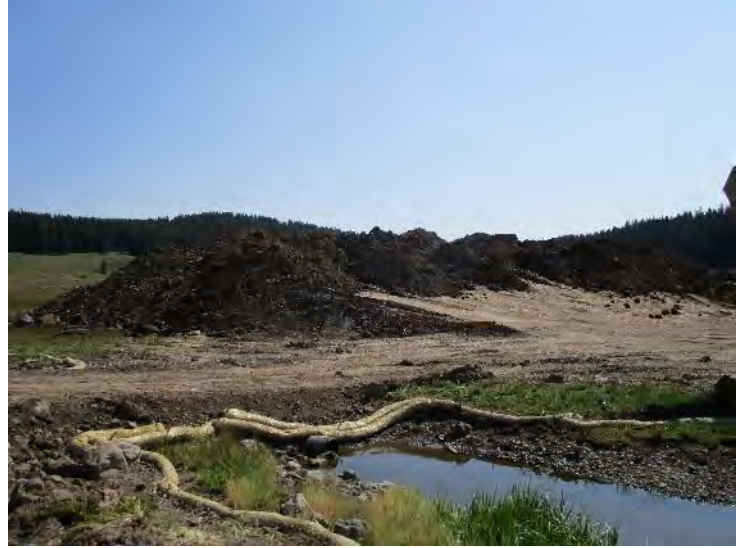
*Photo 12. Newly excavated stockpiled material - Con-Sy plans to transport a shaker/screener to the site to facilitate removal of large D-50 elements*

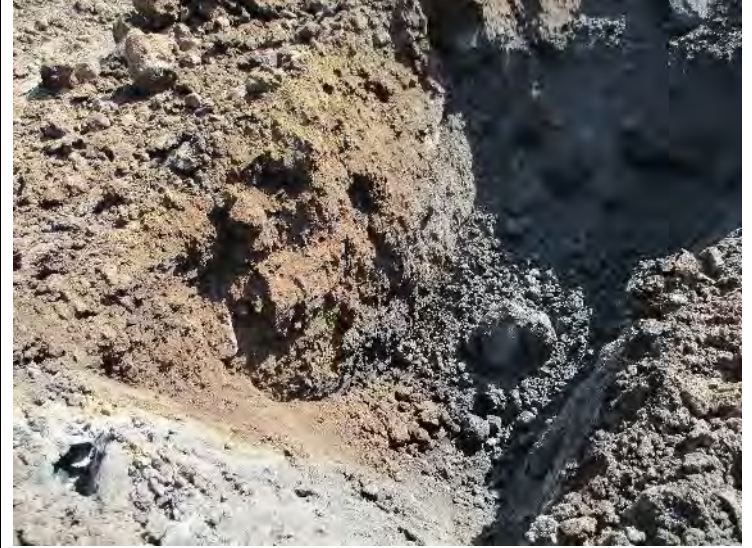
Photo 16. View into excavation directly adjacent to outlet - generally clayey material

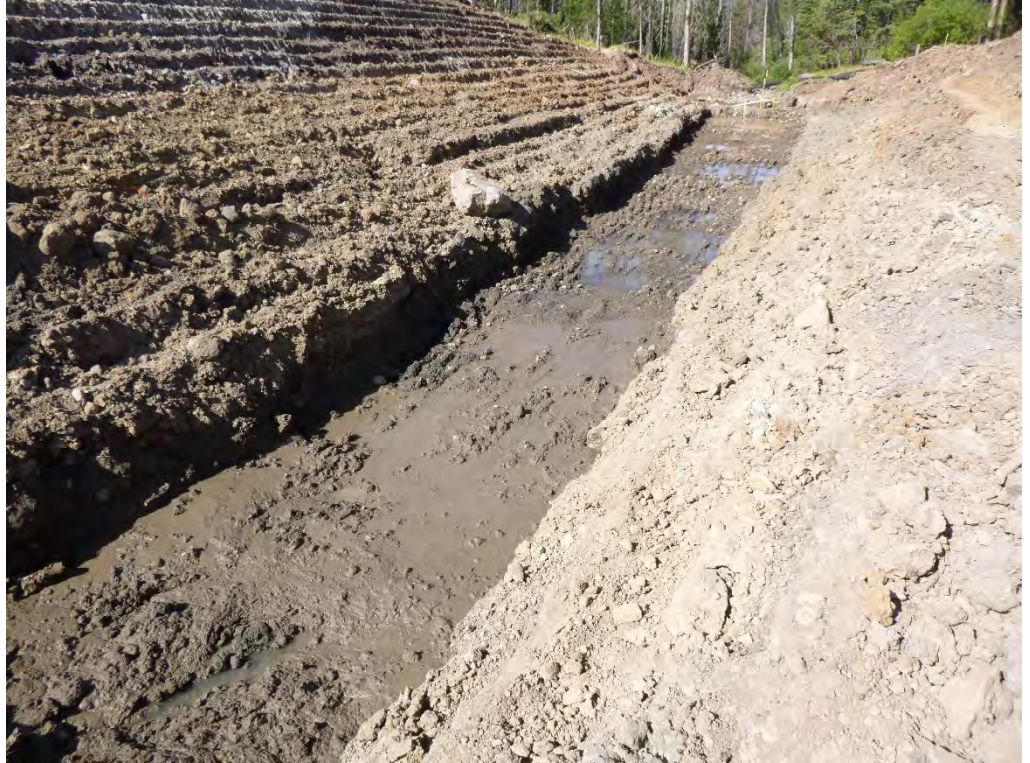
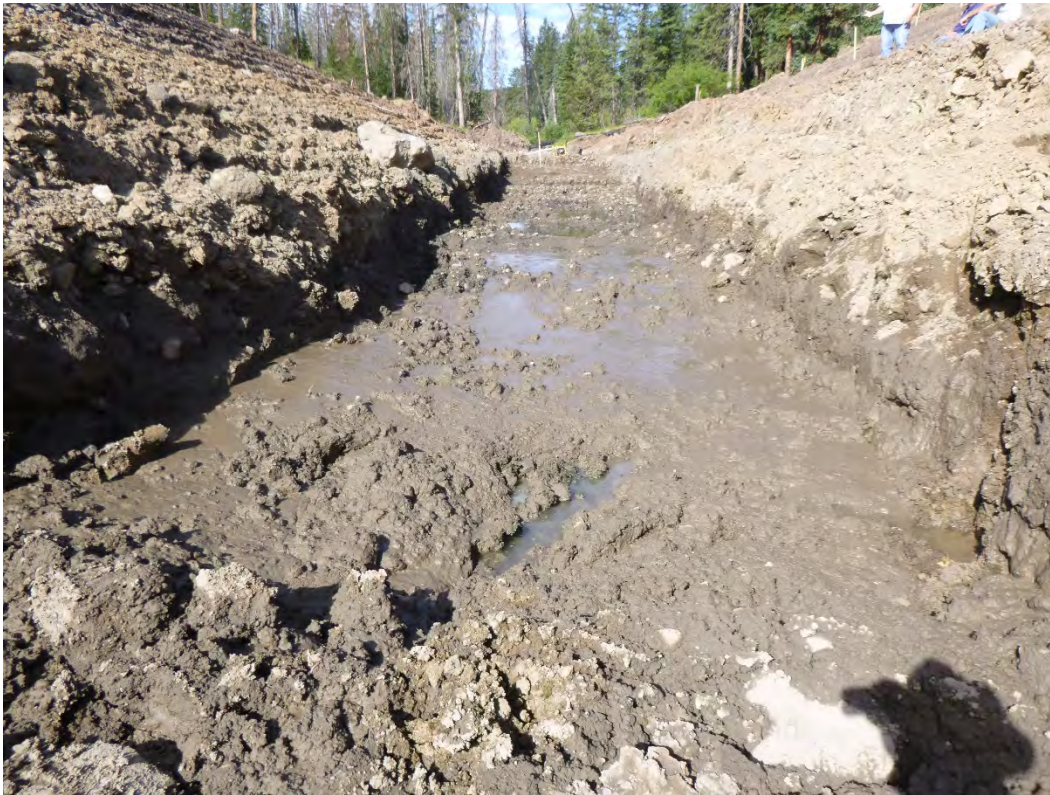
| Problems/Concerns: | <ul style="list-style-type: none"> <li>There is concern that a water source (reservoir, spring, etc) is continually recharging the foundation excavation such that suitable moisture conditions for proof rolling cannot be achieved.</li> <li>The contractor indicated that pumping of accumulated water was successful, but only for a short period of time; less than 24 hours.</li> <li>Flow and amount of water did not seem to be increasing, but no permanent drainage or pumping solution has been implemented.</li> </ul> |

Overall view of outlet works  
foundation looking in downstream  
direction.

View looking downstream along  
outlet works foundation.

Close-up of typical area of standing water; location is near Sta 1+20 for the outlet sand diaphragm.

| Action Items: | <p>Several potential dewatering solutions were discussed with the engineer and contractor including, but not limited to:</p> <ul style="list-style-type: none"> <li>Installing well points along the edge of the foundation (both sides?) in order to promote drawdown of the water source(s) and prevent pooling at the excavation level. Ideas for well points included: <ul style="list-style-type: none"> <li>Three well points proposed by contractor;</li> <li>8-12 inch diameter slotted pvc pipe buried vertically 2-4 feet at strategic locations;</li> <li>Possible gravel or free-draining material placed in and around the wells;</li> <li>Sump pumps installed into each well;</li> <li>Pumping into the existing dewatering pipe (not preferred) or installing a new dedicated drain line for the well points (preferred).</li> </ul> </li> <li>A trench excavation for gravity draining was discussed, but is not preferred at this time.</li> <li>Moving the reservoir bypass to a more upstream location further away from the excavation to reduce any influence it may have.</li> </ul> <p>The engineer and contractor were advised that any dewatering solution that modifies the outlet works foundation (i.e. wells, trenches, etc) will be required to be properly abandoned by a method acceptable to the Engineer and Dam Safety prior to backfilling.</p> |

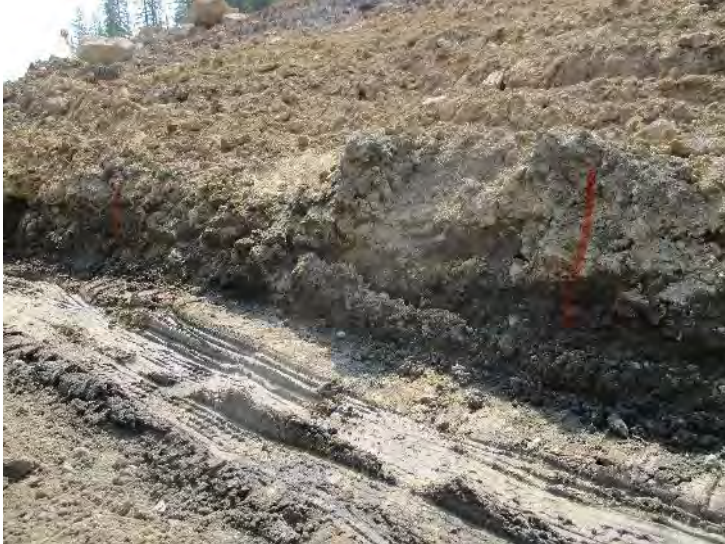
*Photo 3. One of two soft spots identified during first proof roll.*

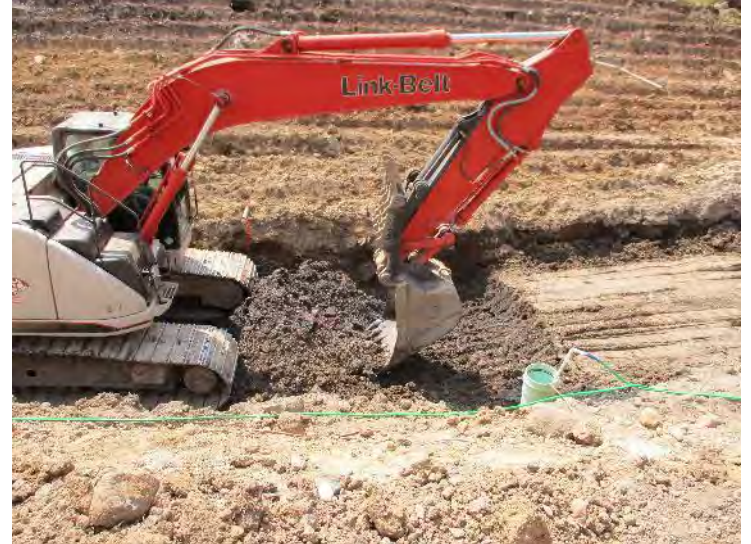
*Photo 4. Two spots identified as yielding during proof roll were overexcavated by two additional feet, then backfilled with embankment materials and compacted.*

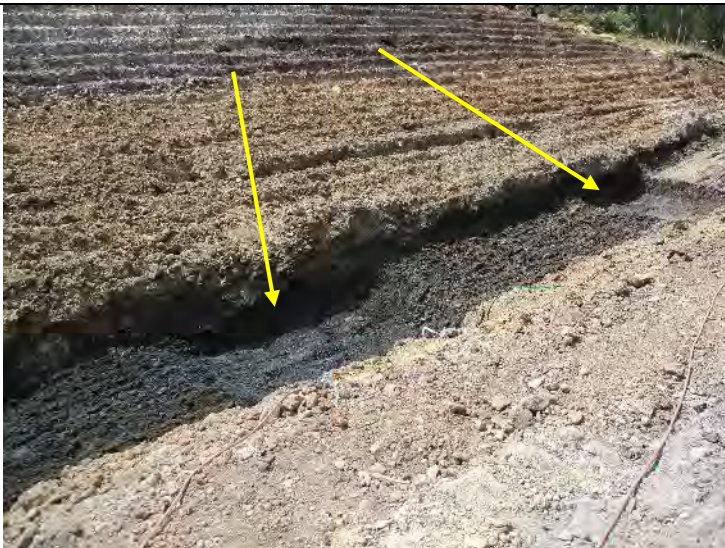
*Photo 5. Two overexcavated spots.*

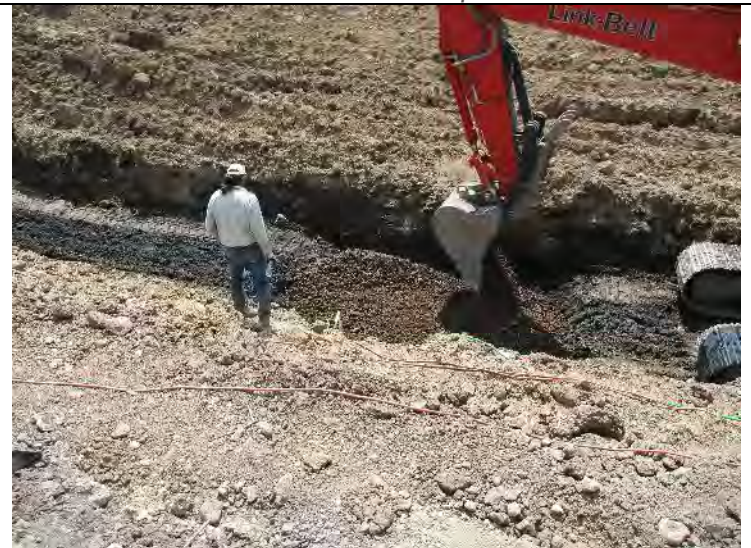
*Photo 6. The excavator spreads embankment material into the 2-foot overexcavated areas.*

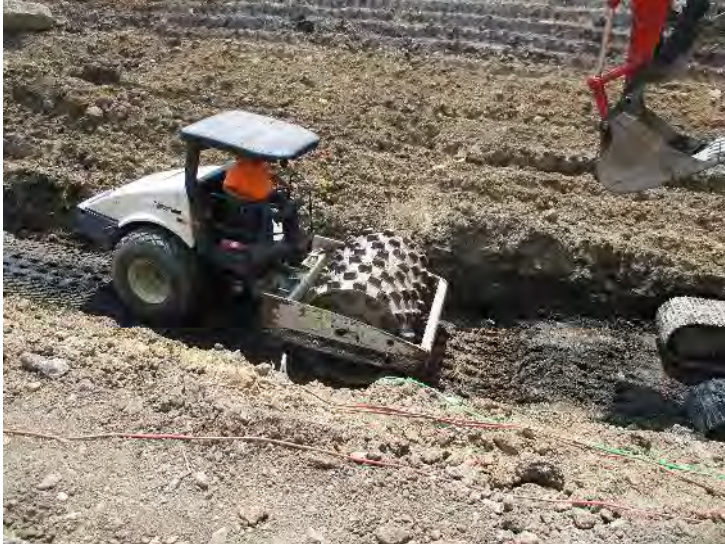
Photo 7. Backfilling: three lifts of embankment materials, each compacted by five passes with a sheepfoot roller.

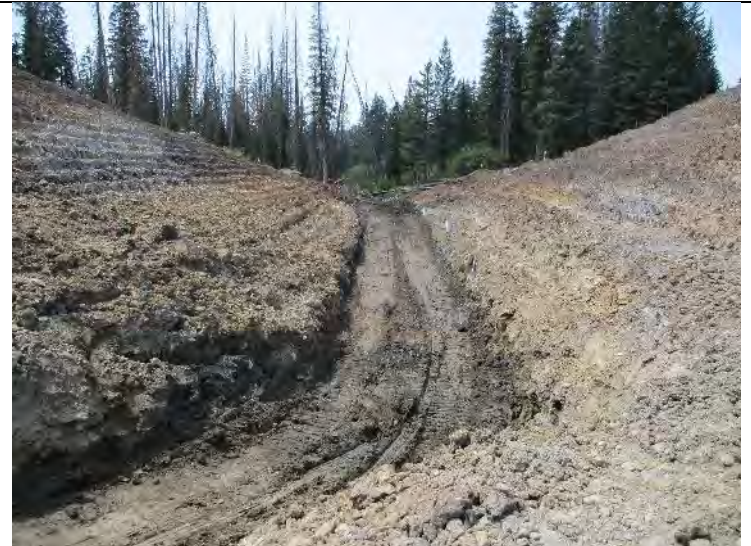
Photo 10. Foreground is the location of dump truck in previous photo, the approximate location of the intake structure (additional excavation needed) and the grade break/base of the equipment access into the outlet trench.

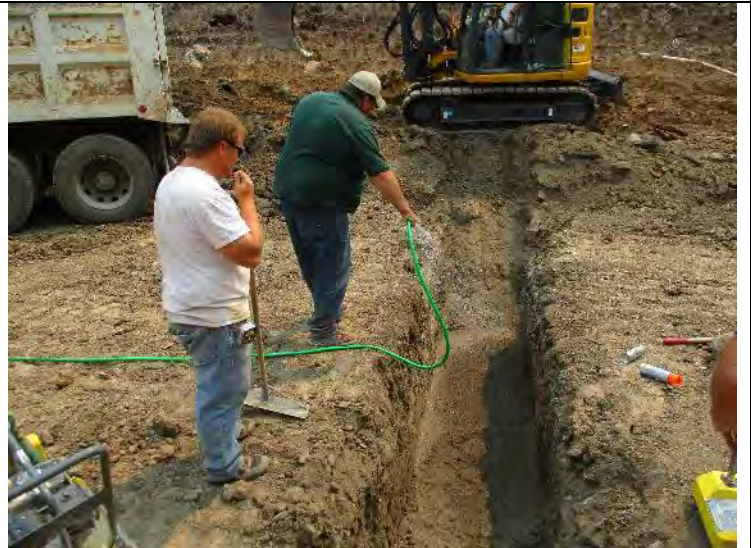
Photo 4. Moisture conditioning the filter material. Con-Sy may opt to apply water while material is in the truck.

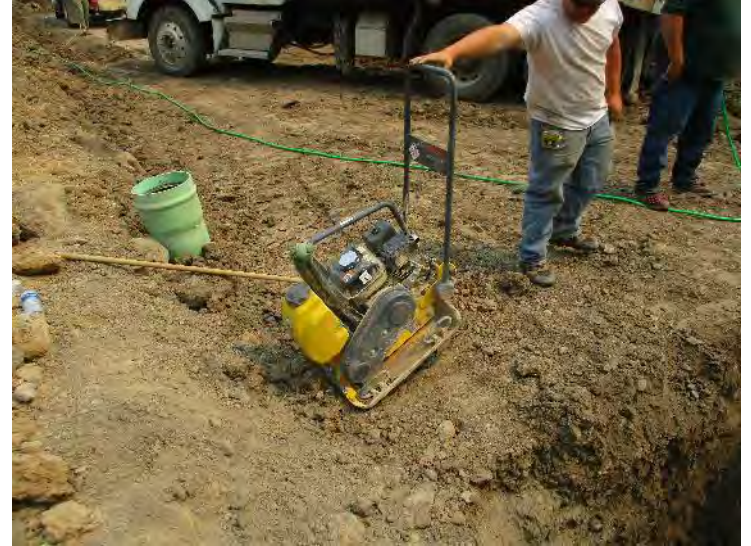
Photo 6. The Wacker Packer. Following one half of the pass, a strap was affixed to the compactor, which was raised by the excavator and turned around to complete the second half of the pass. The Wacker Packer was slightly wider than the trench.

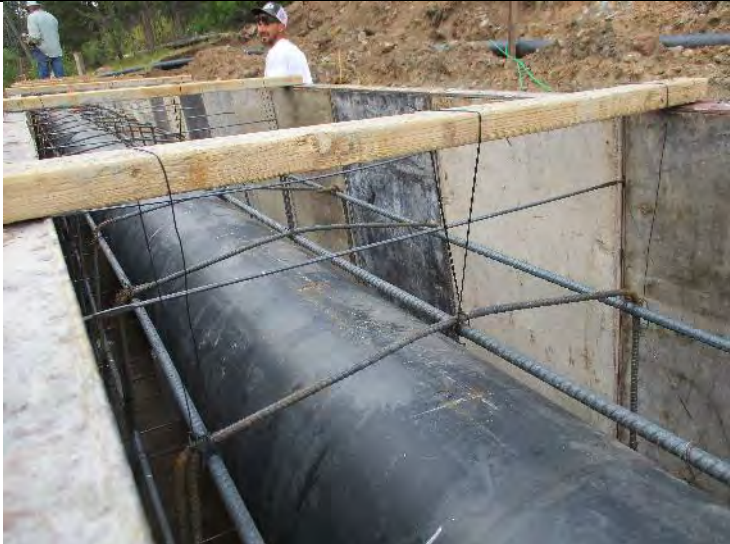
Photo 3. Ties every 6-feet to suspend the structural steel cage a minimum of 3-inches above the ground. Sidewall chairs to be placed to ensure 3-inch clearance from wall forms.

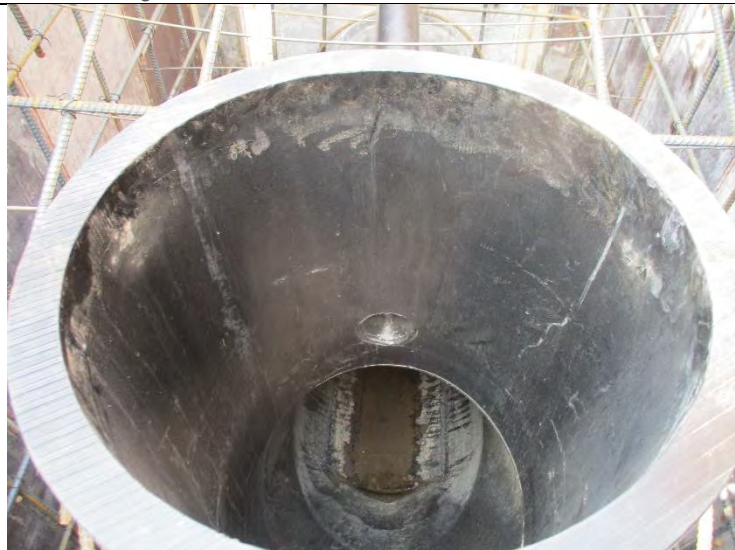
Photo 4. HDPE Pipe is level and must be cut/beveled to accommodate gate as shown in profile in detail B, sheet 12. Air vent penetration is visible in the back of the pipe.

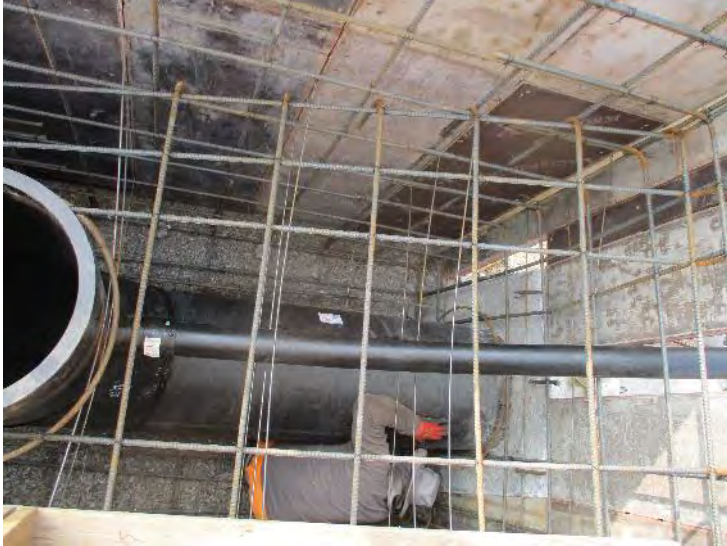
Photo 5. Overhead view of intake structure steel.

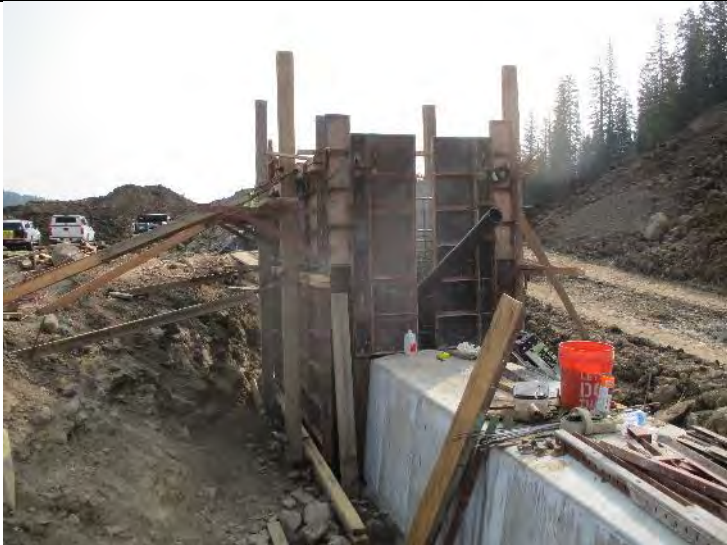
Photo 7. Exterior view of formwork.

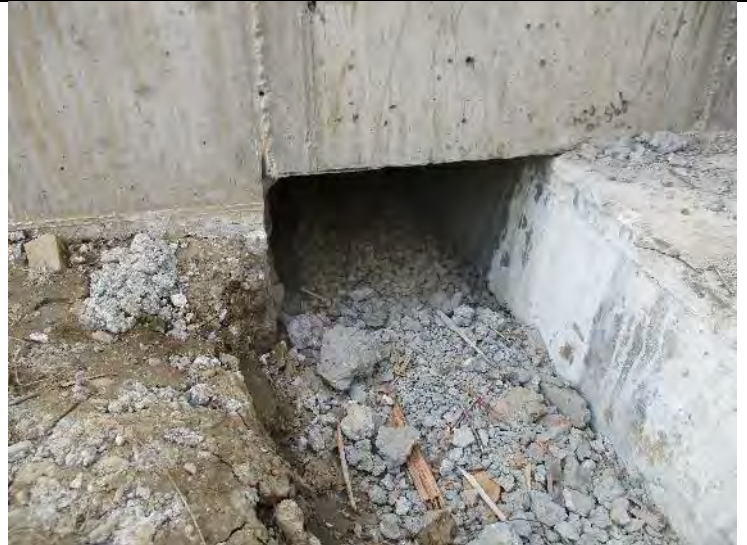
Photo 8. Rectangular void for filter sand, just upstream of outlet headwall (reference detail B on sheet 14).

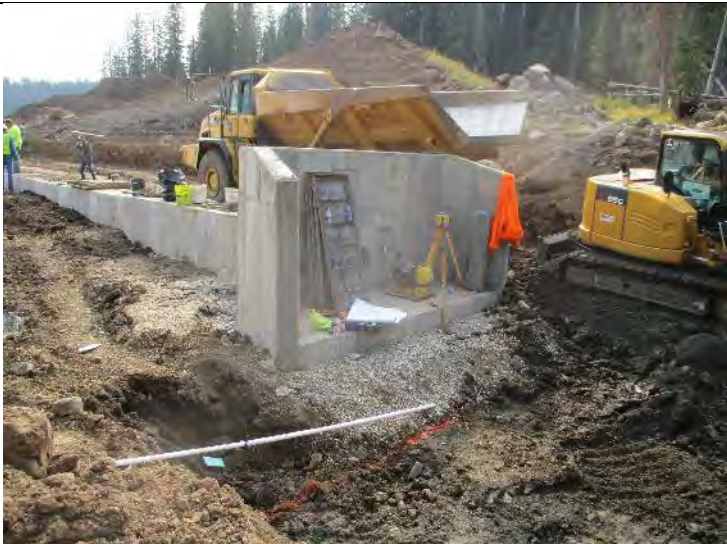
Photo 9. View of the outlet terminal headwall.

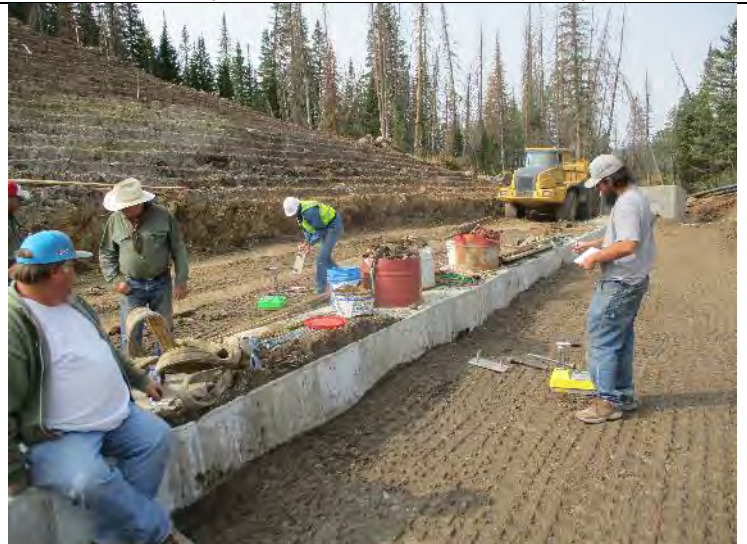
Photo 10. DOWL and Con-Sy collect nuclear gauge readings of the embankment material.

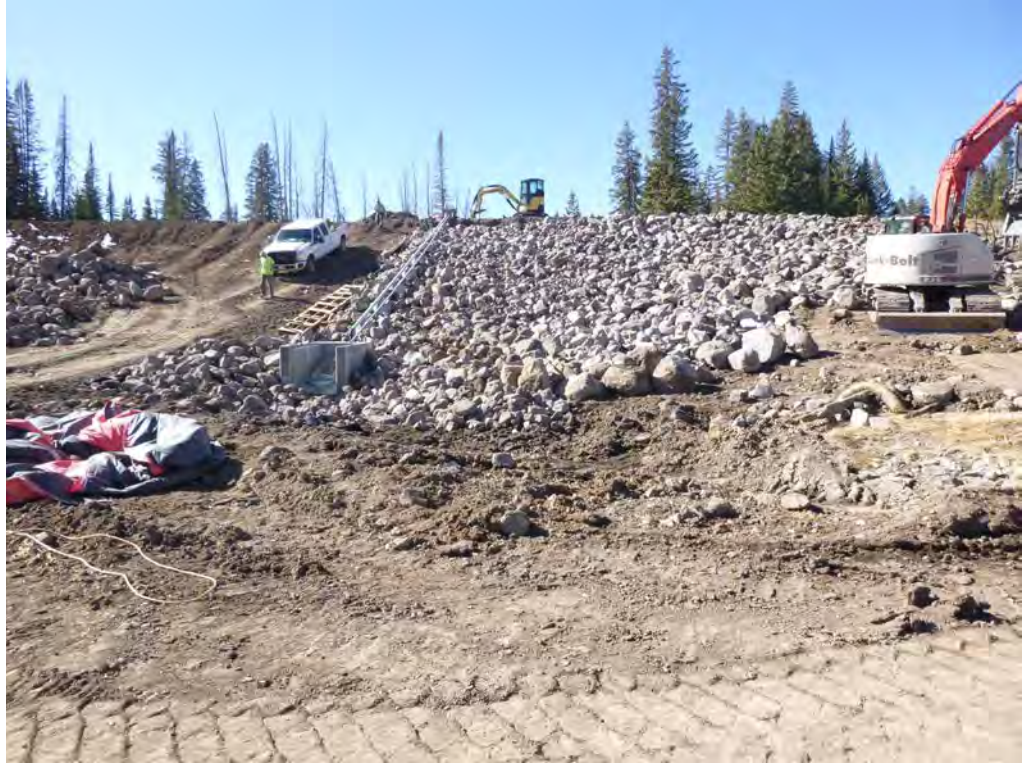
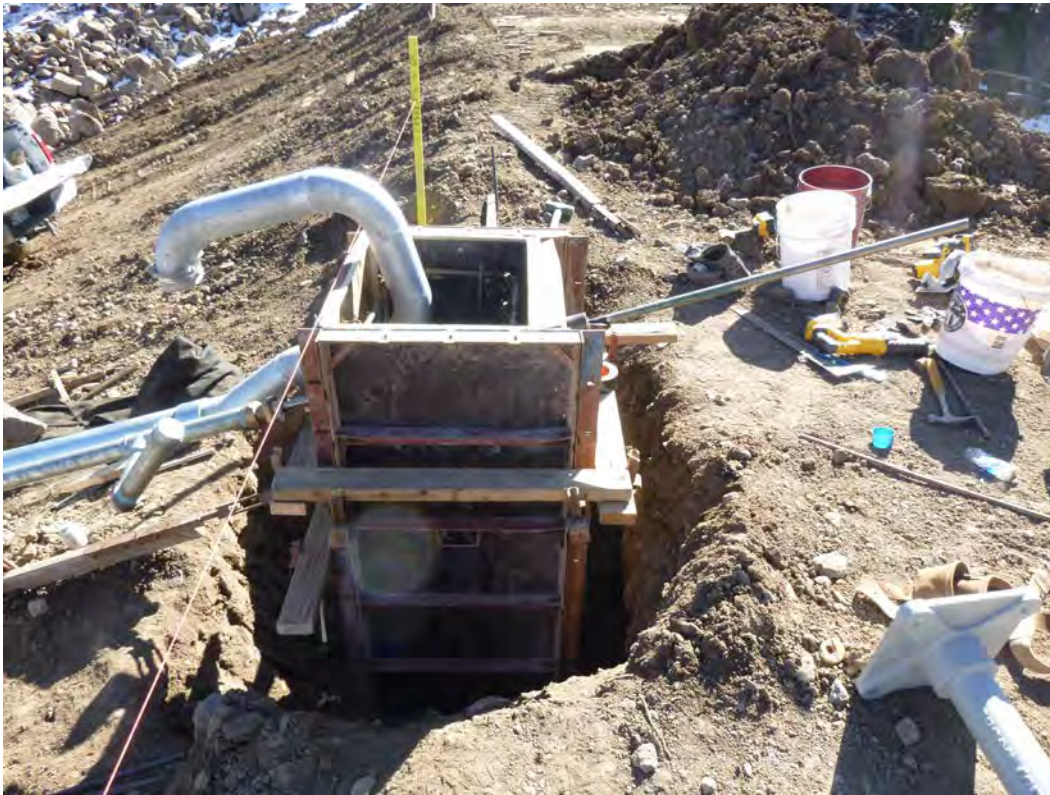
Overall view of breach repair section and upstream outlet works.

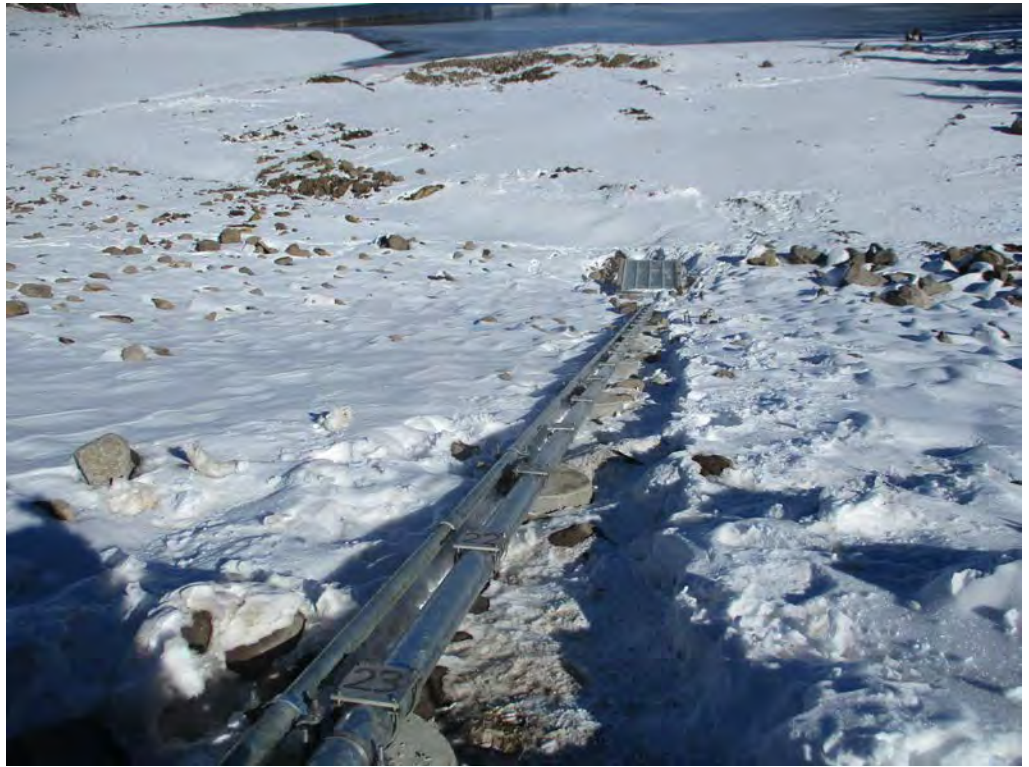
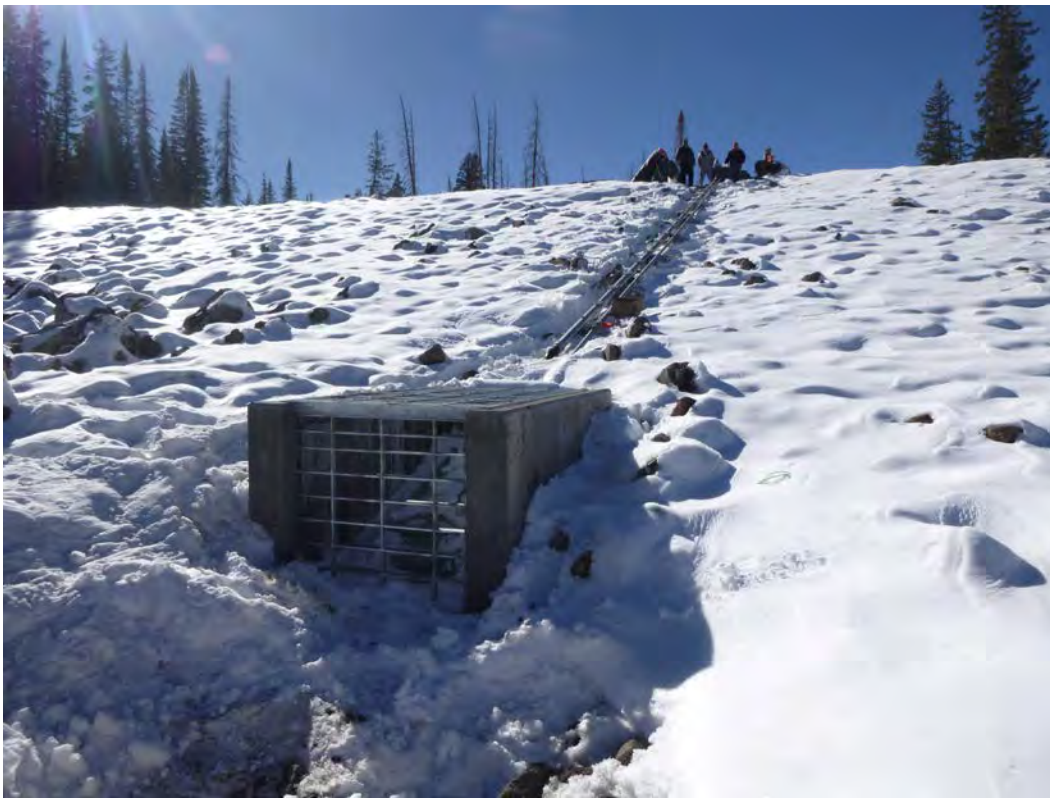
View looking down upstream slope  
along gate stem and air vent  
alignment.

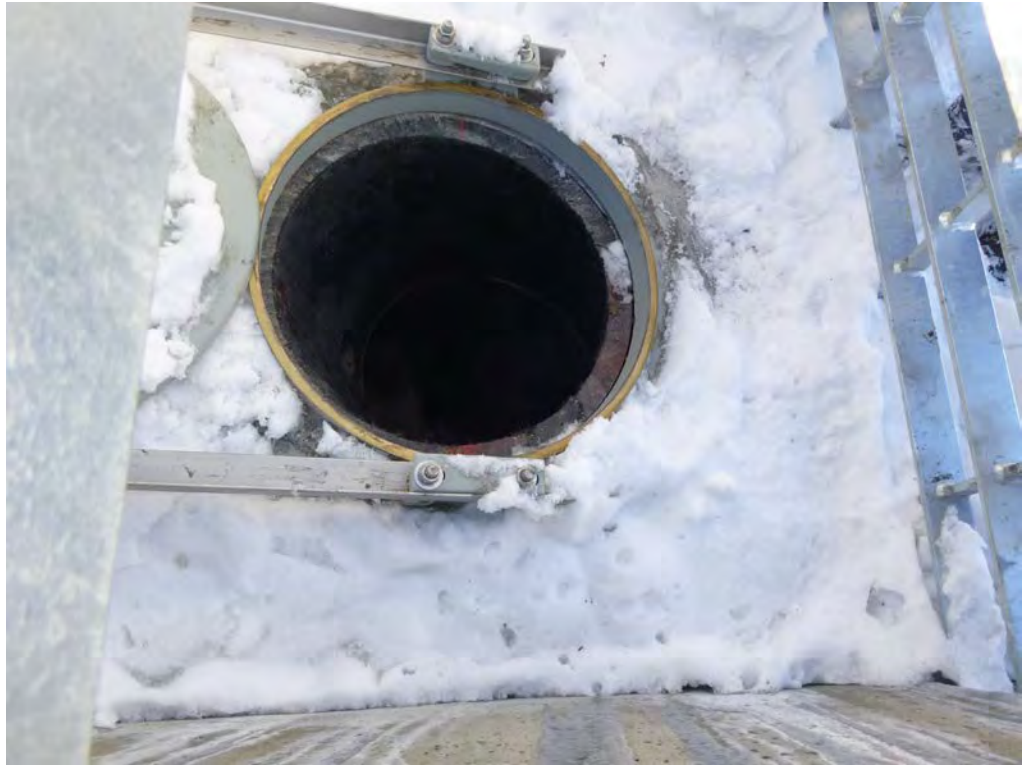
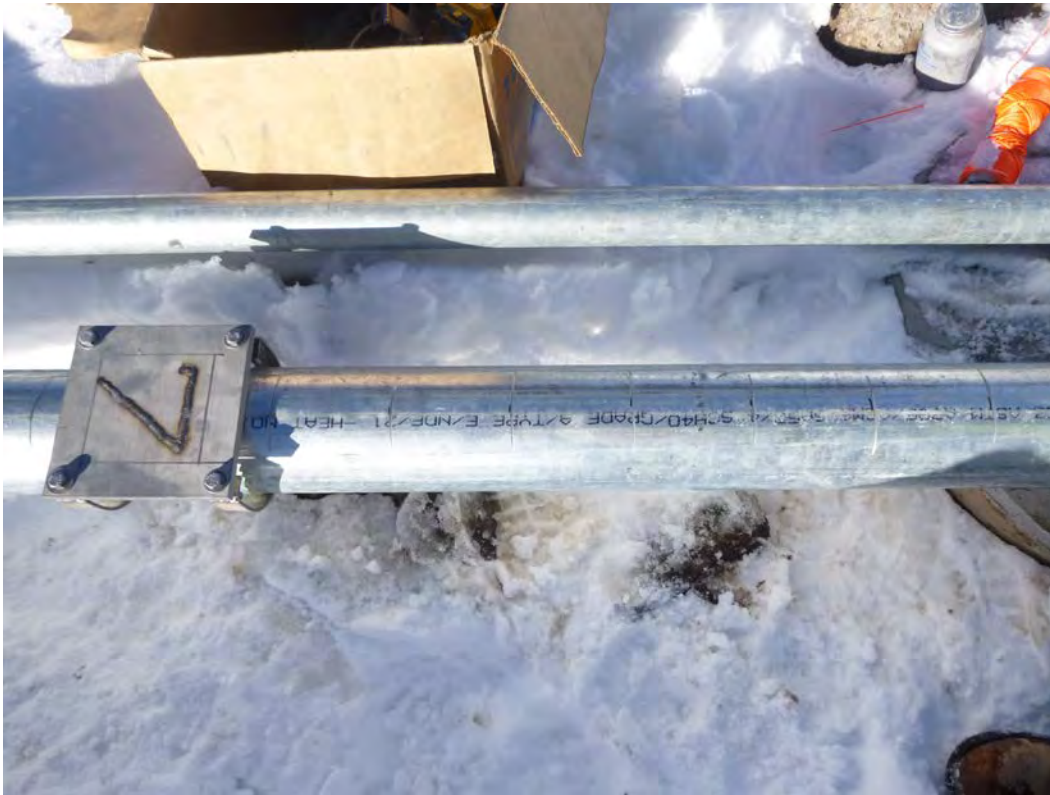
Outlet gate intake structure and  
trashrack.

Outlet gate in full open position  
during exercise.

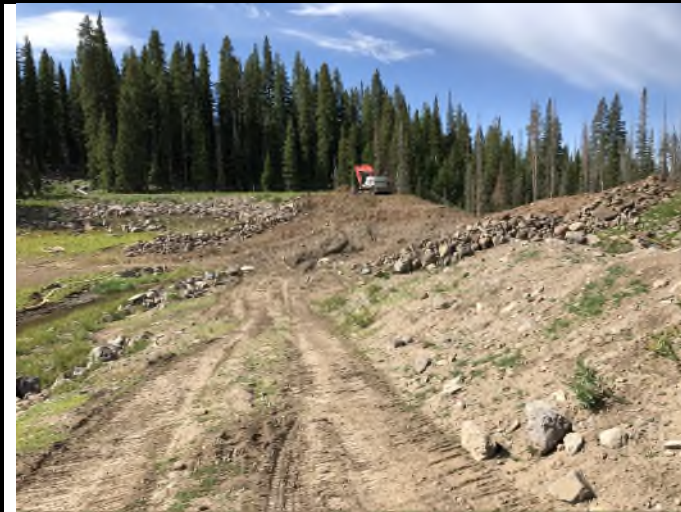
Photo 1. View looking east at existing breach excavation on July 16, 2020.

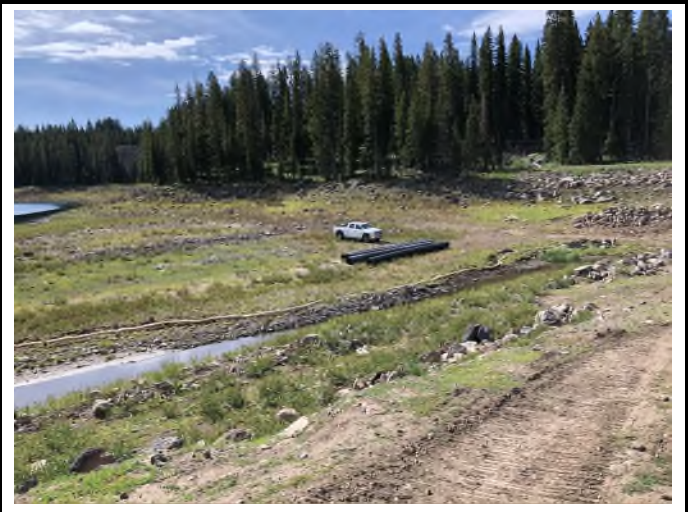
Photo 2. View looking northeast at erosion control measures of inlet channel and HDPE pipe for the outlet.

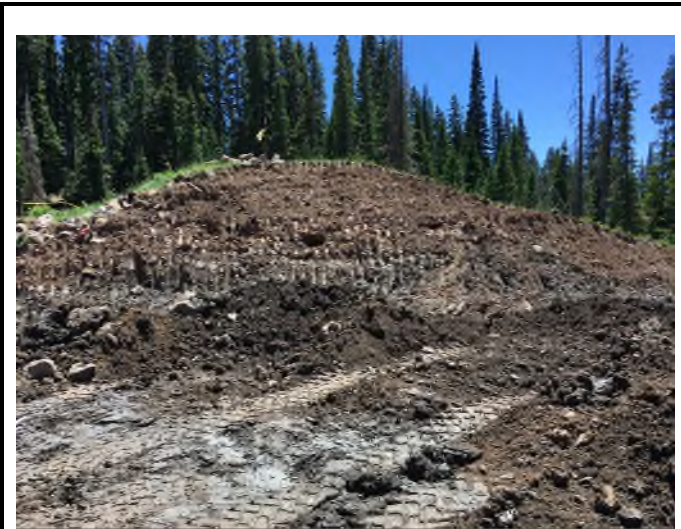
Photo 3. View of breach and outlet prior to start of project. Photo taken on July 13, 2020.

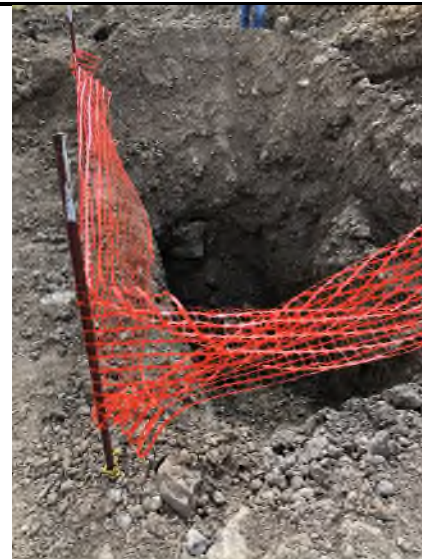
Photo 4. View of test pit excavated on the east side of the existing steel outlet pipe to observe site soils.

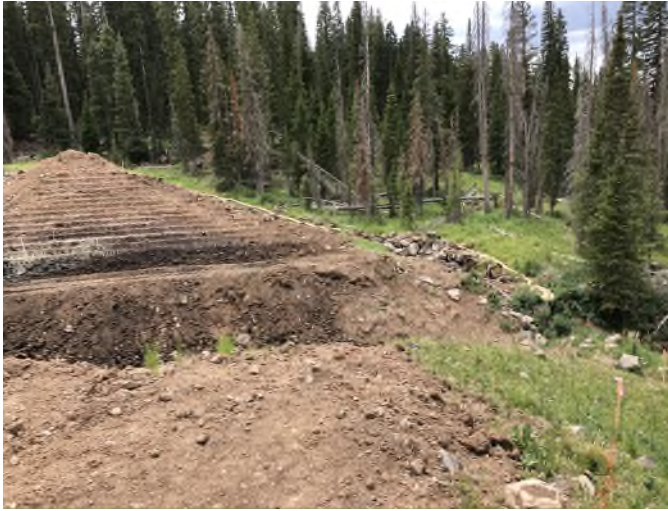
Photo 1. View looking east at existing breach excavation progress on July 22, 2020.

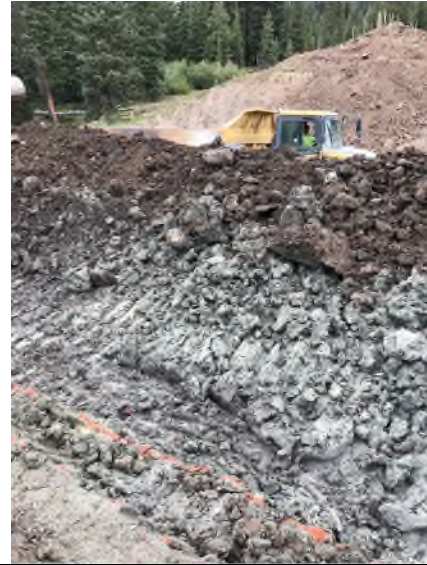
Photo 2. Close-up of blue clay pocket on the east side of the breach excavation

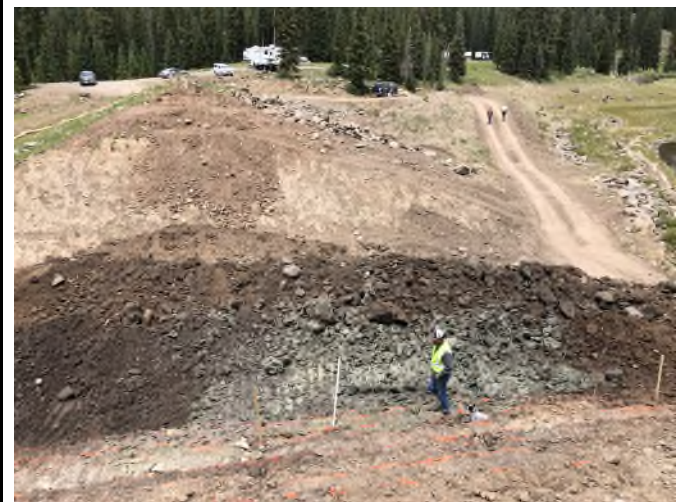
Photo 4. View of grey clay pocket on the east side of the breach excavation looking west towards campground.

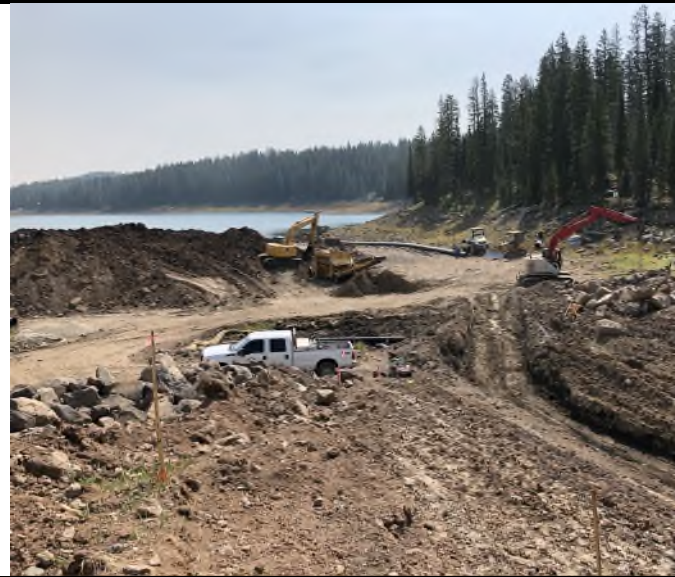
Photo 1. View looking north at outlet channel prior to subgrade proof-roll test on August 14, 2020.

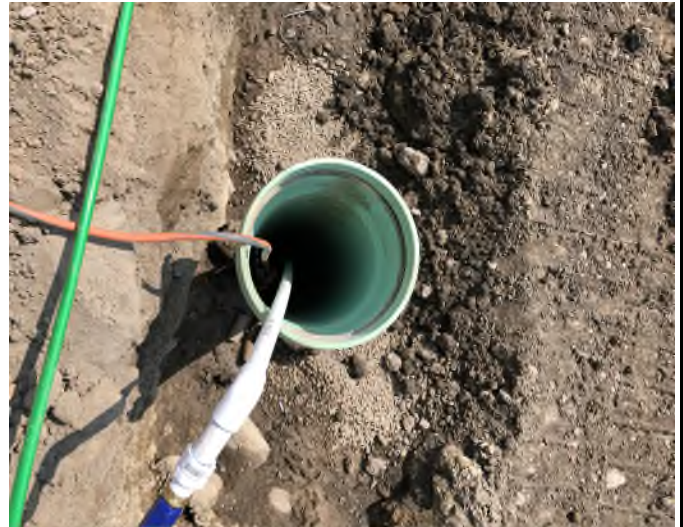
Photo 2. Close-up one of three dewatering wells installed by ConSy. PVC and PureCore pipe connects to the outlet bypass pipe..

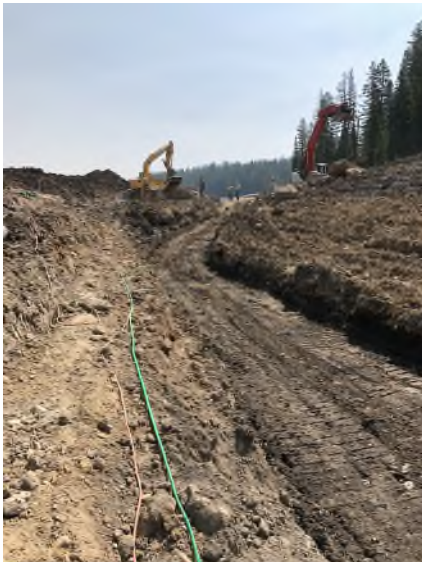
Photo 3. View looking north at subgrade prior to proof-roll test.

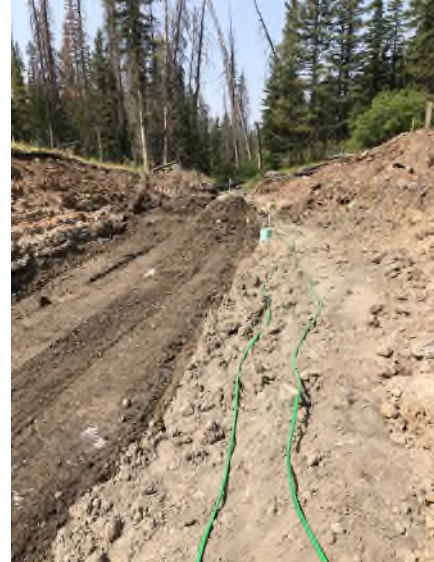
Photo 4. View looking south towards outlet of subgrade after proof-roll test.
