WARD LAKE DAM OUTLET REHABILITATION  
Construction File No. C-0888A  
Dam ID No. 400533

Final Construction Report  
December 22, 2020

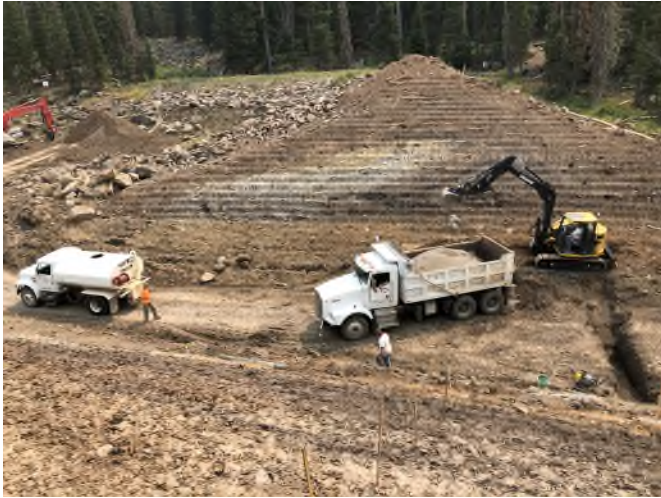
Photo 1. View looking east at sand diaphragm trench at STA 1+20 on 8/19/20. Note water truck dump truck of clean sand and excavator used to place the sand material.

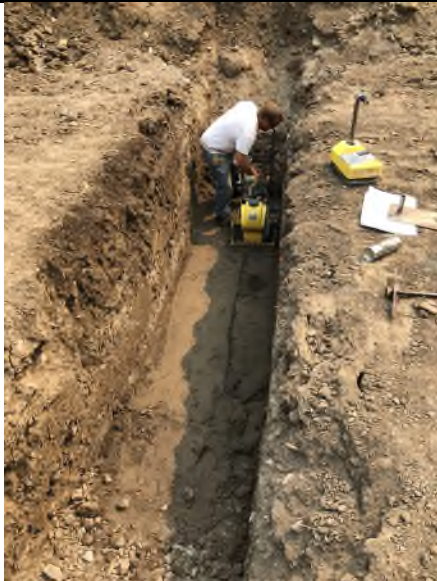
Photo 3. View looking east at sand diaphragm test section.

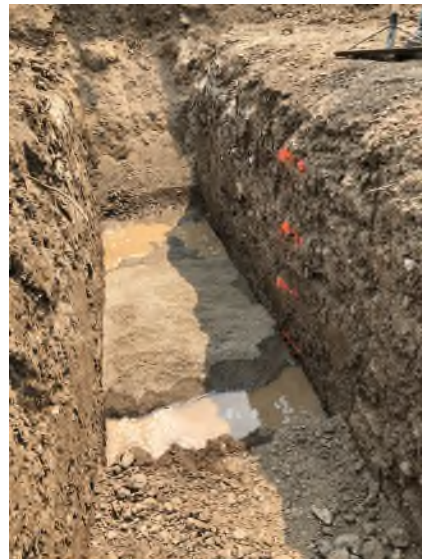
Photo 4. View looking east at initial test section which was too wet for compliant filter sand installation and which was subsequently removed prior to Test #2.

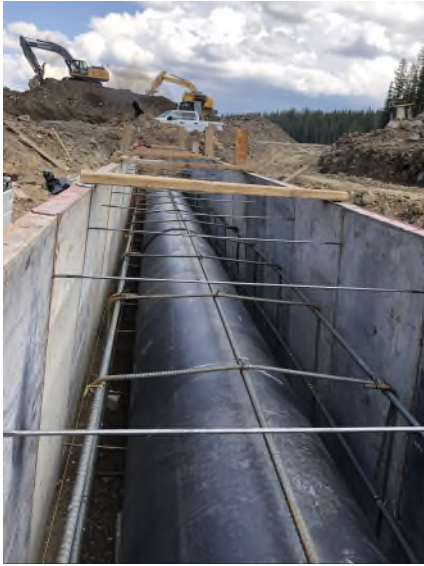
Photo 1. View looking north at HDPE outlet pipe encasement formwork and reinforcing steel.

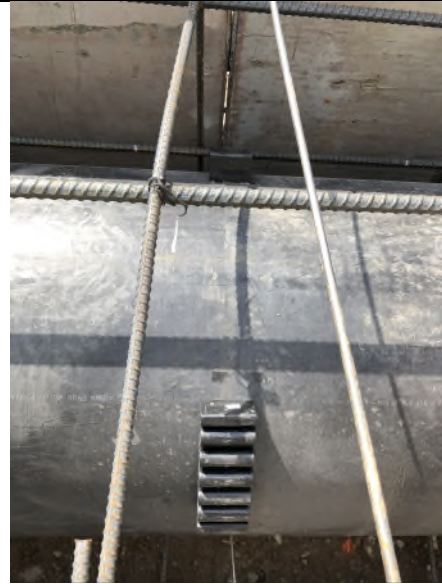
Photo 2. Closeup of fused HDPE flex restraint installed at STA 1+60 per plans.

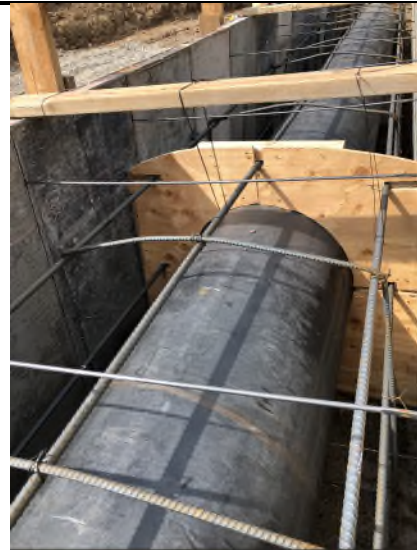
Photo 4. View of typical plywood bulkhead between 20-foot segments of encasement. 2"x4" wood crossbeam at top of photo is typical of 6-foot spacing for wire ties to provide required 5-inch spacing of rebar above the pipe during concrete placement

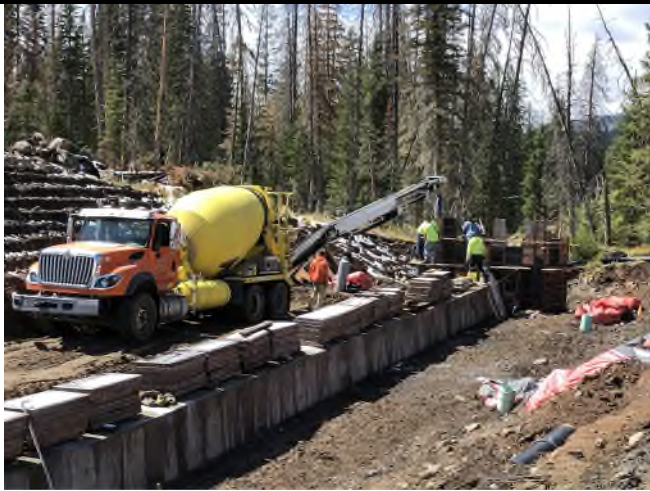
Photo 1. View looking south at concrete placement for the outlet structure.

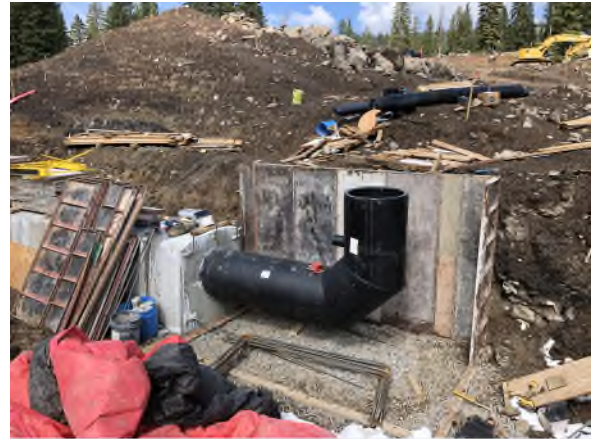
Photo 2. Closeup of fused HDPE inlet pipe prior to forming inlet structure.

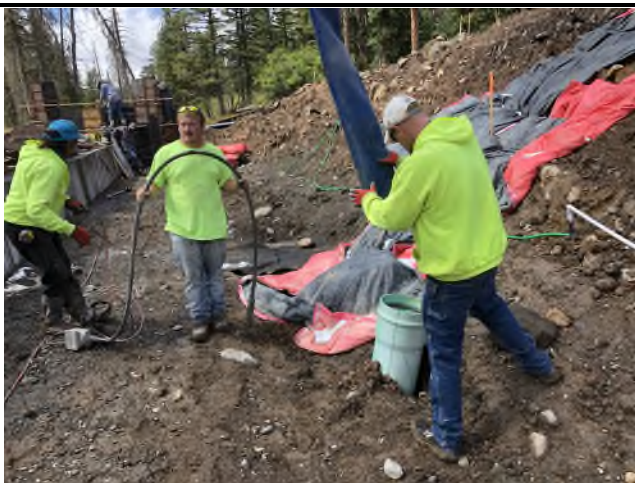
Photo 3. ConSy crew grouting in the dewatering wells with concrete.

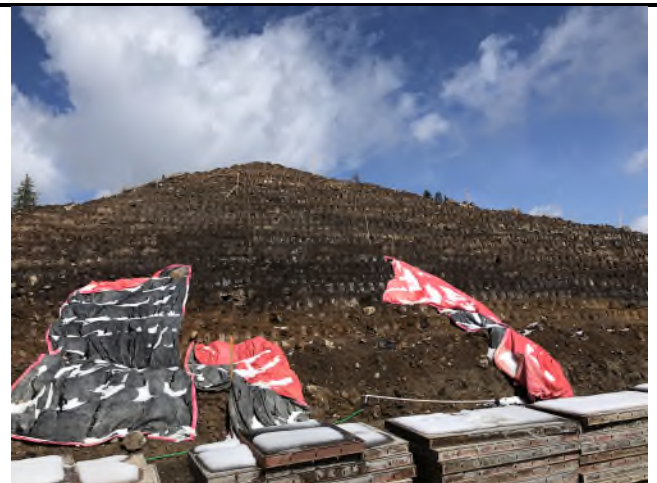
Photo 4. View of concrete blankets used to protect outlet formwork from rain and snow. Note dark areas of the embankment from precipitation events on 9/9 and 9/10.

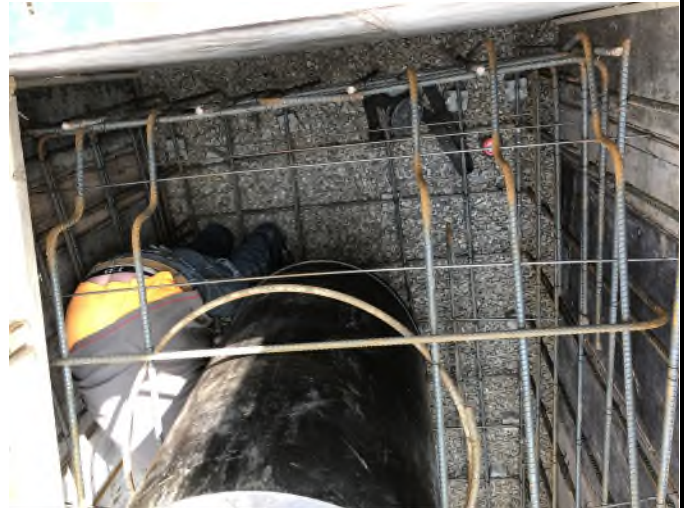
Photo 2. Closeup of inlet reinforcing steel placement.

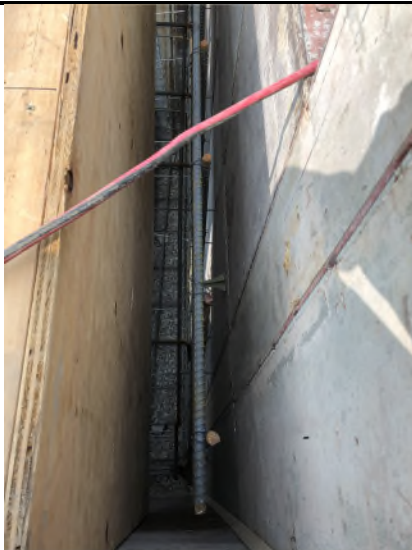
Photo 3. Close-up of inlet wall reinforcement. 2-inch wall chairs were installed prior to placement on the 18<sup>th</sup> to provide required separation

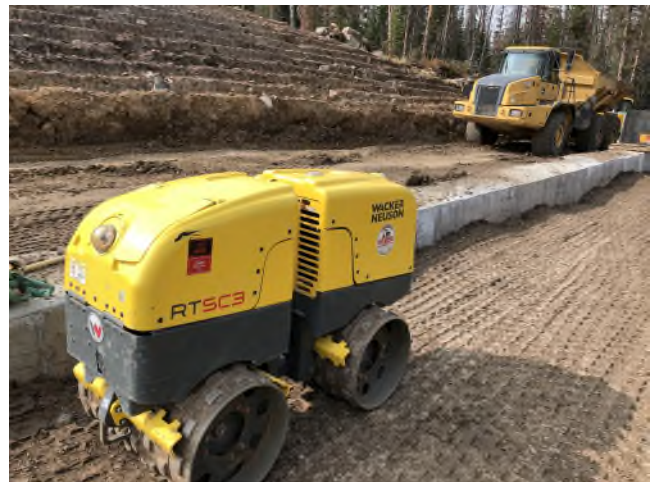
Photo 4. View of remotely operated compactor used to compact the first 3-feet of embankment adjacent to the outlet pipe encasement section.

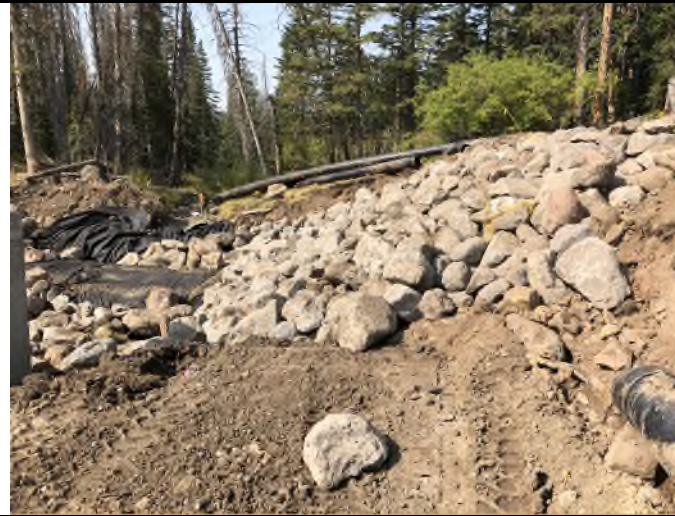
Photo 1. Rip-Rap placement at outlet spillway taking place concurrently with the inlet structure concrete placement on 9/18/20

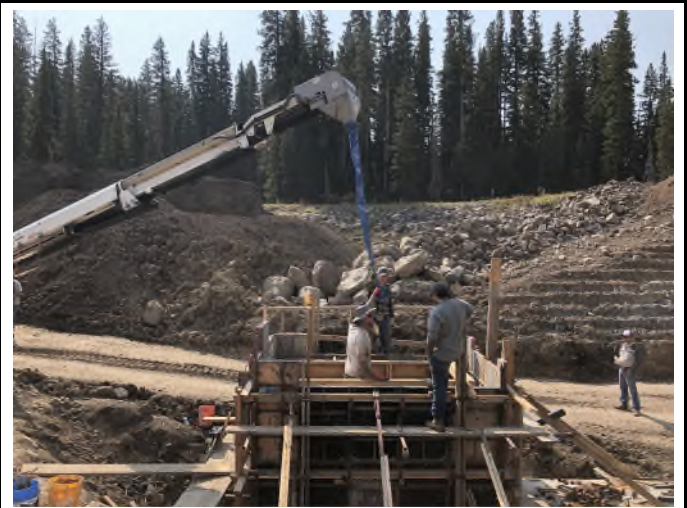
Photo 2. Concrete placement at inlet structure using conveyor belt and tremie.

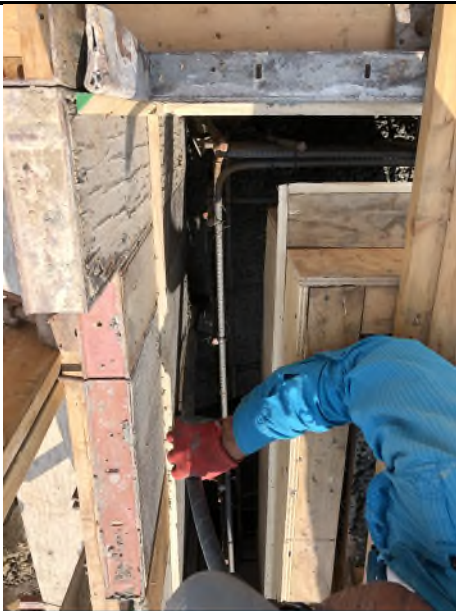
Photo 3. Close-up of inlet wall reinforcement during concrete placement on 9/18/20.

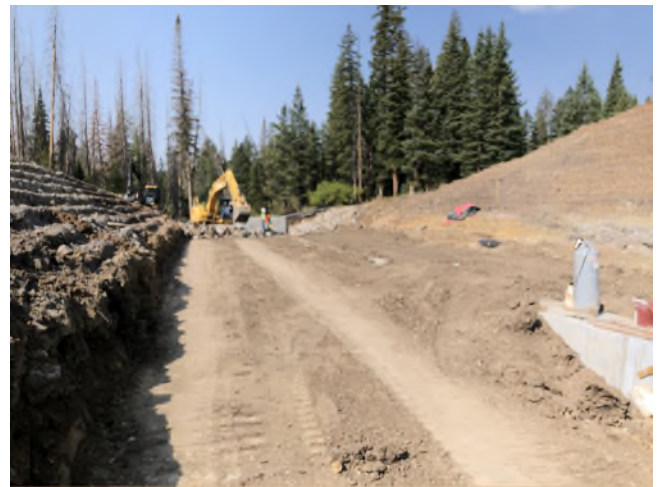
Photo 4. View looking south at the outlet channel on 9/18/20. Backfill is approximately at the top of the outlet pipe concrete encasement.

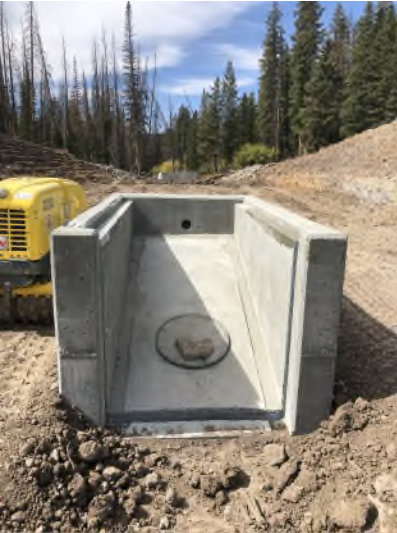
Photo 1. Close-up of inlet structure looking downstream.

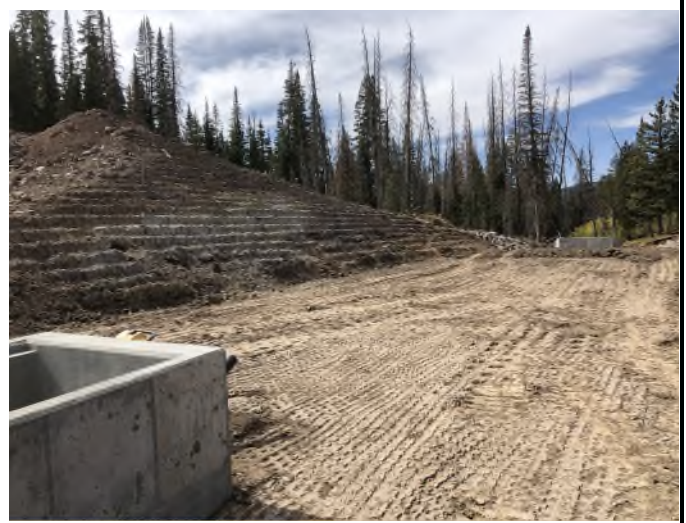
Photo 2. View looking south (Downstream) at embankment fill above the outlet pipe encasement. Note inlet structure on the lower left of the photo.

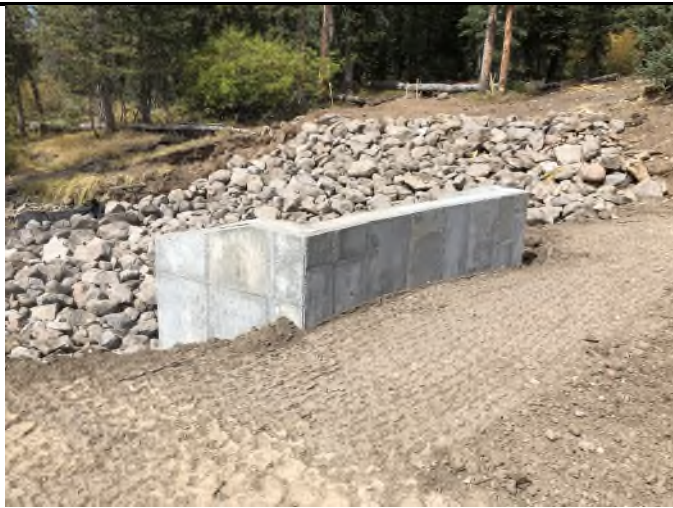
Photo 3. Close-up of the outlet structure and stilling basin rip-rap

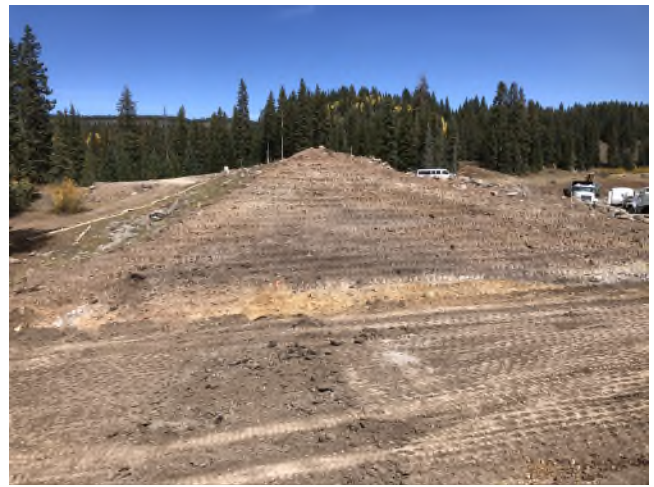
Photo 4. View looking west across the outlet channel embankment.

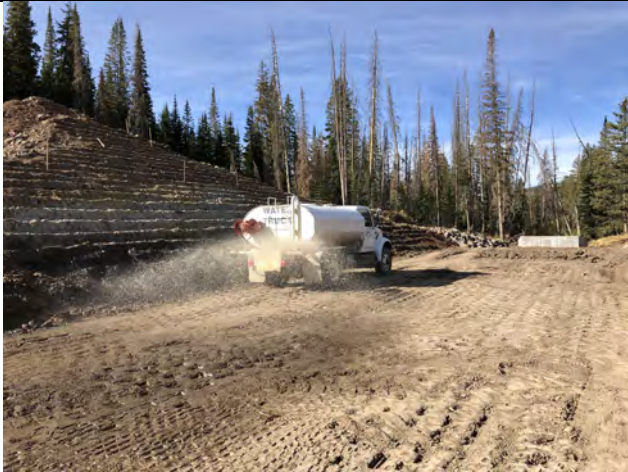
Photo 1. View looking south (downstream) at water truck wetting subgrade prior to embankment material placement. Note previously moistened benches to the left of the water truck

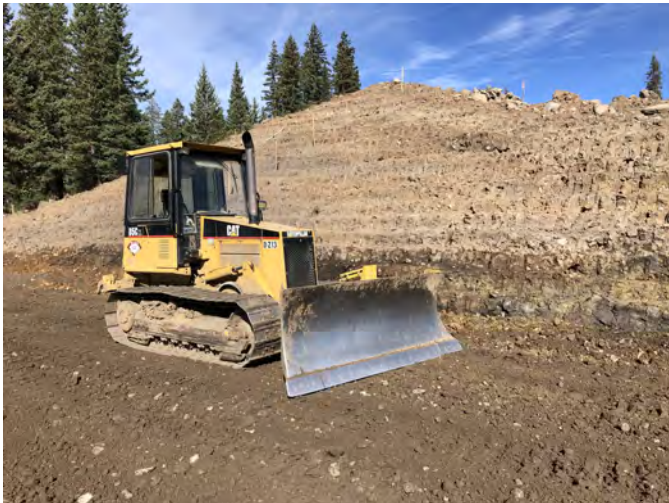
Photo 3. Close-up Cat D5 dozer used to mix and spread embankment material. Note curved blade.

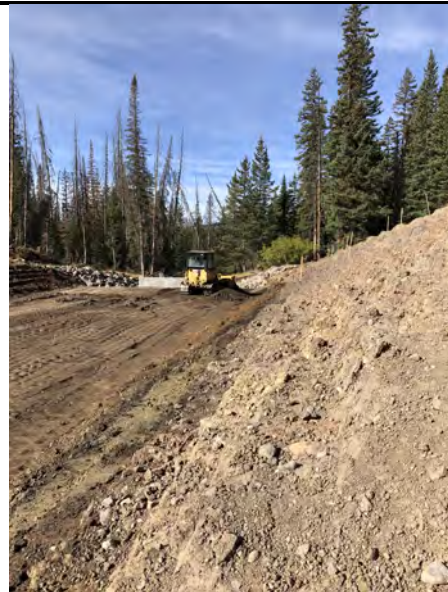
Photo 4. View looking south (downstream) at D5 Cat dozer spreading embankment soil on the first benched lift.

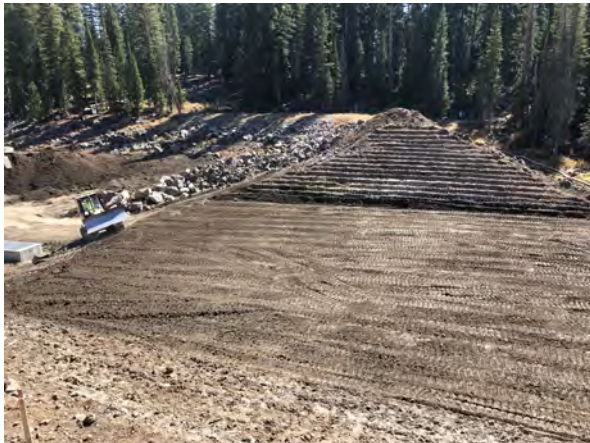
Photo 1. View looking east completed embankment lifts. Note previously moistened benches to the left of the water truck

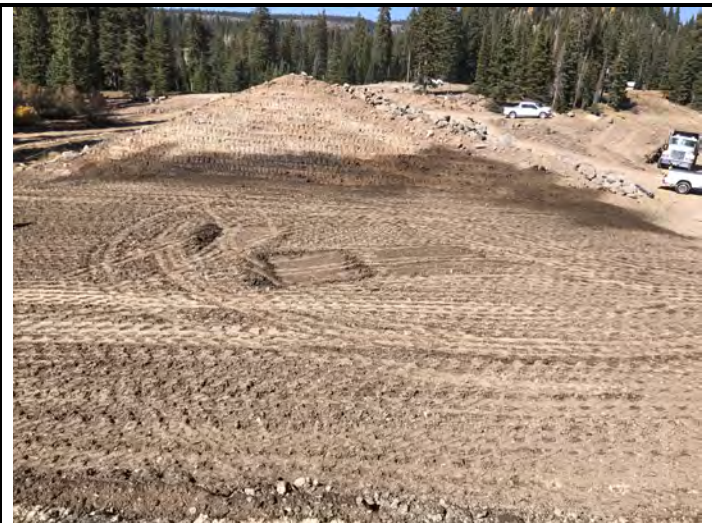
Photo 4. View looking west across breach at typical test location for nuclear moisture-density testing.

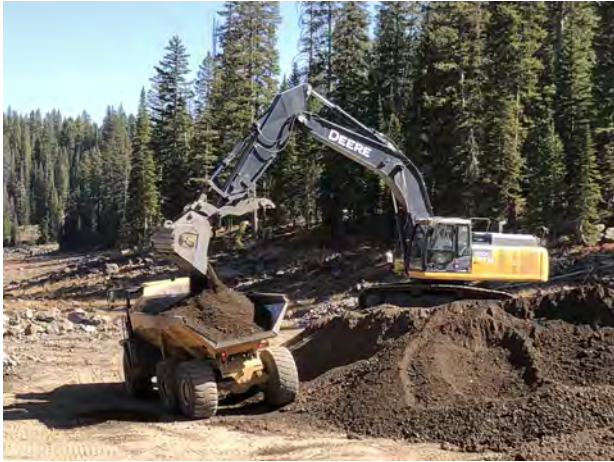
Photo 1. View of loading operation of screened embankment material for placement of on the next embankment lift.

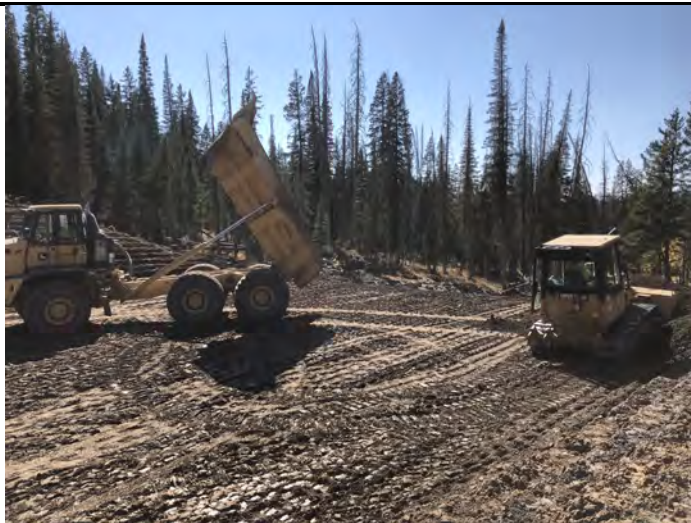
Photo 3. View of embankment material being dumped prior to spreading by D5 dozer

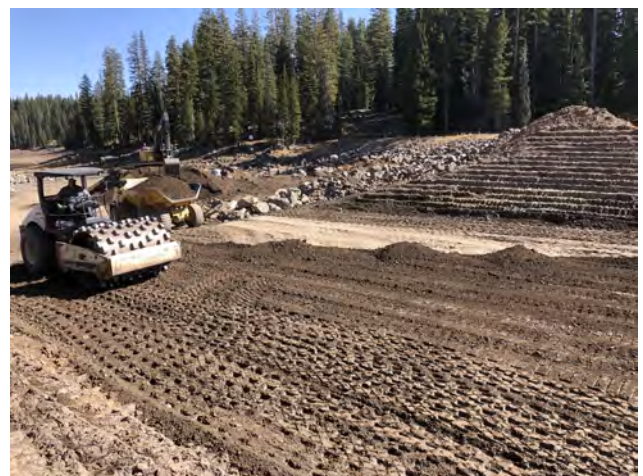
Photo 4. View of compaction of material spread in 8-9 inch lifts. Dump truck is in the background preparing to deliver more screened embankment material

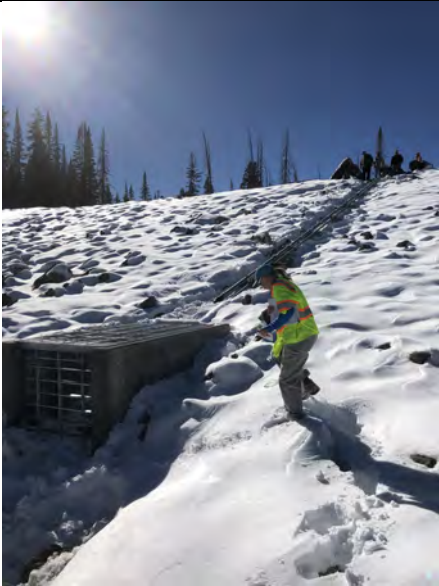
Photo 1. View of inlet structure looking up the upstream dam face. Gate stem is visible in the upper portion of the photo

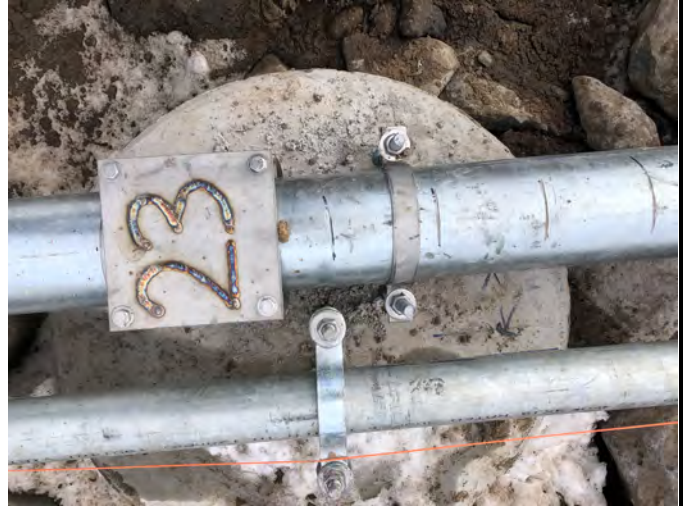
Photo 2. Detail of typical gate stem support pier at the 23-foot level marker.

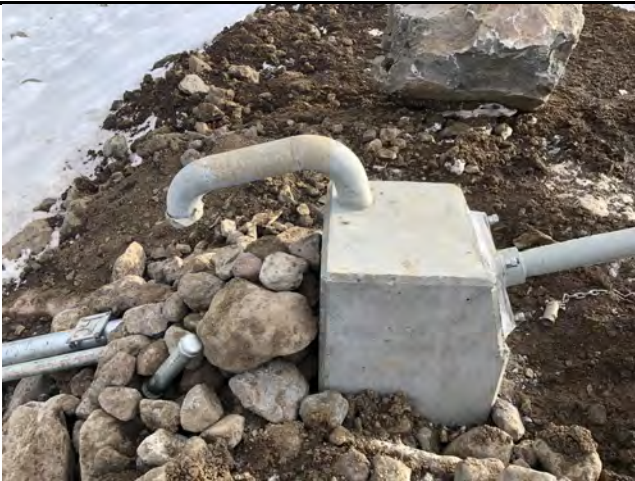
Photo 3. Close-up view of outlet gate control wheel block. Photo taken on 11/20/2020.

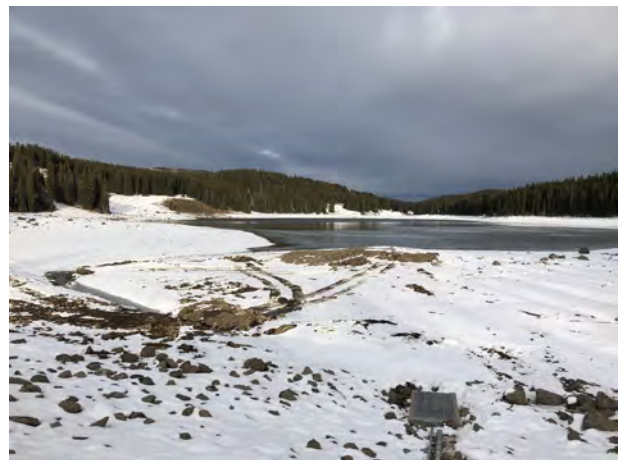
Photo 4. View looking north at Deep Ward Lake. Note inlet structure at bottom of photo. Photo taken on 11/20/2020.
