Rio Grande Stream Management Plan

Rio Grande Basin Roundtable and the
Stream Management Plan Technical Advisory Team

Executive Summary

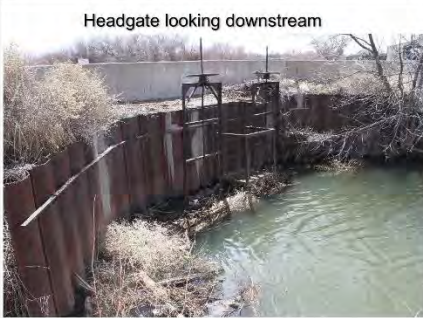
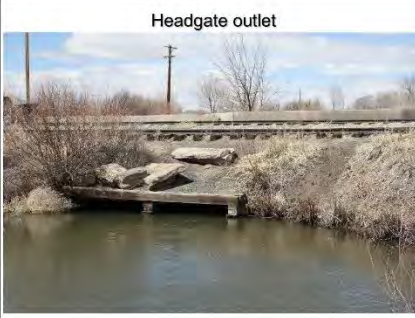
Repair(s) or Improvement(s) Currently Needed: The headgates do not function well and could be repaired or replaced. The flume is often submerged and does not measure accurately. It should also be repaired or replaced. The diversion dam functions for water rights holders, but it could function significantly better if it was replaced. During spring runoff in 2019, the levee forming the bank north of the diversion dam washed out (see photo below). This has occurred in the past, and an updated diversion dam with higher flow and sediment transport capacity is recommended. If the diversion dam is improved, boat and fish passage should be included, especially considering the increasing popularity of recreational boating in the Alamosa area. Diversion structure improvements were also identified in the 2017 Rio Grande River Corridor Feasibility Study. If improvements are made that allow for boat passage, a safe takeout location adjacent to or downstream of the diversion is also recommended. Any required Army Corps of Engineers permitting also needs to be considered. Improvements should carefully consider riparian area restoration near the structure. Additionally, ~1 mile below the headgate, the ditch crosses the Alamosa Ditch, where a portion of water is diverted from the Westside to the Alamosa. See map below. The water rights holders in both ditches would like to improve the diversion at this junction, diverting more water to the Alamosa Ditch.

<p>Headgate looking downstream</p>

<p>Headgate outlet</p>

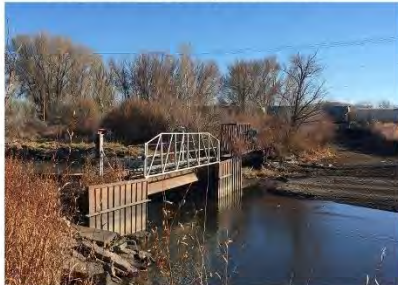
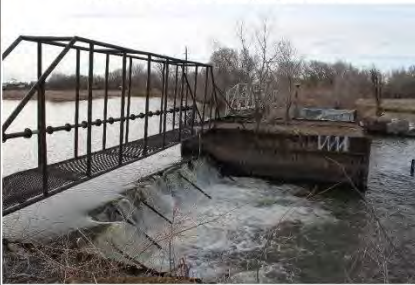
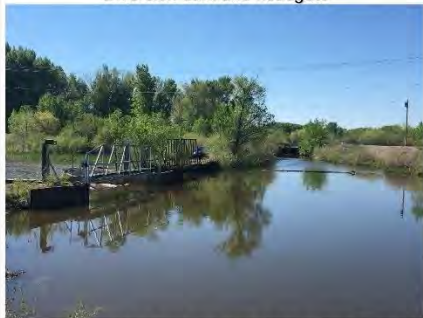
<p>Diversion dam looking downstream</p>

<p>Diversion dam looking upstream</p>

<p>Diversion dam and headgate</p>

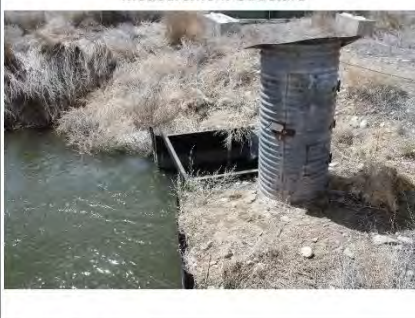
<p>Measurement Structure</p>	
<p>RIO GRANDE DIVERSION INFRASTRUCTURE INVENTORY</p>		<p>Rio Grande Stream Management Plan</p>
<p>WESTSIDE DITCH</p>		
<p>PHOTO LOG</p>

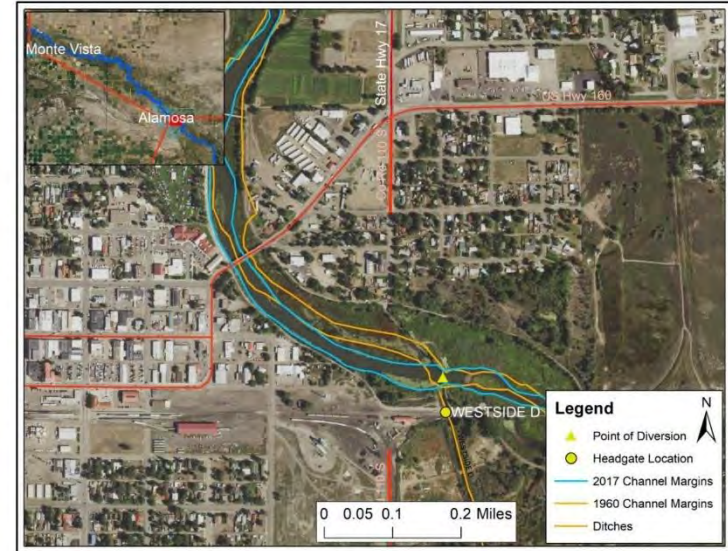
Headgate location with 1960 and 2017 channel margins overlaid.

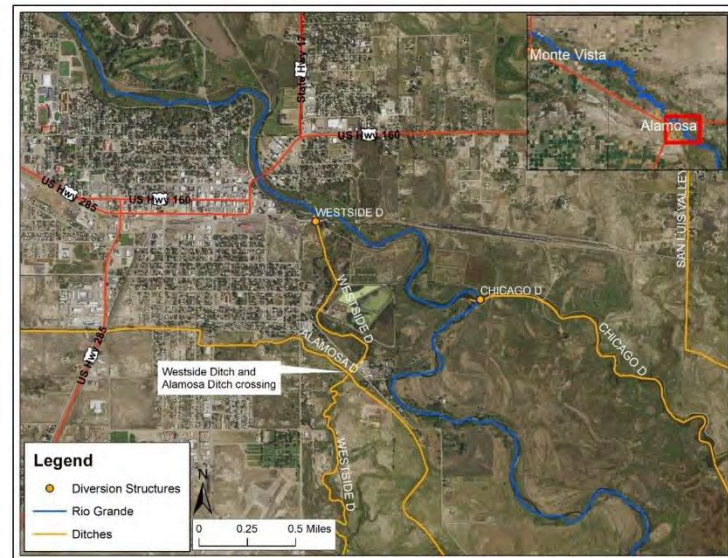
Westside Ditch and Alamosa Ditch junction, ~1 mile beyond of the headgate.

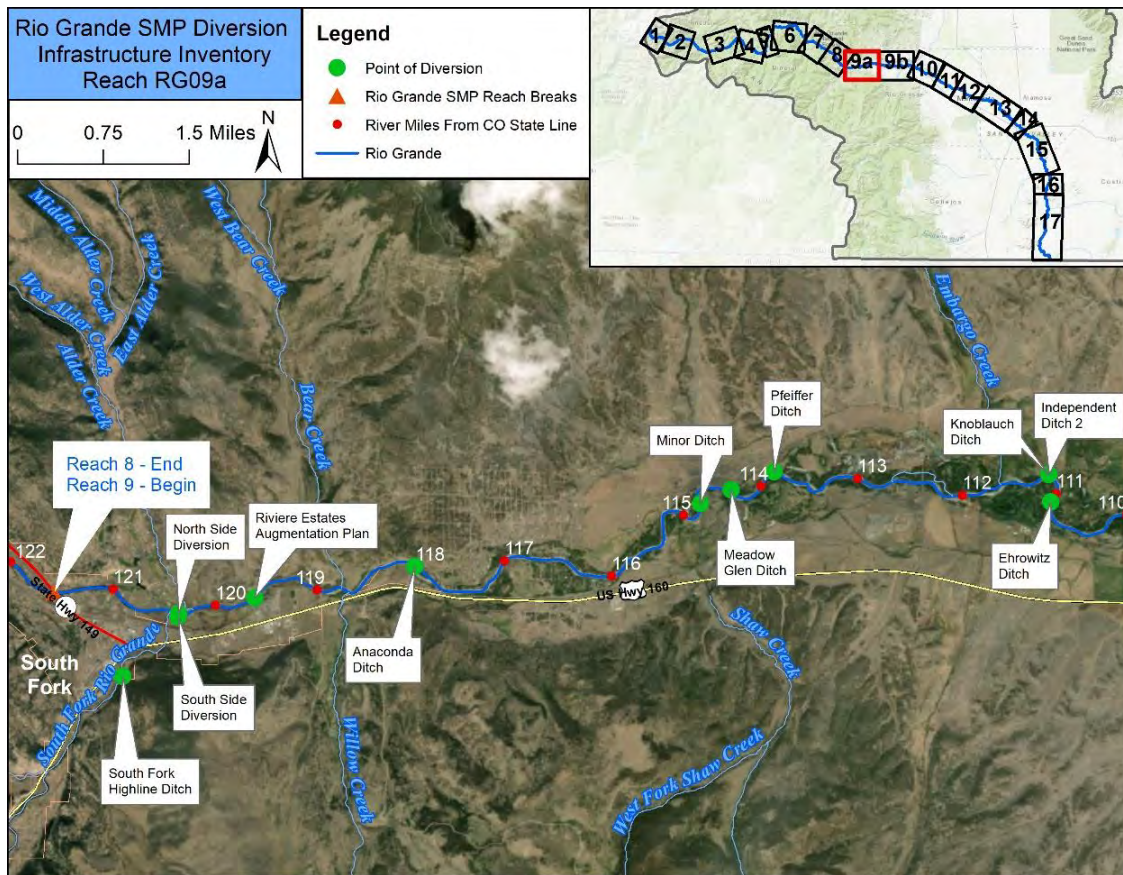
RG09a Diversion Infrastructure

South Fork Highline Ditch: This structure is located on the South Fork Rio Grande and functions effectively overall. A concrete diversion dam spans the river and has semi-permanent metal posts which support stop boards and increase head pressure during low flows. The headgate is located on the east side of the river. The headgate is set in concrete. The flume currently measures accurately, but may need to be replaced in the near future due to rust damage.

South Side Diversion: A small rock diversion dam on the south side of the river submerses the structure's point of diversion. Water is pumped directly from the river. The pump is housed in a small building and is metered. It is located just downstream of a pedestrian bridge serving the Rio Grande Club & Resort golf course. The channel is relatively stable in this reach and is not expected to migrate significantly in the future. There were no major issues identified at this structure.

water to the headgate and an overflow channel directs return flows back to the river. Sedimentation in the feeder channel requires regular maintenance. Additionally, the return flow structure has sunken and makes headgate control challenging. Based on the assessment of this structure, the TAT recommends either the installation of a new diversion dam at this location or relocating the diversion upstream, with the possibility of using the existing Independent Ditch 2 diversion. A new diversion dam, either in its current location or moved upstream, would effectively divert water and reduce maintenance. Repair or replacement of the return flow structure is also recommended to improve control of flows to the headgate.

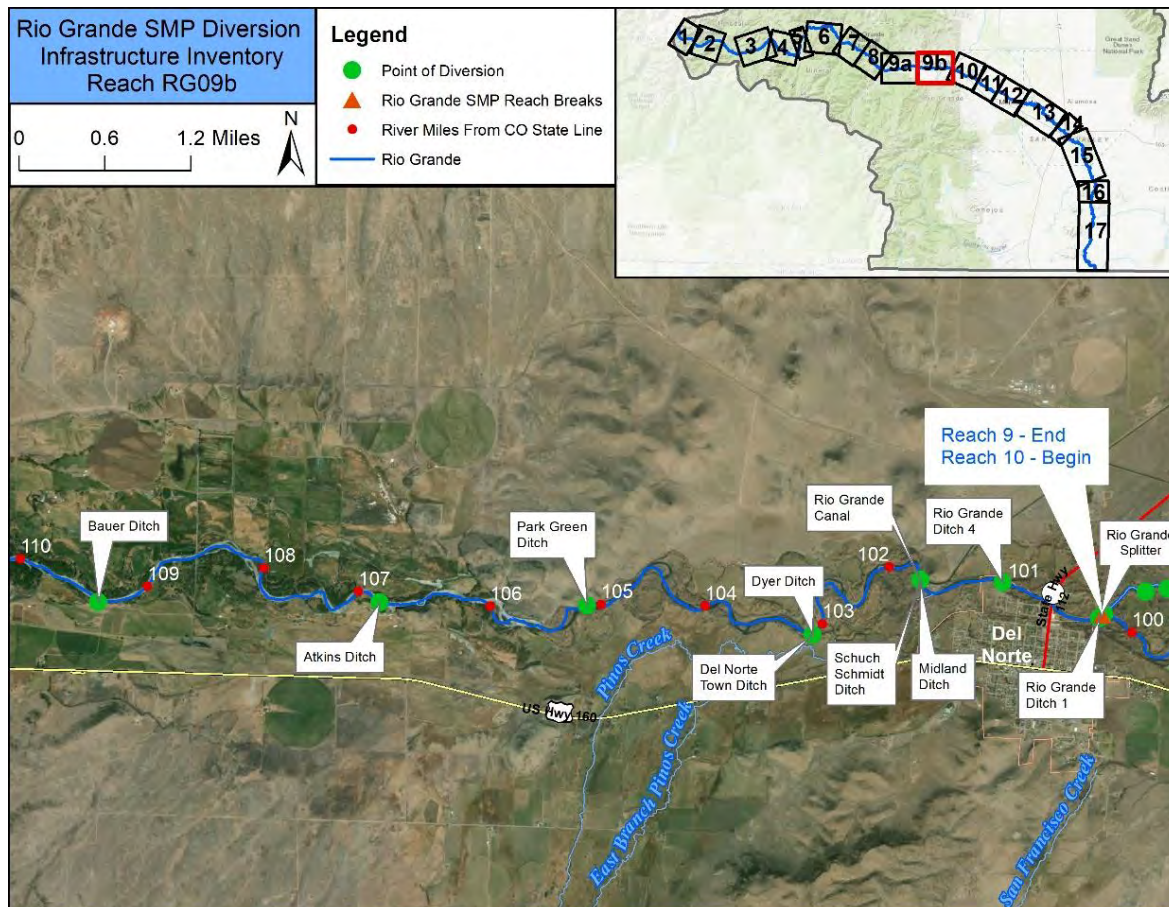
RG09b Diversion Infrastructure

Bauer Ditch: There is no diversion dam, but this ditch functions on grade with the river. Occasionally, this ditch has difficulty diverting its full decree due to the lack of a diversion dam. The point of diversion is located on the outside bend of the river, just downstream of the apex. The river channel has migrated very little in the last 45 years, although localized bank erosion has occurred. Bank stabilization structures were installed upstream and downstream of this structure in 2009 to mitigate bank erosion. Flows are directed into a feeder channel located on the south bank. The feeder channel is approximately 1,200 ft long and delivers water to the headgate. A 2 ft culvert (see report card) returns overflow water to the Rio Grande. The feeder channel and a significant portion below the headgate are within the floodplain. This is problematic due to constant erosion by the river as well as sediment deposition in the feeder channel. The TAT recommends raising the elevation of the feeder

channel and/or installing a sluice gate to mitigate sediment accumulation. Additionally, a small diversion dam would enable the ditch to operate at all flow levels.

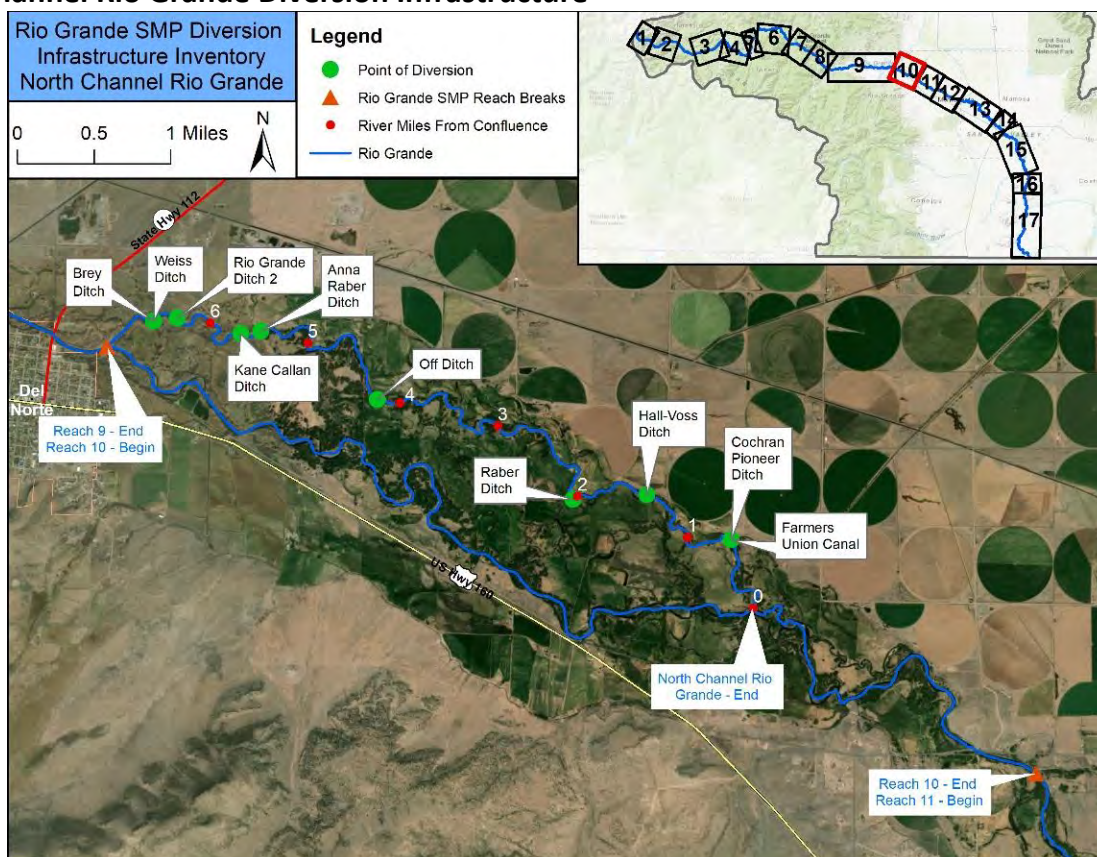
North Channel Rio Grande Diversion Infrastructure

Weiss Ditch: This structure is located on the south bank of the North Channel Rio Grande just upstream of Brey Ditch. The channel has remained very stable in this reach and is not expected to migrate significantly in the near future. The headgate is located on the outside of a meander and has no trash rack. It is difficult to operate and functions poorly. A very minimal rock diversion dam, shared with the Brey Ditch, is located just downstream of this structure and does not appear to significantly benefit this ditch. When this ditch is in priority, flows are high enough that a diversion dam is not necessary. The diversion dam is unstable and in poor condition. The flume for this structure could not be located. Given the issues identified, the TAT recommends headgate improvement and the installation of a functional measurement device. To reduce maintenance and improve efficiency of both this ditch and the Brey Ditch, consolidation of the two structures is also an option. If consolidation was pursued, the TAT recommends replacing or improving the diversion dam.

Brey Ditch: This structure is located on the North Channel of the Rio Grande just downstream of Weiss Ditch. The channel has remained very stable in this reach and is not expected to migrate significantly in the near future. This structure's diversion dam is shared with the Weiss Ditch, directing water into a short feeder channel and to this ditch's headgate. The diversion has difficulty diverting water at low flows and the ditch has insufficient capacity to convey its full decree during high flows due to debris and sediment accumulation. Given these challenges facing water users, the TAT recommends replacing or improving the diversion and possible consolidation with the Weiss Ditch to reduce overall maintenance for both ditches. Whether or not consolidation occurs, ditch enlargement is also recommended to allow for conveyance of higher flow.
