Junkins Fire, Final Report

Coalition and Collaboratives

PREPARED FOR LAVWCD, CWCB (PO # POGG1 PDAA 201700000986)

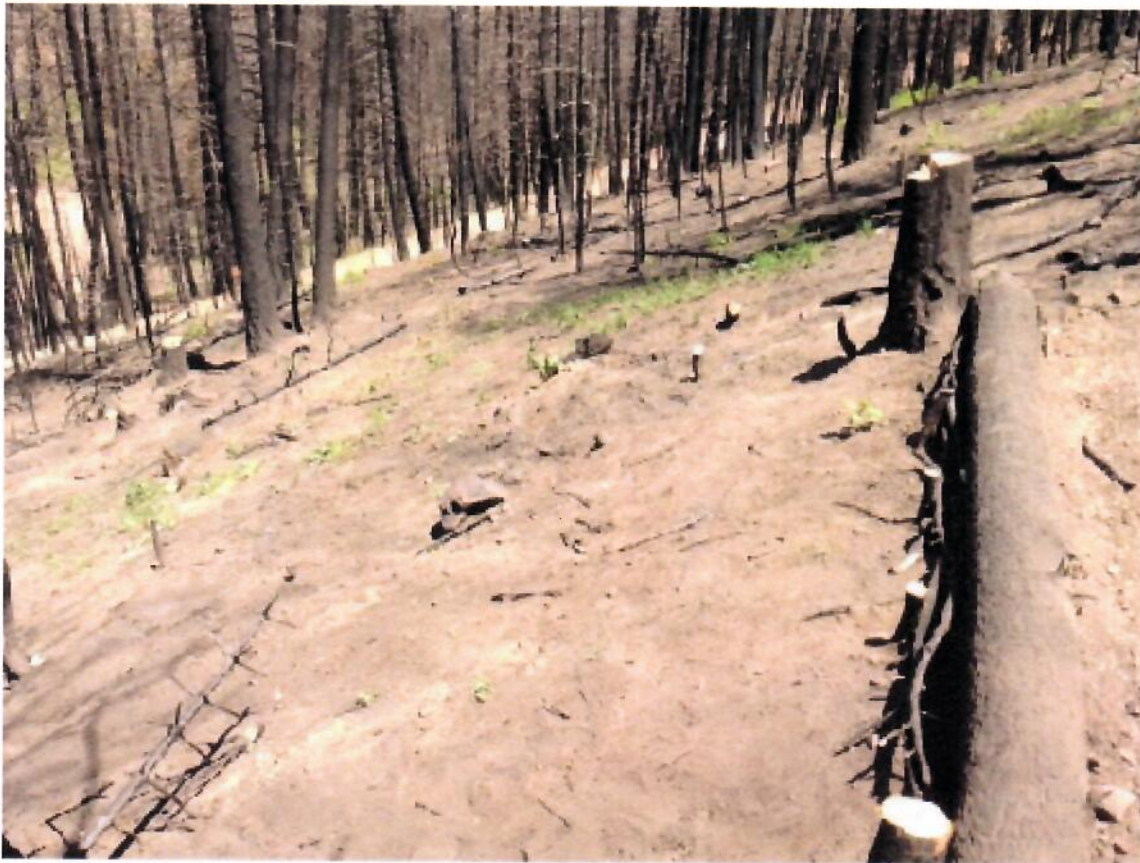
Steep burned slope

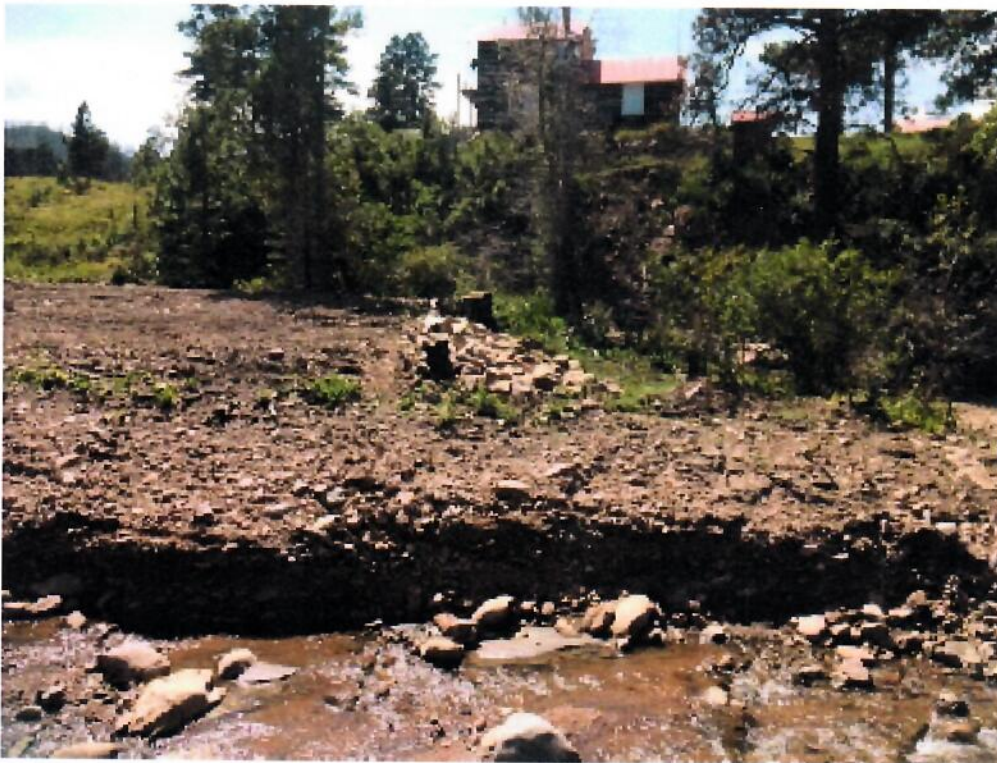
Actual Deliverables: The main objectives were met. The steep bank below the home is intact. To the left of the two stumps in the picture is a 30" diameter buried tree. This photo was taken after an estimated 50 year event that took place during construction. The J-hook is fully exposed. The footer thalweg rock weathered the storm. The top rock is farther down stream. Sediment is starting to build between and behind the rocks. Burned trees jammed up during the flood in the live trees just down stream of this photo. This caused an hydraulic lift, when the dam broke it then sucked the first structure in the channel down stream. The vertical bank in this area is about three feet high. We believe it will continue to heal over time.

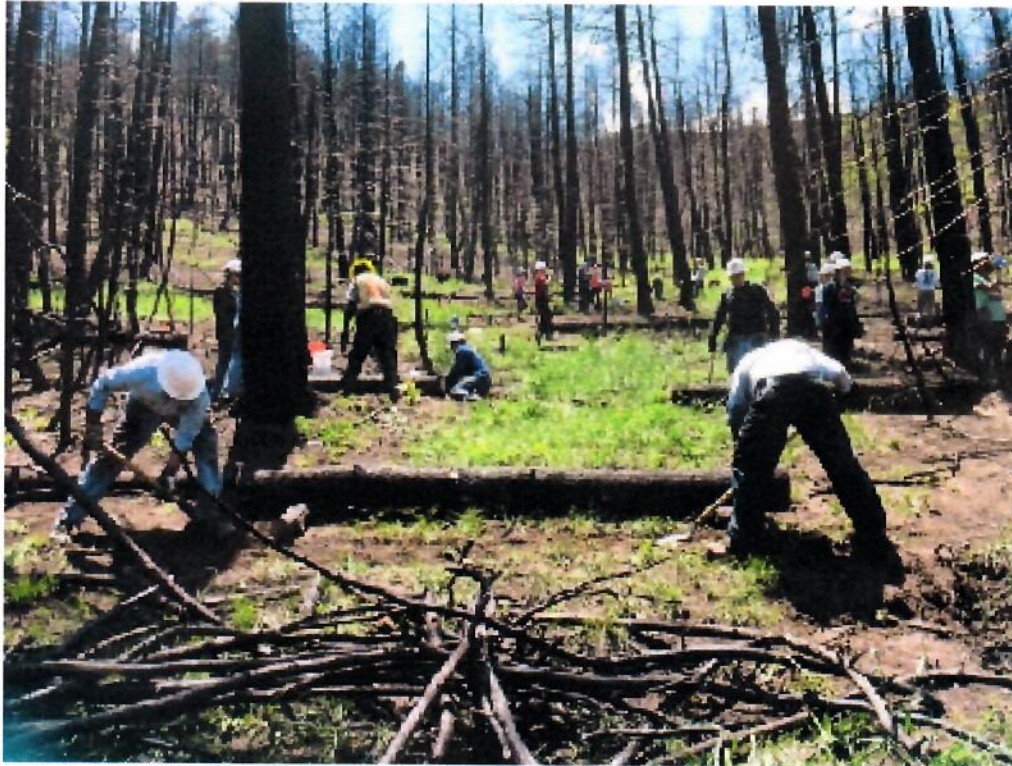
The modified crib walls were mentioned heavily in our monthly reports; below are some after pictures. It is hard to find the structures. This was taken after a storm event.
