RE: Swan River Restoration Project: Year Four Monitoring Report (SPK-2015-00780)

## Monitoring Report-Swan River Restoration Project Summit County, Colorado 2020 Year Four Monitoring

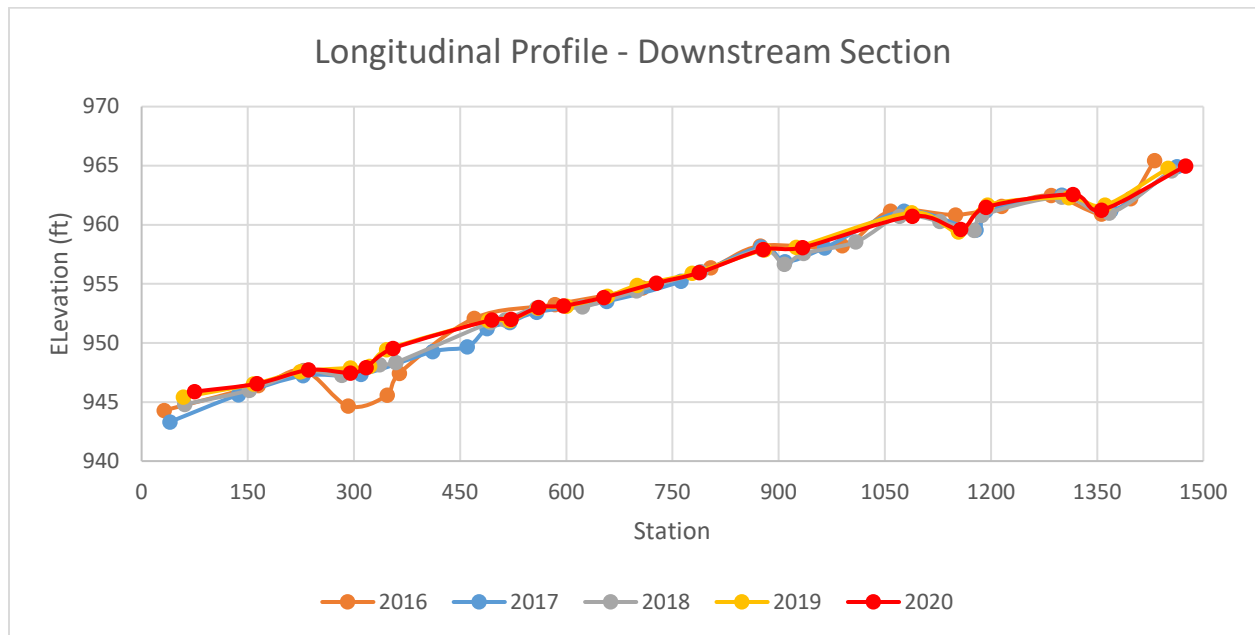
**Graph 2. Longitudinal Profile of Downstream Section**

The numeric results indicate that on average there is very little change from year to year in the profile. The largest variations that have occurred from 2016 to 2020 are at Stations 16+50 (0.6-foot increase), 20+75 (0.4-foot increase), and 42+95 (0.4-foot decrease). All other points were within +/- 0.3 feet from the as-built condition. The magnitude of all changes is small, particularly given the limits of accuracy when surveying on cobble sized material. Any changes are very minor and indicate that the channel profile has remained stable.

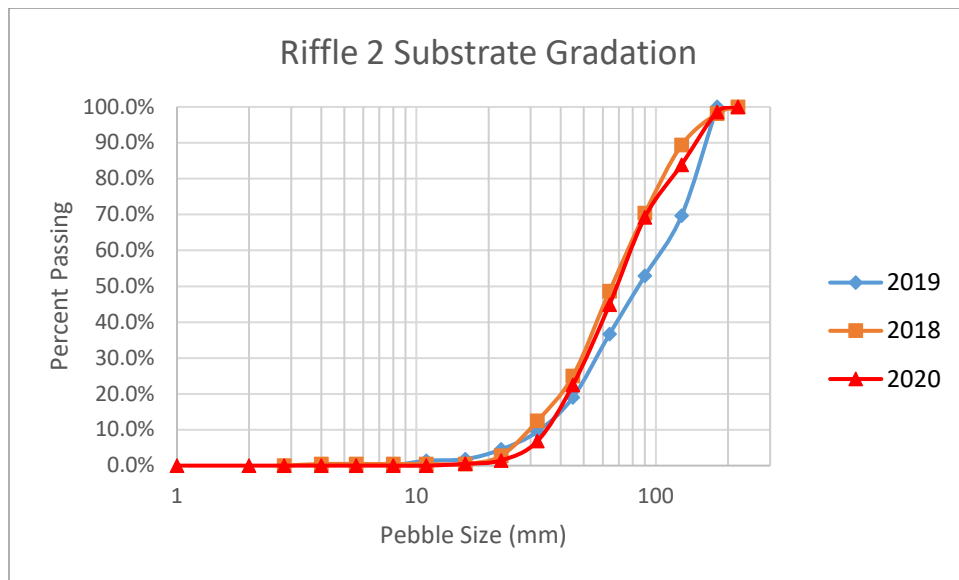
**Graph 9. Gradations at Riffle 2**

Based on gradations, substrate material at all locations classifies as well graded coarse-grained gravel. Minimal fines observed result in a high HSI score of 1, which indicates that from a sediment standpoint the riffle sections are fully functional (See **Figure 1** below). A comparison of gradations from the pebble count show a slight trend of having slightly less coarse material at the surface in 2020 than in 2019. This minor change could be the result of some coarser material being transported out of the reach during the return to more normal flows of 2020.

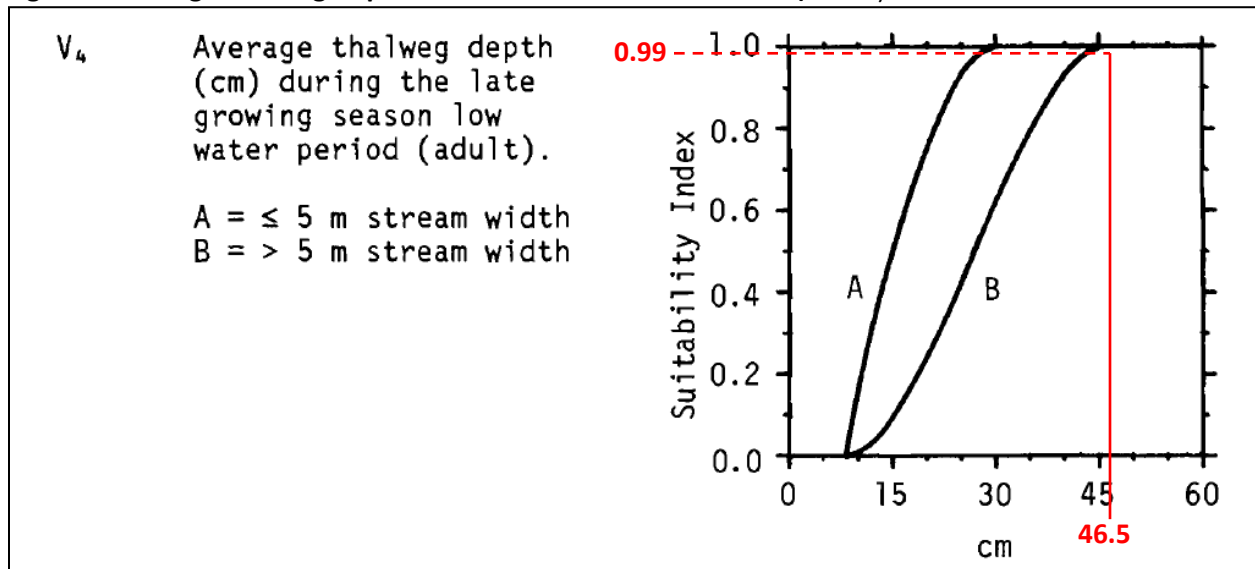
**Figure 2. Average Thalweg Depth - Low Flow Channel Conditions (HSI  $V_4$ )**

The average thalweg depth was measured to be 1.4 feet in 2018, 1.5 feet in 2019 and 1.5 feet in 2020 based on the 93 points sampled. This corresponds to an HSI score of 0.99 and indicates that the stream is fully functional based on this parameter (See **Figure 2** below). The HSI score of 0.99 is a slight increase from the 2018 HSI score of 0.95. The change is very minor but indicates that the project continues to provide excellent overall thalweg depth. **Graph 13** shows that the special distribution of thalweg depths was very consistent from 2018 to 2020 with the deepest pools located between Station 25+00 to 45+00.
