FINAL PROJECT REPORT- POGG1 2020-2979

REPORT DATE	PROJECT NAME	PREPARED BY
February 7, 2022	WSRF Grant – Arkansas-Cottonwood Irrigation Ditch #2 Project	Gracy Goodwin Project Manager
	Grantee: St. Charles Mesa Water District	David Simpson

**ST. CHARLES MESA COTTONWOOD
IRRIGATING DITCH #2
HEADGATE/ AUGMENTATION
STATION**

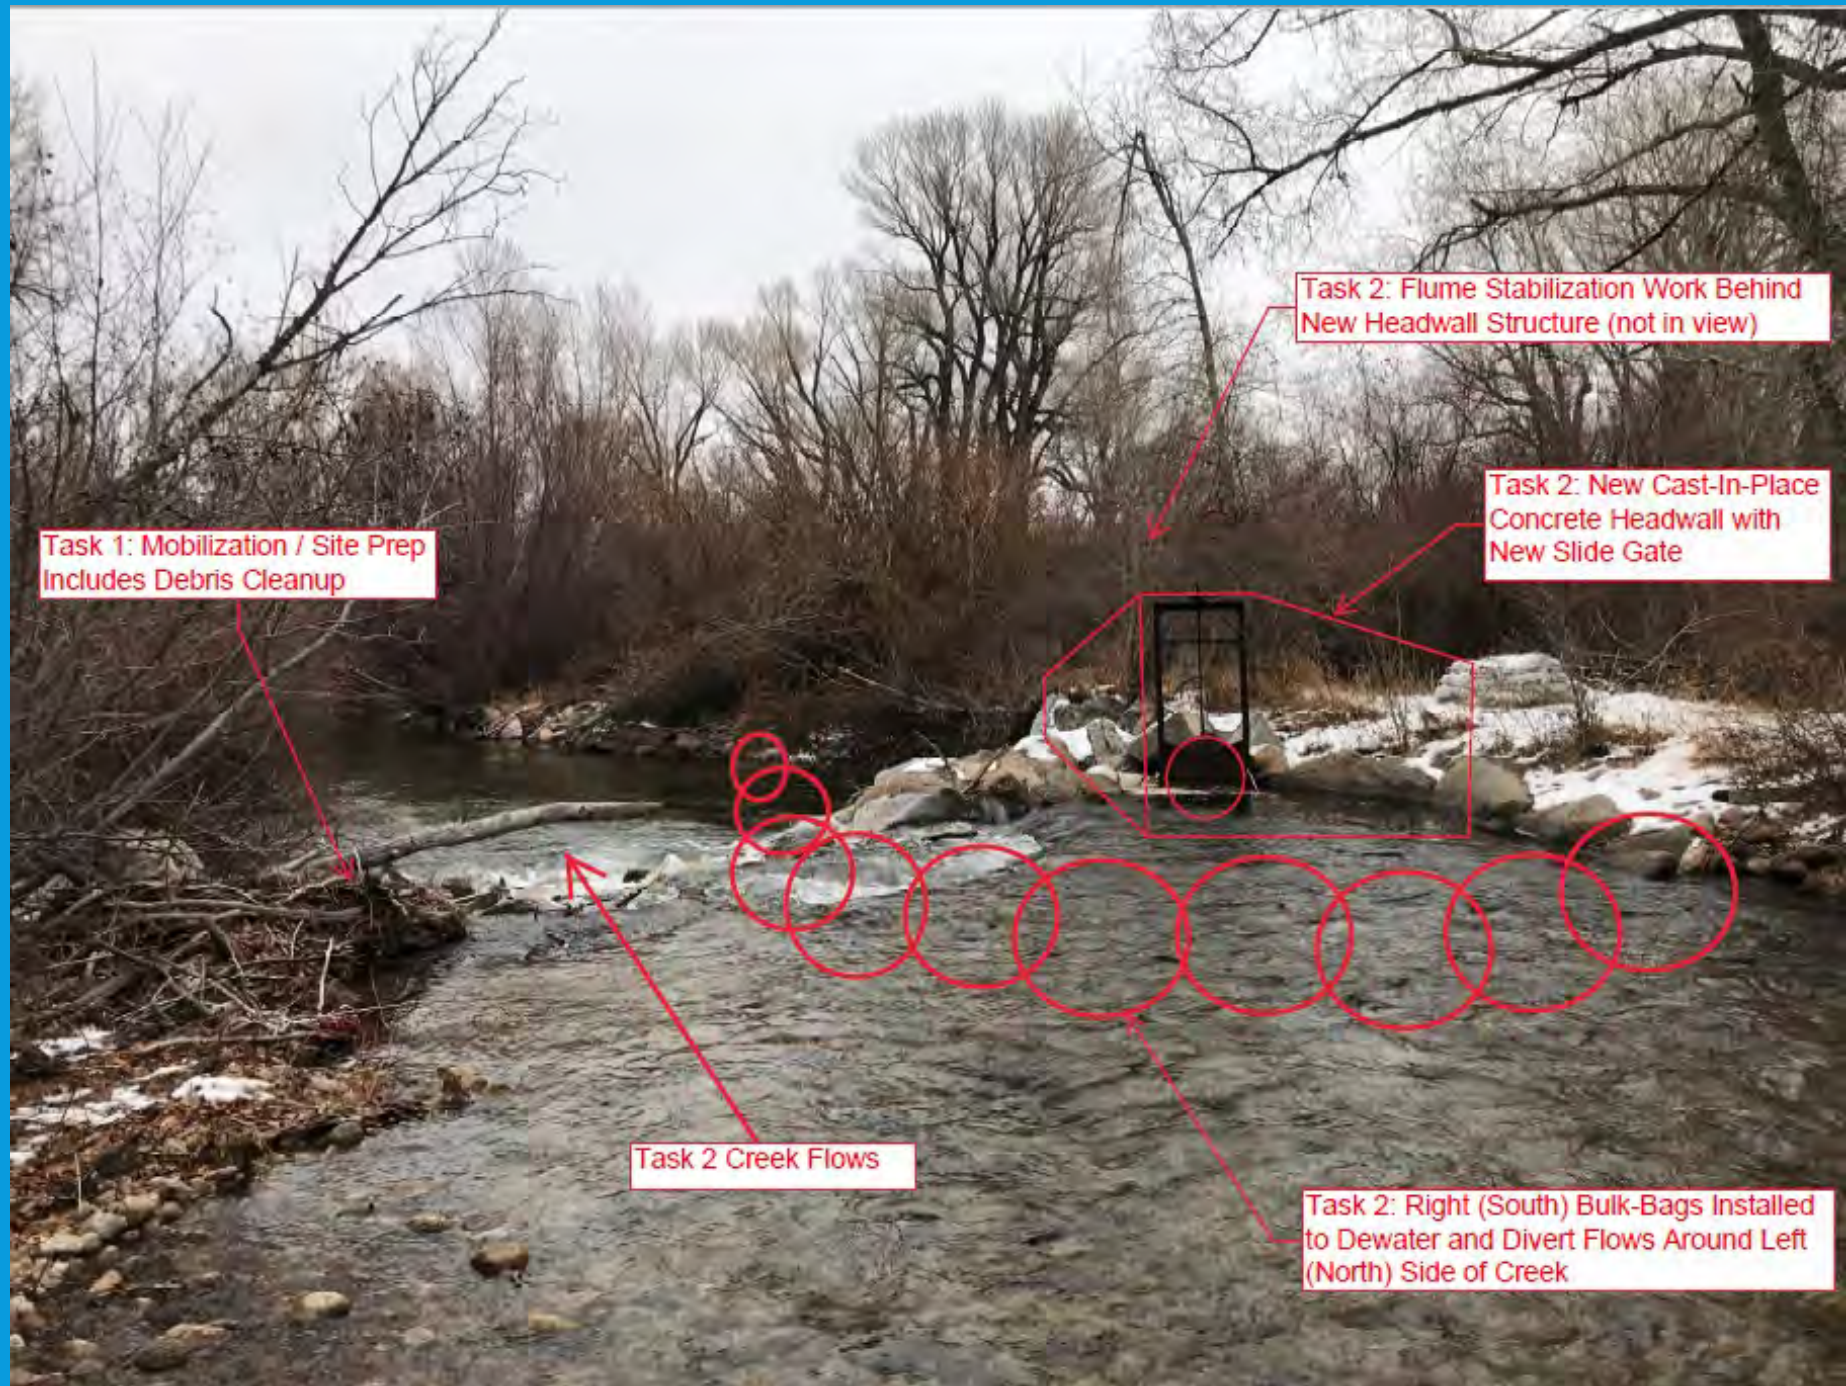
WORK IN PROGRESS

Task 2 (Right – South Side of diversion)

- Installation of bulk bags to dewater the area of construction and divert flows to the North side of the creek.
- Install Cast-in-place headwall and new slide gate

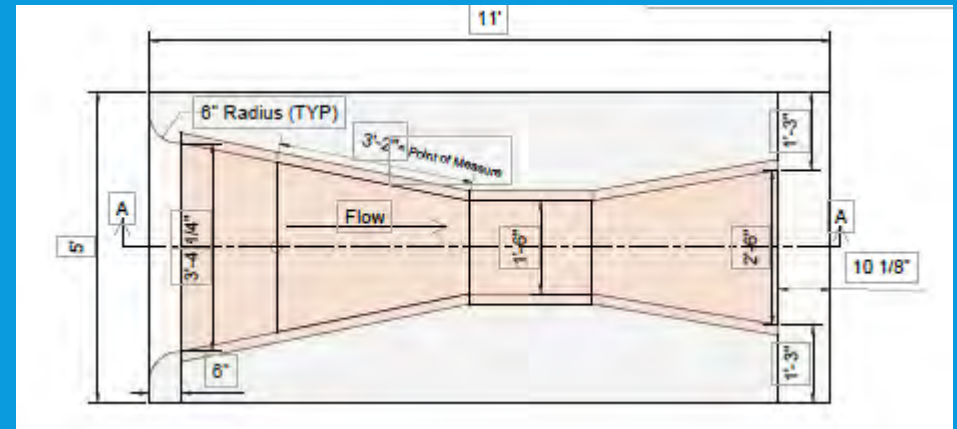
Task 2: Parshall Flume and Measuring Equipment to be Removed and Re-Installed with Concrete Foundation

- Existing flume and measuring equipment to be removed and flume re-installed with a concrete foundation.
- Create more stability and better grading.

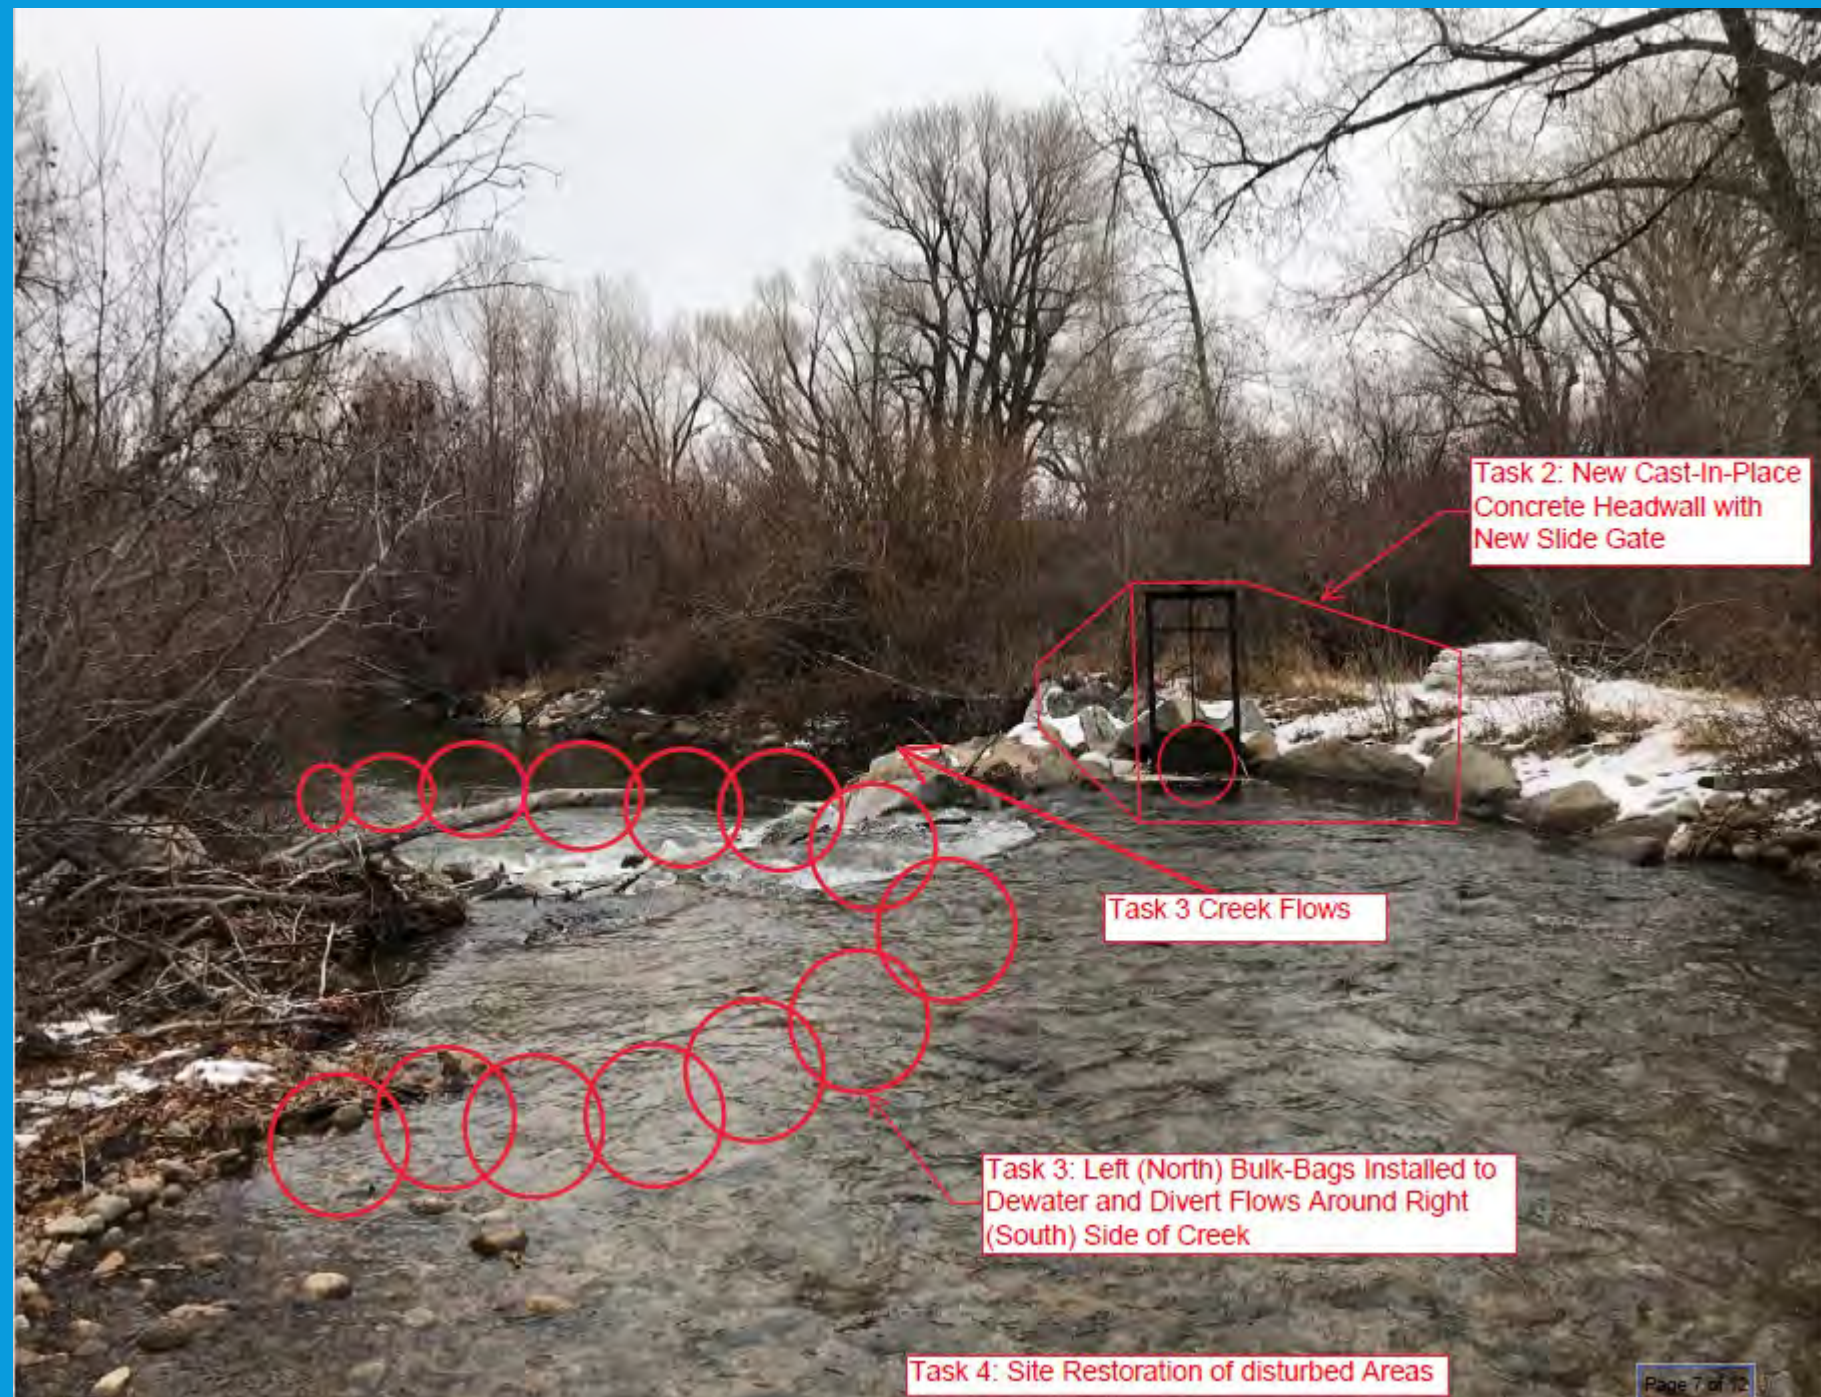
WORK IN PROGRESS

Task 3 (Left- North side of diversion)

- Installation of bulk bags to dewater the construction area
- Installation and grouting of riprap
- Reinforcement for erosion control
- Preservation of floodwall and protection of fishery flow
