Upper Culebra Watershed Assessment Report

In Progress Draft

Prepared for Costilla County Conservancy District

Tailwater Limited

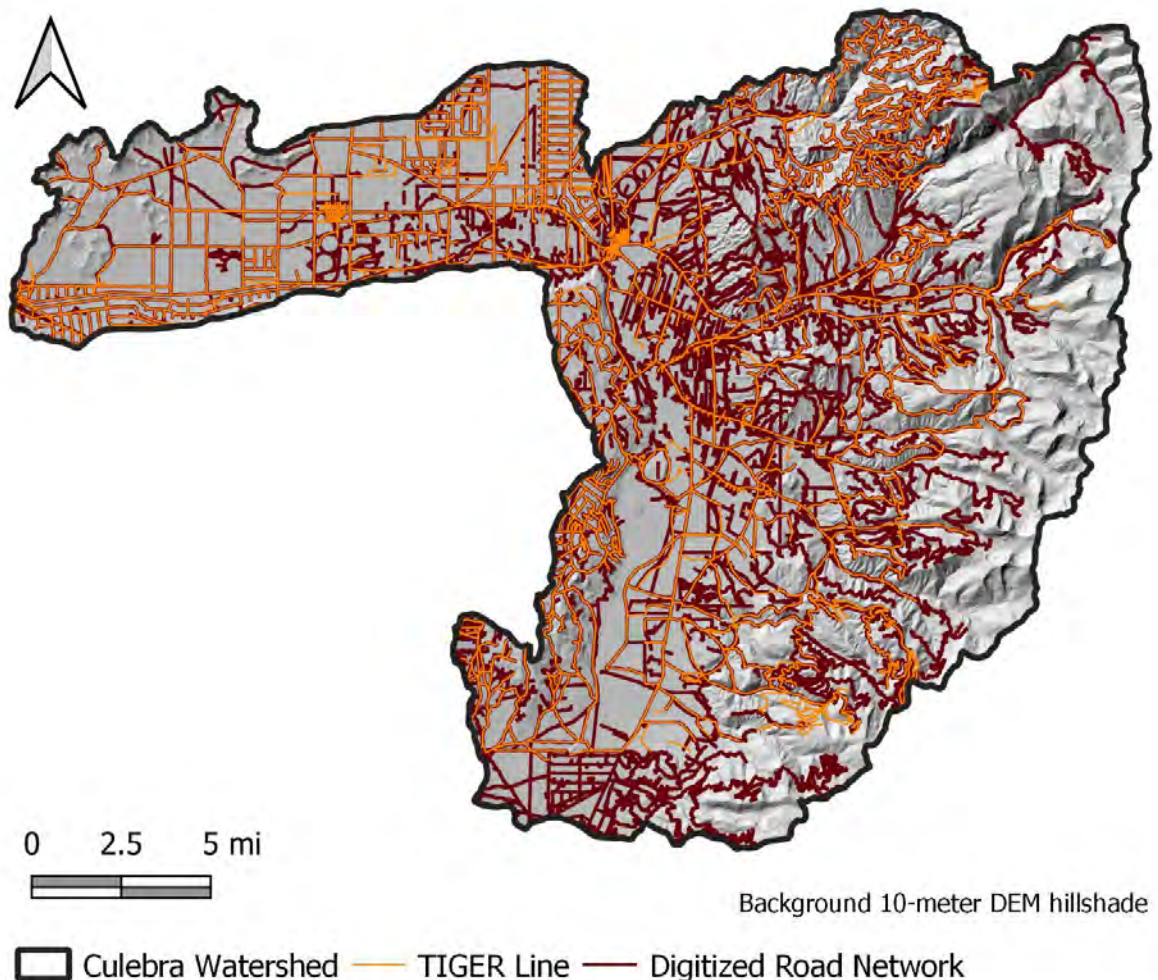
Access is one factor in determining areas within the watershed that are routinely visited by people. Digital street mapping was obtained from the United States Census Line Files (U.S. Census Bureau, 2015). Within the Culebra Basin this digital dataset represented lower basin county roads very well, but poorly represented forest roads and areas that are infrequently traveled. A digital network of roads was developed using the Census Line files as a basis and adding roads, that according to recent aerial imagery, were not delineated, moving roads that were improperly located, and deleting roads that did not exist for use in the assessment. The differences between these two networks are shown in Figure 1-15. These files provide a starting point for building a more complete inventory of roads and could be updated with additional attributes for Safety and Emergency Management Planning.

Figure 1-15 Roads and vehicle damaged routes in Culebra Watershed and Tiger Line Files Streets (U.S. Census Bureau, 2015) base map.

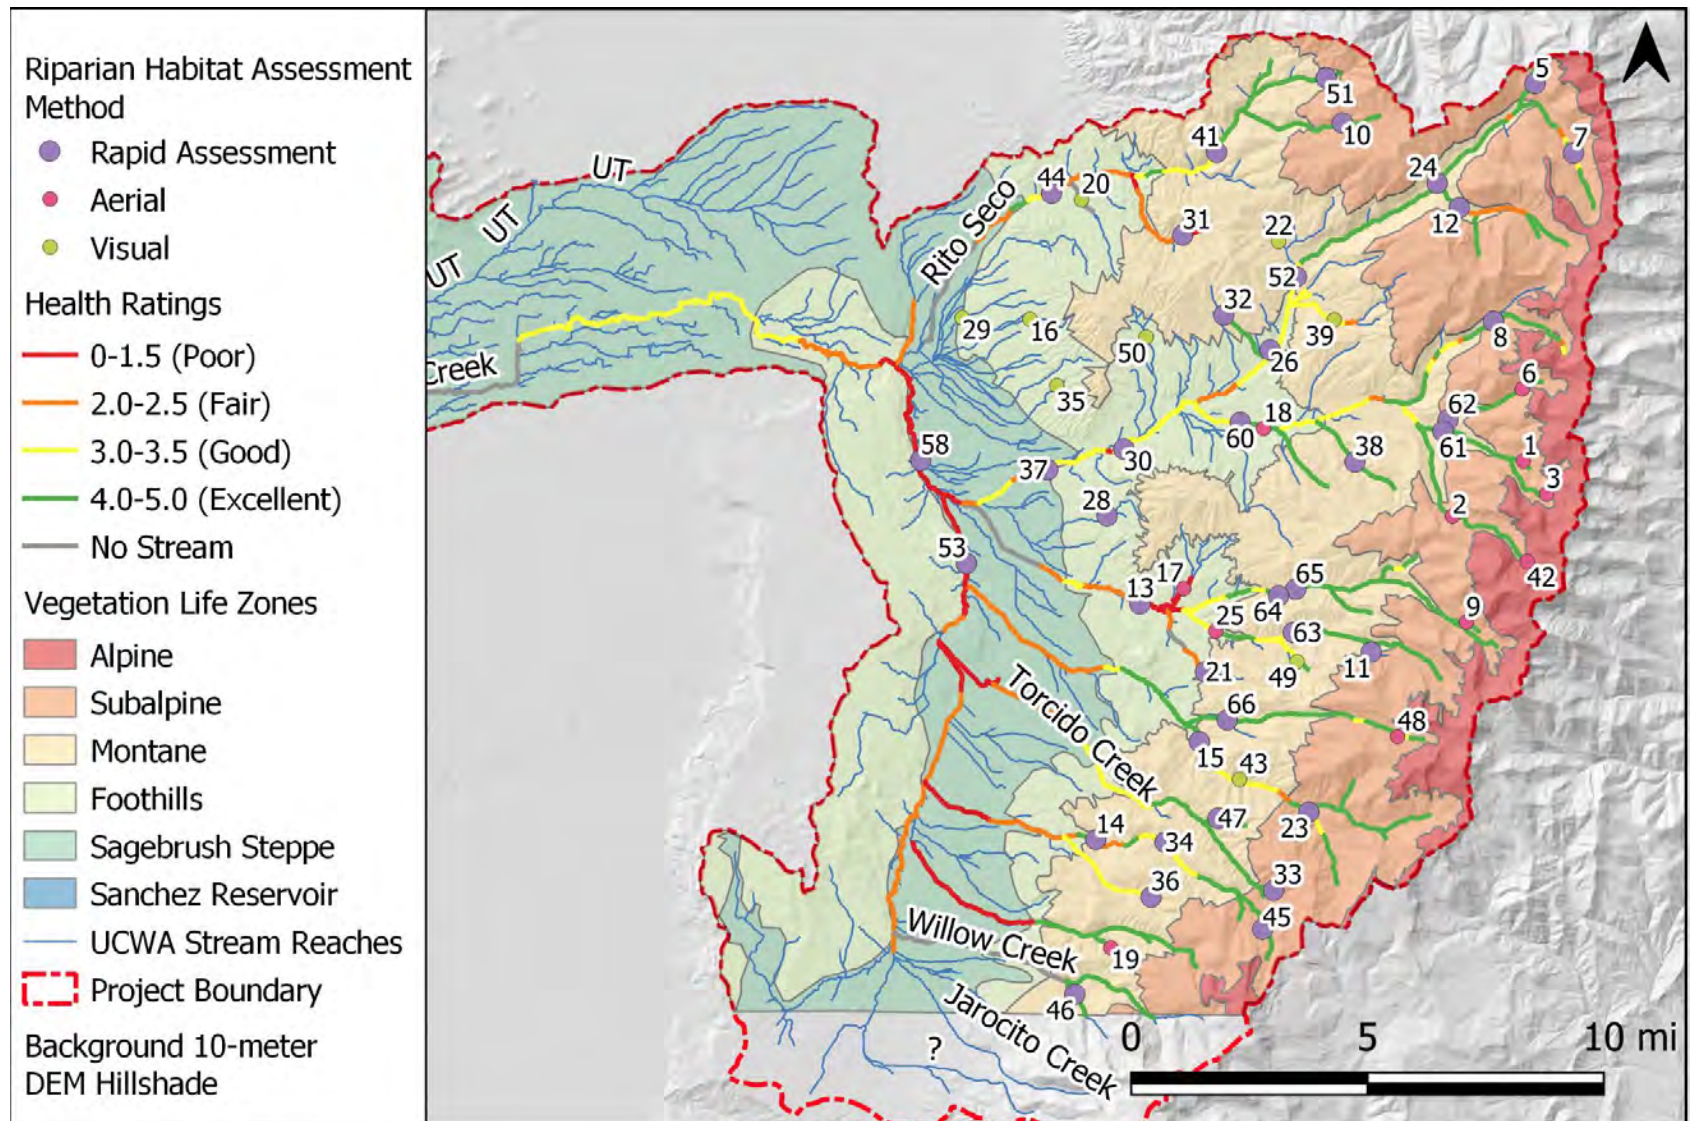
Figure 2-10. Health Ratings Map for entire watershed.

The ratings from visual and aerial assessments were averaged for each reach (Table 2-8 and Figure 2-10). Areas around the Sanchez Reservoir, and creeks in the sagebrush steppe/valley bottom and the lowest rating indicating areas of highest human impacts.

Creek Name	Average Rating
Alamosito	4.37
Bernardino	4.75
Carneros	4.70
Chucilla Alta	4.00
Cuates	4.20
Culebra	2.52
El Fragroso	5.00
El Pedegroso	2.88
El Perdido	5.00
El Poso	3.83
El Rito de Aban	4.00
El Valle	3.68
Jaroso	3.47
North Vallejos	3.59
Rito Agua Azul	3.50
Rito Seco	3.33
San Francisco	3.53
Sanchez Reservoir	1.00
Torcido	4.00
Ventero	1.38
Vallejos	2.88
Willow Creek	5.00

In general, alpine and subalpine riparian areas scored 4 and higher (Figure 2-10), indicating these riparian areas are healthy, and activities that would degrade these areas (e.g., logging, grazing, roadways, etc.) should be avoided. Creeks in the lower elevations of the watershed, where activities like grazing and agriculture are more prevalent, scored under 4 (Figure 2-10), indicating the need for active and passive management. Specifically, Rito Seco, Jaroso, Culebra, El Pedegroso, Sanchez Reservoir, Ventero Creek, and Vallejos Creek scored the lowest within the UCWA. These creeks and tributaries have been highly impacted by past and current land use. Heavy incision (i.e., downcutting) of creeks, non-native plant species, low canopy structural diversity, and floodplain intrusions are a few of the issues that should be addressed in these reaches to accomplish desired watershed benefits.

There are several reaches that should be prioritized for active restoration due to their low ratings, as indicated in Figure 2-10, while higher scoring reaches should be protected. The health rating maps for each tributary highlight areas (Appendix C) provides a visual representation of these reaches. General restoration recommendations are provided below.

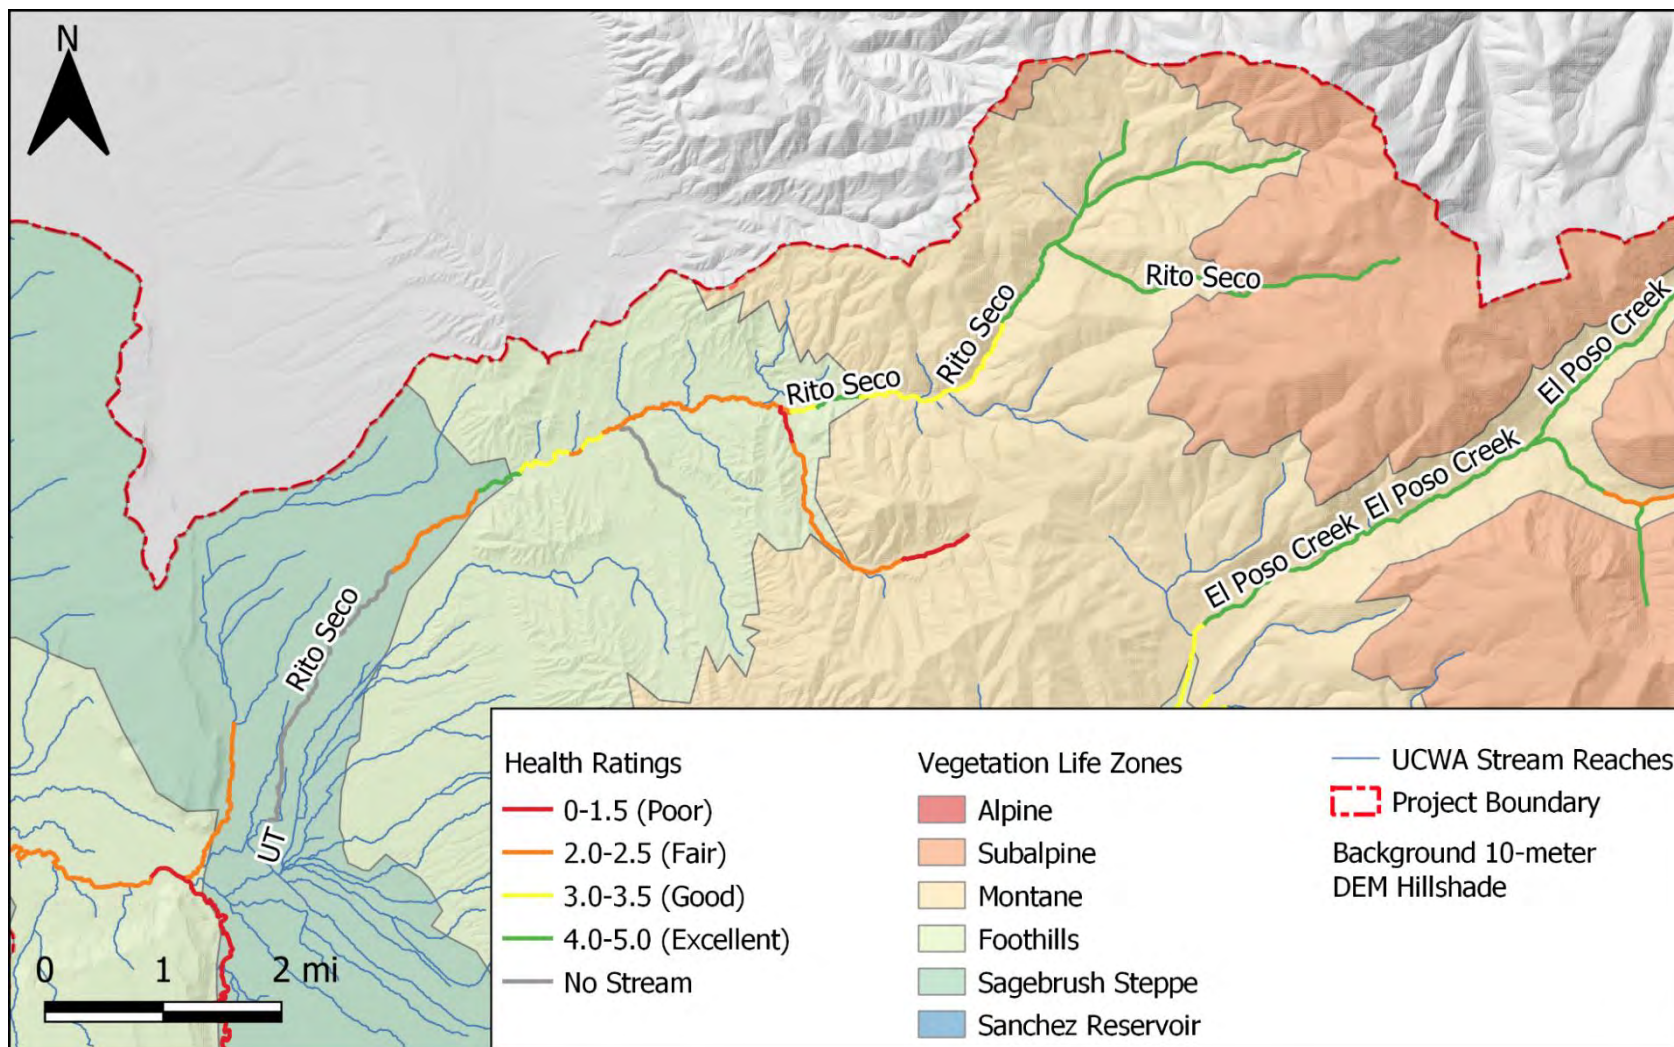
Figure 2-11 Rito Seco riparian health rating map.

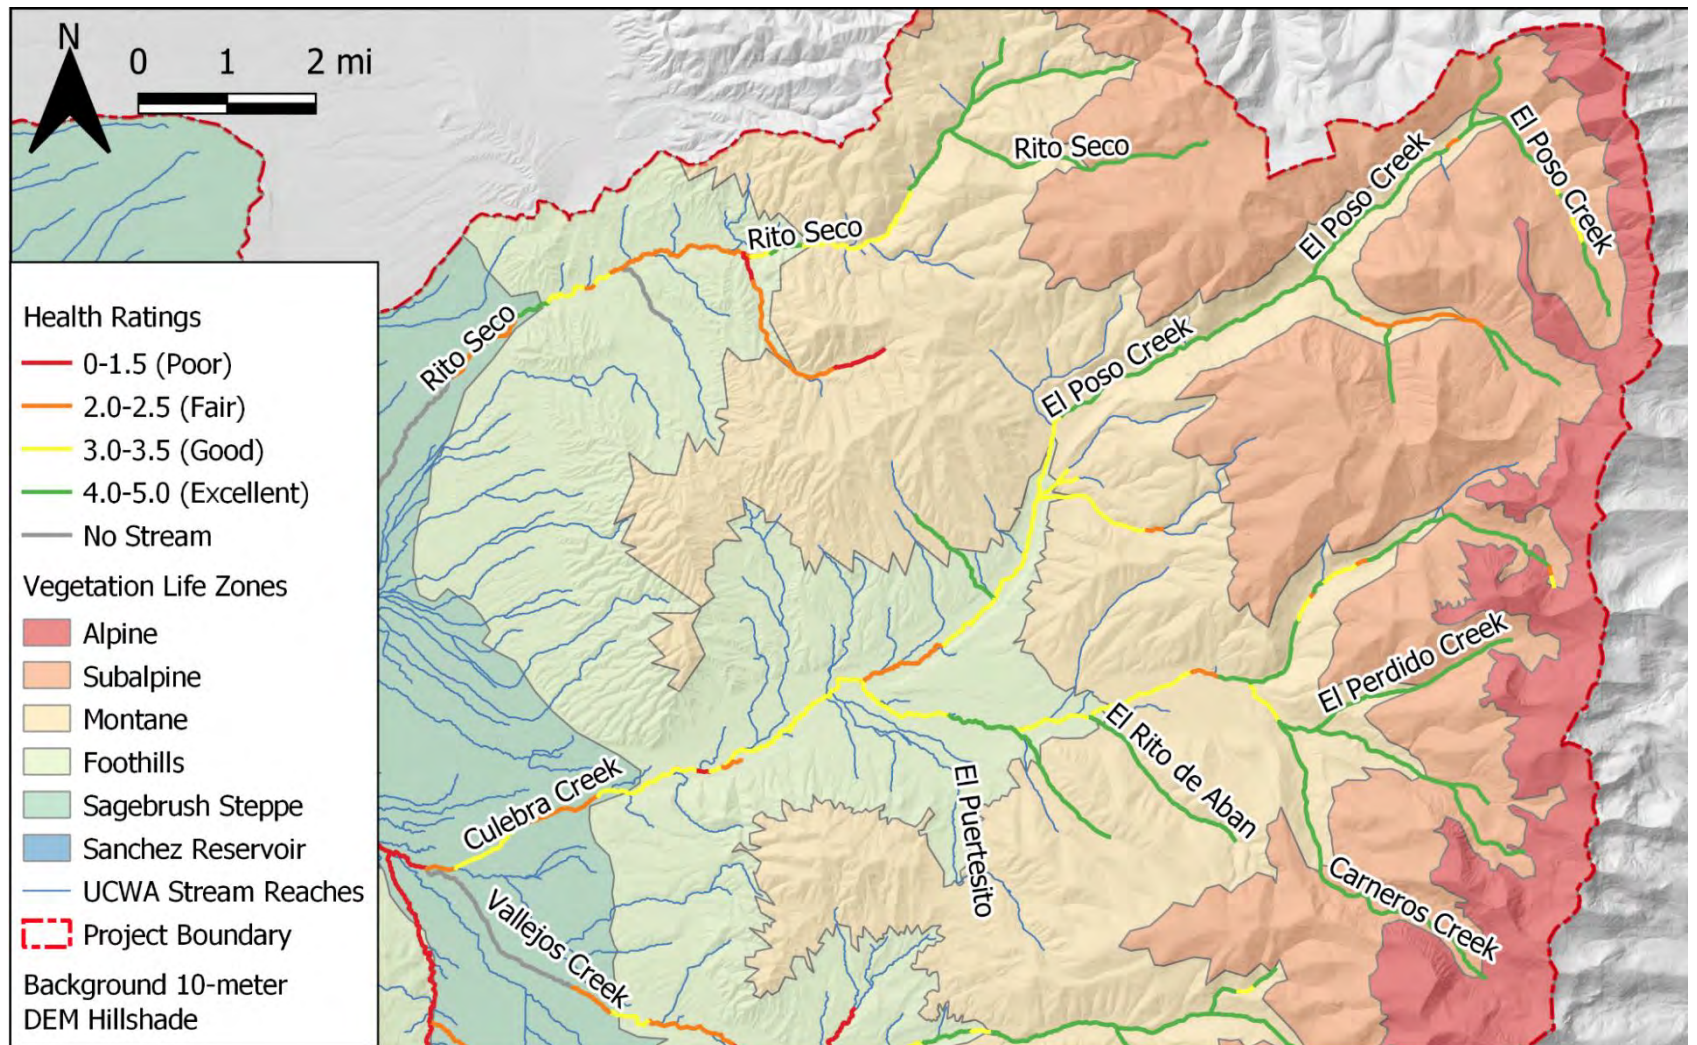
Figure 2-12 El Poso and Upper Culebra Creek riparian health rating map.

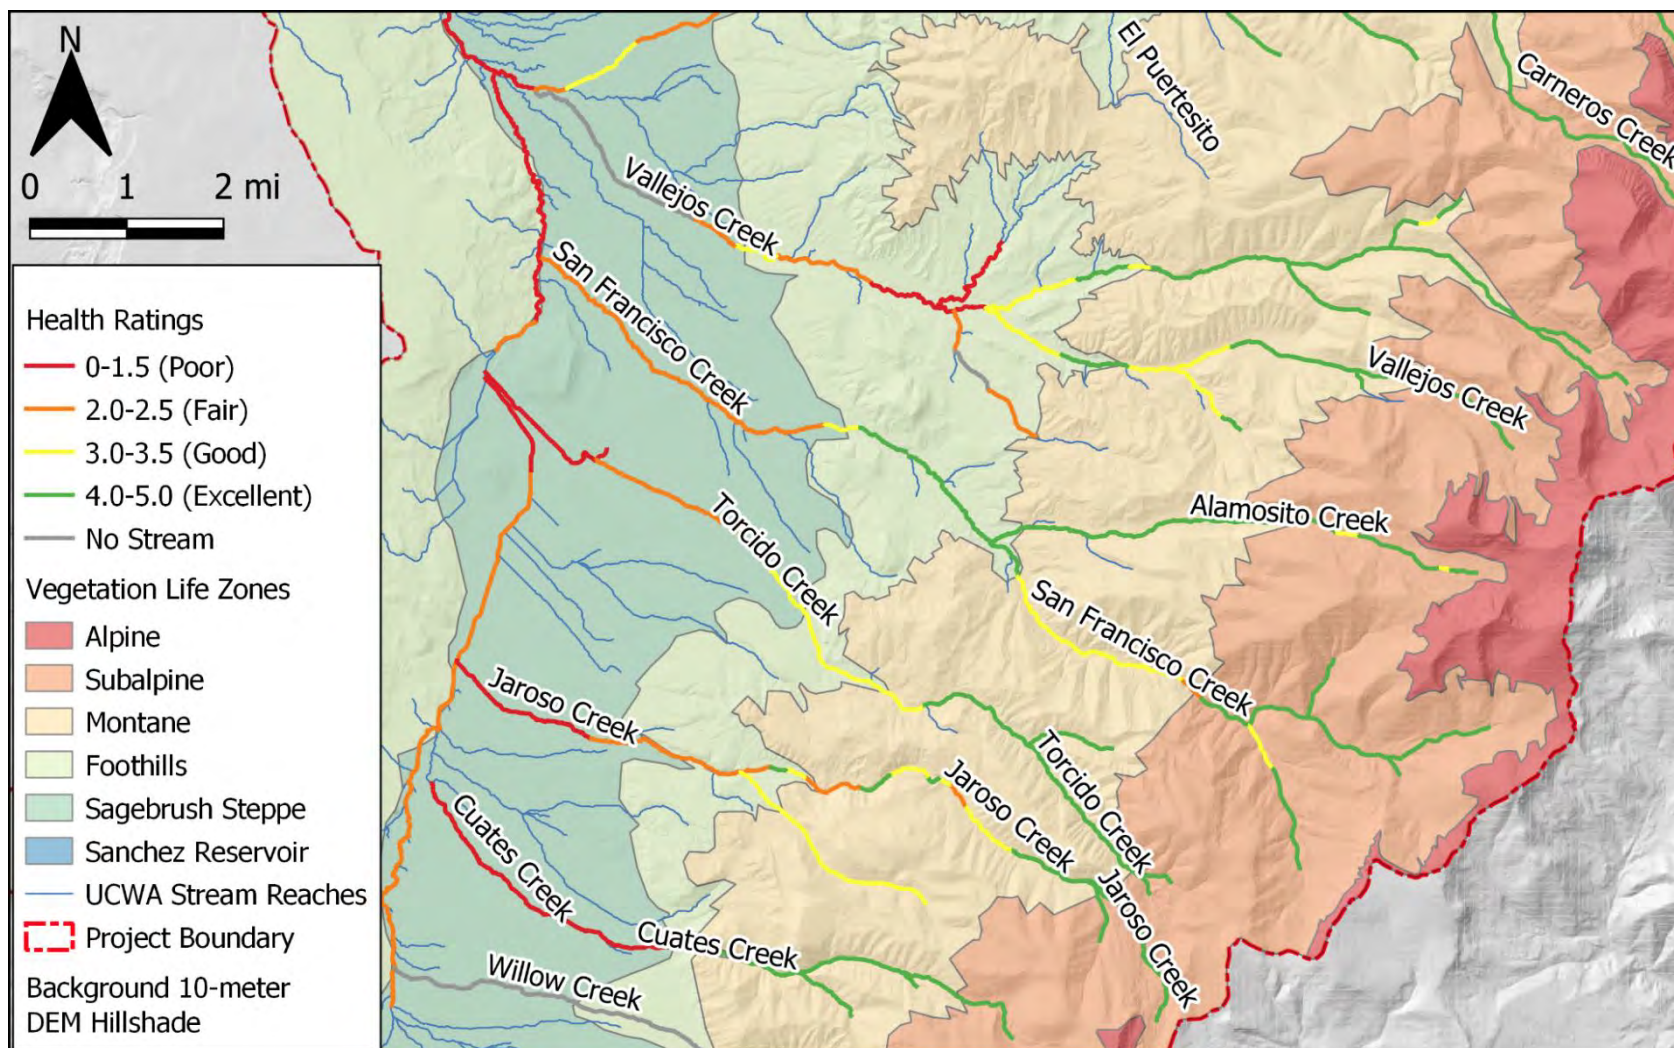
Figure 2-13 Vallejos Creek, North Vallejos Creek, San Francisco Creek, Torcido Creek, and Jaroso Creek riparian health rating map.

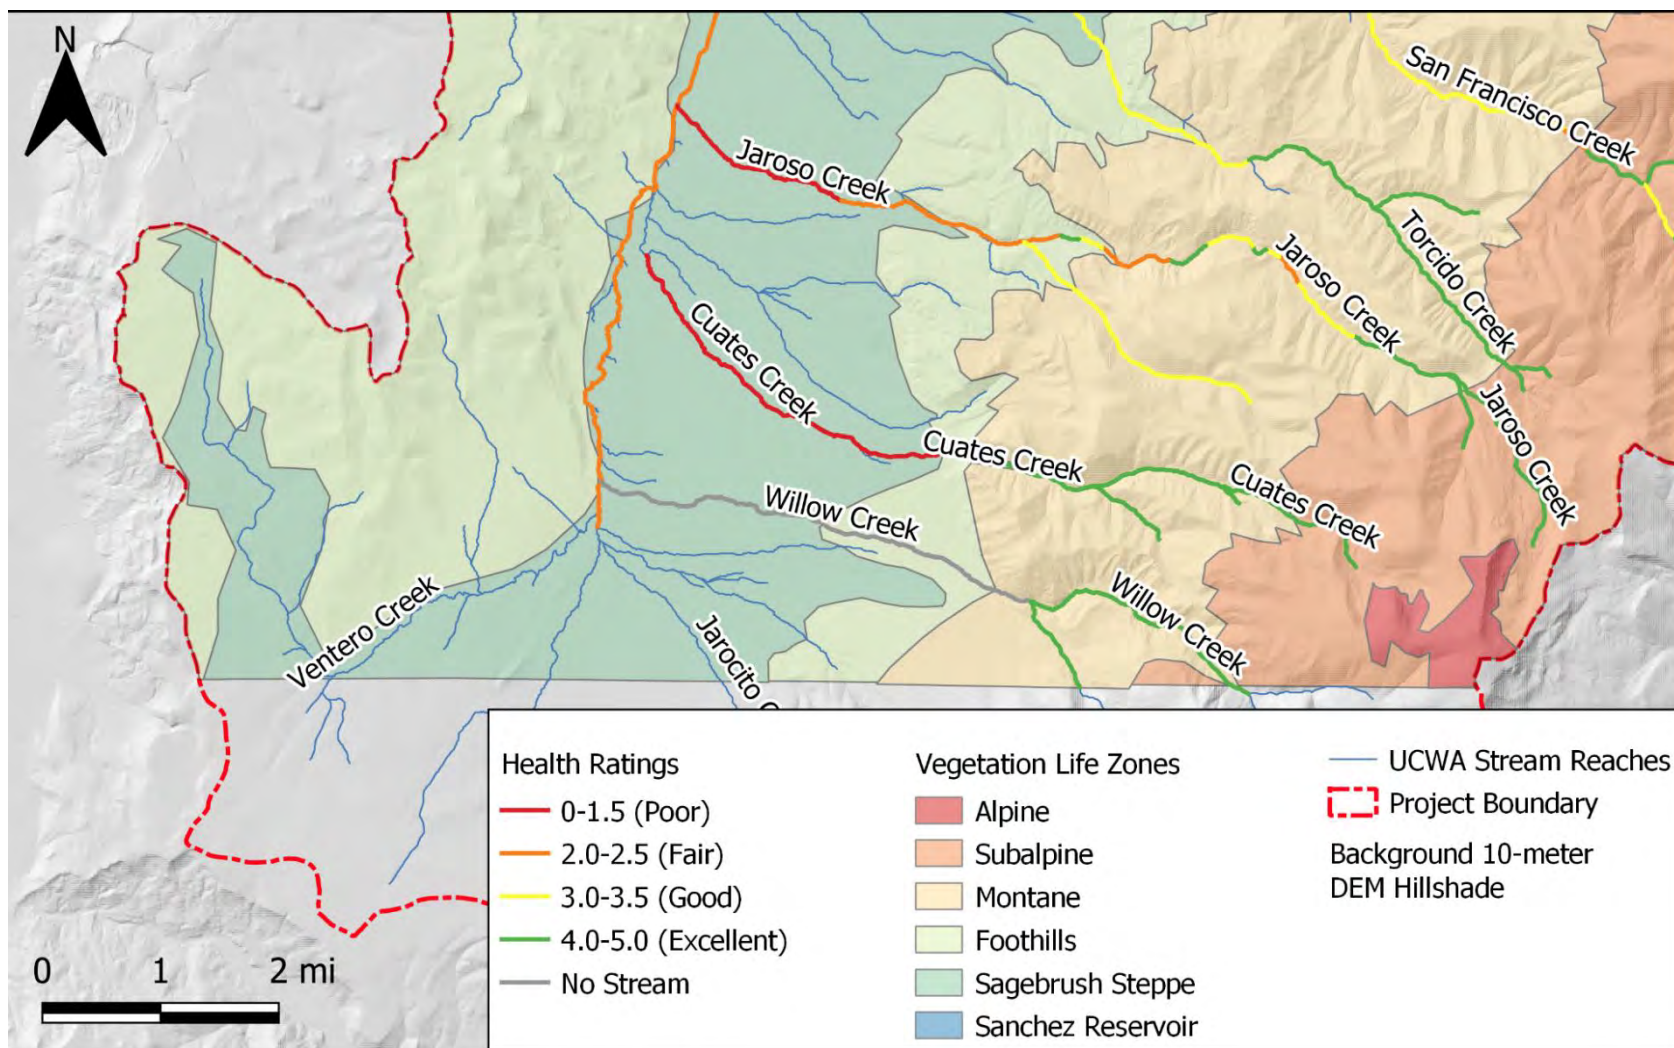
Figure 2-14 Jaroso Creek, Cuates Creek, and Willow Creek riparian health rating map.

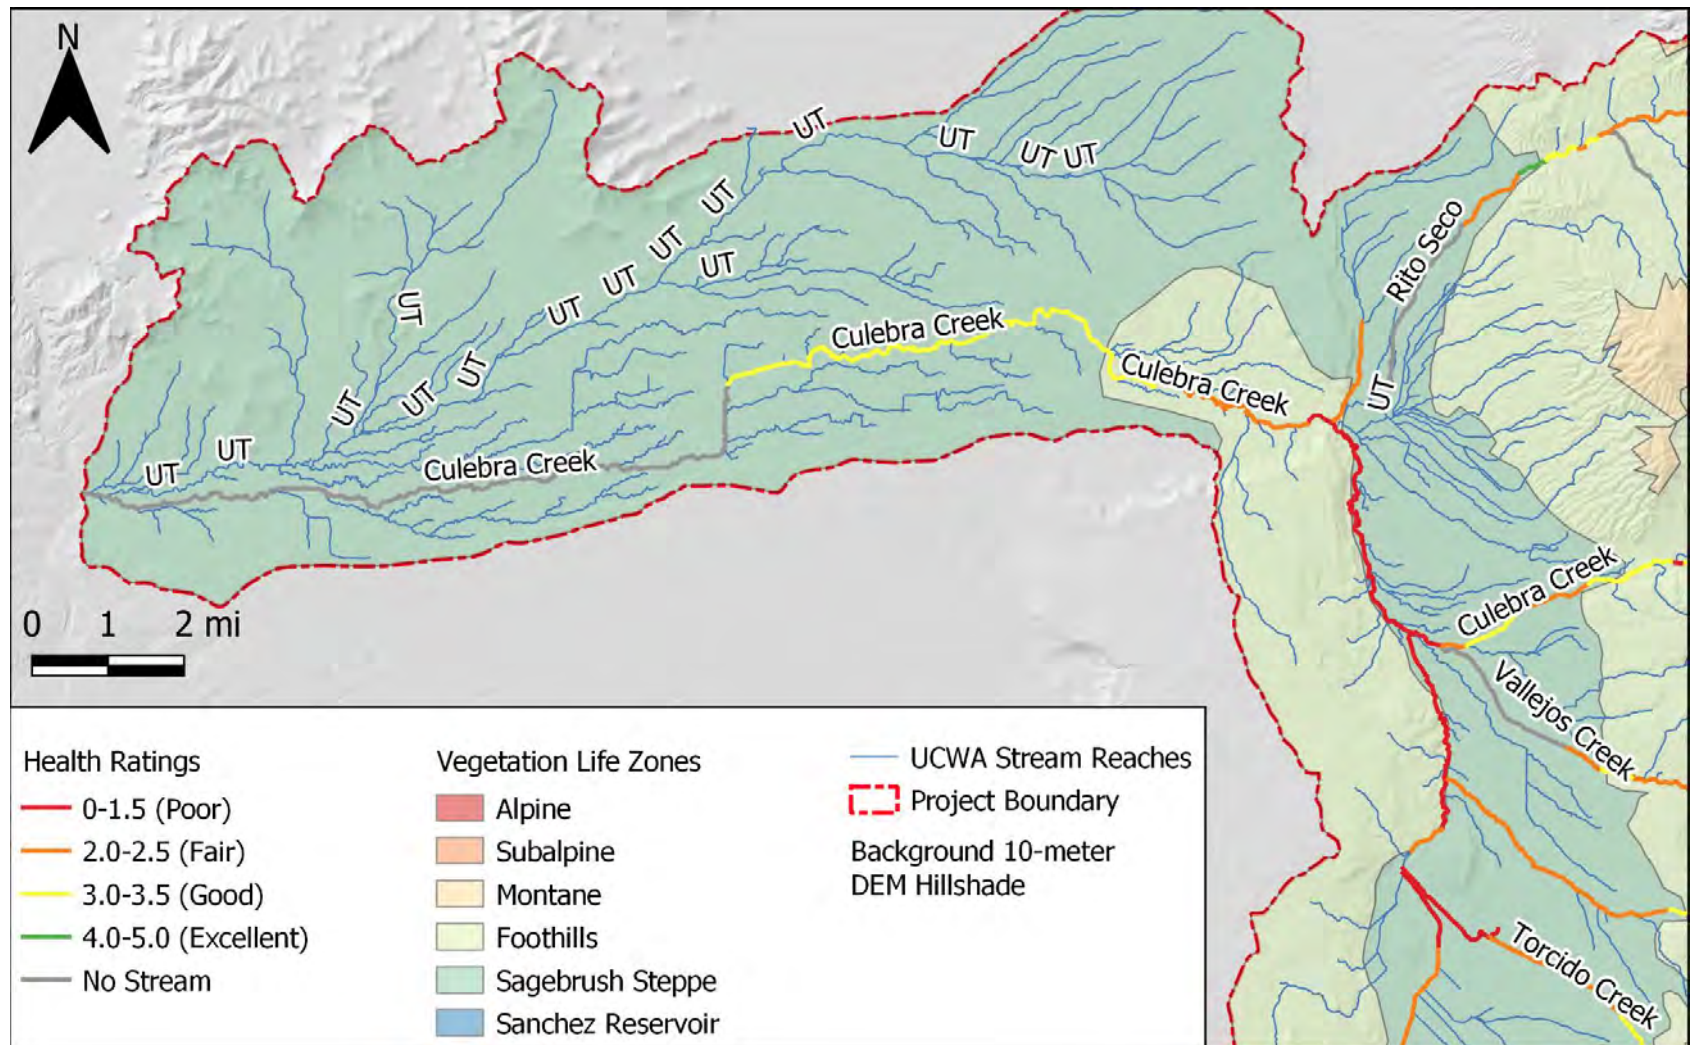
Figure 2-15 Lower Culebra Creek riparian health rating map.

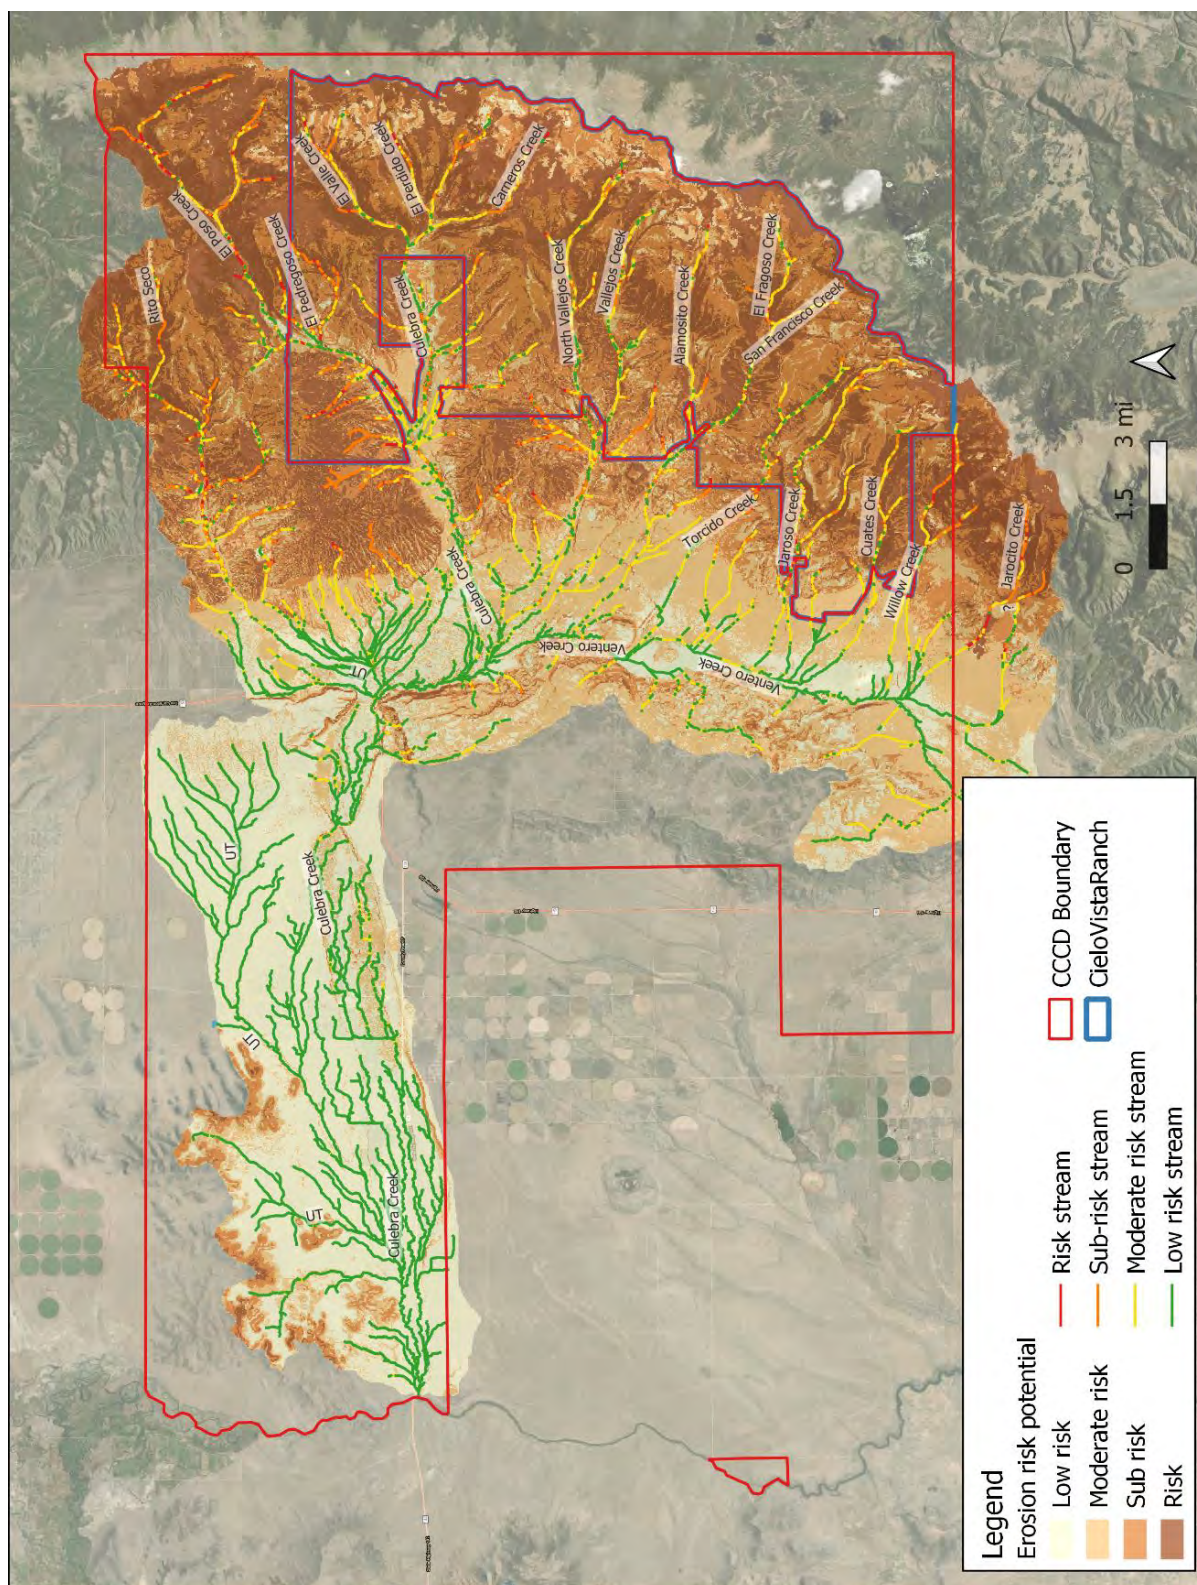
The soil erosion potential model (or risk area model), as described in de La Hoz (2020), used to identify potential areas of degradation and identification of areas for field data collection was based on Renard et al. (1997) and Laflen & Flanagan (2013) . The model used different factors to assess soil erosion potential at a watershed scale. These factors consider the effect of topography (slope), soils (soil type and soil erodibility), rain (precipitation), and land cover (vegetative cover, plant litter, and soil surface) on erosion. The distribution of erosion risk potential values generated by the model were used to establish four erosion risk classes (risk, sub-risk, moderate risk, low risk) and a GIS layer based on each of these risk classes was generated (Figure 3-2). A GIS layer of perennial streams within the Upper Culebra Watershed was overlapped on the risk area model and each resulting risk class layer. Subsequently, stream reaches corresponding to each risk class were extracted and a layer of stream reaches in each risk class was generated. Risk, sub-risk, moderate risk, and low risk stream segments accounted for roughly 16%, 22%, 30%, and 31% of the total stream network length, respectively (Figure 3-3). Since each risk class depicts segments of streams that are relatively uniform in character, geology, vegetation, and soils, this classification was used to narrow the natural variability in physical variables affecting attributes of streams.

Figure 3-2. Culebra Watershed erosion risk potential classification and corresponding stream reach categories

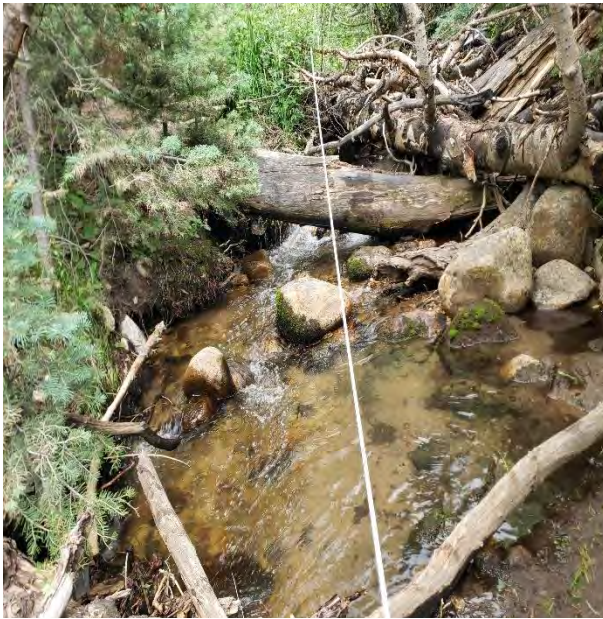
Figure 3-4 Alamosito Creek, Link no 981, slow water habitat.

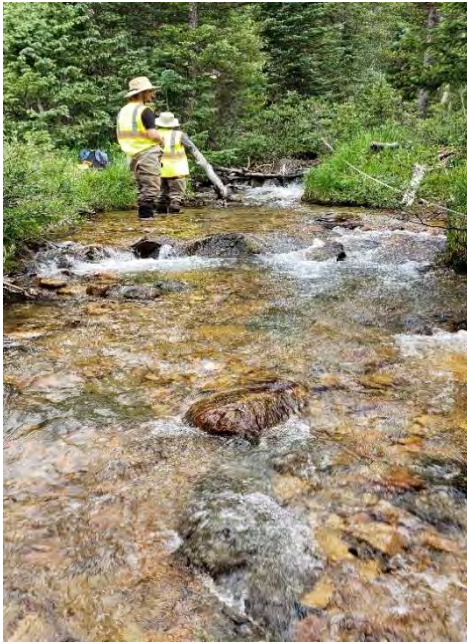
Figure 3-5 Canova Creek, link no 2652, slow water habitat.

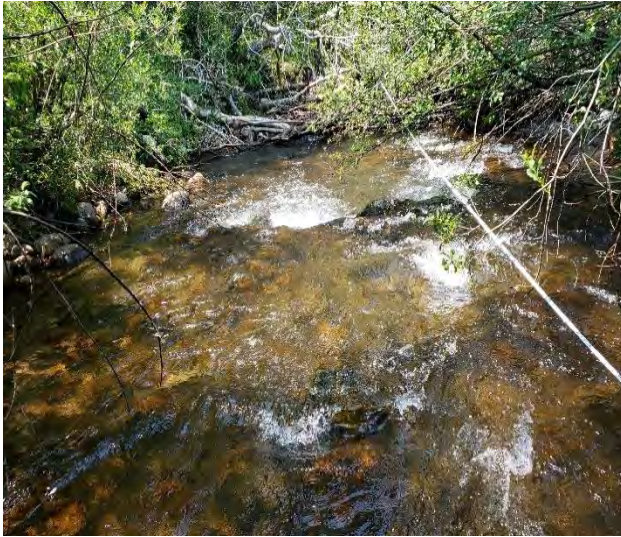
Figure 3-7 Culebra Creek, link no. 3068, slow water habitat.

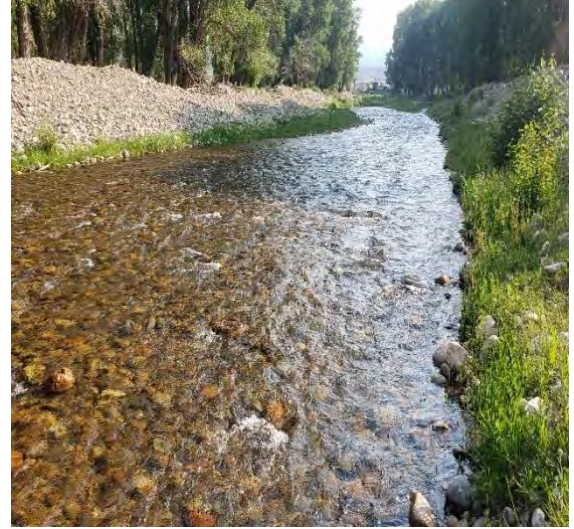
Figure 3-7 Culebra Creek, link no. 3644, fast water habitat.

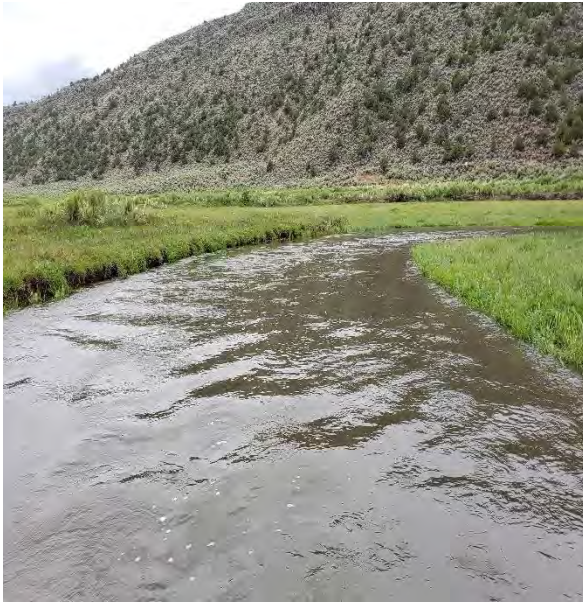
Figure 3-9 Culebra Creek, link no. 3860, slow water habitat.

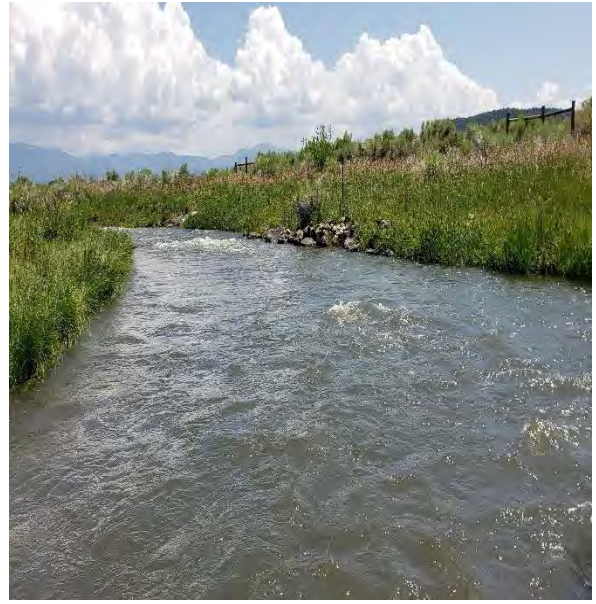
Figure 3-9 Culebra Creek, link no 3804, slow water habitat.

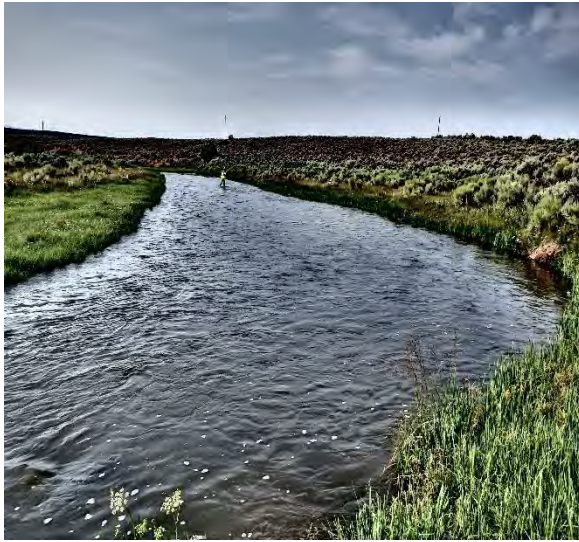
Figure 3-10 Culebra Creek, link no 3932, fast water habitat.

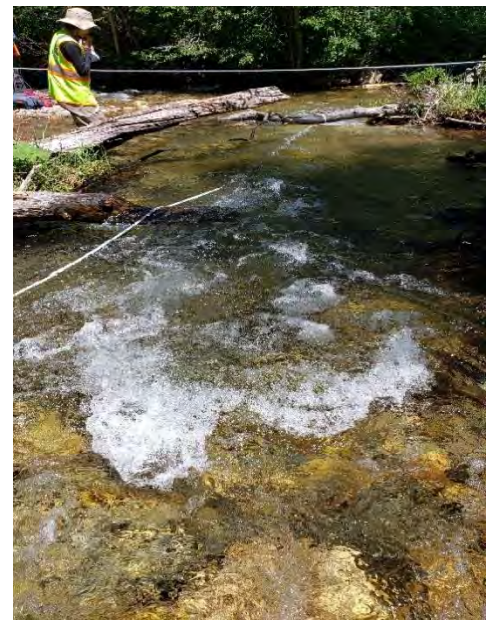
Figure 3-11 El Poso Creek, link no. 3476, slow water habitat.

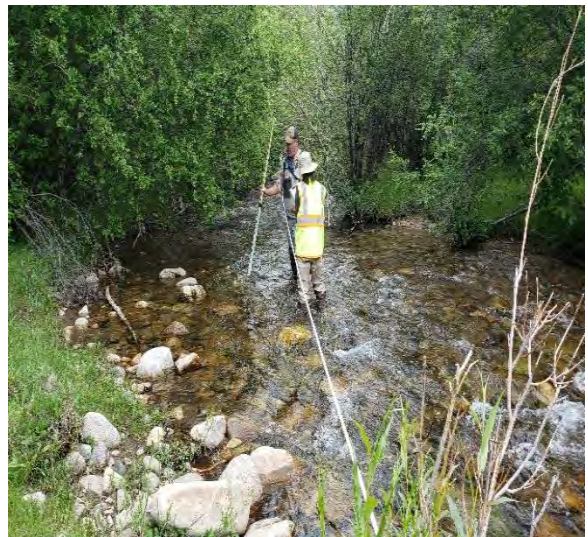
Figure 3-12 El Poso Creek, link no. 3532, fast water habitat.

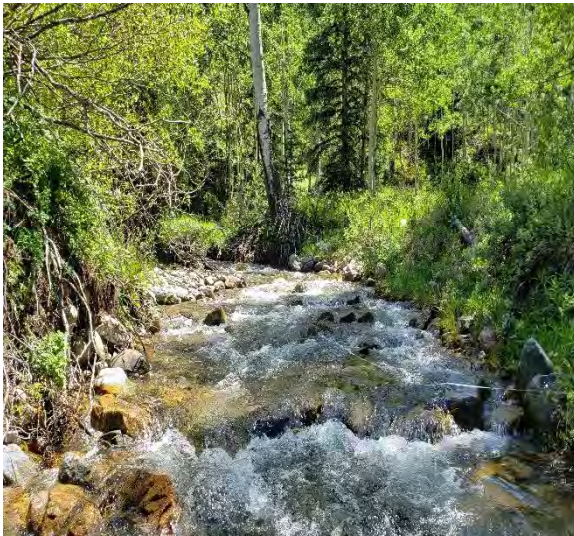
Figure 3-14 El Poso Creek, link no. 379, fast water habitat.

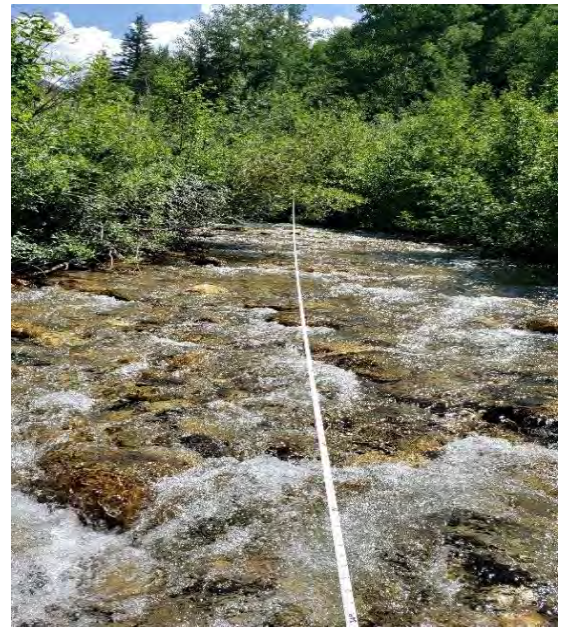
Figure 3-13 El Poso Creek, link no. 3500, fast water habitat.

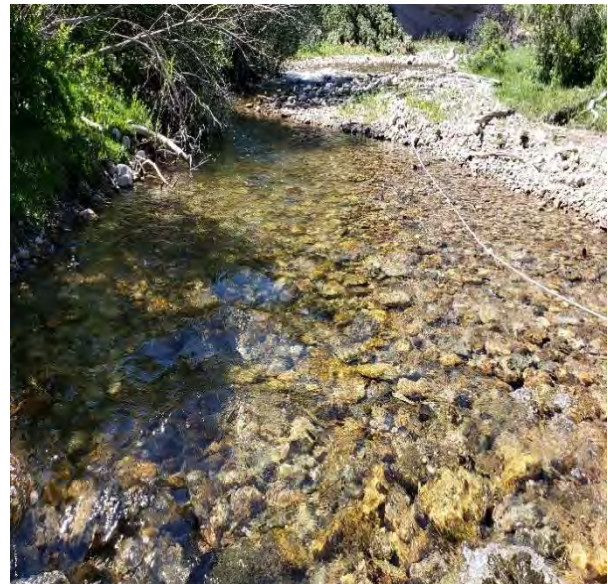
Figure 3-15 El Poso Creek, link no. 3508, slow water habitat.

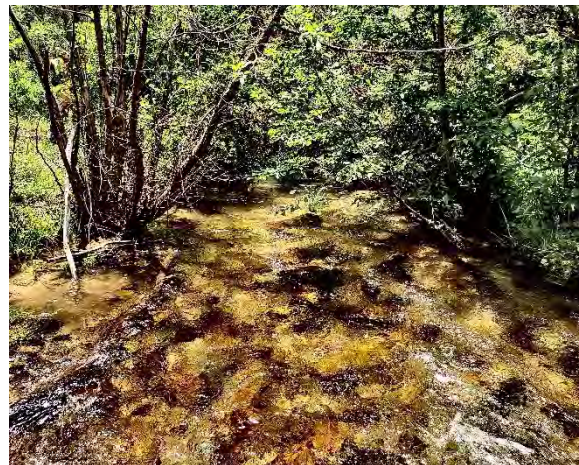
Figure 3-16 North Vallejos Creek, link no. 3180-U, slow water habitat.

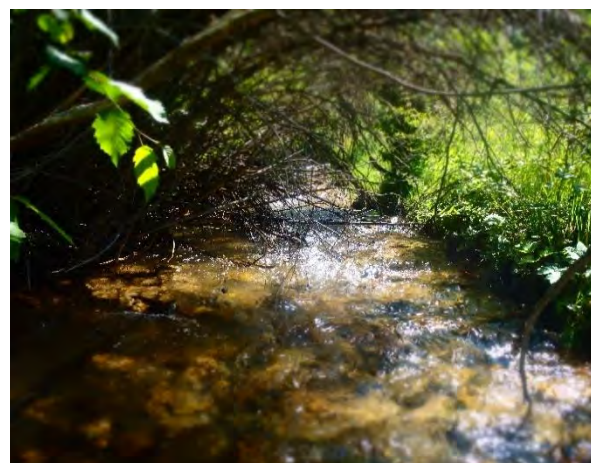
Figure 3-17 North Vallejos Creek, link no. 3180-D, fast water habitat unit.

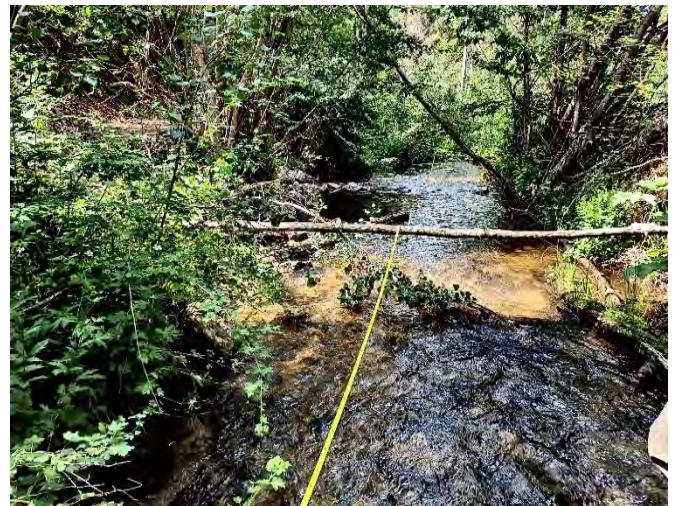
Figure 3-18 Rito Seco, link no. 315, fast water habitat unit.

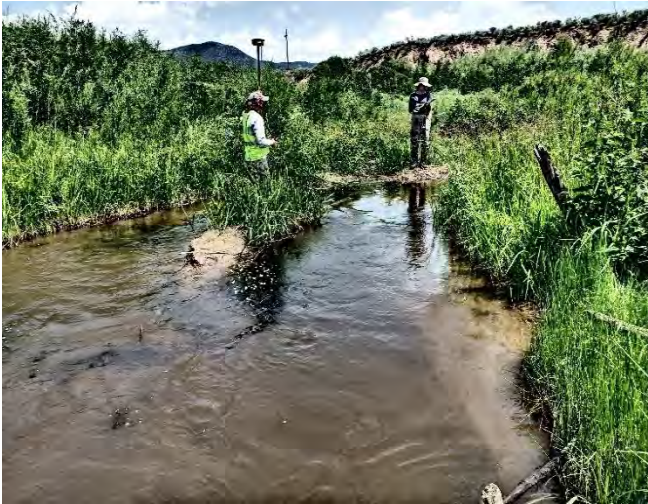
Figure 3-19 Rito Seco, link no. 3484, slow water habitat unit.

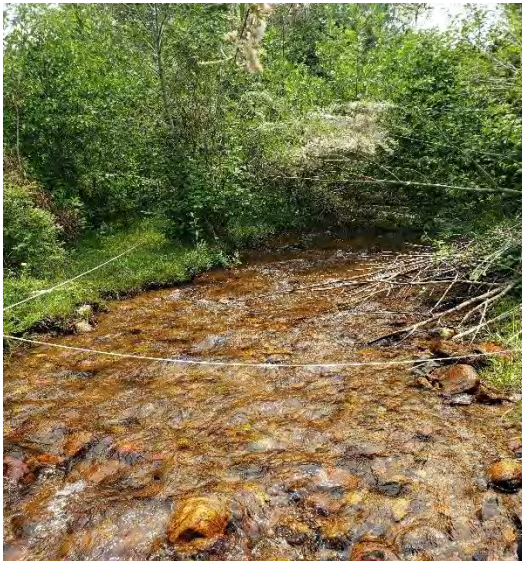
Figure 3-20 San Francisco Creek, link no. 925-D, fast water habitat unit.

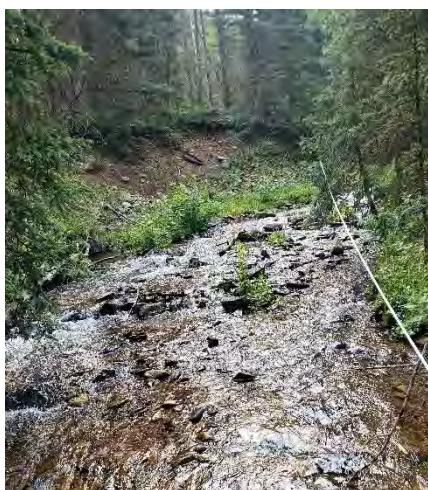
Figure 3-21 San Francisco Creek, link no. 925-U, fast water habitat unit.

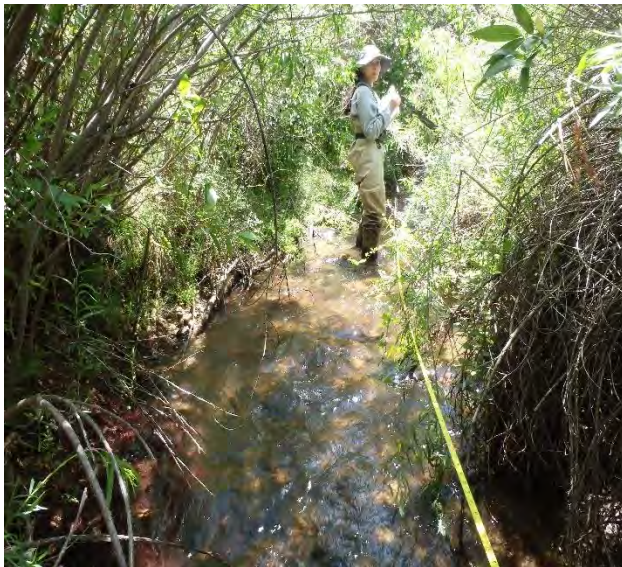
Figure 3-22 Vallejos Creek, link no. 1013, fast water habitat unit.

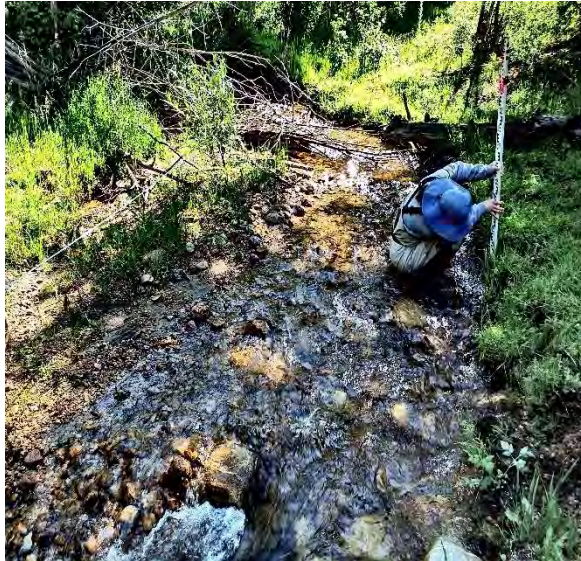
Figure 3-23 Vallejos Creek, link no. 933, fast water habitat unit.

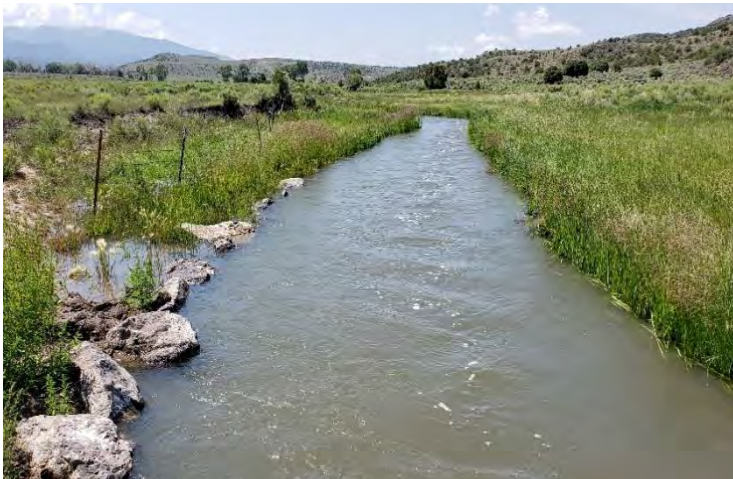
Figure 3-24 Ventero Creek, link no. 3732, fast water habitat unit.
