Upper Culebra Watershed Assessment Report

In Progress Draft

Prepared for Costilla County Conservancy District

Tailwater Limited

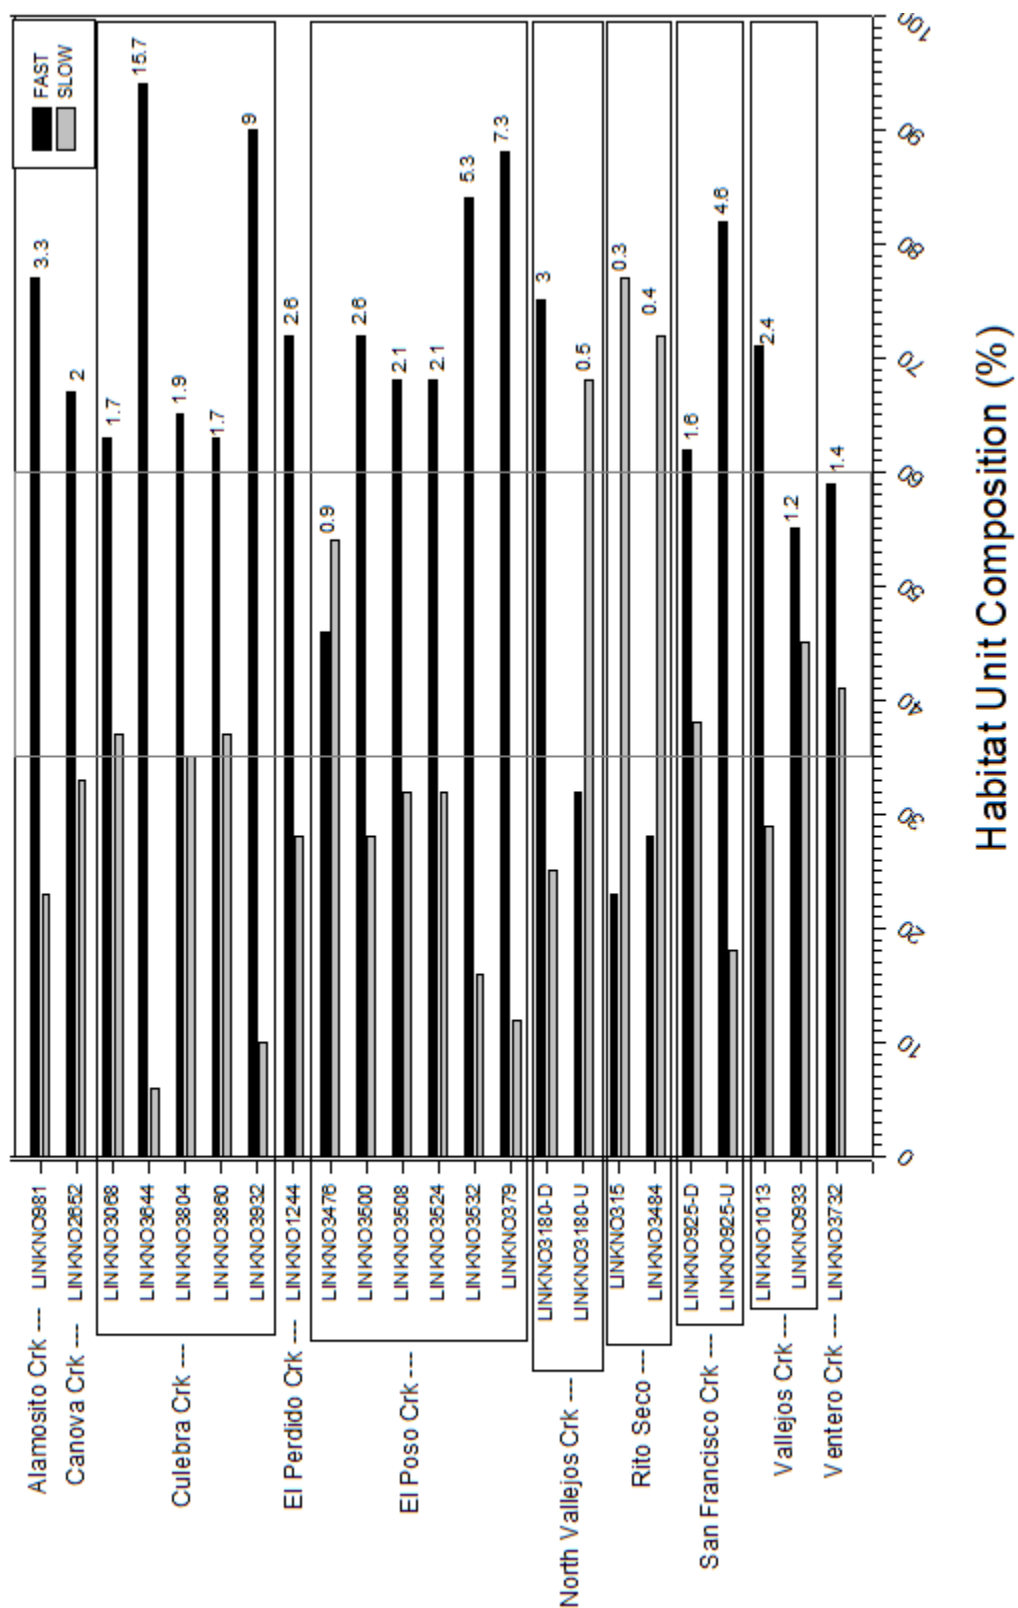
Figure 3-25. Habitat delineation. Fast and Slow habitat composition across Culebra Creek Watershed sites. Numbers on right of bars denote Riffle-Pool ratios. Lines at 35% and 60% denote pool habitat reference condition (Alves J. E., Patten, Brauch, & Jones, 2008).

None of the stream reaches surveyed met the 1:1 pool-riffle ratio criterion suggesting that in-stream restoration efforts could improve habitat availability and quality across the watershed. Of all channels surveyed, the uppermost reach at El Poso (LINKNO3476) was the closest to meet that criterion with a 0.9 ratio, followed by the upper Vallejos Creek site (LINKNO933) and Ventero Creek (LINKNO3732) with 1.2 and 1.4 ratios, respectively (Figure 3-25). The uppermost reach at El Poso, the upper reach at North Vallejos (LINKNO3180-U), and both reaches at Rito Seco (LINKNO0315, LINKNO3484) were the only reaches where pool habitat was predominant (Figure 3-25). At most channels surveyed, more fast water (riffle/run) habitat units than slow water (pool) habitat units were observed and the sites with the lowest proportion of pool habitat were observed at Culebra

Creek (LINKNO3644, LINKNO3932) and El Poso Creek (LINKNO379, LINKNO3532; Figure 3-25). Other sites where the proportion of pool habitats is suitable (between 35% and 60%) for cutthroat trout rearing habitats included the uppermost Culebra Creek reach (LINKNO3068), Culebra Creek LINKNO3860), and the lower reach at San Francisco Creek (LINKNO925-D; Figure 3-25). Mean residual pool depth varied across survey sites but was generally greater than 0.3m and appeared adequate to support fish during periods of low flow conditions (Kalb & Caldwell, 2014) (Harig & Fausch, 2002). Management efforts designed to reduce pool-to-riffle ratios, increase pool frequency, and increase pool depth could help improve habitat condition and function along the Culebra Creek Watershed.

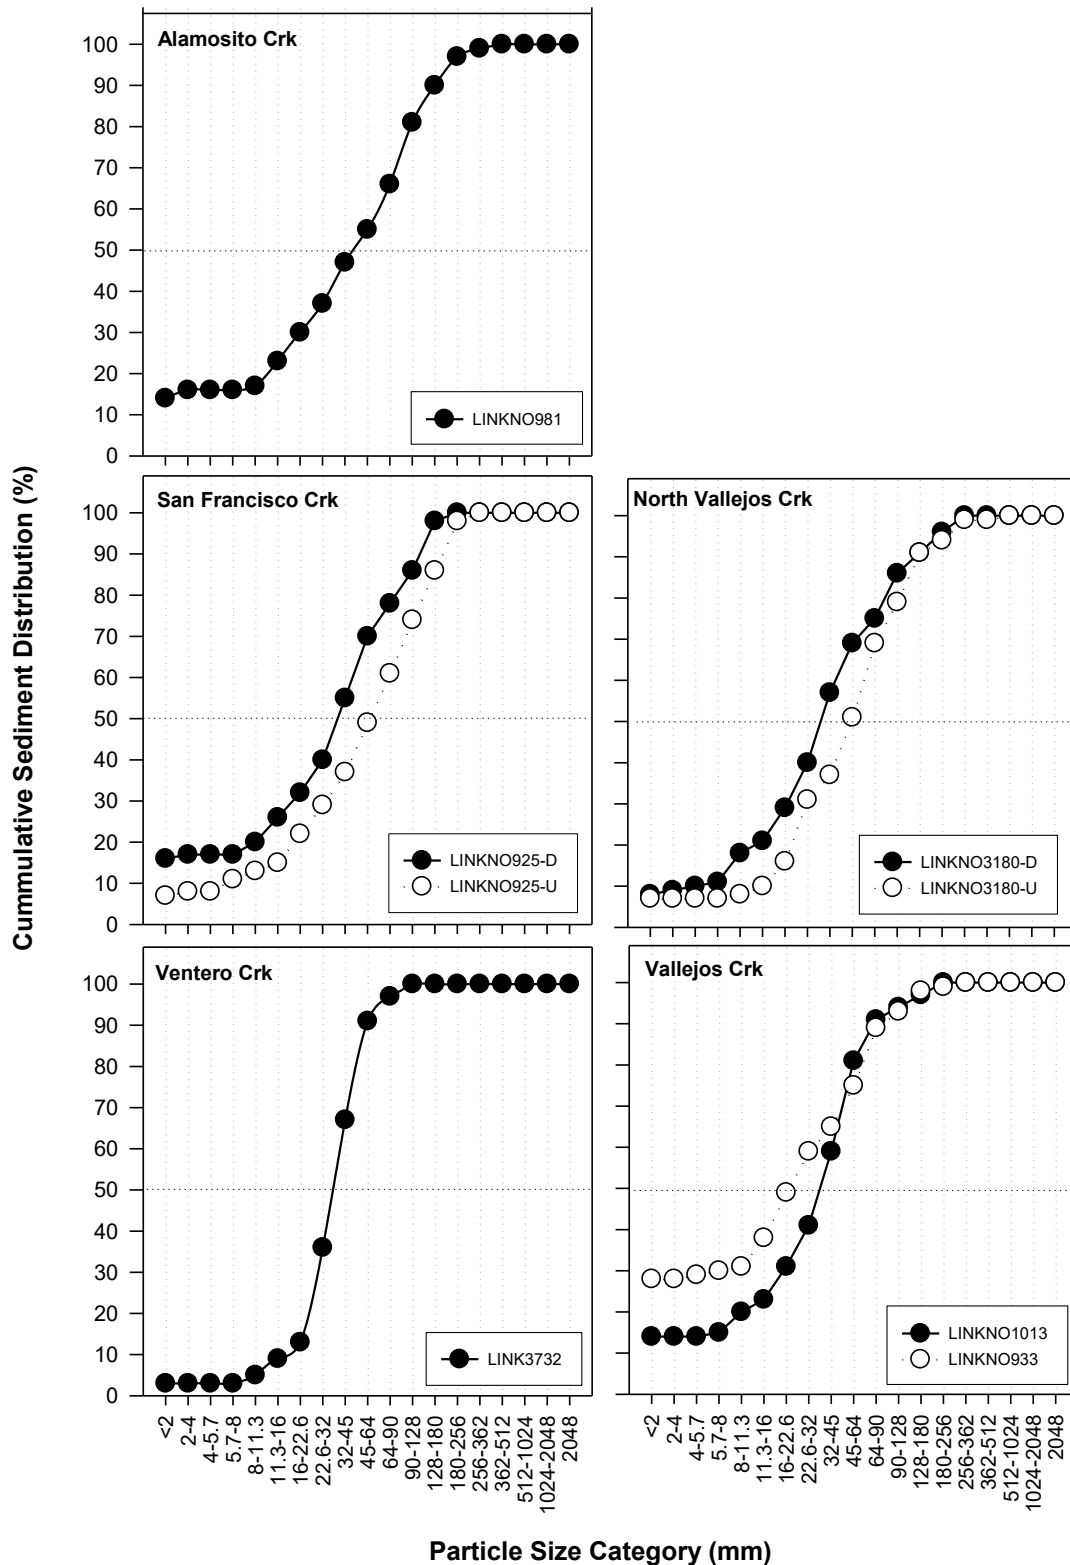
Median substrate size at the lower San Francisco site was very coarse gravel (32-45mm) and the median pebble size at the upper site was small cobble (90mm-128mm) at the upper site (Figure 3-27). Fine particles (<2mm) accounted for 16% and 7% of the substrate composition at the lower and upper sites, respectively (Figure 3-27).

The substrate composition at both Vallejos Creek sites was similar. Median substrate size at the lower site was very coarse gravel (32mm-45mm) and the median at the upper site was coarse gravel (22.6mm-32mm; Figure 3-27). However, the percentage of fine particles was higher at the upper site than at the lower site; 28% and 14%, respectively (Figure 3-27).

Figure 3-27. Cumulative sediment distribution at survey sites along Alamosito, San Francisco, Ventero, North Vallejos, and Vallejos creeks.

exceed 10% of total substrate (Alves J. E., Patten, Brauch, & Jones, 2008). Although spawning substrate occurs throughout the streams surveyed, a high proportion of fine sediment was observed at Alamosito Creek (LINKNO0981), Culebra Creek (LINKNO3068, LINKNO3860, LINKNO3932), San Francisco Creek (LINKNO0925-D), and both Vallejo Creek reaches (LINKNO1013, LINKNO933; Figure 3-27 and Figure 3-28), where high fine-sediments levels can limit fish embryo survival and emergence (Magee, McMahon, & Thurow, 1996) (Bjornn & Reiser, 1991).

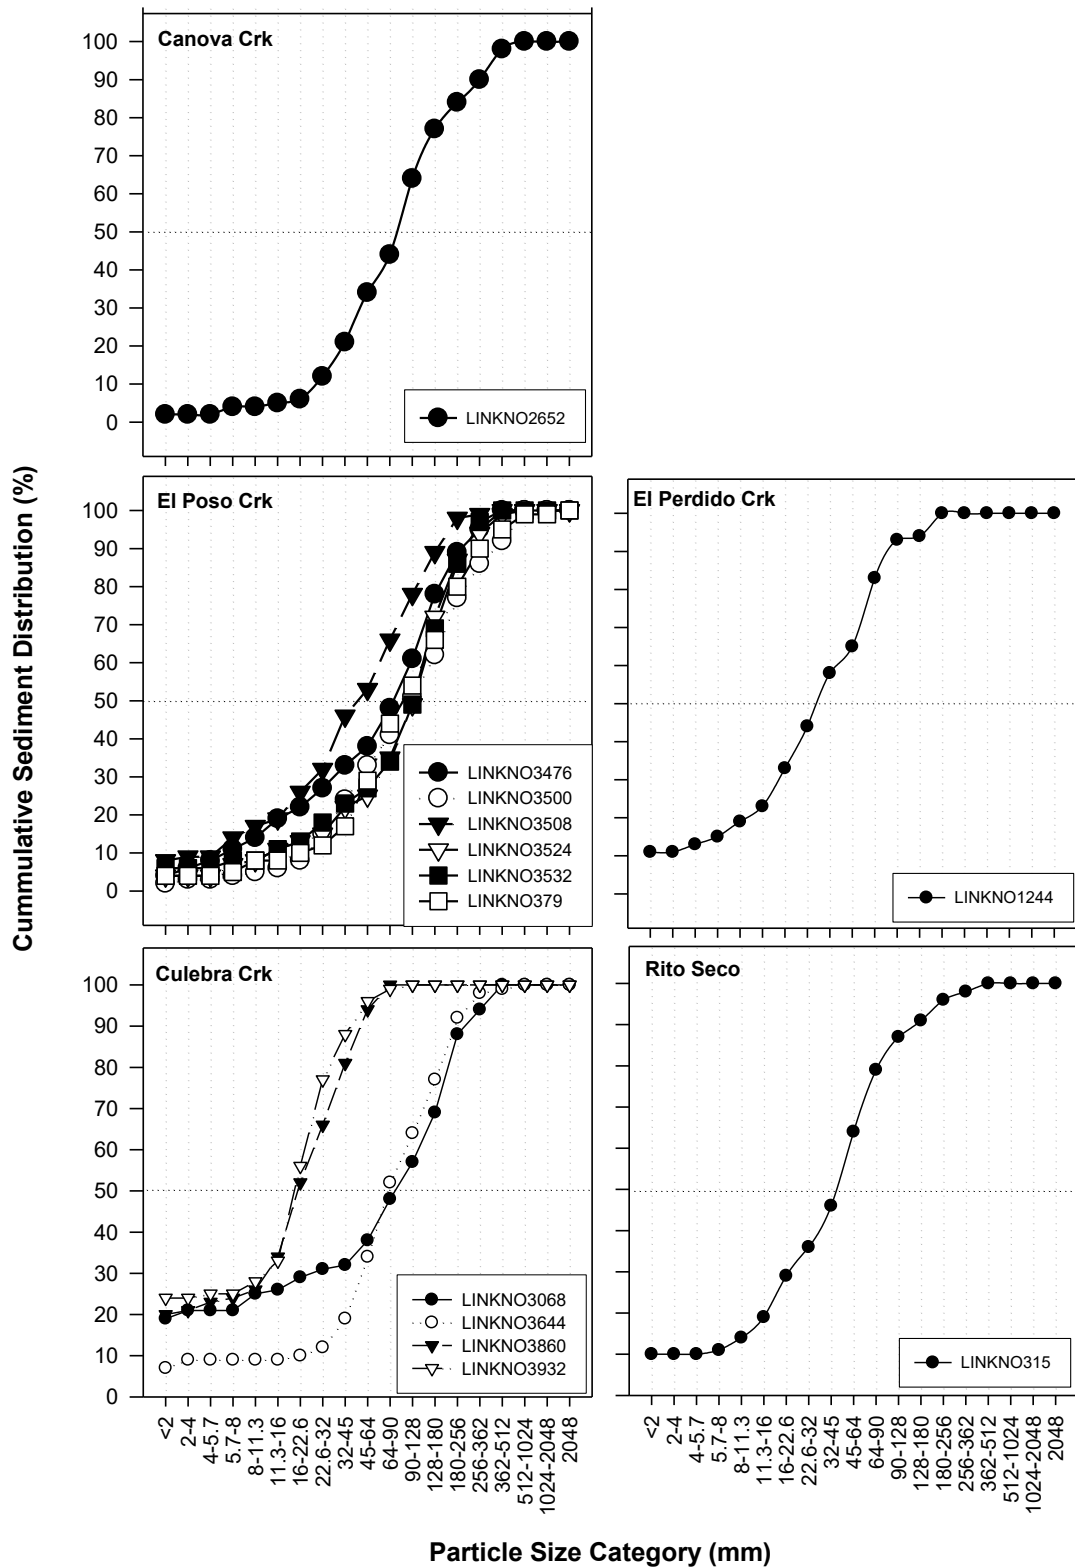
At the upper Rito Seco site, the median substrate size was very coarse gravel (45mm-64mm), and the percentage of fine sediment (<2mm) was 10% (Figure 3-28). A pebble count was not completed at the lower Rito Seco site, but fine substrate was predominant (sand-silt).

Figure 3-28. Cumulative sediment distribution at survey sites along Canova Creek, El Poso, Culebra, El Perdido, and Rito Seco creeks.

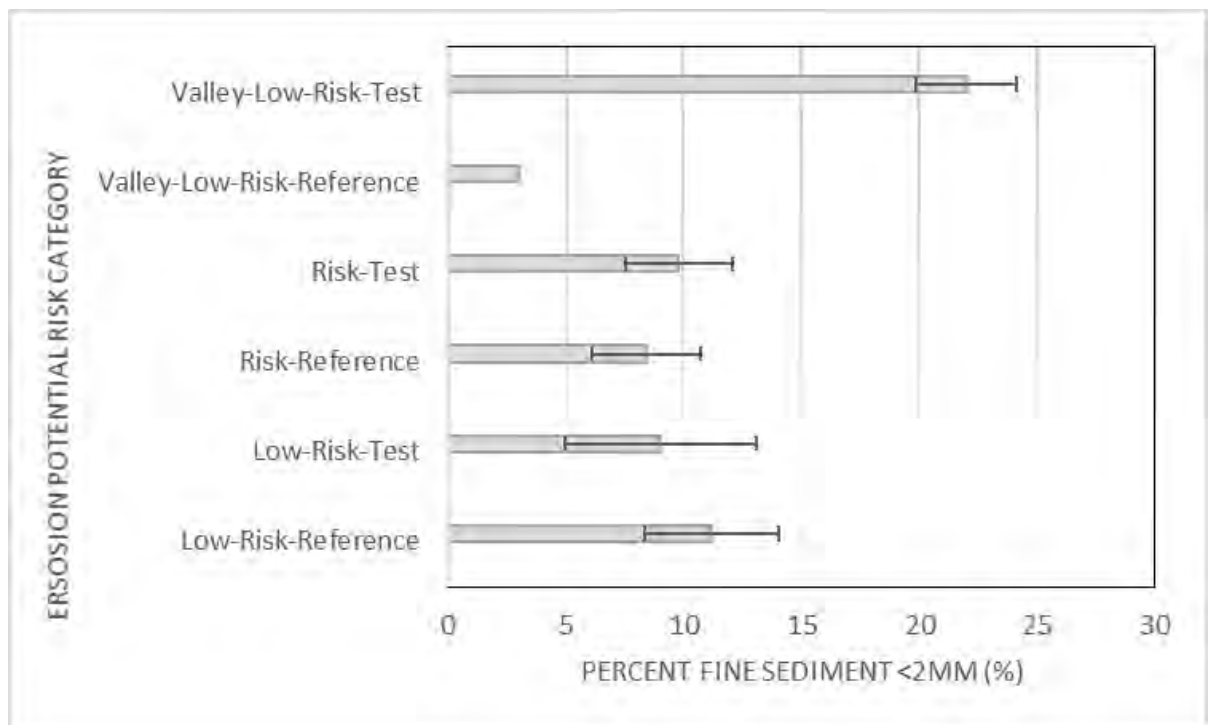
Figure 3-29 Summary of fine sediment (<2mm) in relation to erosion potential risk categories. Error bars denote standard error.

In general, differences in the amount of fine sediment between sites located in high and low risk erosion potential areas were not observed (Figure 3-27 to Figure 3-29). The only significant difference in percent fine sediment between reference (Ventero Creek LINKNO3732) and test sites (Culebra Creek LINKNO3804, LINKNO3860, LINKNO3932) was observed in low elevation, low risk sites in the valley. A pattern of high, fine sediment abundance consistent with erosion risk potential areas was not observed, suggesting that hillslope surface erosion is not the main source of fine sediment in stream channels. At low elevation and low gradient reaches, where erosion risk potential is low or moderate, such as the lower Rito Seco reach surveyed, road surface erosion is likely a source of fine sediment (typically <1-2 mm, sand and finer).

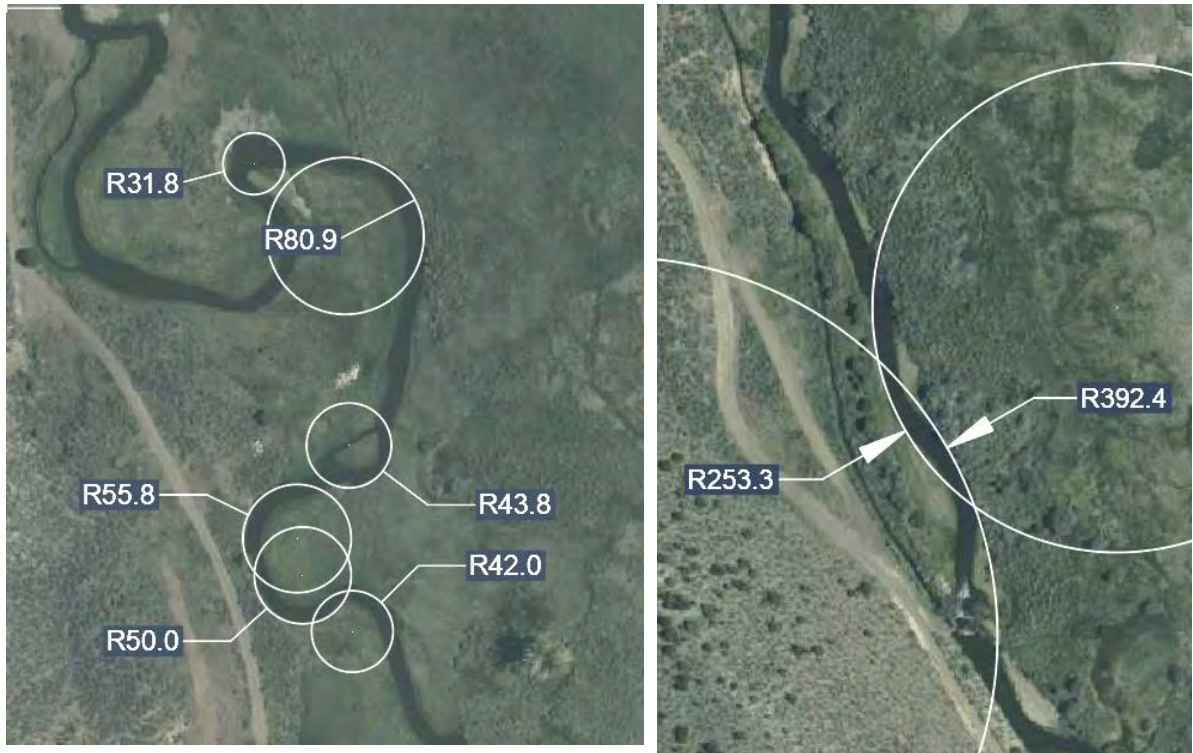
Figure 4-5 Example radius of curvature measurements from Ventero Creek above Culebra Creek near ventero202107150915, bankfull width 19.5-23 ft. Note the erosion near bend with 31.8 ft radius. Left photo upstream of straightened reach shown in right photo.

Ventero Creek (Ventero202107150915) is two miles upstream of the Ventero/Culebra Creek Confluence. The drainage area of the reach is 120 square miles. A longitudinal profile of water surface and thalweg and four cross-sections were measured at this reach. The measured reach has an average slope of 0.33%. The Rosgen Stream Classification for this reach is a C4 stream type. Desktop radius of curvature measurements are shown in Figure 4-5 for this site.

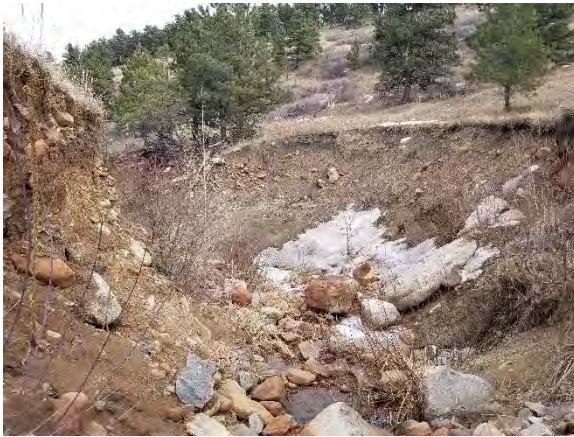
Figure 4-6 Example of gully erosion below stock pond in Colorado Rocky Mountains.

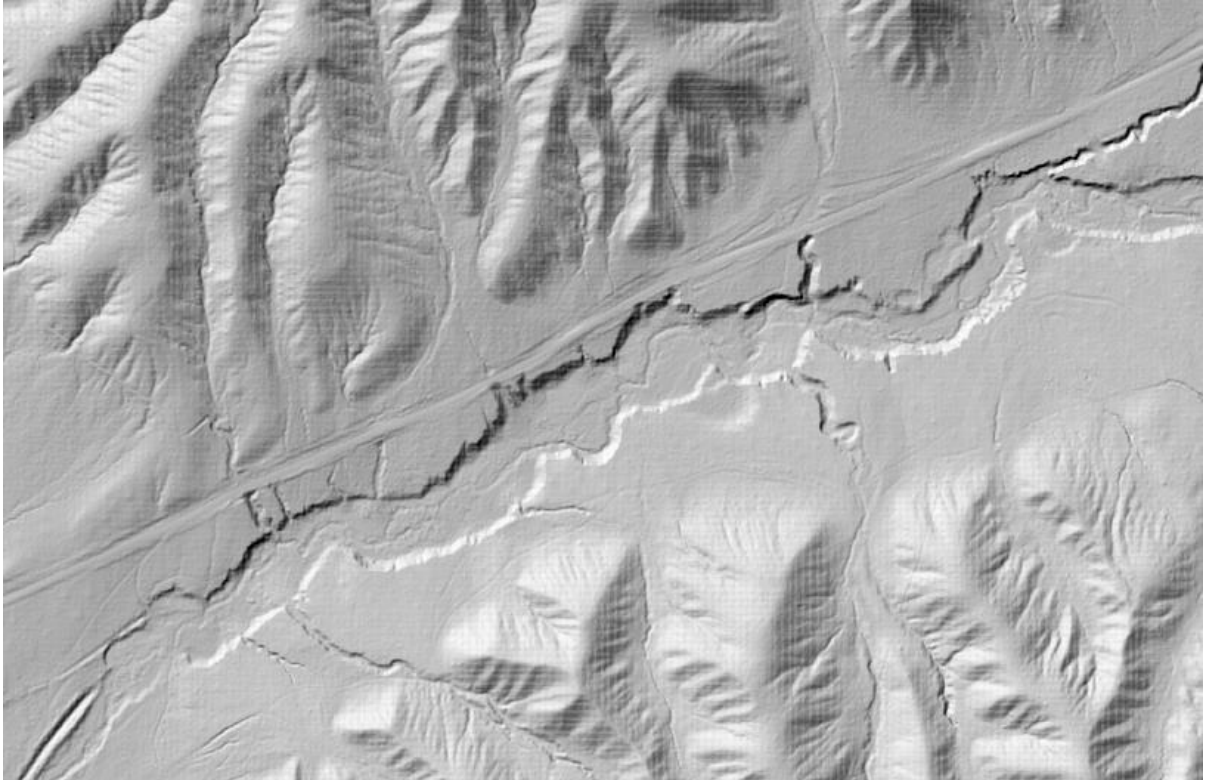
Hillshade visualizations can help identify instabilities, such as vertical banks, pattern inconsistencies, and places of aggradation and degradation. Hillshade visualizations of the digital elevation model were also used to identify areas of interest within the Culebra Basin. Figure 4-14 shows an example of hillshade visualization showing Rito Seco. Notice how easy it is to spot headcuts adjacent to the incised channel.

Figure 4-14 Hillshade visualization of Rito Seco. Notice headcuts feeding the channel and channel incision.

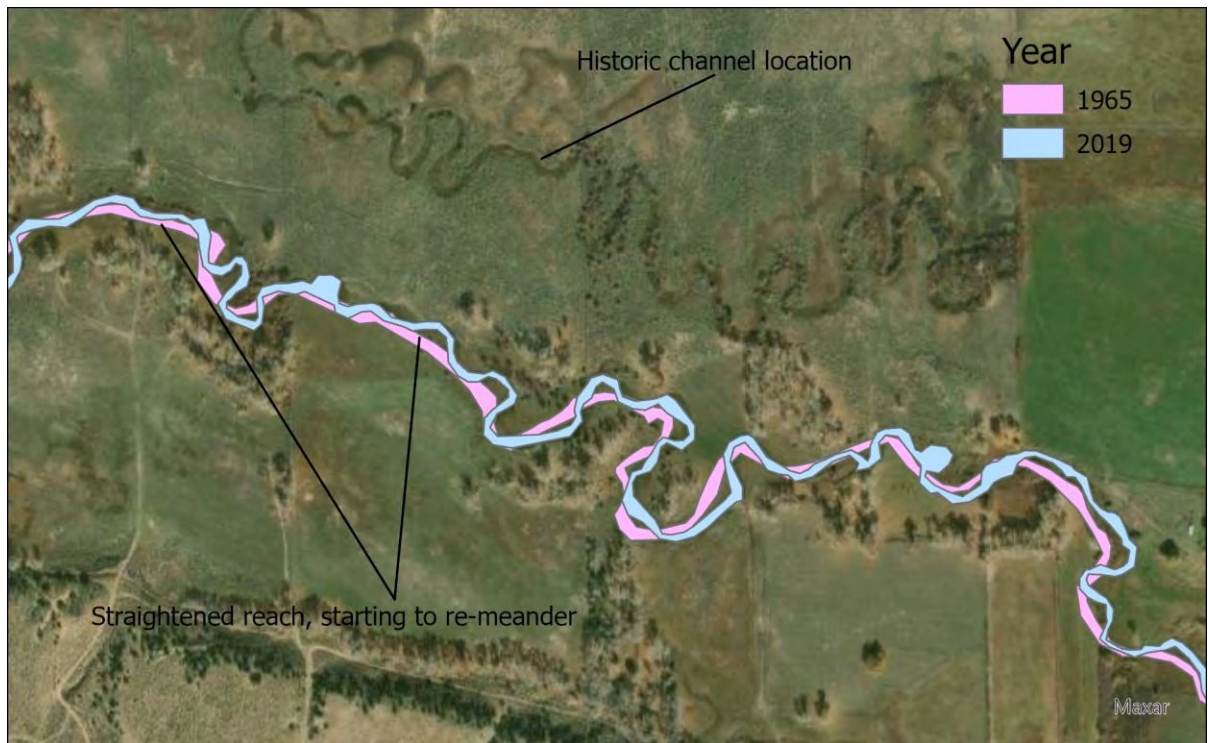
Overall review of Culebra Creek in the lower basin found potential issues with the channels pattern. The stream is channelized (Figure 4-18) and slightly entrenched in sections. Inspection of radius of curvature in aerial photographs throughout the stream was found to be both too small and too large to be sustainable throughout the reach. The meander bends with tighter radii are more likely to avulse over time. Meander bends that are too large are an indication of straightening which can result in accelerated bed and bank erosion, increased stream velocities, and decreased aquatic habitat.

Comparing 1965 aerial imagery with current conditions shows some minor changes in channel pattern below San Luis, highlighted in Figure 4-18. Comparison of the 1965 and current aerial imagery shows the landscape to be stable and no significant increases in development (Figure 4-19).

Figure 4-18 Lower Culebra Creek 1965 to present stream channel comparison.

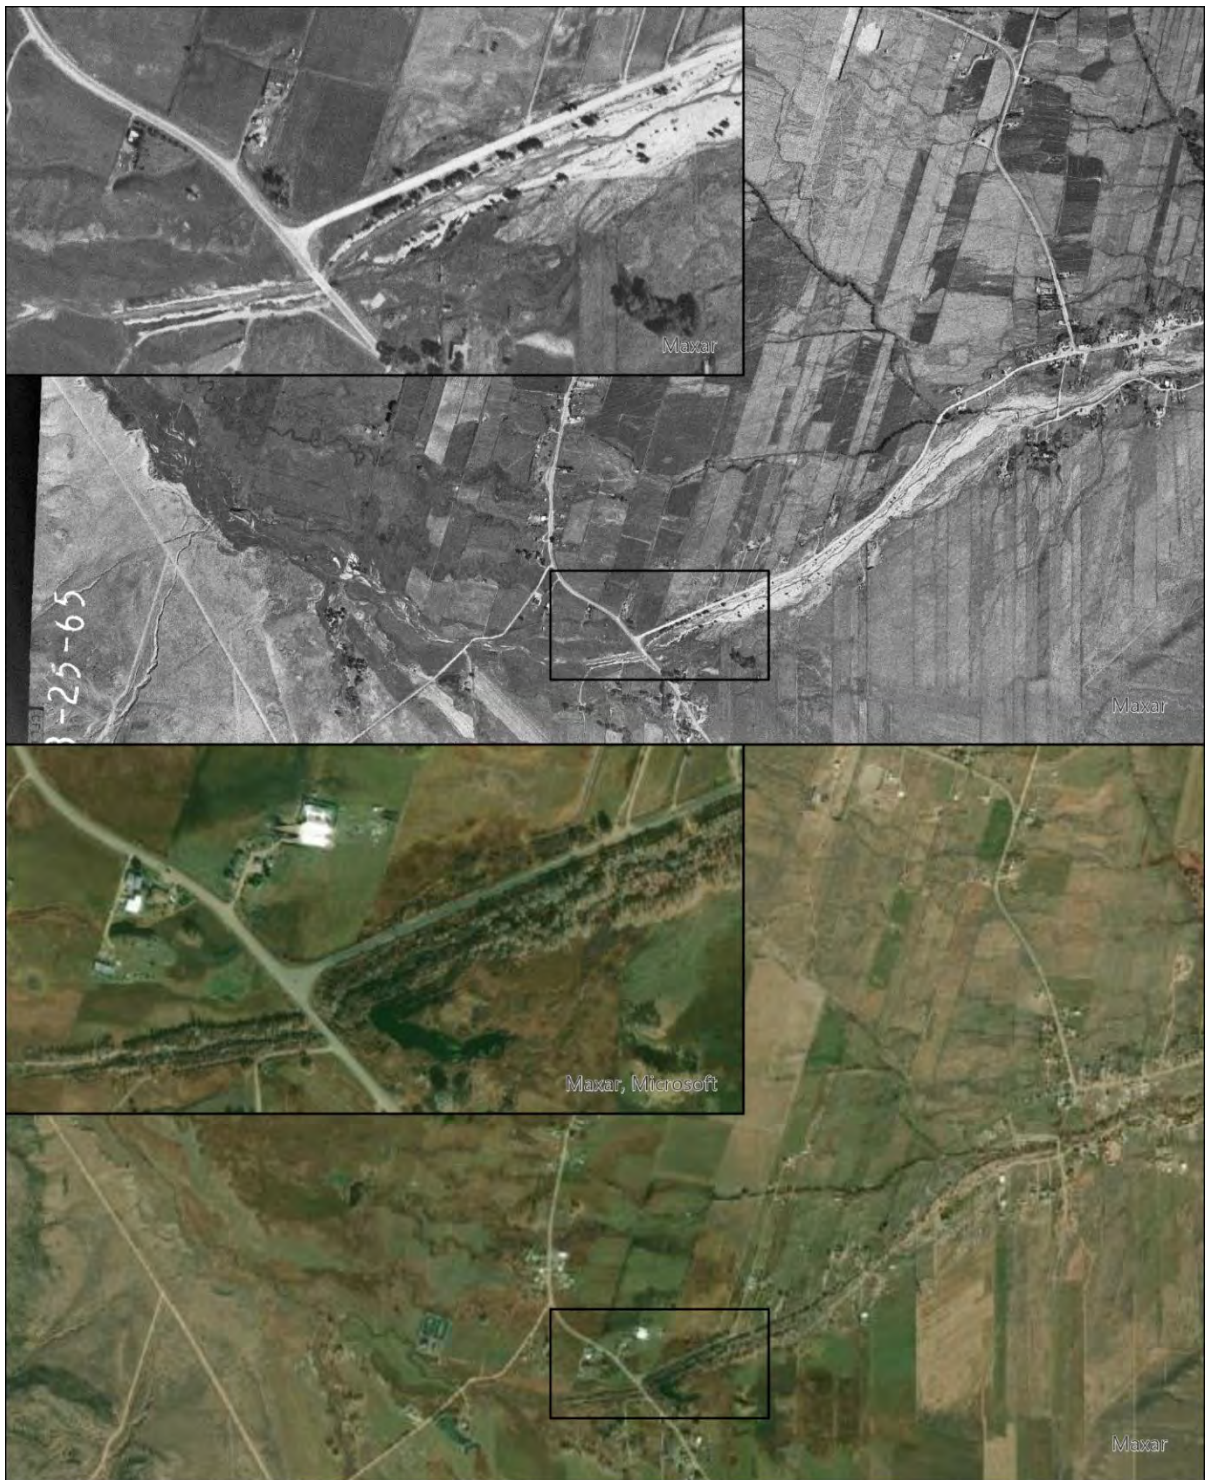
Moving upstream toward the confluence with Ventero Creek active aggradation is observed in Culebra Creek upstream of County Road 21 (Figure 4-20). Comparing the two time periods, the riparian vegetation is sparse in 1965 and has since grown. There is a change in the County Road 23.8 bridge and some increase in number of structures within this area. A wetland and pond are present in the current aerial photographs on the southeast corner of the County Road 21 and L.7 intersection that is not present in the 1965 aerial imagery. Sediment piles and channel pattern below County Road 21 suggest that the channel is being maintained and sediments actively being removed. In 1965 the channel upstream of County Road 21 would classify as a Rosgen Type “D” having a high width to depth ratio and no entrenchment. The levees present along the channel would classify as either a B or G stream type based on entrenchment and low sinuosity. Based on valley type and slope the reference stream type for this reach is a Type “C” stream with sinuosity greater than 1.2 and good access to the floodplain.

Figure 4-20 Culebra near confluence with Ventero Creek 1965 to current aerial review.

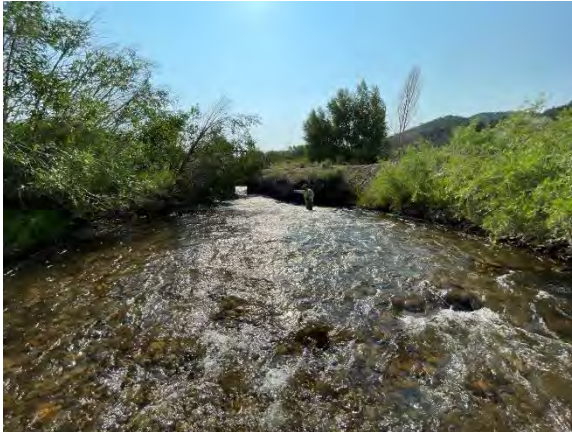
Figure 4-21 Culebra Creek (16) looking downstream towards the Sanchez Headgate.

Inspection of the aerial imagery revealed depositional areas upstream of the Sanchez Canal Diversion, and bank erosion. As is discussed further in Section 4.3.2.2, the width of Culebra Creek is reduced at the headgate (Figure 4-21). This is causing sediment to deposit or aggrade behind the structure. Bank erosion is seen upstream of the diversion, beyond the depositional area. The channel is

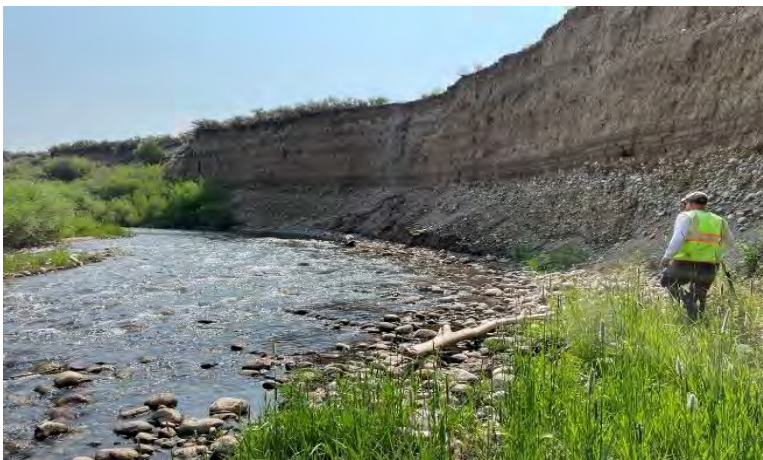
Figure 4-22 Culebra Creek (18) looking upstream towards high terrace cutbank, notice toe in middle of photo becoming saturated, this will eventually slough off into the river and the bank will continue to erode.

The assessment crew walked Culebra Creek (16) up through most of Culebra Creek (18). In Culebra Creek (18), Culebra Creek actively cuts into a high terrace (Figure 4-21 and Figure 4-24). The channel has been pushed to the edge of the valley to make room for agricultural fields.

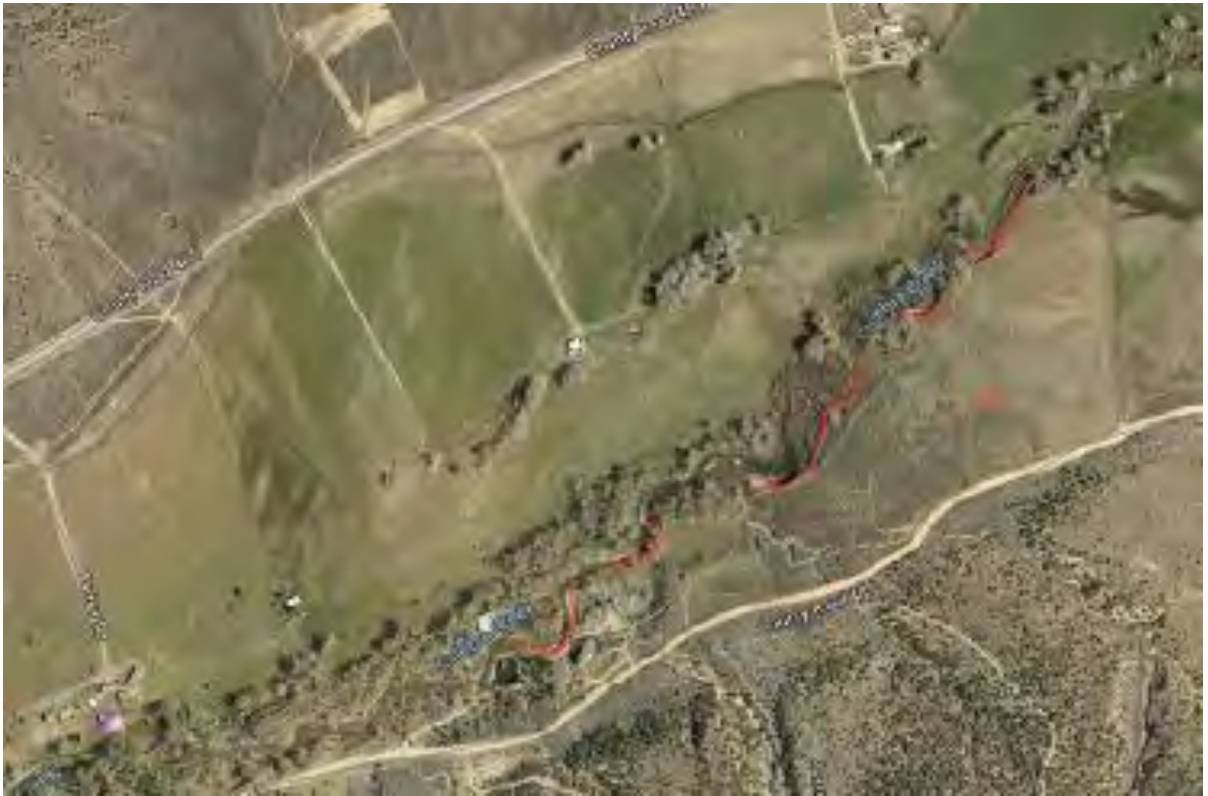
Figure 4-24 Areas where Culebra Creek is cutting into high terrace above Sanchez Canal.

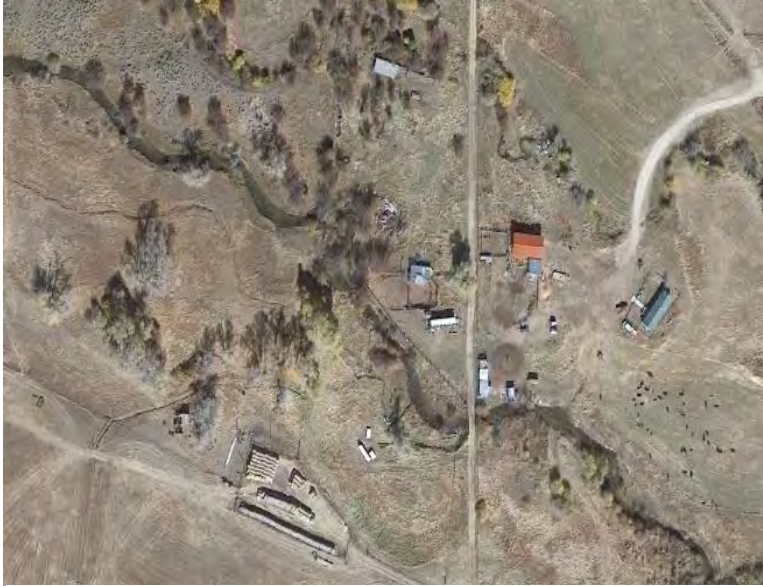
Figure 4-26 Google Earth screen capture of Culebra Creek (8) notice tight radius of curvature in the channel pattern near middle of photo to the left of the red roofed structure and in lower left-hand side of photo.

The channel appears to have been channelized in locations. There are at least two very tight radiuses of curvatures in the reach (Figure 4-26 and Figure 4-28). These are likely to avulse (chute cut-off), causing the channel length to become shorter, increasing the slope of the channel, and potentially causing the channel to incise. The current channel at the upstream profile in Figure 4-28 is approximately four feet lower than the current channel with a narrower floodplain corridor than the historic channel (Figure 4-29).

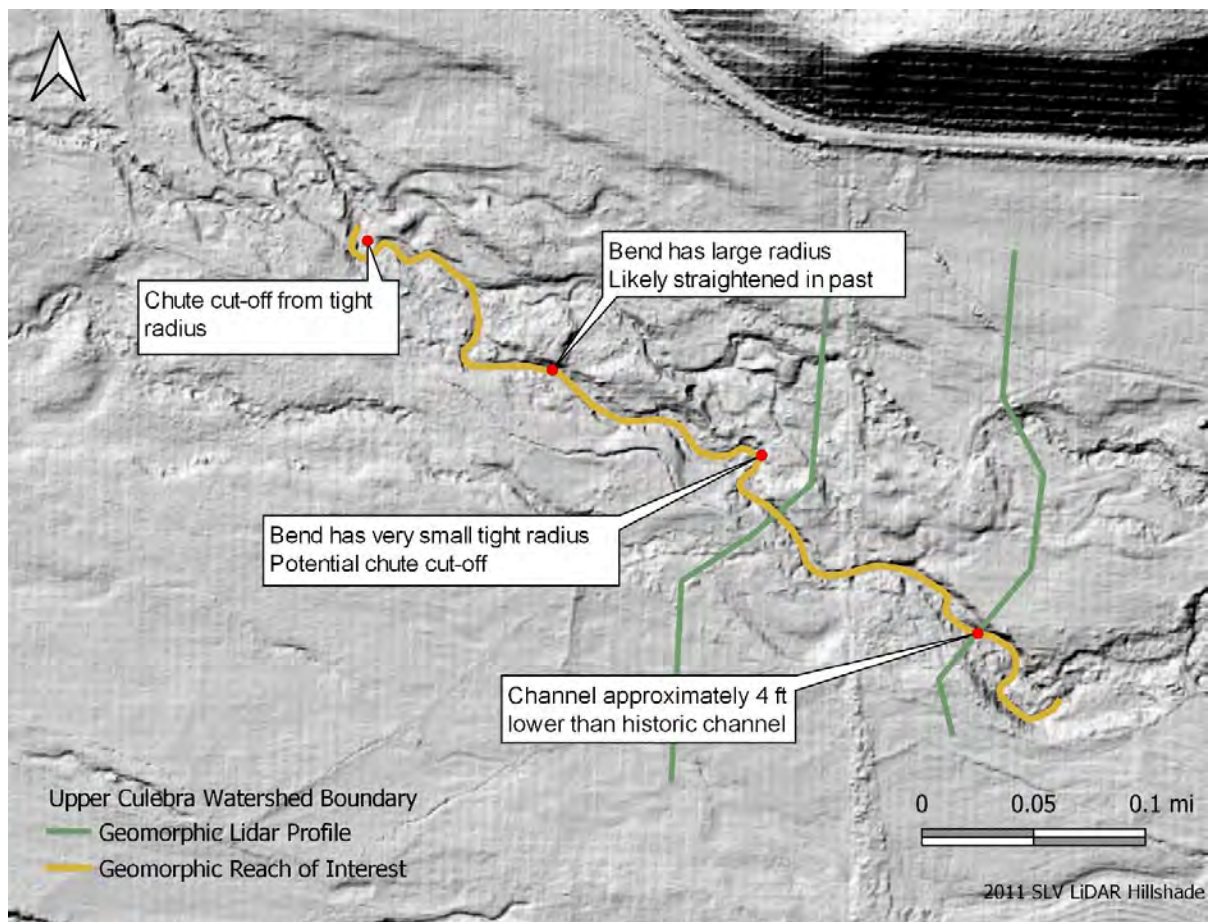
Figure 4-28 Overview of geomorphic observations in reach 8.

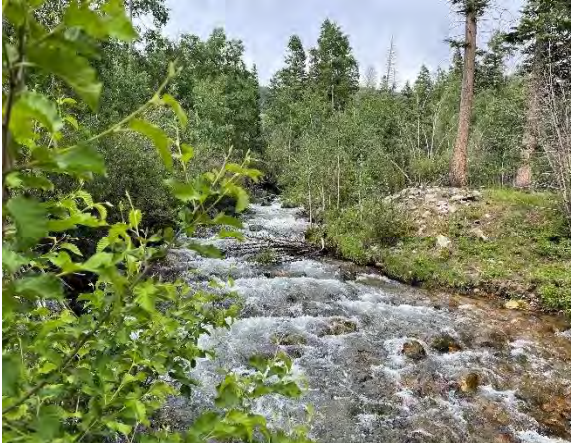
Figure 4-30 Culebra Creek (4). Steep section of Culebra Creek.

These reaches were identified because aerial imagery showed the presence of drops in the channel and bank erosion at Culebra Creek (reaches 3 and 4) (Figure 4-32). Riparian vegetation, especially at Culebra Creek (reach 3), is absent from these two reaches (Figure 4-30).

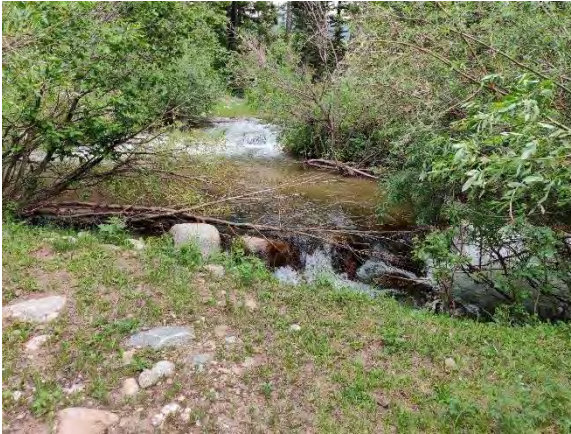
structures in the channel, shown in Figure 4-31. The channel upstream of these drops is likely to aggrade due to the reduction in channel slope, and large pools are likely to form below the structures resulting in potential structural failure.

Figure 4-31 Rock cross-vane with large drop.

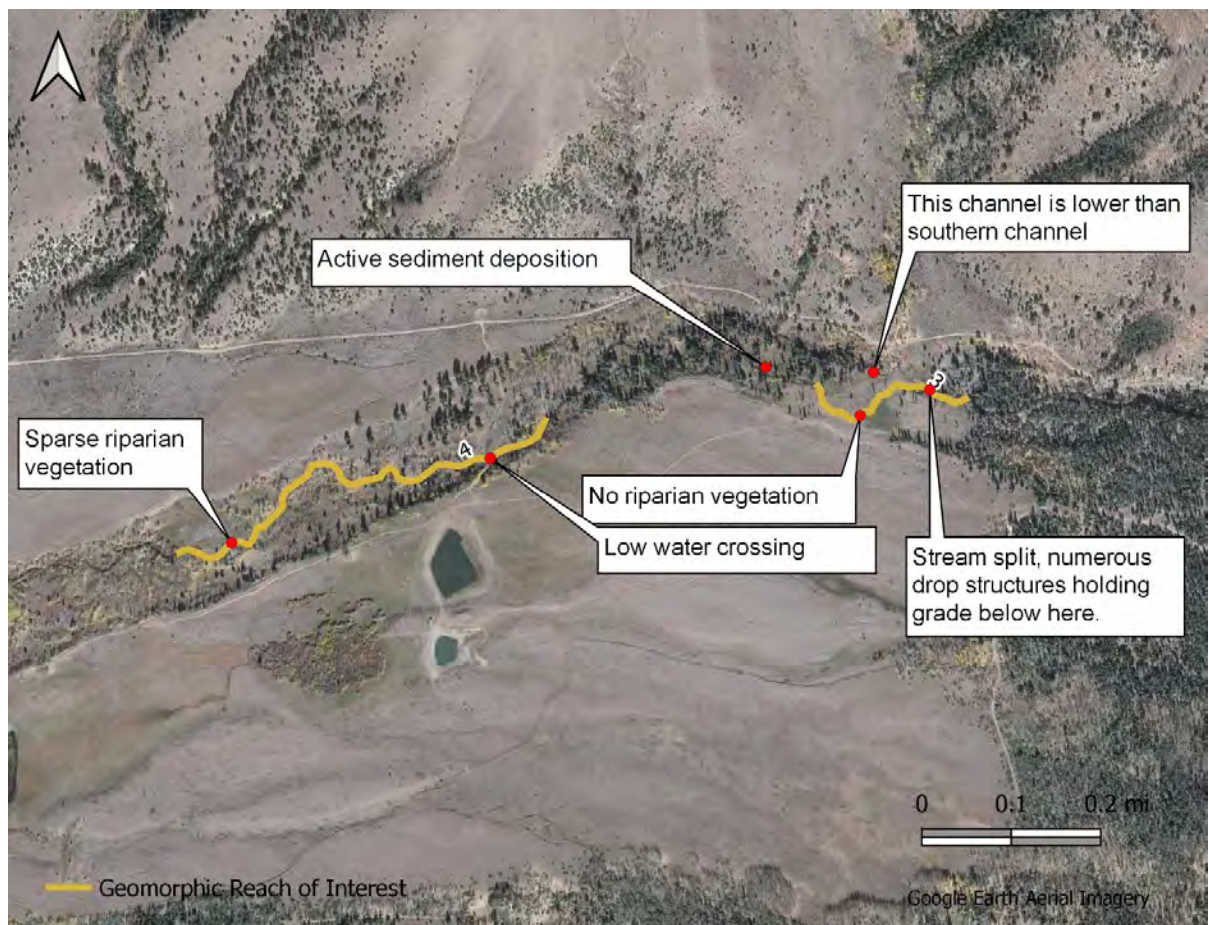
There is evidence of grazing in and around both reaches. Reach 3 is not aligned with lowest part of the valley which is north of the reach suggesting that the channel may have been moved in the past. This region is in a transition zone for the valley type as it expands. Due to this expansion of the valley and reduction in slope deposition would be expected as channel velocities decrease, especially on the floodplain as it widens.

Figure 4-33 Geomorphic observations from Culebra Creek reaches 3 and 4.

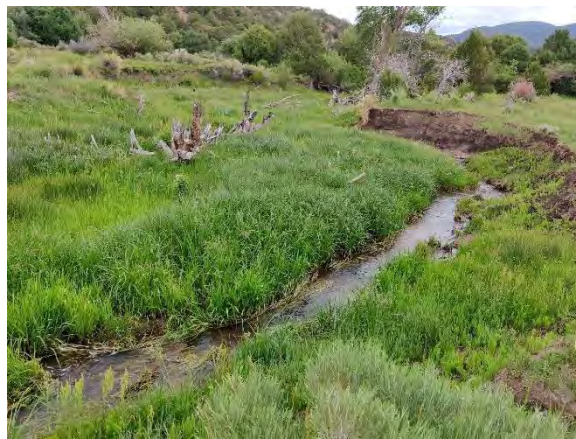
Figure 4-34 Jaroso Creek (2) notice developing floodplain adjacent to the channel and vertical bank in the background.

where the channel was straightened, areas where tight bends have formed in response to this straightening, cutbanks, and lack of vegetation. The pattern is unstable with radiuses of curvatures that are both too big and too small. The channel is widening its floodplain by cutting into the high terraces, creating cutbanks (Figure 4-34). Vegetation, especially woody shrubs, is noticeably absent from this reach. This reach is where the valley transitions from confined to unconfined. The area does not have structures and preserving this state will reduce fluvial hazards within the alluvial fan, especially in reach 20 and the areas upstream.

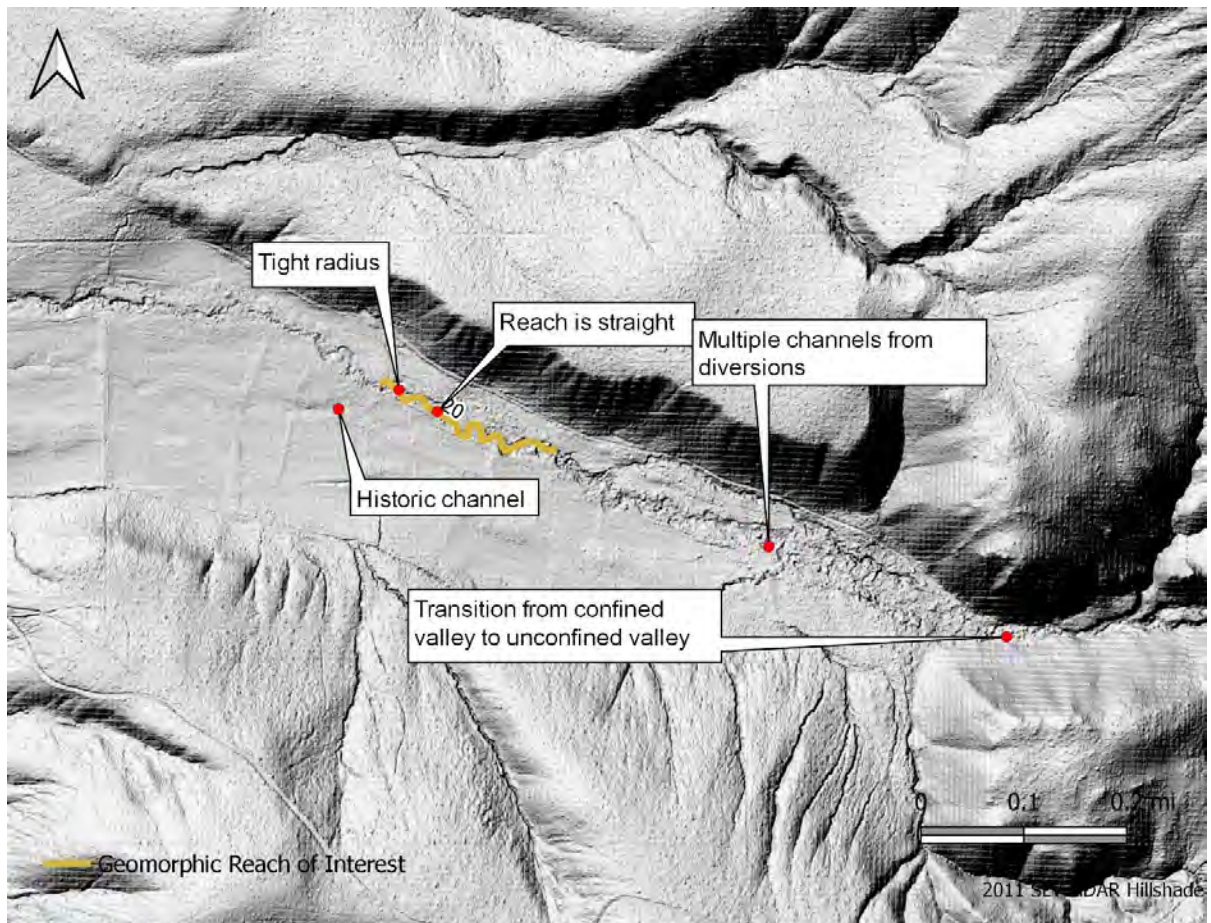
Figure 4-35 Jaroso Creek geomorphic reach 20 observations

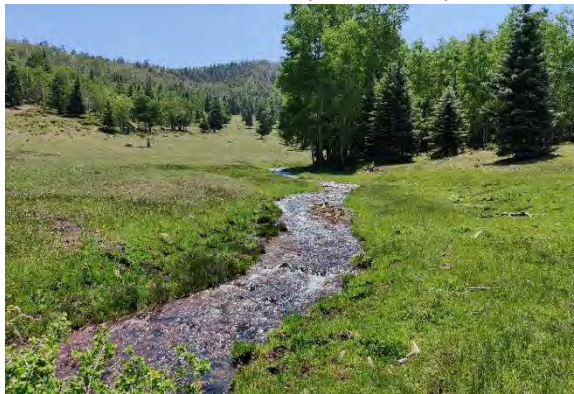
Figure 4-36 Jaroso Creek (13) notice lack of wood shrubs in riparian corridor.

Heavy grazing may be impacting the channel through these reaches (Figure 4-36) in addition to road crossings.

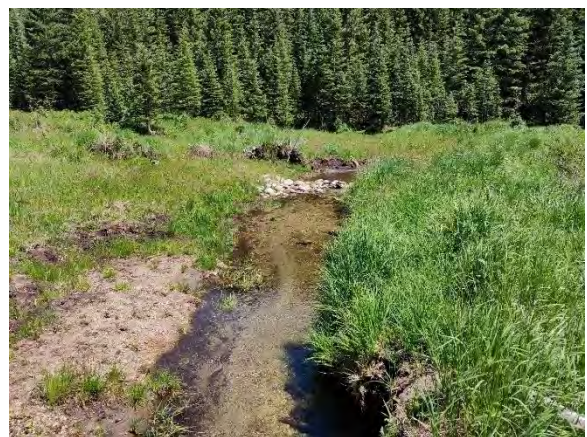
Figure 4-38 El Perdido Creek (1) notice channel incising through sediments.

A visual assessment of El Perdido Creek (1) was performed. The team noted that the meadow was a relic beaver complex during the site walk. There was deposited sediment throughout the valley within the meadow. Relic channels, dams, and ponds were observed throughout the meadow in this area. The current channel was cutting down through the sediments (Figure 4-38). There may still be beaver activity present through this meadow. While this area showed bank erosion, it will stabilize and form a new meadow for grazing over time.

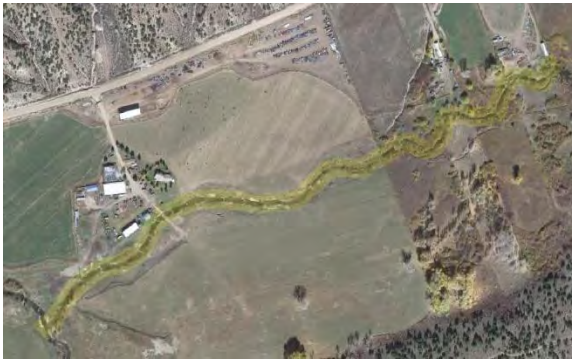
Figure 4-41 El Poso Creek (9) notice lack of vegetation and change in floodplain across property lines. Yellow highlight is reach.

A review of aerial imagery indicated bank erosion, potential issues with channel pattern, and lack of vegetation through El Poso Creek Reach 9 (Figure 4-42). The confluence of this reach and Culebra creek has the flows of El Poso creek flowing perpendicular to the flow in Culebra Creek. As noted by boulder structures, a river restoration project has been constructed on this property. The channel through the downstream end of this reach appears to be overwide and channelized in sections. The reach measurement shows the channel thalweg to be approximately 5.5 feet

In contrast, the channel thalweg is approximately 3.5 feet below the adjacent fields in the upstream portion of the reach. Increasing the sinuosity, riparian planting, adjusting the channel to have proper dimensions in pattern, profile, and cross-section could improve the function of the channel. Reconnecting the channel with the historic floodplain could increase sub-irrigation and improve water availability later in the season.

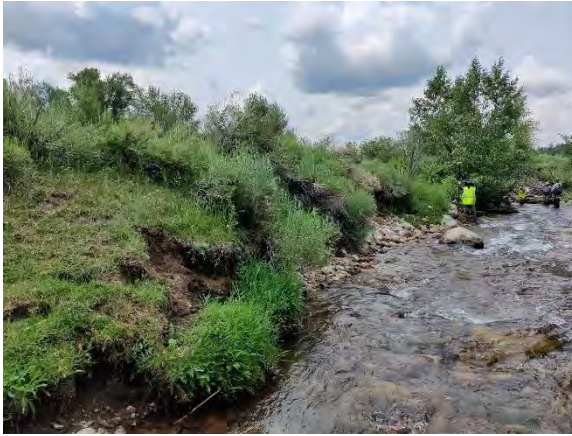
Figure 4-43 El Poso Creek (7) notice bank erosion on river left bank.

A review of aerial imagery of El Poso Creek (7) (Figure 4-44) identified cutbanks, potential issues with channel pattern, cutbanks, and an overwide low water crossing. This reach is below an actively degrading arroyo, supplying sediments to El Poso Creek. The tight radius of curvatures in the reach suggests a high likelihood of an avulsion occurring. Sections of the reach look channelized or straightened, which may be evidence of prior avulsions. The low water channel crossing is overwide and devoid of vegetation. Noticeable cutbanks are occurring within the reach and bars are forming.

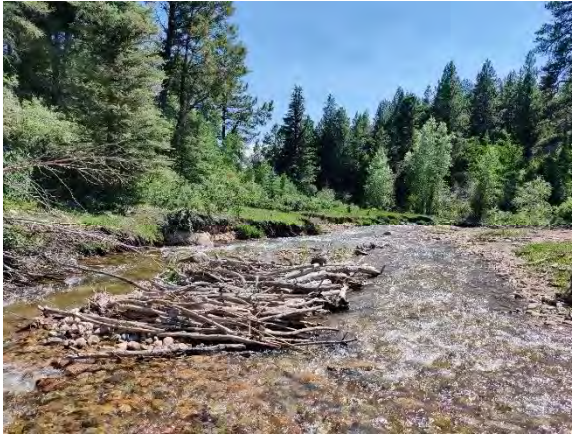
Figure 4-45 El Poso Creek (6) notice vertical banks river left.

A review of aerial imagery of El Poso Creek (6) (Figure 4-46) revealed the presence of cutbanks and signs of aggradation throughout the reach. The channel through this section is over wide in places (Figure 4-45). The channel is cutting into a high terrace at the downstream end and is becoming entrenched in segments. Evidence of grazing and impacts to riparian vegetation is apparent throughout the reach.

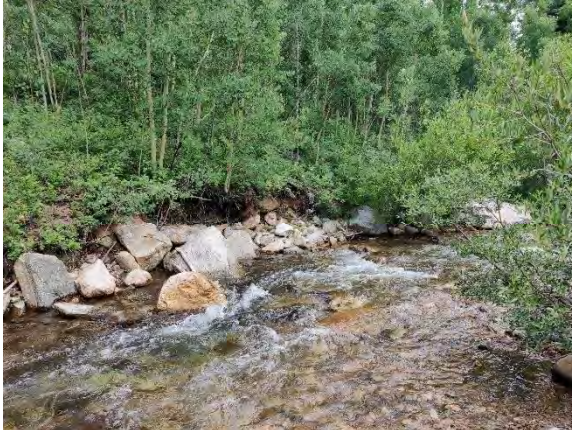
Figure 4-47 El Poso Creek (5) notice bank erosion occurring on river right.

A review of aerial imagery of El Poso Creek (5) (Figure 4-48) revealed the presence of cutbanks and signs of aggradation in the reach. The reach starts just upstream of houses near the channel. In front of the houses, it looks like channel work has been completed. Channel work looks to have created big drops and large pool in and near the homes. Bank erosion was observed within the reach (Figure 4-47) and the channel is aggrading behind the big drops in the reach.
