Upper Culebra Watershed Assessment Report

In Progress Draft

Prepared for Costilla County Conservancy District

Tailwater Limited

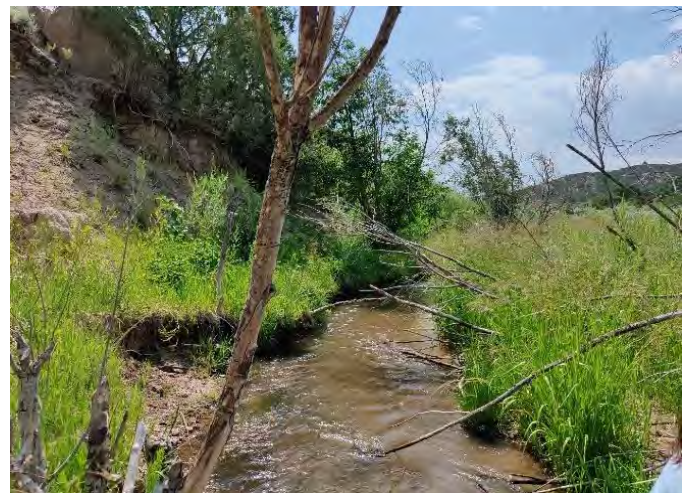
The channel is widening its floodplain and becoming more stable at the new elevation (Figure 4-51). Riparian vegetation is filling in, and beavers have been impacting the channel.

Figure 4-51 Rito Seco (19) notice channel cutting into high terrace, left side of photo.

Drainages feeding Rito Seco through this section create gullies, as those channels adjust to the new base elevation. Rito Seco road through this reach is at risk because of the head cuts occurring within the gullies and the bank erosion cutting into the terrace along the main channel. The reach ends just upstream of a historic dike that traverses the valley.

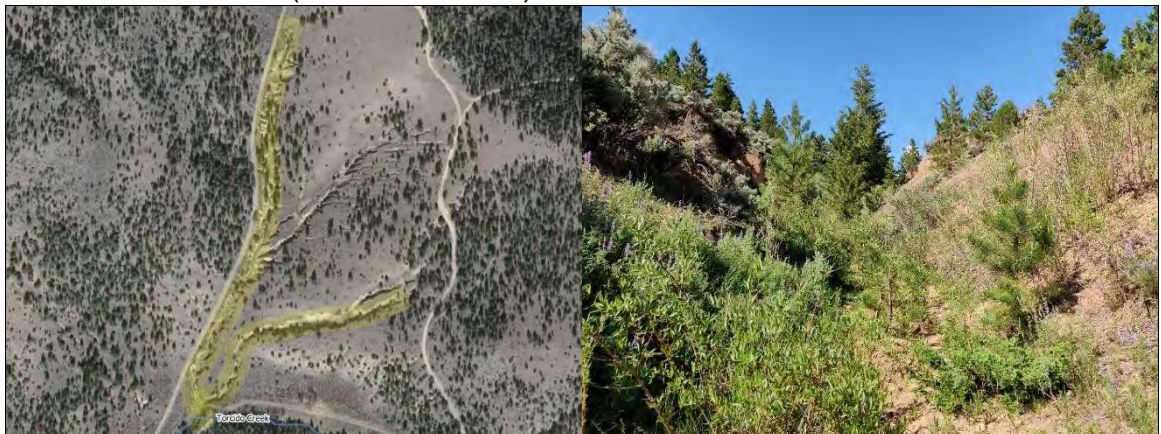
Figure 4-53 Left Torcido (11 and 12) Aerial view of headcuts forming above Torcido Creek. Right view from the ground Torcido (11 and 12) notice vegetation filling in the gully.

A review of aerial imagery identified two large headcuts/gullies forming above Torcido Creek (Figure 4-53, left). There are headcuts in the foothills near where the mountains meet the valley throughout the Culebra Basin. The headcuts appear to be stabilizing, and vegetation

is starting to fill in the gullies and stabilize the banks (Figure 33, right). There was evidence of grazing and cattle trails in and around these headcuts.

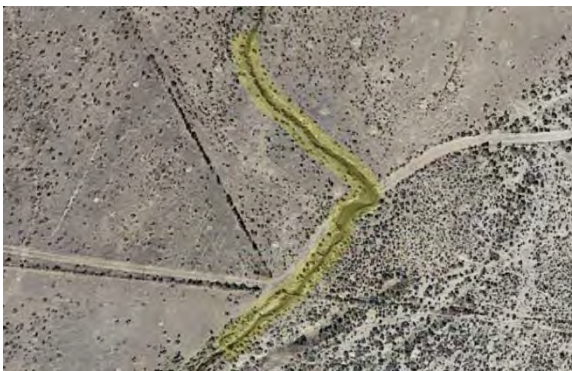
Figure 4-56 Historic alluvial channel Rito Seco drainage (23) notice channel pattern and interaction with other ditches/canals/and channels.

Reach 23 is a historic alluvial channel in the Rito Seco Basin. This reach showed tight radius of curvatures and vertical banks. This area has ditches/canals/and channels coming together (Figure 4-56).

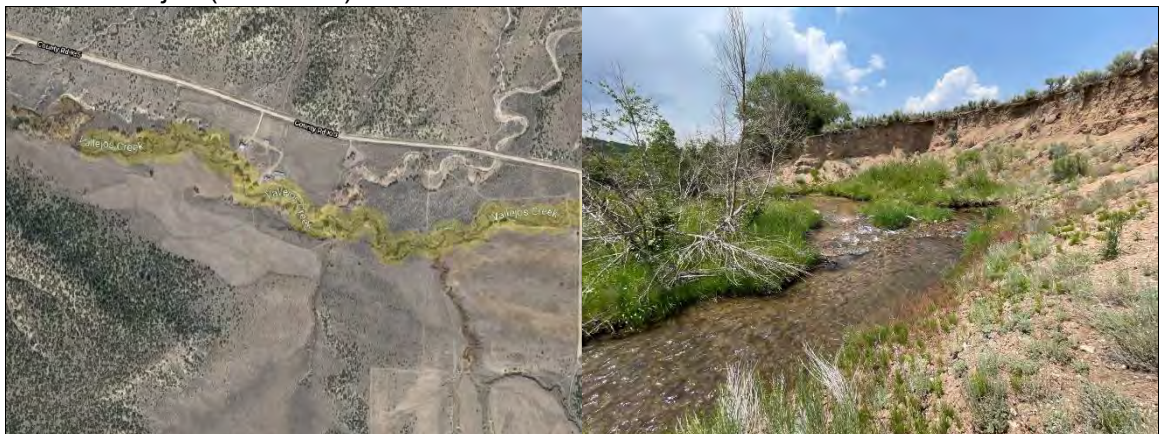
Figure 4-58 Left aerial view of Vallejos (14) notice pattern and gullies contributing to the reach. Right Vallejos (14) notice channel cutting into high terrace.

A review of aerial imagery of Vallejos (14) (Figure 4-59) identified vertical banks, and channel pattern issues from the confluence of North Vallejos Creek and Vallejos Creek downstream 1.5 miles. The channel through this reach has radiuses of curvatures that are too big and too small. Gullies feed sediments into the channel through the reach (Figure 4-58, left). The channel appears to have been pushed up against a high terrace and is incised in places (Figure 4-58, right).

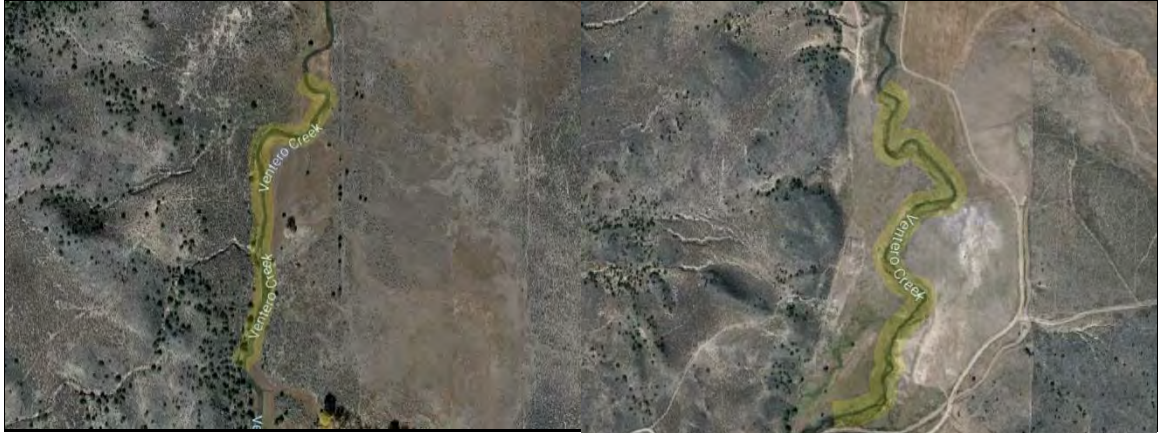
Figure 4-60 Left aerial view of Ventero Creek (21) notice channel pattern, channel appears to have been channelized. Right aerial view of Ventero (22) notice channel pattern.

A review of aerial imagery of Ventero (21 and 22) (Figure 4-61) revealed cutbanks, signs of aggradation, signs of entrenchment, and channel pattern issues occurring within the reach (Figure 4-60).

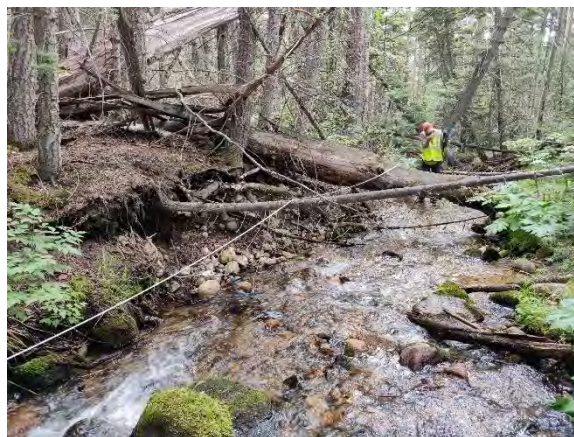
Bank erosion was observed on banks within the reach (Figure 4-64). Large wood in and around the channel corridor affects the channel's function. Log jams were observed on-site where smaller gravels and sands back up behind the debris jams.

Figure 4-64 Alamosito Creek Bank Erosion

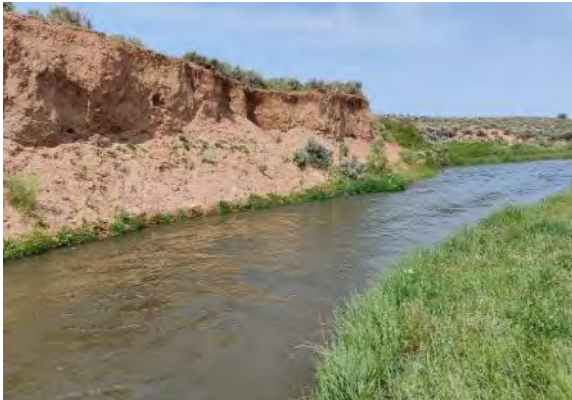
Figure 4-65 Culebra Creek (Culebra202107201100) bank erosion

As shown in Figure 4-65, bank erosion was observed within the surveyed reach. The floodplain within this reach is constricted by levees and/or high terraces, especially at the upstream and downstream ends (Figure 4-66). The channel has been channelized, or straightened, and pushed up against the high terrace. Sinuosity in the channel seems to be increasing towards the middle of the surveyed reach. To improve the function of the reach, reducing or removing floodplain constrictions could reduce erosion potential during high flows. Increasing the sinuosity of the channel will also reduce the slope of the channel. Overall, the channel has a good floodplain connection.

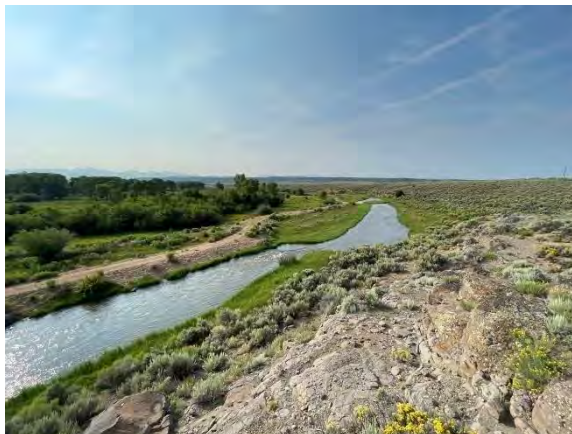
Figure 4-66 Culebra Creek looking upstream notice road/level on the right side of the picture and high terrace/rock outcrop on the left.

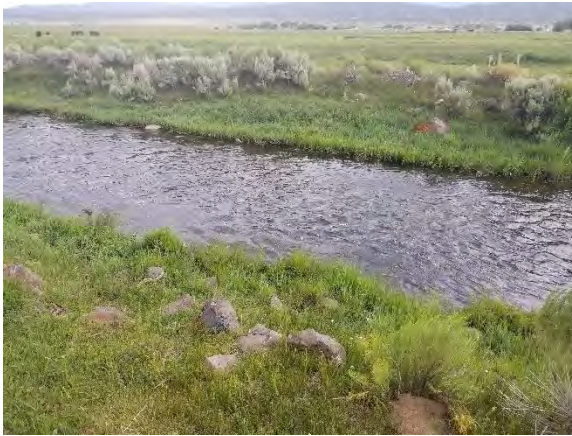
Figure 4-67 Culebra202107061515 channelized section of Culebra Creek.

Culebra Creek (Culebra202107061515) is just upstream, south, of County Road N8 near the stream gage Culebra Creek at San Luis. The drainage area of the reach is 248 square miles. Longitudinal profile of water surface and thalweg along with five cross-sections were measured at this reach. The measured reach has an average slope of 0.3%. The Rosgen Stream Classification for this reach is a C4 stream type.

The channel appears to have been straightened through the survey reach and is incising (Figure 4-67). Bank erosion and

channel instability were observed on-site. Woody shrubs and overhead cover are noticeably absent from this reach.

The function of this reach could be increased by adding sinuosity to the reach, while also adding more defined lateral scour pools and habitat.

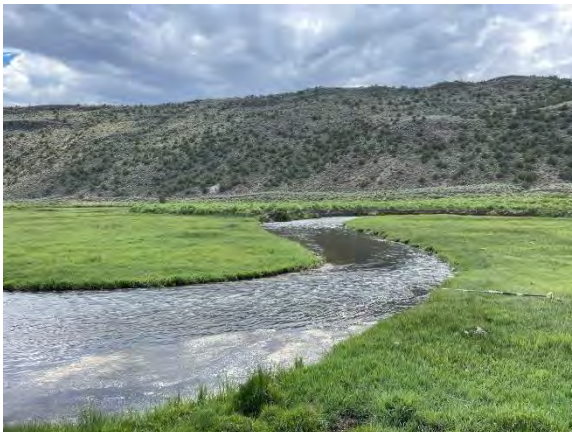
Culebra202107141337

Figure 4-68 Culebra Creek (Culebra202107141337). Notice cutbanks in background of photo.

Culebra Creek (Culebra202107141337) is just upstream of Culebra202107061515. The drainage area of the reach is 248 square miles. A longitudinal profile of water surface and thalweg along with five cross-sections were measured at this reach. The measured reach has an average slope of 0.3%. The Rosgen Stream Classification for this reach is a C4 stream type.

The channel is more sinuous than in the measured reach immediately downstream. There is still evidence of bank erosion through the reach (Figure 4-68). The bank erosion

through this reach and the reach downstream is likely caused by channelization or straightening of the channel. Heavy grazing is likely impacting these reaches. Woody vegetation along the banks of Culebra Creek is noticeably barren of woody vegetation and overhead cover. The valley bottom was noticeably wet, like a floating sod mat. Irrigation return flows are contributing to this.

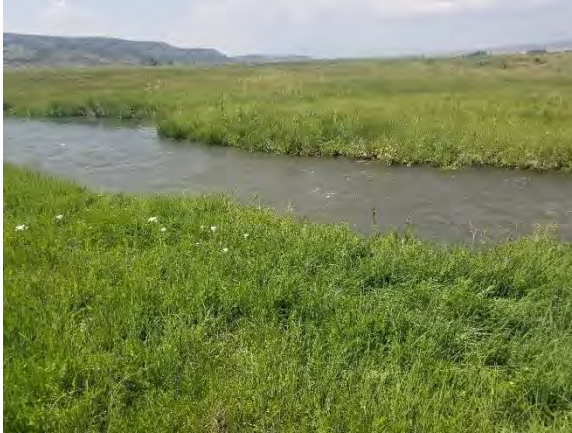
Culebra202107151340

Figure 4-69 Culebra Creek (Culebra202107151340) notice tall vegetation along banks.

Culebra Creek (Culebra202107151340) is about a half-mile downstream of the Culebra Creek and Ventero Creek confluence. The drainage area of the reach is 243 square miles. A longitudinal profile of water surface and thalweg along with three cross-sections were measured at this reach. The measured reach has an average slope of 0.3%. The Rosgen Stream Classification for this reach is a C4/5 stream type.

reaches, this reach does not appear to be as heavily grazed at the time of the survey (Figure 4-69).

To improve the function of Culebra Creek through this reach consider increasing the sinuosity of the channel, reducing slope. Use lateral scour pools to create habitat and energy dissipation.

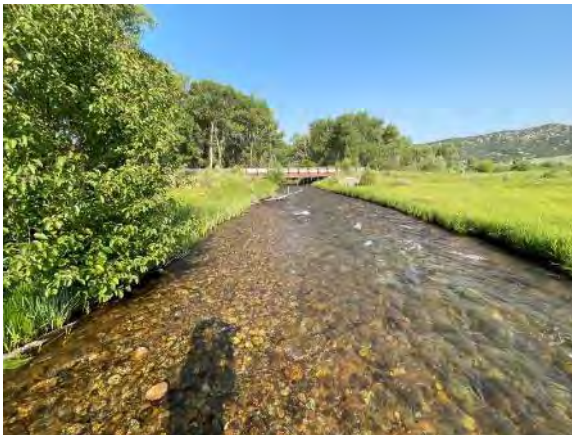
Culebra202107130903

Figure 4-70 Culebra Creek (Culebra202107130903) stable cross-section.

Culebra Creek (Culebra202107130903) is just upstream of Road 23.5. The drainage area of the reach is 79.8 square miles. A single cross-section was measured at this reach. The Rosgen Stream Classification for this reach is a C3 stream type.

The measured, stable cross-section is downstream, 0.3 miles from the Sanchez Diversion (Figure 4-70). The channel had a good floodplain connection and did not appear to be overwide. The thalweg was deep, and there was a little overhead cover on the banks.

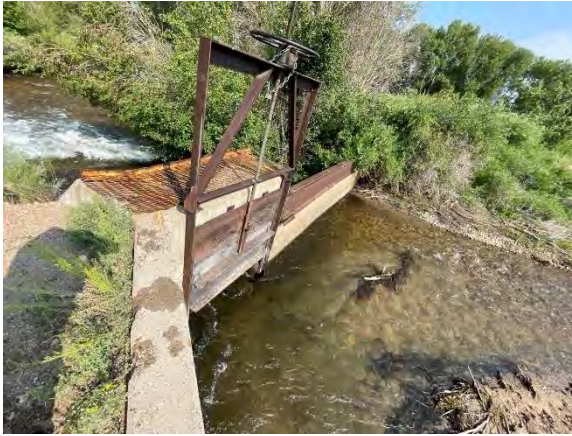
Figure 4-71 Headgate across Culebra Creek for the Sanchez Canal.

Culebra Creek (Culebra202107130809) is immediately upstream of the Sanchez Diversion. The drainage area of the reach is 79.8 square miles. The longitudinal profile of water surface and thalweg along with three cross-sections were measured at this reach. The measured reach has an average slope of 1.45%. The Rosgen Stream Classification for this reach is a C3 stream type.

The headgate at this site (Figure 4-71) is causing geomorphic issues in and around the channel including restricting Bankfull width, floodplain width, and increasing channel velocity. The headgate reduces the width of Culebra Creek and its floodplain down to four feet. The width reduction backs up the water causing sedimentation upstream of the headgate. By backing up the water, the velocity of water in the channel reduces above the headgate reducing the channel's stream power, thus reducing its capacity to transport sediments. As suggested by the continuity equation, water velocities through the headgate increase.

Reducing sediment sources, expanding the floodplain, and increasing the width of the channel through the headgate could improve the geomorphic function of the Culebra Creek through this section. Water velocities through the current configuration of the headgate should be evaluated as a potential barrier to the upstream migration of aquatic life through the reach.

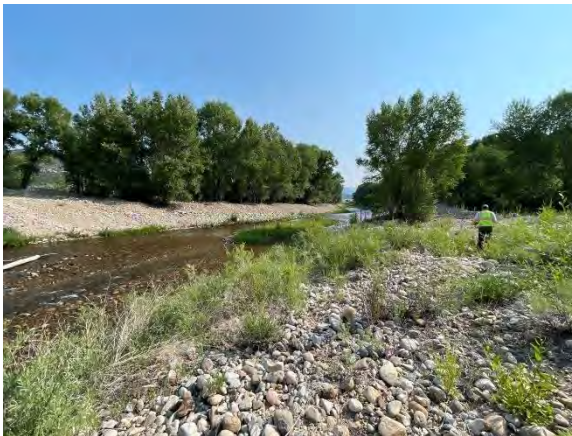
Figure 4-72 Culebra Creek above Sanchez Diversion.

In Figure 4-72, sediments were observed piled up along the banks of the Culebra immediately upstream of the headgate. Piling

sediments along the banks, as they are throughout this reach reduces the floodplain width. By narrowing the floodplain, flow depths on the floodplain increase during flood events. This increase in depth increases the applied shear stress on the floodplain. Thus, increasing the channel's capacity to move sediments and cause erosion during high flow events.

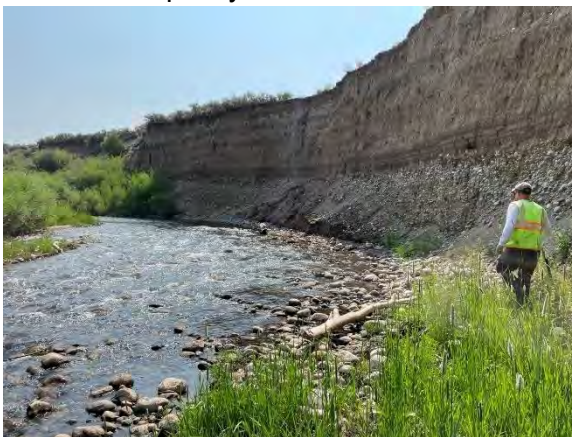
Figure 4-734-74 Culebra Creek 1.5 miles upstream of Sanchez Diversion. Potential source of sediment at the diversion.

1.5 miles upstream of the surveyed reach, a large cutbank was observed. This vertical bank contributes to the sediments being deposited above the headgate (Figure 4-734-74). Gullies upstream of this site are also likely contributing sediments to Culebra Creek.

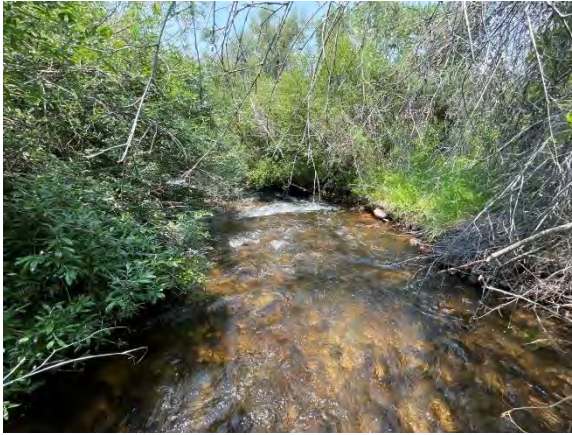
Culebra202107131235

Figure 4-75 Culebra Creek (Culebra202107131235) with heavy canopy cover and riparian vegetation.

Culebra Creek (Culebra202107131235) is 1.4 miles downstream of County Road M.5. The drainage area of the reach is 31.3 square miles. The longitudinal profile of water surface and thalweg along with two cross-sections were measured at this reach. The measured reach has an average slope of 2.3%. The Rosgen Stream Classification for this reach is a C3b ('C3' little 'b') stream type.

The measured reach in this section of Culebra Creek has dense riparian vegetation throughout the reach (Figure 4-75). The channel substrate, cobble with an intermixing

While the reach is in good condition, it is possible to improve the channel function, including geomorphic pools and floodplain reconnection in locations. Reconnecting the channel to the floodplain in locations may provide the opportunity to reduce water velocities through the reach, providing habitat.

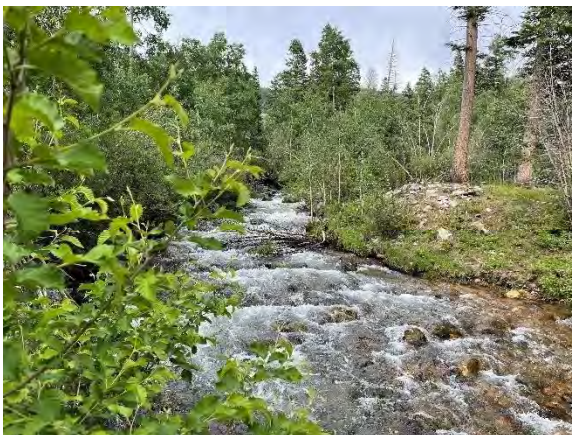
Culebra202106231622

Figure 4-76 Culebra Creek (Culebra202106231622). Steep section of the creek.

Culebra Creek (Culebra202106231622) is 1 mile downstream of El Valle and Carneros Creek Confluence. El Valle and Carneros Creek come together to form Culebra Creek. The drainage area of the reach is 22.5 square miles. The longitudinal profile of water surface along with a cross-section were measured at this reach. The measured reach has an average slope of 4.3%. The Rosgen Stream Classification for this reach is a B4a ('B4' little 'a') stream type.

The channel is overwide through this reach (Figure 4-76). The width-to-depth ratio is 35. Often with overwide reaches, there is a

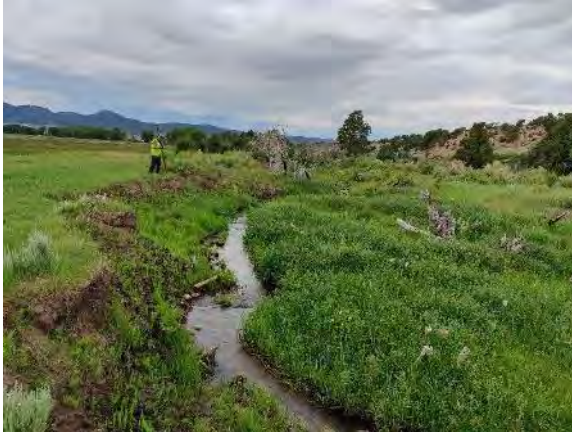
Jaroso202106250930

Figure 4-77 Jaroso Creek (Jaroso202106250930). Notice channel next to high terrace but building a new floodplain.

Jaroso Creek (Jaroso202106250930) is 1 mile upstream of County Road 21. The drainage area of the reach is 8.53 square miles. A longitudinal profile of water surface and thalweg, and three cross-sections were measured at this reach. The measured reach has an average slope of 1.3%. The Rosgen Stream Classification for this reach is a C5 stream type.

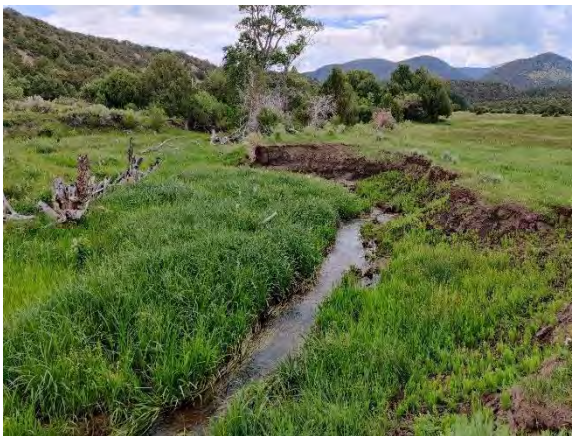
Bank erosion was observed within the reach (Figure 4-78). The reach has become entrenched but is trending towards stability by building a floodplain at a lower elevation.

Figure 4-78 Jaroso Creek (Jaroso202106250930) bank erosion.

The channel could continue stabilizing itself at the new base level. The gully that it is in may continue to widen out until the belt width is sufficient for the channel and gradient of the stream. There is an opportunity to do a Priority 1 restoration project, putting the channel back up on the higher terrace through this reach. Doing so may raise groundwater levels through the valley, improve sub-irrigation for crops and create a more stable stream channel, with opportunity for aquatic and riparian habitat improvements.

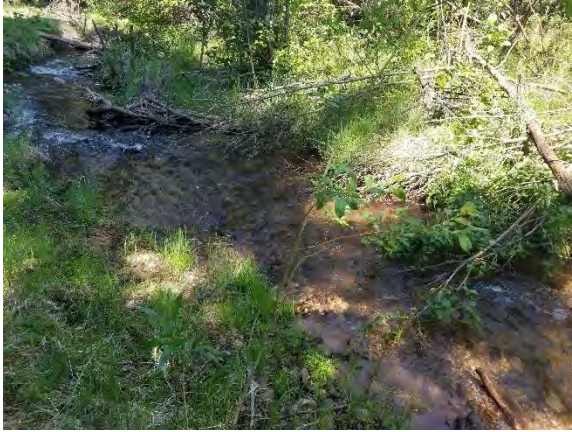
Jaroso202106221008

Figure 4-79 Jaroso Creek (Jaroso202106221008) notice wood in stream and healthy riparian community.

Jaroso Creek (Jaroso202106221008) is 1.2 miles upstream of Jaroso202106250930. The drainage area of the reach is 5.39 square miles. A longitudinal profile of water surface and thalweg and one cross-section were measured at this reach. The measured reach has an average slope of 3.4%. The Rosgen Stream Classification for this reach is a C4b ('C4' little 'b') stream type.

Figure 4-79 shows Jaroso Creek through the measured reach. There is wood incorporated into the banks and a healthy riparian community. This provides stability to the reach. In and around the reach there is

evidence of grazing, which has caused impacts to bank stability, but the reach seems to be in a stable state.

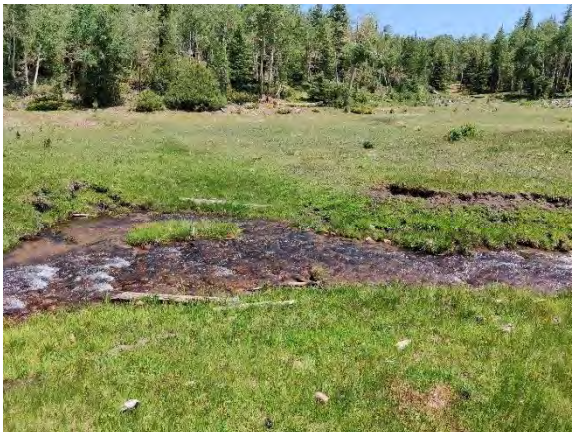
Jaroso202106221147

Figure 4-80 Jaroso Creek (Jaroso202106221147) notice bank erosion, caused by hoof shear, and overwide channel.

Jaroso Creek (Jaroso202106221147) is 2 miles upstream of Jaroso202106221008. The drainage area of the reach is 4.03 square miles. A longitudinal profile of water surface and thalweg and three cross-sections were measured at this reach. The measured reach has an average slope of 2.9%. The Rosgen Stream Classification for this reach is a C4b ('C4' little 'b') stream type.

This reach runs through a high meadow. There is a noticeable lack of vegetation, especially woody plants, along the banks. Due to hoof shear, bank erosion was observed in the measured reach (Figure 4-80), and the

The function of the reach could be improved with grazing management and plantings. There is river restoration potential through the reach as well, narrowing the channel, creating pools, and incorporating wood and fish habitat features.

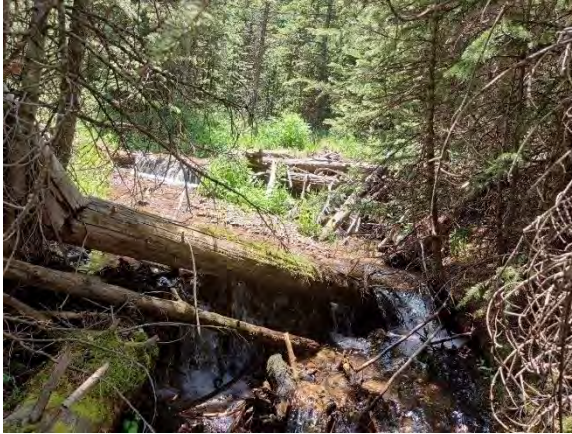
UTJaroso202106221324

Figure 4-81 UT Jaroso (UTJaroso202106221342) step pool system.

UT Jaroso (UTJaroso202106221324) is 0.6 miles upstream of the channel's confluence with Jaroso Creek, three miles upstream of Jaroso202106221147. The drainage area of the reach is 0.63 square miles. A longitudinal profile of water surface and a cross-section was measured at this reach. The measured reach has an average slope of 14.5%. The Rosgen Stream Classification for this reach is an A4a+ ('A4' little 'a' plus) stream type.

UT Jaroso, through this reach, is a step-pool system. Notice all the wood steps or drops in Figure 4-81. The channel appears to be in a

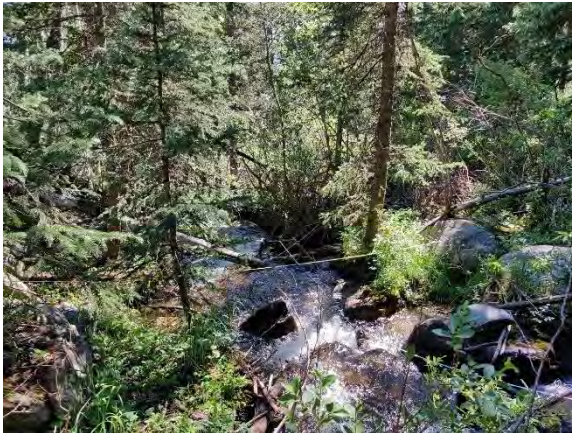
ElPerdido202107071236

Figure 4-82 El Perdido Creek (ElPerdido202107071236) heavily wooded, steep, confined channel.

El Perdido Creek (ElPerdido202107071236) is about 0.3 miles upstream of the Bernardino/El Perdido confluence. The drainage area of the reach is 0.87 square miles. A longitudinal profile of water surface and thalweg and two cross-sections were measured at this reach. The measured reach has an average slope of 16.4%. The Rosgen Stream Classification for this reach is a A4a+ ('A4' little 'a' plus) stream type.

The channel through the measured reach is very steep and heavily wooded (Figure 4-82). The reach is a stable step-pool/cascade system, steps being composed of both wood

and boulders. The reach seems to be in a pseudo-stable condition. No evidence of grazing was observed in this section.

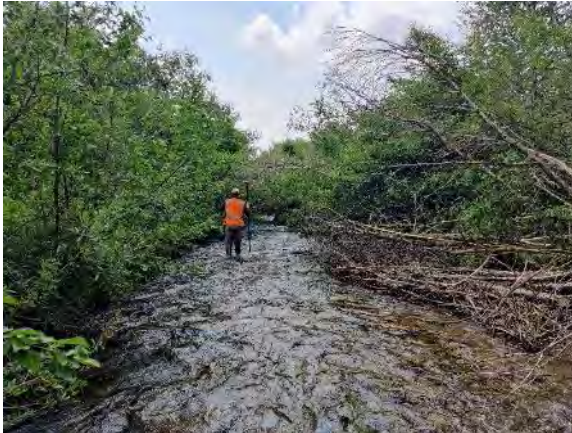
ElPoso202107111312

Figure 4-83 El Poso Creek (ElPoso202107111312) notice woody vegetation on banks.

El Poso Creek (ElPoso202107111312) is 2 miles upstream of the El Poso Creek Culebra Creek Confluence. The drainage area of the reach is 29.8 square miles. A longitudinal profile of water surface and thalweg and two cross-sections were measured at this reach. The measured reach has an average slope of 2.0%. The Rosgen Stream Classification for this reach is a C3 stream type.

The channel within the reach could benefit from more pools.

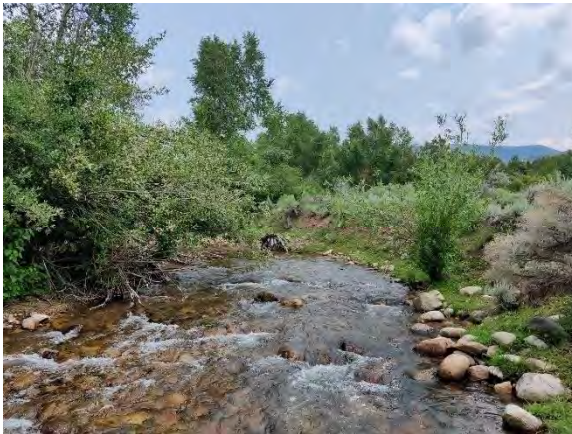
ElPoso202107111030

Figure 4-84 El Poso Creek (ElPoso202107111030) wood vegetation on river right bank, erosion on river left.

El Poso Creek (ElPoso202107111030) is one mile upstream of ElPoso202107111312. The drainage area of the reach is 28.5 square miles. A longitudinal profile of water surface and thalweg and two cross-sections were measured at this reach. The measured reach has an average slope of 2.4%. The Rosgen Stream Classification for this reach is a B3 stream type.

Bank erosion and channel instability were observed through this measured reach. There is evidence of hoof shear along the banks, cutbanks, and mid-channel bars are forming.

the reach contributes to stability, but the channel is likely to continue to destabilize. The formation of mid-channel bars in the channel suggests that the channel is overwide. The is entrenched. Grazing management could improve the channel through this reach, and there is potential to improve the reach with restoration.

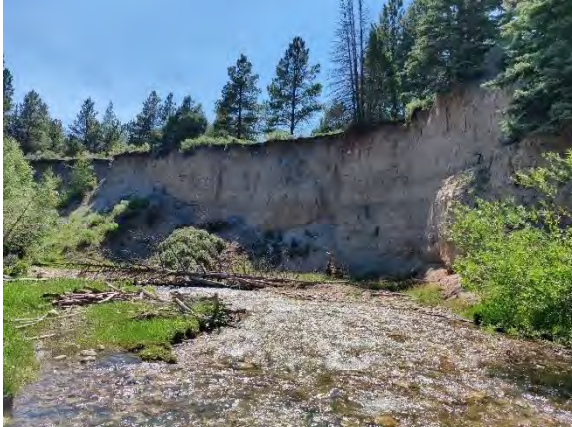
ElPoso202107101515

Figure 4-85 El Poso Creek (ElPoso202107101515). Notice channel cutting into high terrace.

channel is cutting into a high terrace, as shown in Figure 4-85. The channel through this reach could benefit from grazing management, planting, and stream restoration.

Through this reach, the channel has good riparian vegetation, including woody plants. There is evidence of grazing in and near the channel, and the channel is overwide. The

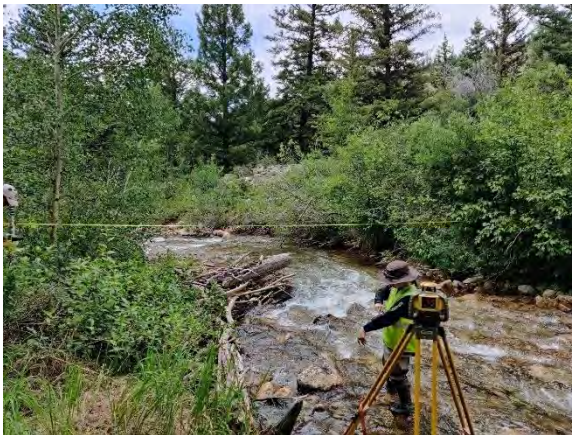
ElPoso202107091115

Figure 4-86 El Poso Creek (ElPoso202107091115) notice riparian vegetation along banks.

El Poso Creek (ElPoso202107091115) is 0.75 miles upstream of ElPoso202107101515. The drainage area of the reach is 18.0 square miles. A longitudinal profile of water surface and thalweg and two cross-sections were measured at this reach. The measured reach has an average slope of 2.9%. The Rosgen Stream Classification for this reach is a B3.

The stream is stable through the measure reach. The banks are supported by vegetation. There are willows and alders in the riparian corridor. There is bedrock control in the reach. Large wood and deep pools are found in the reach.

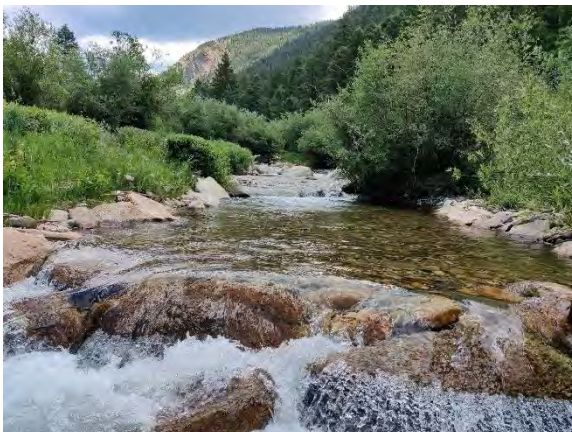
Figure 4-87 El Poso Creek upstream of ElPoso202107091115, notice drop structures and boulder bank protection.

Upstream of this reach, a quarter of a mile, a field crew observed stream work completed in the channel below houses. The stream work incorporated big drops into the channel. Below these drops were deep pools, and above the drops, it looked like aggradation occurred due to the reduced slope.

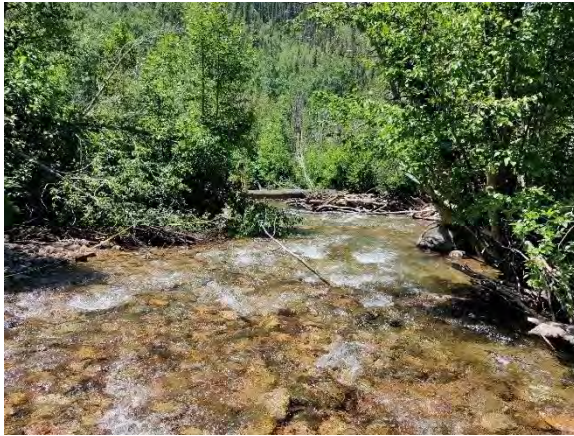
ElPoso202107101145

Figure 4-88 El Poso Creek (ElPoso202107101145) notice wood vegetation along banks and bright channel bottom.

Channel instability was observed through the measured reach. Instabilities included bank erosion and sediment deposition on the floodplain, namely cobbles. There was evidence of wood debris jams occurring in the reach. The reach experienced a flooding event in recent history.

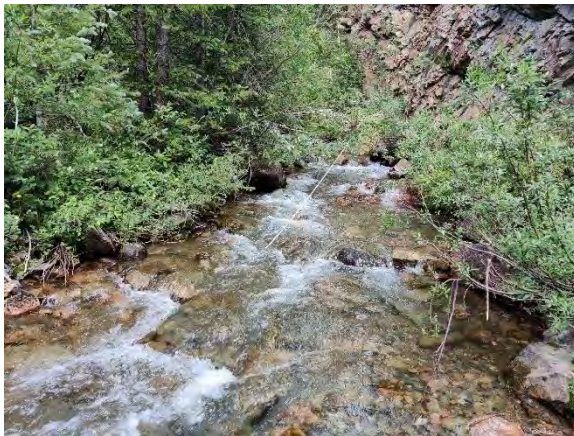
ElPoso202107081130

Figure 4-89 El Poso Creek (ElPoso202107081130) notice bedrock outcrop on river left and dense vegetation along banks.

The measured reach has a dense woody riparian community along its banks (Figure 4-89). The reach is stable with good riparian vegetation and substrate controls. The channel is bedrock controlled, both laterally and vertically.

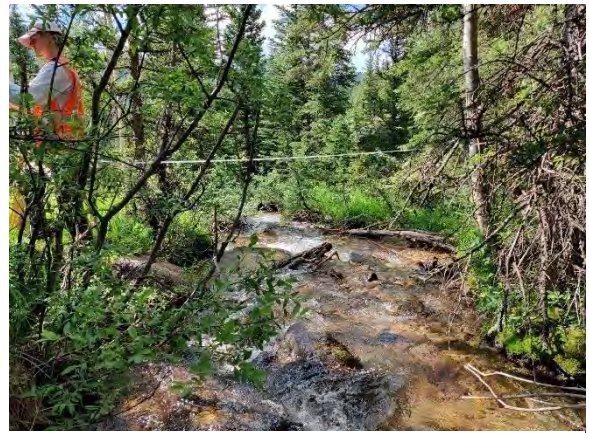
UTEIPoso202107081500

Figure 4-90 UT El Poso (El Poso2021070815) aka Canova Creek steep reach with healthy riparian corridor.

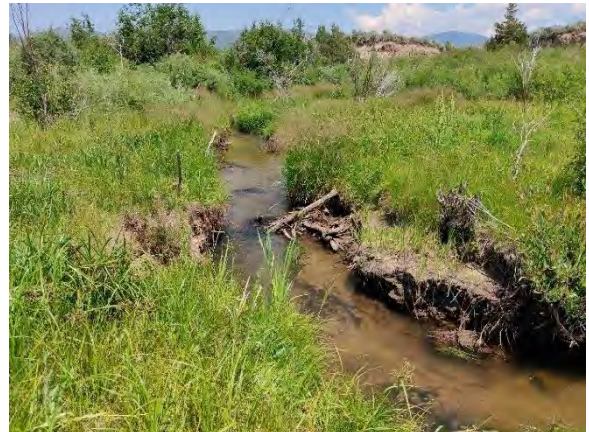
RitoSeco202107121234

Figure 4-91 Rito Seco (RitoSeco202107121234) notice bank erosion in the foreground.

Bank erosion was noticed in the measured reach (Figure 4-91). This channel has incised to a lower base elevation. The surrounding landscape indicates that Rito Seco was historically a heavy contributor of sediments. The channel appears to be stabilizing at a lower elevation. In areas through the measured reach, the channel was well connected with the floodplain, yet it looks as if the channel is incising in other areas. Figure 4-91 shows the channel downcutting through what looks like historic sediments, deposited behind an old beaver dam. There is evidence of beavers both upstream and downstream of the measured reach. If left alone, the channel will continue to stabilize. Gullies are forming with drainages connected to the channel. The channels being formed by these headcuts will continue to move up-basin until pseudo stable slopes are obtained by the forming channel.

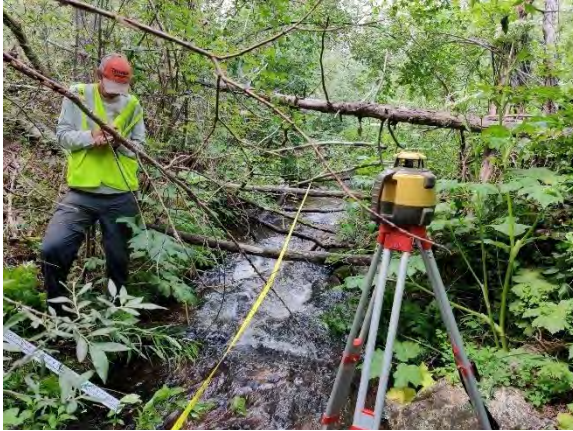
RitoSeco202107191045

Figure 4-92 Rito Seco (RitoSeco202107191045) steep channel with great alder/willow riparian

Rito Seco, through the measured reach, is steep and seems stable. The wood vegetation and the substrate provide stability through the reach. As shown in Figure 4-92, wood is plentiful on-site, providing both stability and habitat.

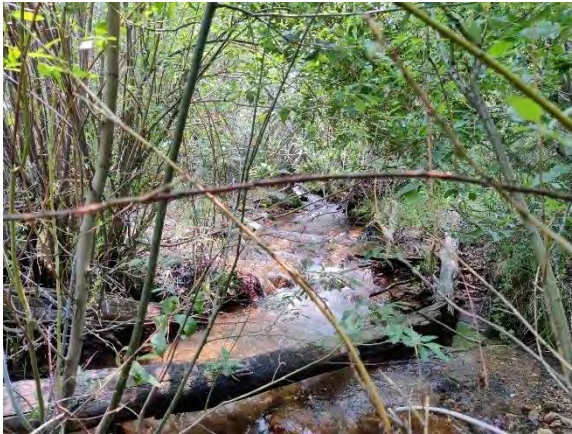
SanFrancisco202107121234

Figure 4-93 San Francisco Creek (SanFrancisco202107121234) notice canopy cover and healthy riparian vegetation.

Overall, the measured reach was stable (Figure 4-93). Sediment deposition was observed on the floodplain upstream of the culvert, towards the middle of this reach. A high concentration of fine particles was observed in the channel substrate, suggesting that the channel is aggrading. Grazing impacts the channel, with hoof shear and bare earth observed in and around the channel. Vegetation through the reach provides stability to the channel.

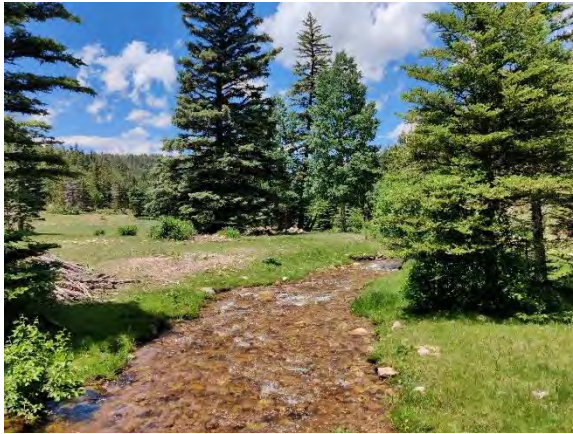
SanFrancisco202106241234

Figure 4-94 San Francisco Creek (SanFrancisco202106241234) notice lack of vegetation, especially woodies and overwide channel.

Channel work has been performed in and around this reach. There is boulder bank protection and drop structures added. The vegetation through this reach does not seem to be at its full potential, and there is an apparent lack of woody shrubs (Figure 4-94). The channel may be overwide through this section. There is evidence of overgrazing in the vicinity of the stream. The road and grazing impact the channel's function in this reach. The channel also appears to be

Increasing the length of the channel by adding sinuosity will reduce the bankfull slope and improve the reach function along with vegetation planting and grazing management. The addition of more pools would also add energy dissipation and habitat benefits.

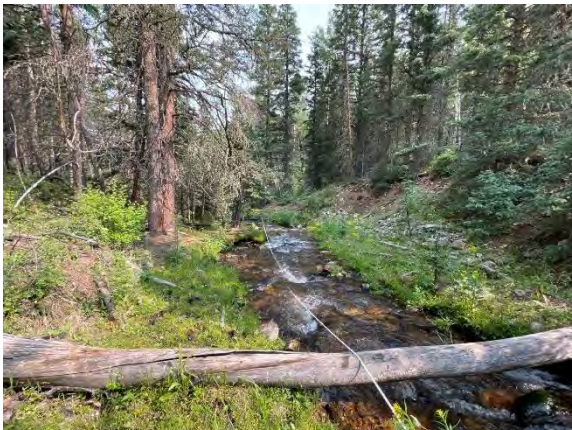
SanFrancisco202107120920

Figure 4-95 San Francisco Creek (SanFrancisco202107120920) lot of wood in steep channel with small floodplain.

confluence of San Francisco Creek and El Fragoso Creek and continues up El Fragoso Creek. There is a small floodplain forming along the banks of the channel (Figure 4-95). Impacts from grazing were observed in and along the banks of the channel. The presence of wood, in the channel and along the banks and the larger substrate size help stabilize the channel. Consider grazing management to improve the function of the channel.

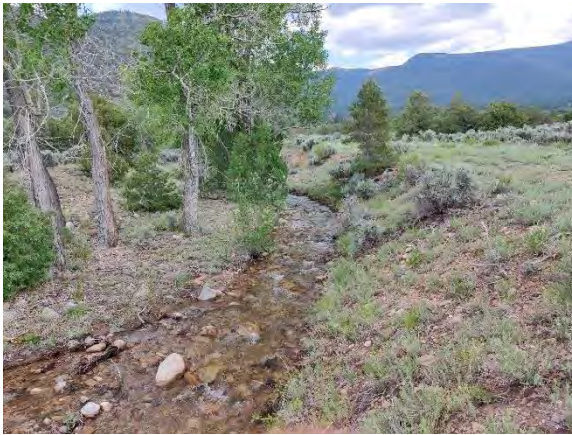
SCuates202106171403

Figure 4-96 South Cuates Creek (SCuates202106171403) channel against high terrace. Floodplain has cobble deposition.

channels connects the two streams. The channel through the measured reach appears to be stable. It looks as though the channel has cut down through a high terrace and is establishing itself at a lower base level. There is a defined floodplain in the valley bottom. Cobbles were observed and are being actively deposited on the floodplain.

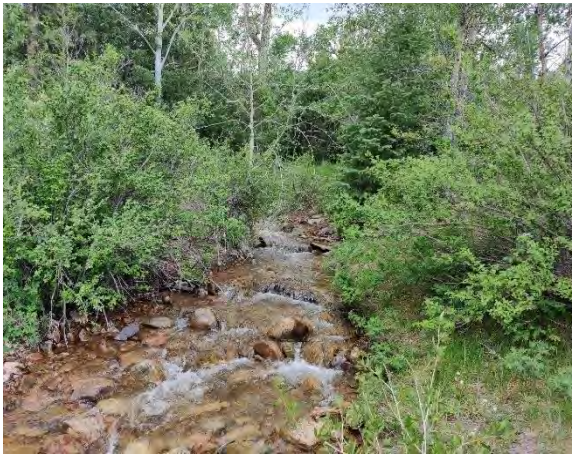
SCuates202106171351

Figure 4-97 South Cuates Creek (SCuates202106171351) is a stable reach with strong riparian community.

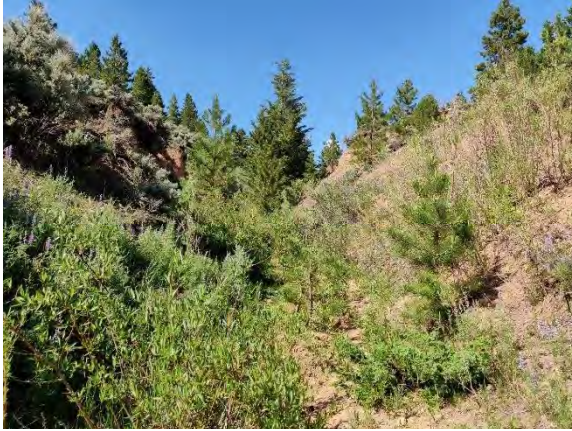
Figure 4-98 Gully above Torcido Creek, notice established vegetation suggesting gully is stabilizing.

A review of aerial imagery along the Torcido drainage gullies have formed where trees are not prevalent on the landscape. Two gullies have formed immediately upstream, north northeast, of the measured reach (Figure 4-98). The gullies have supplied sediment to the measured reach. The gullies appear to be stabilizing, and it did not appear that the channel below was actively receiving sediments and aggrading

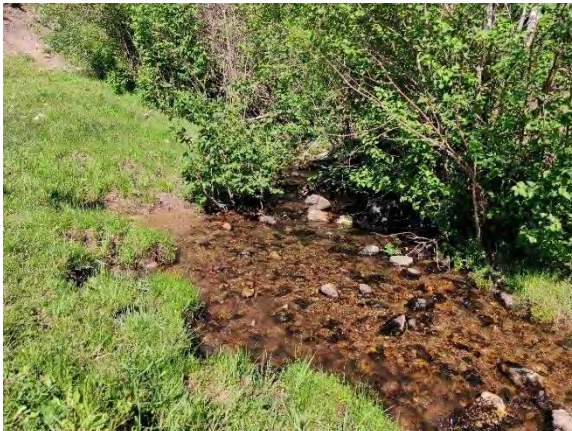
Torcido202106211640

Figure 4-99 Torcido Creek (Torcido202106211640) notice hoof shear along banks.

There is evidence of grazing in and along the creek in this reach (Figure 4-99), and it is overwide. Woody vegetation is absent on river right, left side of photo in Figure 4-98. Grazing management and riparian planting could help improve the function of the channel in this area.

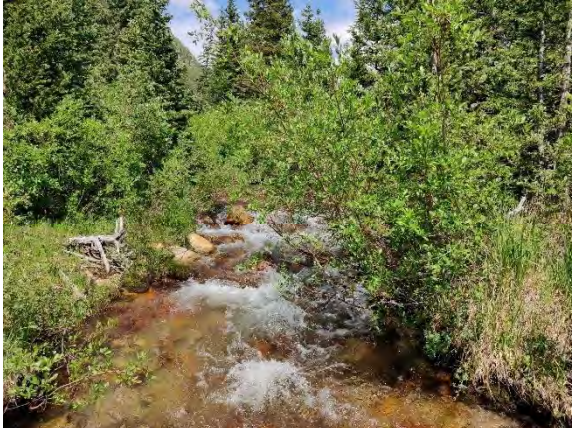
Valle202106231452

Figure 4-100 El Valle Creek (Valle202106231452) notice healthy riparian vegetation, including woody shrubs, along the banks.

disturbances upstream of the site. It looks like a potential relic beaver dam blew out. The vegetation in and around this site is healthy and will continue to fill in, narrowing the channel. Managing grazing through this reach will help ensure that the vegetation can continue to work towards stabilizing the channel. There may be a restoration opportunity upstream of this reach.

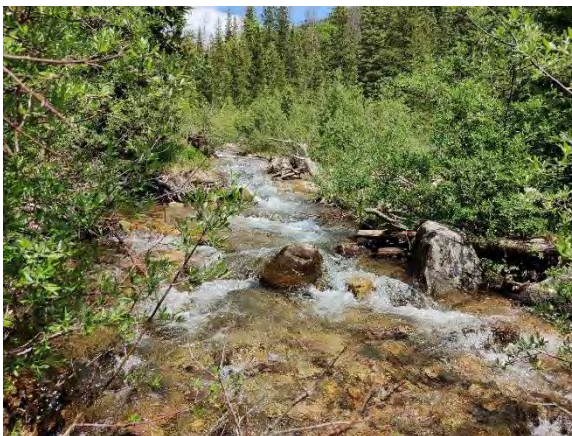
Valle202106231410

Figure 4-101 El Valle (Valle202106231410) notice riparian community along channel margins.

There was evidence of recent and historic beaver activity in and around the measured reach. The riparian community around the reach is in good condition. The channel is

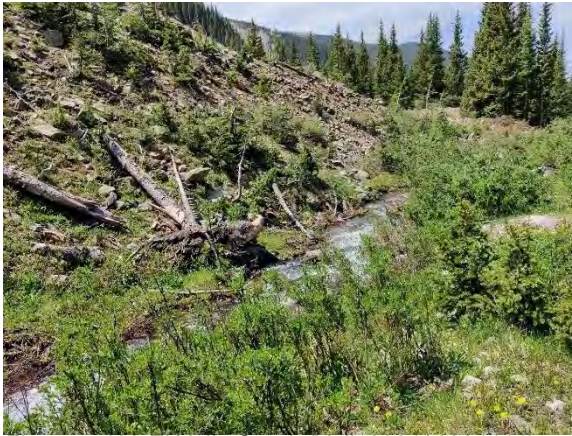
Valle202106231111

Figure 4-102 El Valle Creek (Valle202106231111). Channel is nearing tree line elevation. Notice the boulder scree field next to the channel.

There is evidence of grazing within the measured reach. The banks and channel are stable. The channel corridor has good riparian vegetation (Figure 4-102). Runoff flow down the roads in the vicinity of the site, a potential

cause for sediments in the channel. Alluvial fans and rocks slides are likely to impact the channel through this reach. Notice the steep boulder scree slopes in Figure 4-102.

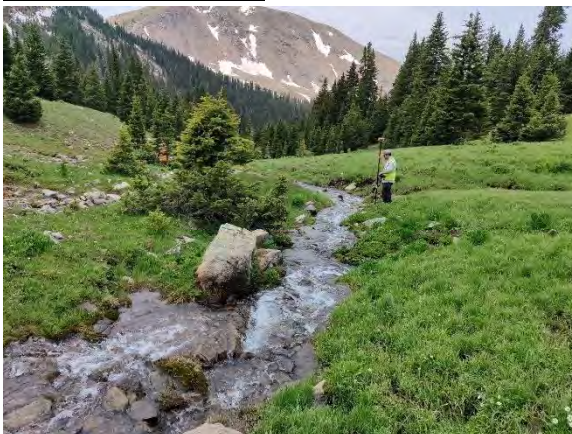
Valle202106231157

Figure 4-103 El Valle Creek (Valle202106231157) channel near tree line. Photo showing braided section below alluvial fan.

woody shrubs along the bank margins and evidence of grazing throughout the reach (Figure 4-103). The banks show signs of hoof shear, and there is erosion on the floodplain where the banks have been trampled. To improve the reach function, grazing management for the area should be considered.

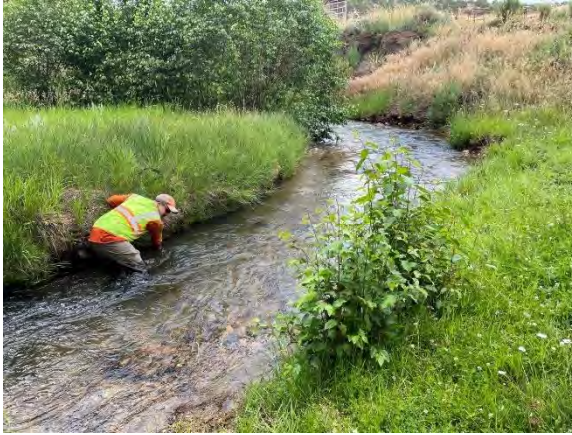
Vallejos202107201315

Figure 4-104 Vallejos Creek (Vallejos202107201315). Notice undercut bank on river left, left side of photo. In the background notice bank erosion/instability.

There were signs of instability through the reach. Vertical banks were observed in the measured reach. The channel is incising. It appears that the channel may have been channelized and straightened in the past and

is trying to widen its floodplain. Undercut banks observed in measured reach can be great aquatic habitat (Figure 4-104). Grazing management and river restoration could improve the function of this reach. There may be opportunity to connect the river with its floodplain and improve fish/aquatic habitat.

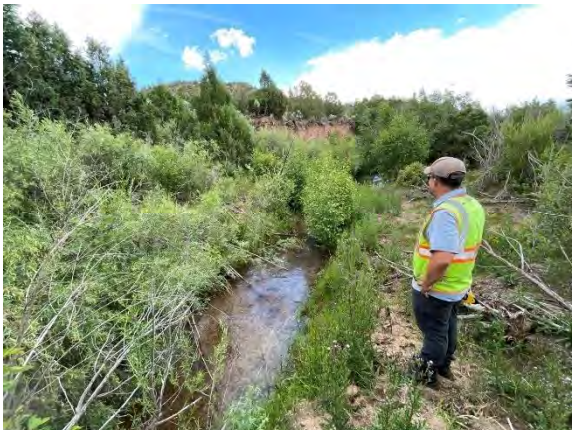
Vallejos202107181307

Figure 4-105 Vallejos Creek (Vallejos202107181307) notice sandy deposition on bank and woody shrub riparian vegetation.

The channel seems to be unstable through the measured reach (Figure 4-105). The channel is cutting into a high terrace on the

downstream end. There was evidence of heavy grazing in areas in and around the reach channel corridor. The reach is heavily vegetated with alder, willow, and pinon (Figure 4-105). The bottom of the channel was noticeably slick. Grazing management and a river restoration project could improve the function of Vallejos Creek through this reach.

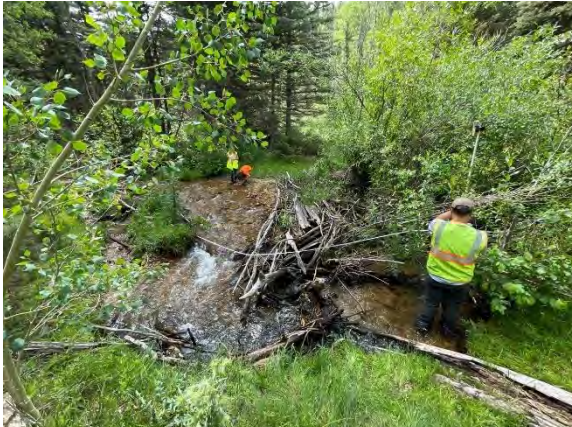
Vallejos202107180915

Figure 4-106 Vallejos Creek (Vallejos202107180915) steep channel with high concentration of woody vegetation along channel margins.

shrubs, is prevalent through the site and aiding in stabilization (Figure 4-106). Fine sediments seem to be aggrading in the measured reach. The upstream source of those sediments was not observed. Signs of grazing were observed within the reach.

The channel through the measured reach is showing signs of instability. The channel is cutting against a high terrace in the measured reach. Riparian vegetation, including woody

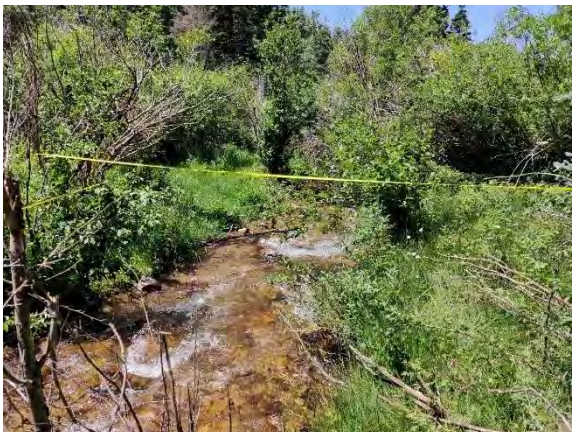
NorthVallejos202107221200

Figure 4-107 North Vallejos Creek (NorthVallejos202107221200) notice riparian corridor including woody shrubs.

shrubs, provides stability to the reach (Figure 4-107).

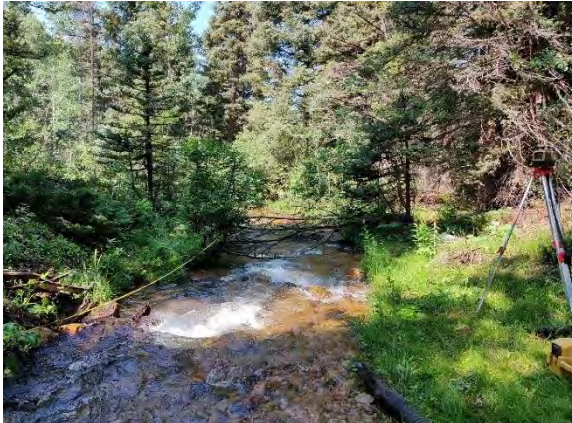
NorthVallejos202107221020

Figure 4-108 North Vallejos Creek (NorthVallejos202107221020) channel has decent vegetation along its margins.

banks. Riparian vegetation, especially woody shrubs, provides stability to the site (Figure 4-108). Wood in the channel also seems to be supplying beneficial habitat.

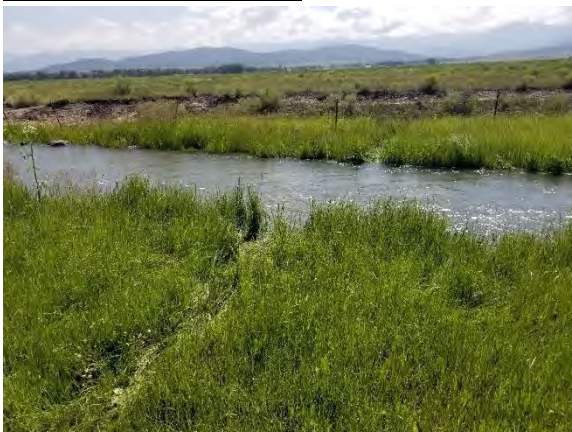
Ventero202107150915

Figure 4-109 Ventero Creek (Ventero202107150915) notice grassy vegetation along banks and on floodplain. Bank erosion can be seen in the

Grazing is prevalent in and around the project reach (Figure 4-109). The upstream control of Sanchez Reservoir heavily influences the

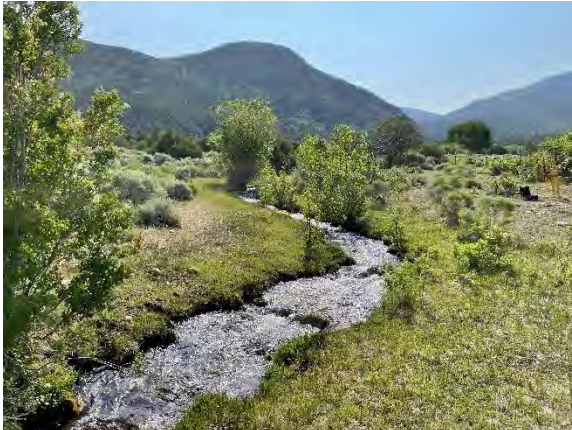
Willow202106160946

Figure 4-110 Willow Creek (Willow202106160946) notice woody shrubs on bank and sinuosity of the channel.

grazing along the channel, with hoof shear occurring along the banks. Wood vegetation is present along the channel margins. The channel has good floodplain access (Figure 4-110).

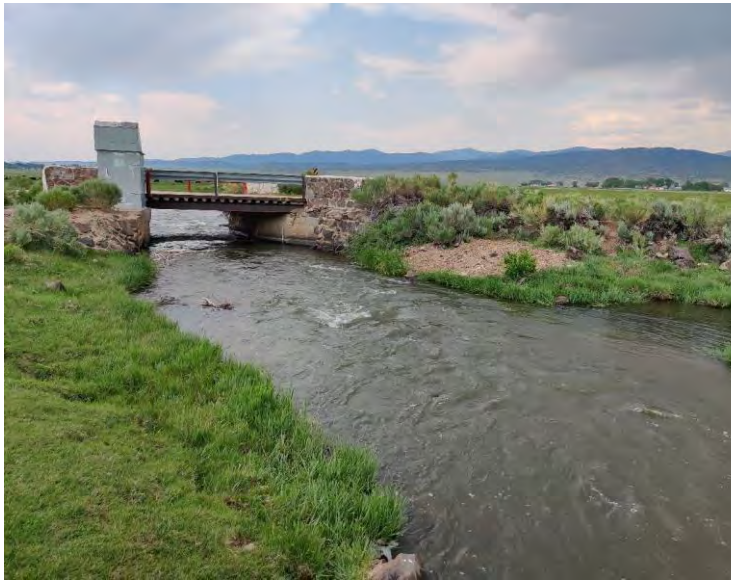
Figure 5-3 Looking downstream at Culebra at San Luis gaging station. Recording equipment is housed in shelter on left bank.

Culebra Basin is located upstream of San Luis on the Culebra (CULSANCO) (Figure 5-2). The control structure for this gage is a concrete Parshall flume with a concrete stilling well on the left edge of water (Figure 5-3). While this gage provides records for water administration below San Luis and water releases from Sanchez Reservoir, it does not provide the necessary data to administer water within the upper basin. Measurements at this gage are impacted by diversions and regulations upstream. Mean daily flows at CULSANCO are shown in
