Upper Culebra Watershed Assessment Report

In Progress Draft

Prepared for Costilla County Conservancy District

Tailwater Limited

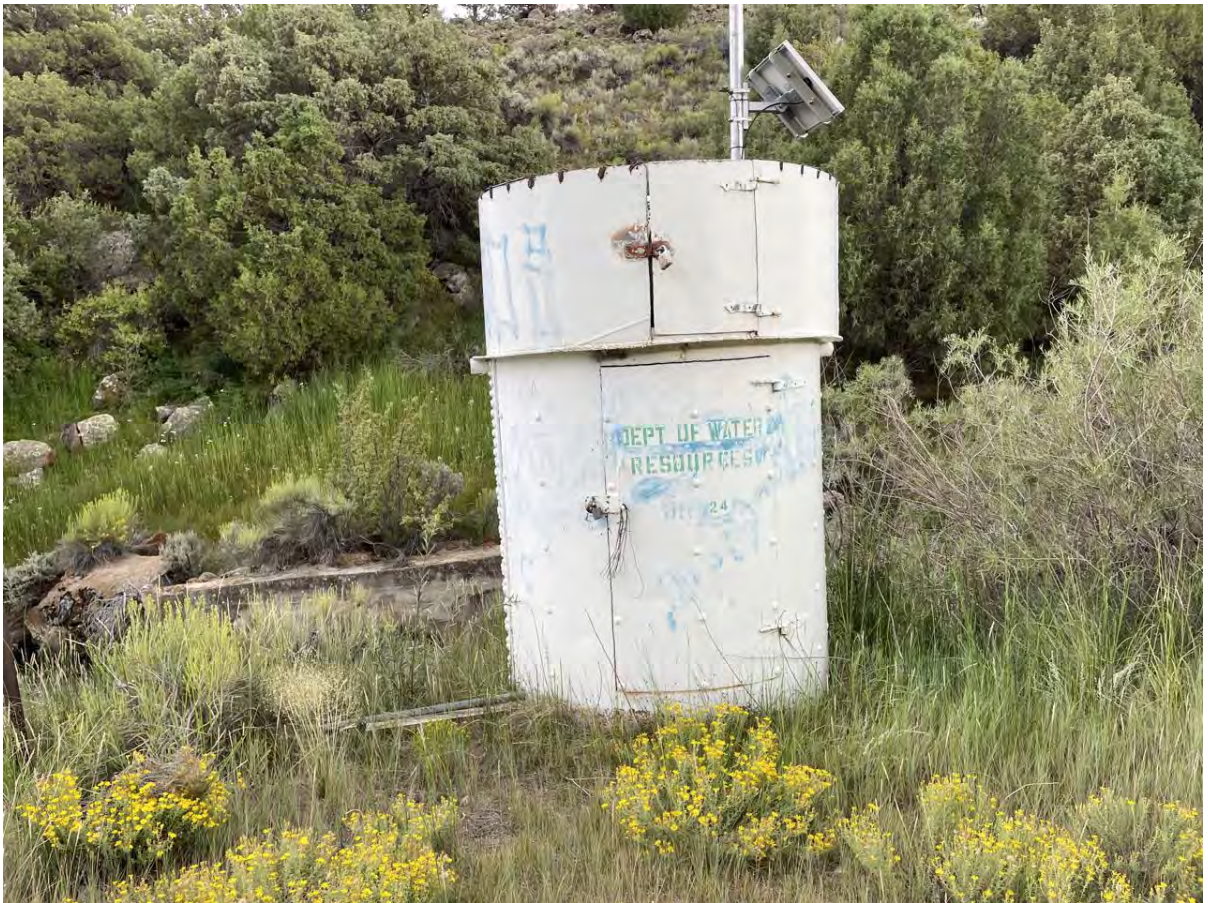
Ventero Creek below Sanchez is an administrative gage measuring the flow released from Sanchez Reservoir (Figure 5-7). This record provides an opportunity to evaluate a gage that has not been periodically inspected and does not currently receive routine discharge measurements. This gage is located at a standard 10-foot Parshall flume and is currently operated with a variable shift curve (2402004AVS-18-1) applied April 26, 2018 and was last verified by a measurement dated April 25, 2018. A variable shift curve is used to define shifts that vary with stage. The variable shift curve appears to have been developed to apply a -0.05 ft shift above a stage of 0.90 ft and a 0.00 ft shift at a stage of approximately 0.56 ft to fit the measurement made April 25, 2018. The resulting variable shift curve shows a 9.03 percent difference from the standard 10-foot Parshall Flume rating at a discharge of 29.2 cfs. At this site, historical measurements above and below 30 cfs showed shifts between 0.00 ft and -0.02 ft (Table 5-1), so a -0.05 ft shift is greater than any shift historically observed. While conditions may have existed that resulted in the greater shift, it is unknown to the author if this change also affected lower discharges, if it was temporary from changes in approach conditions or algal growth, or if the measurement was an error. The use of the variable shift curve does not align with the historical measurement, and this curve needs to be further verified and potentially adjusted.

Figure 5-7 Ventero below Sanchez Reservoir gaging station.

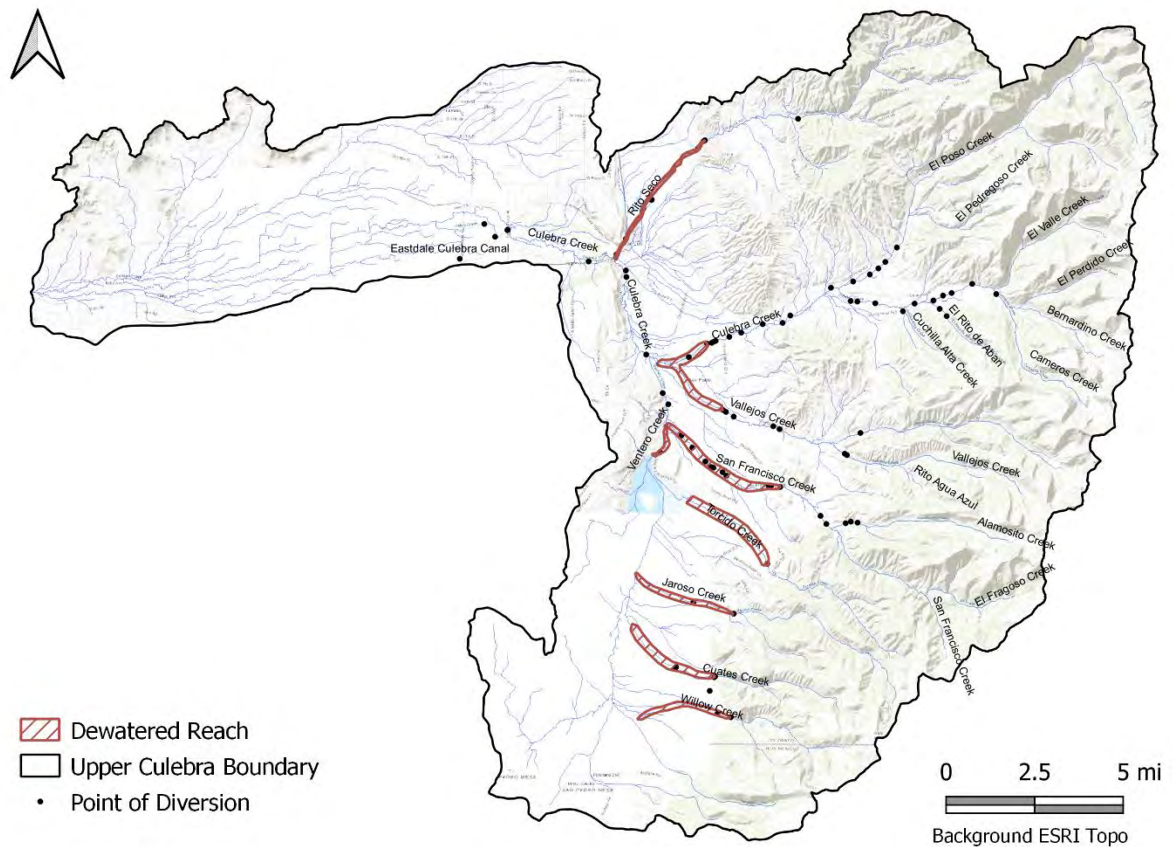
Diversion structures that sweep, or divert all the water from the channel, can determine where aquatic habitat may be impacted due to inadequate water. Diversion structures that sweep the rivers and streams include Vallejos Ditch, San Francisco Ditch, San Acacio Ditch, Cerro Ditch. The smaller structures on Jaroso, Cuates, and Willow Creek may also dewater the reaches or naturally dewatered as the water flows over the alluvial fan. The upstream most diversion structure on these creeks may generally be considered the end of fisheries habitat. The reach on Ventero Creek below Sanchez Reservoir is at risk of dewatering due to dam operations. The dewatered areas are shown in Figure 5-34.

Figure 5-34 Stream reaches where dewatering occurs frequently or is at risk of occurring.

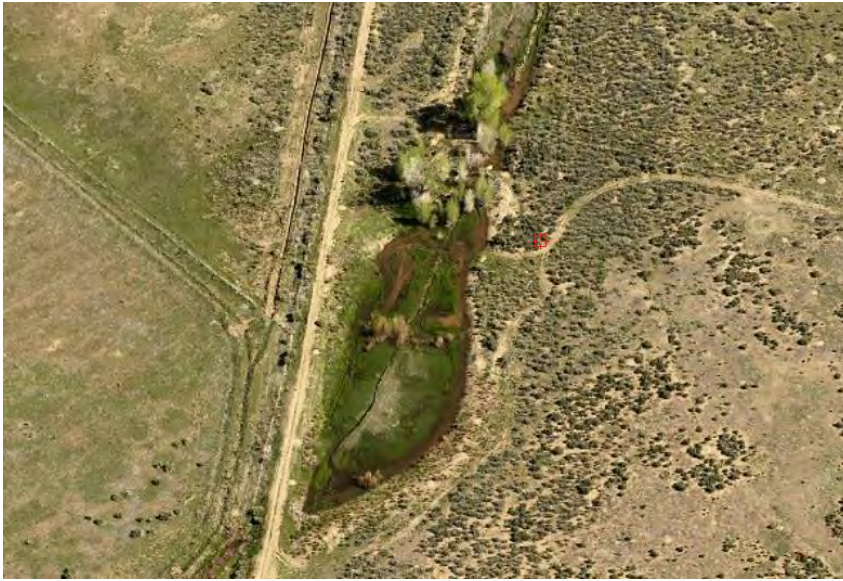
The Espinosa Ditch structure appears to cause significant changes in the flow pattern along Rito Seco. The June 3, 2019, EagleView Aerial imagery shows water backed up around this structure near the road (Figure 6-3). The width of the wetted area in this reach is approximately 100-feet with signs of tracking and sediment deposition. The stream in this reach is likely to rebuild a floodplain at an elevation lower than the historic floodplain; this is a baseline shift.

Figure 6-3 Espinosa Ditch, EagleView aerial imagery dated June 3, 2019.

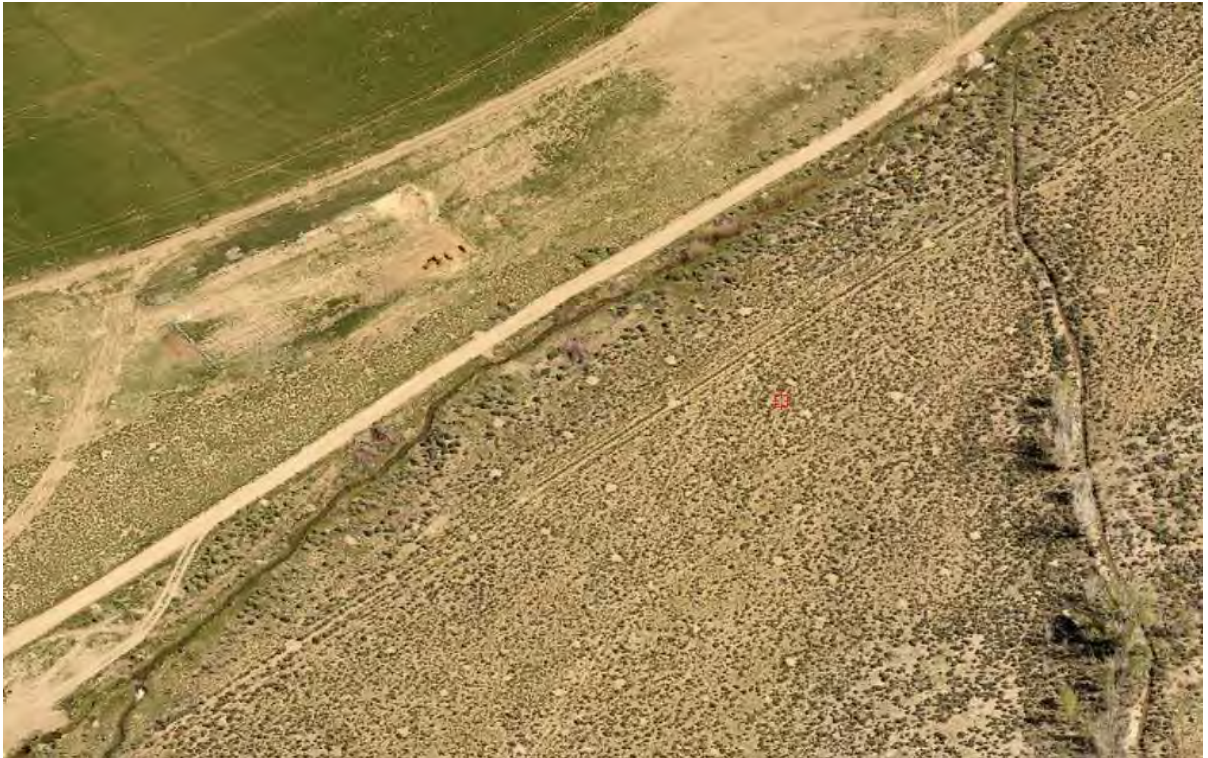
Diversions for the Salazar Ditch are measured through two flumes, the North and South Parshall flumes (Figure 6-4). The Salazar Ditch diverts upstream near the upper end of one of the historic dikes on the left edge of Rito Seco (Figure 5). These structures were reported to be maintained in good condition and are included in the Battle Mountain Gold Augmentation Plan.

Figure 6-4 North (upper right) and South (lower left) Parshall flumes for Salazar Ditch.

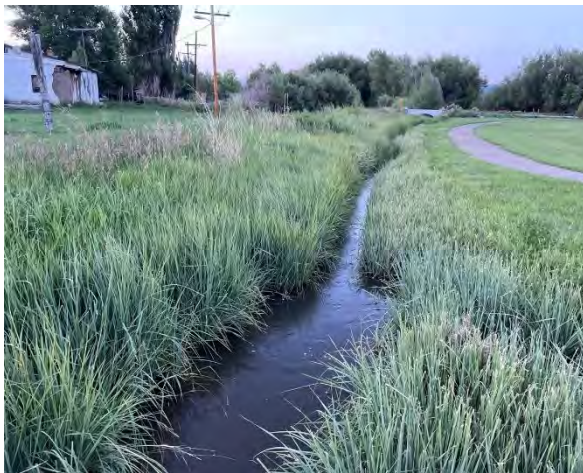
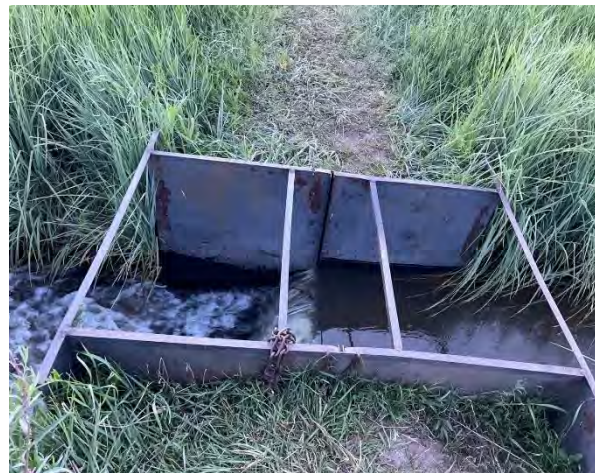
The assessment crew visited Montez Ditch headgate on July 29th, 2021. The headgate was in fair condition with gate leakage (Figure 6-6). No measurement structure on this ditch was found. Water users have reported issues maintaining the ditch, which flows through the town, as the number of users has decreased over time. Portions of this ditch are piped through town. Water users stated that this ditch was historically used to water orchards and gardens through town. Riparian vegetation along this reach consists primarily of grasses. The stream channel is straight through this reach.

Figure 6-6 Montez Ditch headgate, metal splitter box with no observed measurement structure.

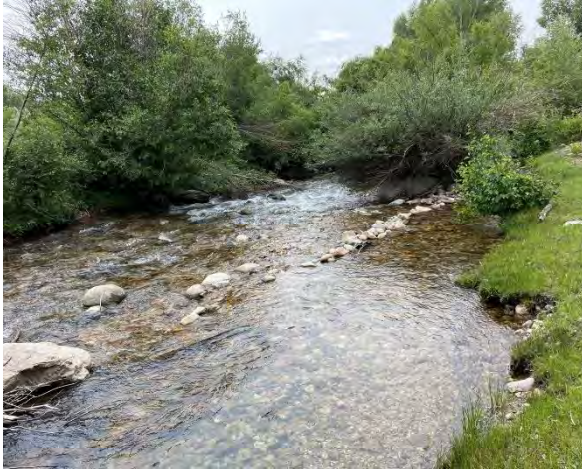
This structure, with a headgate, is located on Cielo Vista Ranch; it was one of the structures where a detailed walk along the structure was performed to evaluate the condition of the ditch. During the site walk, no flume was located along the channel within the first ½ mile of the diversion dam. The ditch had significant leakage back to the creek in multiple locations. Like many ditches in the watershed, a culvert was used to carry water over the arroyo. During the site visit on July 11, 2021, water in the ditch exceeded ditch capacity, and overland flow was observed back to the creek (Figure 6-8).

Figure 6-8 Hand built cobble diversion dam. No risk of flooding, ditch may trap fish.

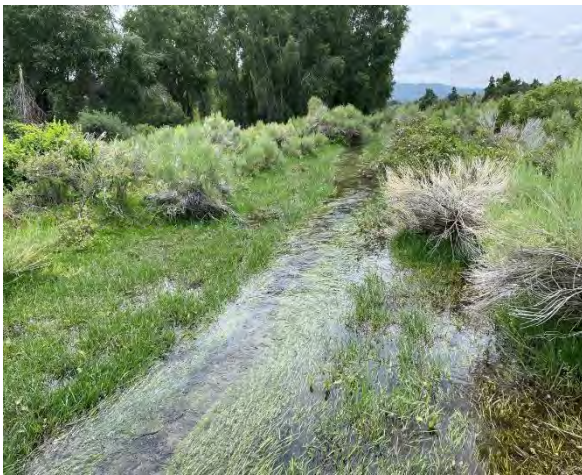
The ditch did not have the capacity to convey the volume of water being diverted (Figure 6-10), which was leaking back to the creek at the time of the site walk. This excess leakage increases the opportunity for the water in the stream to be contaminated with excessive erosion and leaching (Figure 6-11). The excess water is spread across the landscape, unused, increasing the potential for evaporation and reducing water available to downstream water users (Figure 6-11 and Figure 6-12). The excess diversion also reduces the water within the portion of the creek downstream of the diversion beyond what is necessary for conveyance. The assessment did not evaluate whether the structure was in priority or measure the volume of water being diverted.

Figure 6-10 Water diverted into ditch was greater than ditch capacity resulting in overland flow back to creek.

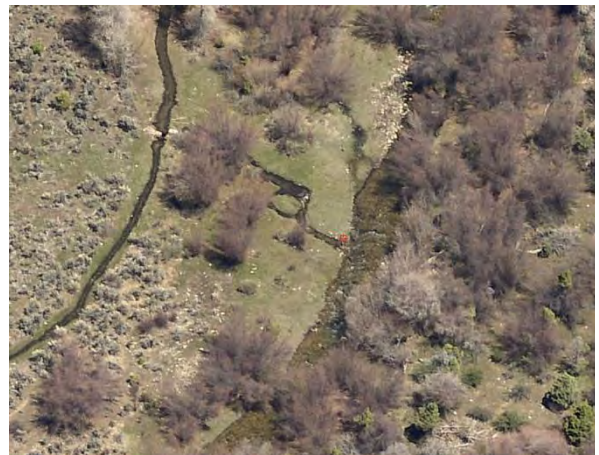
Figure 6-11 Flow returns from excess diversion.

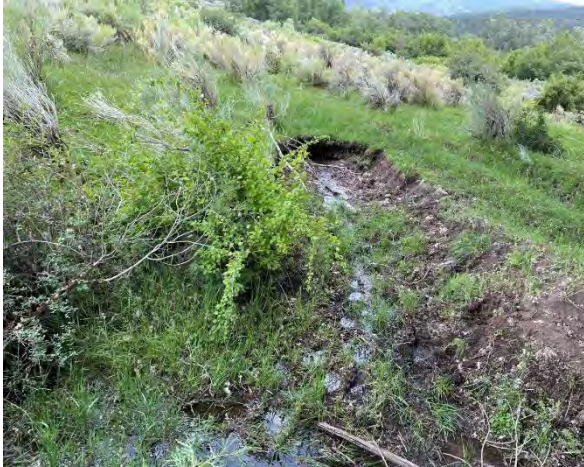
Figure 6-12 Erosion from ditch seepage.

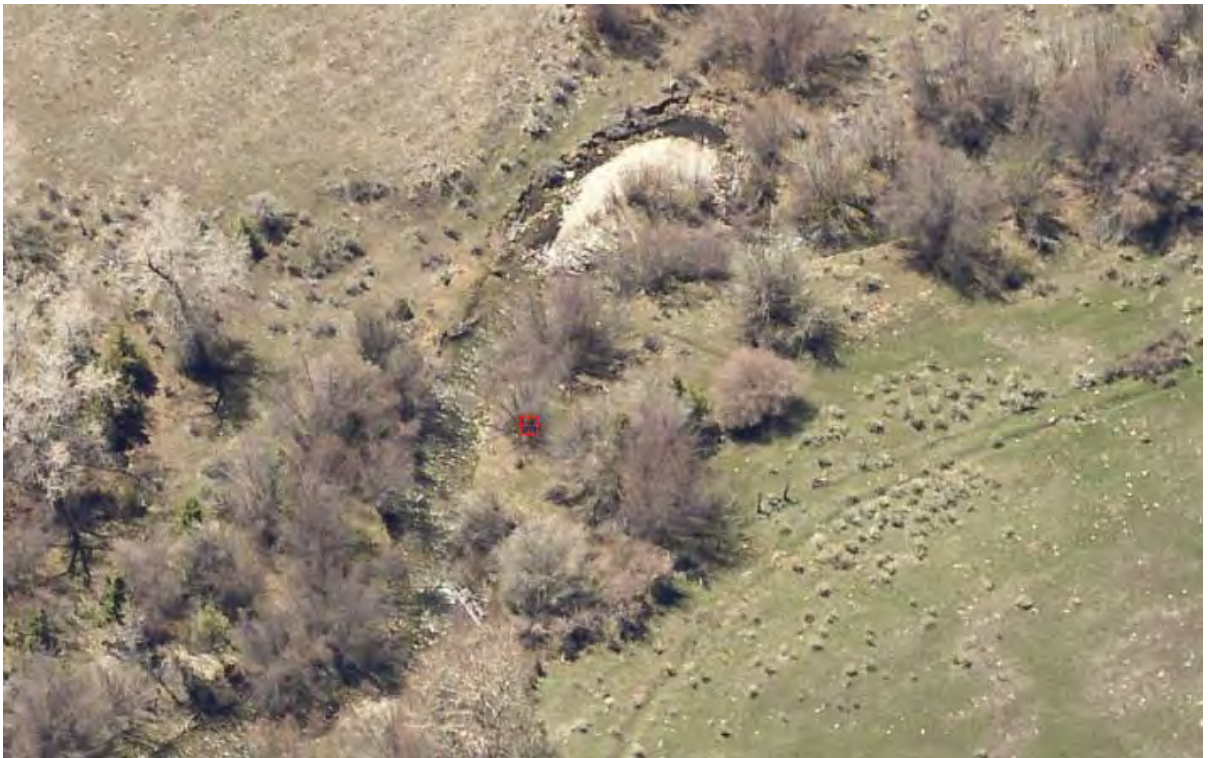
The Fox Ditch Headgate structure does not appear to pose an excessive flood risk. Channel degradation was observed upstream of the diversion dam (Figure 6-13). Aerial imagery shows elevation drops below the diversion structure. These drops may inhibit fish passage (Figure 6-14). No water measurement structure was observed in aerial imagery or reported within CDSS (November 30, 2021). This was one of the structures with recorded headgate orders within the CDSS system indicating the need for a lockable headgate.

Figure 6-13 EagleView imagery of the Fox Ditch Diversion Dam. Notice sediment deposition in the upper third of the photo.

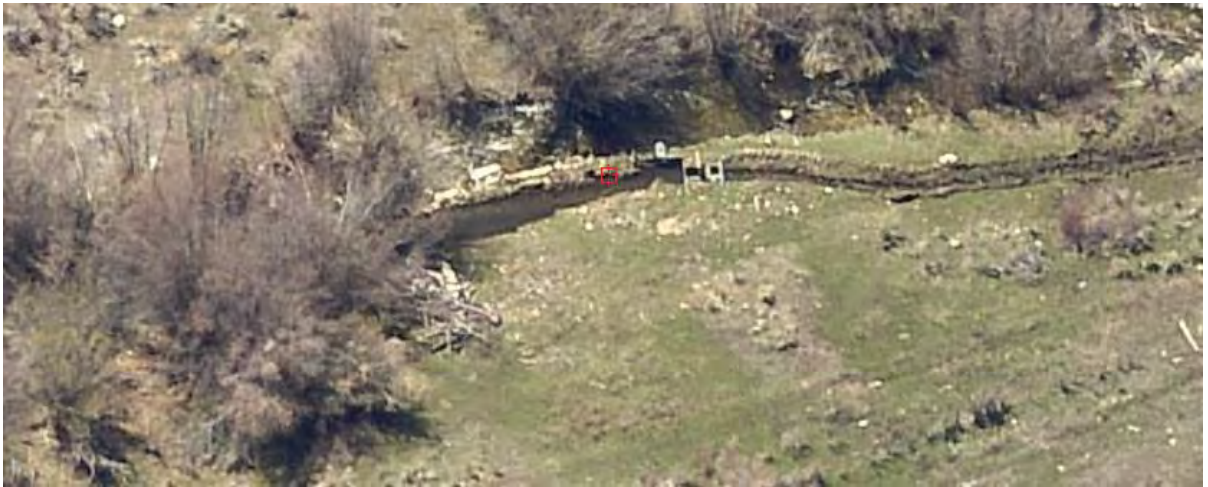
Figure 6-14 EagleView Imagery of the Fox Ditch diversion dam.

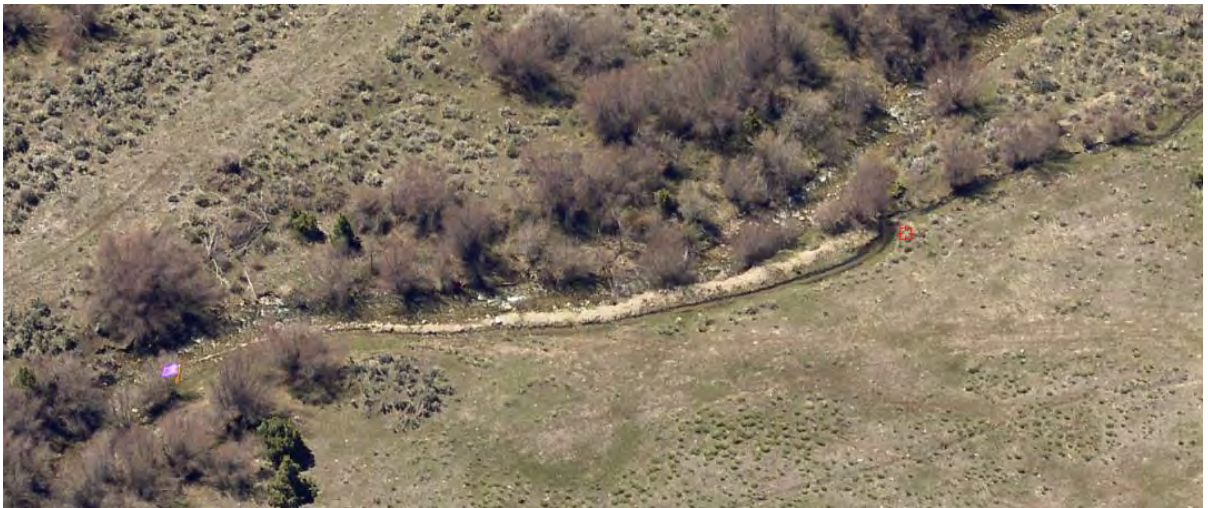
The Clarita Vigil Ditch structure was identified in aerial imagery, shown in Figure 6-15 (approximate coordinates: 473681, 4116042 UTM Zone 13N.). The ditch has a Parshall flume measurement device. Imagery shows scour below the Parshall flume. No regulation structure was observed at headgate. The El Poso Creek stream channel shows some bank instabilities upstream. This ditch is conveyed across an arroyo in a pipe (Figure 6-16), which could be at risk of failure in the event of debris blockage or high flows in the arroyo. The pipe may be promoting sediment deposition prior to El Poso Creek.

Figure 6-15 Clarita Vigil Ditch Point of Diversion. Image from EagleView Connect Explorer – May 13, 2019

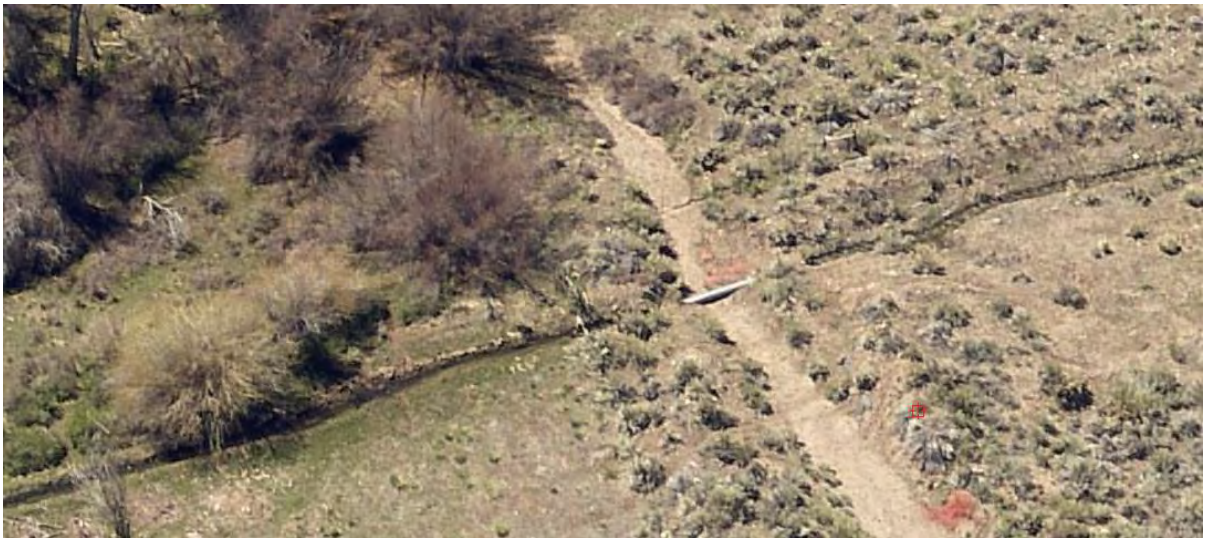
Figure 6-16 Pipe across arroyo - Clarita Vigil Ditch. Image from EagleView Connect Explorer – May 13, 2019

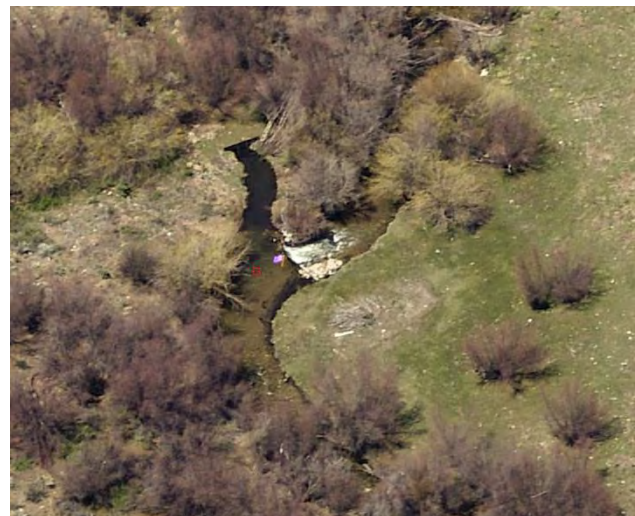
The Albert and Vigil Ditch diverts from the left edge of water of El Poso Creek. The diversion dam is constructed of cobble and debris, as observed from the May 13, 2019, EagleView aerial imagery. Sediment is being actively deposited above the diversion dam with a visible drop downstream (Figure 6-17). As of December 1, 2021, no measurement structure was listed in CDSS. A metal splitter box for return flows is located approximately 600 feet below the point of diversion. Riparian vegetation is present on the left edge of water around the diversion and sparse on the right edge of water near the diversion.

Figure 6-17 Albert and Vigil Ditch Diversion dam in EagleView aerial imagery dated May 13, 2019.

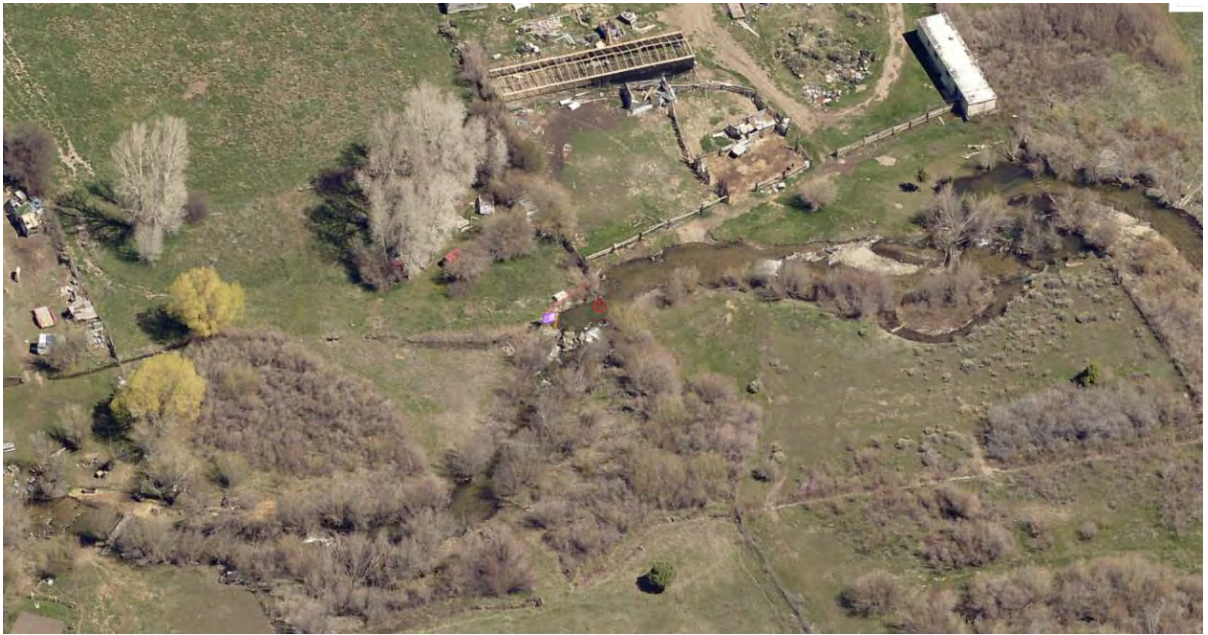
Antonio Sanchez Ditch has a significant drop below the diversion dam structure which appears to be constructed using debris. The debris dam is causing upstream over widening and mid-channel bars within the El Poso Creek (Figure 6-18). Riparian vegetation is not present on left edge of water above the stream. The structure has gates to regulate flow. The structure is not passable by fish. A measurement structure was not identified. Bank erosion upstream of the structure contributes sediment to El Poso Creek.

Figure 6-18 Antonio Sanchez diversion structure, sediment deposition as mid-channel bars observed above the structure along with bank erosion. Structures present in floodplain. EagleView Connect Explorer – May 13, 2019

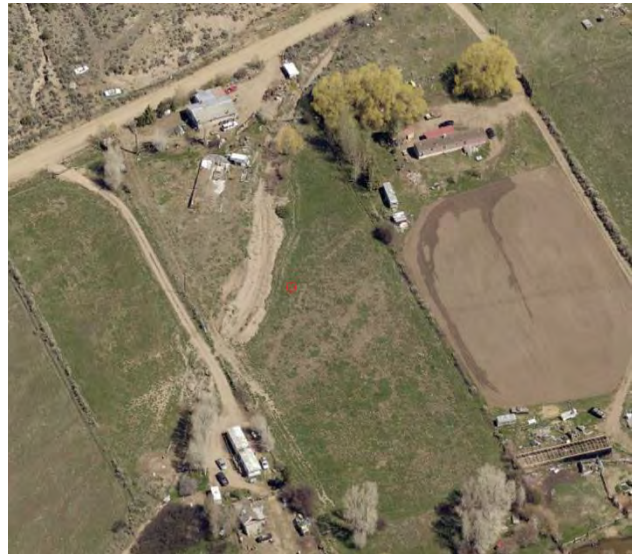
Just below the diversion structure is a confluence with an arroyo that appears to be contributing sediment to El Poso Creek. Figure 6-19 shows the farm north of the Antonio Sanchez Ditch, which is near an arroyo with a high sediment load. Infrastructure and crossing improvements and an upstream sediment trap could improve conditions on this farm and reduce sediment loading to El Poso Creek.

Figure 6-19 Sediment loading on farm. EagleView Connect Explorer – May 13, 2019

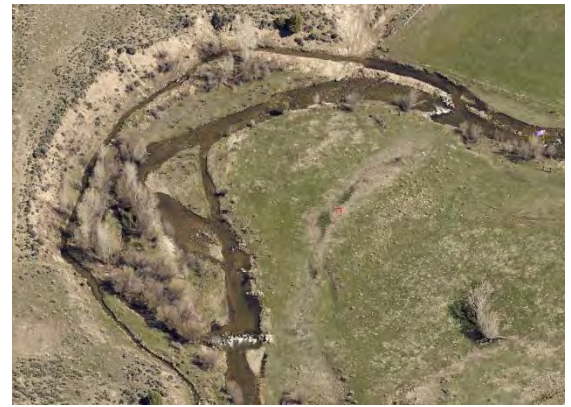
The Guadalupe Sanchez Ditch structure, located on the right bank of Culebra Creek, is the largest in this reach serving approximately 175 acres, (2020 CDSS tabulation accessed December 1, 2021). The structure does not appear to have a headgate to regulate flow. This reach has active erosion and mid-channel bars indicating instability. There is no riparian vegetation on left edge of water of El Poso Creek (Figure 6-21). No measurement structure was identified in the imagery or listed in CDSS (November 30, 2021). This portion of El Poso Creek was likely re-located. El Poso Creek appears to be channelized directly upstream of the Guadalupe Sanchez Diversion combined with the 90-degree bend in the river to meet the bridge at County Road L.7 (Figure 6-20).

Figure 6-21 Guadalupe Sanchez Ditch.
EagleView Connect Explorer – May 13, 2019

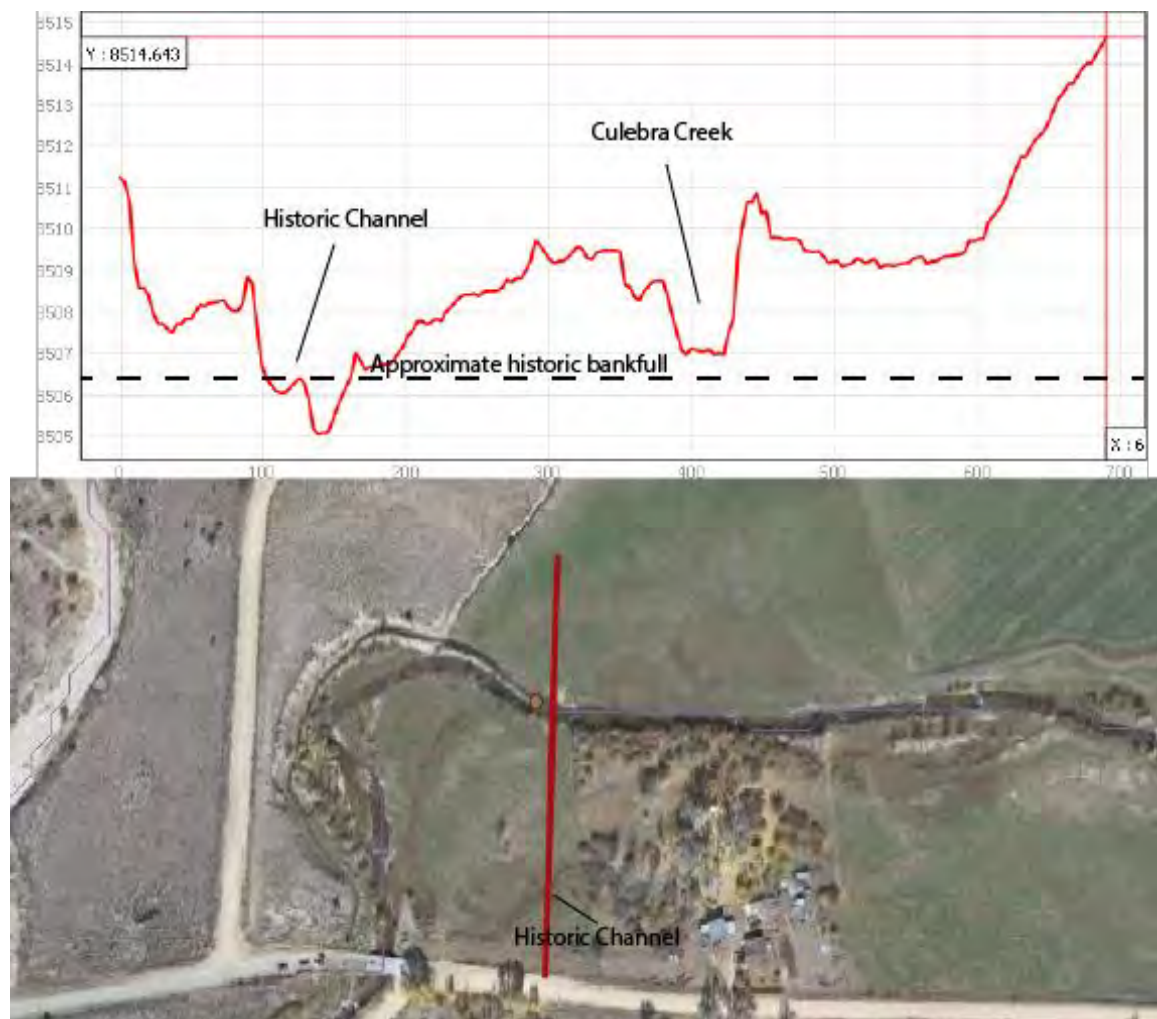
Figure 6-20 Guadalupe Sanchez 2011 Lidar profile. The present-day Culebra Creek channel is approximately two feet higher than the historic channel and wider than the historic channel (approximately 32 ft vs 55 ft).

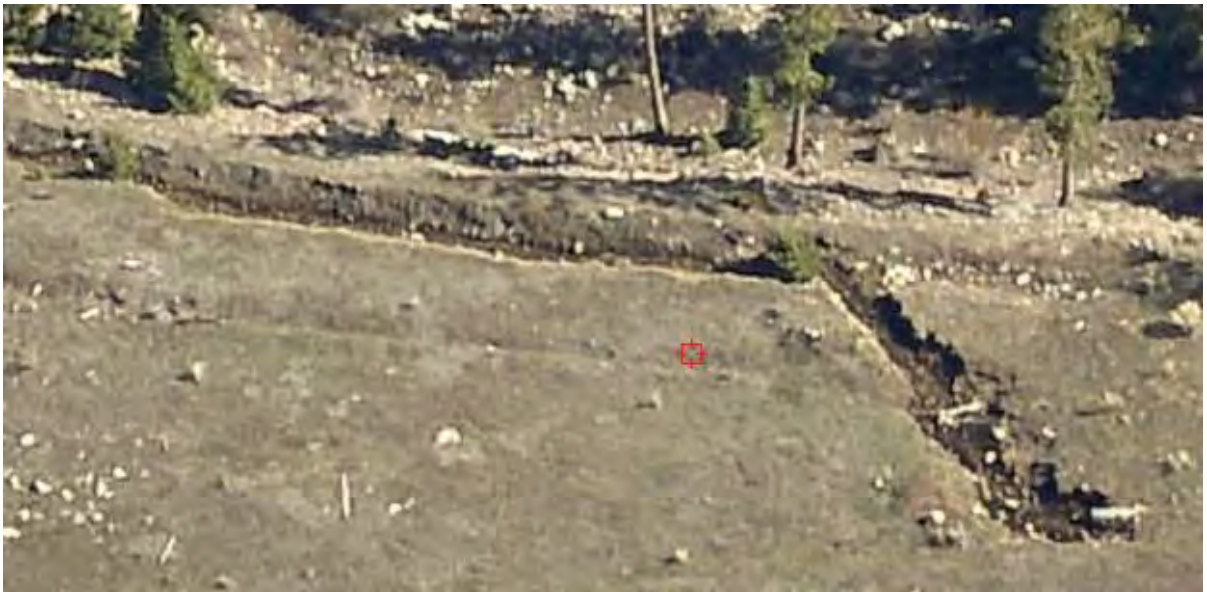
The diversion structure on Canon Valle Ditch was not visible in aerial imagery. The ditch is piped a distance and then emerges from the ground on a terrace (Figure 6-22). Erosion is present in the ditch below the pipe. Providing outlet protection below the pipe would reduce erosion and downstream sediment deposition within the ditch. No measurement device was identified in the aerial imagery or listed in CDSS. This structure would be a viable candidate for a locking headgate, fish screening, and measurement structure to improve fisheries habitat and increase fishery range.

Figure 6-22 Canon Valle Ditch below pipeline.

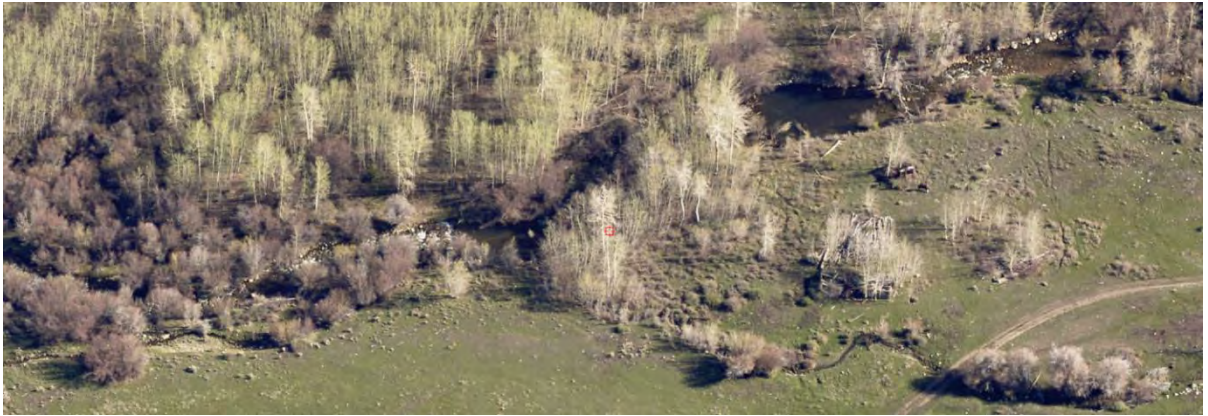
Canon Ditch No. 1 has a small diversion dam made from rock (Figure 6-23). The channel appears to be slightly over widened upstream. Vegetation along left edge of water is in fair condition. This reach may have had some restoration work completed in the past, as there appears to be boulder toe (boulders placed along the bank to prevent bank erosion) visible along the banks. The stream is split in this reach to bring water over to the headgate and returned to the stream. A measurement flume was found in the ditch with some debris in the inlet (Figure 6-24 and Figure 6-25).

Figure 6-23 Canon Valley Ditch diversion structure. Ditch diverting water on right edge of water, shown at the bottom of photo in EagleView aerial imagery from May 14, 2019.

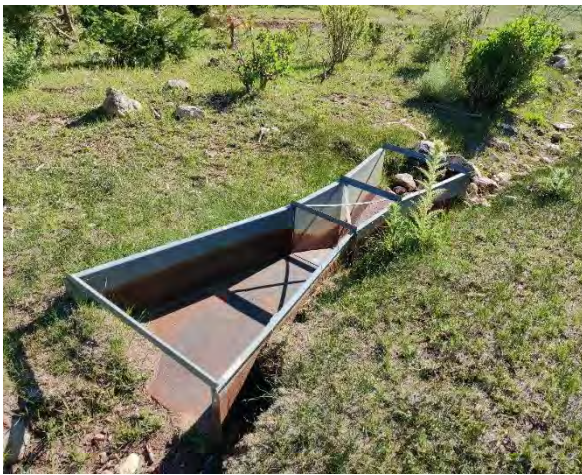
Figure 6-24 Measurement flume Canon Ditch No. 1.

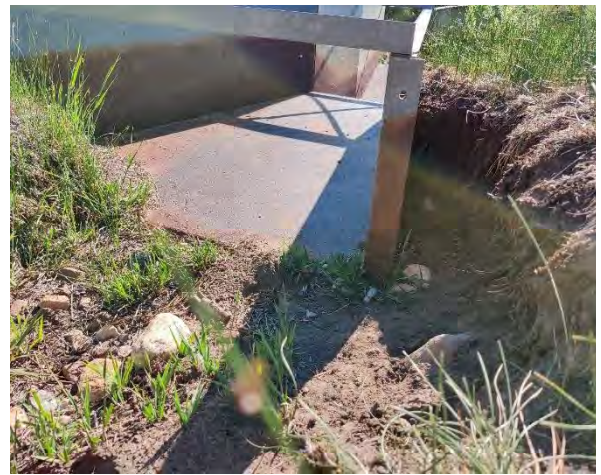
Figure 6-25 Measurement flume with debris in inlet and scour downstream. Scour noted on left edge of flume.

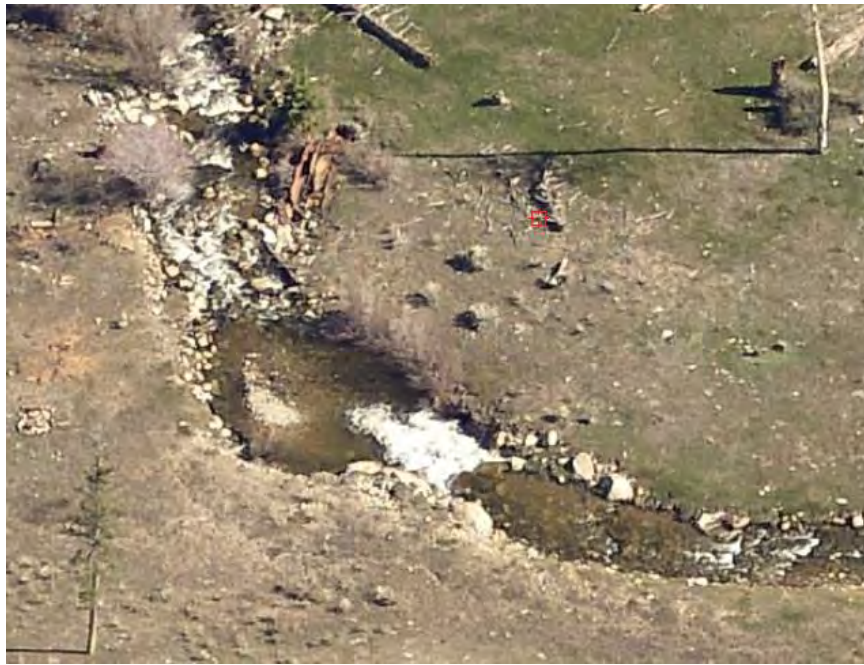
Stream stabilization structures in this reach include structures that were installed backward. The center of the structure is downstream of the arms, rather than upstream, as would be typical of this type of structure. Installing the structure this way forces water toward the banks rather than towards the center of the channel (Figure 6-26). Also noted is the significant drop height on the structures. In most circumstances, it is recommended that the drop height is limited to a maximum of $\frac{1}{2}$ foot to reduce scour depth in a cobble bed stream.

Figure 6-26 Stream stabilization structures near Canon Ditch No. 1. Note structure is placed backward, with the furthest downstream point occurring in the middle of the structure.

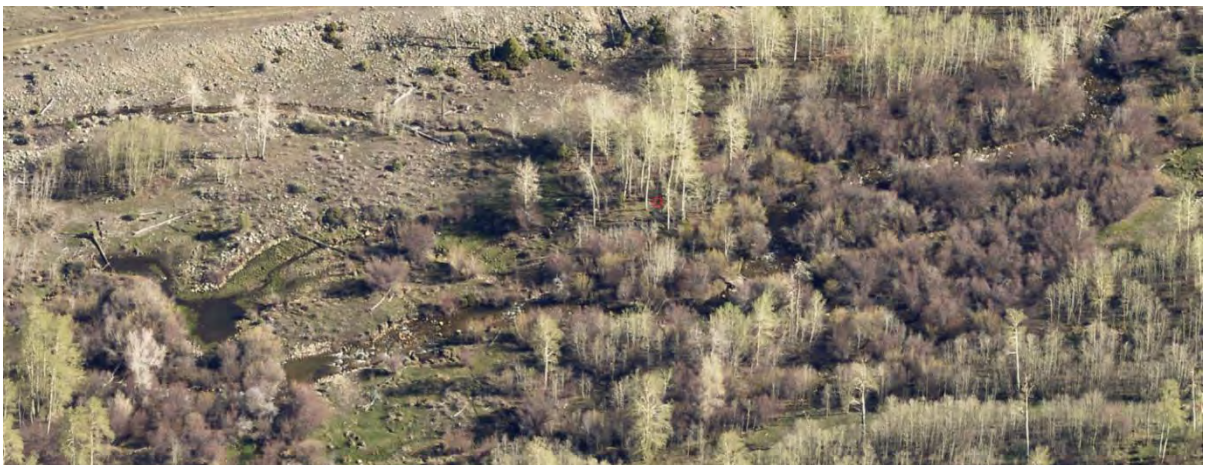
The Jose M Sanchez Ditch does not have a measurement structure listed in CDSS, and the structure was not identified on available aerial imagery. The headgate is a rock dam (Figure 6-27) with multiple rock dams throughout the reach. Significant erosion was noted during the system review in portions of the ditch that could benefit from stabilization (Figure 6-28).

Figure 6-27 Jose M. Sanchez Ditch Headgate. EagleView Connect Explorer – May 13, 2019

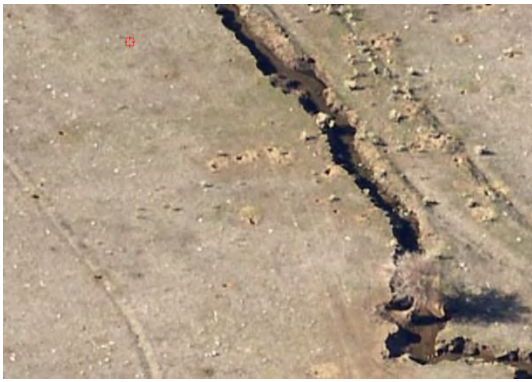
Figure 6-28 Jose M Sanchez Ditch showing significant erosion throughout portions of the ditch.

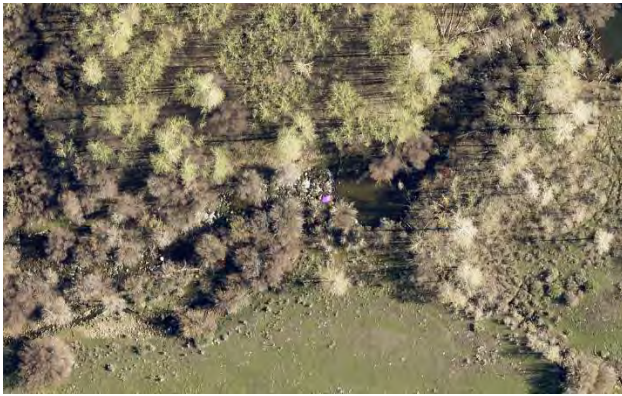
Water is diverted from Culebra Creek just upstream of County Road 25.5 (Figure 6-29). A rock diversion dam diverts water on the right bank toward the south. The ditch is possibly abandoned without reclamation.

Figure 6-29 Unknown ditch diversion on Culebra Creek upstream of County Road 25.5.

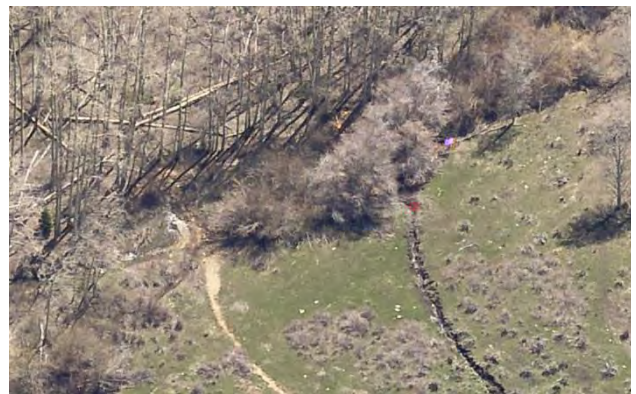
The Alfonso Ditch diverts from Alban Creek. A review of aerial imagery did not identify a structure to regulate flows on this ditch (Figure 6-30). The stream below the diversion has a cattle trail crossing that contributes sediment to the stream. This structure does not appear to pose a significant risk of flooding and being on a smaller tributary should rank lower on prioritization for fish passage.

Figure 6-30 Alfonso Ditch headgate.

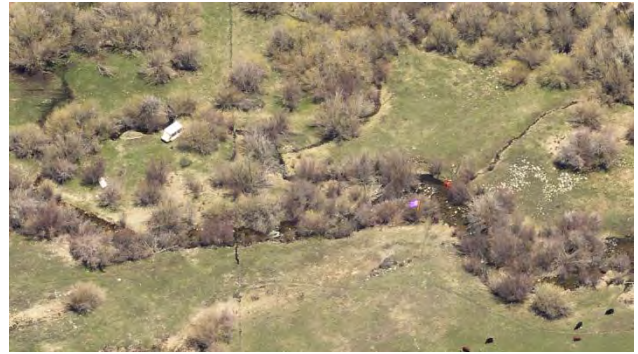
The Gabino Atencio Ditch is a small ditch that does not have a structure to regulate flow. The flow volume appears to be regulated by the ditch size (Figure 6-31). A measurement structure was not identified during the review of aerial imagery. The channel appears to be in good condition, with riparian vegetation along its banks. The structure is just below the ditch return flow. The channel benefits from this water. Additional water may be diverted from return flow just below the point of diversion.

Figure 6-31 Gabion Atencio Ditch Headgate. EagleView Connect Explorer – May 13, 2019

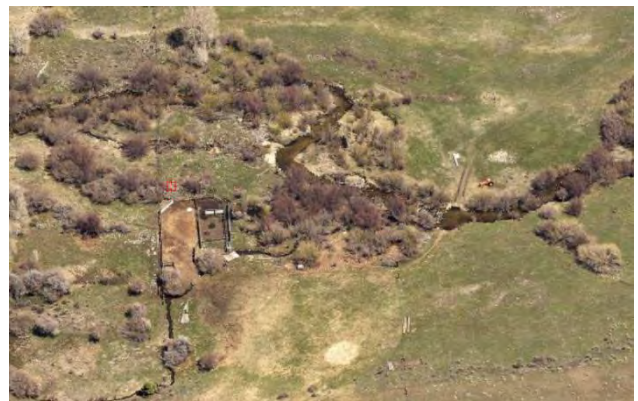
Felipe Vialpando Ditch diversion structure is a small rock structure below a low water crossing (Figure 6-32). Water is taken on the left side of the creek. Riparian vegetation is in fair condition, with no riparian vegetation on left edge of water upstream of diversion. During the review of aerial photography, no measurement structure or regulation structure was identified. The map shows a structure just below the historical Cuchilla Alta Creek channel. In aerial imagery, high-density livestock is shown on the floodplain (Figure 6-33).

Figure 6-32 Felipe Vialpando Ditch. EagleView Connect Explorer – May 13, 2019

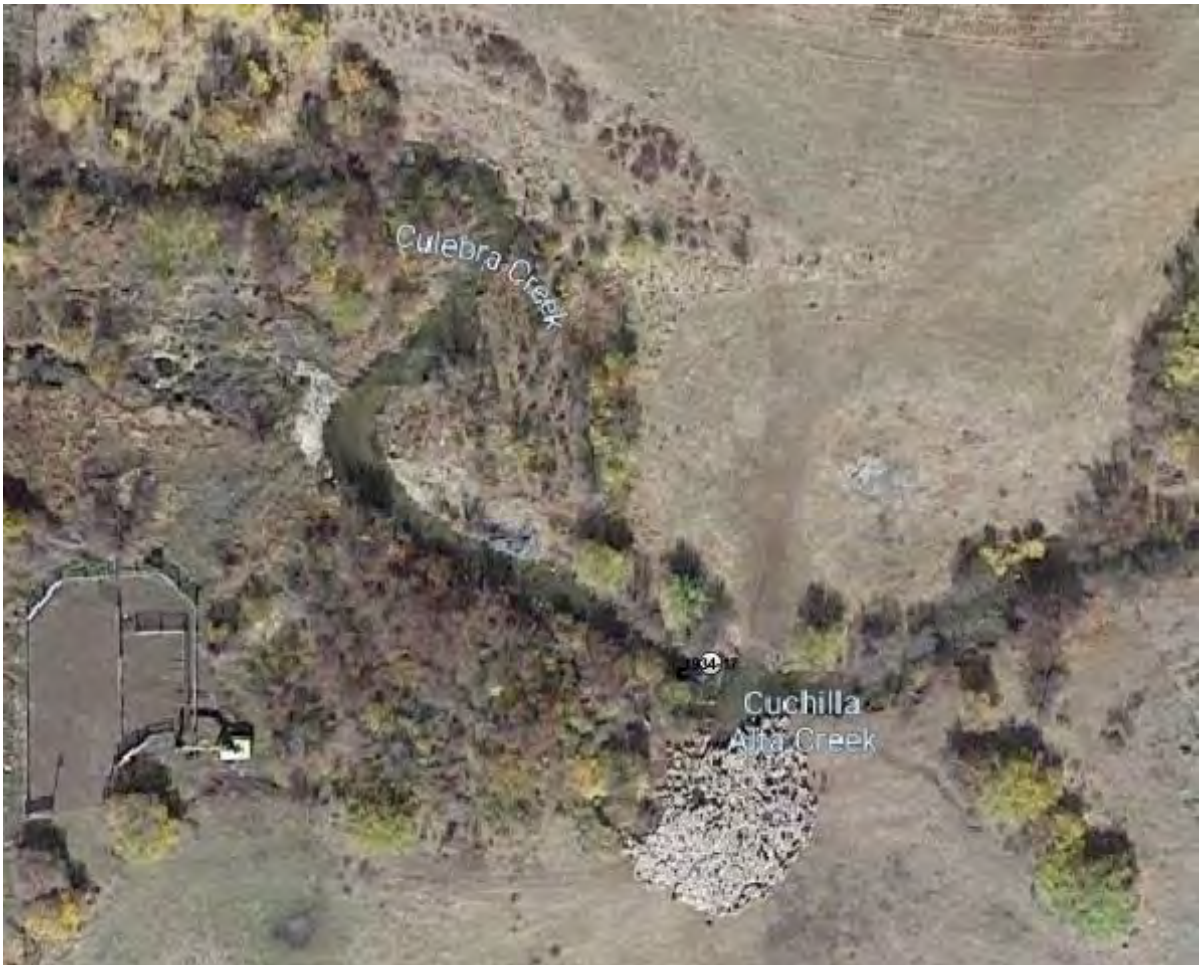
Figure 6-33 High density livestock near headgate. Google Earth Imagery – October 18, 2016.

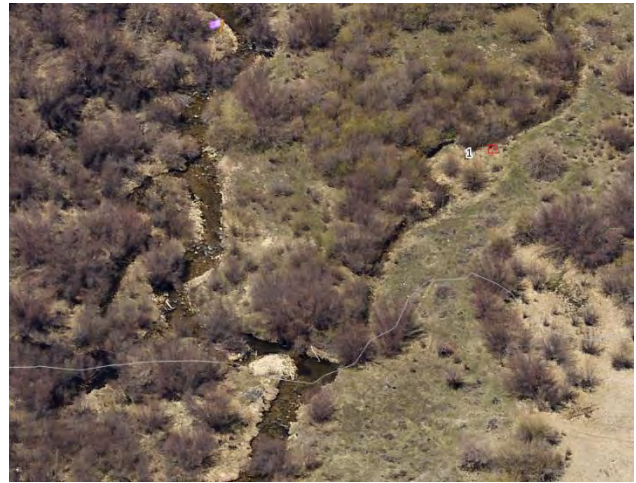
Lobato Ditch No. 1 diverts water from the right side of the creek at a structure that appears to be constructed from rock (Figure 6-35). No headgate or measurement structure was identified in the review of aerial imagery. No measurement structure for this ditch was listed in CDSS.

Figure 6-35 Lobato Ditch No. 1 headgate.

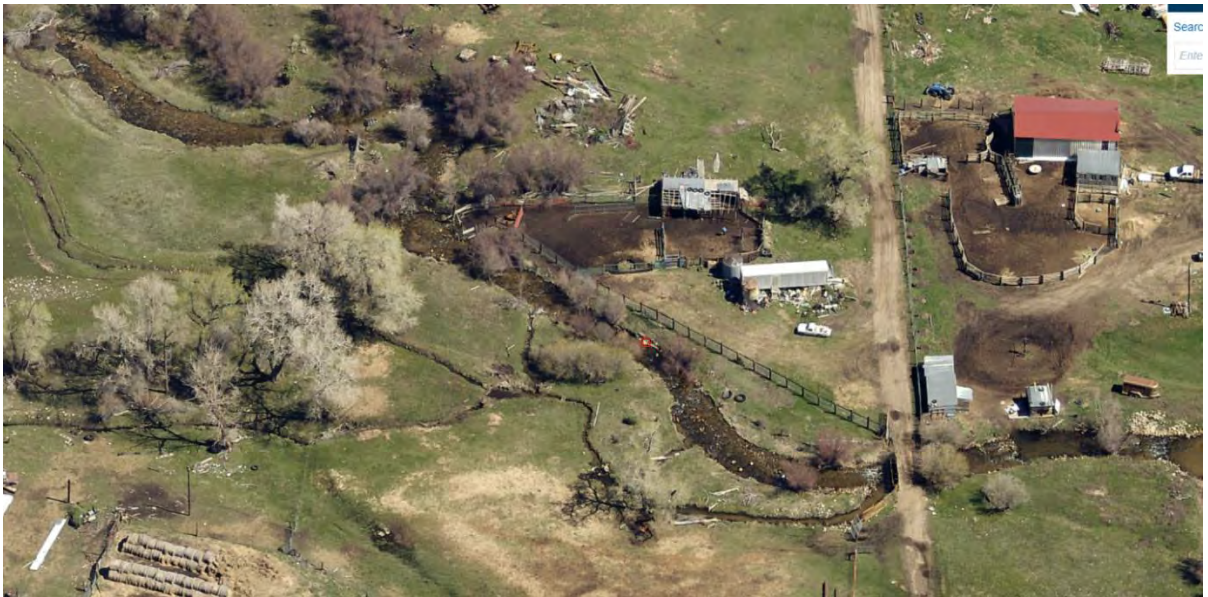
Lobato Ditch No. 2 diverts water from the left side of Culebra Creek (Figure 6-38). A discussion of some of the history of this reach is provided under the Lobato Ditch No. 1 structure. The Lobato Ditch No. 2 structure does not have gates to regulate flow into the ditch. The aerial photograph near the headgate observed return flows from over diversion in multiple locations. Just below the headgate is a high-intensity livestock area. A measurement structure was not identified during the review of aerial imagery. There is minimal riparian vegetation along the ditch. The width of riparian vegetation is approximately 60 feet. The width of the riparian vegetation upstream was approximately 600 feet. There is an abundance of fine sediments in the upstream low water crossing. The low water crossing seems to be frequently used despite the presence of a bridge near the crossing. The structures are likely within the floodplain, flood risk potentially increased by a private bridge over a creek.

Figure 6-38 Lobato Ditch No. 2 Headgate. EagleView Connect Explorer – May 13, 2019

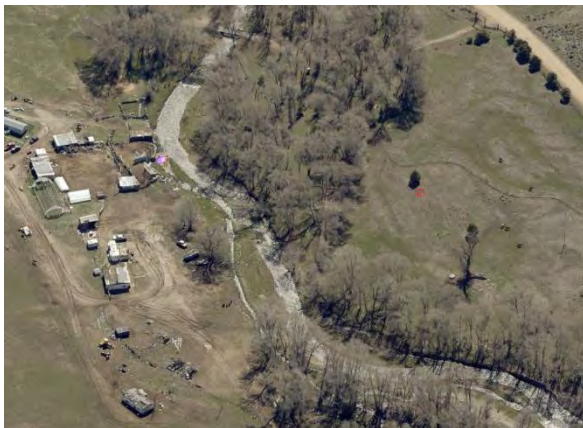
The Pando ditch headgate shows bank erosion along the left edge of water (Figure 6-39). Many structures adjacent to the stream may be at risk of flooding. The risk of flooding does not appear to be increased by diversion structure. No measurement flume was identified during the review of aerial photographs, and none were listed in CDSS (December 1, 2021). The flow is primarily regulated by a rock diversion structure and return flow gate (Figure 6-40 and Figure 6-41). There is evidence of high-density livestock adjacent to the stream (Figure 6-42).

Figure 6-39 Pando Ditch headgate. EagleView Imagery May 13, 2019.

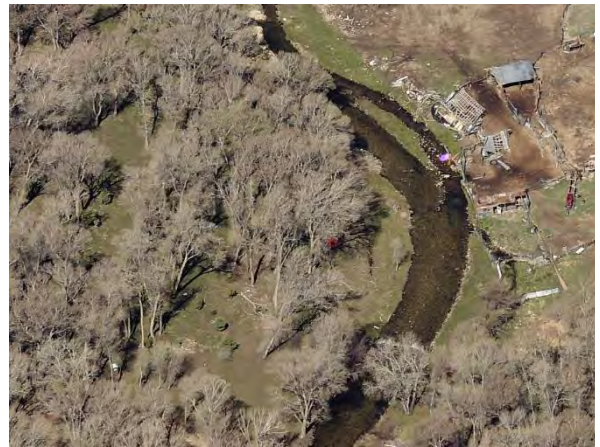
Figure 6-42 High density livestock adjacent to stream, right edge of water. Flow going from bottom to top of photo.
