Upper Culebra Watershed Assessment Report

In Progress Draft

Prepared for Costilla County Conservancy District

Tailwater Limited

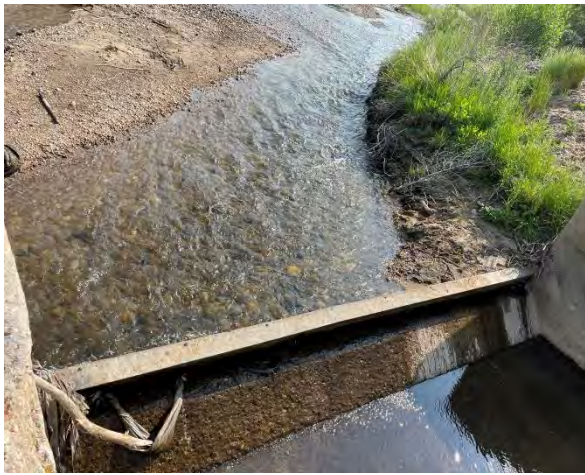
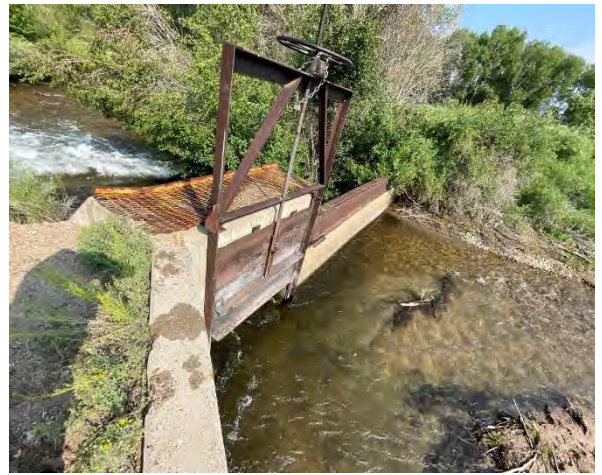
Figure 6-44 Sanchez Canal headgate, headgate seeping into canal. Culebra Creek regulated to flow through four-foot slide gate.

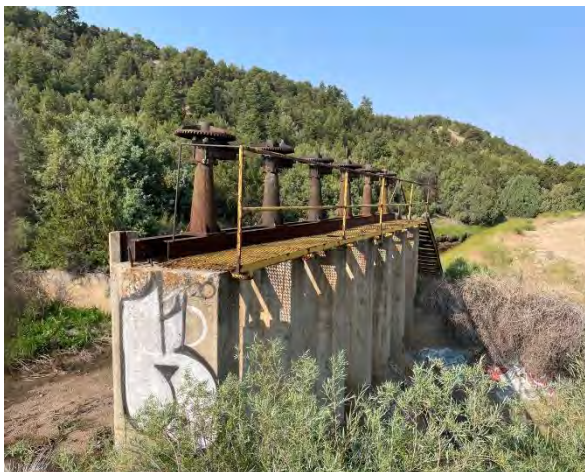
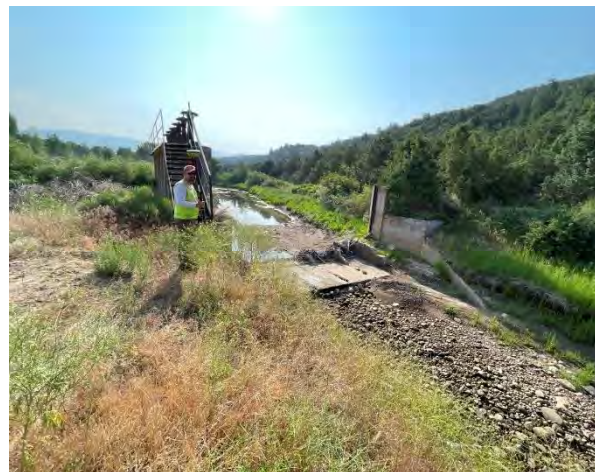
Figure 6-47 Flood gates on Sanchez Canal near Culebra Creek headgate. Concrete apron once had places to insert boards to stop flow down ditch.

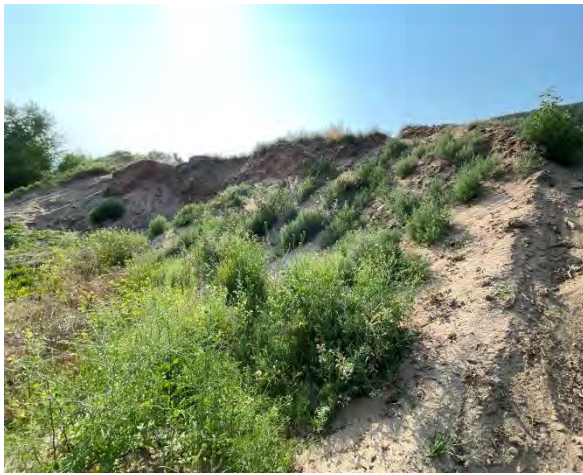
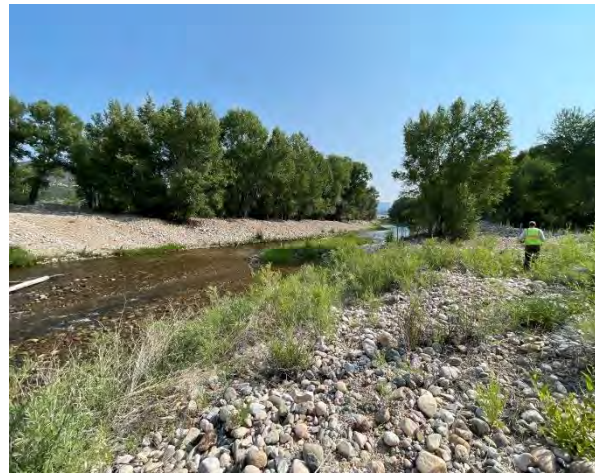
Assessment team representatives visited the diversion structure on July 21, 2021, to evaluate the main structure. During this visit, large piles of sediment were observed along the banks (Figure 6-48) and shown in aerial imagery in Figure 6-45. The diversion structure gates were placed to regulate flow into the creek rather than into the canal (Figure 6-44). Flood gates were deteriorating and do not function to direct flood flows back to the creek (Figure 6-47). Downstream of the structure, sediment piles were noted confining the stream (Figure 6-49), and trash was dumped along the left edge of the stream (Figure 6-50).

Riparian vegetation along the corridor is disturbed by sediment removal from the reach, which also impacts adjacent landowners. Sediment piles increase channel incision, this may increase flood stage and result in unpredictable flow patterns in the event of a flood. The channel above the diversion structure is overwide, increasing stream temperatures and reducing available fish habitat within the reach.

Figure 6-48 Sediment piles from Sanchez Canal.

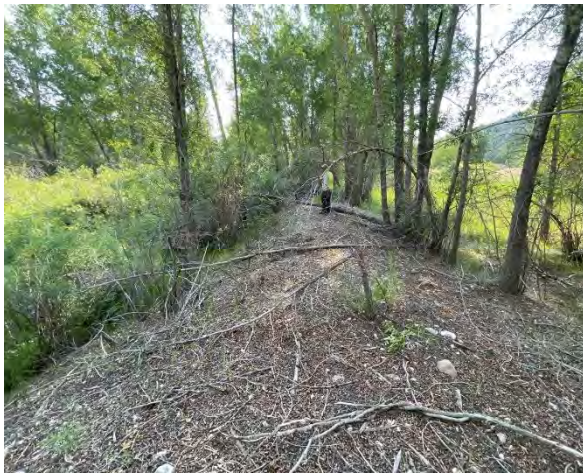
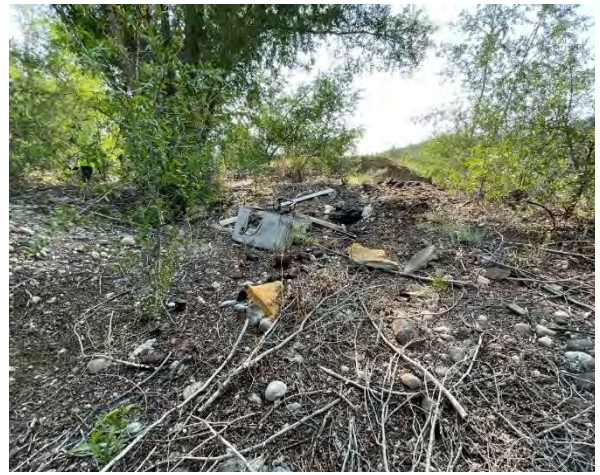
Figure 6-49 Levee or sediment pile along Culebra Creek downstream of Sanchez Canal.

Figure 6-50 Trash dumping near headgate of Sanchez Canal.

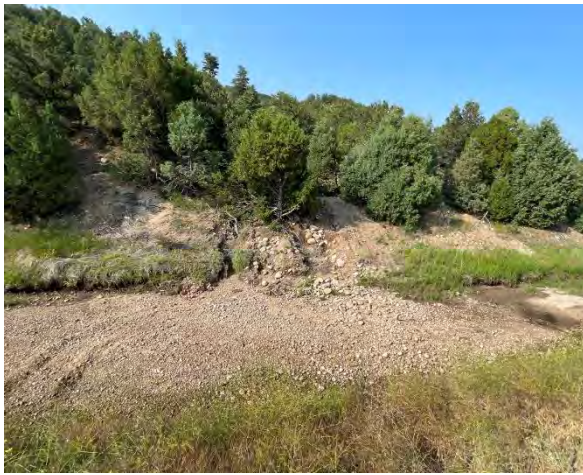
Many areas were noted along the canal where sediments were deposited into the canal (Figure 6-51). These sediments will be transported to Sanchez Reservoir during higher flow events. Excess rainwater was noted within the canal after the rains on July 21, 2021 (Figure 6-52).

Figure 6-51 Canal intercepts sediments and water from hillslopes along the ditch.

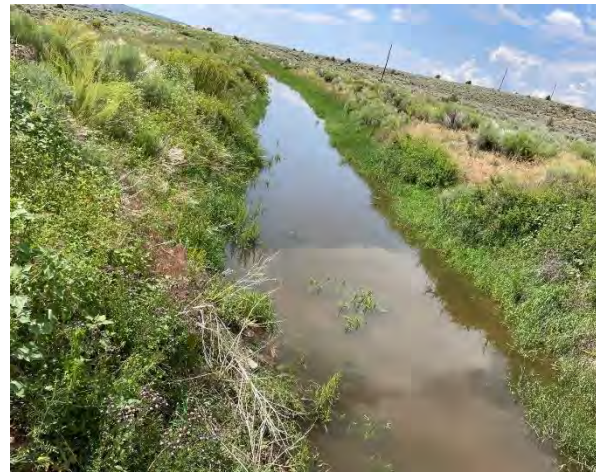
Figure 6-52 Sanchez Canal intercepts rainwater near County Road K.5 on July 22, 2021.

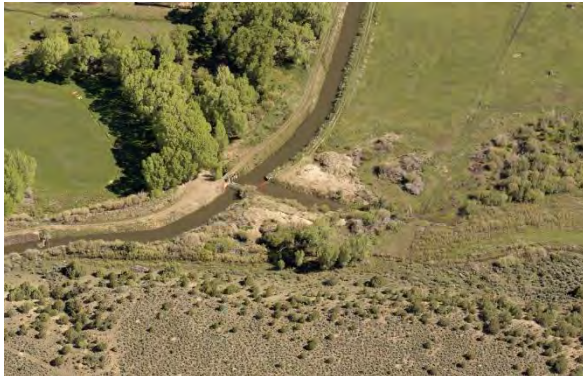
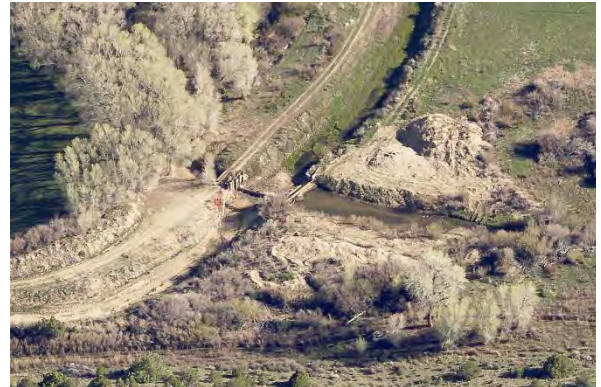
Similar to the main headgate, Sanchez Canal regulates flows in the creeks at Vallejos Creek (Figure 6-53 and Figure 6-54) and San Francisco Creek rather than regulating flows into the canal (Figure 6-55, Figure 6-56, and Figure 6-57). The Vallejos Creek headgates were recently replaced and are in better condition than the other two diversions. Figure 6-54 shows large piles of sediment along the banks near Vallejos Creek, where sediment was removed from the creek. On Sanchez Canal above San Francisco Creek, drains were noted going directly into the canal along with trash. Some of the trash included an older television set that likely includes mercury-containing components, which may impact water quality.

Figure 6-53 Sanchez Canal Vallejos Creek. From EagleView Aerial Imagery dated June 4, 2019

Figure 6-54 Sanchez canal at Vallejos Creek. From EagleView aerial imagery dated May 13, 2019.

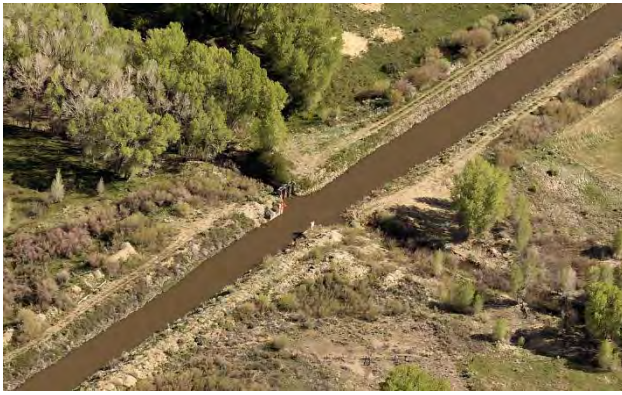
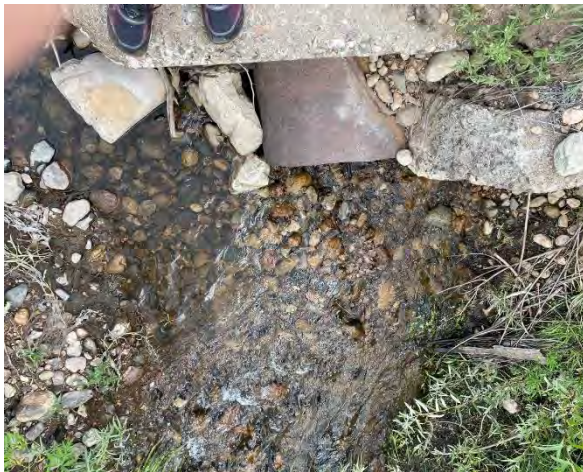
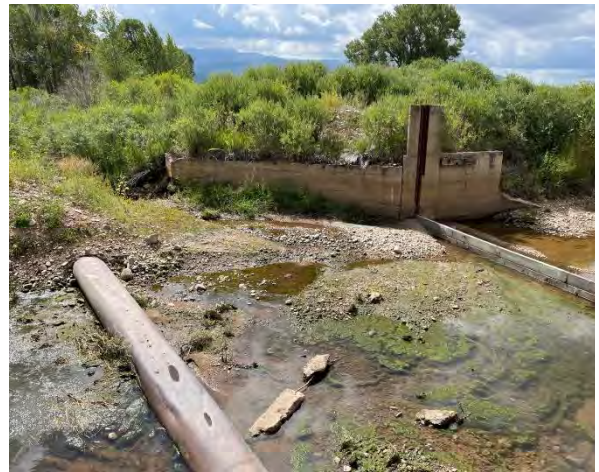
Figure 6-55 Sanchez Canal at San Francisco Creek crossing. From EagleView aerial Imagery dated June 4, 2019

Figure 6-56 San Francisco Creek below Sanchez Canal August 19, 2021.

Figure 6-57 Pipe conveying San Francisco Creek through Sanchez Canal.

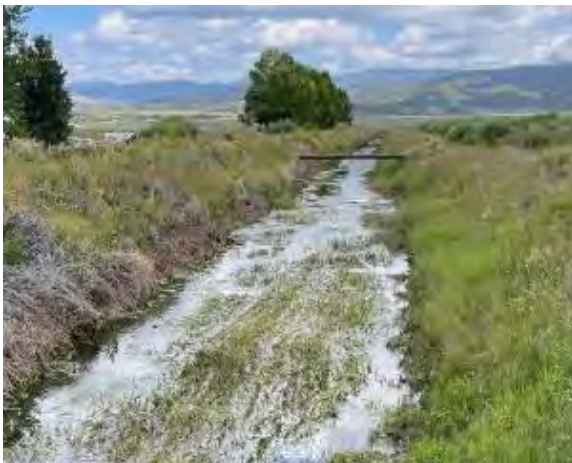
In addition to the issues with the headgates, reports were made that there were issues conveying water across the Sanchez Canal. During the assessment, some of the pipes across the canal were observed (Figure 6-58). In addition, the EagleView aerial imagery shows water being backed up above the canal through the Vallejos and San Francisco Creek floodplains (Figure 6-59 and Figure 6-60).

Figure 6-58 Pipes transporting ditch return flows across Sanchez Canal.

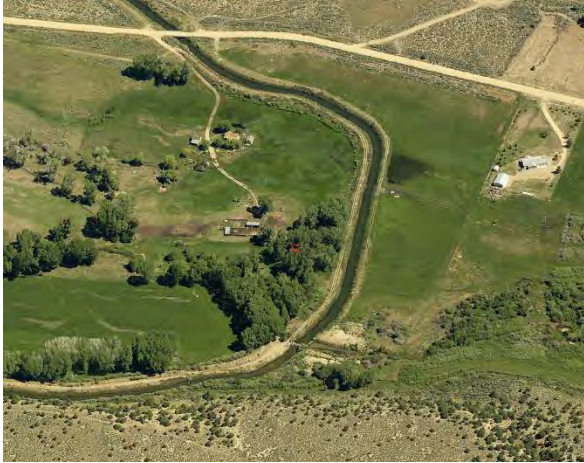
Figure 6-59 Backwater from canal embankment right edge of floodplain Vallejos Creek.

While Sanchez Canal represents exceptional construction and engineering for the period in which it was constructed, improvements could be made to the system to improve operations, reduce conflict, reduce flood and water quality risks, and improve the ecology of the streams that this canal intersects. This structure is impacted by fine sediment erosion upstream of the structure that deposits within the diversion structures from each stream.

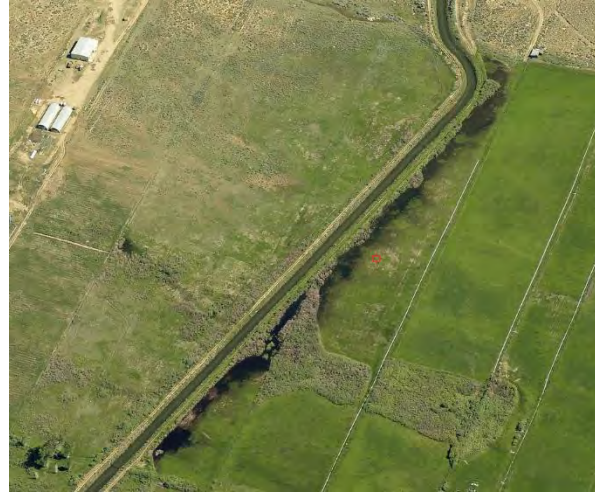
Figure 6-60 Canal causing backwater right floodplain San Francisco Creek drainage.

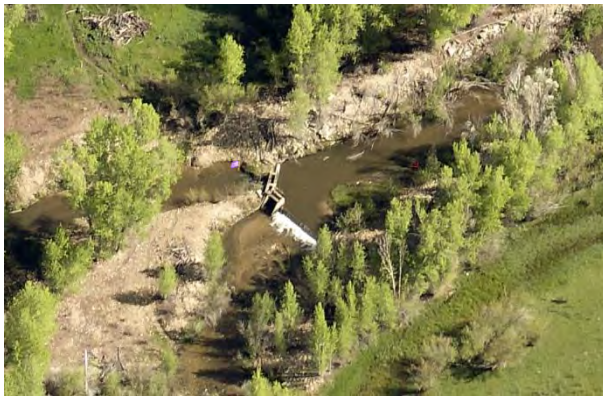
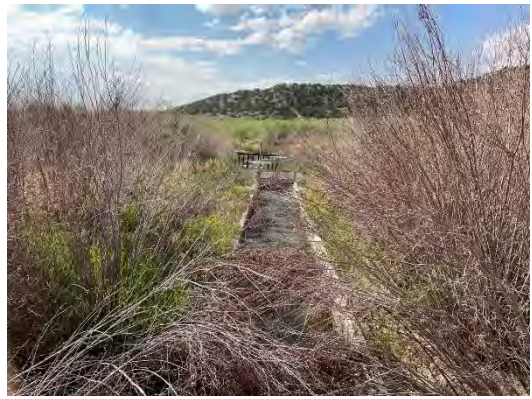
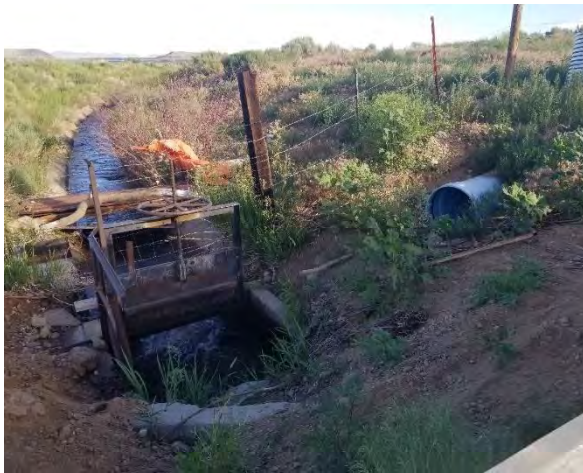
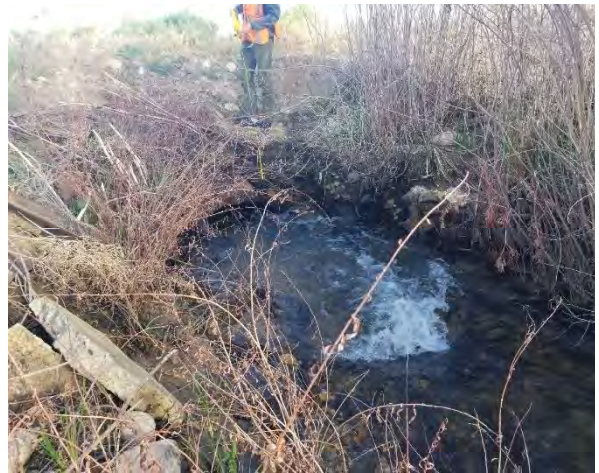
On the Cerro Ditch, historic channel cleaning and bank stabilization appear in the aerial photo on the right edge of water upstream of diversion. The measurement structure for this canal is a 4-ft Parshall flume, and the canal is lined below the headgate. The channel is overwide upstream of the diversion dam, increasing stream temperatures, increasing sediment deposition, bank erosion, and decreasing fish habitat. Sediment deposition upstream of the dam is shown in aerial photography (Figure 59). This diversion dam is likely a fish barrier at some, if not all, stages. The new concrete splitter box appears to be functioning and has improved safety, including catwalk for access (Figure 6-63). This structure is Priority 11, and as such, must pass water downstream to the senior San Pedro Ditch and is not a sweeping point on Culebra Creek. This structure does not appear to cause significant flood risks because there is no development in the floodplain. This is an area to continue to protect from development. Portions of this ditch have been lined; some issues were noted along the ditch with access to headgates due to dense willows that are difficult to remove using typical methods.

Figure 6-61 Cerro Ditch headgate.

Figure 6-62 New concrete splitter box on Cerro Ditch.

Figure 6-63 Cerro Ditch farm headgate.

Figure 6-64 Upstream of culvert above Cerro Ditch farm headgate shown in Figure 6-63

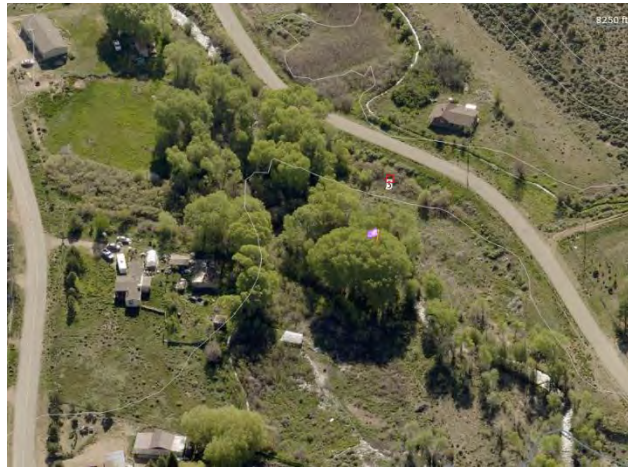
The Mondragon Ditch diverts in an area with multiple residential structures. This reach has good tree cover, but the riparian vegetation becomes sparser in areas. In the EagleView aerial imagery dated June 4, 2019, it appears that some irrigation is occurring directly below the headgate near residential structures, although this may be due to excessive diversions. Because this structure diverts on the same side of the creek and irrigates lands that the Cerro Ditch could also serve, any adjustments to this structure should consider moving the point of diversion up to the Cerro Ditch diversion, thus reducing the number of structures impacting the creek. No assessment of the diversion dam or measurement structure was made.

Figure 6-65 Mondragon Ditch headgate. Ditch shown in lower center of picture.

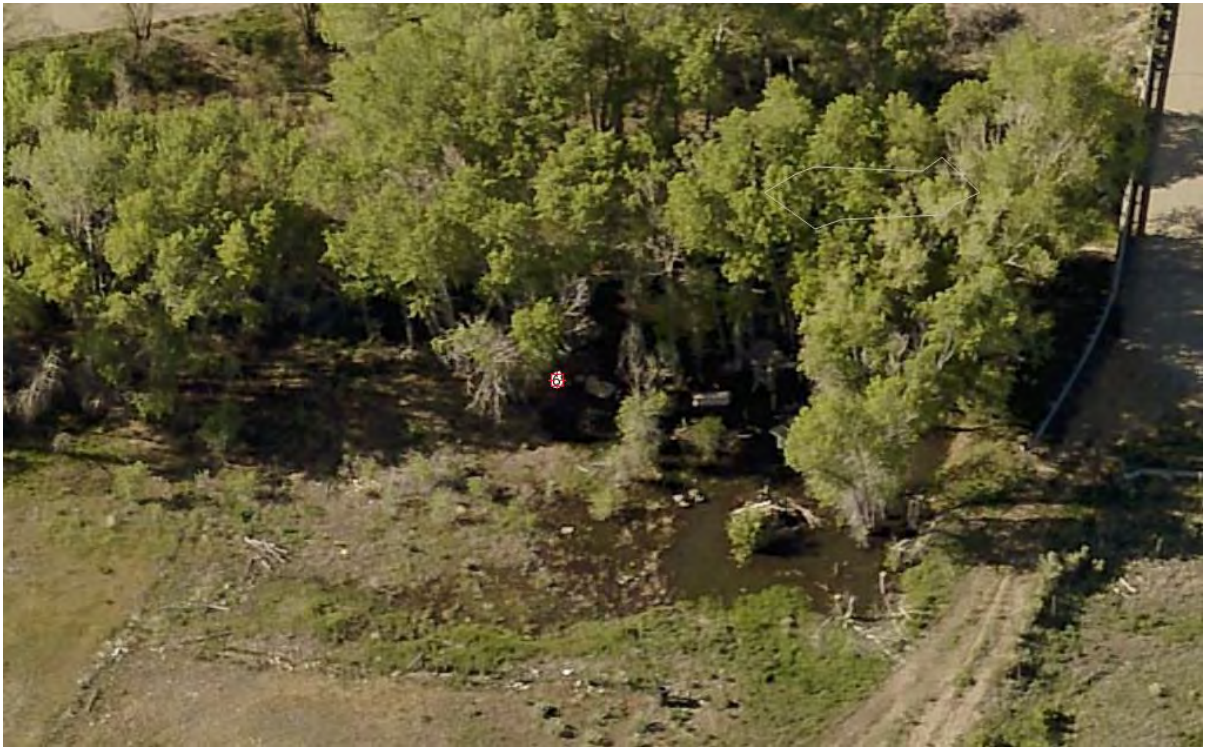
The point of diversion for the Rodriguez Ditch is upstream of County Road 23.8. With a 2001 priority date, this relatively junior water right receives water most years and appears to be functioning. No information was available on the headgate or measurement structure.

Figure 6-66 Water backed up behind County Road 23.8 bridge near Rodriguez Ditch headgate

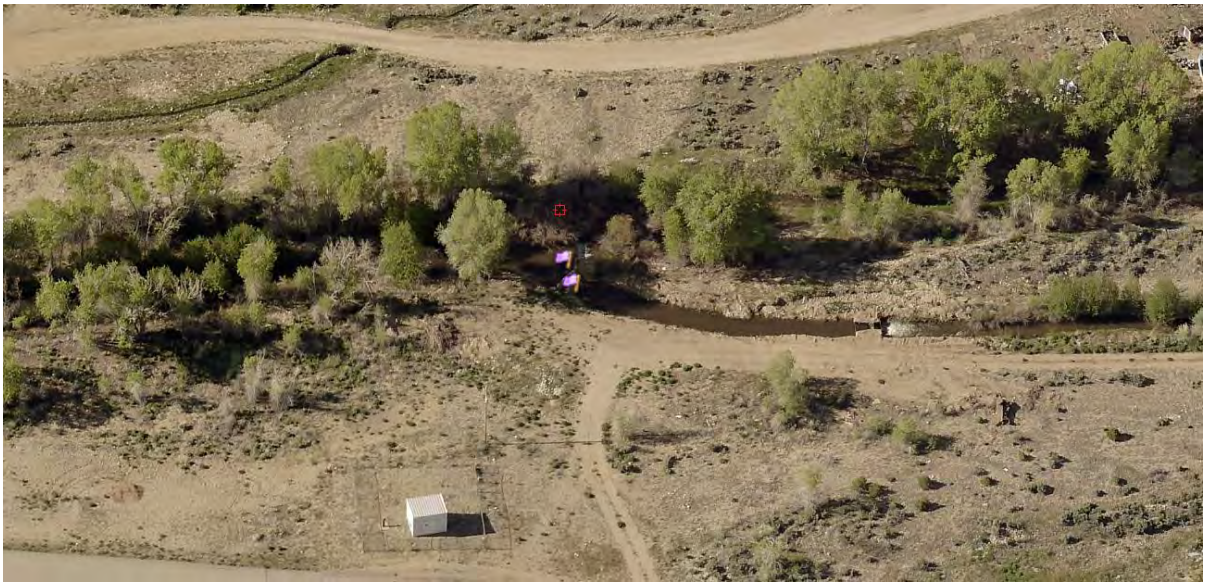
The San Pedro Ditch is the first structure on Culebra Creek that sweeps the stream. This structure is considered functioning with respect to the requirements for diversion structures and the ability to divert water (Figure 6-67). The structure has been channelized by constructing levees on both banks, removing access to the floodplain, and increasing shear stresses (Figure 6-68). Structures upstream have reduced the transportation of sediment and water, therefore, aggradation upstream of the structure is not a concern. The San Pedro 4-ft Parshall flume could be upgraded to include a data logger. The Parshall flume appears to have a significant drop below the structure, increasing downstream erosion. The Culebra Creek channel is severely degraded below the structure due to levees and historic channelization. The San Pedro Ditch diversion dam results in a backwater, which could increase flood risk when combined with the development of this structure. This structure likely impedes fish passage when the structure is not diverting.

Figure 6-67 San Pedro Ditch headgate and measurement flume.

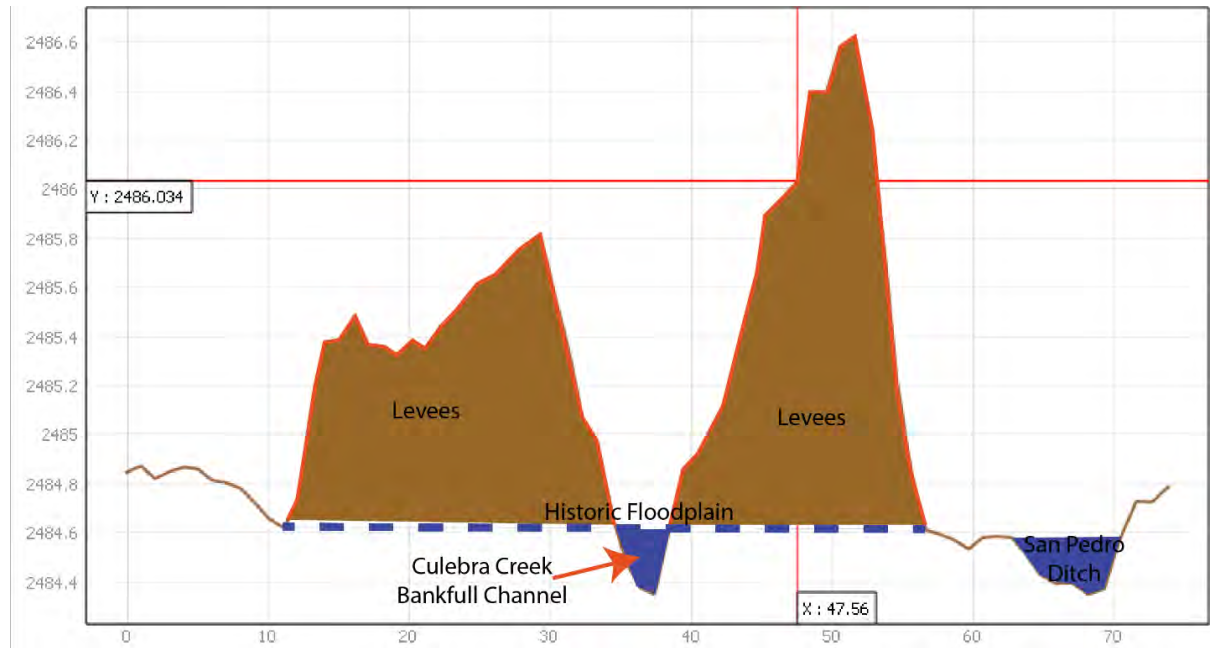
Figure 6-68 Cross-section profile of San Pedro Ditch near the San Pedro Diversion Dam. Note the height of the levees constructed around the creek increasing channel incision. Note units on both axes are in meters.

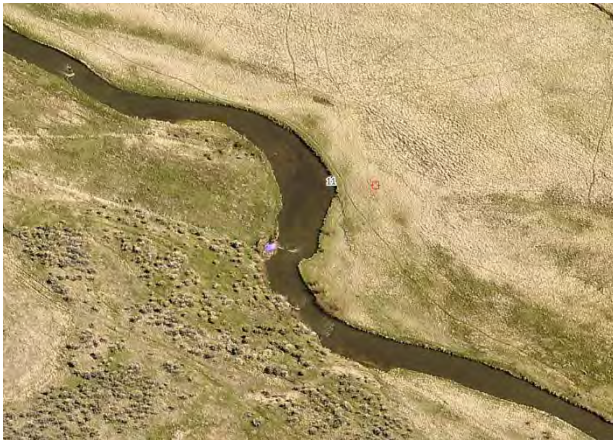
The Lucero Ditch is the first diversion below the confluence with Ventero Creek, diverting water on the left bank. The Diversion dam appears to be a small cross vane structure. No headgate or measurement structure was identified during the available aerial photographs review. The structure was located by following the ditch upstream. No issues with this structure were noted during interviews. The structure does not appear to be a fish barrier. It appears to pass sediment and is not likely to increase flood risk.

Figure 6-69 Lucero Ditch point of diversion. Image from EagleView dated June 2, 2019.

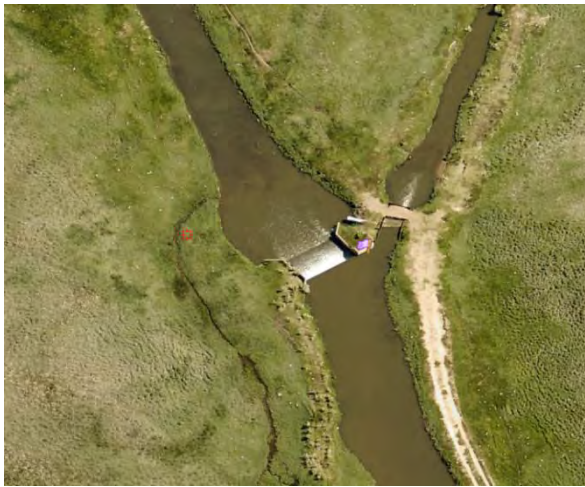
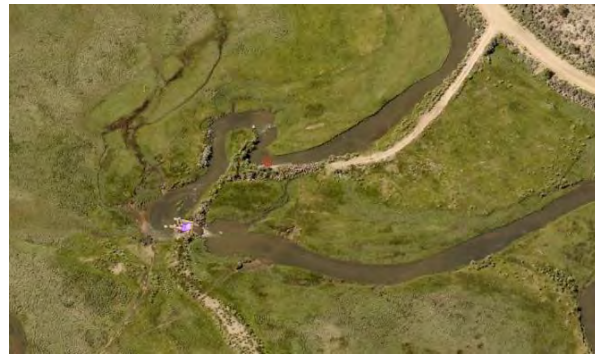
This diversion structure is new and was moved approximately 1,200 feet upstream of the historic diversion dam (Figure 6-70). The new structure does not have any overhead structure, which reduces the risk during flooding. A sediment sluice is present at the headgate. The structure reduces fish passage with an approximately 5-foot drop off the structure. A downstream historic diversion structure was abandoned in place, leaving the concrete structure and floodplain grading in place (Figure 6-71). The structure has a measurement flume without a logging device. There is no riparian vegetation around the structure, and some upland vegetation encroachment along banks. Any improvements to this structure should evaluate flooding around the structure to ensure San Luis People's ditch is not a conduit to increase flooding on San Luis residents. San Luis People's ditch intercepts return flows from the Cerro Ditch (Figure) that are downstream of the measurement flume. Approximately half of this ditch was recently relined with concrete, and in general, the turnouts were reported to be in good condition. The Mayordomo reported that there are issues with seepage that if corrected could improve down-ditch operations, especially for those water users at the end of the ditch.

Figure 6-70 San Luis People Ditch Diversion Dam. EagleView aerial imagery June 2, 2019.

Figure 6-71 Old diversion dam. EagleView aerial imagery June 2, 2019.

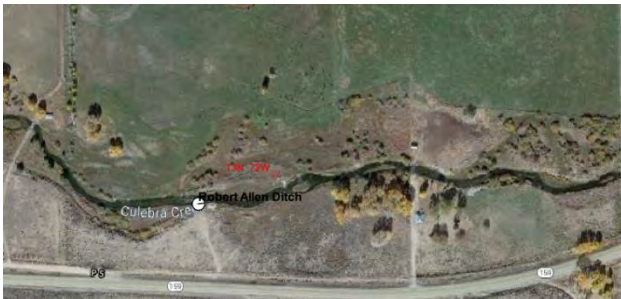
The Robert Allen Ditch diverts water from the left bank of Culebra Creek (Figure 6-72) in a portion of the creek that appears to have been straightened. No information regarding the measurement flume was available or listed in CDSS.

Figure 6-72 Robert Allen diversion structure.

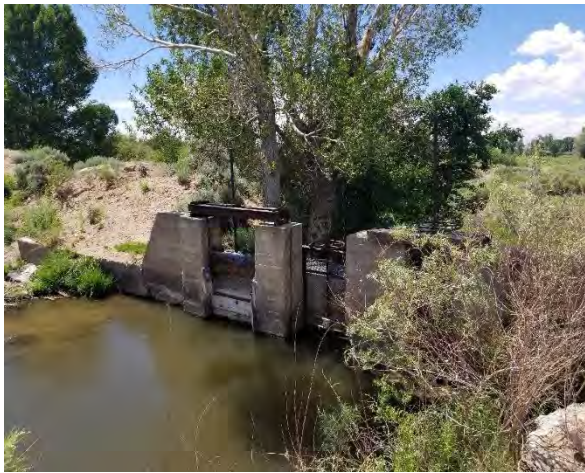
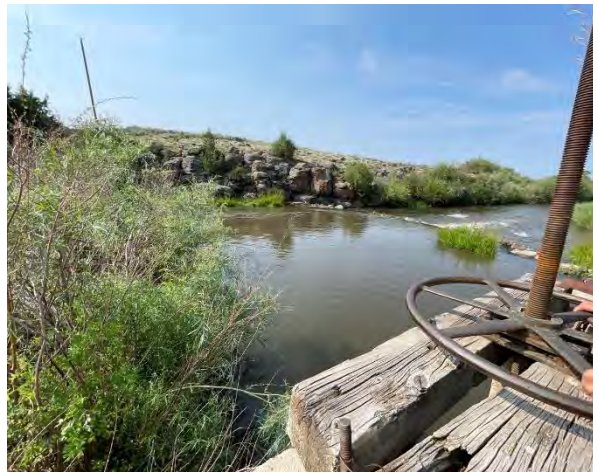
These three ditches use a common diversion dam to divert water from Culebra Creek (Figure 6-73). The diversion dam was recently rebuilt to improve operations at these three structures. The diversion dam backs up water such that houses are infrequently flooded during winter (Figure 6-74).

Figure 6-73 Culebra Cerritos, Island Ditch, and Francisco Sanchez Headgates.

Figure 6-74 Culebra Cerritos, Island Ditch, and Francisco Sanchez diversion dam.

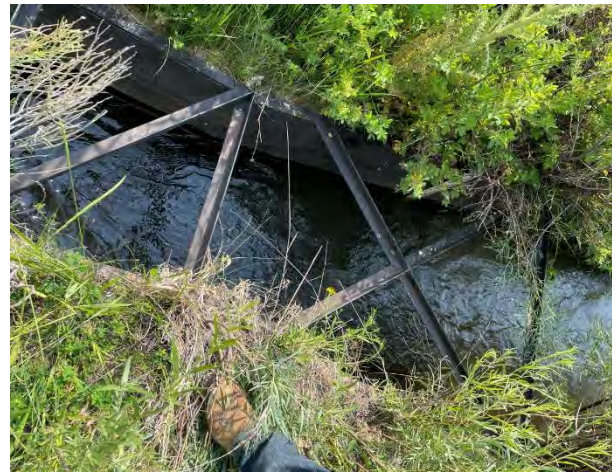
The Francisco Sanchez is the eastern ditch diverted from the diversion headworks. Water users reported that the canal brings sediment down the ditch. The Francisco Sanchez flume was submerged during the site visit (Figure 6-75).

Figure 6-75 Francisco Sanchez measurement flume, submerged - inoperable.

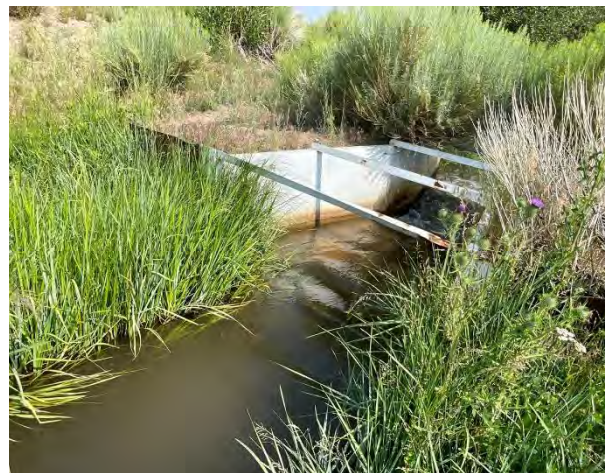
Culebra Cerritos Canal and Island Ditch
Flows into this ditch are measured by a 6-foot Parshall flume (Figure 6-76). The structure was found to have significant growth in the entrance of the flume along with a standing wave. The staff plate was also located in the wrong position along the flume wall. Sedimentation is present along the banks of the canal.

Figure 6-76 Culebra Cerritos Canal and Island Ditch 6-ft measurement flume.

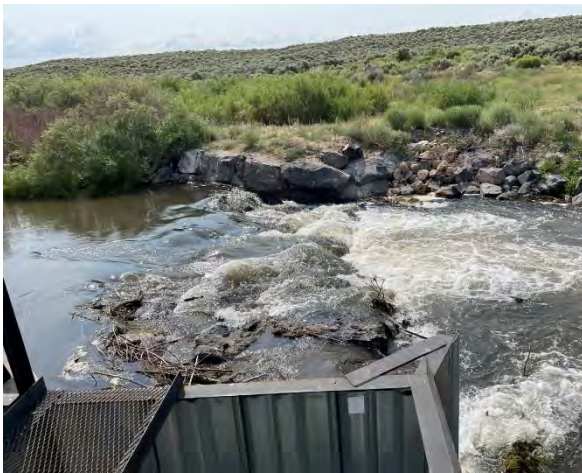
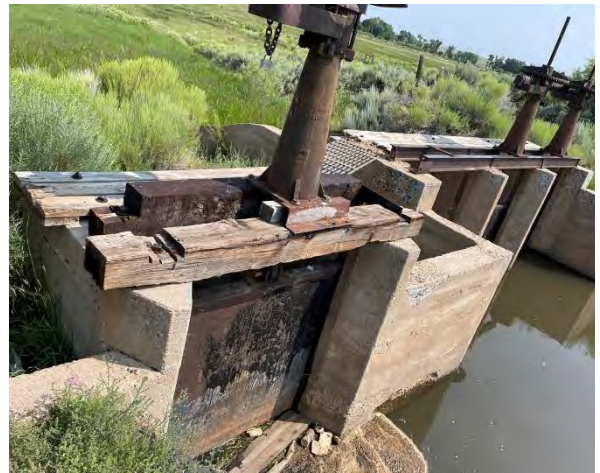
The San Acacio Ditch diversion dam was recently rebuilt (Figure 6-77). This new dam raises the water surface and diverts water more reliably than the previous dam. No changes to the gate structure were made when the dam was rebuilt, and the gates are all difficult to operate and icing in winter makes getting cattle water difficult (Figure 77). There remain issues diverting water when flows are low.

Figure 6-77 San Acacio diversion dam, with trash.

Figure 6-78 San Acacio headgates.

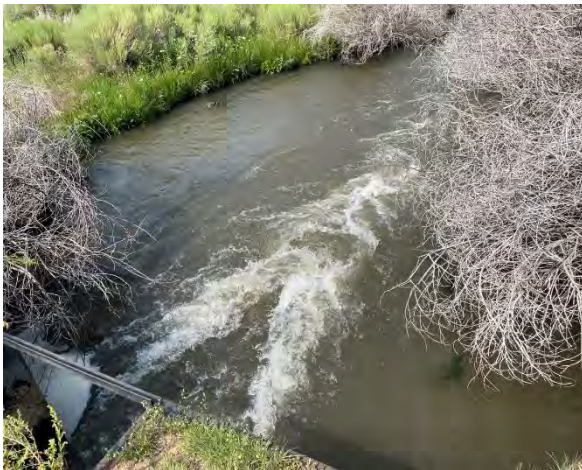
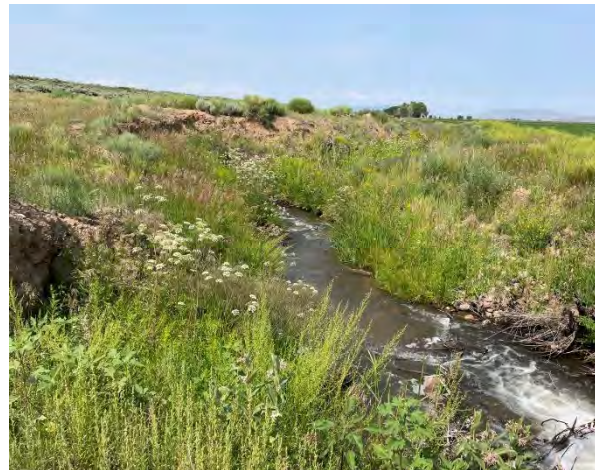
The measurement flume has a good drop through the structure, enabling streamflow measurement, but erosion protection is not present, increasing the risk of washout. Similarly, significant erosion is present below the splitter structure for North and South San Acacio Ditches (Figure 6-79 and Figure 6-80). Many farm headgate structures date back to the 1920s (Figure 6-81), erosion throughout the ditch was observed (Figure 6-80). The downcutting is causing farm deliveries to be less dependable than they once were.

Figure 6-79 Large scour pool between splitter structure for North and South San Acacio Ditches.

Figure 6-80 Erosion along San Acacio ditch.

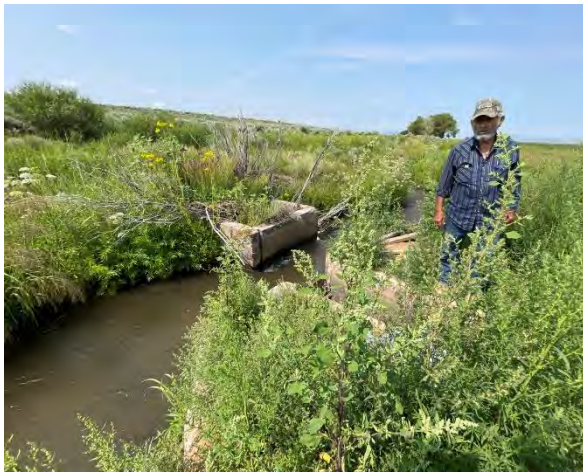
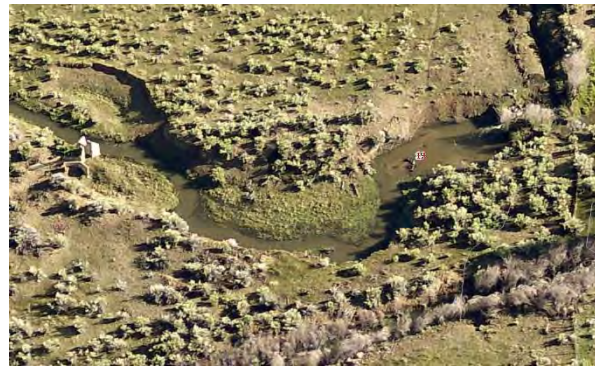
Figure 6-81 Farm headgate from San Acacio Ditch. Estimates indicate that many of these structures may date back to the 1920s.

Figure 6-82 Bank erosion along San Acacio ditch.

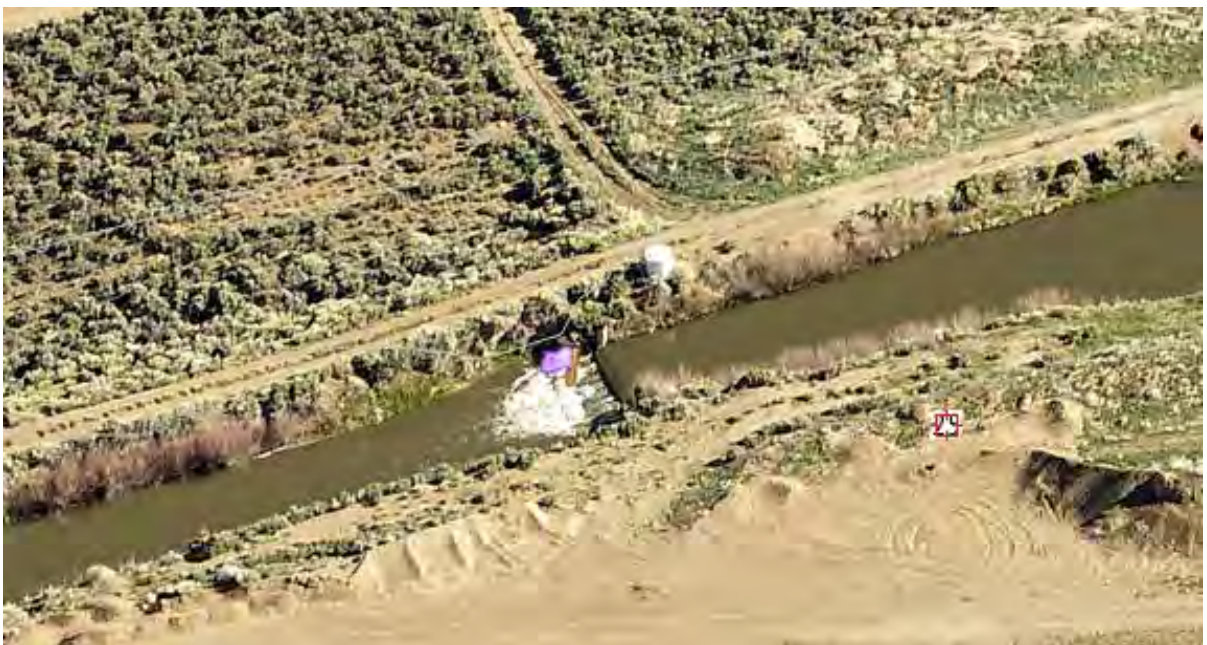
Culebra Eastdale Canal marks the downstream most diversion structure on the Culebra. This structure diverts water from storage and is used directly for irrigation and storage. This structure diverts water during the non-irrigation season. This structure receives all excess flows that were not delivered upstream, making this point in the stream critical in water administration. The structure does include a stilling well and a recording device for the development of records (Figure 6-83). Flooding was not determined to be of significant concern. Sediment deposition in the ditch is preferable to deposition in Stabilization Reservoir. The fish passage may be an issue with this structure, and the reach could provide better habitat for aquatic species.

Figure 6-83 Measurement structure for Culebra Eastdale Canal.

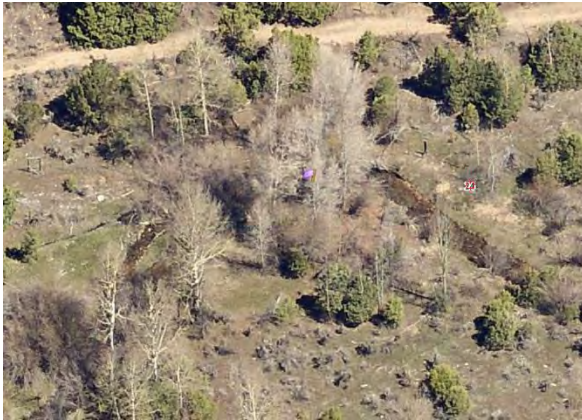
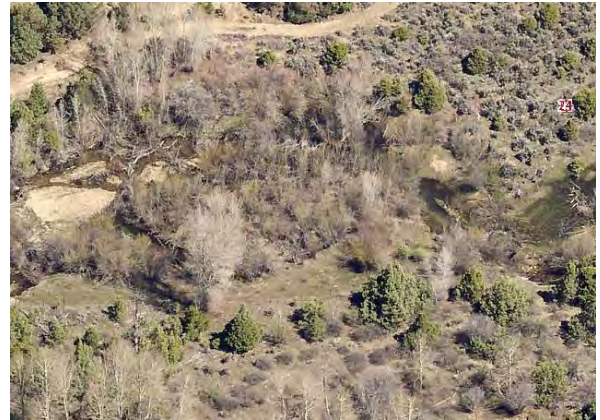
The Ramon Lucero Ditch has a structure that diverts at approximately a right angle from the North Vallejos Creek channel. A Parshall flume and headgates were observed in the aerial photograph (Figure 6-84). No issues were identified with the headgate or diversion structure through interviews. The addition of a fish screen on this structure would prevent fish entrainment in the ditch. The culvert upstream of the diversion may pose a barrier to fish passage which should be evaluated before work on this structure (Figure 6-85).

Figure 6-84 Ramon Lucero Ditch headgate. EagleView imagery May 13, 2019.

Figure 6-85 Reach upstream of Ramon Lucero Ditch diversion. Stream is a multithread channel that is likely a response to excess sediment from upstream sources. Image from EagleView aerial imagery dated May 13, 2019.

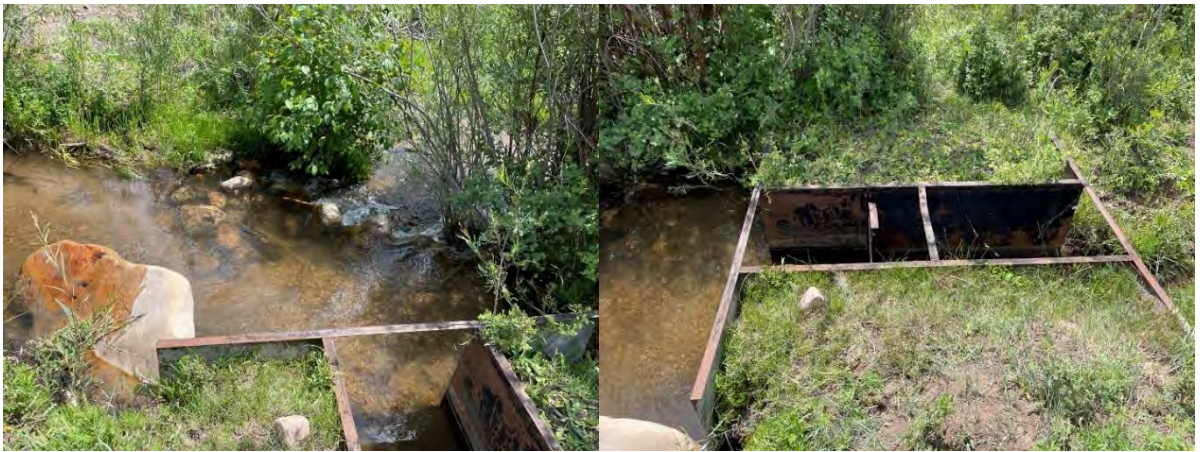
The Bennie and Kiko Ditch diverts water from Vallejos Creek via a 2-foot slide gate (Figure 6-86). During the site visit, the gate was found to be leaking slightly but otherwise in good condition. The 1-foot Parshall flume was full of debris. The debris could be cleaned out to restore the function (Figure 6-87). Erosion was observed in the ditch in its steeper sections. The channel is slightly overwide at the diversion structure, with a mid-channel bar being used to direct flows to headgate. The ditch is conveyed over the arroyo; clearance is approximately 20 ft to the bottom of the gully. The ditch intercepts sediments as it traverses the valley's edge.

Figure 6-86 Bennie & Kiko headgate. Appears to be functioning with some gate leakage.

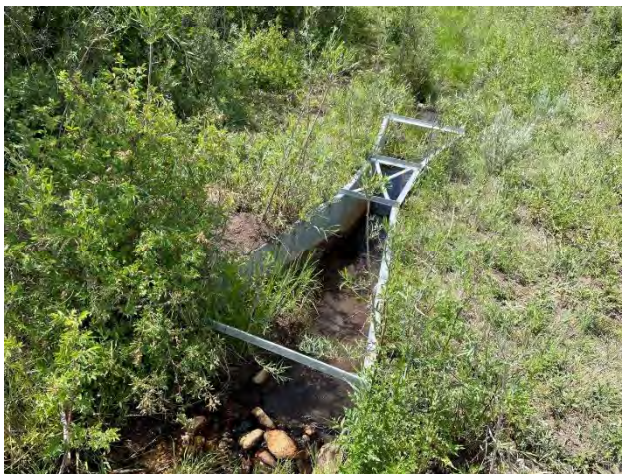
Figure 6-87 Bennie & Kiko 1 ft Parshall Flume with significant debris in structure including grass and rocks.

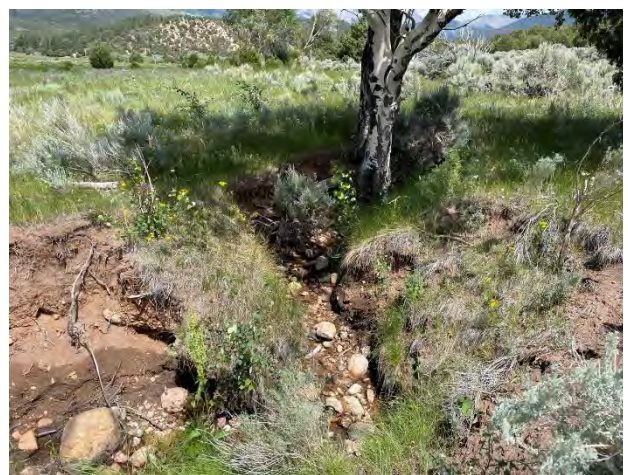
The Julio Gold diverts water from the left bank of the Vallejos just below the headgate of the Bennie & Kiko. The headgate is in thick riparian vegetation and is not visible from historic aerial imagery. During interviews, this structure was reported as having issues with headgates or measurement structures. Downstream degradation was noted on the ditch (Figure 6-88). This degradation will increase sediments to the stream and potentially headcut, reducing head available for irrigation.

Figure 6-88 Julio Gold incised ditch.

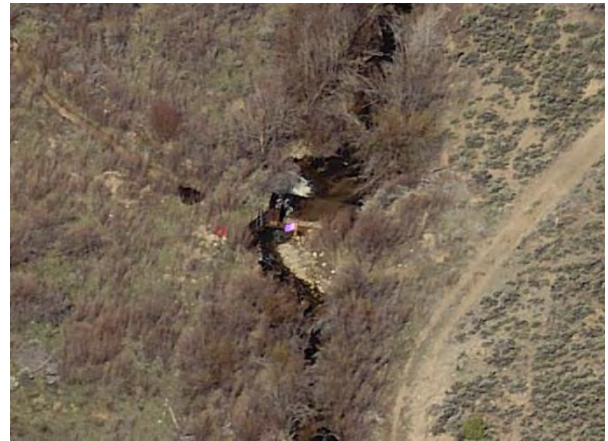
The Guadalupe Vigil diverts from Vallejos Creek. This ditch has a headgate structure, and the riparian corridor appears to be in good condition. It appears that there have been some past issues with sediment in the reach (Figure 6-89). The creek is slightly over widened around this structure. Some channel over widening downstream was observed. This structure may be a barrier to fish passage within this reach. Flooding risk is minimal due to no development within the floodplain upstream of the structure. Improper structure operation may pose a flood risk to downstream structures and personal property.

Figure 6-89 Guadalupe Vigil Ditch headgate. May 13, 2019

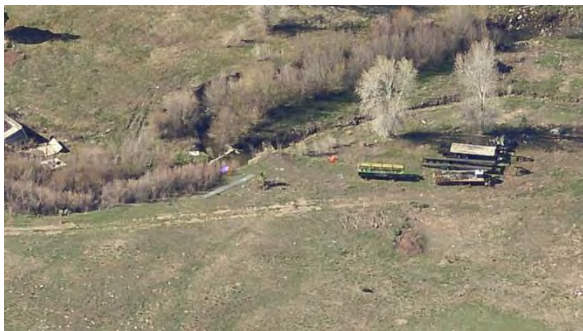
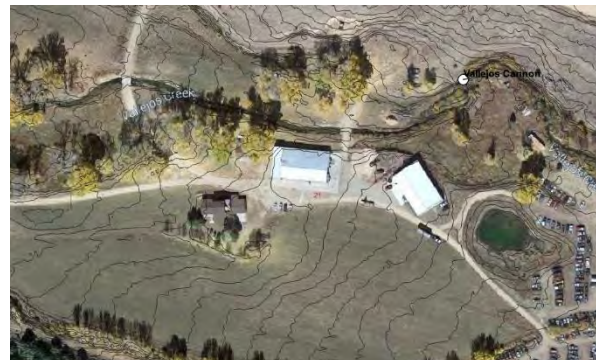
The Vallejos Canon ditch diversion structure is located 200 feet upstream of a commercial building. No issues were identified with this structure related to headgates or measurements structures. EagleView aerial imagery from May 13, 2019, shows the headgate effectively prevents water from flowing down the ditch. Structure placement in the creek likely results in sediment and trash being directed toward the headgate, with fine sediment deposition upstream of the dam. LiDAR indicates a drop across the structure is approximately 1.5 ft, resulting in scour below the structure. Downstream of the diversion dam, culverts have been placed in Vallejos Creek for placement of the driveway may increase flooding by catching debris and may provide for less desirable fish passage. Two driveways are present across the stream, increasing the number of crossings (Figure 6-90). Based on the 2011 LiDAR, the structures were constructed along a higher terrace; however, they may be at risk because they were constructed near the edge of the terrace, which could be eroded by the channel in the event of a flood or slowly over time (fluvial hazard zone) (Figure 6-91). It appears that a portion of the cars stored on the lot are within the floodplain. Grade control structures are present between the two crossings, which likely was straightened and presently has degraded riparian habitat conditions.

Figure 6-90 Vallejos Canon Ditch headgate. EagleView May 13, 2019.

Figure 6-91 Structures along Vallejos Creek near Vallejos Canon ditch.

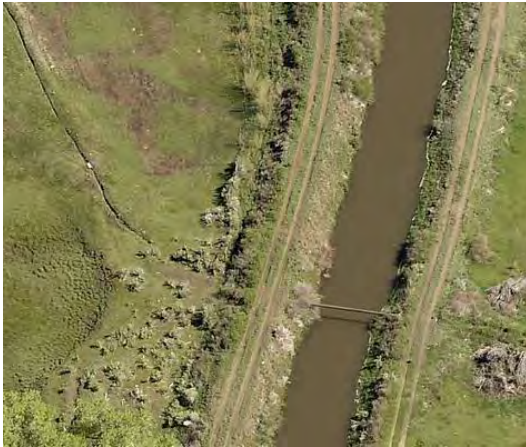
Conditions down ditch on the Vallejos Canon were evaluated through 2019 EagleView aerial imagery. Restrictions in flow may exist due to piping across the Sanchez Canal (Figure 6-92). It was observed that downcutting conditions of the ditch affect land irrigation opportunities and increase sediment contributed from the banks (Figure 6-93).

Figure 6-92 Vallejos Canon Ditch crossing Sanchez Canal.

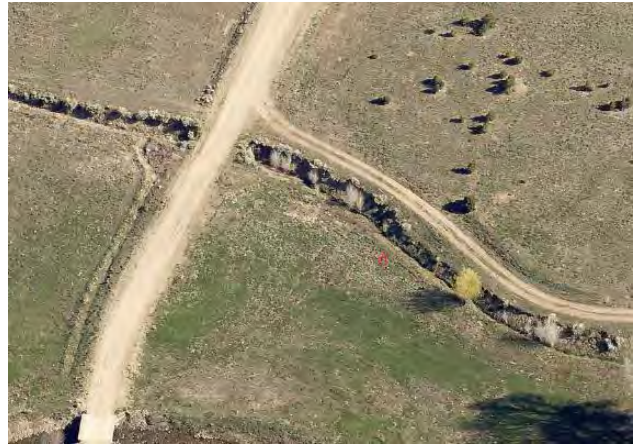
Figure 6-93 Vallejos Canon Ditch - ditch is downcutting

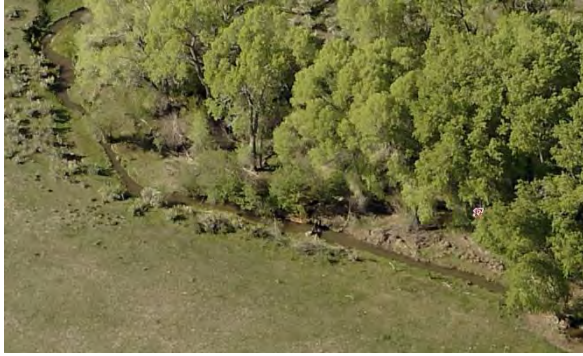
Chavez and Quintana Ditch diverts water from Vallejos Creek on the right (Figure 6-94) and left bank (Figure 6-95). A flow regulation structure was visible in aerial photography, and no issues with the headgate or measurement device were identified during interviews. Aerial imagery shows sediment piled along the banks of the ditch, which may indicate a maintenance issue. A residential structure downstream of diversion is near the banks of Vallejos Creek and could be at risk of flooding. Configuration of the diversion dam and ditch with respect to the channel may increase down ditch flooding in the event of a flood on Vallejos Creek.

Figure 6-94 Chavez and Quintana Ditch headgate on right bank.

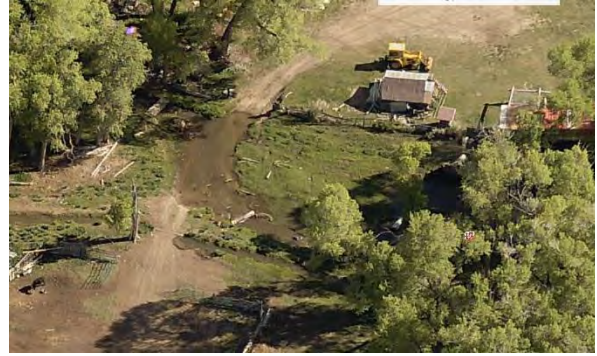
The creek flow spreads across low water livestock crossings, which may be a barrier to fish passage and increase in-stream sediments and water temperature (Figure 6-95). It appears that livestock may frequently be kept in the floodplain.

Figure 6-95 Left bank diversion for Chavez and Quintana Ditch.

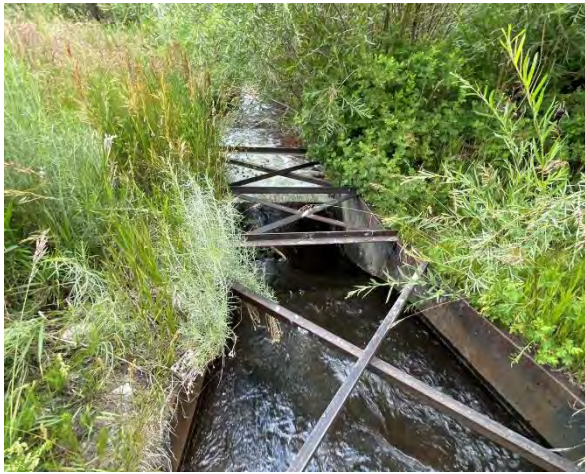
This diversion structure diverts to both the north and south of the creek. The north Parshall flume was clean with a good drop (Figure 6-96). The south Parshall flume had a good drop and some light debris that would affect the accuracy of water measurement (Figure 6-97). The levelness of the structures was not checked during the site visit. The headgate is a concrete structure in good condition. The structure was designed to sweep the channel and had sediment deposition in the structure above gates. Within the channel, the grass is growing below the structure. This structure has an overflow designed to allow flood flows to pass downstream. Overhead structure on the diversion may increase flood elevations around the structure.

Figure 6-96 North Parshall flume was found with good drop and was clean in good condition.
